Final Report

Atlanta's Hotel District: ADA Transition Plan

(A Supplement to STRIDE Project #2012-067S)

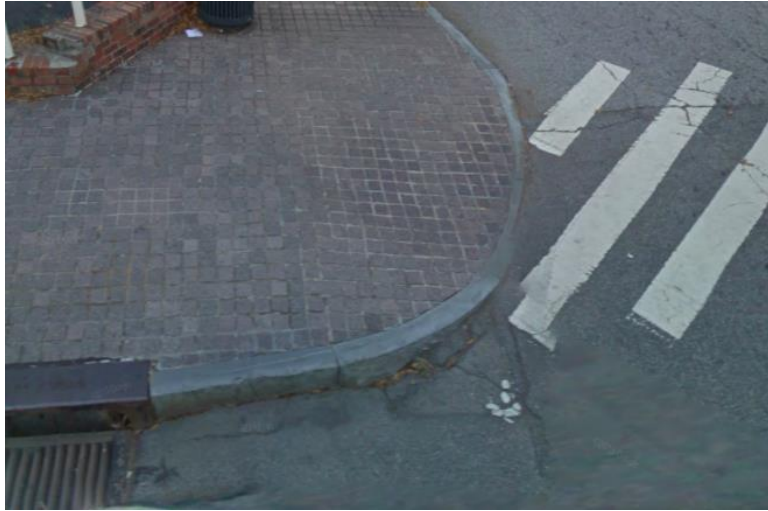
Figure B-51: SW corner of the intersection of Porter Place and Peachtree Street. The wheelchair ramp lacks a detectable warning strip.
