U.S. Department
of Transportation
**Federal Railroad
Administration**

RR 11-11 | May 2011

PERFORMANCE OF PLASTIC COMPOSITE TIES IN REVENUE SERVICE

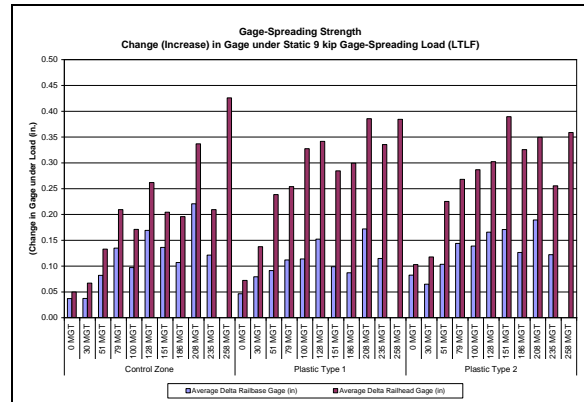
Gage strength degradation is gage widening as a function of applied load and accumulated traffic/tonnage. For the duration of the test (282 MGT), the plastic composite ties performed in the respect of gage strength. Figure 3 shows gage strength degradation test results using light track loading fixture. The plastic composite ties exhibited slightly higher gage spreading than the wood ties, but they exhibited gage strength degradation trends similar to wood ties.

Figure 3. Gage Strength Degradation Test Results

Figure 3 also shows the increased gage strength (reduced gage widening) in the three subzones resulting from regaging (done after 208 MGT but before 235 MGT measurements).

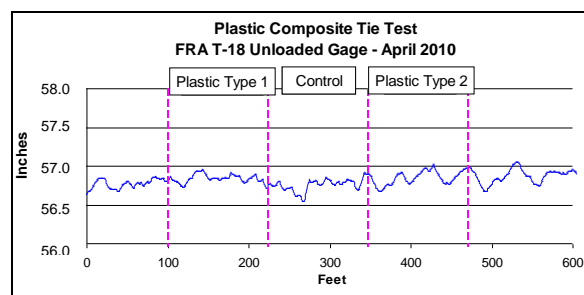
In April 2010, the final track gage measurements were taken in the plastic composite tie and wood tie control test zones using FRA’s T-18 GRMS test vehicle. Figure 4 shows the unloaded gage results, which indicate slightly higher but similar gage in the plastic composite tie zones as compared with the wood tie control zone.

Figure 4. Unloaded Track Gage Test Results of Test Zone

The effect of ambient temperature on the unloaded track gage over a 54°F range (27–81°F) indicate the following maximum changes in gage: 0.24 inch for one type of plastic tie type to 0.5 inch for another plastic tie type, and wood ties 0.16 inch.
