EVALUATION AND PERFORMANCE OF HDPE PIPES UNDER CDOT HIGHWAYS, T-REX, AND OTHER LOCATIONS

Report No. CDOT-2018-09
March 2018

APPENDIX I – FOUNTAIN COLORADO,
DUROMAXX LASER PROFILE INSPECTION,
I-25, MP 122, MP 122.5, AND MP 123 (2013)
LEO JOHN FLECKENSTEIN

Fountain Colorado
3 Year Performance Comparison
DuroMaxx Laser Profile Inspection1
I-25, MP 122, MP 122.5, and MP 123

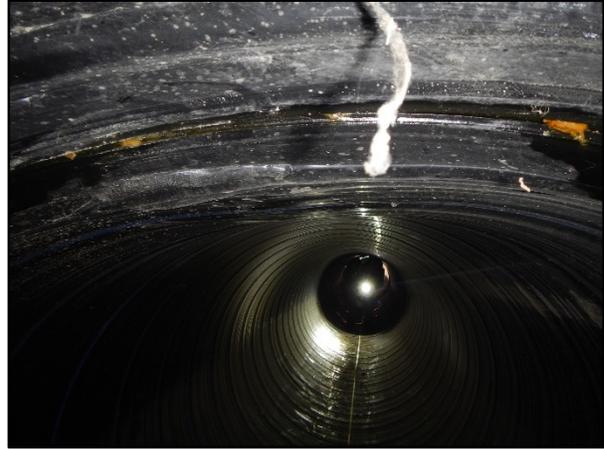
Figure 9. Observed pipe failure detected through visual inspection

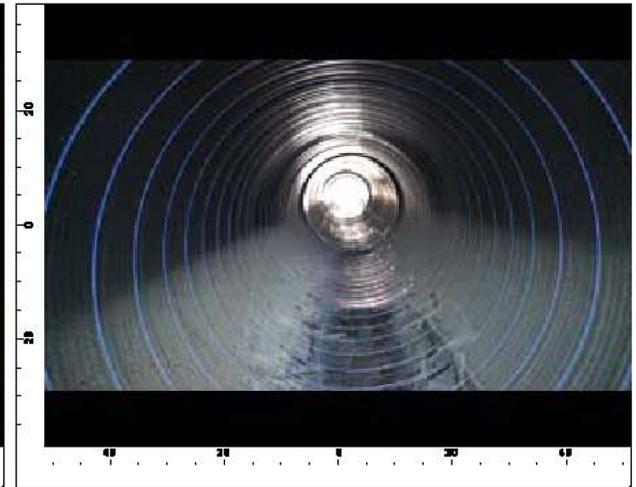
Laser at 1st joint

View of pipe at start, no noticeable deflection or defects.

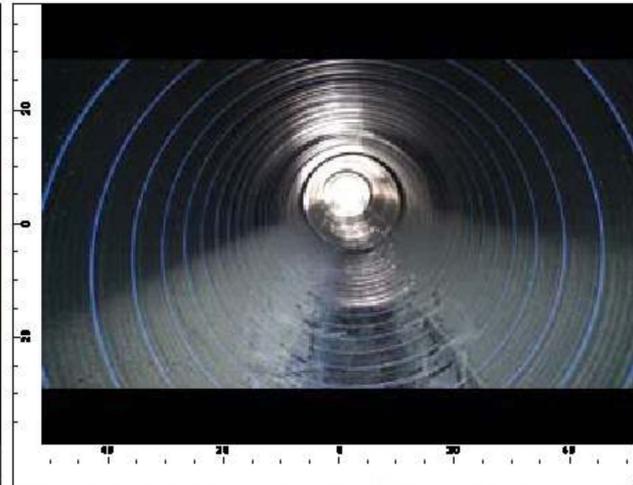
Laser at 1st joint

View of pipe at start, no noticeable deflection or defects.

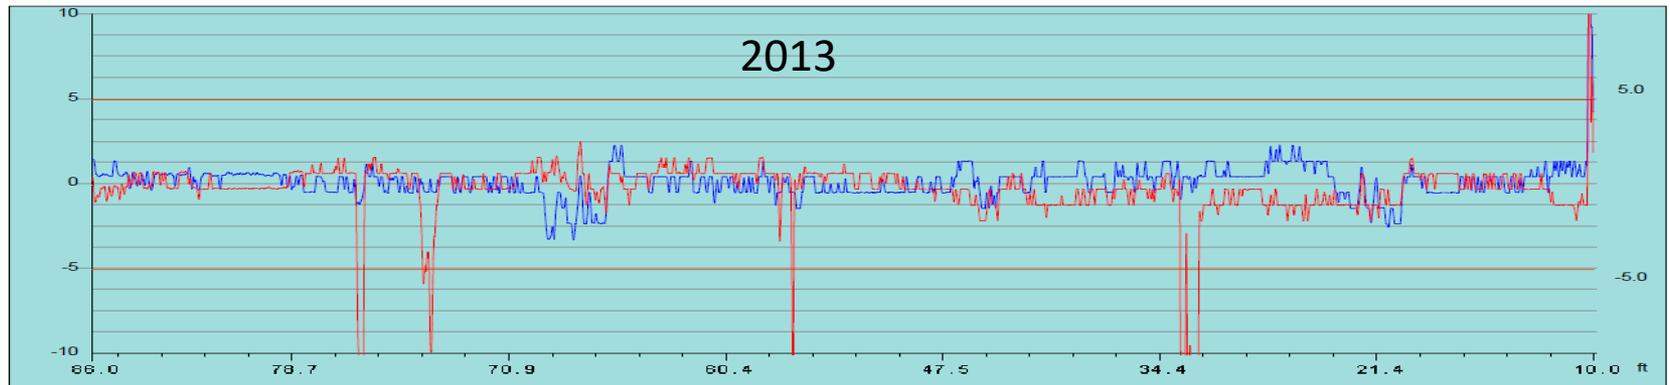
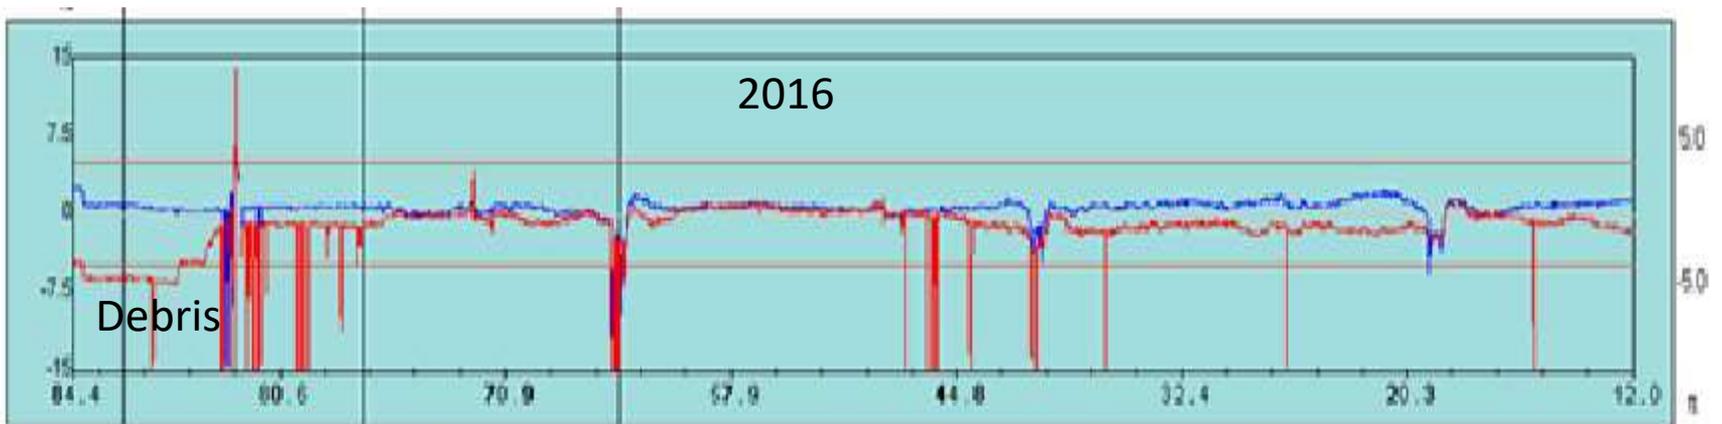
Performance Summary MP 123 (Northern Pipe)

The inlet end of the structure had been severely damaged by a vehicle, minor punctures from construction stakes were still visible. Overall no significant change was observed in the overall condition or shape of the structure.

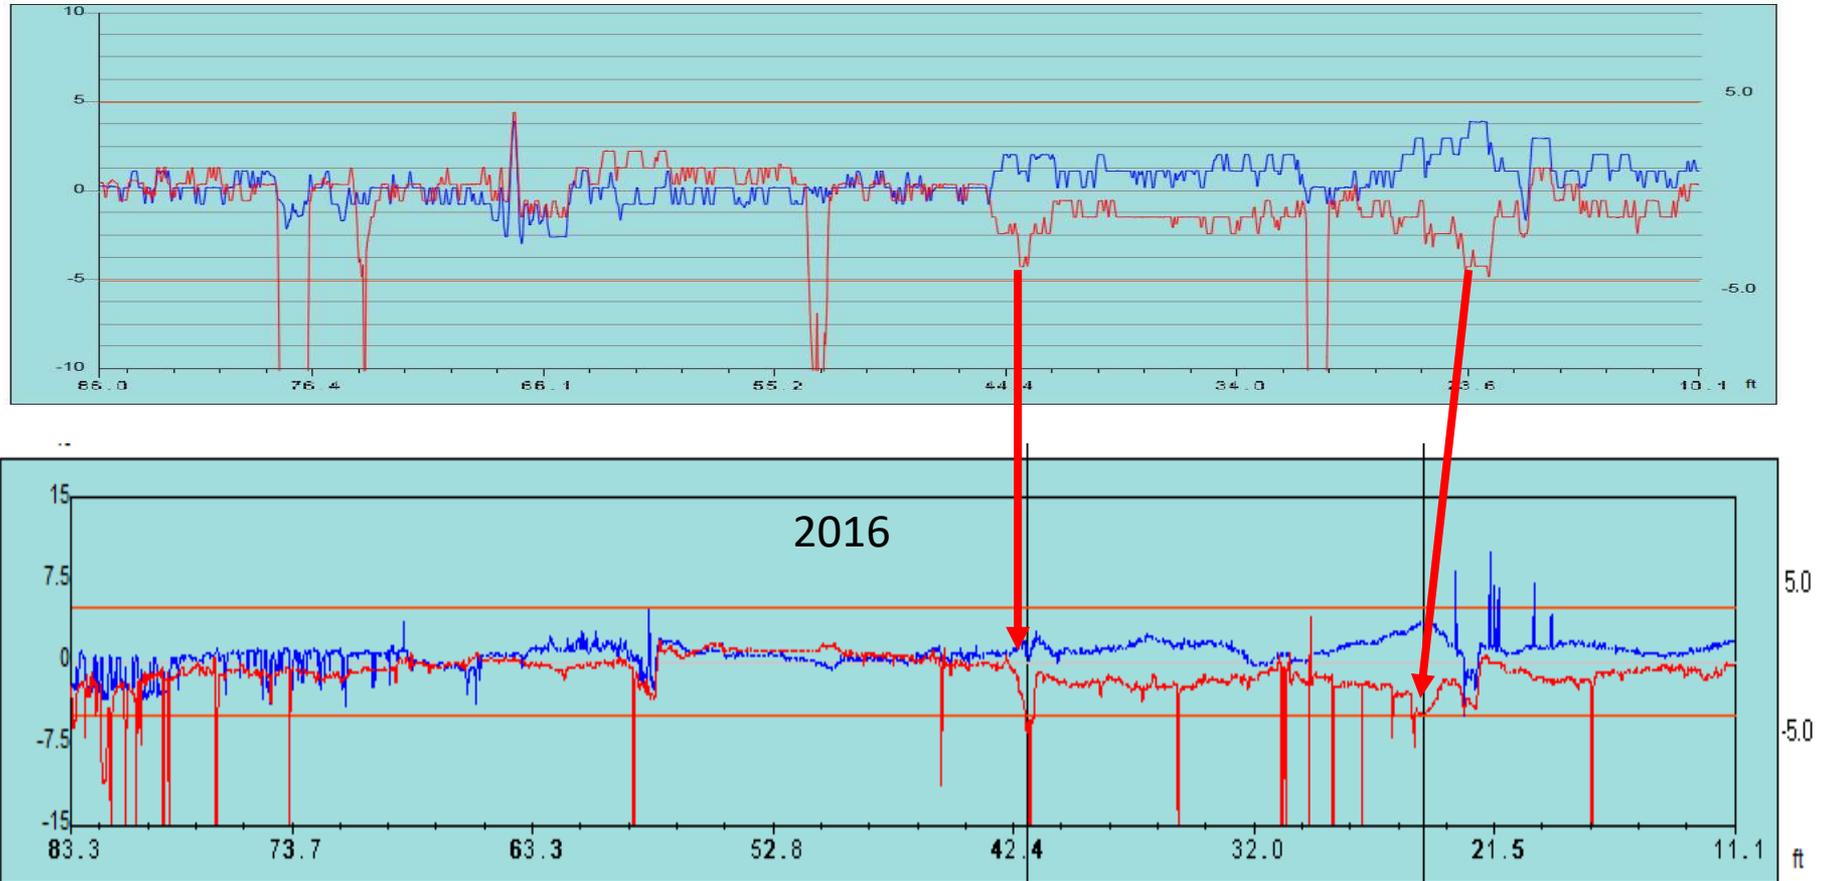
Performance Summary MP 123 (Middle Pipe)

The inlet end of the structure had been severely damaged by a vehicle, minor punctures from construction stakes were still visible. It appears that some possible slight increase in deflection has occurred around at 23 and 42 ft. Deflection at 5%.

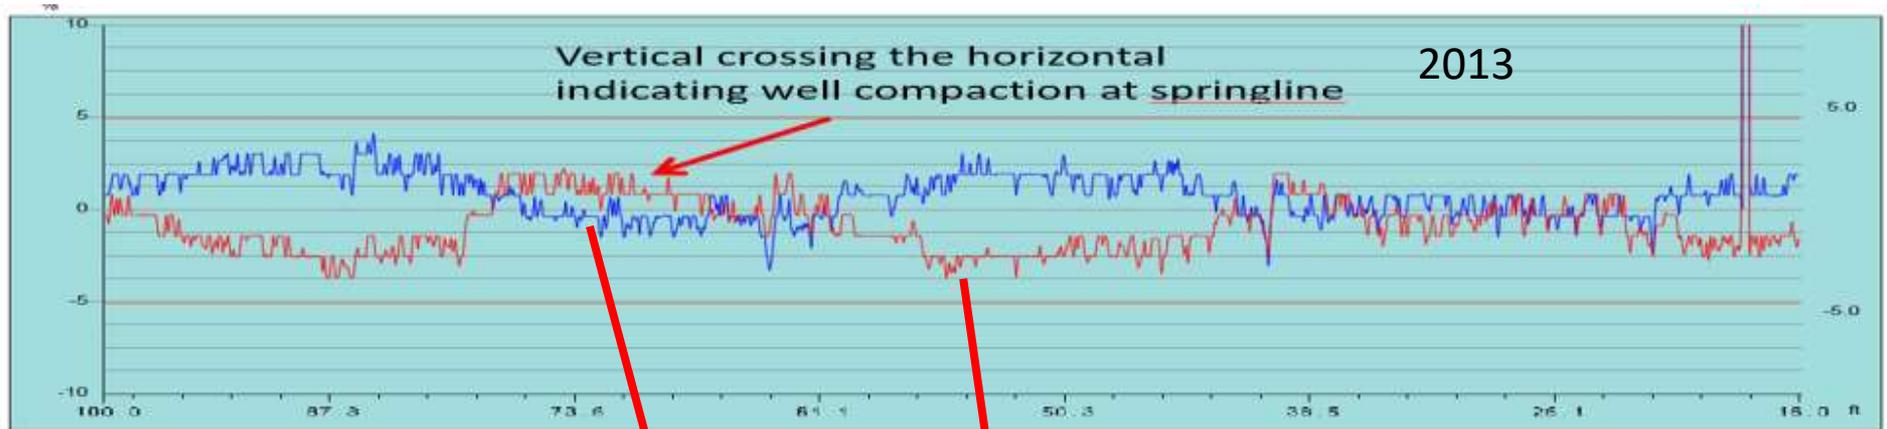
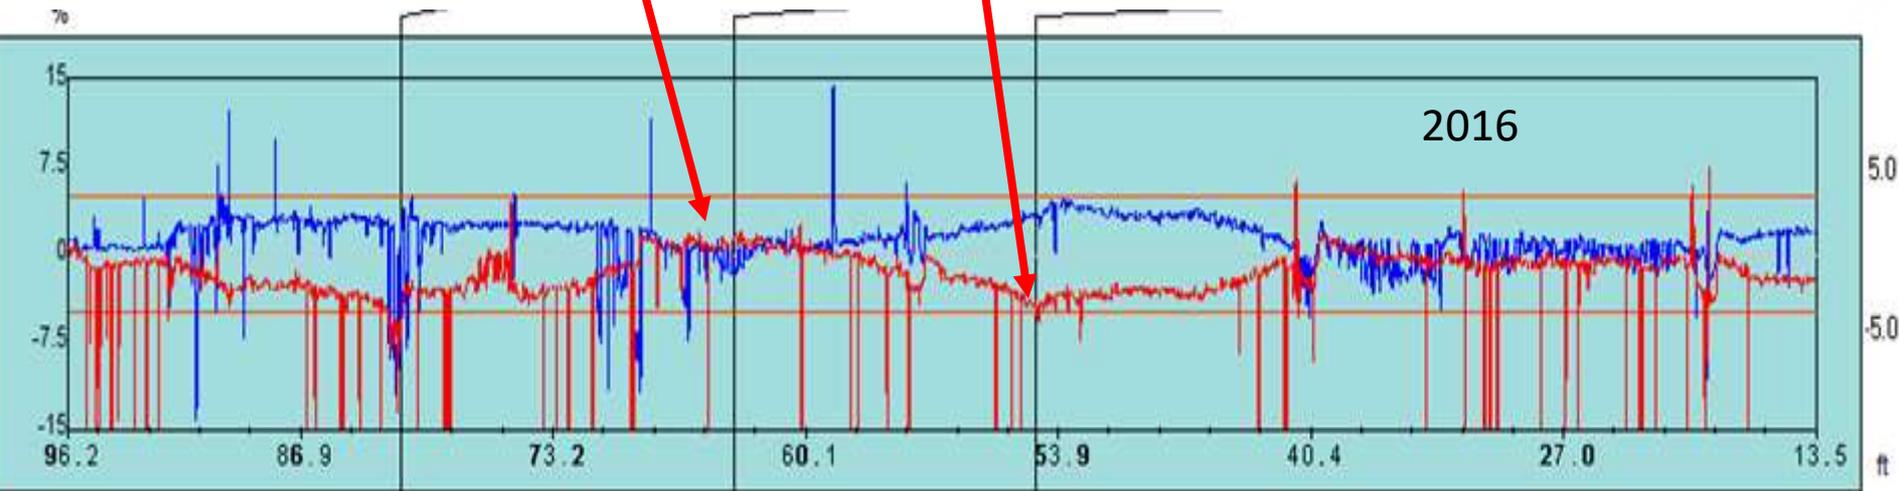
Performance Summary MP 122.5

Minor puncture was noted near the outlet end during the 2016 inspection that was not documented during the 2013 inspection. Deflection is still under 5%, but it appears that additional deflection has occurred in the center of the structure since the 2013 inspection.

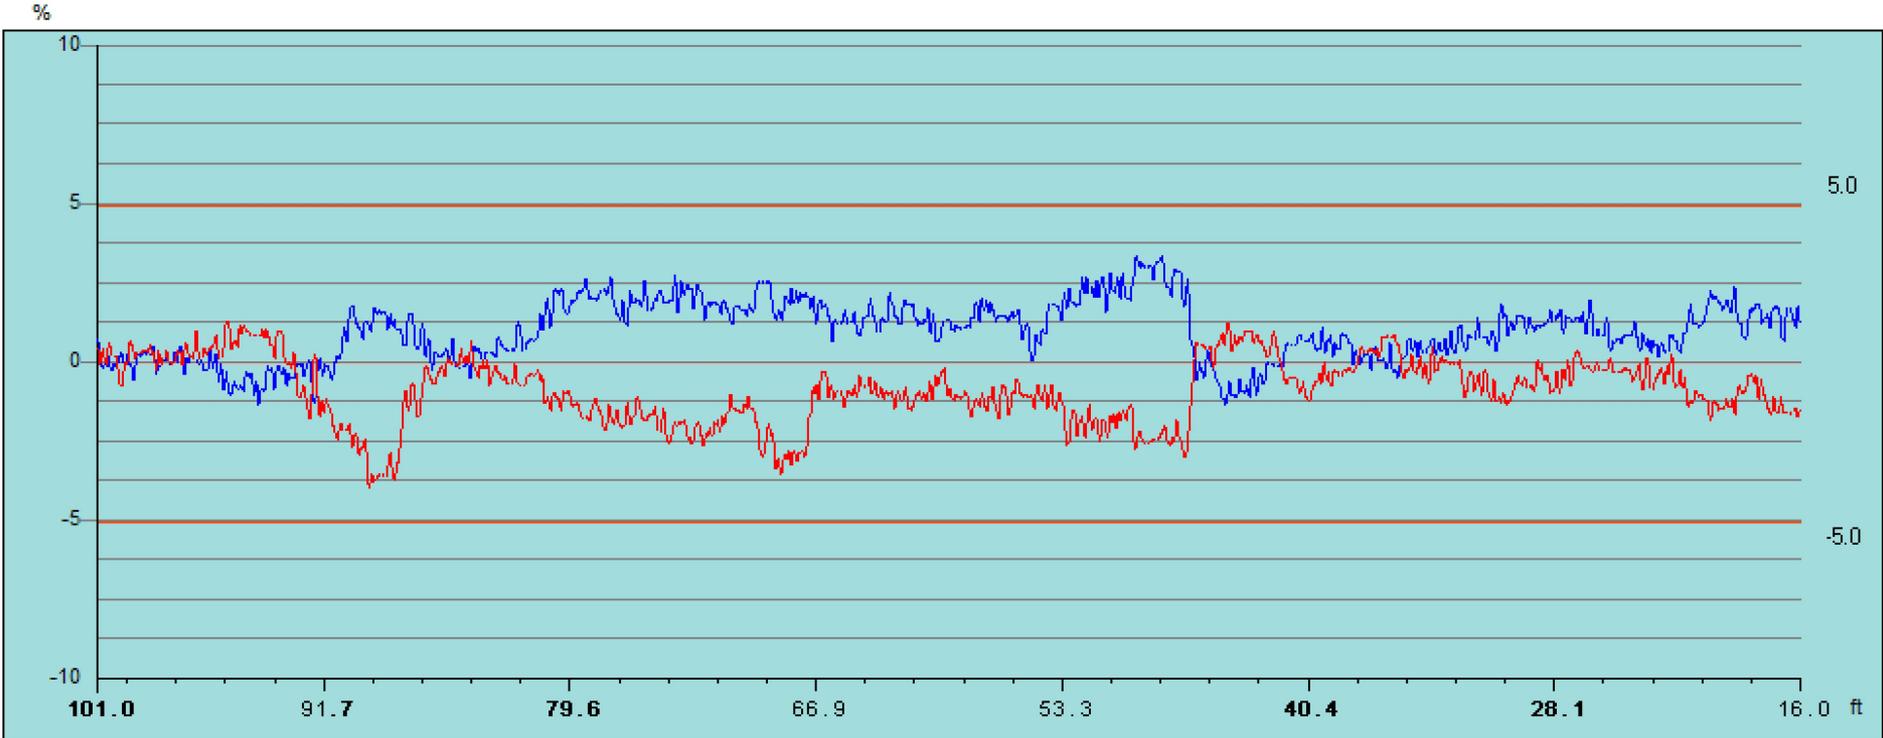
Ovality Summary Report

Ovality slightly over 5% at 90 ft. Spike due to camera tilting at joint.

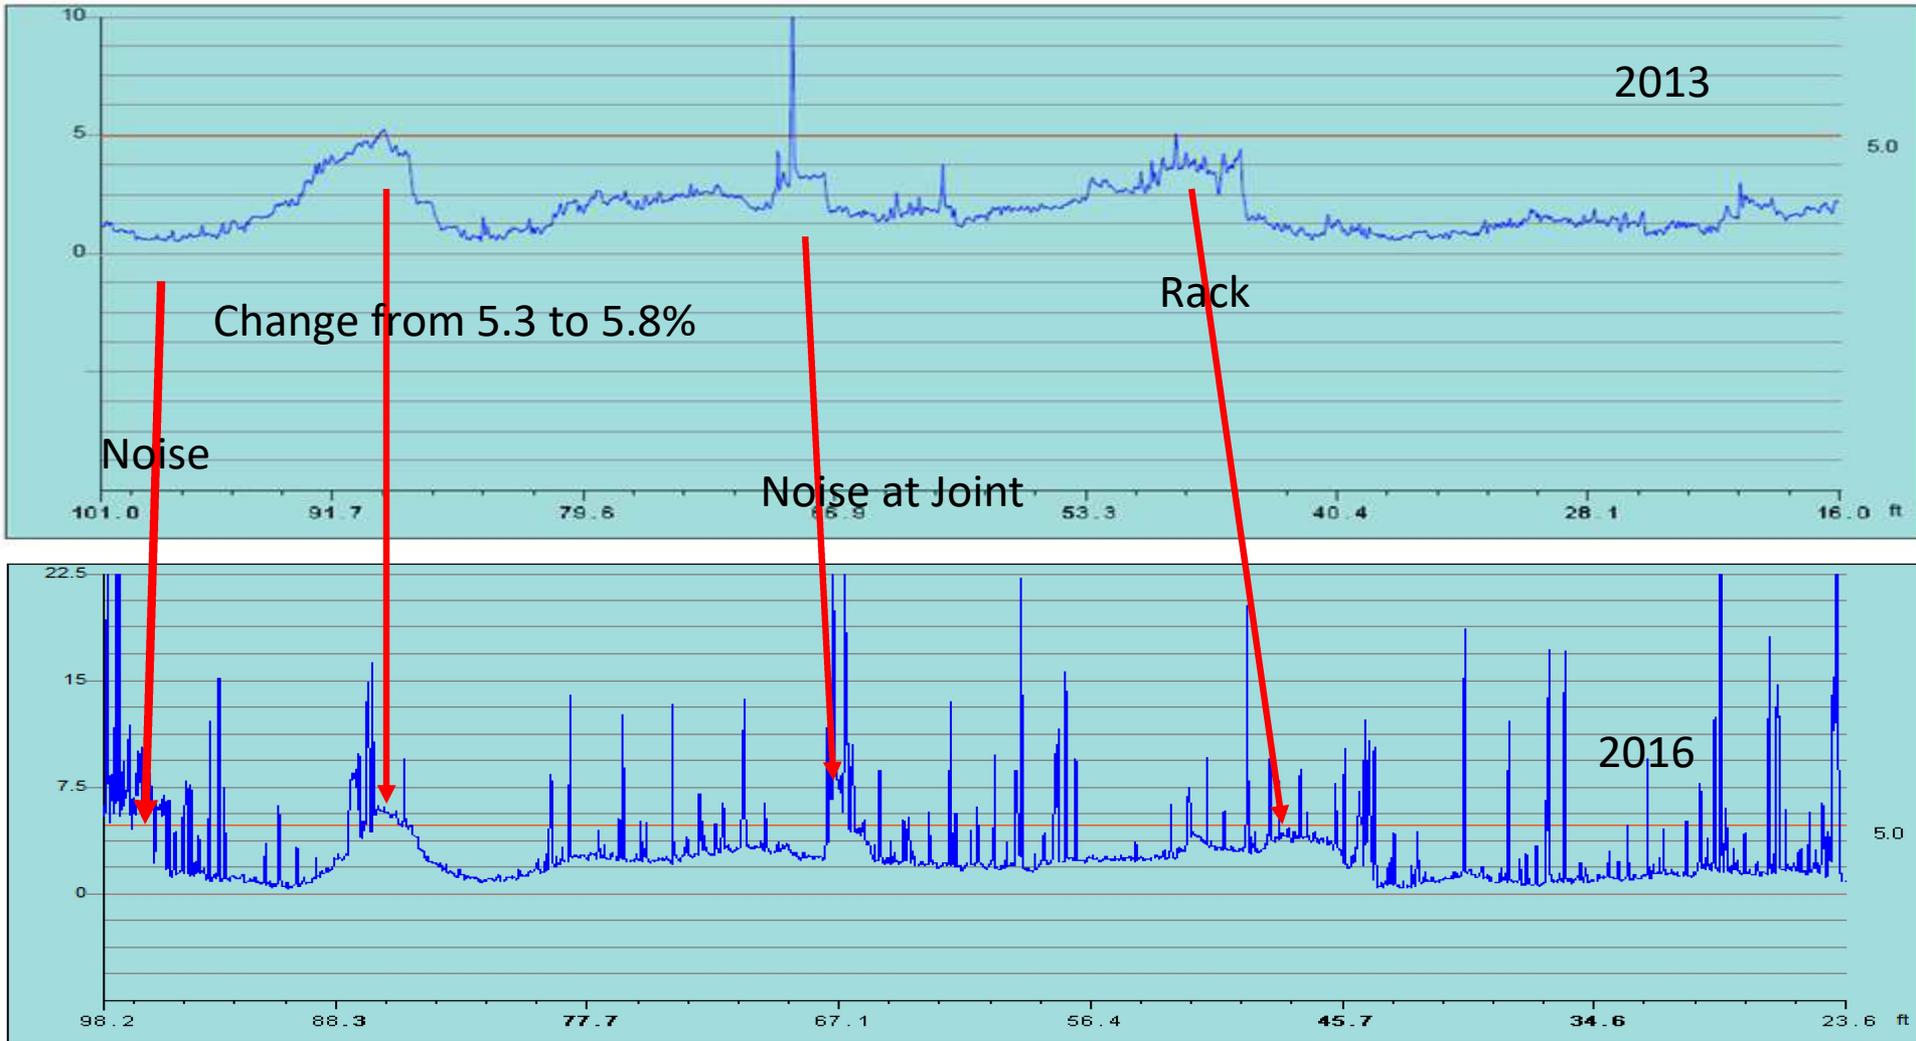
Performance Summary MP 122

Racking, Deflection, Minor punctures have been documented near the outlet end of the structure. Uneven flowline/hump and wall waviness have been documented mid pipe. Dent, deflection and racking has been documented towards the inlet end. Increased has occurred towards the inlet end of the structure that is not under pavement. Crown and possible invert curvature has occurred.
