MID-AMERICA TRANSPORTATION CENTER

Report # MATC-UNL: 100

Safety Investigation and Guidance for Work-Zone Devices in Freight Transportation Systems Subjected to Passenger Car and Truck Impacts with New Crash Standards

2010

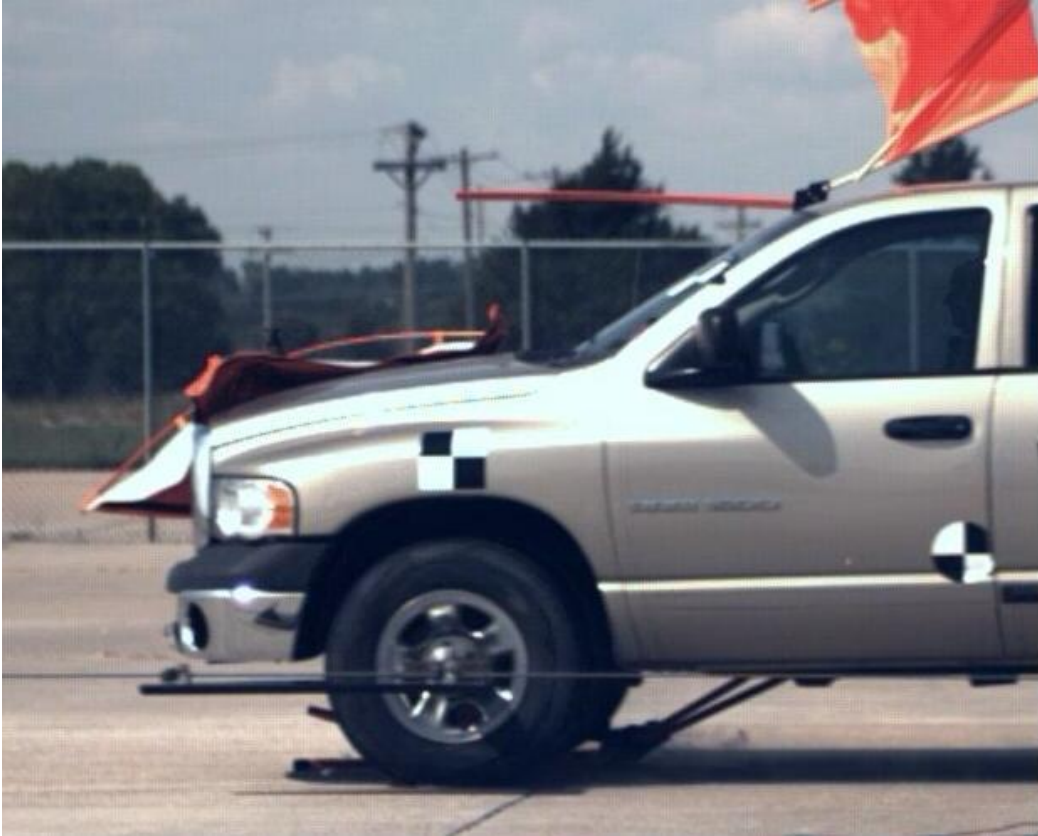
Stands with excessive stub lengths remaining after impact can potentially catch on the undercarriage of the vehicle and drag along under the vehicle with heavy contact (System No. 4A). When the legs are oriented head-on to the vehicle, the stand can rotate such that the legs contact and penetrate the vehicle's floorboard. Even though the ground clearance is much greater for the pickup truck when compared to the small car, the potential for penetration has been shown to be a problem with both vehicles. As shown in Figure 102, when the vertical springs at the base were pushed over, the two front legs of the system were forced upward into the undercarriage of the pickup truck resulting in one leg penetrating the left-side floorboard.

Figure 102. System No. 4A, X-Footprint Base Floorboard Penetration

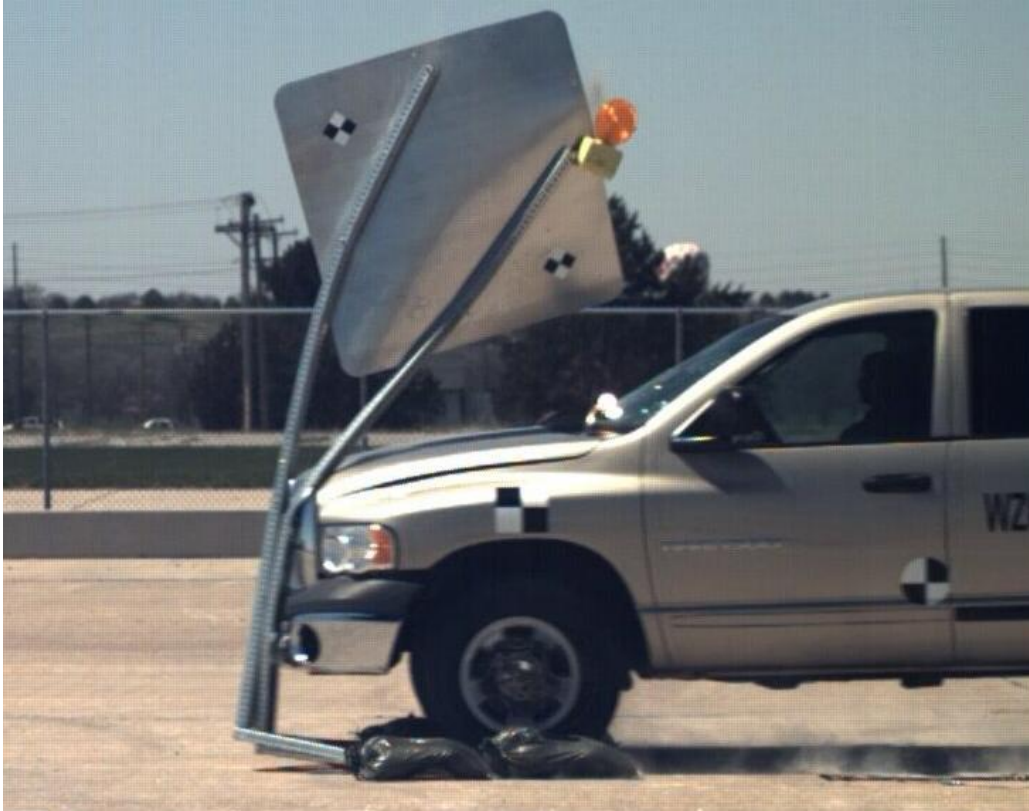
Figure 104. System No. 1B, Base-Bending Mast

mast typically releases from the stand late in the event, if at all, which adds to the amount of flex in the sign panel and mast. When the mast bends or has a delayed fracture, it is more likely that the sign panel or flag assembly will impact the windshield at a high rate of speed. When the connection between the upper and lower masts fails upon impact, the mast and sign panel cause insignificant damage (System Nos. 3B and 4B).

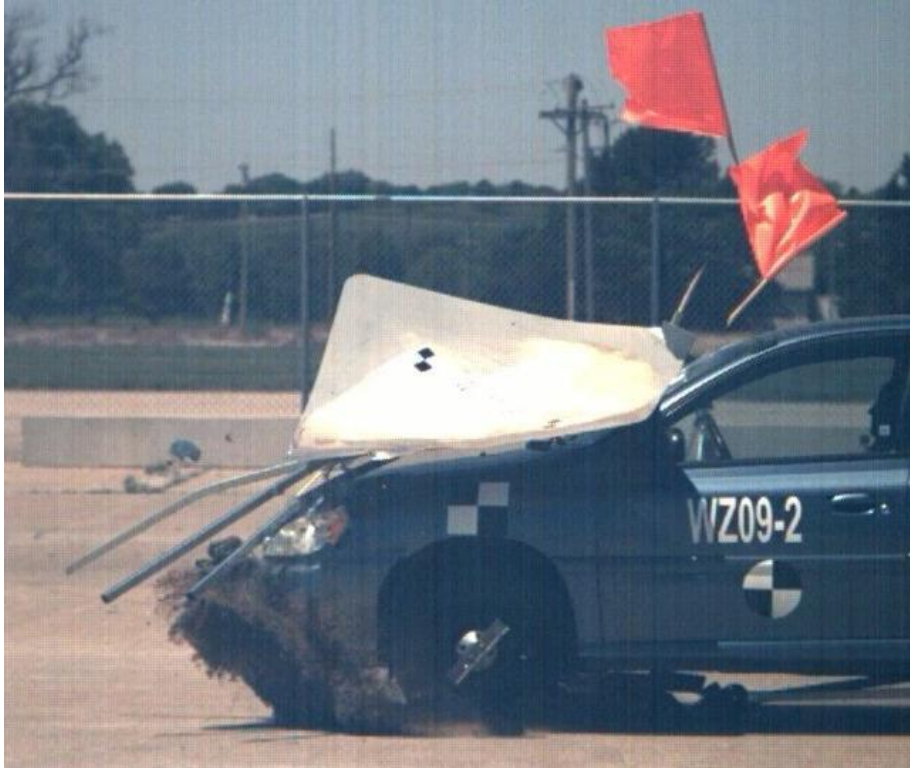
Sign stands that resemble a tripod shape when oriented 90 degrees to the vehicle were found to have a potential to rotate and rise into the air, resulting in the top of the support impacting and penetrating the windshield, as shown in Figure 105 (System No. 2B). Since the legs and mast were not intended to breakaway or yield significantly, the motion and weight of the entire system had the potential for significant windshield damage.

Figure 105. System No. 2B, Tripod Oriented at 90 Degrees

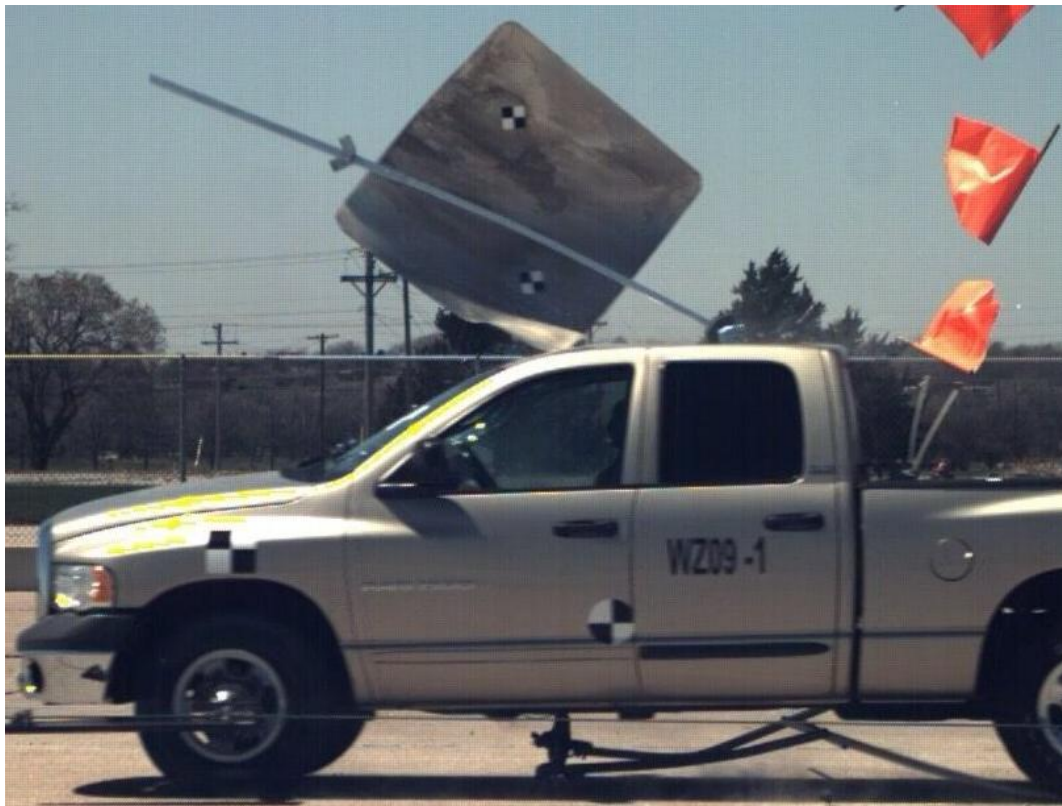
mast end exposed with the potential to rotate into and penetrate the roof, as shown in Figure 106 (System Nos. 1A). Some of the wood dowels fractured in their holders, thus disengaging the flags. However, the flags and the exposed flag holder did not show any potential for vehicle damage (System No. 2A). Some flag holders did not disengage the flags upon impact; therefore, these flags and holders followed the trajectory of the mast (System No. 4B). Most of the time, the addition of flags did not negatively affect the safety performance of a work-zone traffic control device. However, if the wood dowels fracture as the flag holder or mast penetrates the windshield, the fractured ends become flying debris and a potential hazard to the occupants of vehicles (System No. 2B). Fiberglass flag staffs would have performed in a different manner than the wood-dowel flags, but it is unclear what effect they would have on the safety performance of any of the work-zone traffic control devices.

Figure 106. System No. 1A, Flag Holder Penetrating the Roof
