# Testing and Evaluation of a Portable Workzone Sign Support: FOIL Test Numbers 98F008 and 98F009

PUBLICATION NO. FHWA-RD-98-183

DECEMBER 1998

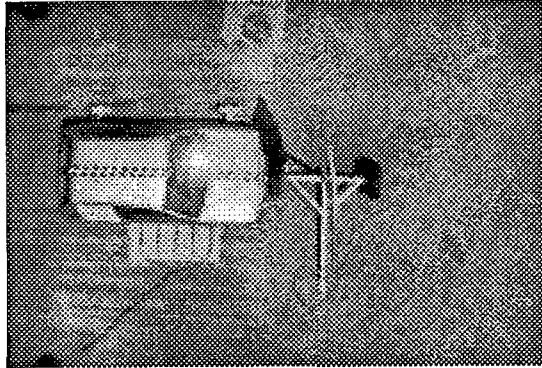
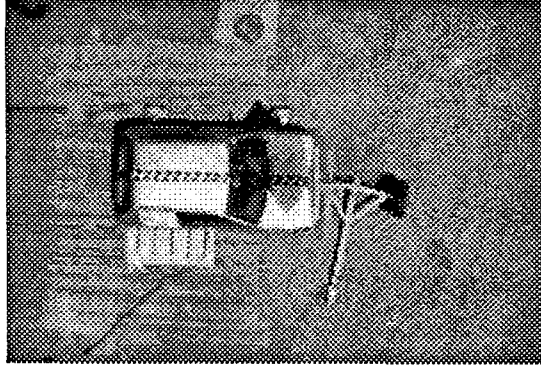
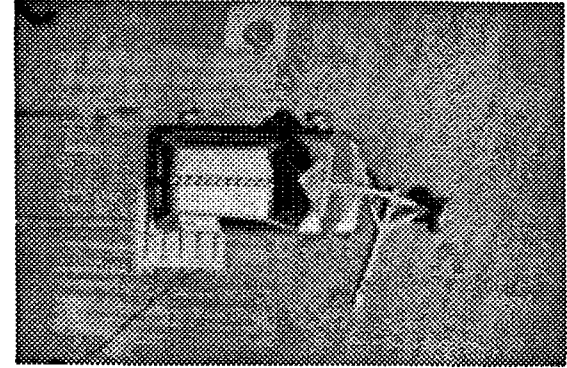
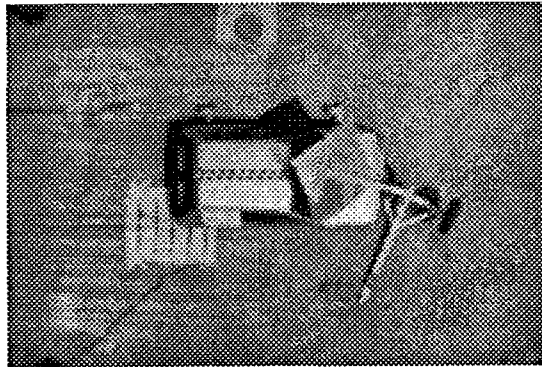
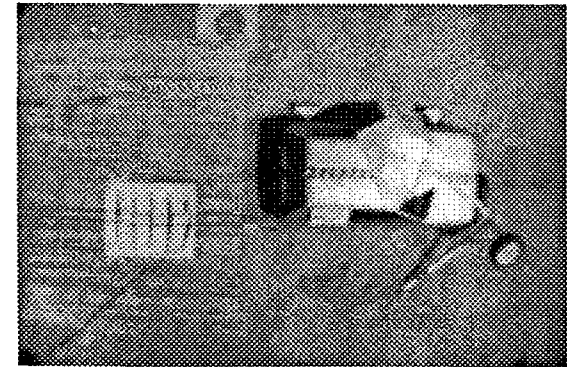
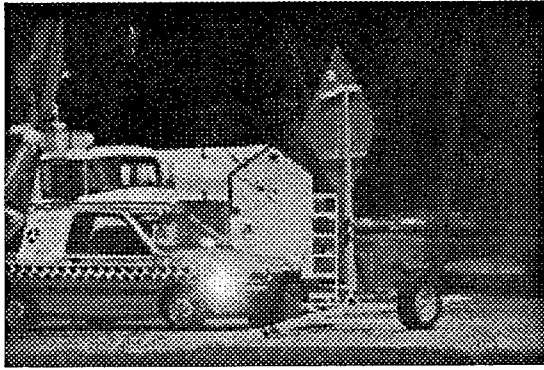
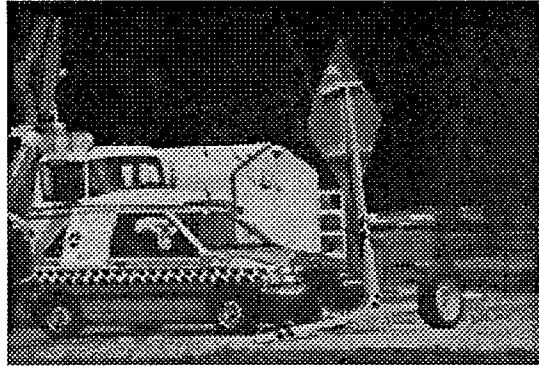
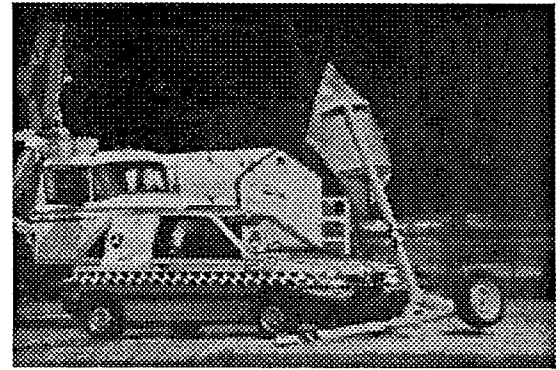
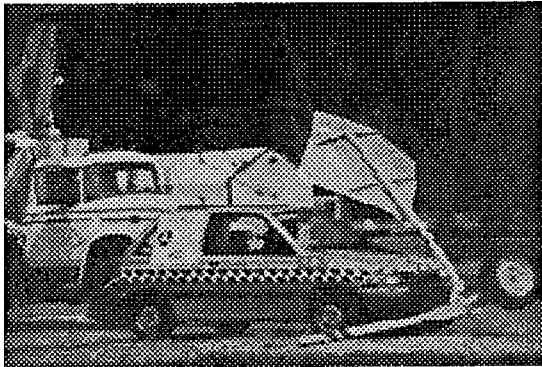
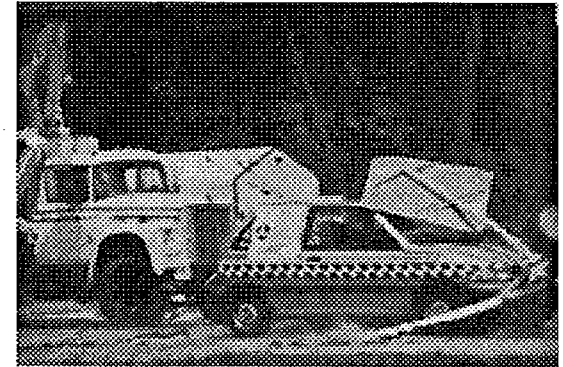
Figure 5. Test photographs during impact, test 98F008.

**Test 98F008.** The Ford Festiva was accelerated to 100.4 km/h prior to striking the portable sign trailer. The Ford Festiva centerline struck the sign trailer at one wheel as intended. The wheel of the sign trailer began to tuck under the vehicle and the axle began to buckle directly behind the wheel at 0.006 s. Movement of the sign trailer frame was observed at 0.010 s. The sign trailer pivoted about the end of the trailer tongue at the hitch. The struck wheel had folded over flat but remained attached to the axle by 0.054 s. The folded wheel assembly and buckled axle initiated the sign panel motion toward the windshield. The sign panel made contact with the windshield at 0.100 s. No contact between the sign post or panel and the hood was observed. As the vehicle continued to push on the end of the axle and sign panel, the sign trailer continued to rotate clockwise. The sign trailer was also being lifted by the vehicle's front end. The vehicle remained in contact with the sign trailer until approximately 0.250 s. The vehicle continued

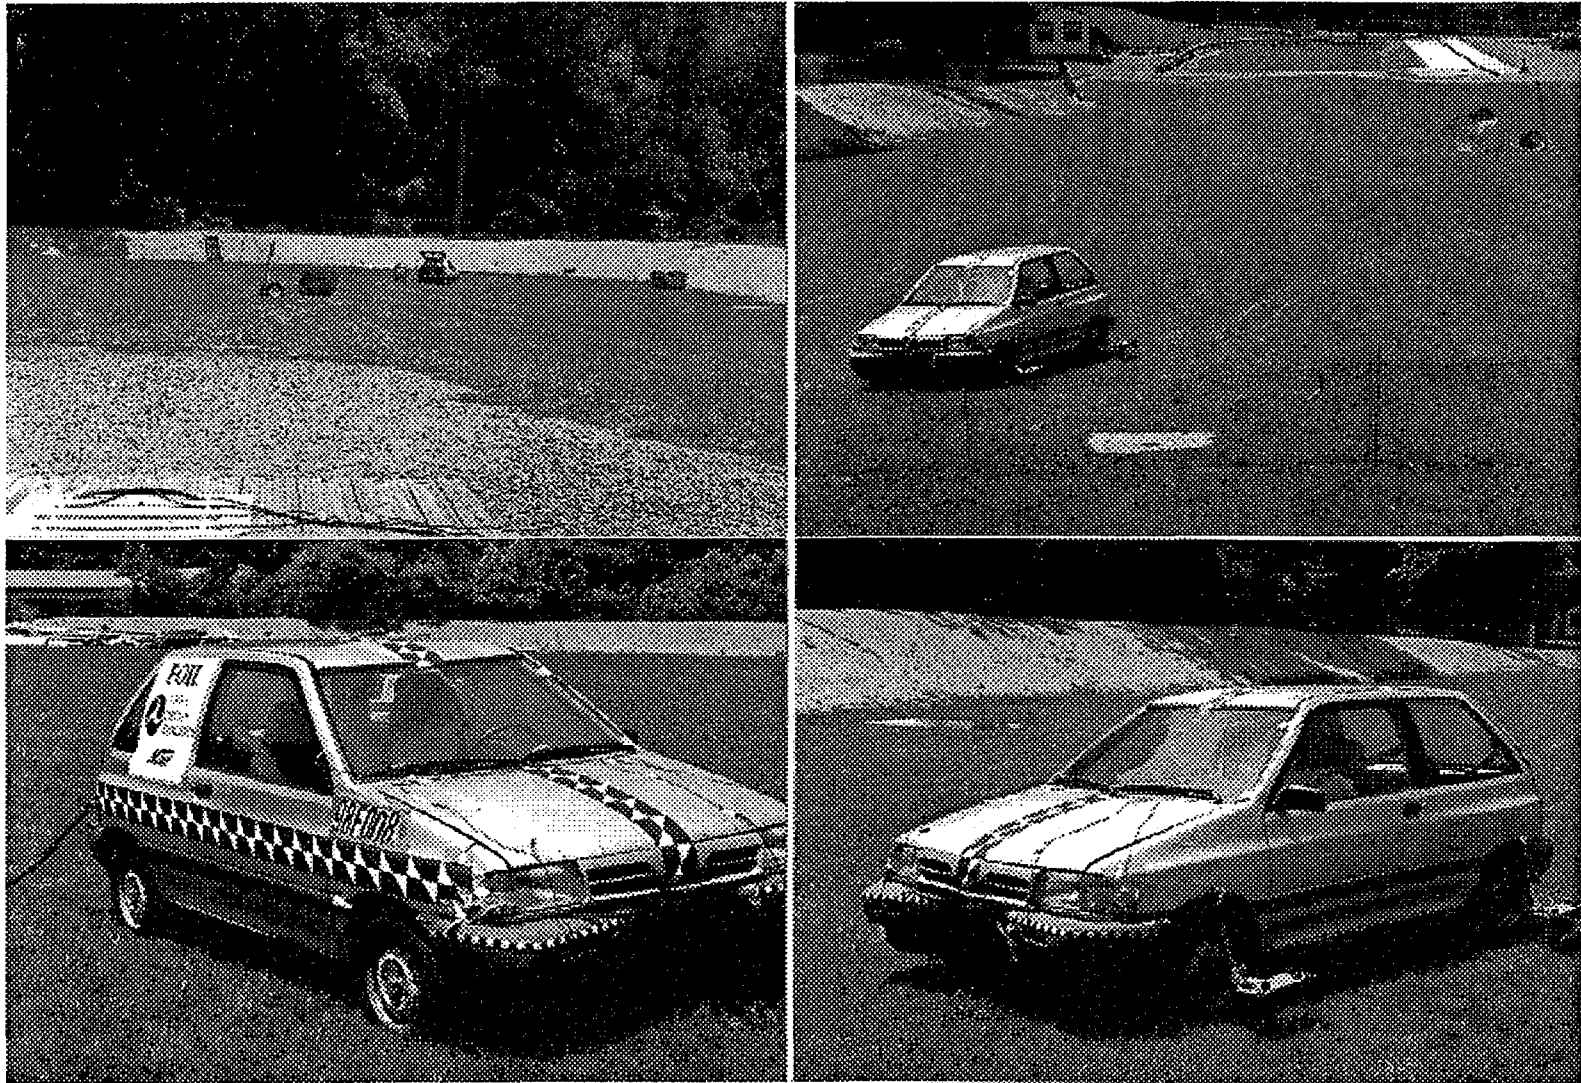
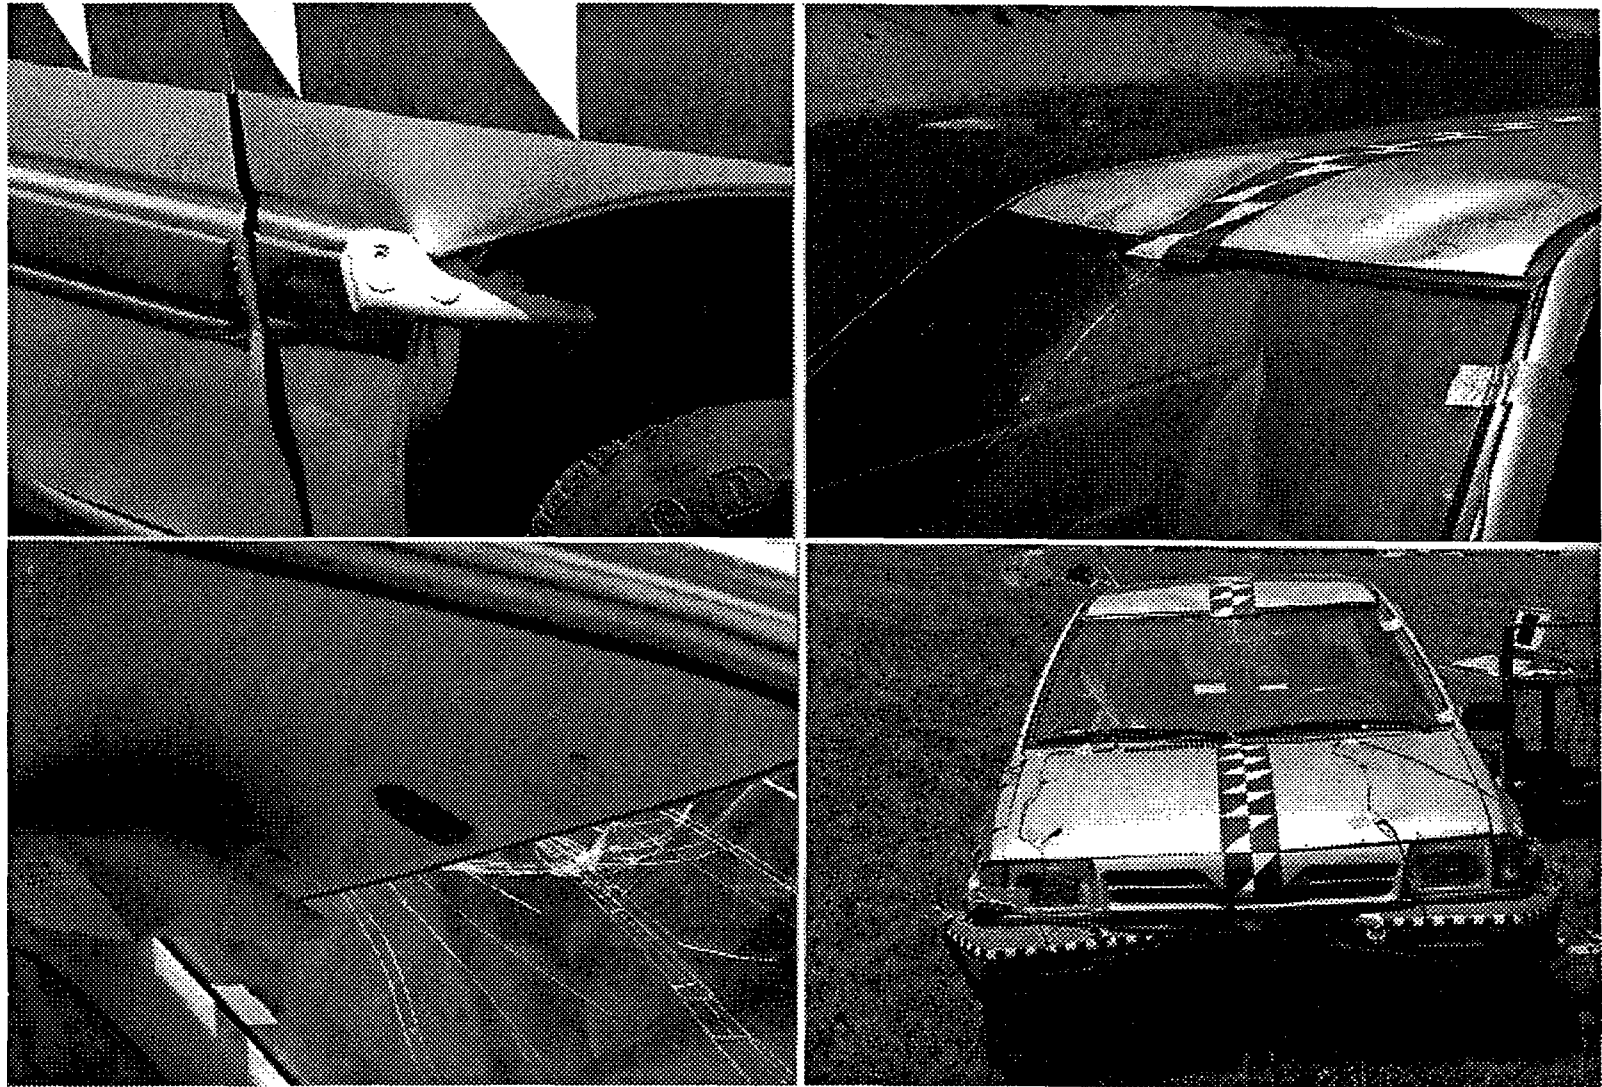
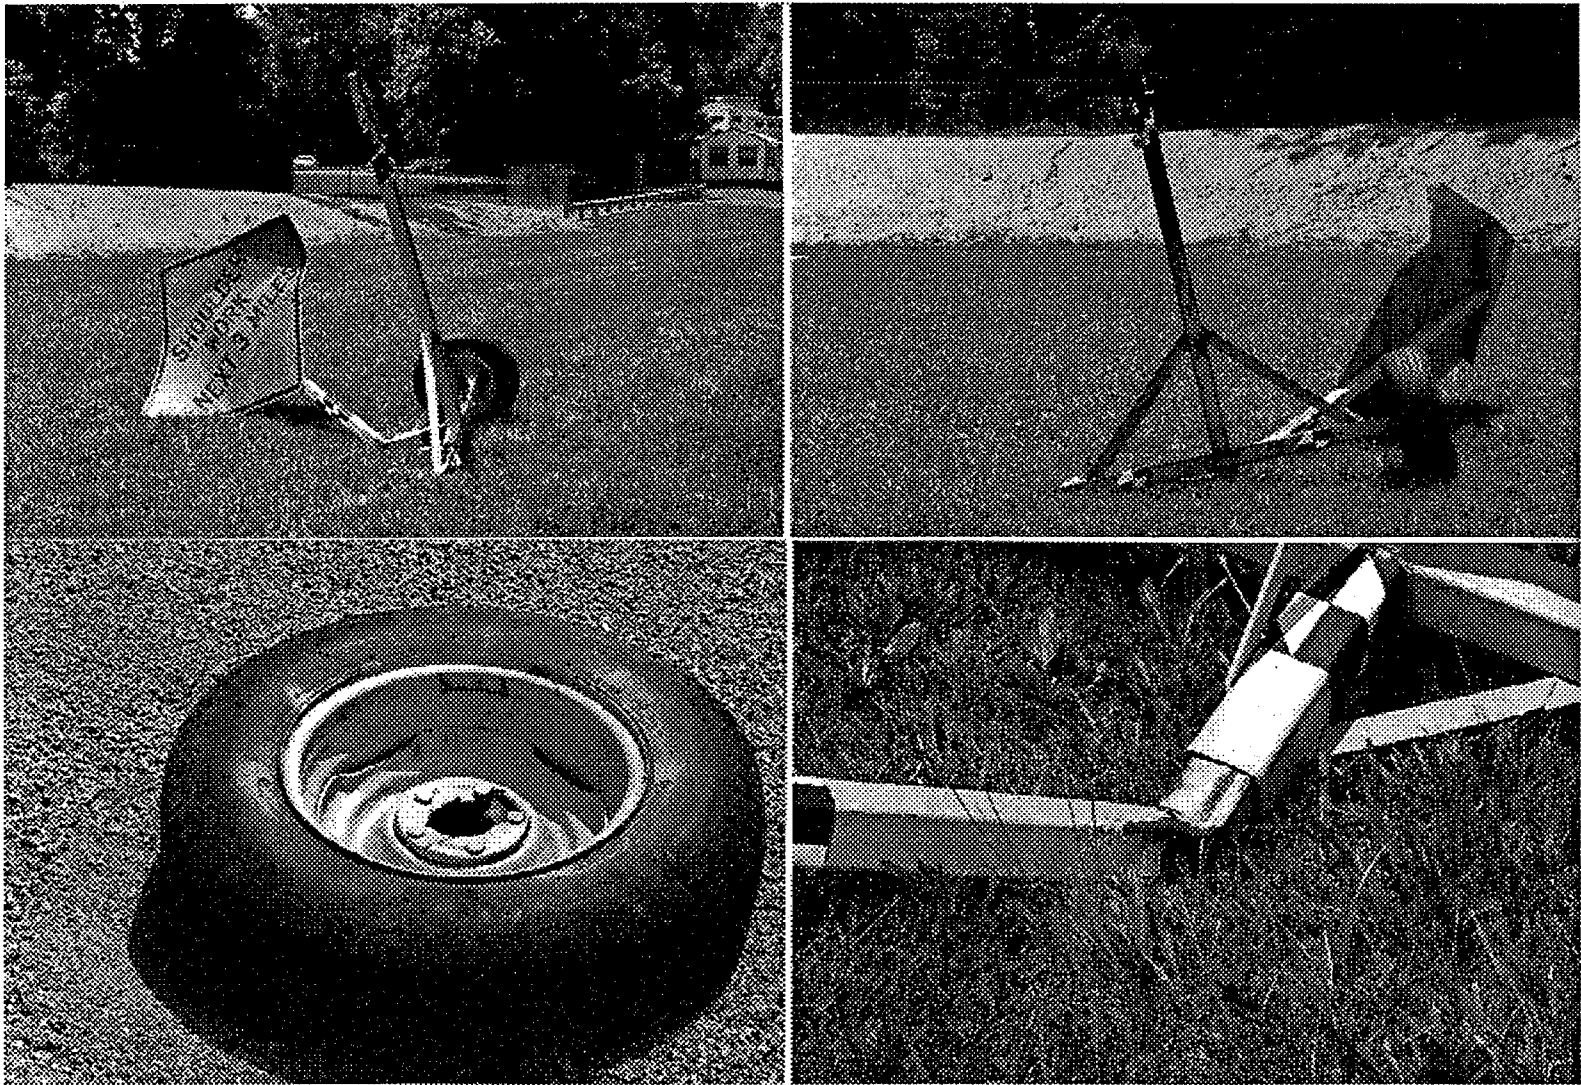
Figure 8. Post-test photographs, test 98F008.

b. Vehicle damage. Damage to the Ford Festiva consisted of minor to significant cosmetic dents to the bumper and roof. The maximum crush of the bumper was 159 mm and the roof was dented approximately 20 mm. The windshield was cracked but there was no intrusion and no loss of visibility. No debris from the test vehicle was observed in the runout path of the vehicle. The vehicle trajectory did not change after contact with the sign. No yaw was observed in the test vehicle's path. The vehicle remained stable throughout the test.

c. Test device damage. Damage to the portable sign trailer was substantial. The axle and sign post buckled severely. The sign panel remained fastened to the sign post, and the post remained inside the trailer sleeve. The sign trailer landed 49 m downrange and to the right of the test vehicle's trajectory. The struck wheel hub broke at the spindle and the tire rolled 103 m downrange. The sign trailer could not be repaired and reused without significant structural repair.

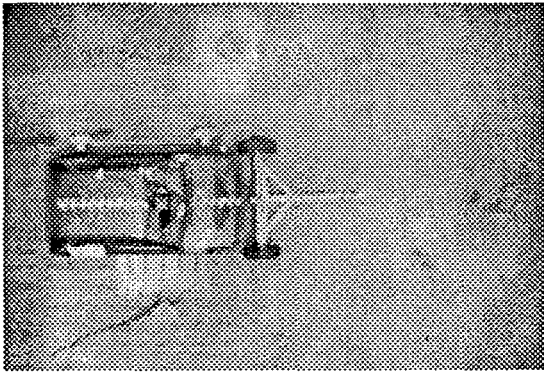
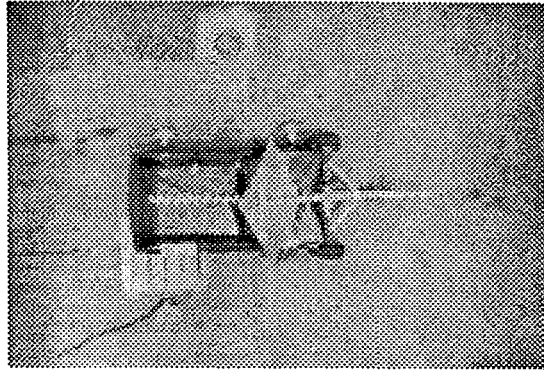
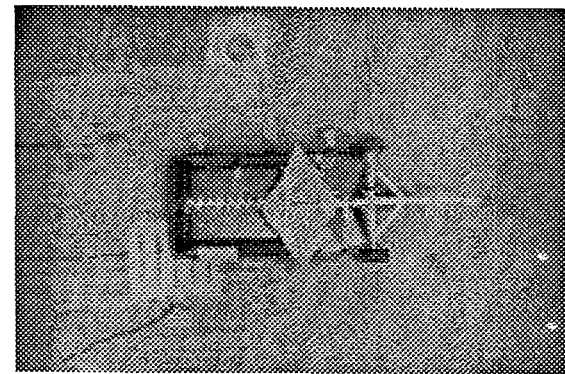
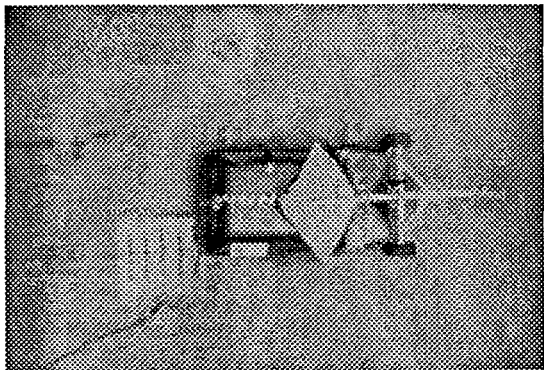
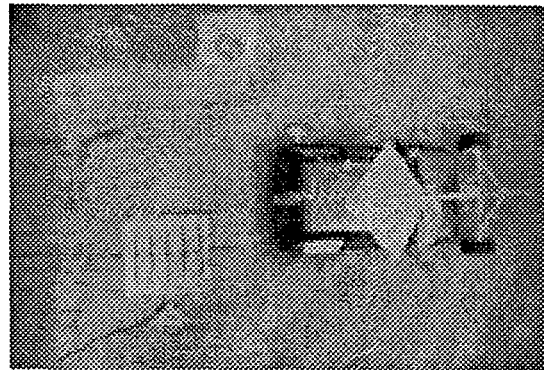
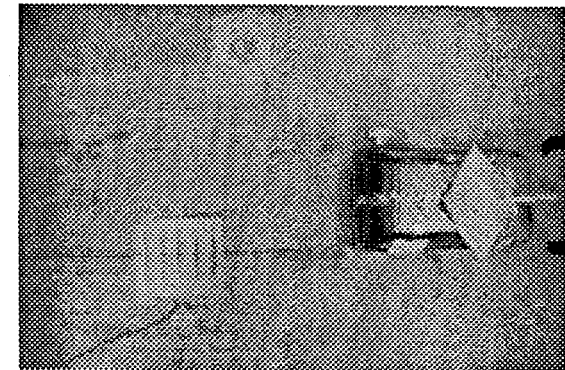
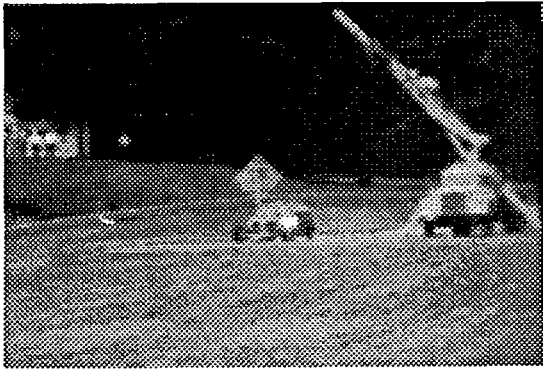
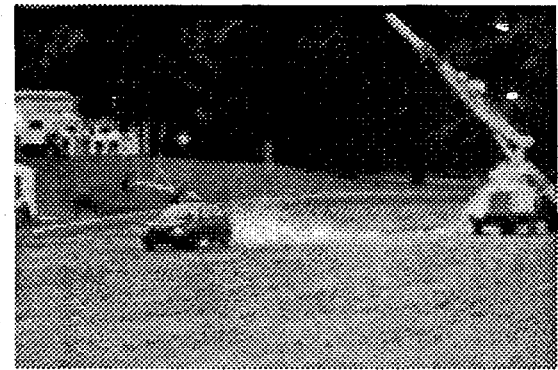
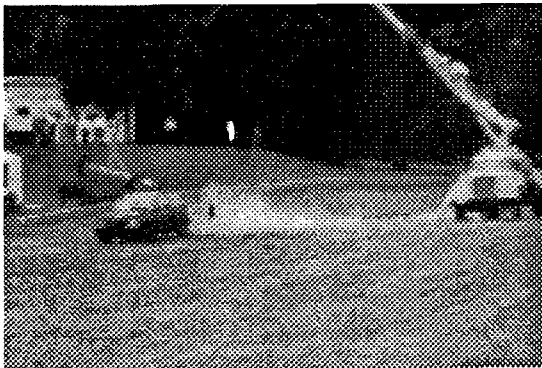
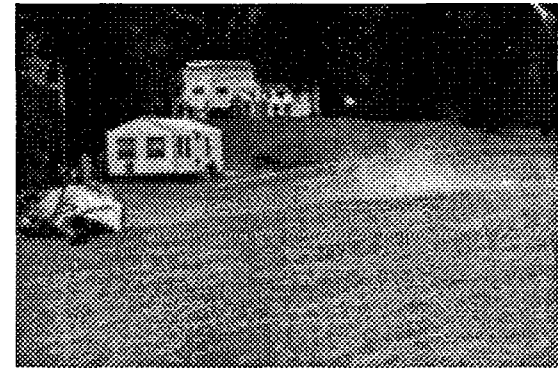
Figure 23. Test photographs during impact, test 98F009.

**Test 98F009.** The Ford Festiva was accelerated to 99.1 km/h prior to striking the portable sign trailer. The Ford Festiva centerline struck the sign trailer on the sign post between the trailer's two tires. The sign trailer began to move on contact and the bumper, grill, and hood had crushed significantly by 0.026 s. The vehicle bumper contacted the sign trailer 230 mm above the trailer's axle, but on the sign post sleeve (not directly on the sign post). The contact and the inertia of the tall sign post caused the sign panel and post to rotate down on top of the vehicle, striking the windshield at 0.110 s. The sign trailer's tongue and hitch pushed through the soil slightly before being rotated upward as the sign tipped toward the vehicle. The entire trailer was lifted up and rode on the hood of the vehicle before being launched upward and away from the vehicle. The maximum height of the sign trailer was approximately 2.3 m. The vehicle continued along its original line of trajectory. The sign trailer landed 75 m downrange from its original position and to the left of the vehicle's trajectory. The sign trailer remained intact, although with significant structural damage.

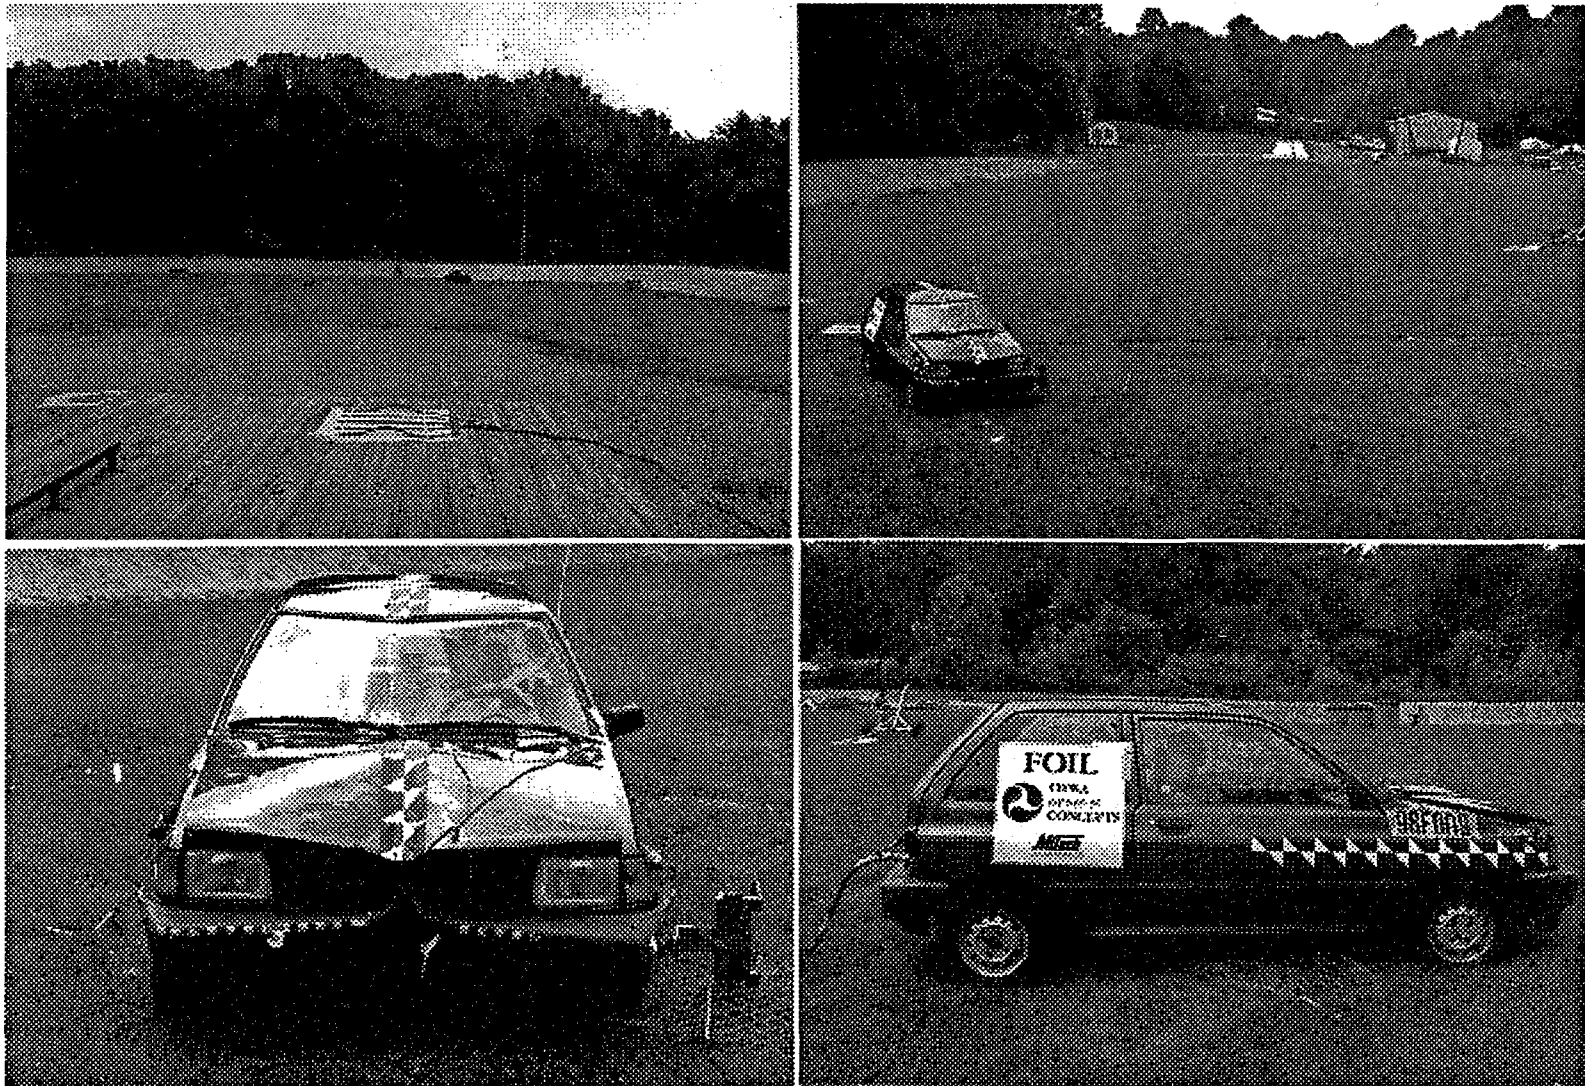
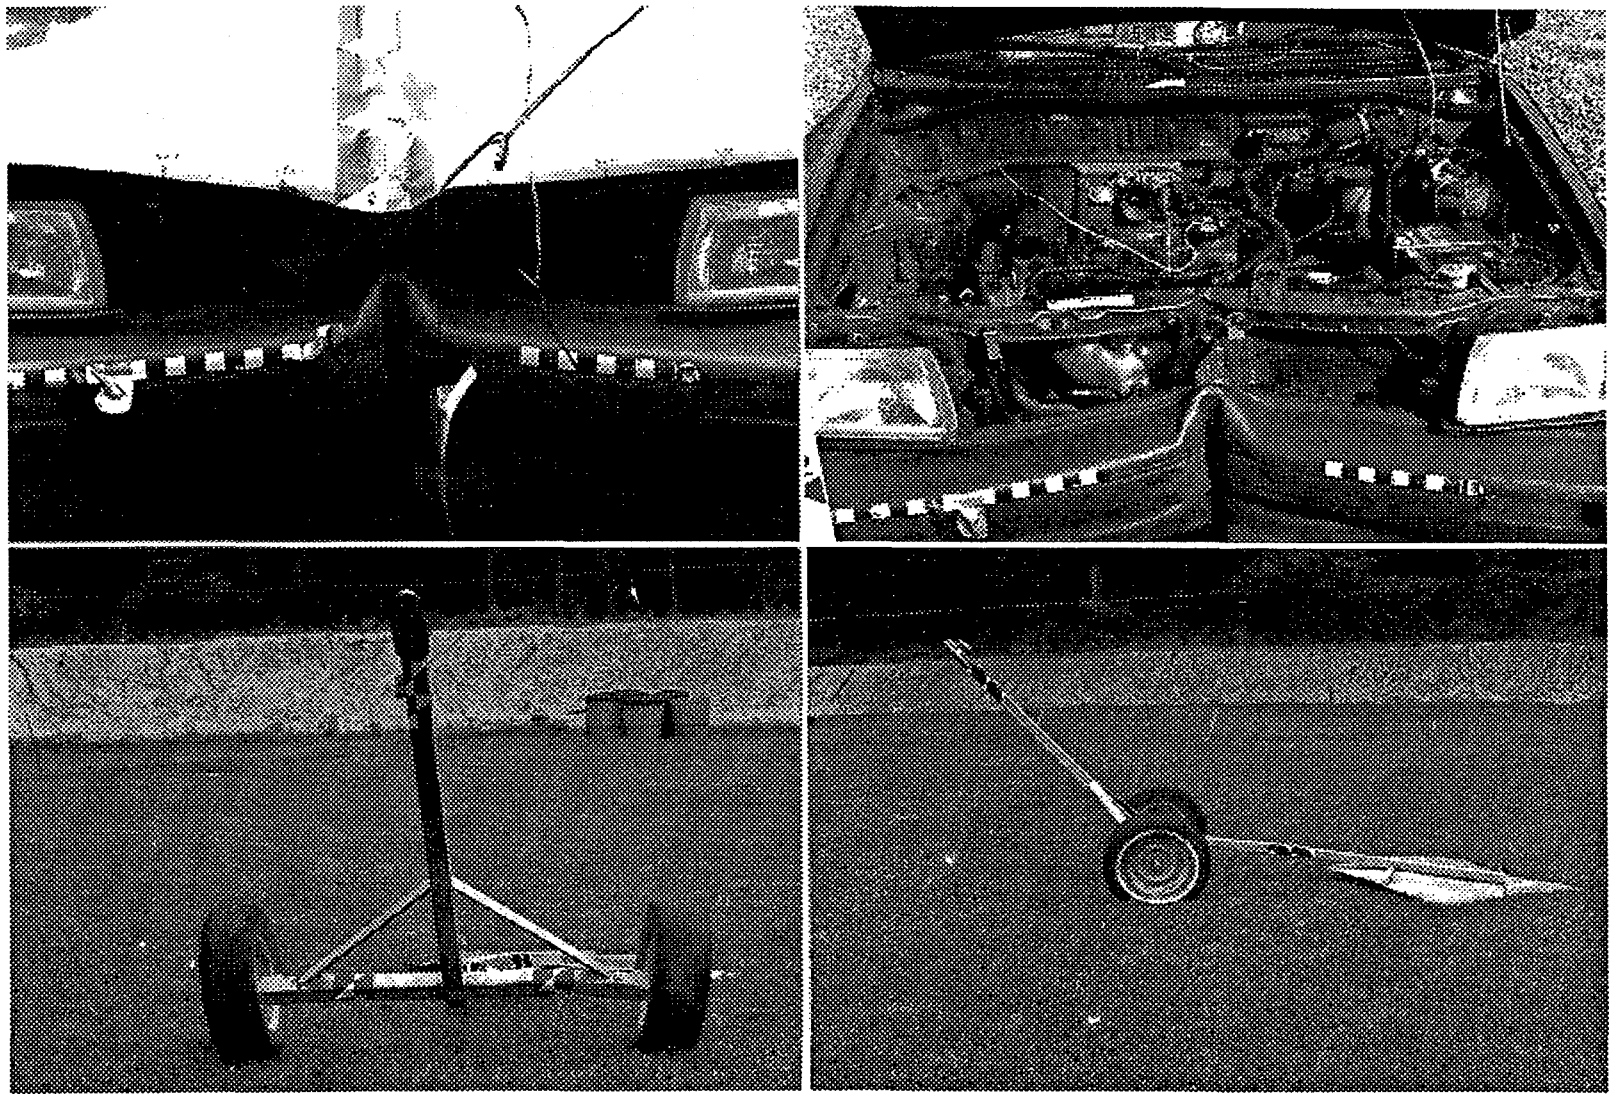
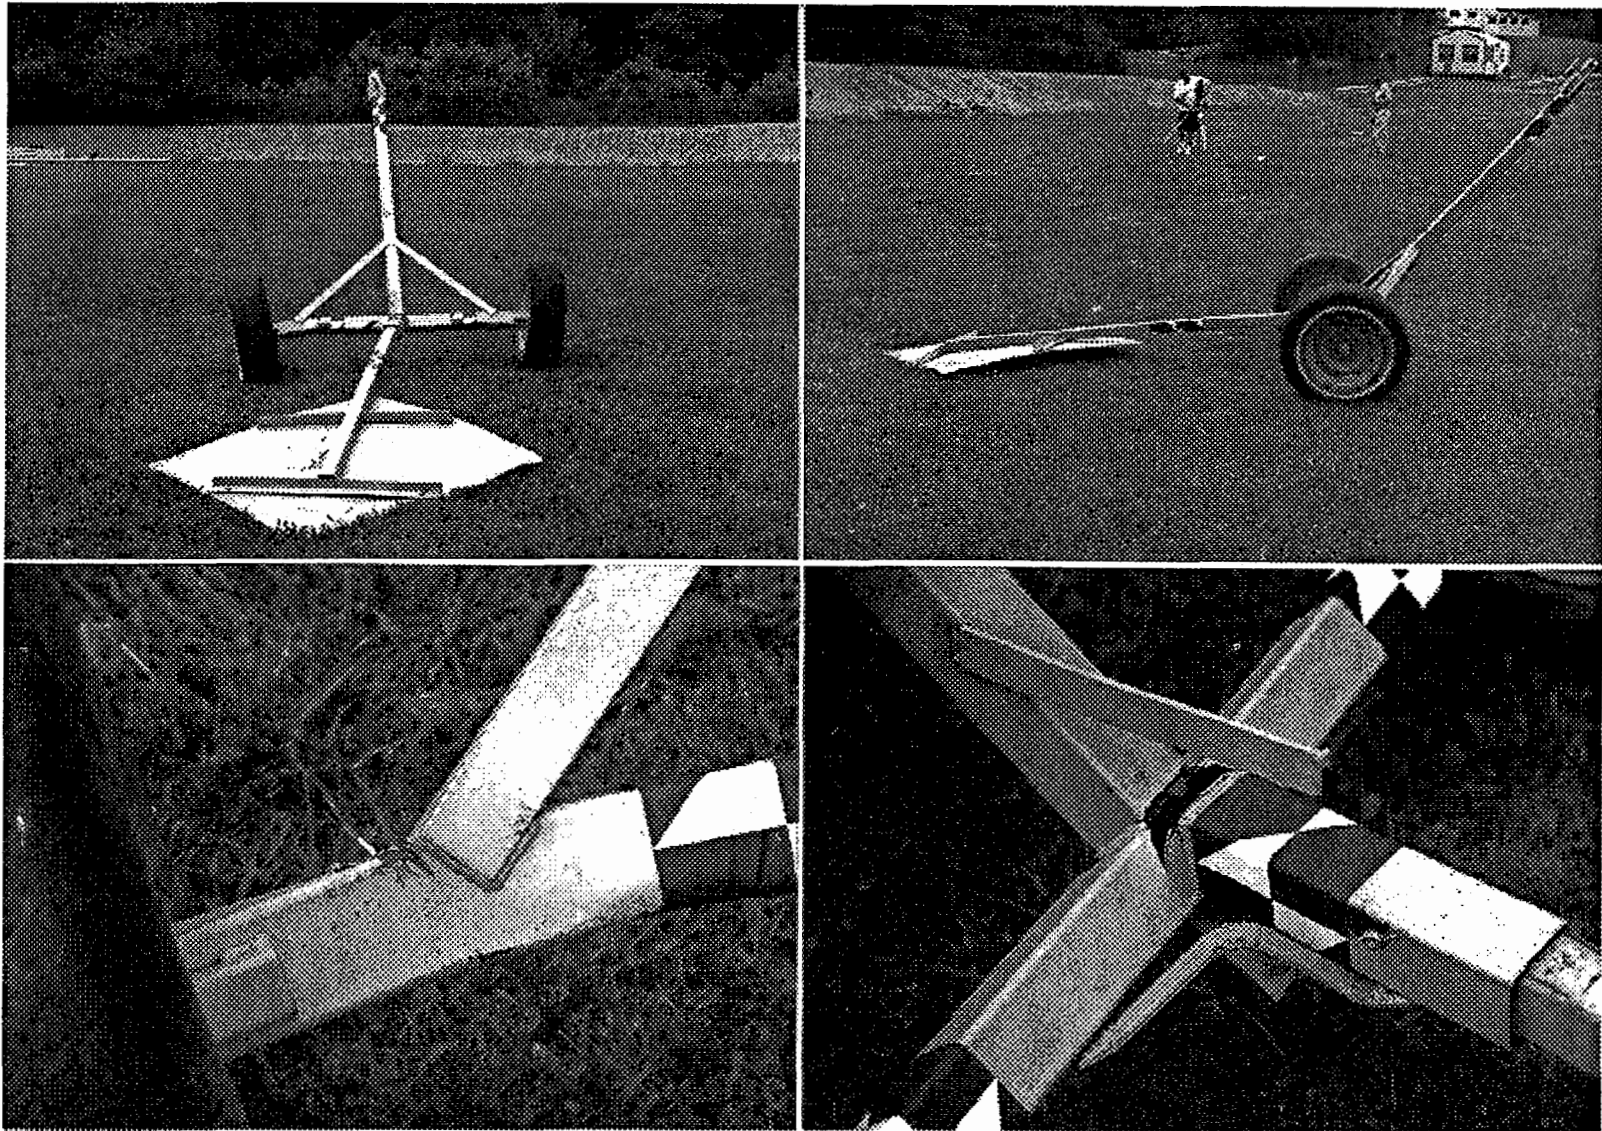
Figure 26. Post-test photographs, test 98F009.

b. Vehicle damage. Damage to the Ford Festiva consisted of minor to significant cosmetic dents and crush of the bumper, hood, and roof. The maximum crush of the bumper was 249 mm and the roof was dented approximately 50 mm. The windshield was cracked but there was no intrusion and no loss of visibility. No debris from the test vehicle was observed in the runout path of the vehicle. The vehicle trajectory did not change after contact with the sign. No yaw was observed in test vehicle's path. The vehicle remained stable throughout the test.

c. Test device damage. Damage to the portable sign trailer was substantial. The axle and sign post did not buckle, however, the base of the sign sleeve tore from the axle. Both axle/spindle connections were bent inward, causing both wheels to have severe "toe-in." The sign panel remained fastened to the sign post and the post remained inside the trailer sleeve. The sign trailer landed 75 m downrange and to the left of the test vehicle's trajectory. The sign trailer could not be repaired and reused without significant structural repair.
