**CALSPAN ON-SITE MOTORCOACH FIRE INVESTIGATION
SCI CASE NO.: CA09030**

**VEHICLE: 1995 MOTOR COACH INDUSTRIES (MCI)
MODEL: 102-D3**

LOCATION: PENNSYLVANIA

INCIDENT DATE: APRIL 2009

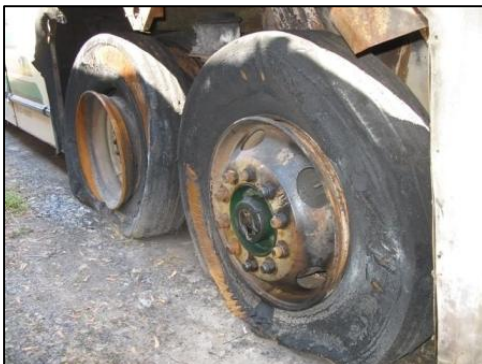
The fire spread forward and involved the left rear drive and tag axle tires. The full circumference of the sidewall of the tag axle tire was burned with the top 30 percent completely burned through with the steel cords exposed. The tire lost air pressure and the sidewall de-beaded from the steel wheel. The tire tread that remained in contact with the pavement was not burned. The drive axle tires were burned in a similar pattern to the tag axle tire. The outer aspect of the upper sidewalls were burned full-thickness, consuming approximately 30 percent of the sidewall surface. The tread was burned with the exception of the tire patch that was in contact with the pavement. Both left side drive axle tires de-beaded from the wheels. During the tow process, these tires rotated on the wheels causing the burned portion of the tires to rotate to the 6 o'clock positions.

The burning tires produced high heat and the resulting fire consumed the rubber deflector shield that was mounted to the top surface of the wheel opening. The sheet metal above the tires was heavily oxidized from the heat with various levels of oxidation radiating from the edges of the burn pattern to the area directly over the tire positions. The fire consumed the air ride suspension bladders and burned the shock absorber bushings from the shock mounts. The aluminum rub rail mounted over the rear axle positions was melted. **Figures 5 and 6** are views of the fire damage to the left drive and tag axle tires.

Figure 5. Fire damage to the left drive and tag axle tires.

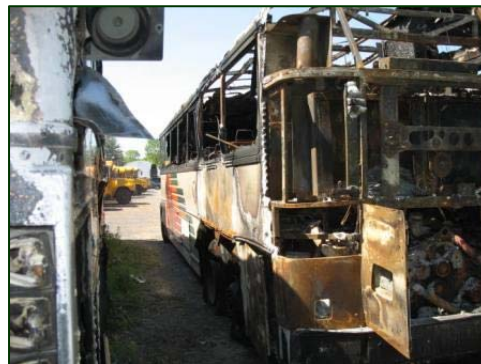
The fire damage to the left side body of the motorcoach extended from the back left corner to the forward aspect of the rear axle positions. The engine compartment door at the left rear lower side of the vehicle displayed evidence of high heat oxidation on the forward upper quadrant. The paint and primer were burned from the sheet metal and the aluminum rub rail that was attached to the lower aspect of the door was melted.

Figure 6. Left rear view of the fire damage to the motorcoach.

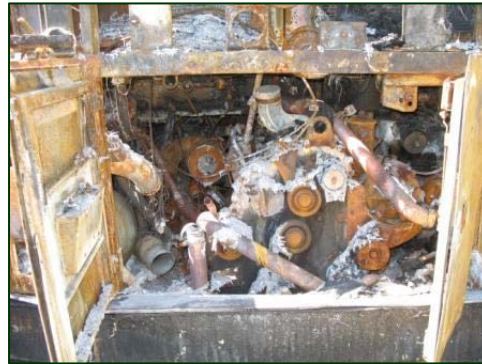
The engine compartment exhibited severe damage with all rubber, plastic and aluminum components consumed by the fire. The turbocharger was mounted on the left side of the engine (driver's side) and consisted of a cast iron housing on the exhaust side (forward in relation to the motorcoach) with an alloy impeller encased within an aluminum housing. A cast iron body that contained an oil line for lubrication separated these two components. A vacuum operated valve with a synthetic line was mounted to the top of the turbocharger unit that regulated the waste gate via a linkage rod. The aluminum impeller housing and the fins on the impeller were melted. A molten aluminum drip pattern of the impeller hub was present at the 6 o'clock position on the cast iron turbocharger housing. The top left area of this housing displayed high heat oxidation. **Figure 7** is a view of the engine compartment in an exemplar motorcoach. **Figure 8** is the engine compartment in the fire involved motorcoach.

Figure 8. View of the engine compartment of the involved motorcoach.

The plumbing located above the turbocharger consisted of large diameter copper tubing with soldered and rubber connector joints. The rubber was burned from the tubing and the band clamps separated resulting in displacement of this tubing.

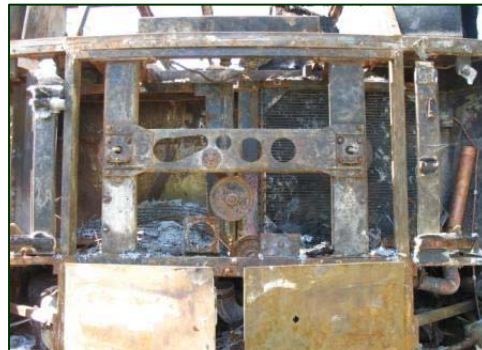
Serpentine-type belts and large width V-belts powered the compressors, the various pumps and the cooling fans for the air conditioning (AC) condenser and the radiator. These belts were completely consumed. The AC condenser was aluminum and was mounted vertically above the engine, left of the centerline. The majority of the AC condenser was melted and dripped into the engine compartment.

The radiator was copper cored and was not burned in the fire. All hoses associated with the cooling system were consumed in the fire. A reservoir tank for the cooling system was mounted above the AC condenser and the radiator, and was centered over the engine compartment. The lines for this tank were consumed in the fire. **Figures 9 and 10** are of the AC condenser and the radiator and associated components.

Figure 10. View of the same components of the involved motorcoach.

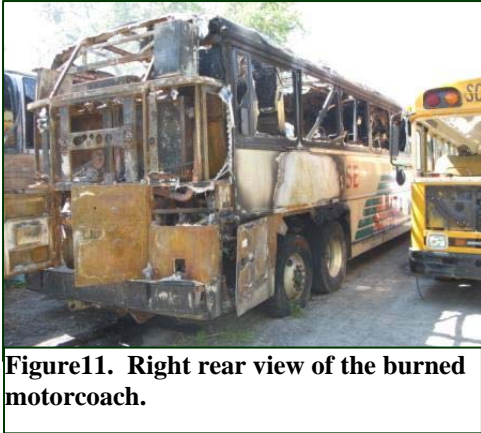
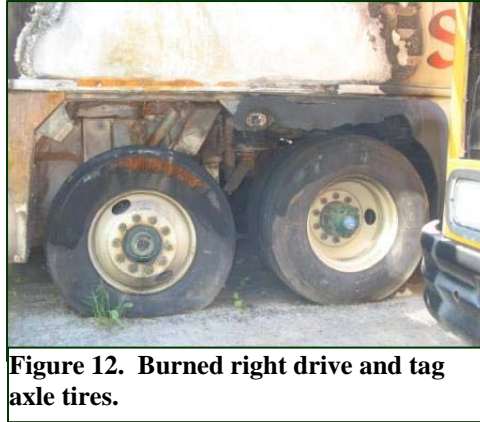
The top 50 percent of the right tag axle tire was burned with the outer (upper) aspect of the sidewall burned full thickness with the steel belts exposed (**Figure 12**). Air loss was complete, although the tire beads remained engaged to the steel wheel. The upper 50 percent of the right drive axle tires were burned; however, these tires maintained air pressure.

The painted sheet metal above the right rear tires was burned with high heat oxidation present over the tag axle tire. The aluminum trim above the tag axle tire was melted. The rubber spray deflector mounted over the axle positions was burned, but intact at the

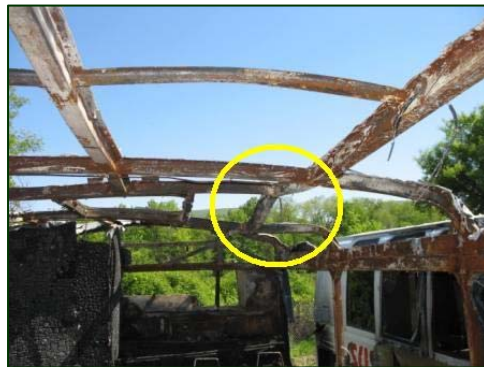
The rear 40 percent of the aluminum roof panels were consumed by the fire. This covered the approximate area of passenger seat rows 6-11. The left side roof structure, at the second to last roof bow and the longitudinal roof rail deflected approximately 8 cm (3 in) downward due to heat (Figure 13). The longitudinal rail adjacent to the rear roof emergency exit sagged due to the heat. The oxidation of the roof structure was most prevalent at the rear left aspect of the passenger compartment. The emergency roof exits were completely consumed by the fire.

Figure 13. Fire related deformation of the left side roof structure.

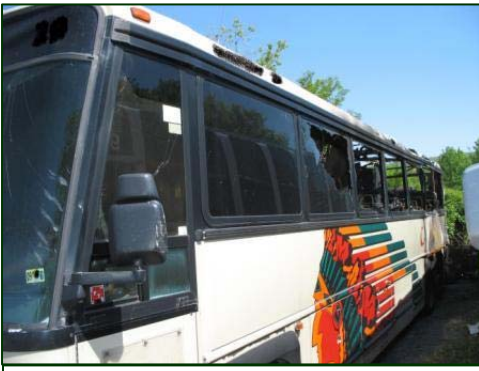
The left side contained six large laminated glazing panels along the 11 rows of seats. The most forward glazing panel was in place, cracked at the upper area, and smoke/soot covered on the inside surface. The second left side panel was cracked diagonally with approximately 40 percent of the glazing missing over the aft upper area. The remaining glass was smoke/soot covered. The remaining glazing panels (3-6) were completely consumed by the fire. **Figure 14** is a view of the left side glazing.

Figure 14. Left side glazing damage.

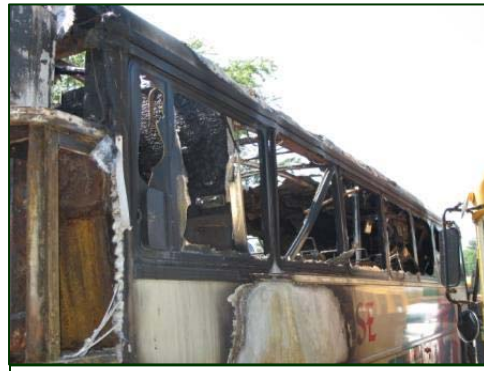
The right side of the motorcoach was equipped with seven glazing panels. The forward glazing panel was intact with heat cracking at the upper surface with heavy smoke/soot buildup on the inside surface. The upper rear aspect of the second glazing panel was burned (approximately 25 percent) with the balance of the glass cracked with smoke/soot covering the inside surface. The 3-7 glazing panels were completely consumed by the fire. **Figure 15** is a view of the right side glazing.

Figure 15. Right side glazing damage.

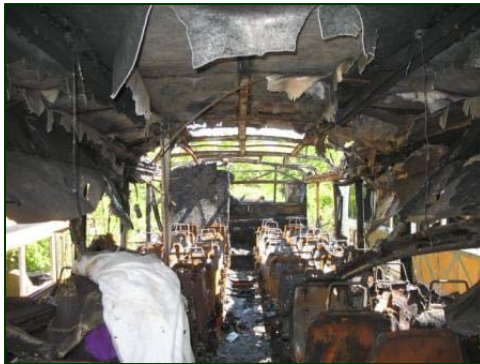
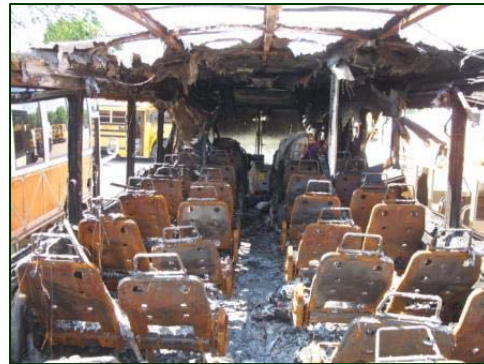
As the fire spread to the passenger compartment through the rear floor and through the side glazing above the rear axles, the interior materials provided additional fuel. The seat fabric and foam cushions were burned from the back of the second row to the rear of the passenger compartment. Rows 4-11 were completely burned with only the tubular steel frames remaining in place. The hard plastic armrests were burned at these rows. The seals in the pneumatic seat back recline mechanisms for rows 4-11 were burned, resulting in the seat backs reclining fully rearward.

The first two rows of passenger seats sustained minimal damage from the fire. The damage was primarily to the seat backs and the head restraints. The driver's compartment was not consumed by the fire. The pneumatic seat, the safety belt, the controls and the instrument panel were intact and covered with smoke and soot. The instrument panel gauges remained visible behind a light coating of film from the smoke/soot. **Figures 16 and 17** are interior views of the involved motorcoach.

Figure 16. Rearward view of the interior of the involved motorcoach.

Figure 17. View looking forward of the interior of the involved motorcoach.

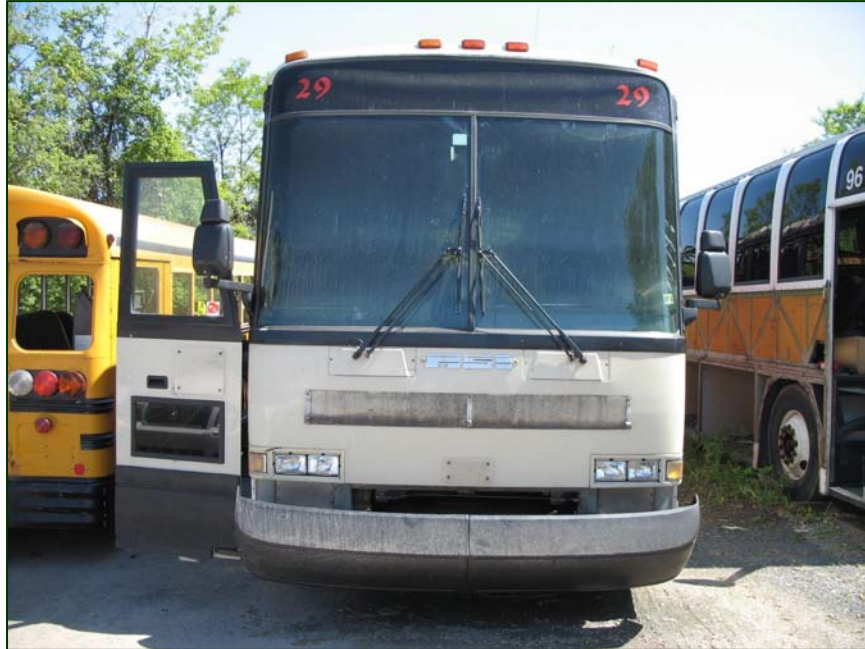
In **Figure A-1** (frontal view) attached, I observed smoke staining to the windshield with some heat cracks along the driver side near the top. There was no remarkable fire damage observed, including to the spare tire attached to the undercarriage in the front center. These observations are consistent with a fire originating toward the rear driver side.

Figure A-1. Front view of the motorcoach.

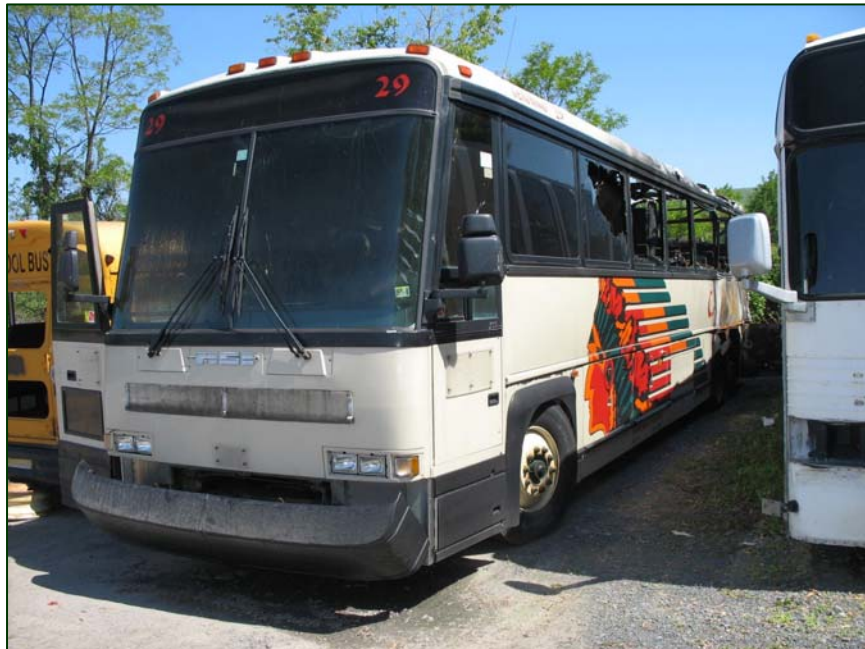
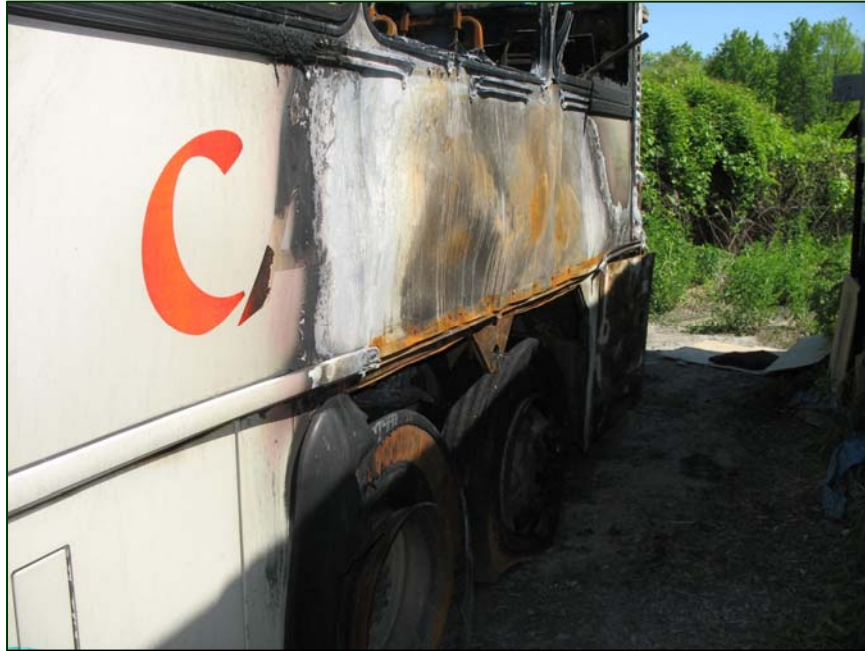
The driver side of the motorcoach, **Figures A-2 and A-3** (driver side views) was visually inspected. The fire damage revealed minimal heat damage to the front third of the motorcoach with paint remaining on the surfaces. The front driver side tire still remained intact and was not damaged by the fire. There was some smoke damage to the driver side window with moderate heat damage observed high indicating that the fire progressed from the rear toward the front. As I traversed toward the rear, I observed very heavy heat damage about at the midpoint of the motorcoach where fire patterns had started moving in an upward direction from the rear. The oxidation on the lower surfaces revealed minor blistering with heavier oxidation to the upper portion where the windows had melted away and the roof was missing. The driver side rear of the vehicle revealed the heaviest fire damage with very heavy oxidation to the lower panels where the engine compartment was housed, **Figure A-4** (engine panel view). There was also very heavy oxidation above the rear tire housing **Figure A-5** (wheel well view) where the heat from the burning tires caused an upward intense fire movement. This area appeared to be secondary heat damage and was a by-product of the fire progressing from the underside in the engine compartment, **Figure A-6** (rear of wheel well).

Figure A-2. Driver's side view of the motorcoach.

Figure A-3. Area over the driver's side rear axles.

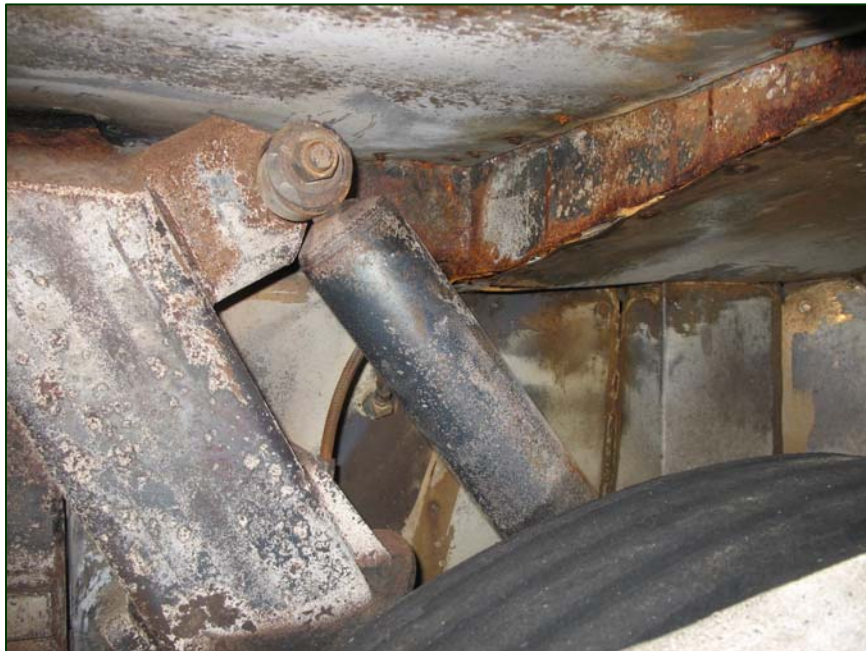
Figure A-6. Area above the left tag axle.

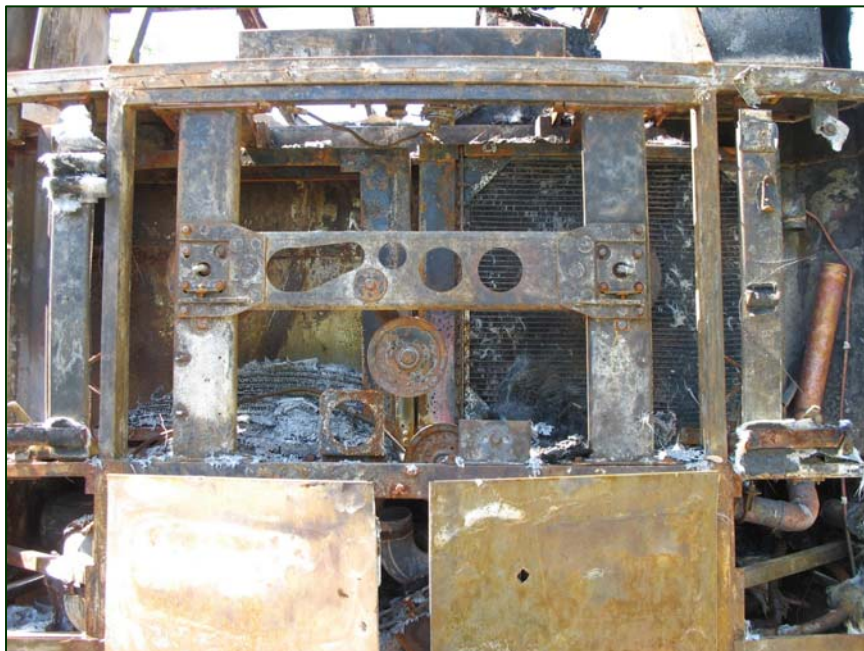
The heaviest heat damage to the undercarriage was observed on the driver side below the rear bumper. There was also heavy oxidation to the roof structure above the driver side rear. A closer view **Figure A-8** (view of cooling core) revealed heat damage directionally from the engine compartment on the driver side.

Figure A-8. Air conditioning condenser (left) and radiator (right).

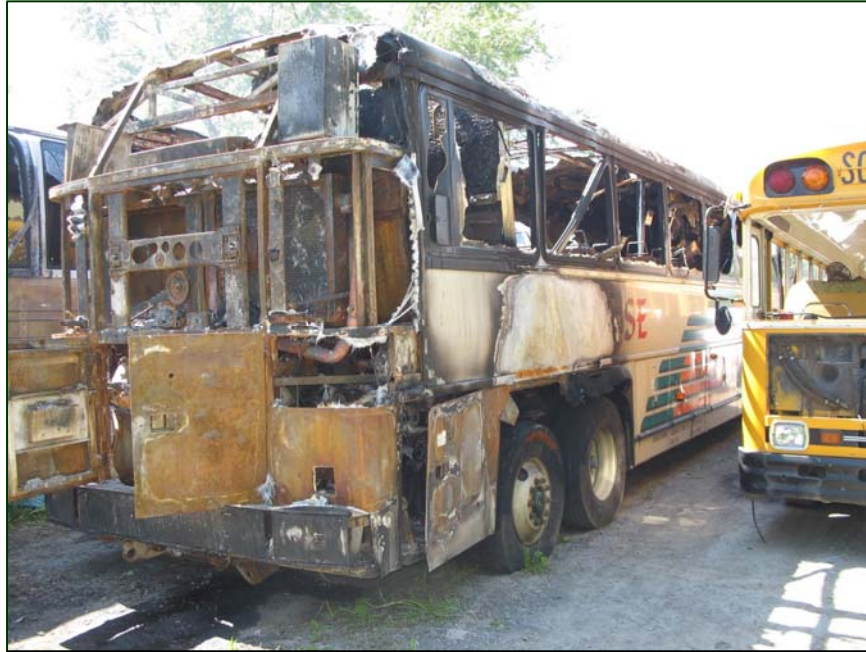
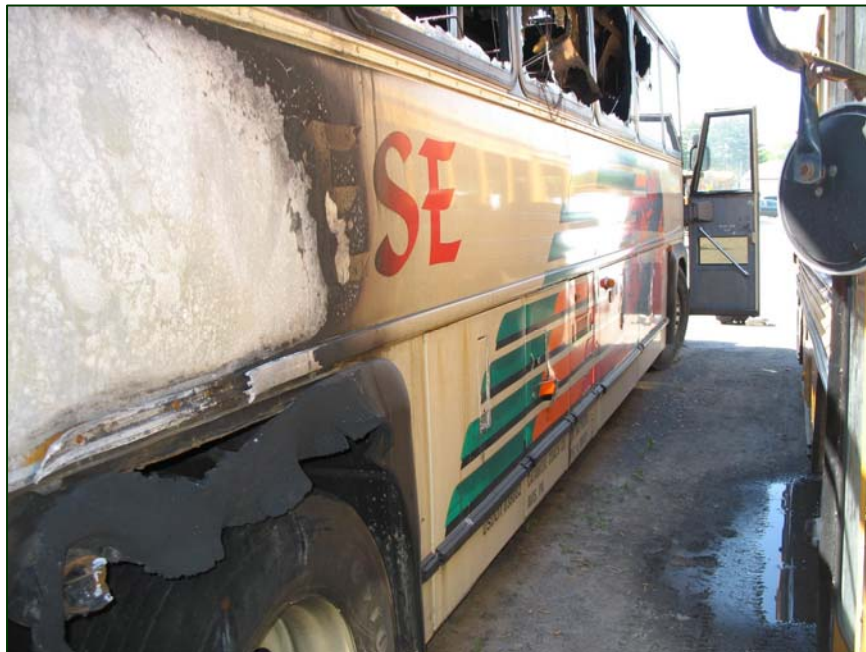
The passenger side, **Figures A-9 and A-10** (passenger side view), revealed fire damage from the rear progressing toward the front with less heat and fire damage than the driver side. There was oxidation visible around the engine compartment panel and extension to the wheels, again with less damage than the driver side. This was consistent with the fire origin coming from the driver side through the interior of the engine compartment. As I moved toward the front on the passenger side, the fire and heat damage became less on the exterior. However; there was fire damage observed through the windows and roof line that indicated the fire progressed from the rear toward the front.

Figure A-9. Left rear view of the passenger's side of the motorcoach.

Figure A-10. Closer view of the passenger side of the motorcoach.

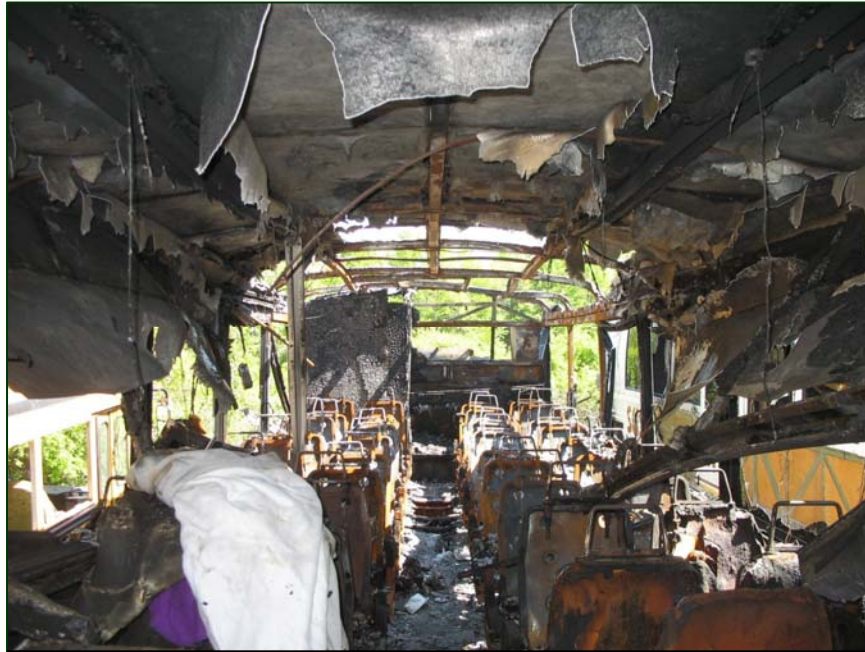
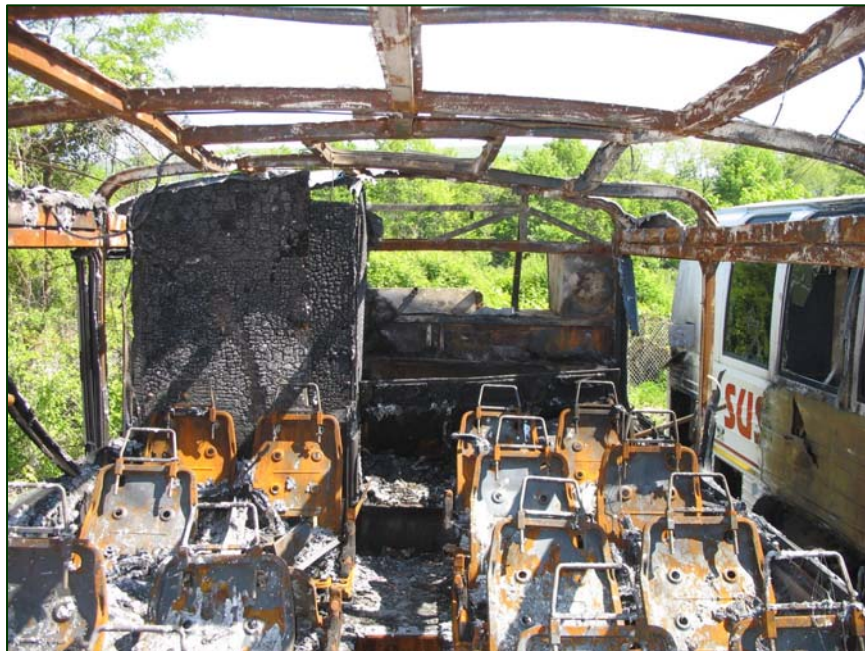
As I entered the interior of the motorcoach, **Figures A-11 and A-12** (interior view from front toward the rear), I observed heat and fire damage that was consistent with the fire originating in the right rear driver side. The fire movement was from this corner upward from floor level with heavy damage above this area. The roof system revealed very heavy damage in the right rear corner and the oxidation patterns on the rear of the seats revealed fire progression from the last two seats forward. Each seat ahead of this area became less heat stressed and the fire damage diminished toward the front. The floor was visually examined, **Figures A-13 and A-14** (floor looking from front toward the rear). The fire and heat damage is consistent with the fire progressing from under the plywood flooring from the rear driver side toward the front. The fire traveled via the conduit chase on the floor that was covered with plywood. **Figure A-14** also represents how the fire originated under this area over the engine compartment with heavy oxidation patterns revealed on the metal wall and floor structure in this area.

Figure A-11. Interior view of the motorcoach looking rearward.

Figure A-12. Interior view toward the rear of the motorcoach.

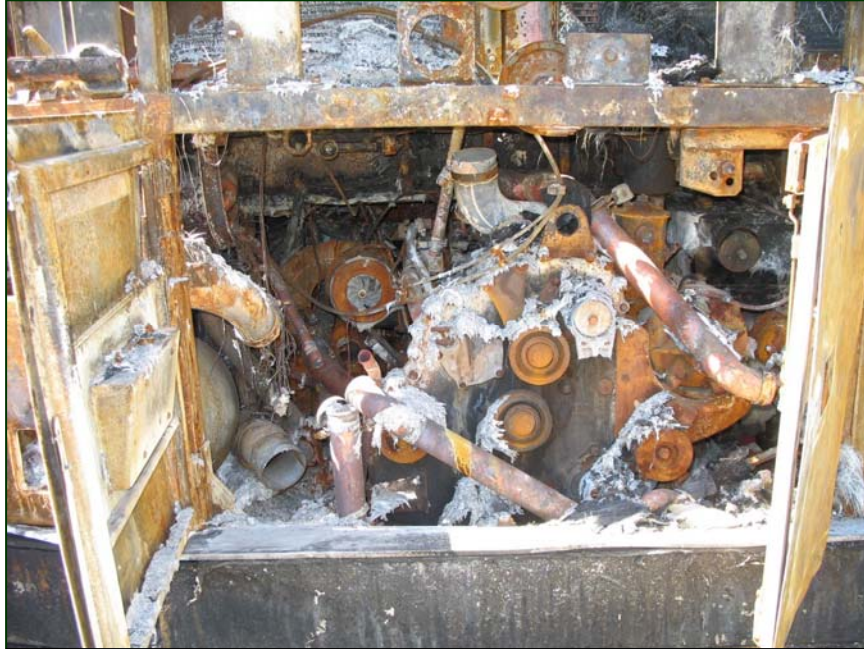
After making the determination that the fire originated in the engine compartment, **Figure A-15** (view of engine compartment from rear), the fire damage in this area revealed very intense heat and fire damage to the area around the turbocharger **Figure A-16** (view of rear of the turbocharger). The oxidation and melting of the metal products in this area indicated that heat traveled away from this area. The turbocharger had an aluminum housing around an aluminum alloy impeller with both of these items revealing very intense heat stress. This indicated that the fire originated in or near the turbocharger. The heat and oxidation damage observed on the cast iron turbocharger housing is also consistent with the fire originating at this area.

Based on the evaluation of the motorcoach and the information that was provided, I was able to determine that the origin of the fire was in the engine compartment along the rear driver side. Further, I opine that the ignition source for this fire was directly related to the turbocharger. A more detailed inspection of the engine components by a mechanical engineer may reveal the actual failure or scientific finding regarding the cause.

Figure A-15. Engine compartment of the motorcoach.
