Technical Assistance Report 17-01TA-C

Cracked Pavement Investigation

Re: H.003496
I-49 North: Segment J
Caddo Parish
DRAFT Cracked Pavement Investigation

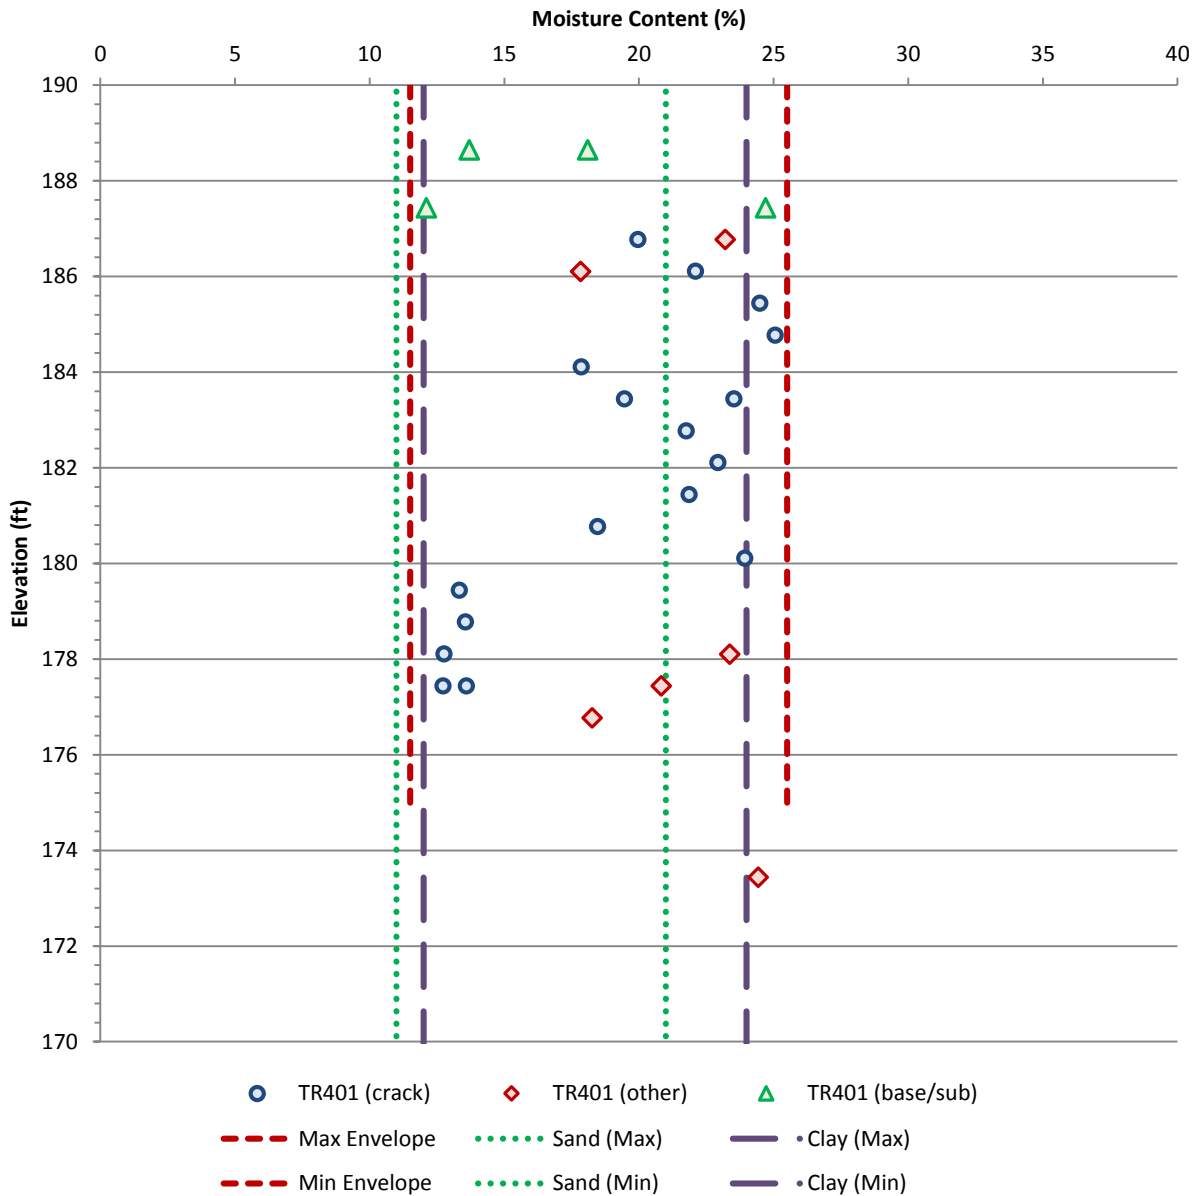
Figure 2: Moisture Content (from Nuclear Density Gauge) vs. Elevation

Figure 2 and Figure 3 show the field moisture contents and dry densities determined from the nuclear density testing plotted against approximate elevation. The values are divided into 3 groups: tests

Based on these plots, some of the test results indicate moisture contents higher than the upper bound established for compacted lean clays. Many of the tests fall significantly higher than the upper bound established for compacted sands. Similarly, several of the tests for dry density fall below the lower bound for both compacted sands and lean clays. It should be noted that the majority of the classification tests submitted for fill acceptance indicated that the borrow material was comprised of silty sand. Only a few of the tests were classified as lean clay. Unfortunately, the type of material in each tested lift was not recorded on the nuclear density test documentation, so it is not possible to separate each of the plotted points into clay and sand categories.

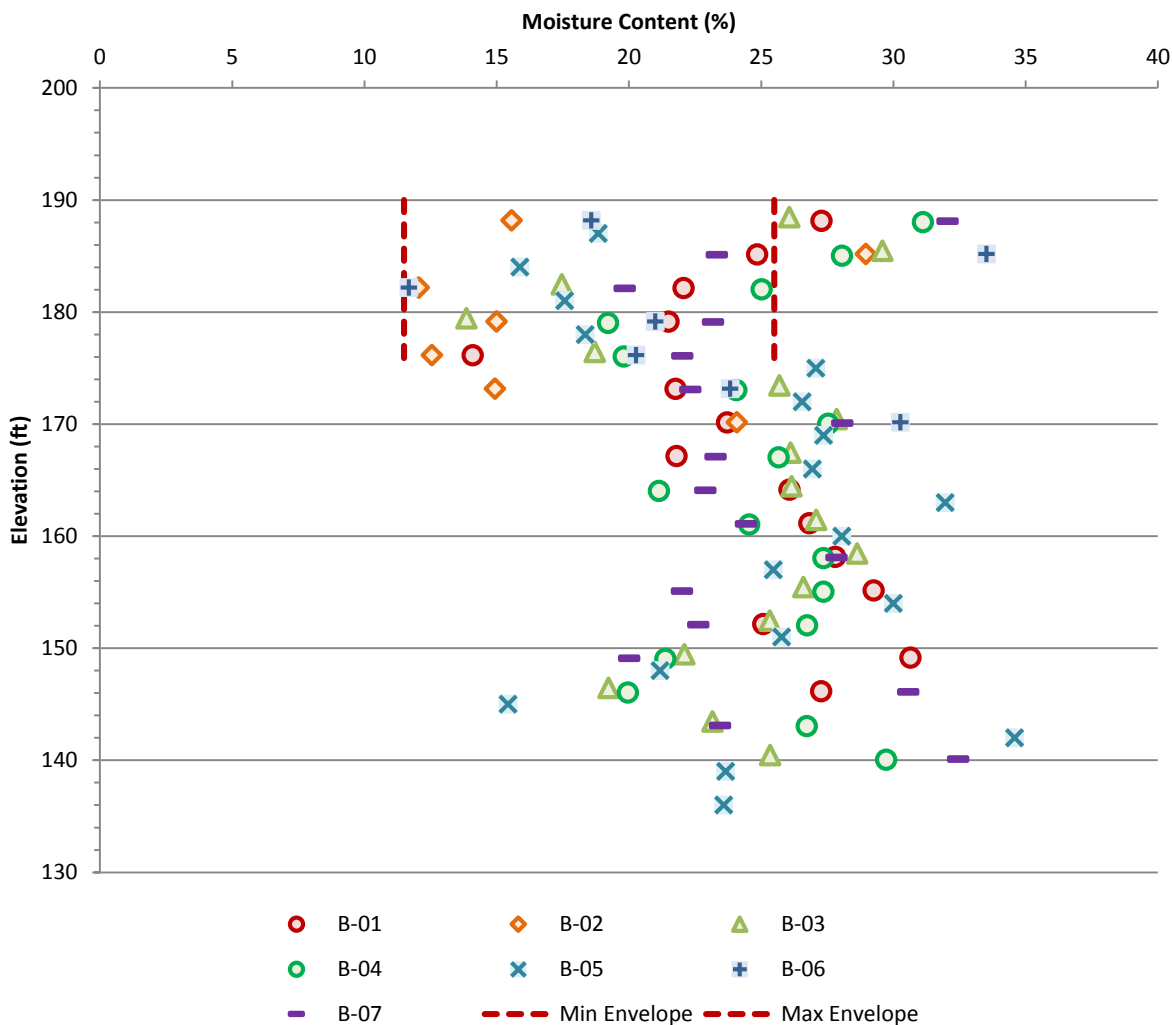
Figure 4: Moisture Content (from Laboratory Testing) vs. Elevation

The min/max envelope for the in-place nuclear density testing was then superimposed on the moisture content versus elevation data from the geotechnical laboratory, shown in Figure 4 below.

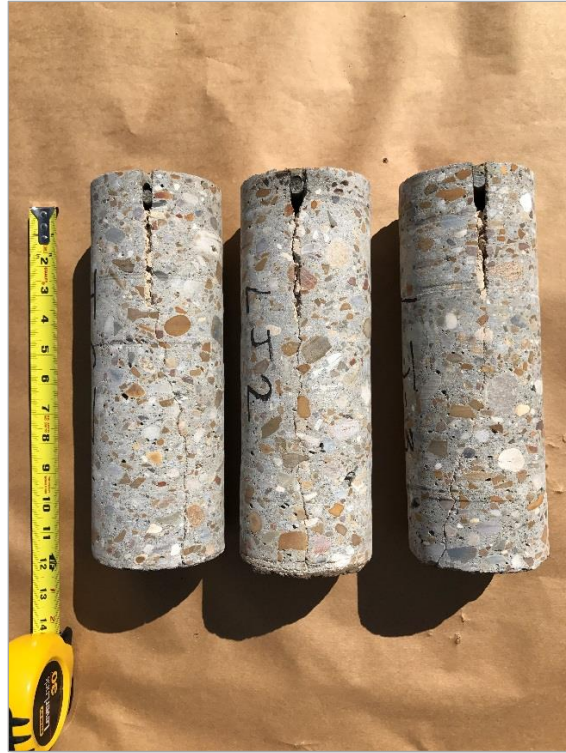
Figure 6: Cores from the Centerline

Figure 6 presents a photograph of the cores obtained at the centerline longitudinal joint. The saw cuts are as specified in DOTD standard plan CP-01 Detail B, with a 4-inch deep saw cut and a 1-1/2-inch widened cut for the backer material and sealant. The cracks below the saw cut extend full-depth into the concrete, indicating that the joint functioned as designed.

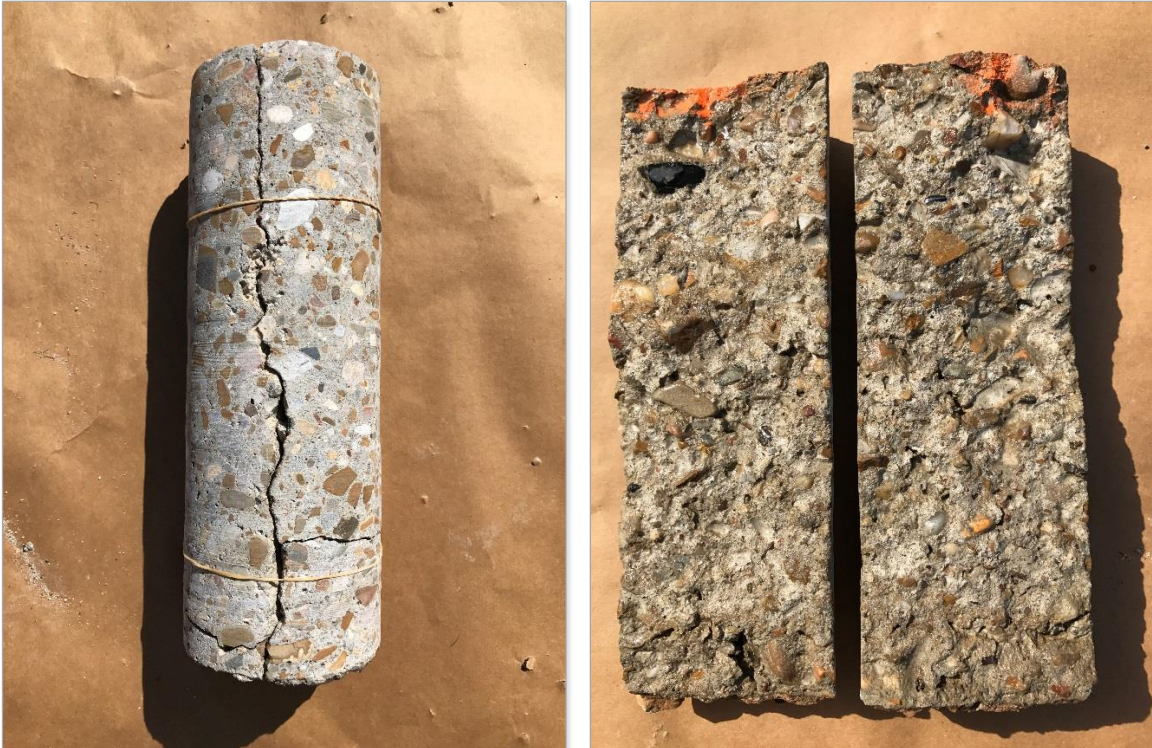
Figure 7: Cores from the Longitudinal Joint

Figure 7 shows pictures of cores obtained over the longitudinal crack. The concrete in the core appears to be uniformly distributed, showing no evidence of aggregate segregation or vibrator trails. There is no evidence of excessive entrapped air voids.

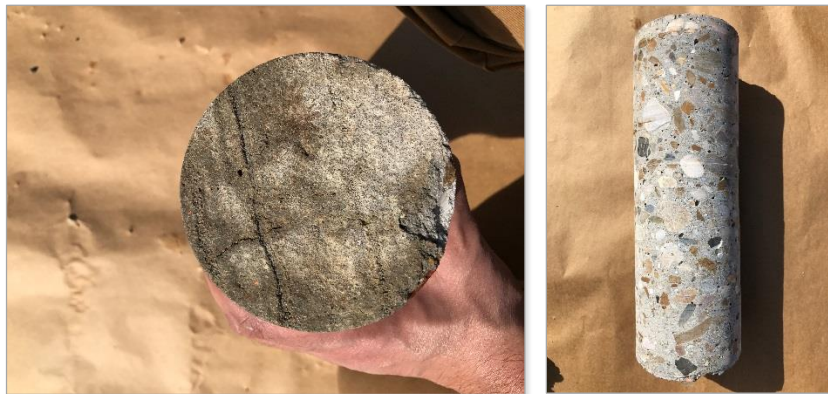
Figure 8: Core from one of the Replacement Panels

On the roadway, the longitudinal crack extends over a length of 21 panels, with replacement panels on both ends of the crack. However, the longitudinal crack does not extend into the replacement panels. Close observation by the district personnel revealed a small crack on one of the replacement panels and a core was extracted at that location. However, visual observation of the core showed that the crack did not extend full depth into the concrete (Figure 8).

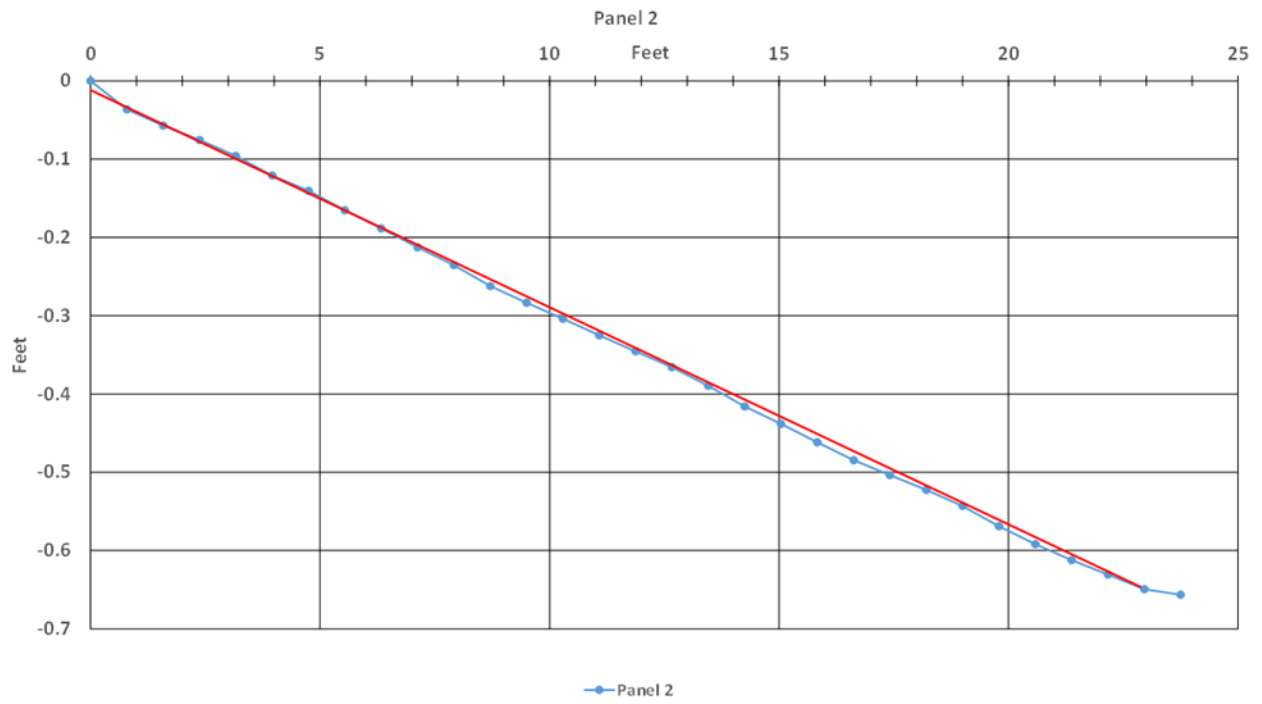
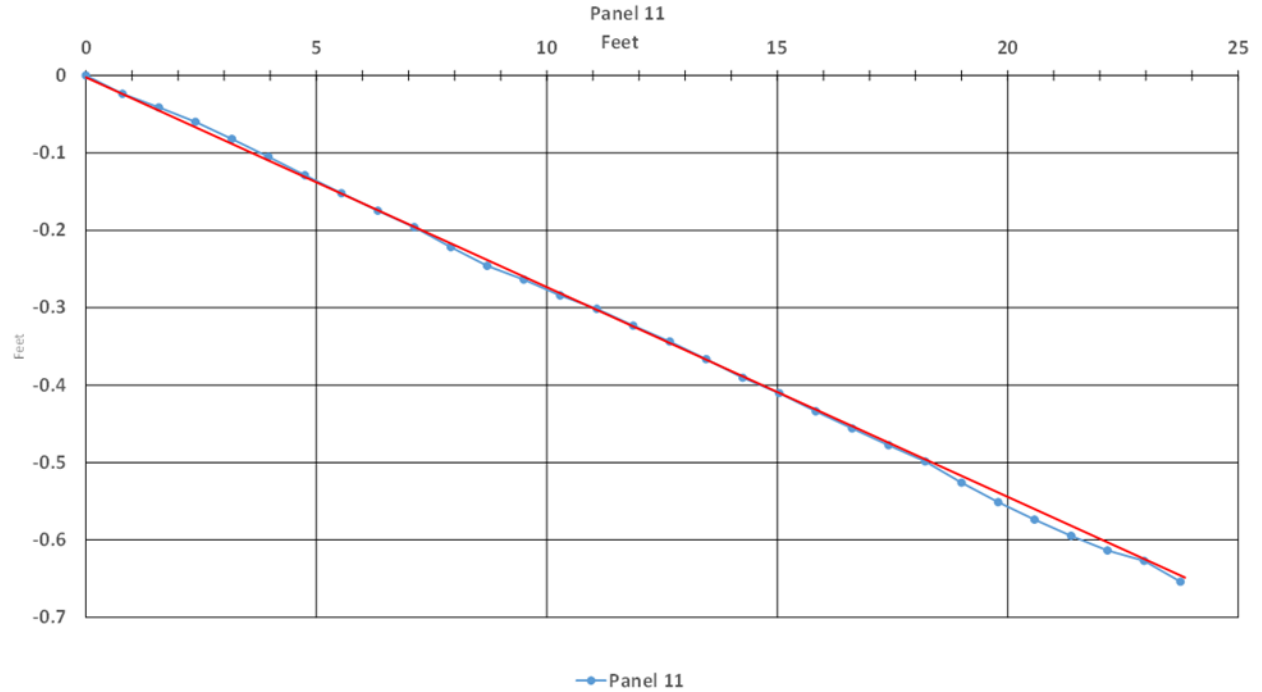
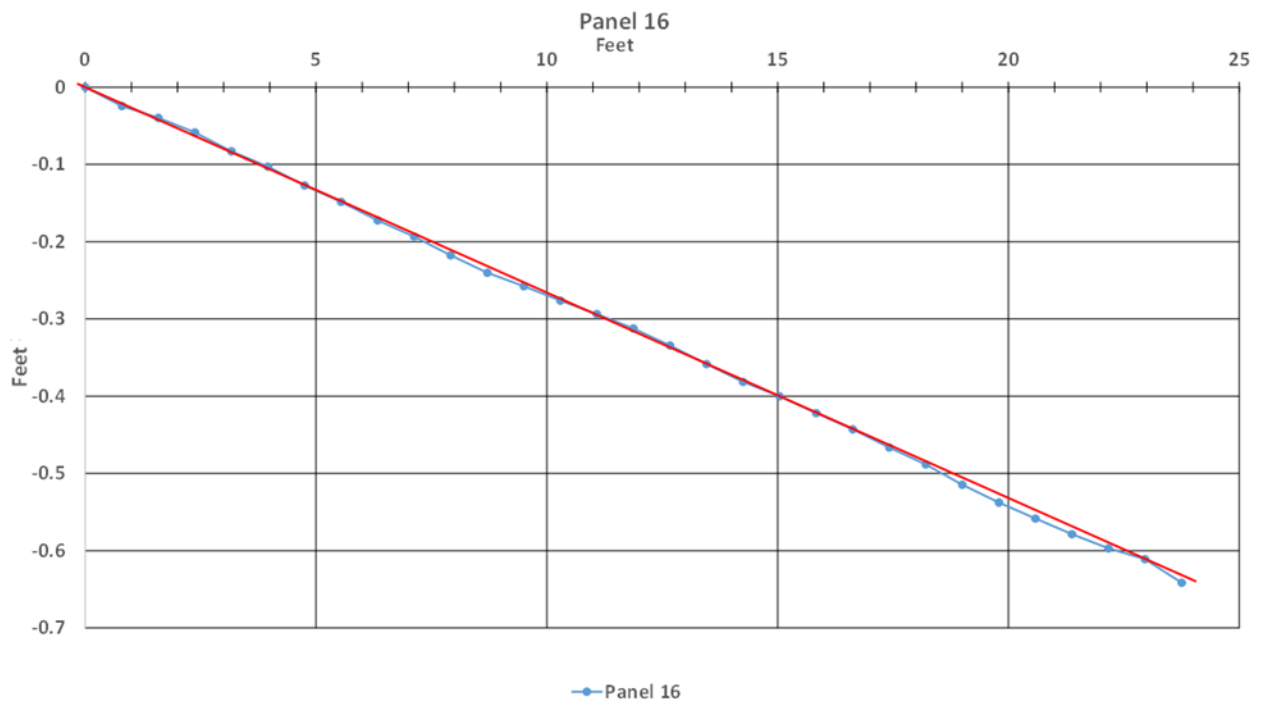
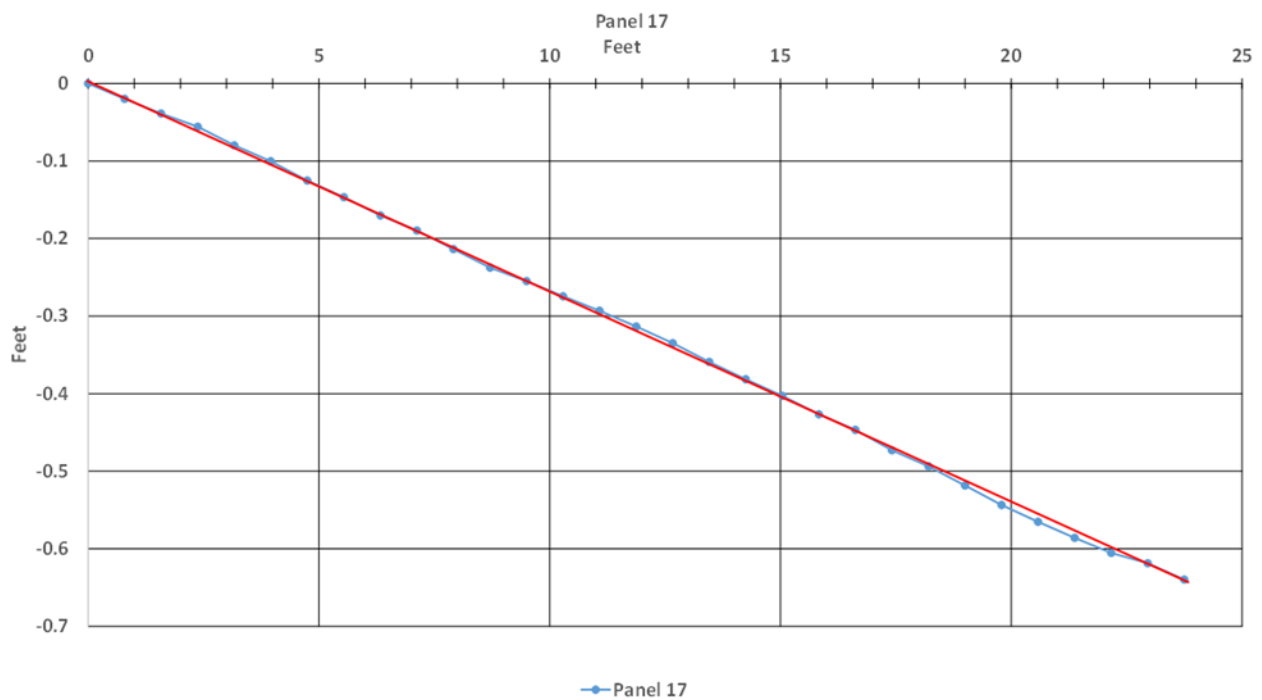
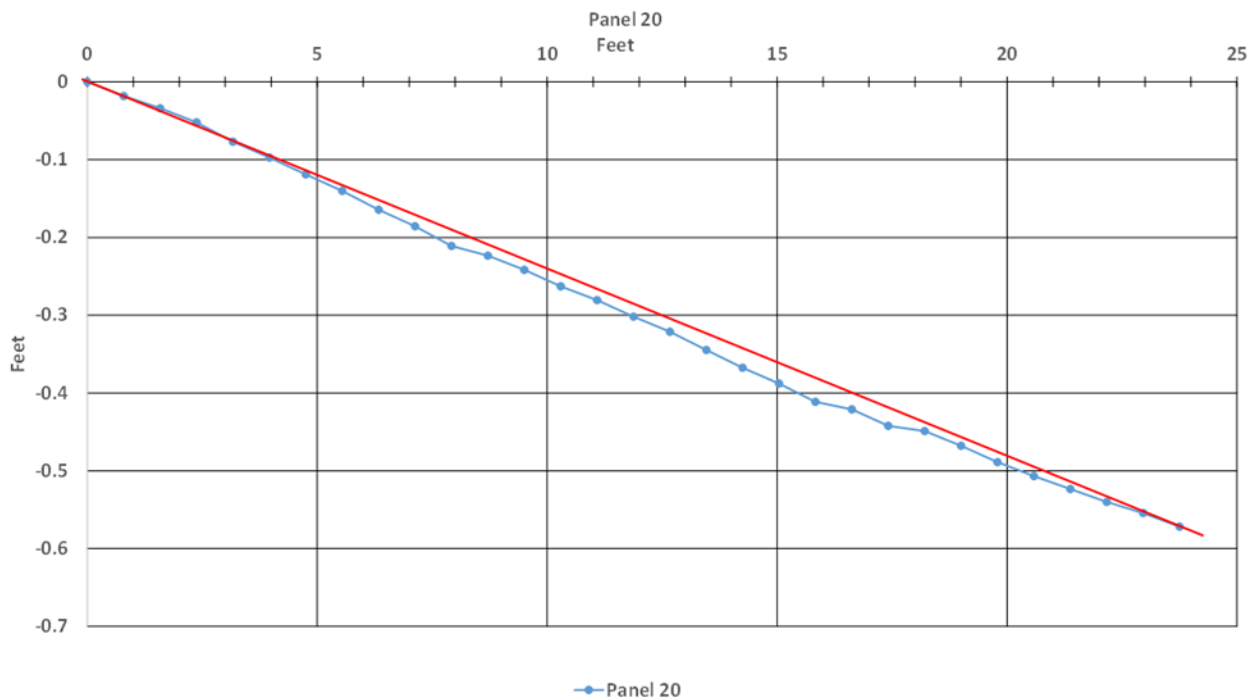
The walking profiler was used to measure changes in the cross slope of the pavement at panels, 2, 11, 16, 17, and 20 and the results are presented in Figures Figure 9 through Figure 13. Measurements began at the inside edge of the inside lane and ended near the outside edge of the outside lane. Rumble strips interfered with taking of readings on both shoulders. The blue line represents walking profile data while the red line represents the theoretical pavement surface, which should be straight from lane edge to lane edge in areas outside of horizontal curves and transitions. All panels were outside of curves and transitions. Most of the panels showed a slight depression occurring in the outside panel. The longitudinal crack was at 15 ft. The results indicated that some movement had occurred in the outside lane.

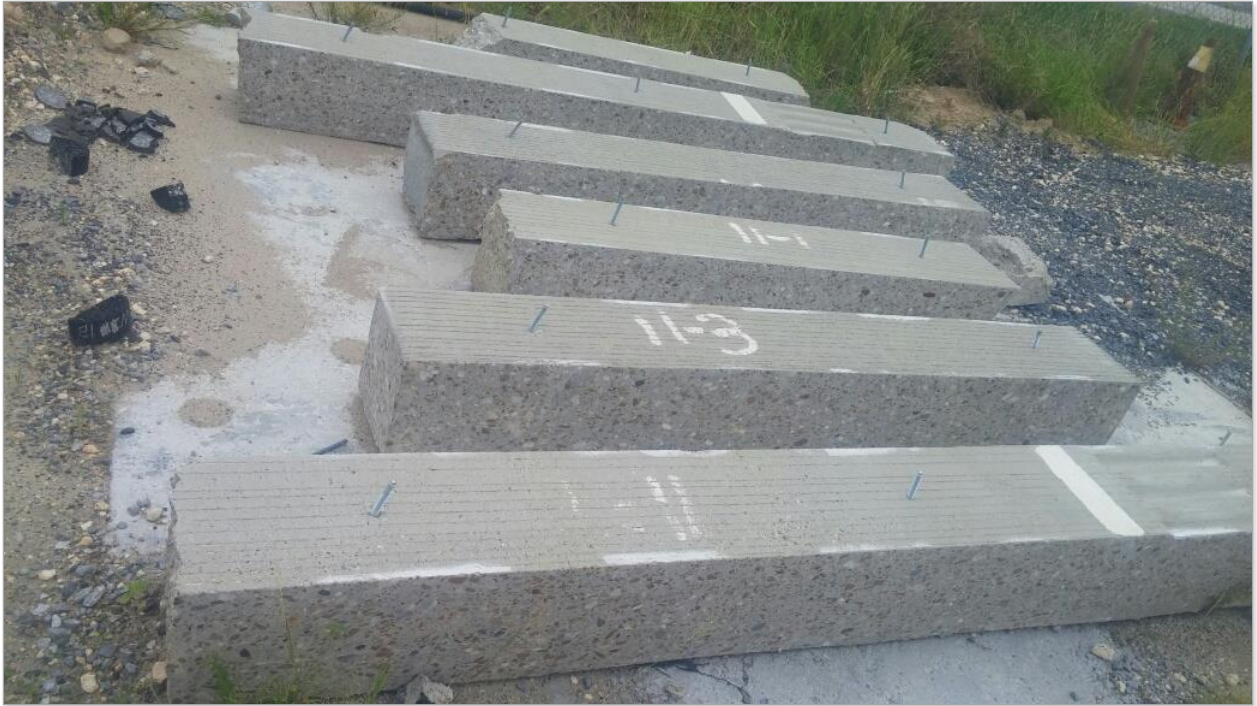
Figure 14: Concrete cross section

- The concrete showed no segregation or abnormalities thought the depth or cross section (See Figure 14);
- The 4-inch granular layer was cracked directly below the pavement crack (See Figure 15); and
- The soil cement was cracked approximately 10-15 inches toward the centerline of the pavement compared to crack within the pavement (See Figure 16).

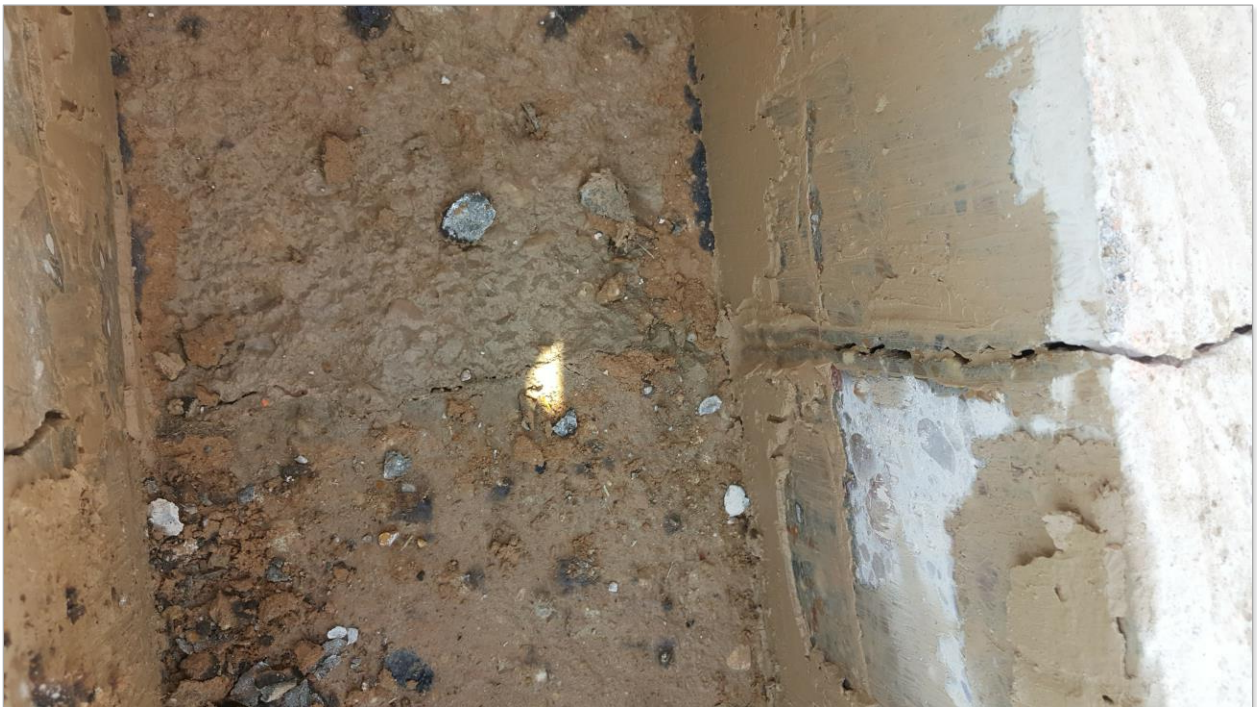
Figure 15: 4-inch granular crack

These results show that the cracking is most likely top down and is behaving like a cantilevered beam with the weaker soil cement layers failing at shorter distance from centerline versus the stronger concrete layer failing at the longer distance from centerline as expected.
