Report No.  
SSRP-16/12

**Evaluation of Durability and Wear Characteristics of  
Viscous Fluid Dampers for Seismic Bridge Retrofits  
with Significant & Sustained Traffic Loadings**

**Santiago Creek Damper Tests**

Final Report.

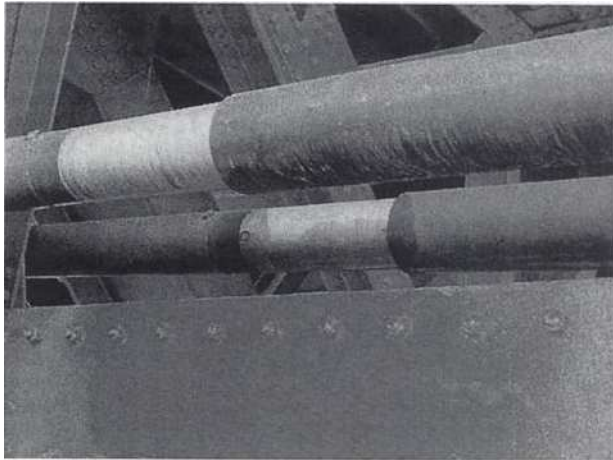
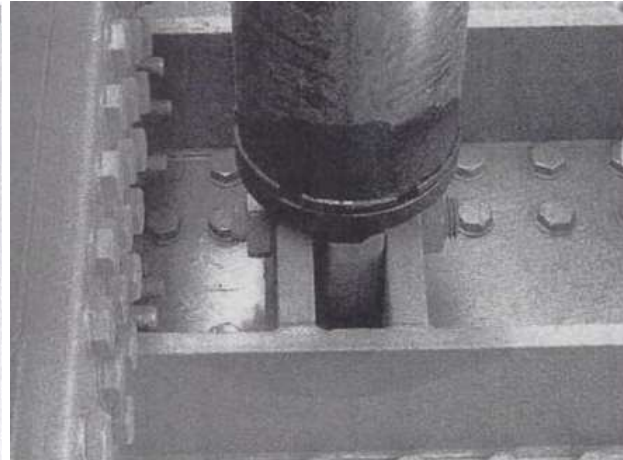
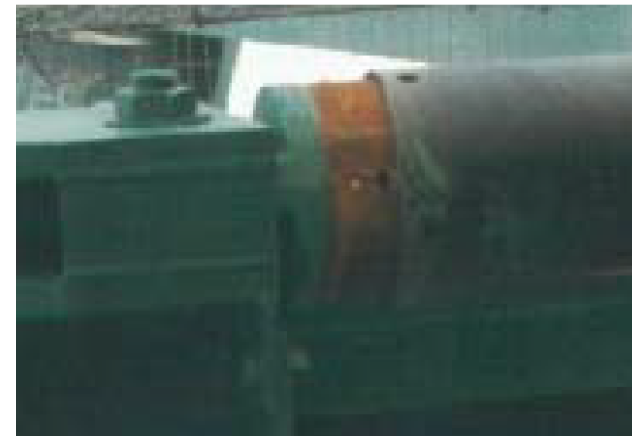
Figure 1. Evidence of fluid leaking in 200K ip dampers installed on Vincent Thomas bridge. a) Leakage at midsection of bottom dampers tower – deck connection, b) Leakage at clevis at the tower connection, c) Sheared bolts on the damper protective covers at the truss connection and sliding of the cover away from the clevis connection. VTB provided the first detailed examination of the in-service problem of leaking dampers.

Evidence of such leakage may indicate the damper service environment is largely different from what was originally expected [2] with consequences of subjecting the damper assembly and seals to accelerated wear. The damper construction incorporates a series of static and dynamic seals – that may degrade under the actual live loads. The question of seal selection and wear follows from observations that live traffic load induced deflections are of larger amplitudes and higher frequencies than the dampers were expected to experience. In the case of VTB, the vendor’s design “ambient vibration” was established at 6 million cycles per year at 0.2 Hz, 0.05 inch double amplitude [3] for total travel of 5 miles/year. Documented “ambient” vibrations at the site in 2001 were closer to 0.1 inch peak amplitude at 0.4 Hz, with spikes correlating to heavy truck traffic up to 0.5 inch peak amplitude. Thus, the dampers are experiencing substantially larger ambient motions than anticipated in the design. Despite concurrence with the general idea that larger live loads may be contributing to leakage – inspection evidence reveals several anomalies. For example in Figure 1a we examine the two 200Kip dampers installed side by side at the same tower – main deck truss connection. This adjacent installation guarantees that both dampers are subjected to similar in-service environment but only one was observed to be leaking. We surmise that other factors, for example, the specifics of construction, installation protocol or installation anomalies may also be a contributing factor. The need to replace and re-evaluate these dampers has prompted an earnest investigation of specific causes and possible remedial measures.

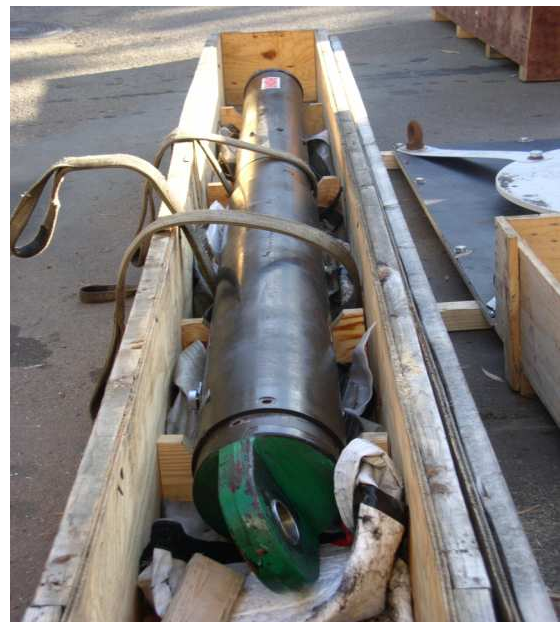
**Figure 2.** VTB 200 kip damper SN#009 as received at UCSD. Note displaced and rotated sleeve cover due to sheared bolts.

all damper fluid. As a prior example from the field failures, Figure 2 shows a recovered VTB damper with a stripped sleeve with a complete loss of damper fluid.

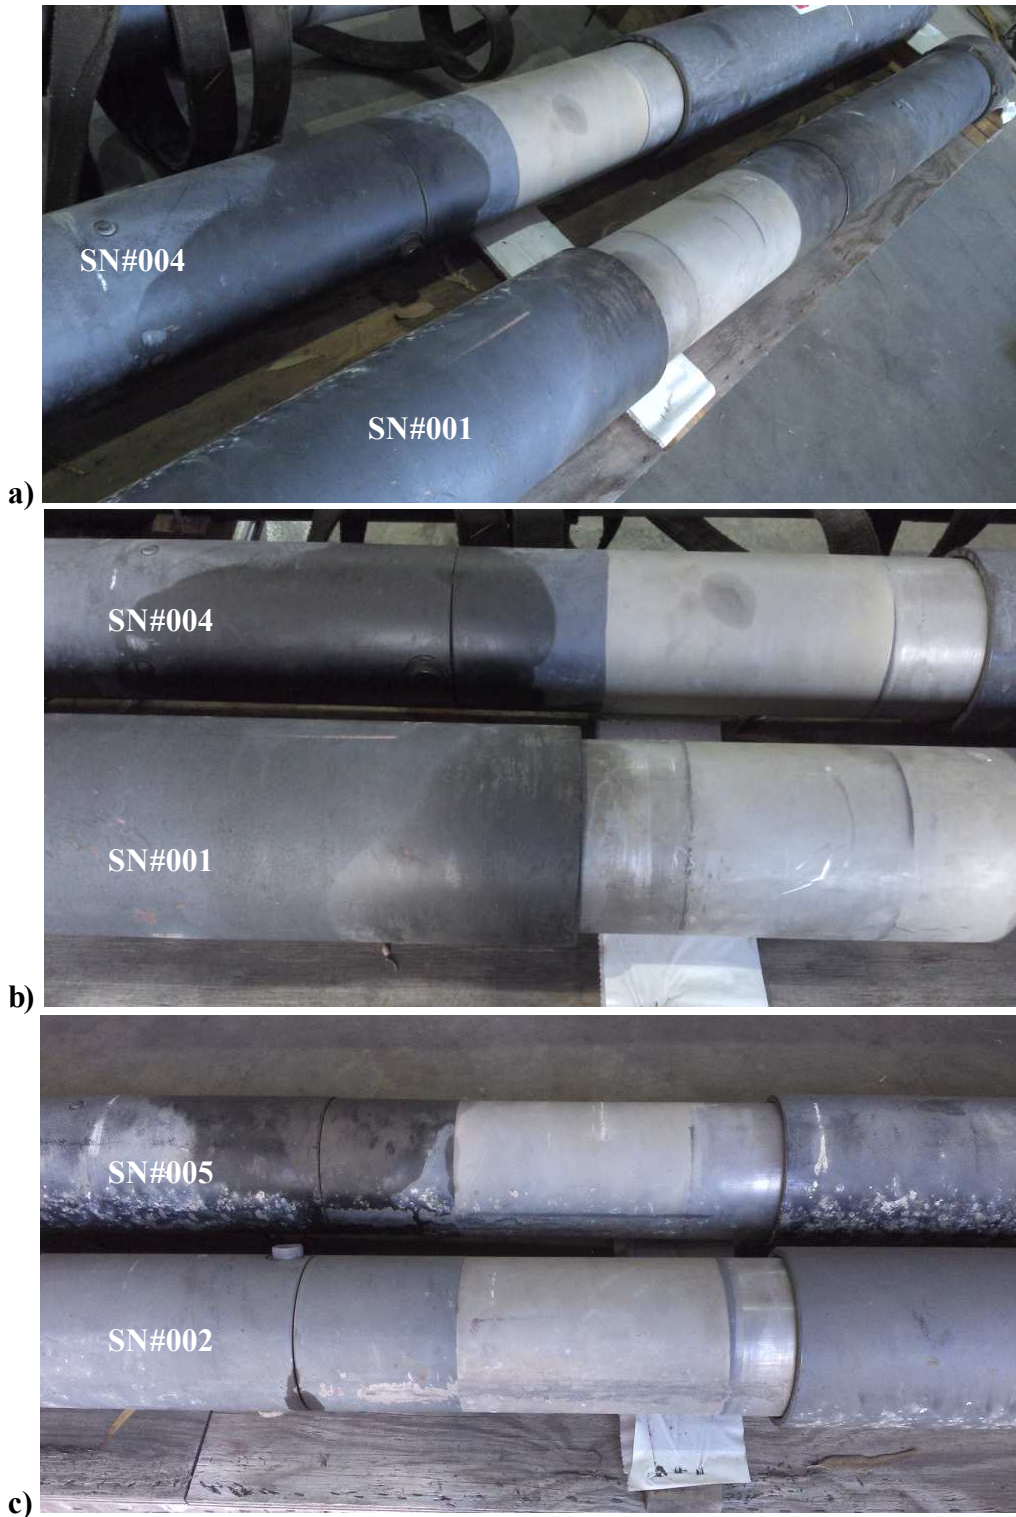
Figure 4 shows close-up view of the leakage in several dampers. In Figure 4(a),(b) SN#004 is leaking at the threaded connection (E) only while SN#001 also shows weepage at the sleeve cover (C). Looking back to the construction detail, traces of fluid leak at (C) most likely originate from the front bearing failure. Figure 4(c) shows wide disparities in observed leakage in different dampers. Another comparison is shown in Figure 5 for SN#002 and SN#005 where the former looks relatively clean, figure 5(a), and the latter appears to be leaking profusely, figure 5(a), (b). SN#005 condition was to be poor on account of the large stain at the threaded connection (E) with additional leak stains at the clevis/ tang – perhaps indicative of leakage at the rear bearing or the reservoir chamber, Figure 5(c).

Any weepage observed on the sleeve cover, and at the tangs is taken to be direct evidence of bearing damage – as the only viable leak path originates from the bearings. Leakage at the threaded connection is somewhat deceptive as the leak path does not traverse any seals, bearings and could stem from construction defects. *We note that thread sealants are employed during the assembly process and these may become embrittled and crack under repeated service loading.*

**Figure 4:** Inspection of as-received Enidine dampers recovered from Santiago Creek. a) Leakage at the thread in SN#004 and leakage at thread and seepage at sleeve cover in SN#001, b) Close up view of leaks in (a); c) Varying degrees of thread leakage in SN#002 and SN#005. No seepage observed in either damper SN#002, SN#005 sleeve covers.

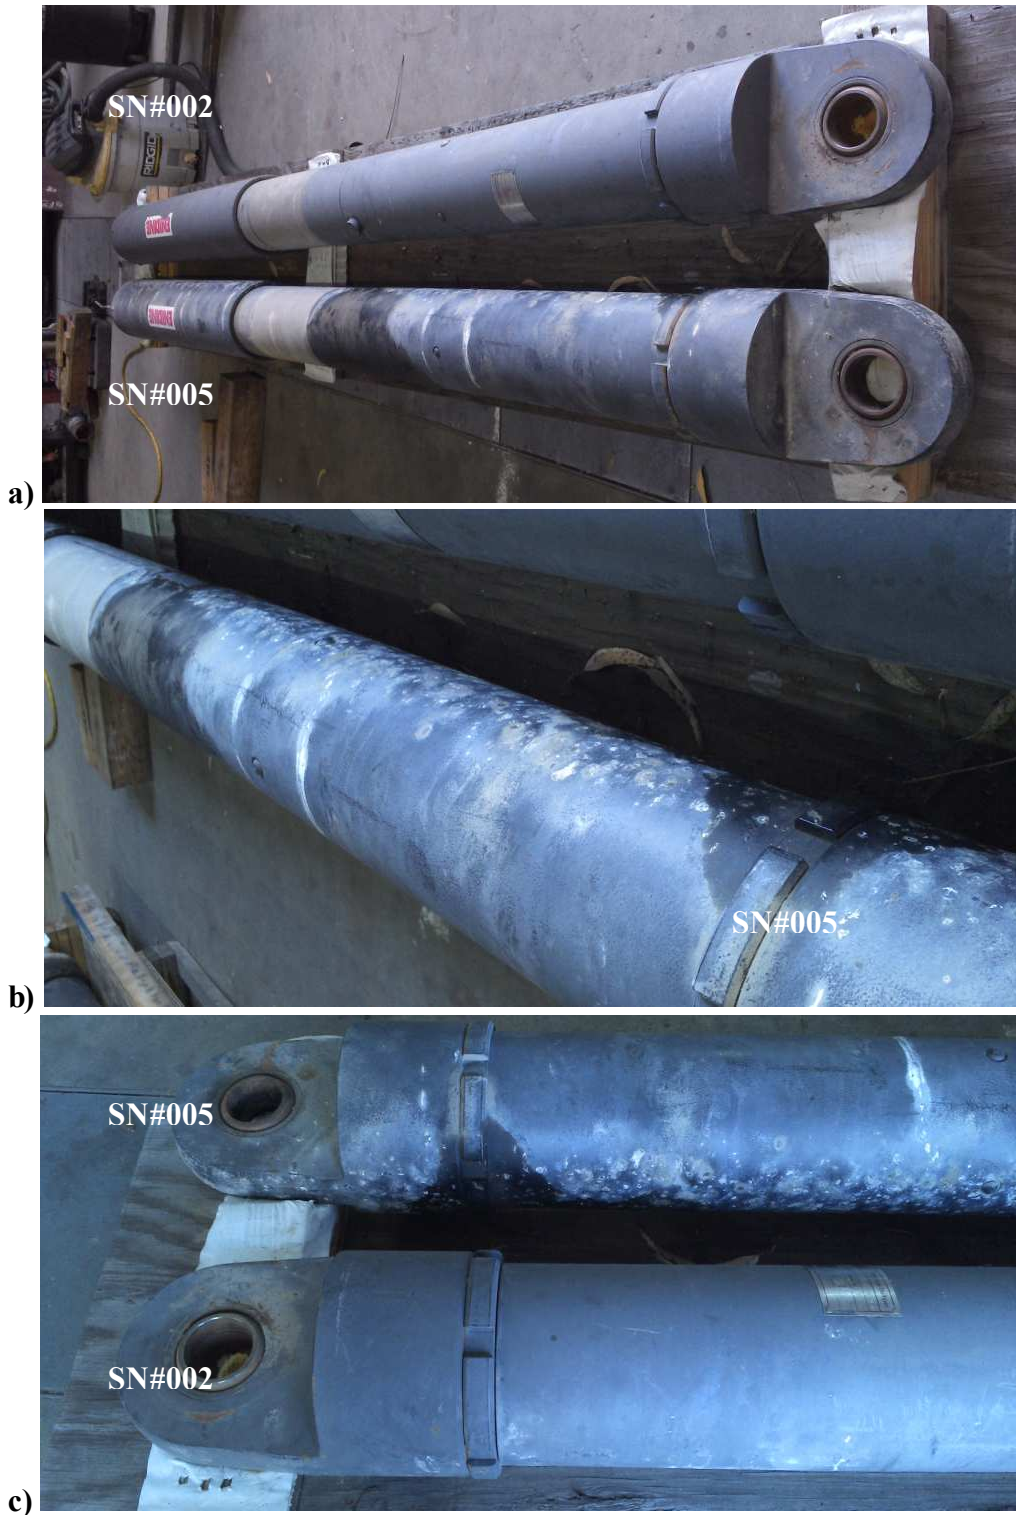
**Figure 5:** Comparative visual examination of dampers SN#002, SN#005. a) Damper 002 (top) is reasonably clean but 004 (bottom) shows profuse leakage at threaded joint and at clevis/tang connection. b) close-up of leakage at tang connection, c) comparison of 002 and 005 tang.

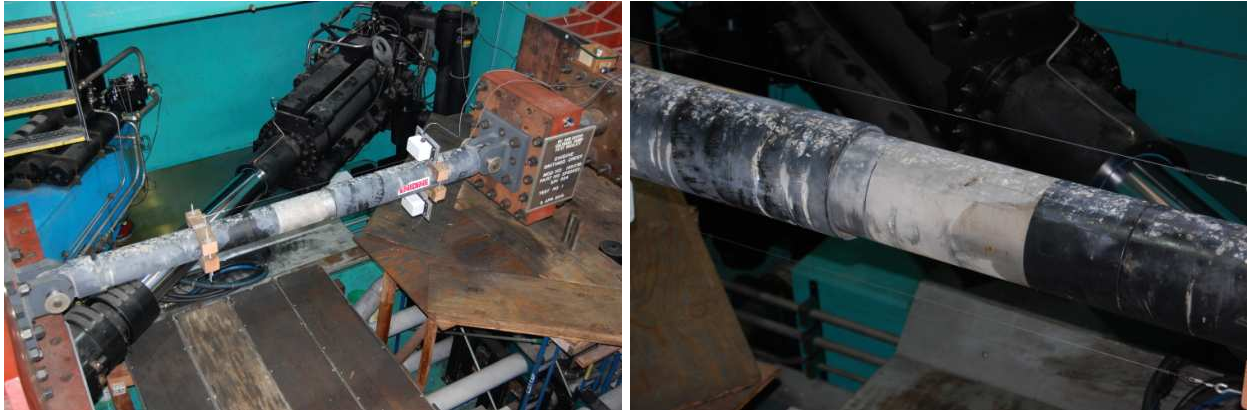
**Figure 7.** Overview of SN#004 as mounted for testing and leaking at the threaded connection.

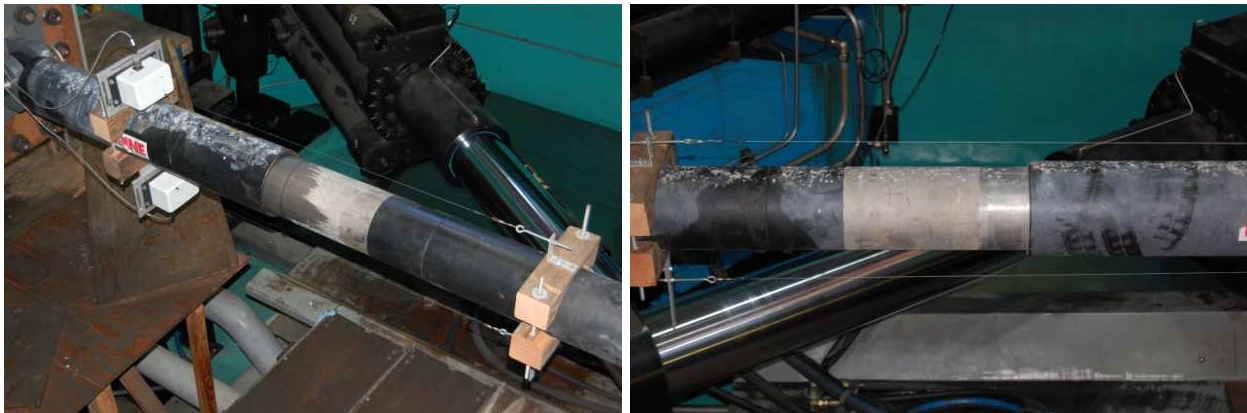
**Figure 8** a) SN#006 leaking at the sleeve cover, b) SN#001 leaking at the threaded connection

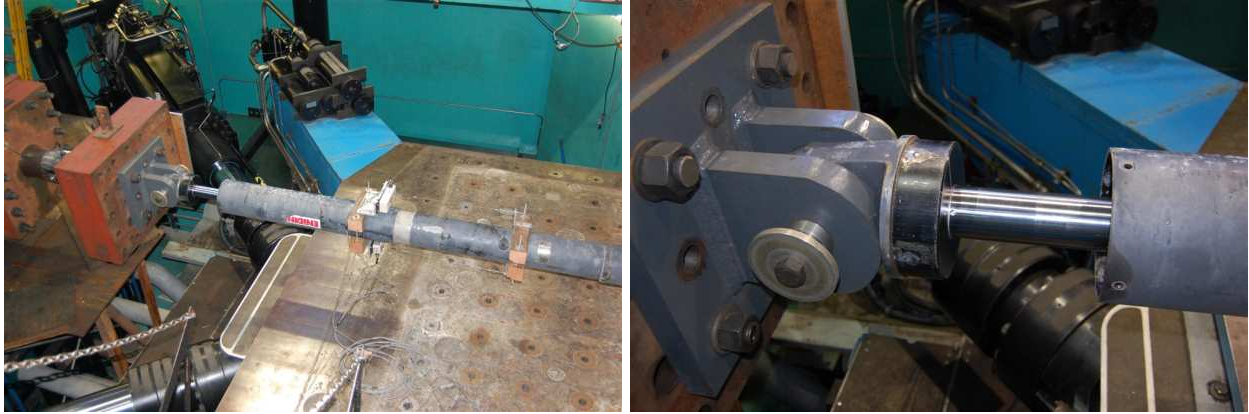
A noteworthy observation is the shear failure and stripping of the damper sleeve screws, occurring just prior to the onset of the 5<sup>th</sup> cycle, in SN#003, #004 and #006 dampers. Looking back, Figure 3 shows that the damper sleeve is affixed to the clevis via 4 screws (also labeled as location G). Similar stripping events are observed on VTB, Figure 1©, and in VTB recovered dampers, Figure 2. This shear failure is observed at the end of the compression cycle, during load reversal into the tension cycle, and just prior to the onset of the 5<sup>th</sup> cycle. This is evident from the near vertical force curve, at the end of the 4<sup>th</sup> cycle, at -11 in. displacement in Figure 9 for the SN#003, #004 and #006 dampers. Once the sleeve is stripped, no further displacement can be recorded from the sleeve mounted displacement sensor resulting in the vertical force curve.

Figure 13(a) shows an overview of the displaced sleeve cover as recorded at the conclusion of the 5 cycle test for SN#003 damper. Figure 13(b), shows the two sheared bolts that can be seen close up from this viewing angle. This sleeve stripping event allows a look into the cavity to explore the damper front bearing (Figure 3, location A). Figure 14(a) shows a clean sleeve interior and the front bearing for SN#003 damper and Figure 14(b) shows an oily sleeve interior typical of slight leakage at the front bearing. This fluid leakage condition assessment was indicated earlier in Table 1.

**Figure 13.** (a) Overview of stripped sleeve, and (b) close up of sheared bolts on SN#003 damper.

It is necessary to explore the origin and, more importantly, the impact of such sleeve failures on current test results and subsequent service. The sleeve failure derives from increased frictional events at the sleeve-cylinder interface and the binding of the sleeve to the telescoping cylinder column bending during the compression cycle. Open air damper installations cause weathering of the cylinder surface and debris accumulation can significantly increase the surface roughness leading to higher frictional loading. The binding effects are specific to initial construction tolerances in the damper build along with any subsequent wear that may further exacerbate the gaps between piston rods and bearings. A quantitative estimate of the binding and frictional forces necessary to cause complete shearing failure of the sleeve screws is

The impact of sleeve failure on current test result is discussed in the next section. Loss of sleeve cover in service will result in a loss of piston rod stiffness, thereby exhibiting greater bending, and result in significantly greater pressure and wear at the front bearing location. Such a failure will be deemed as a terminal event as this inevitably leads to bearing failure and loss of
