BR27568 – Experimental Shear Capacity Comparison Between Repaired and Unrepaired Girder Ends

Carol Shield, Principal Investigator

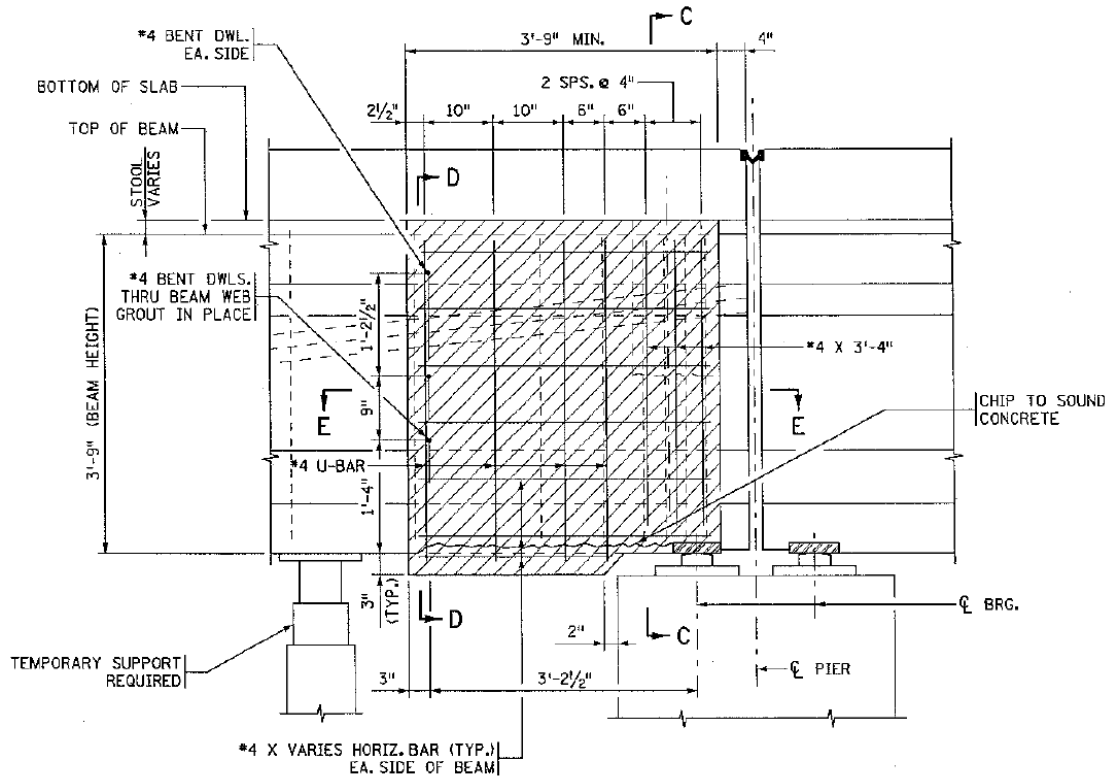
VIEW A-A
(EXTERIOR SIDE OF FASCIA BEAM)

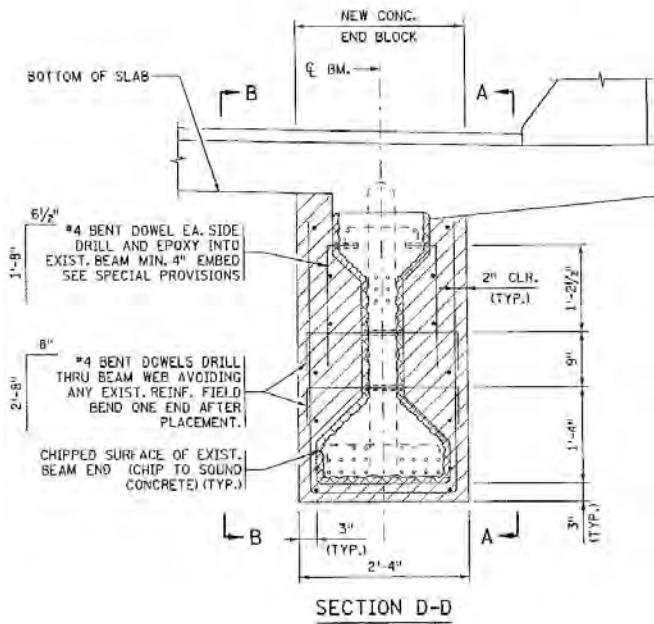
Figure 1.1 Repair – Elevation

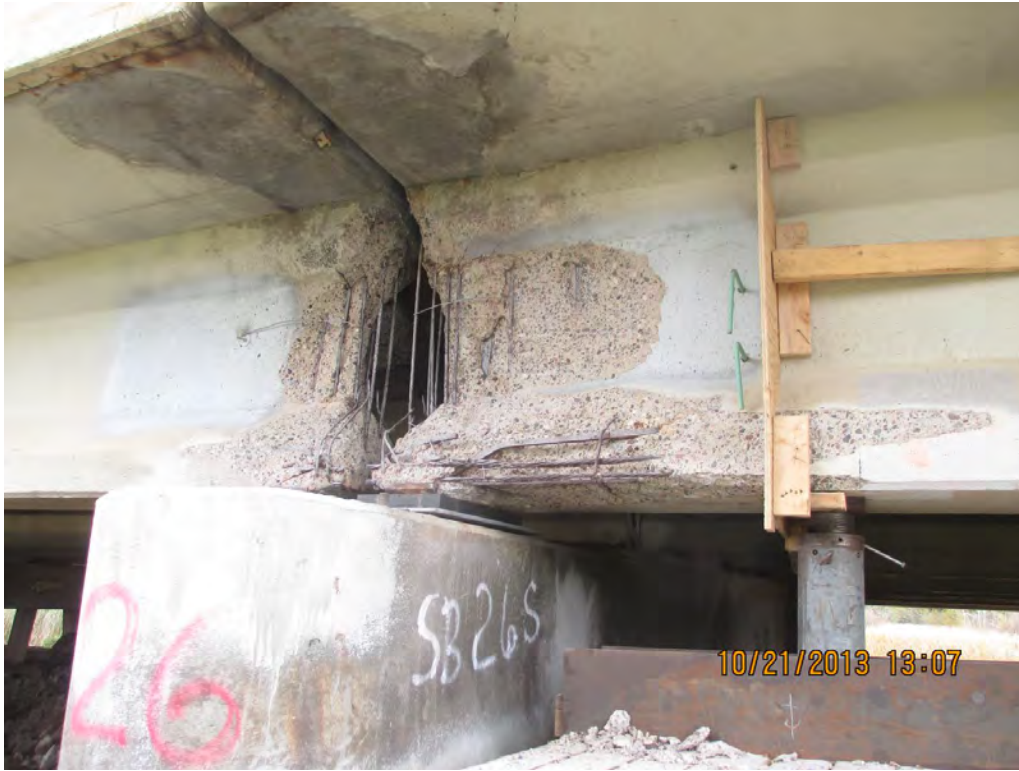
Figure 1.3 Severely corroded girder at Pier 26

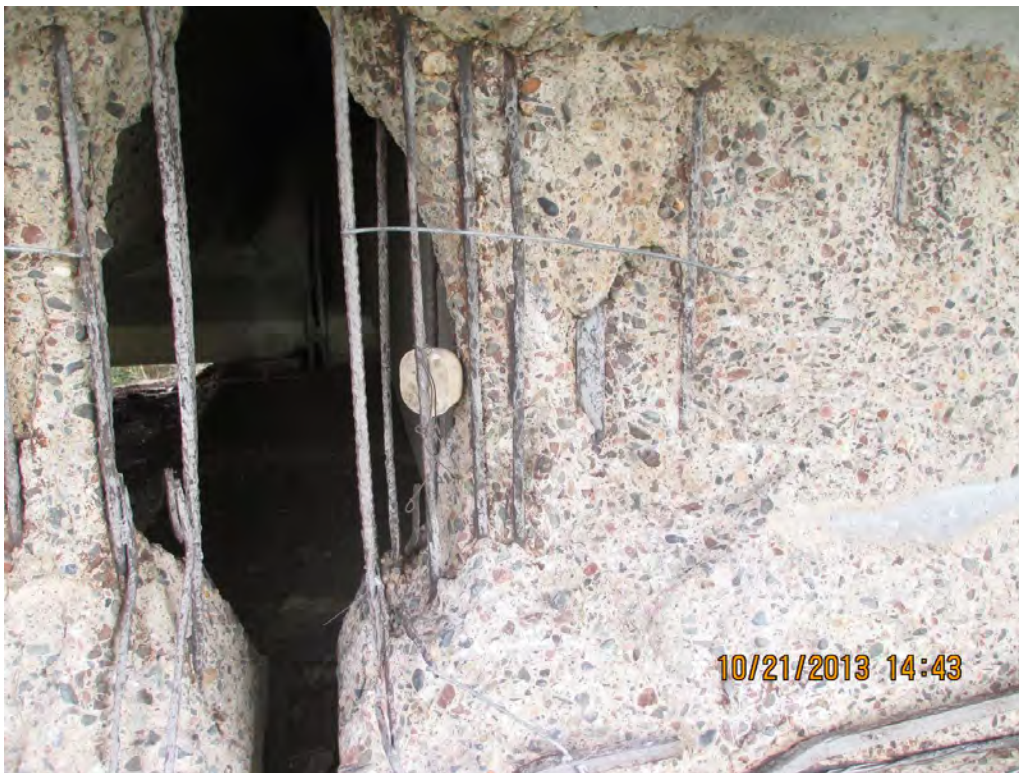
Figure 1.4 Damaged concrete and transverse reinforcement in girder at Pier 26

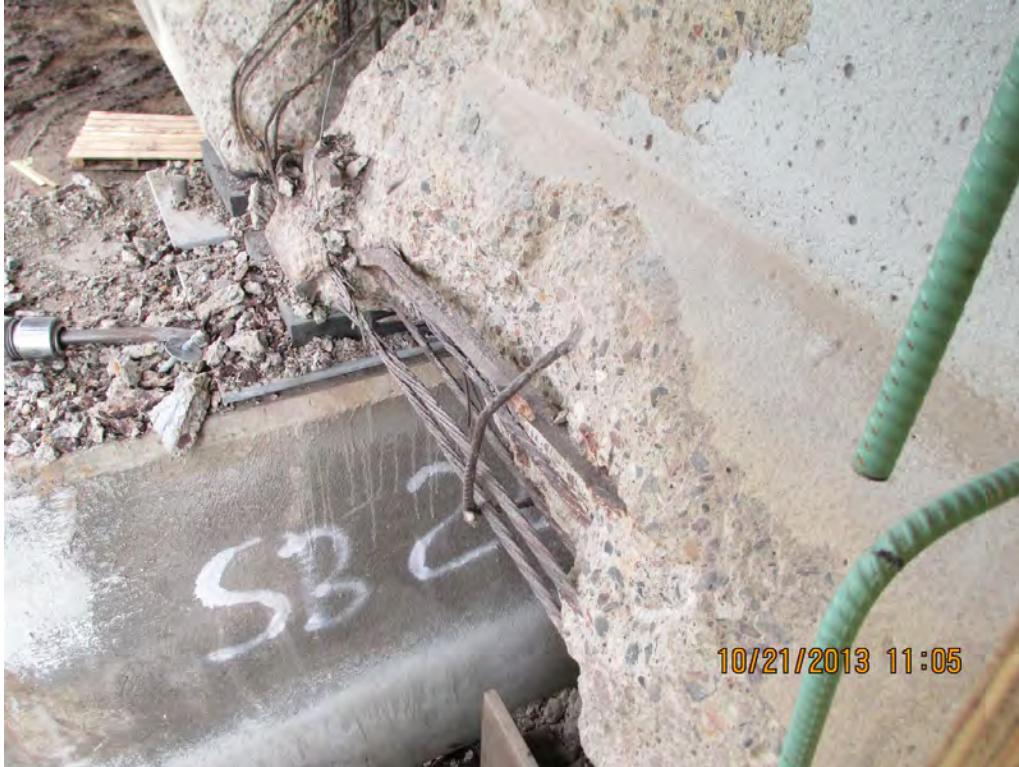
Figure 1.5 Exposed strand in girder at Pier 26

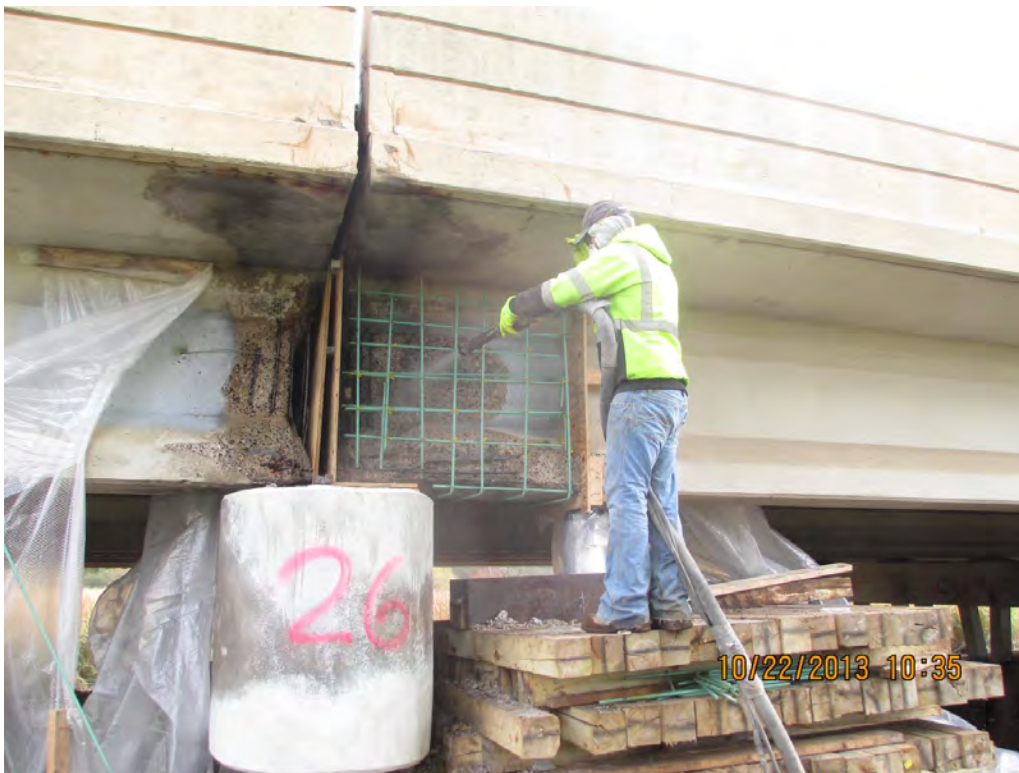
Figure 1.8 Shotcreting of repair on girder at Pier 26

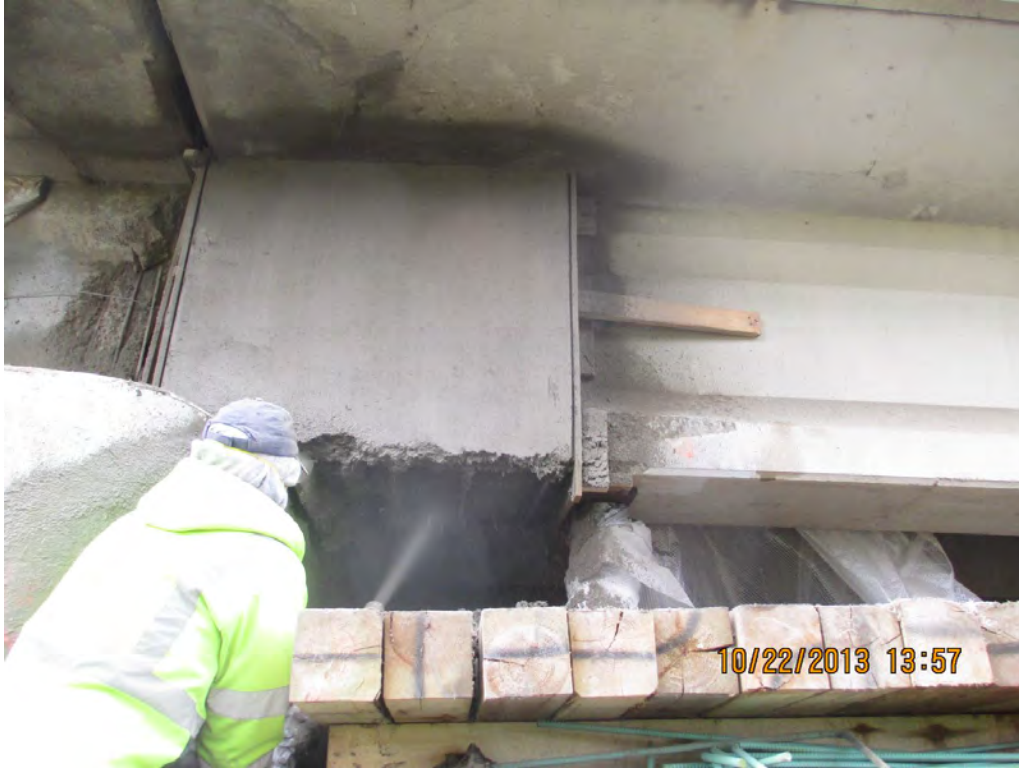
Figure 1.9 Shotcreting the bottom surface of the repair on girder at Pier 26

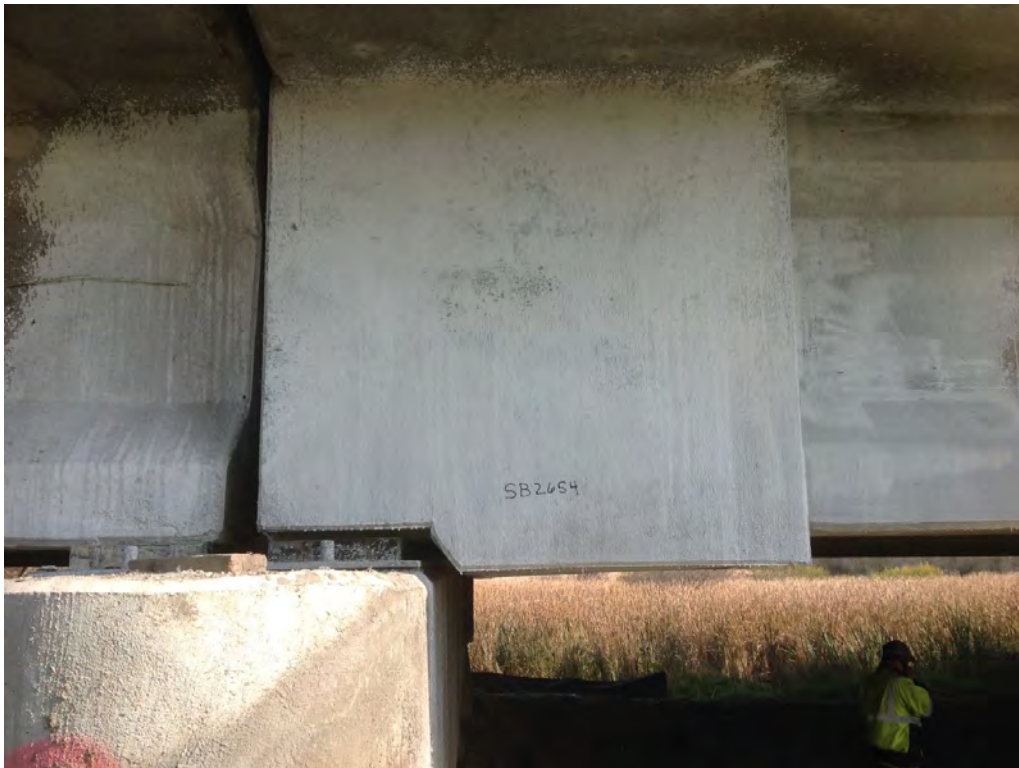
Figure 1.10 Finished repair on girder at Pier 26

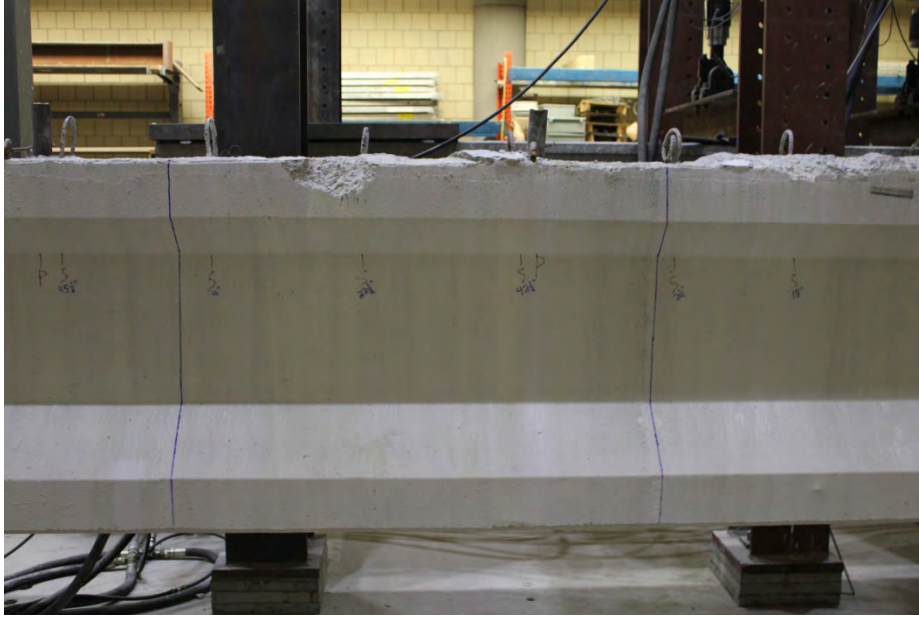
Figure 2.1 Typical top flange condition after slab removal

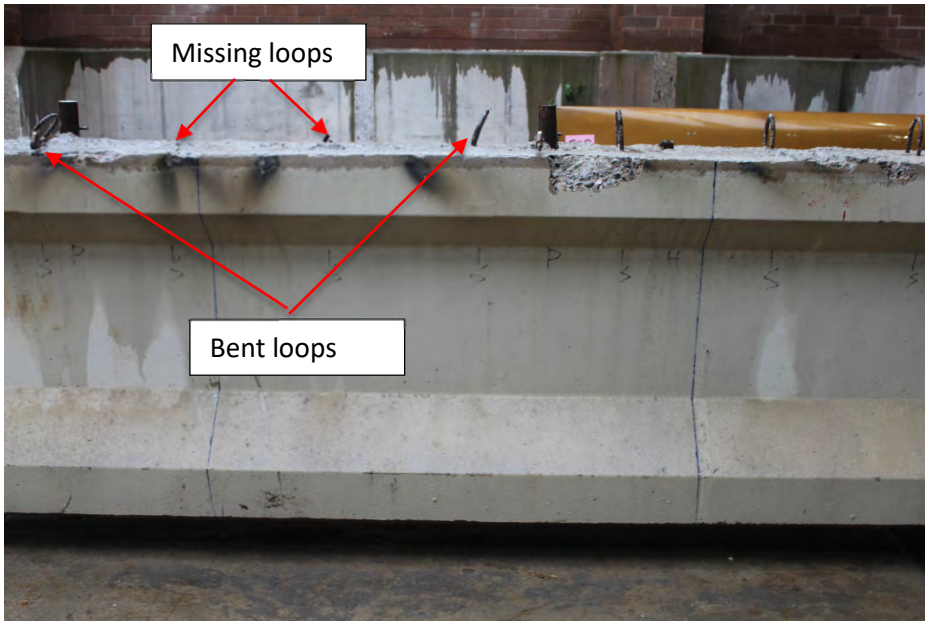
Figure 2.2 Damage to protruding part of transverse reinforcement Girder P2

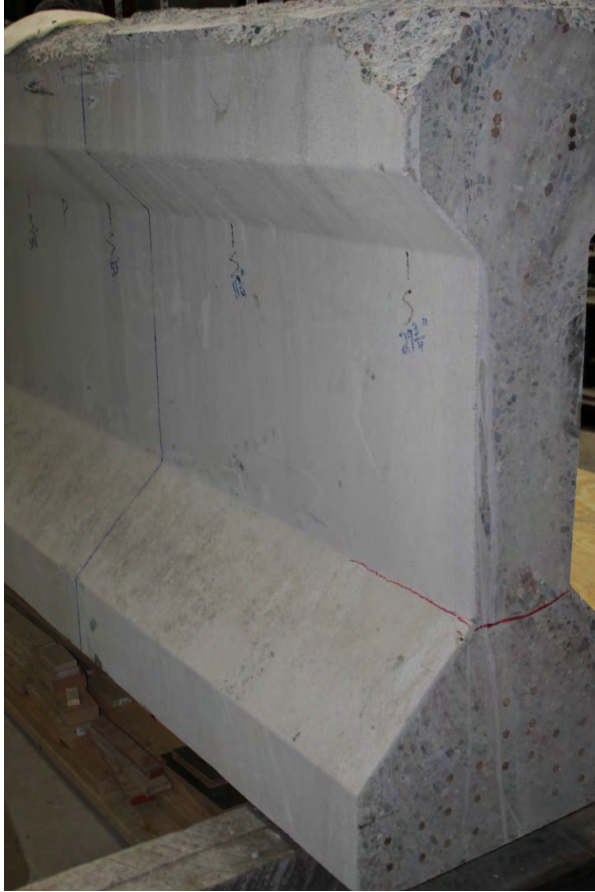
Figure 2.3 Typical cut-end horizontal crack in Girders P2, P4, and P26 (marked in red)

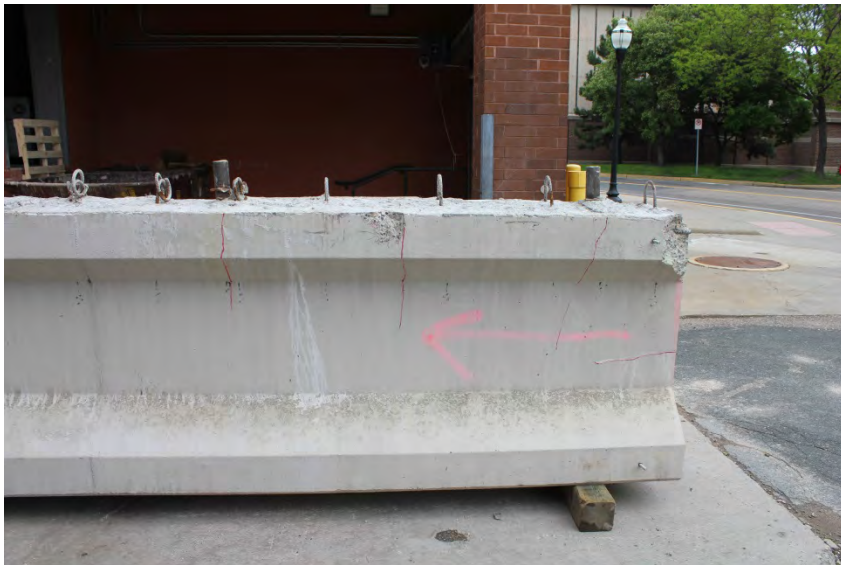
Figure 2.4 Girder P24 cut-end cracking

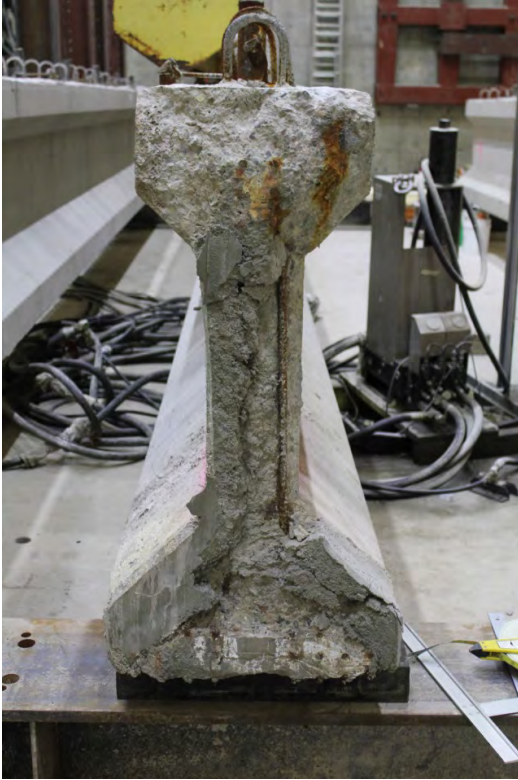
Figure 2.5 Corrosion of transverse reinforcement at the end of interest on Girder P24

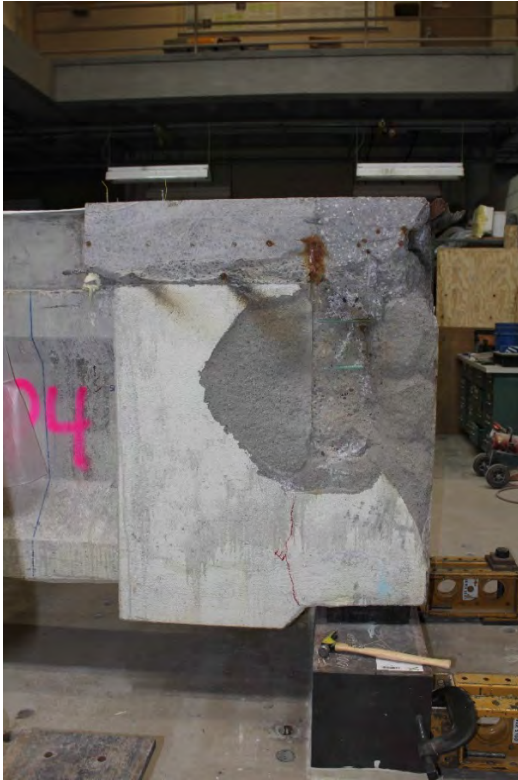
Figure 2.6 Damage to the repair on the diaphragm side of Girder P4

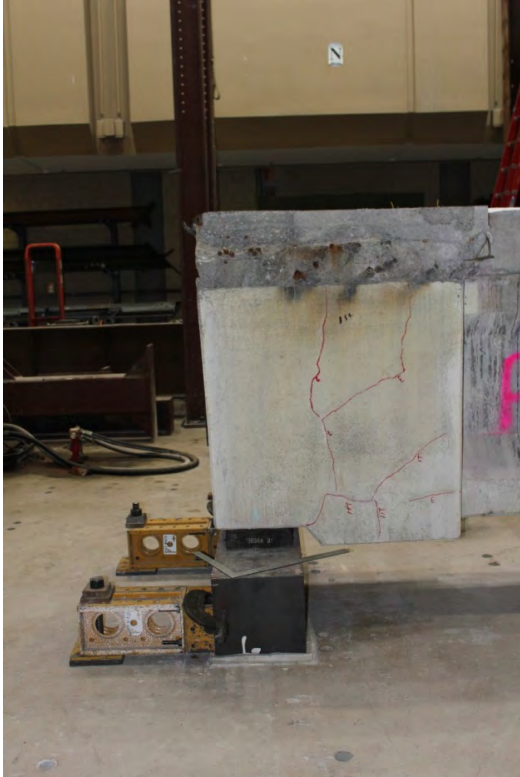
Figure 2.7 Girder P4 as-received cracking on the exterior side at the repaired end

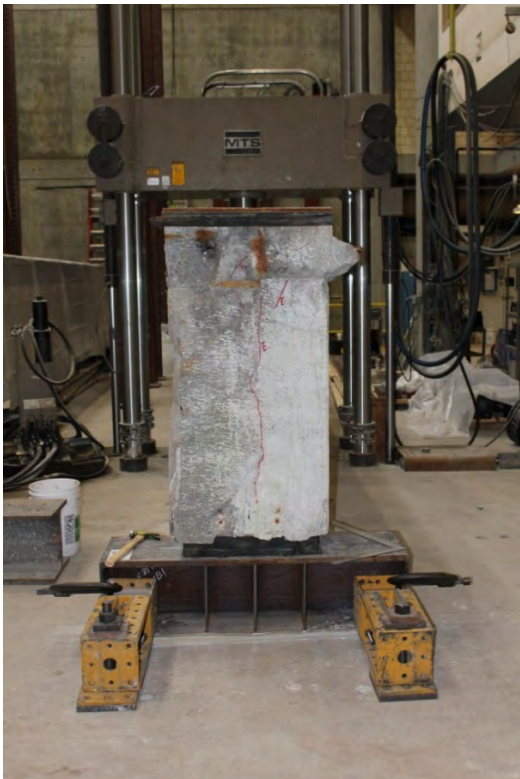
Figure 2.8 End view of Girder P4 (repaired end)

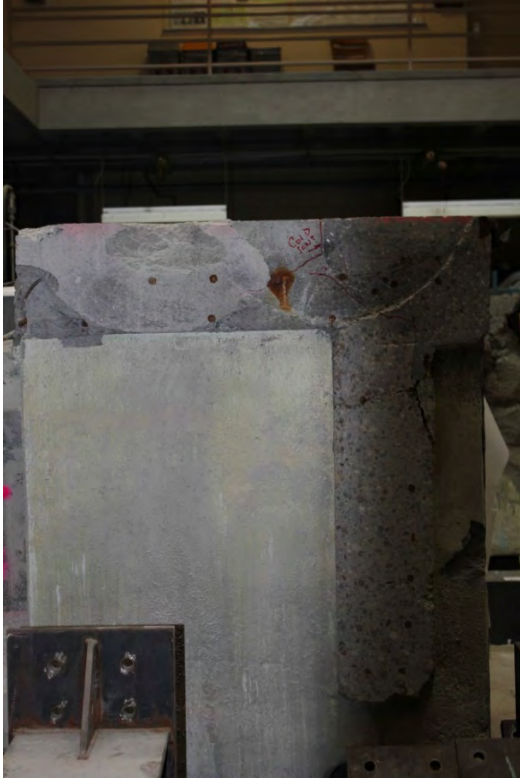
Figure 2.9 Girder P26 on diaphragm side

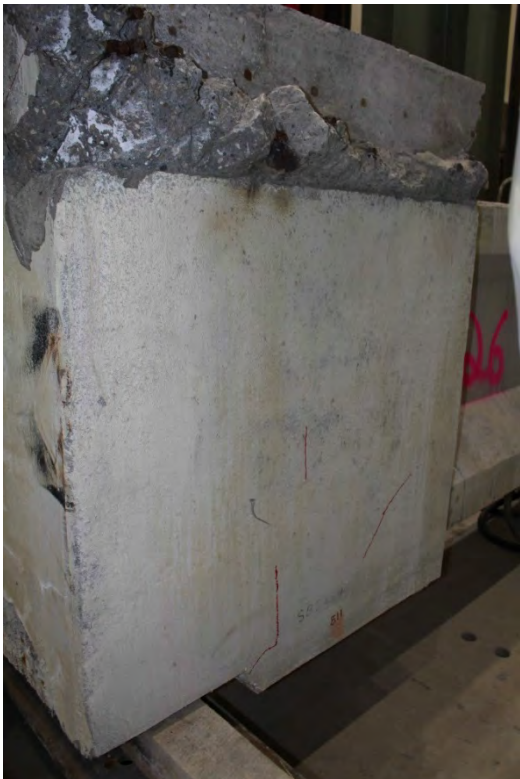
Figure 2.10 As-received cracking on Girder P26 on exterior side

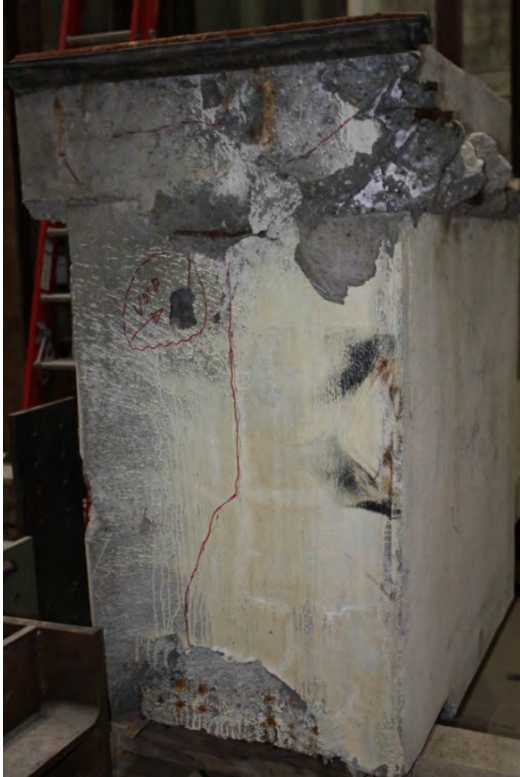
Figure 2.11 Girder P26 end condition

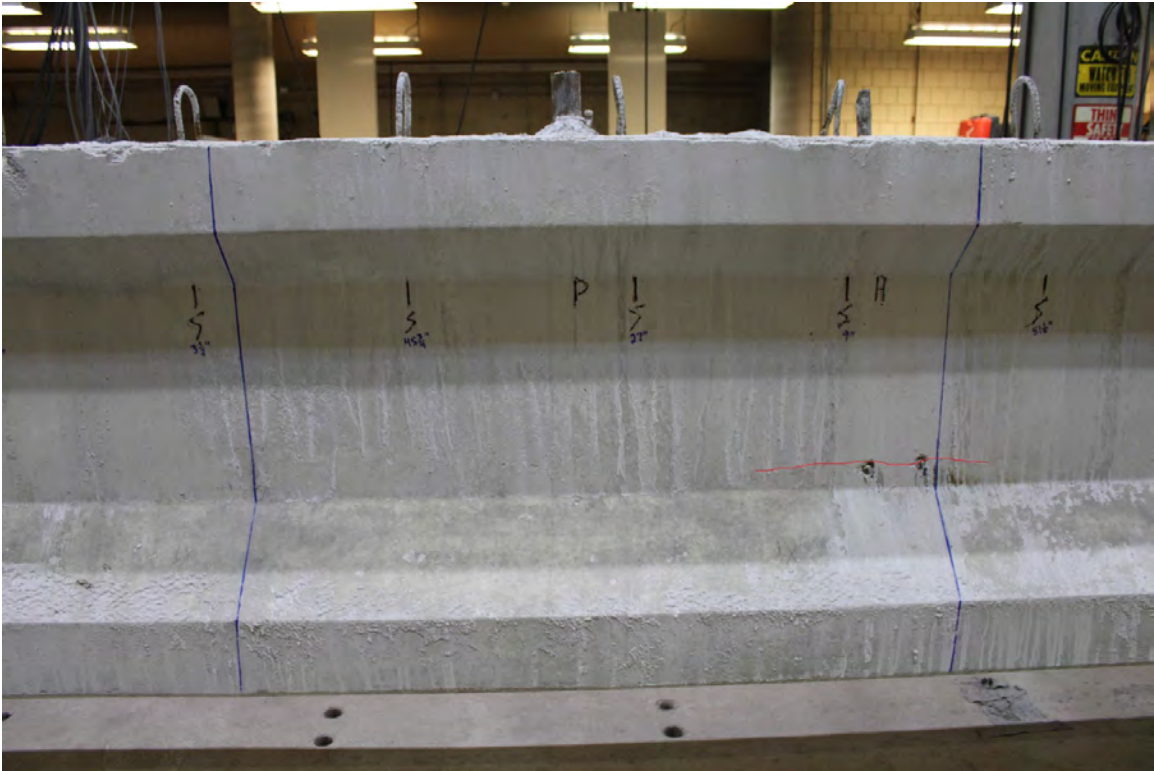
Figure 2.12 Typical horizontal crack near the diaphragm connection

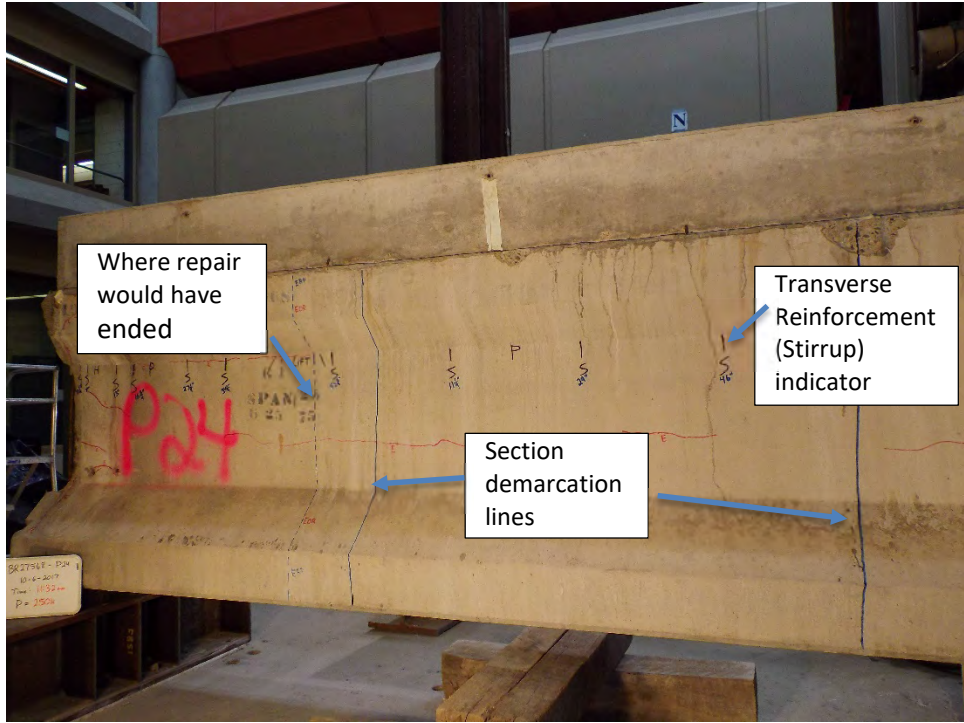
Figure 3.5 Girder P24 prior to testing showing solid blue lines dividing the girder into sections, a dashed blue line in the end section indicating where the repair ended on Girder P26, and the location of the transverse reinforcement

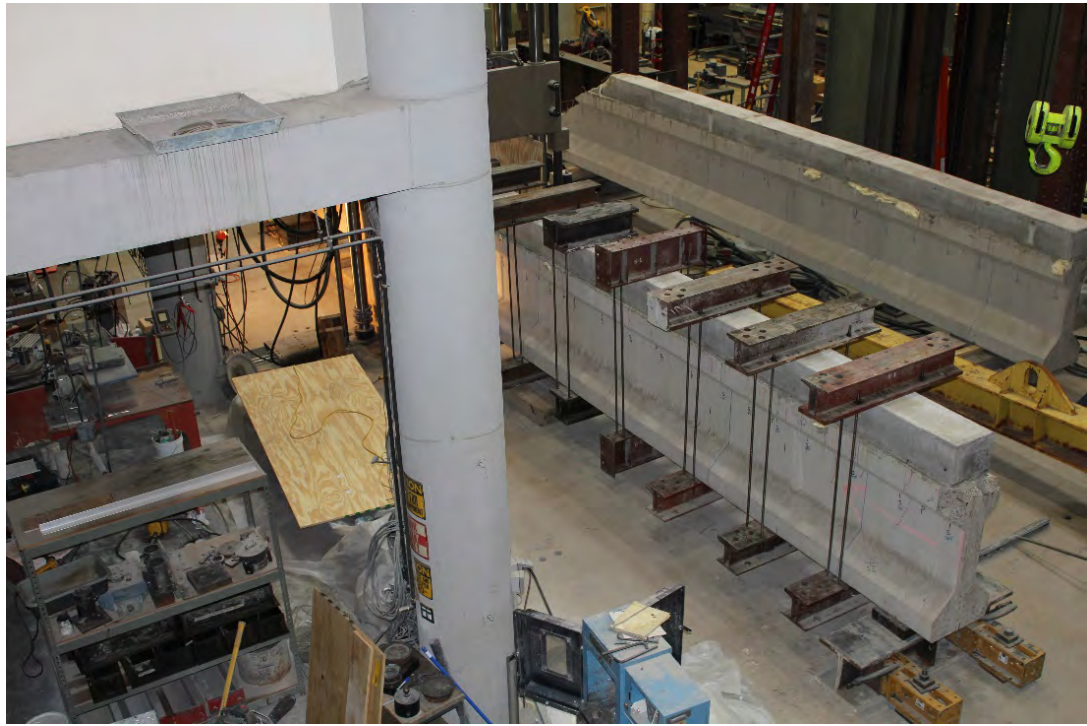
Figure 3.6 External shear reinforcement located between load point and cut end of girder

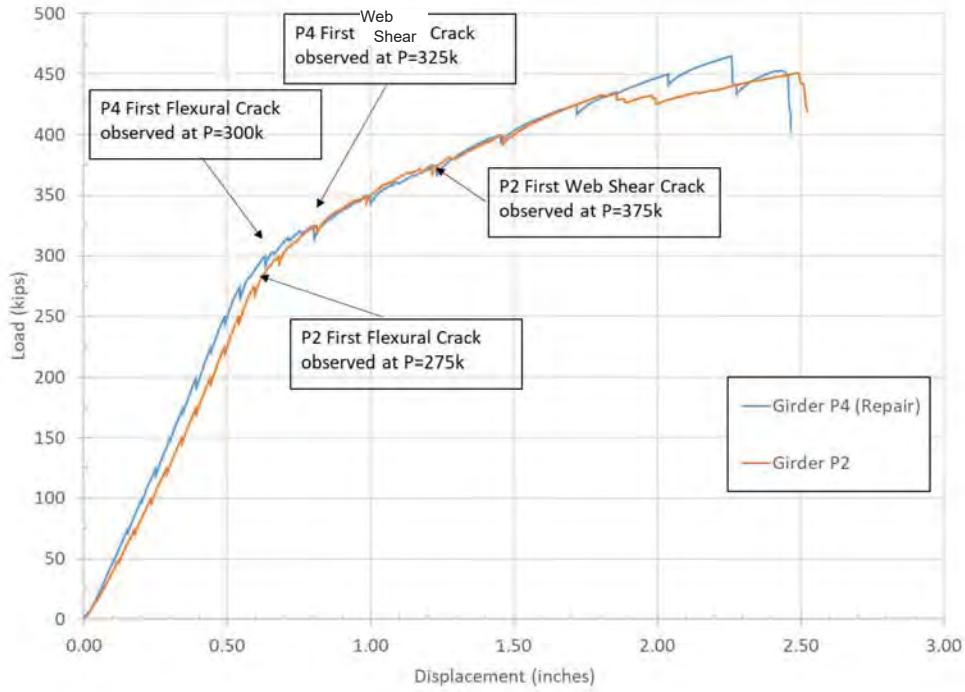
a) Girders P2 and P4

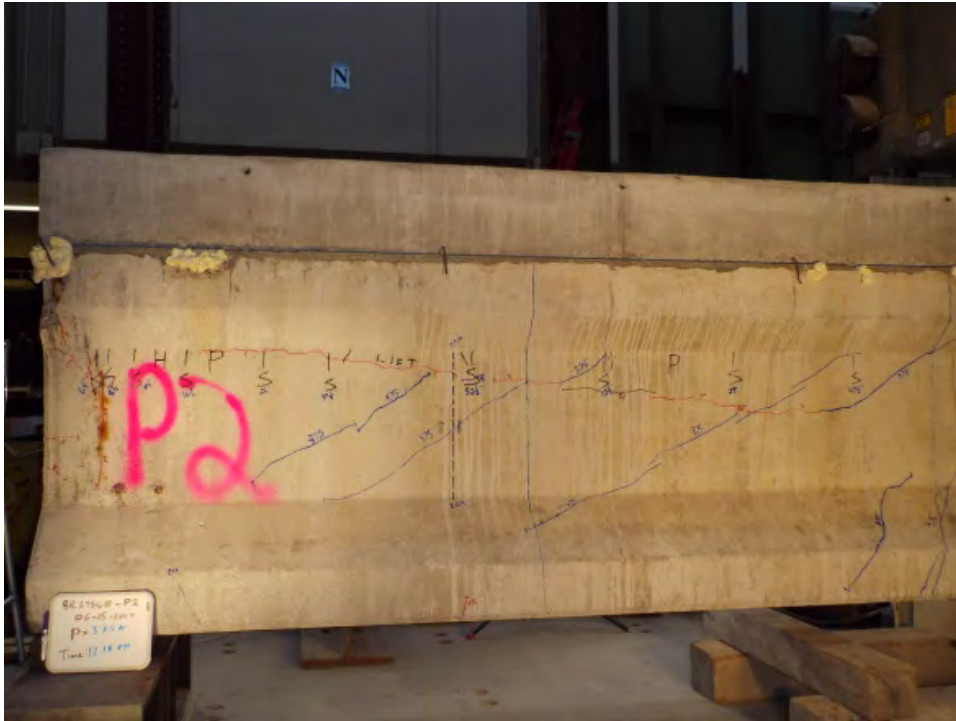
Figure 4.2 Girder P2 web shear cracking $P= 375$ k

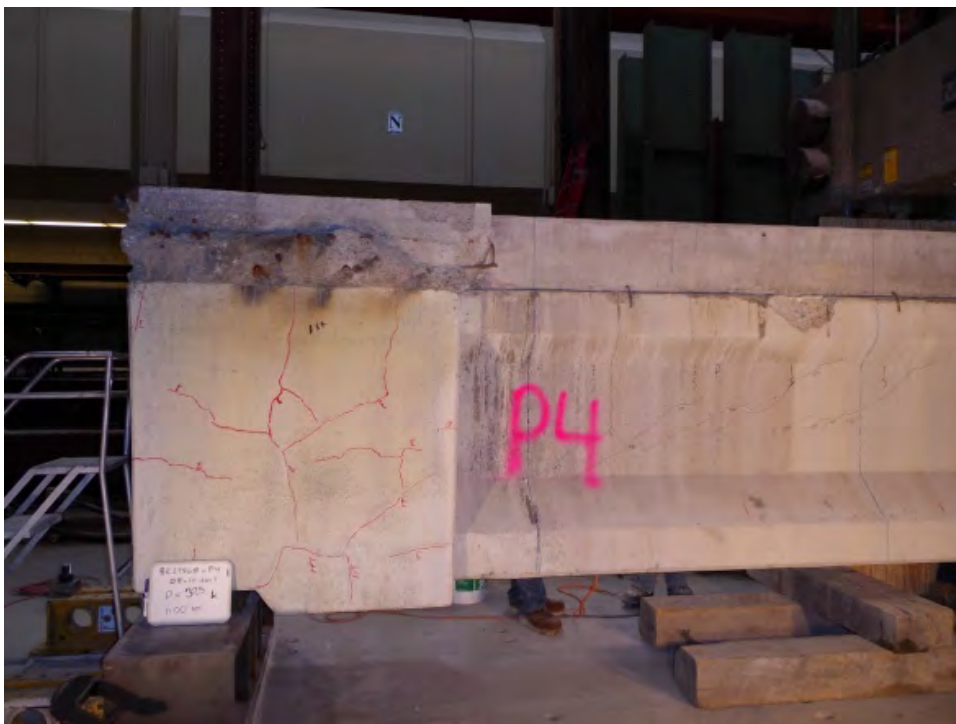
Figure 4.3 Girder P4 web shear cracking $P= 325$ k

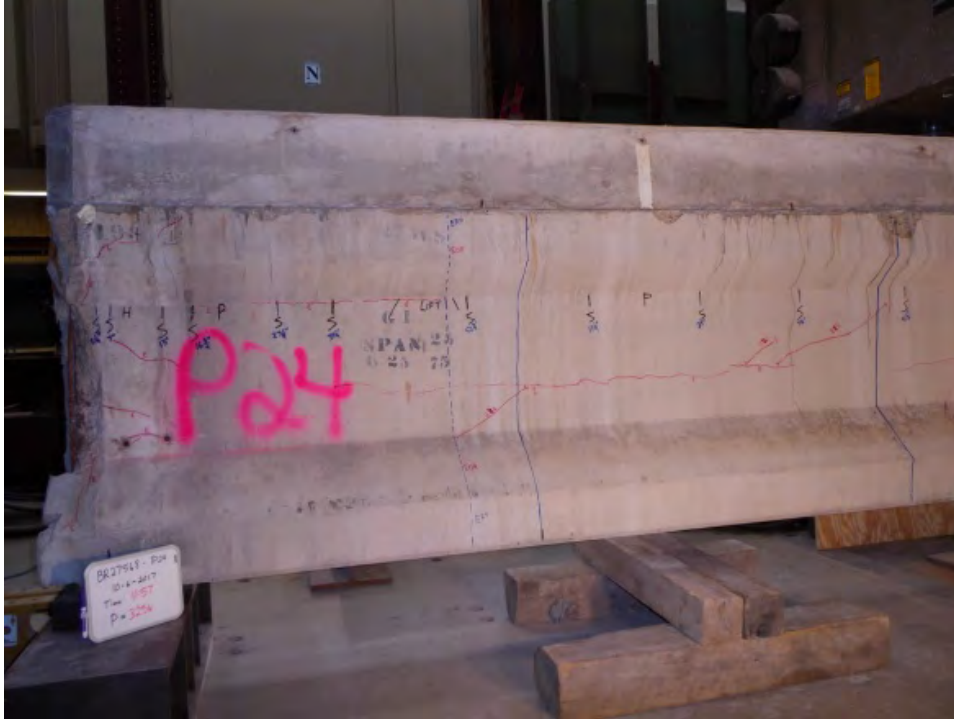
Figure 4.4 Girder P24 web shear cracking $P=325k$

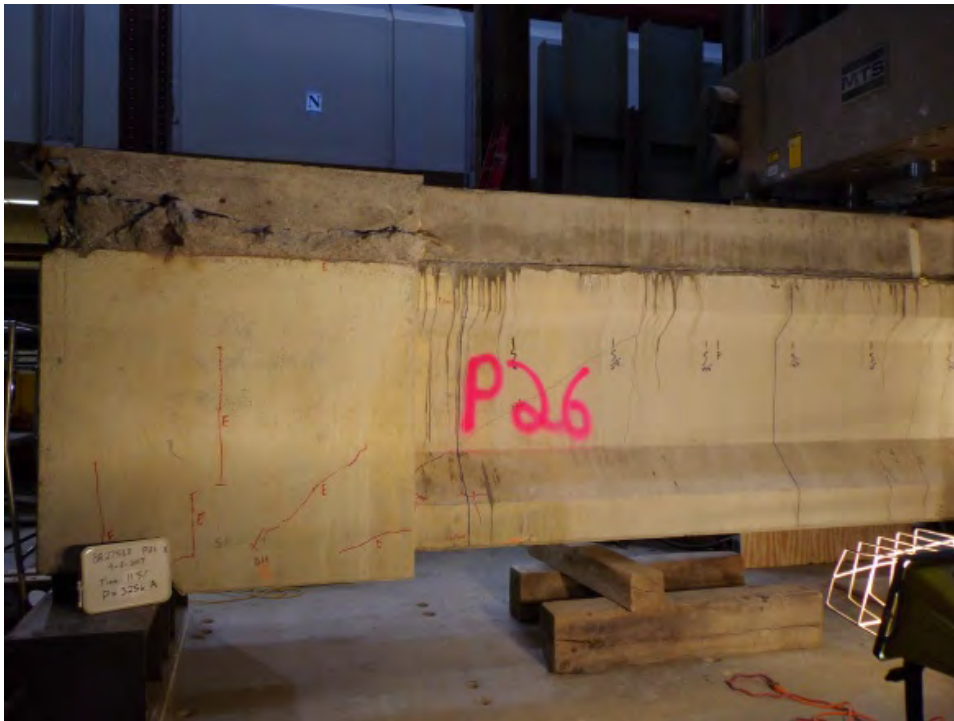
Figure 4.5 Girder P26 web shear cracking $P=325k$

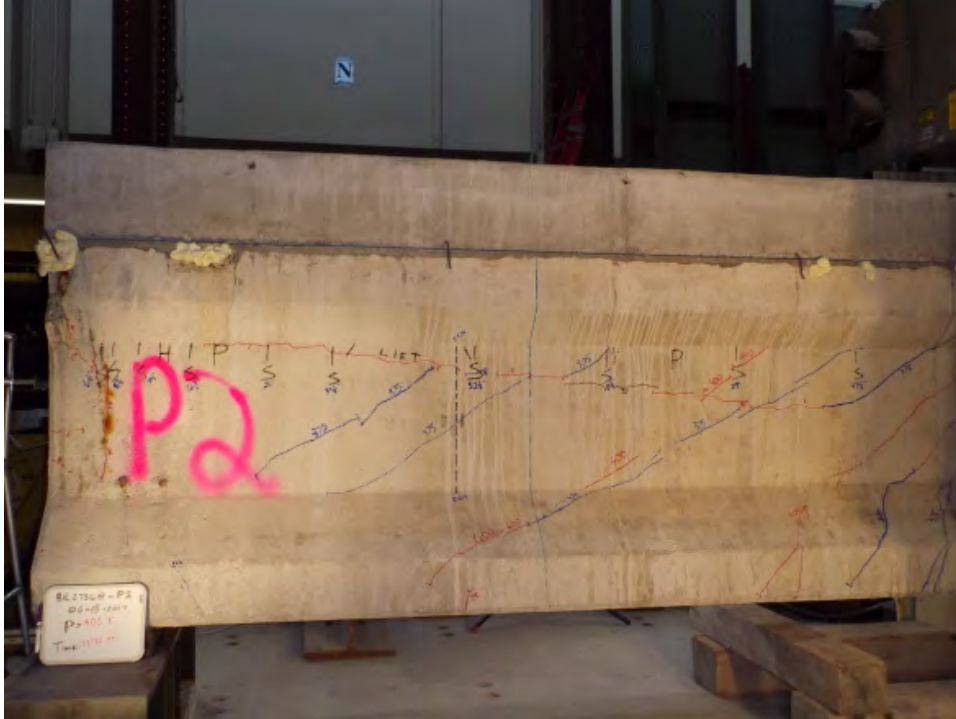
Figure 4.6 Girder P2 last load pause before failure, P=400k

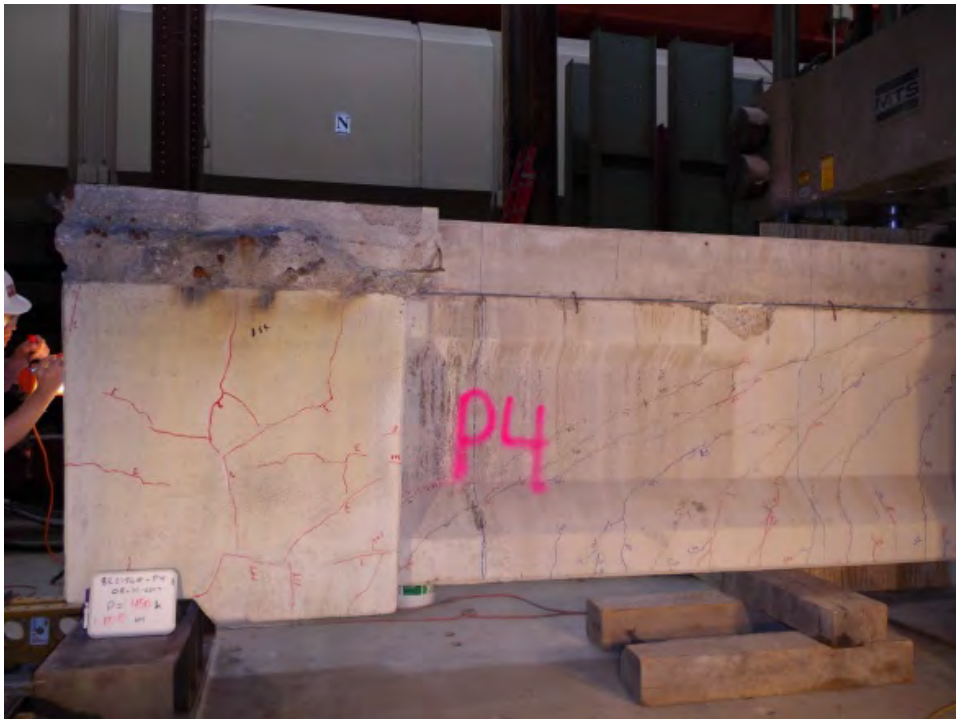
Figure 4.7 Girder P4 last load pause before failure, P=450k

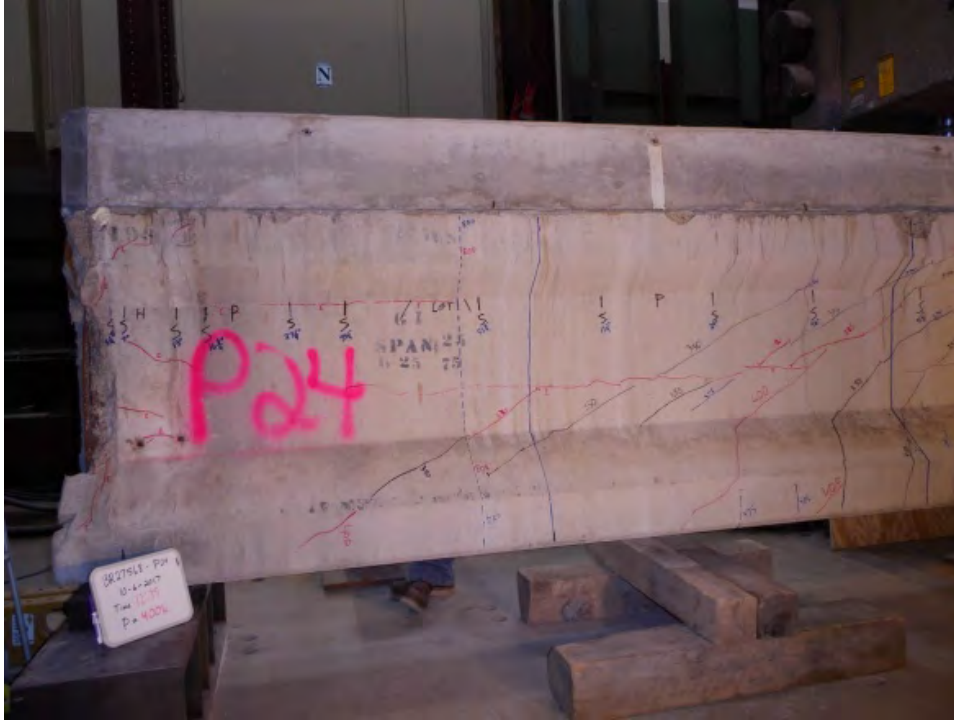
Figure 4.8 Girder P24 last load pause before failure, P=400k

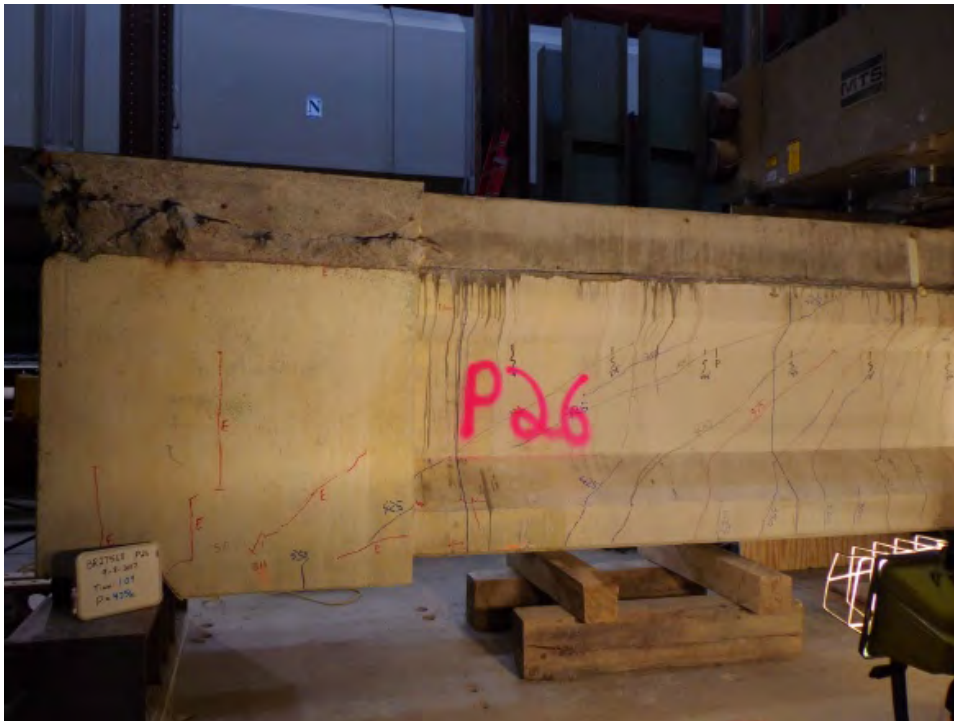
Figure 4.9 Girder P26 last load pause before failure, P=425k

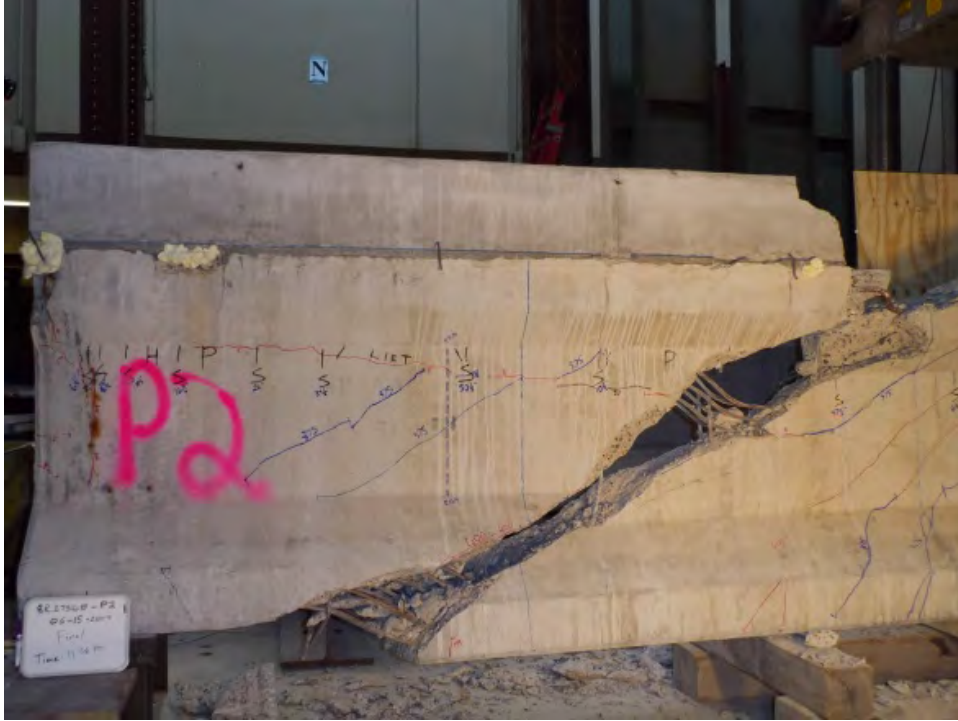
Figure 4.10 Girder P2 after failure

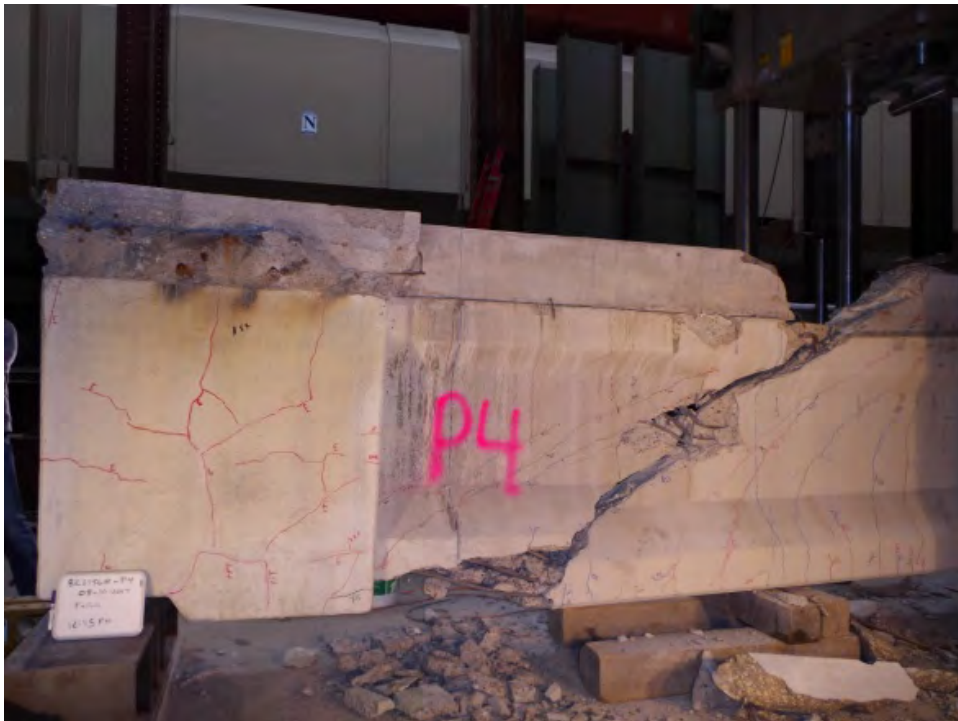
Figure 4.11 Girder P4 after failure

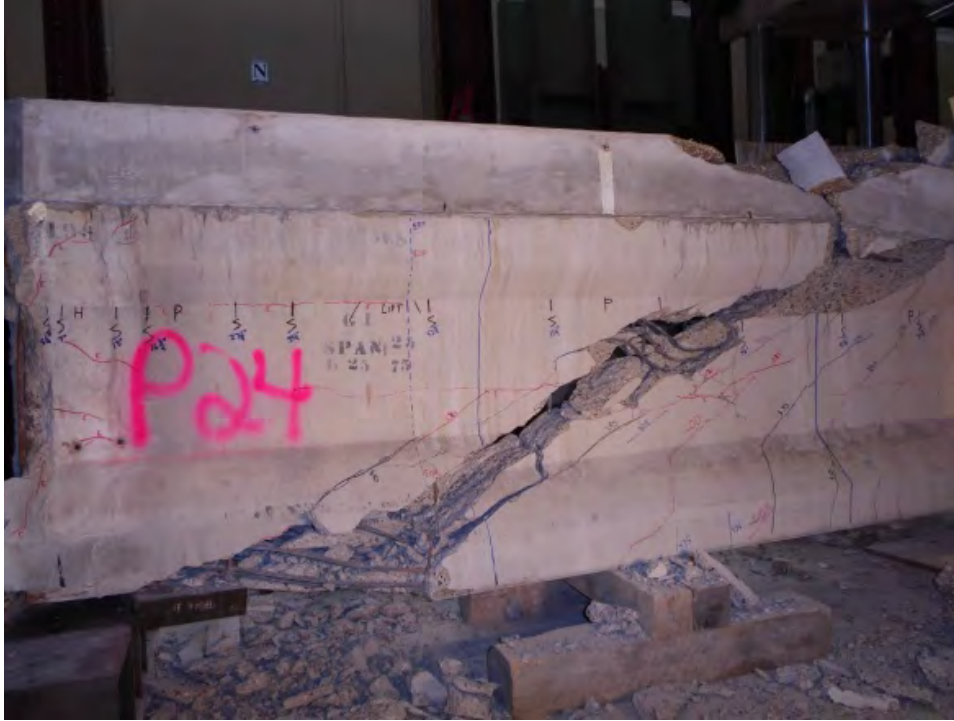
Figure 4.12 Girder P24 after failure

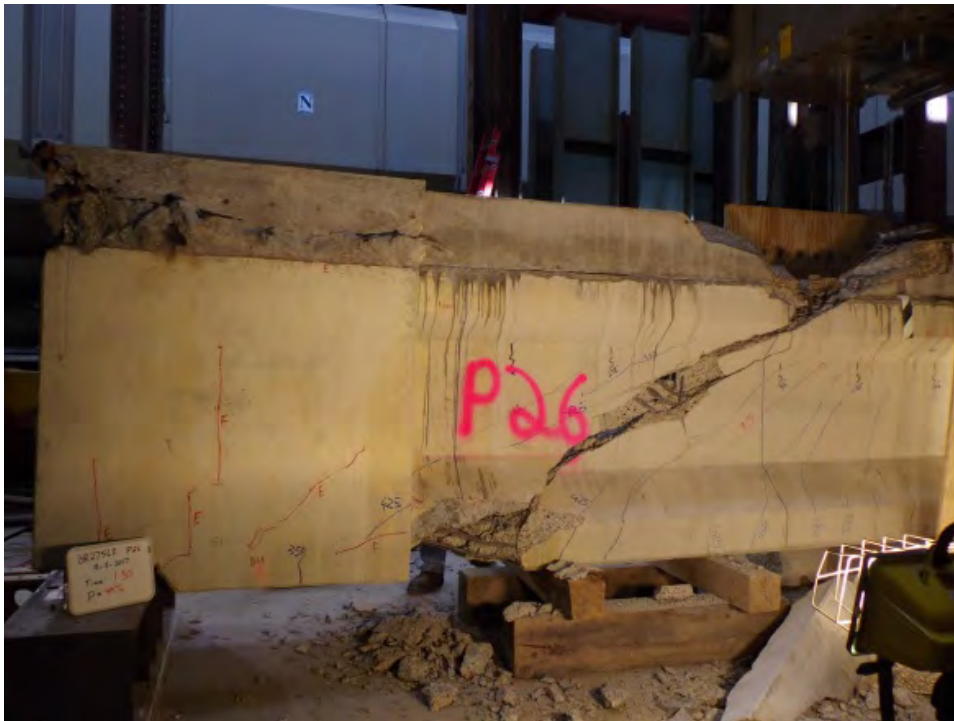
Figure 4.13 Girder P26 after failure
