BR27568 – Experimental Shear Capacity Comparison Between Repaired and Unrepaired Girder Ends

Carol Shield, Principal Investigator

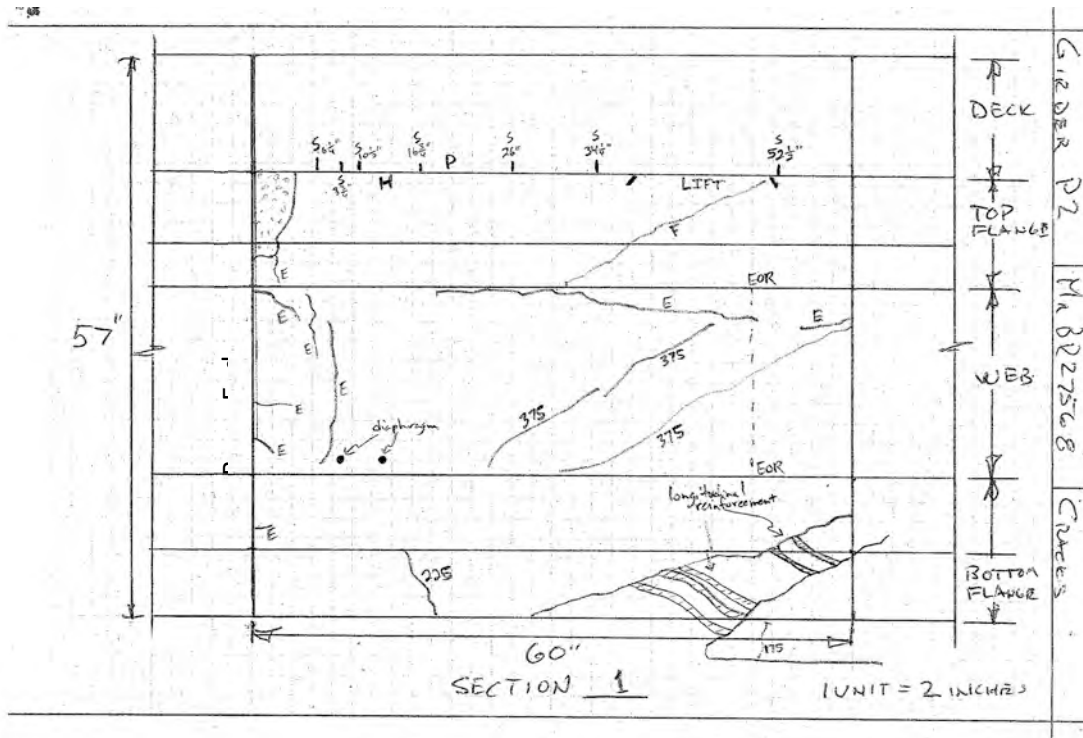
Figure 4.14 Girder P2 crack pattern – Section 1 (See Figure 3.4 for Section limits)

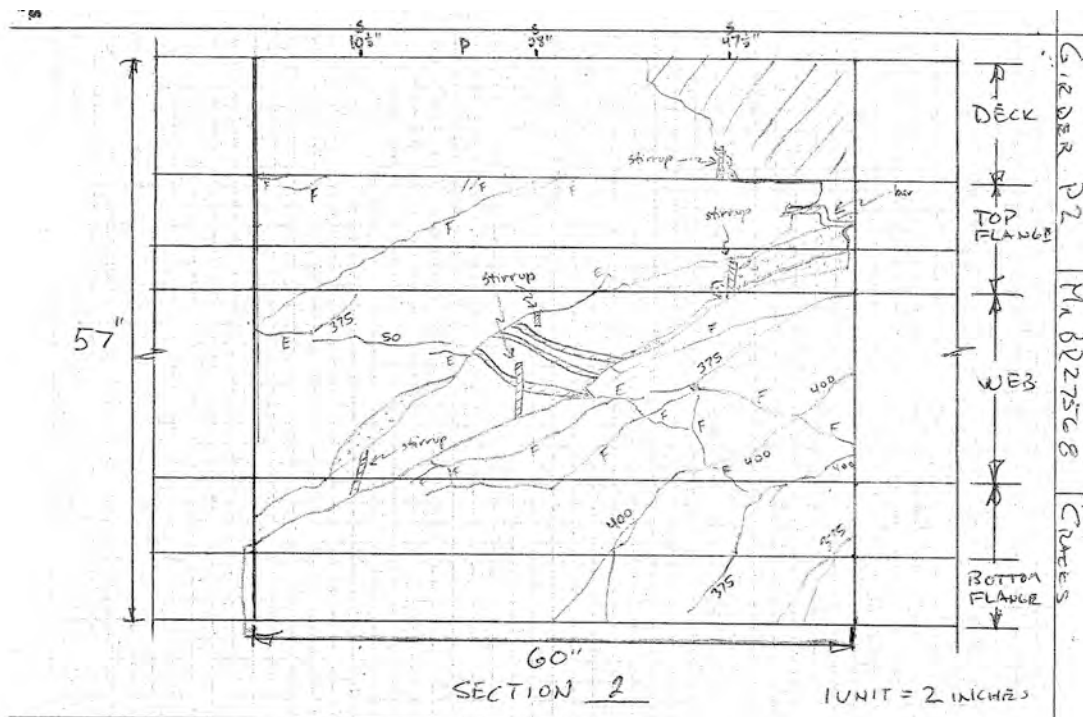
Figure 4.15 Girder P2 crack pattern – Section 2

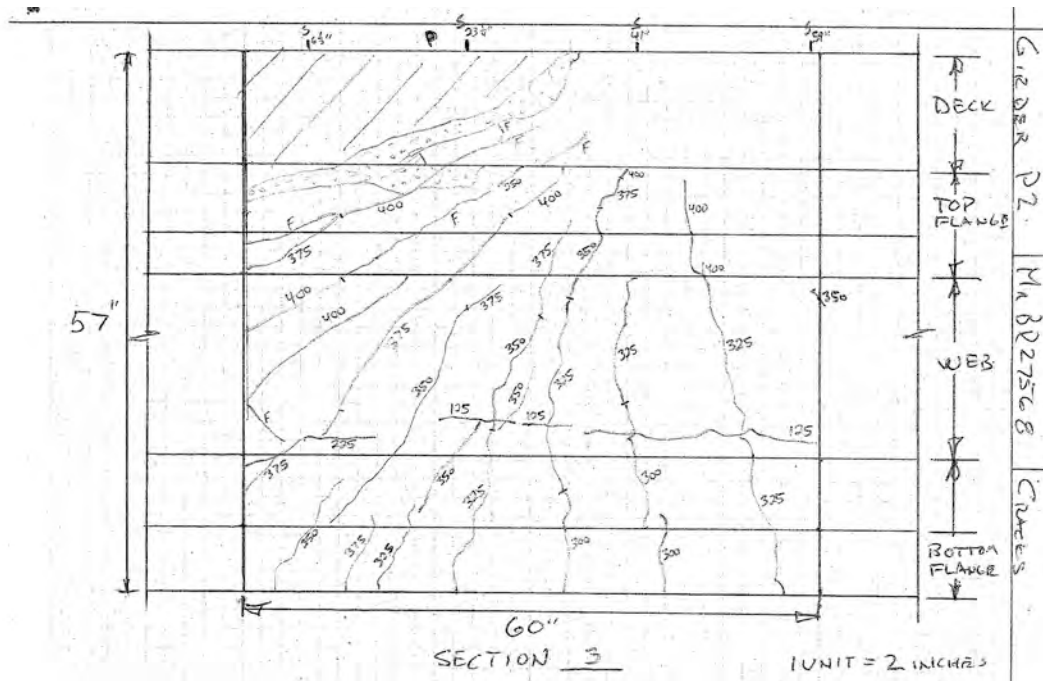
Figure 4.16 Girder P2 crack pattern – Section 3 (first flexural crack on South side at 300k)

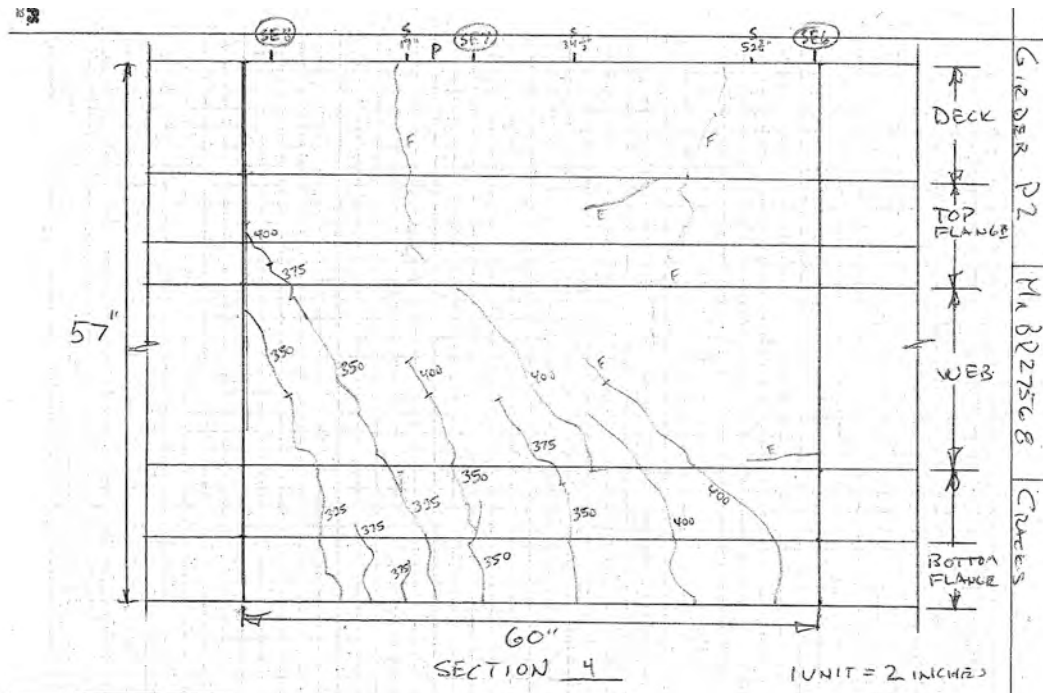
Figure 4.17 Girder P2 crack pattern – Section 4

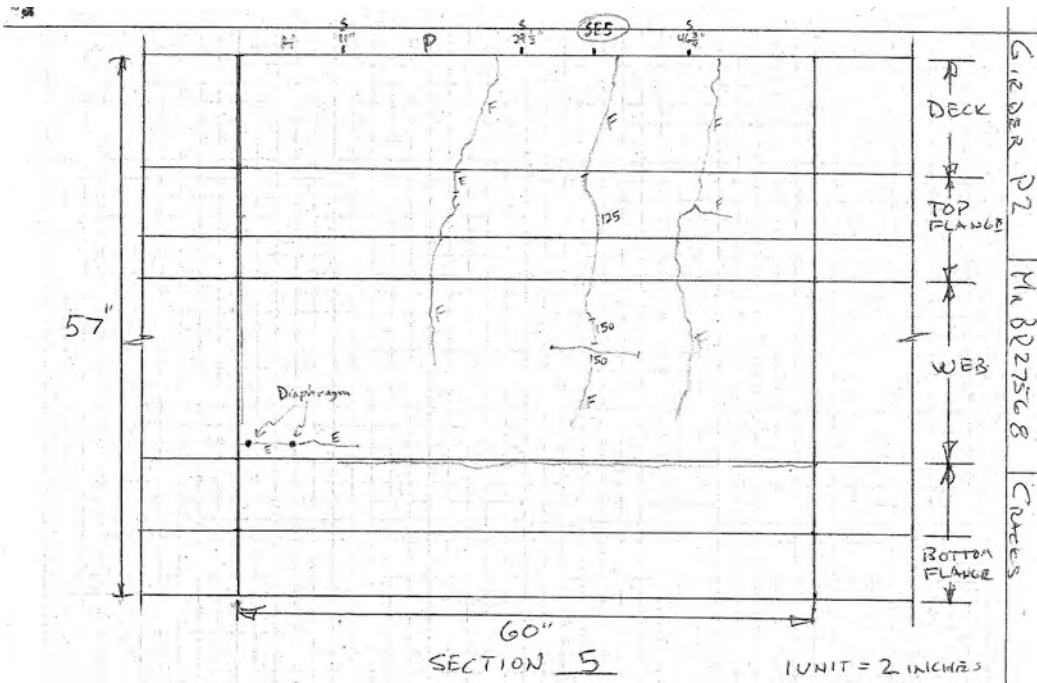
Figure 4.18 Girder P2 crack pattern – Section 5

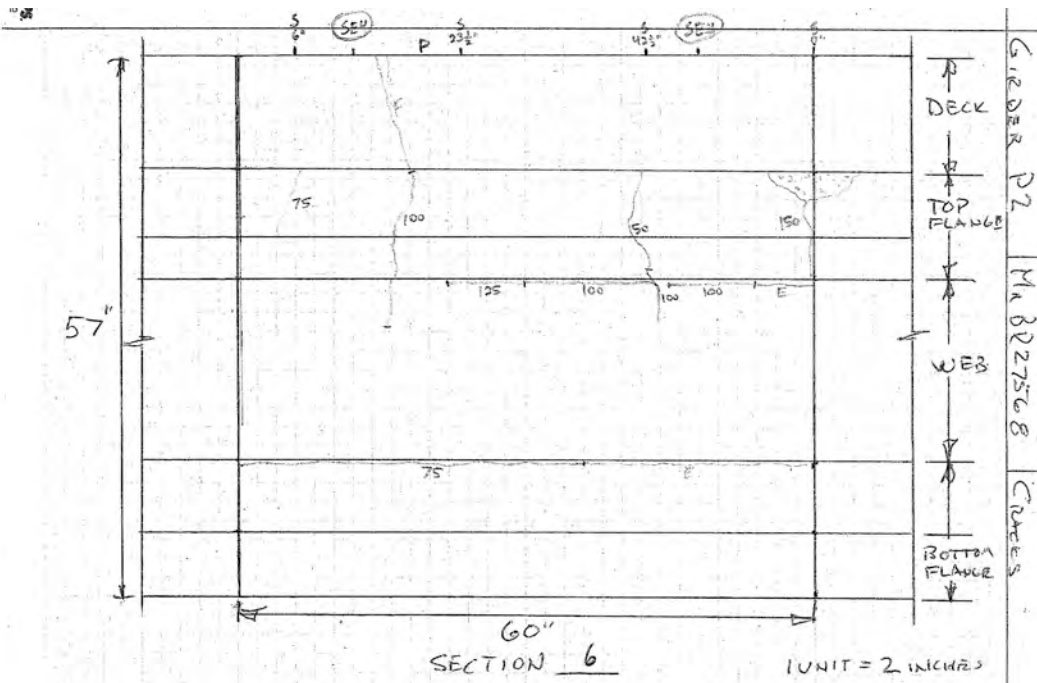
Figure 4.19 Girder P2 crack pattern – Section 6

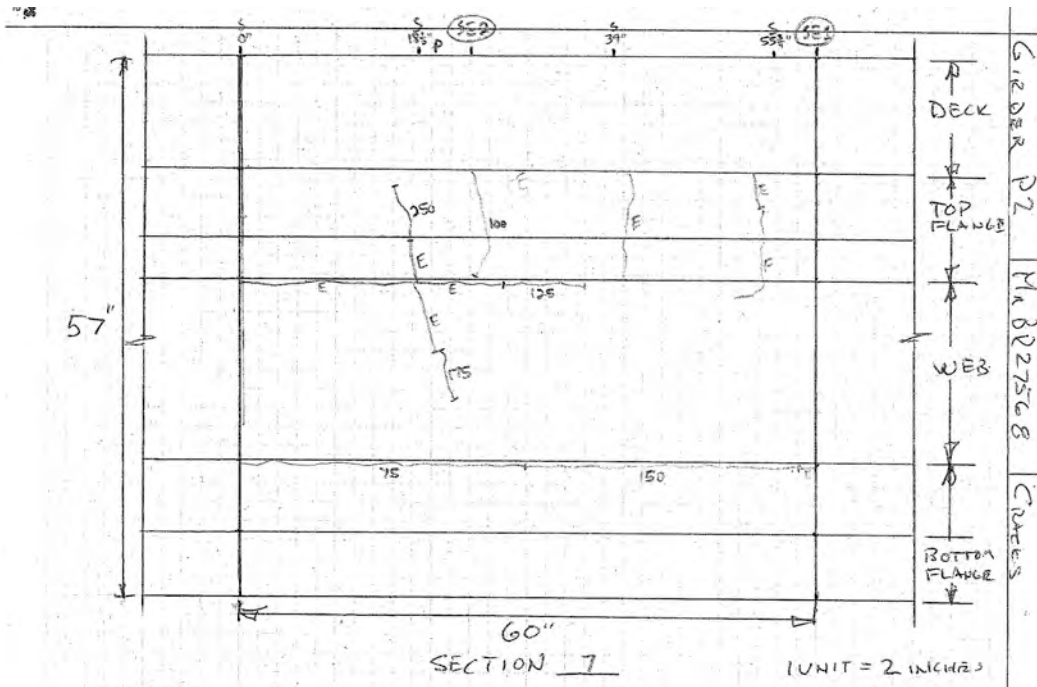
Figure 4.20 Girder P2 crack pattern – Section 7

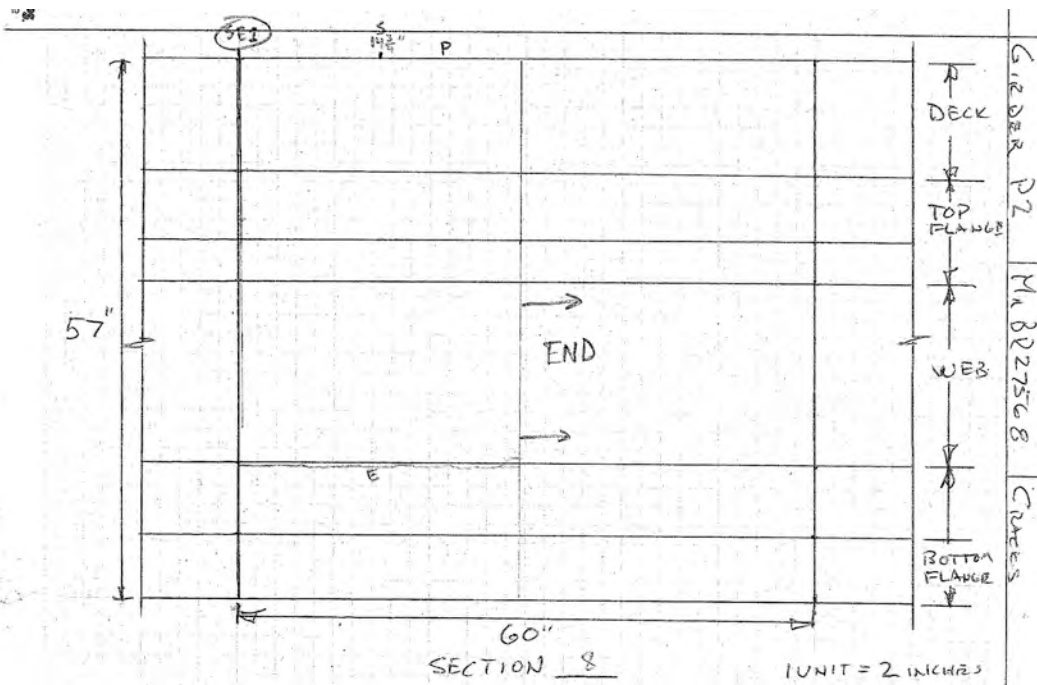
Figure 4.21 Girder P2 crack pattern – Section 8

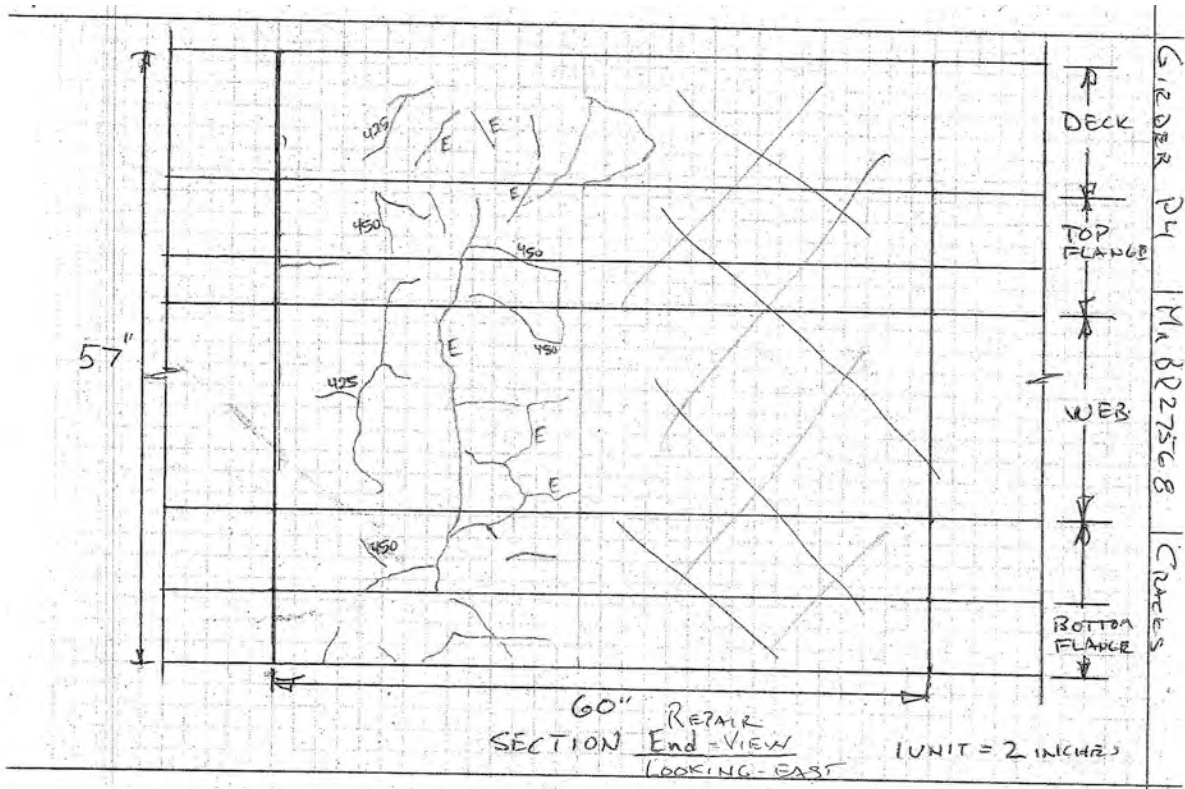
Figure 4.22 Girder P4 crack pattern – repair end view

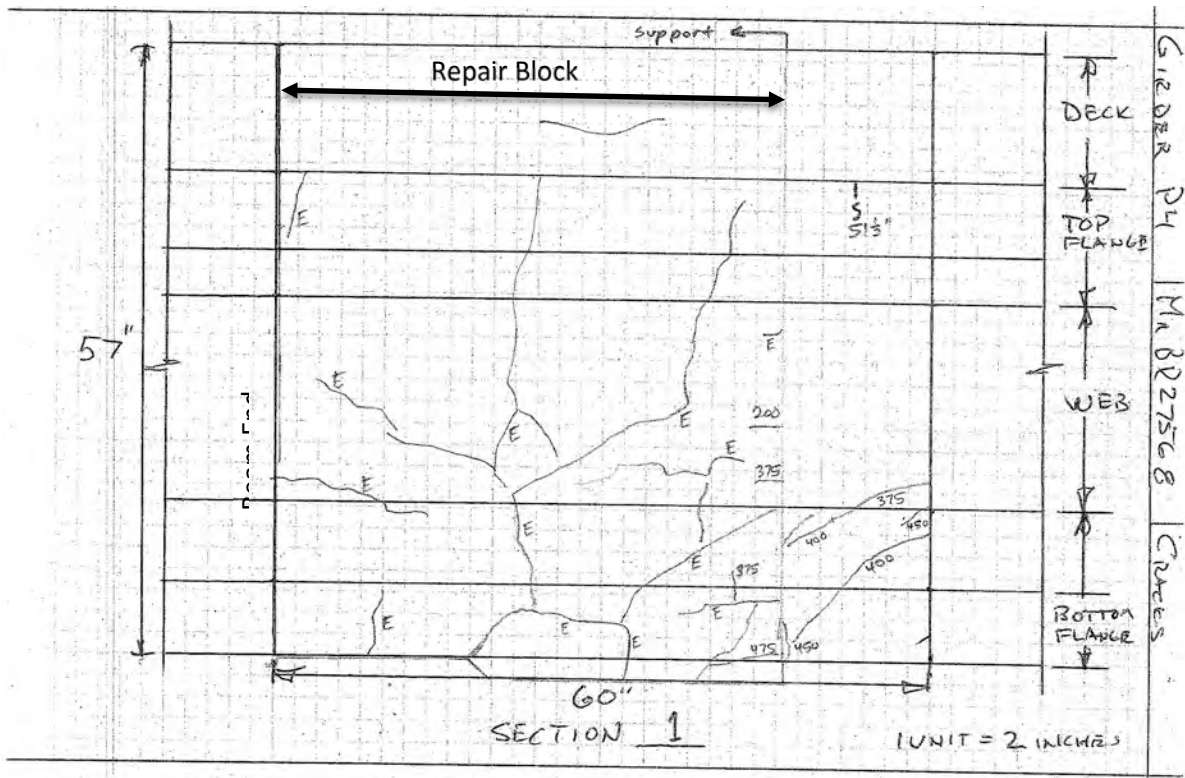
Figure 4.23 Girder P4 Crack Pattern – Section 1 (See Figure 3.4 for Section limits)

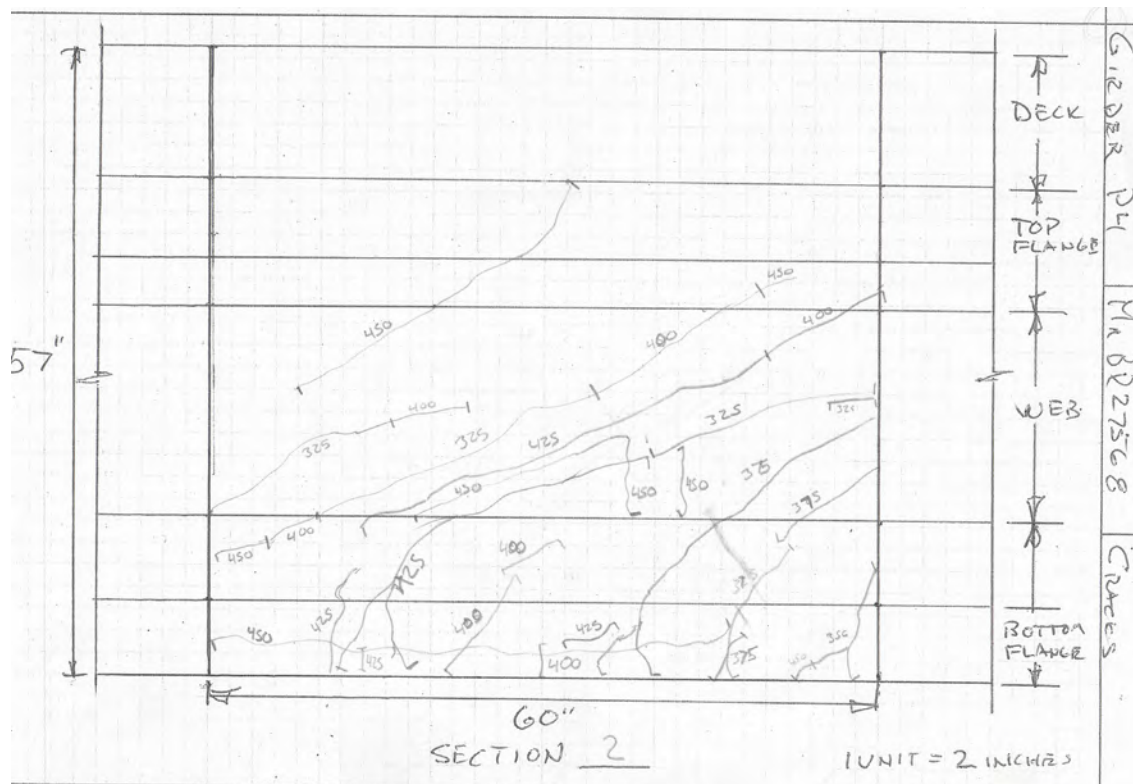
Figure 4.24 Girder P4 crack pattern – Section 2

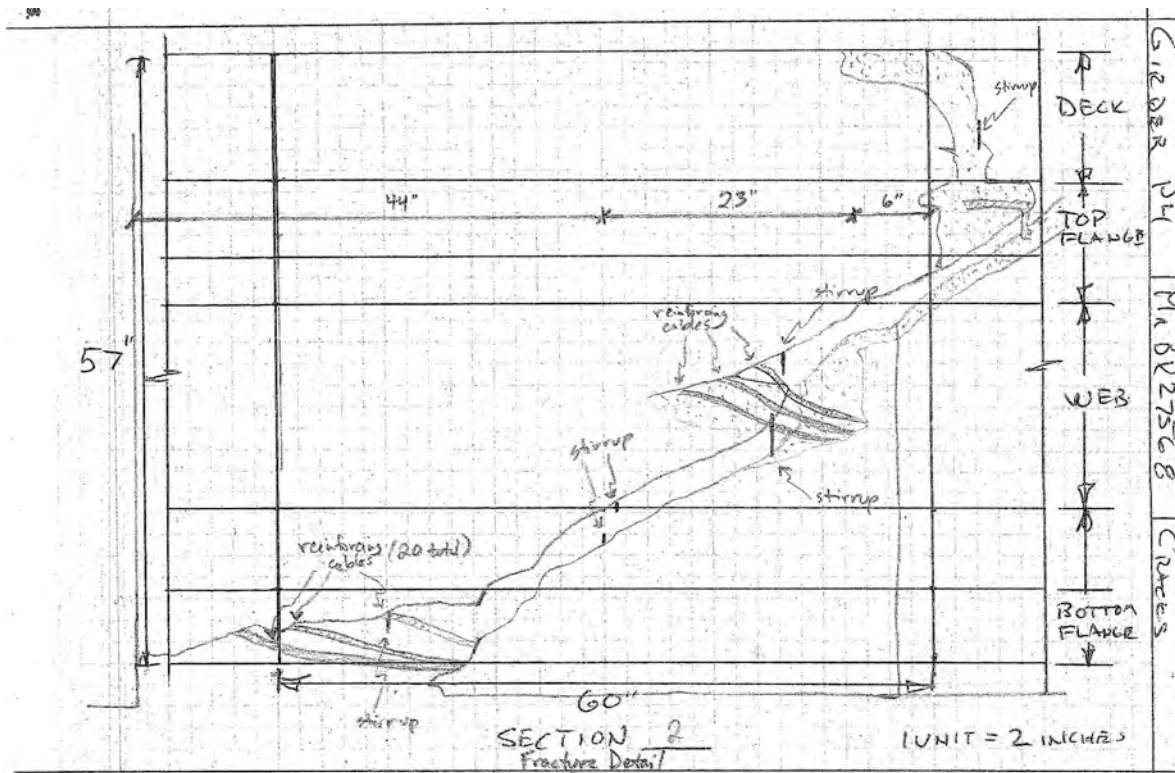
Figure 4.25 Girder P4 crack pattern – Section 2 (Bar Fracture Detail)

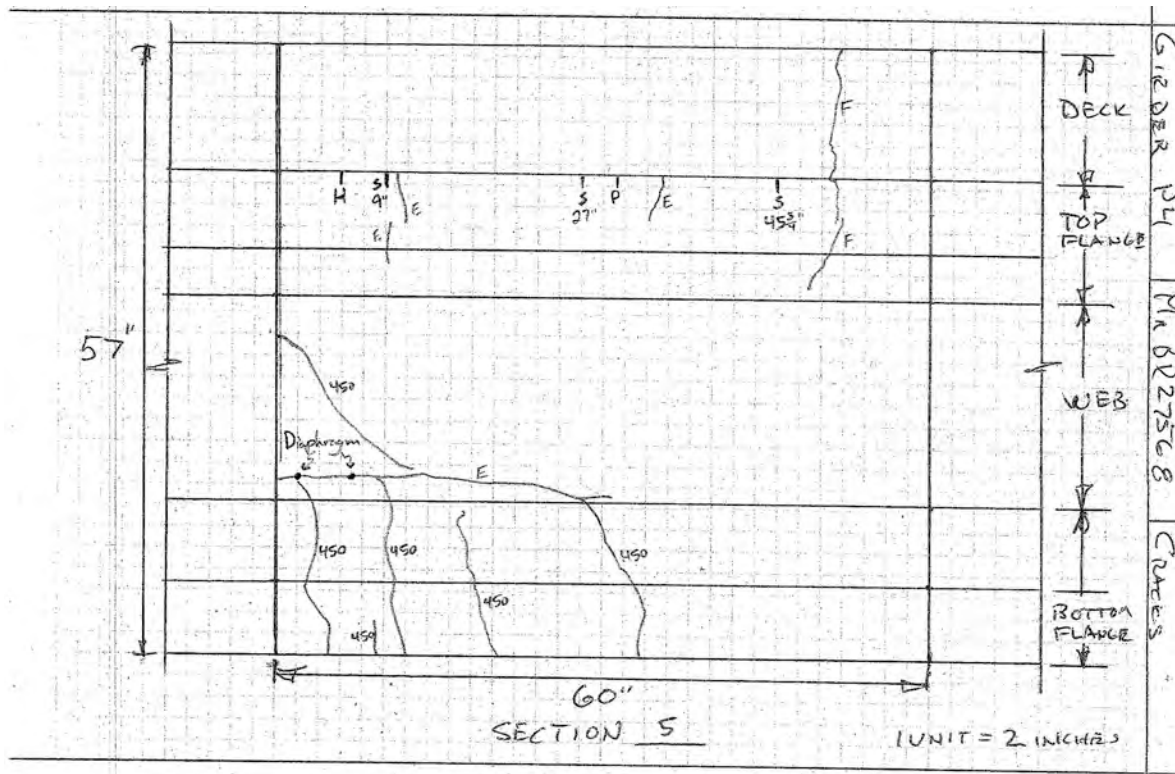
Figure 4.28 Girder P4 crack pattern – Section 5

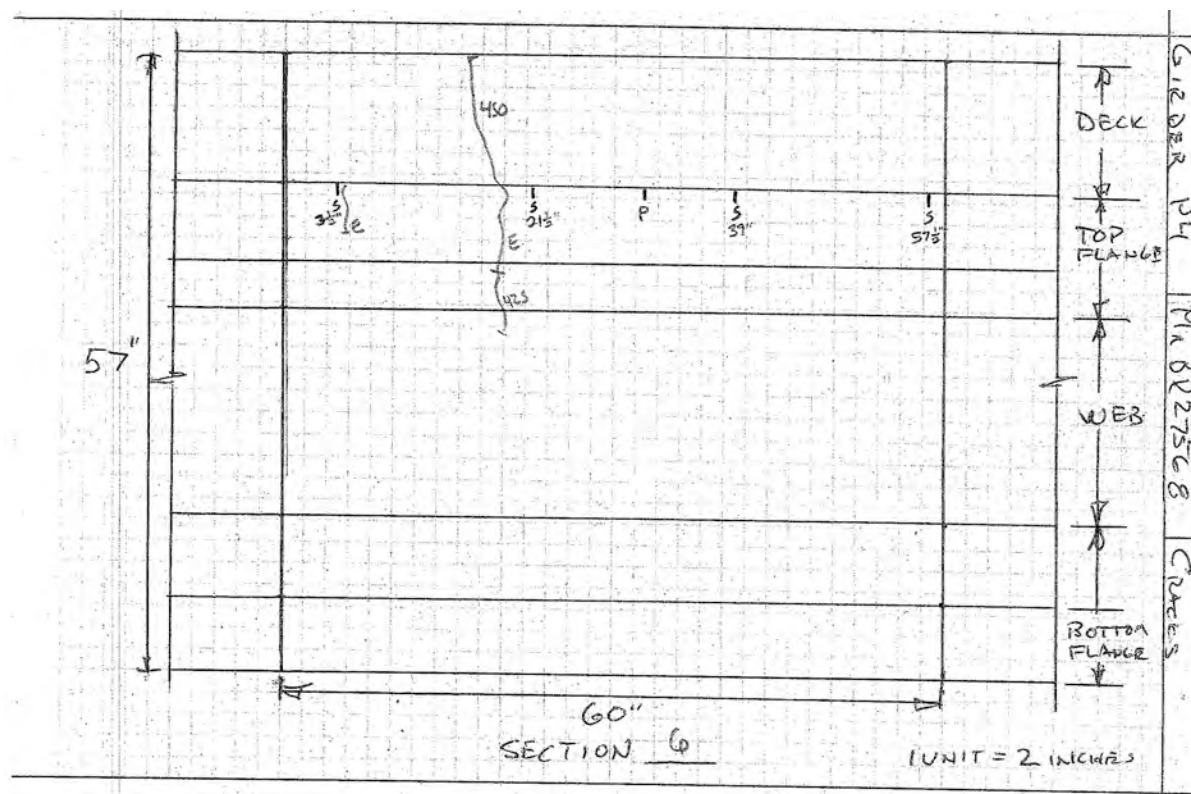
Figure 4.29 Girder P4 crack pattern – Section 6

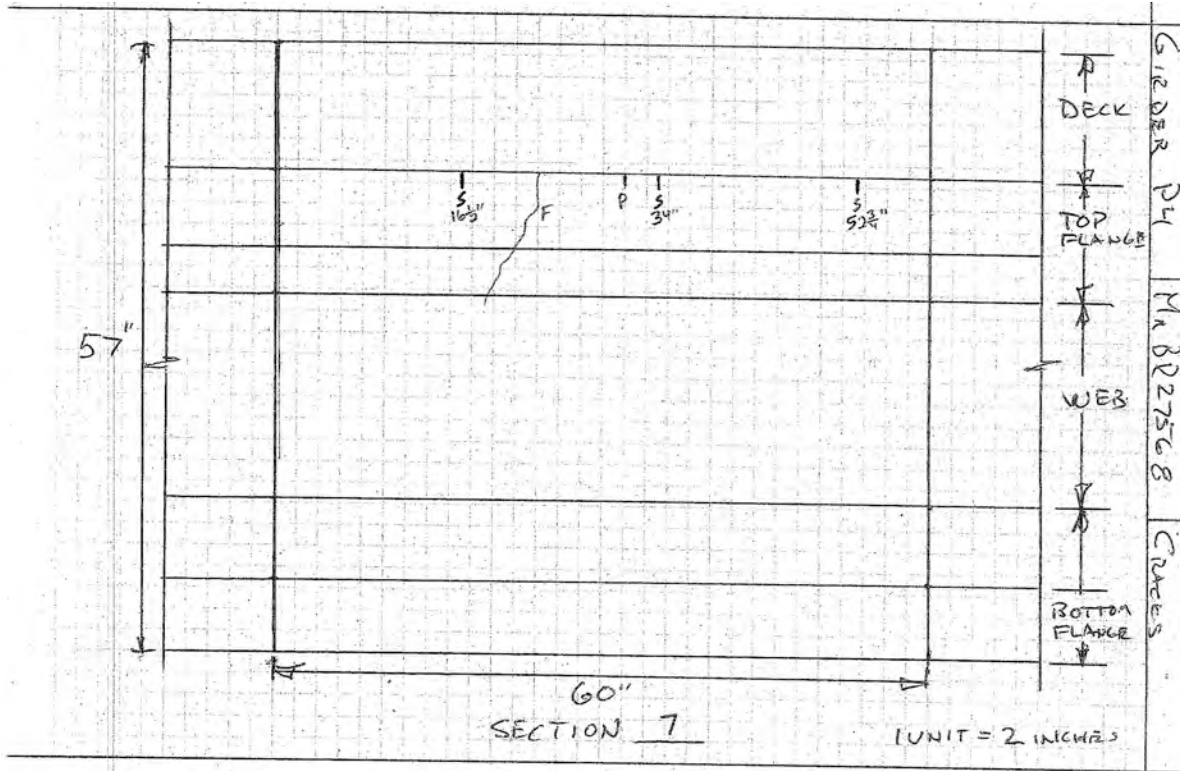
Figure 4.30 Girder P4 crack pattern – Section 7

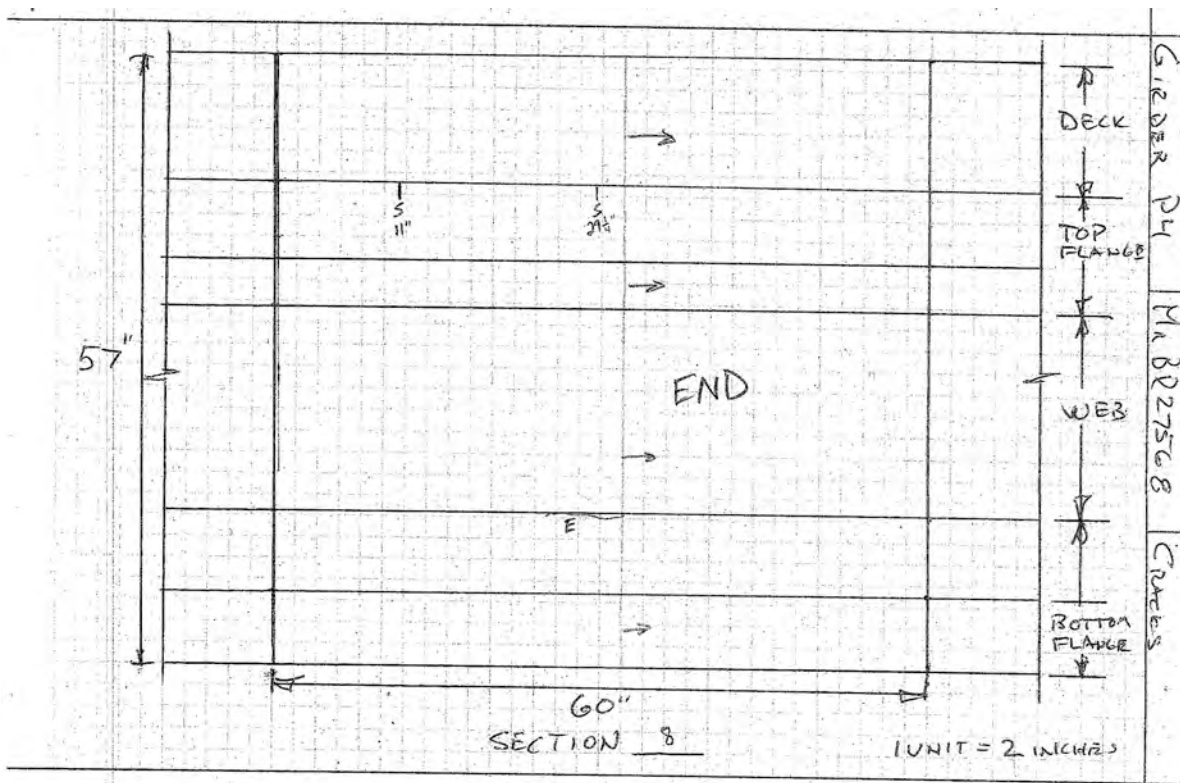
Figure 4.31 Girder P4 crack pattern – Section 8

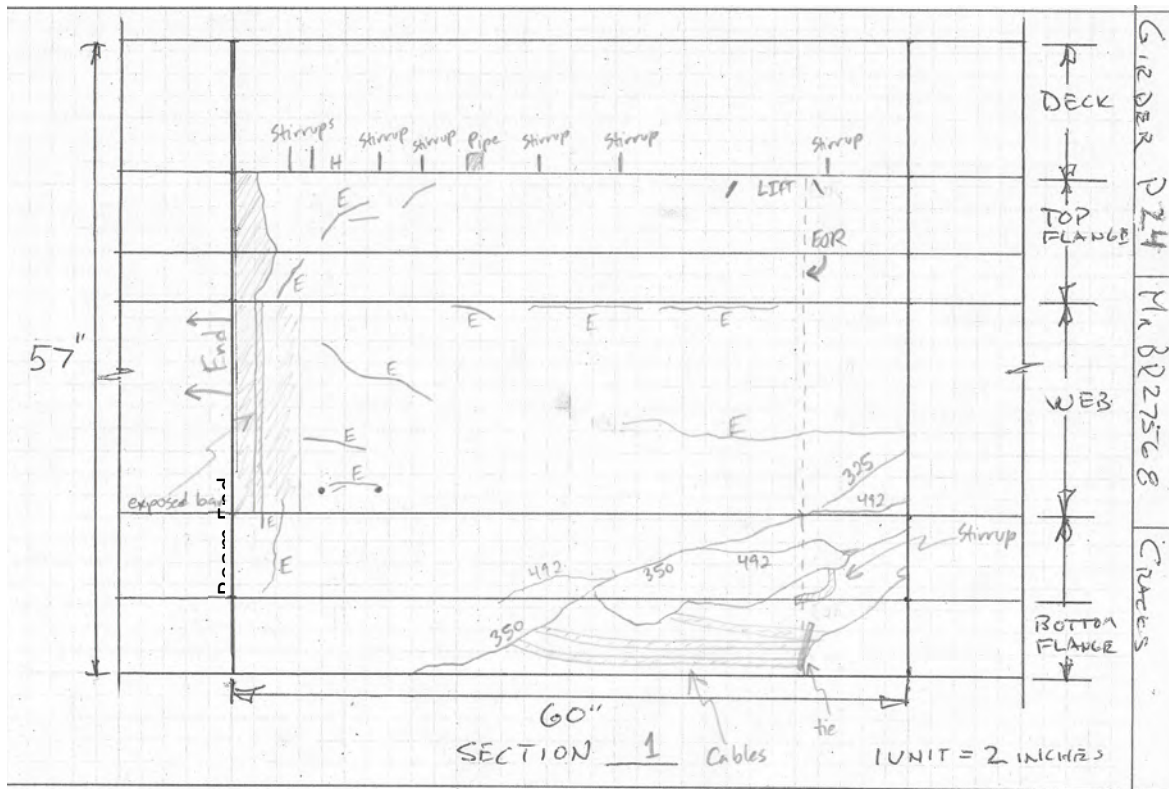
Figure 4.32 Girder P24 crack pattern – Section 1 (See Figure 3.4 for Section limits)

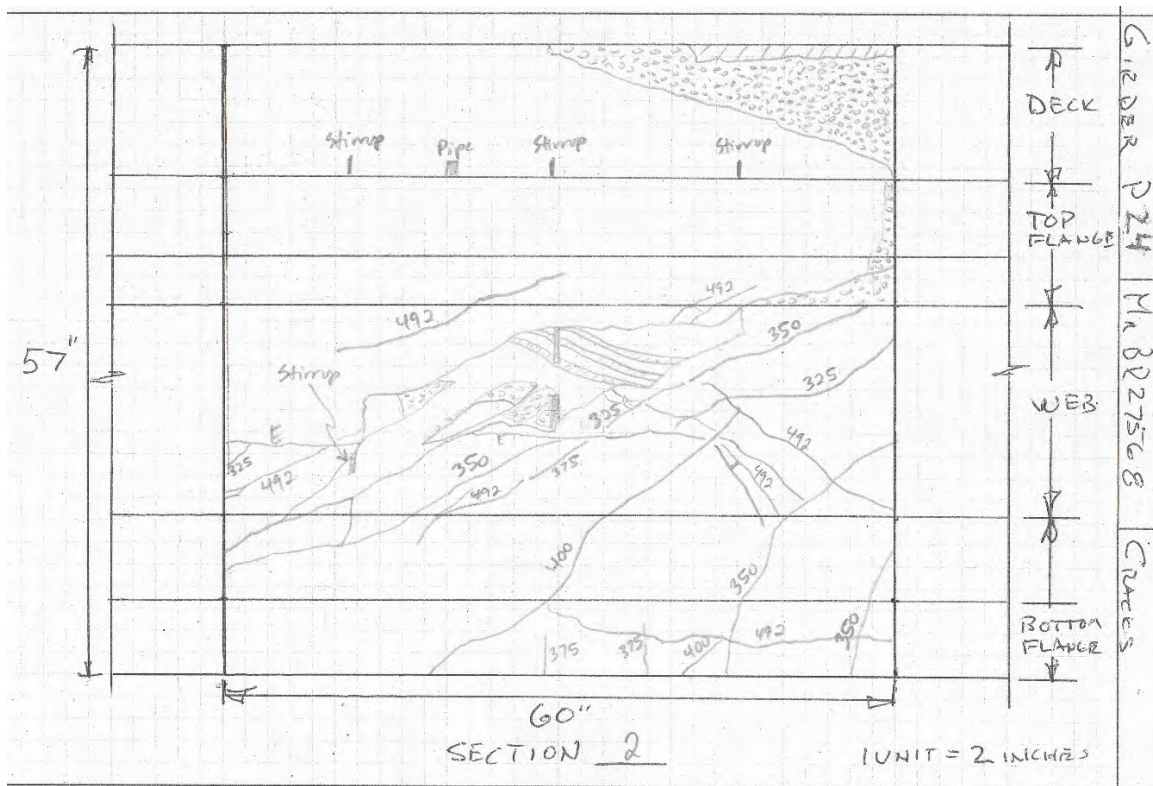
Figure 4.33 Girder P24 crack pattern – Section 2

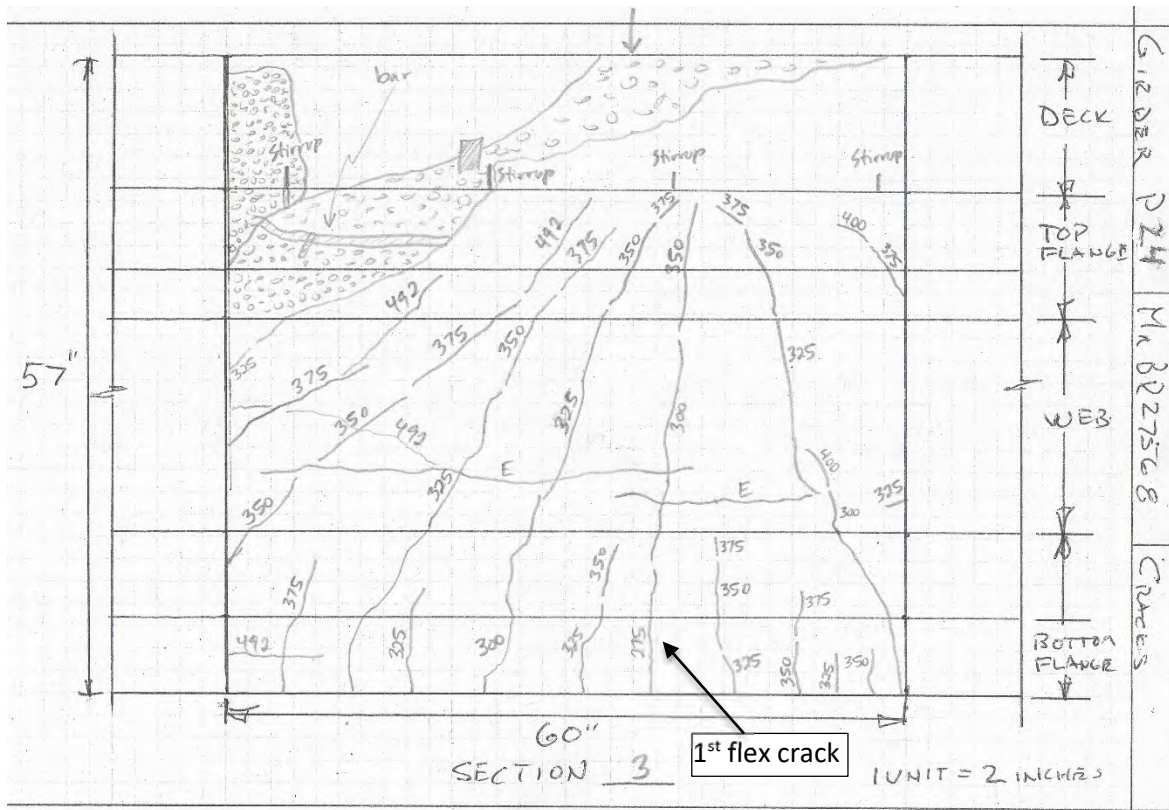
Figure 4.34 Girder P24 crack pattern – Section 3 (first flexural crack at 275k)

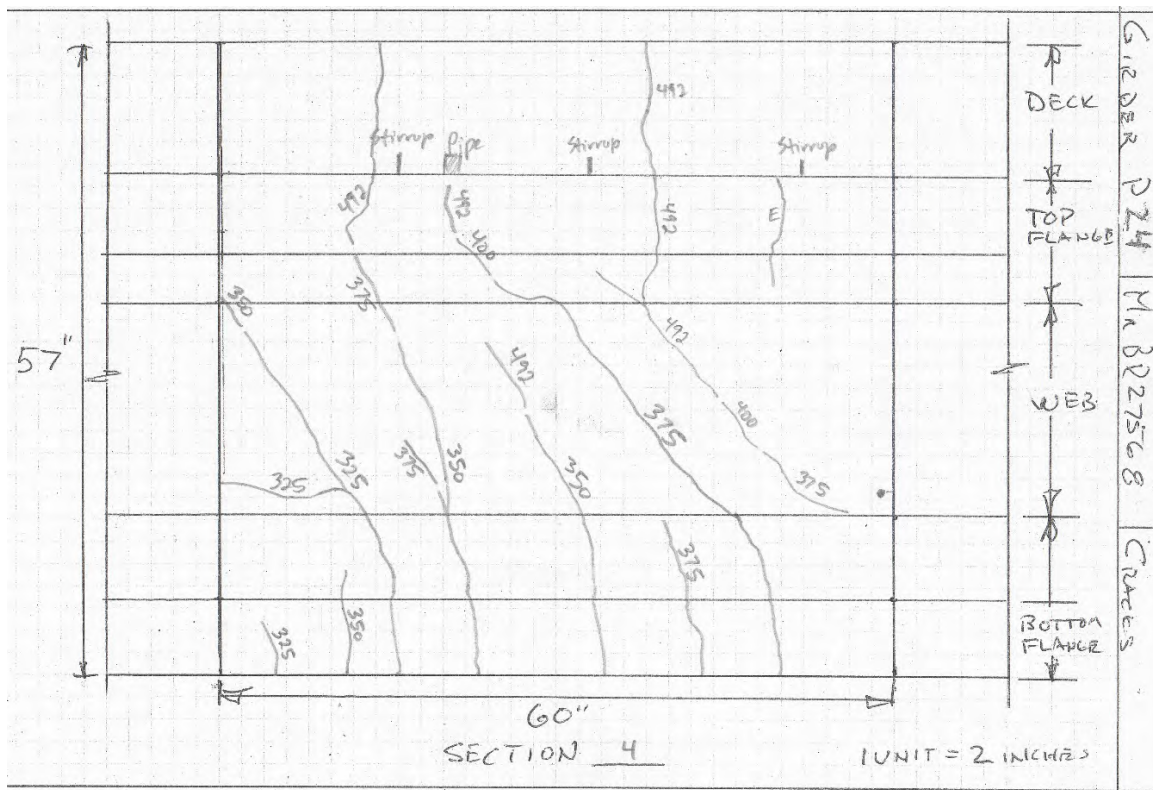
Figure 4.35 Girder P24 crack pattern – Section 4

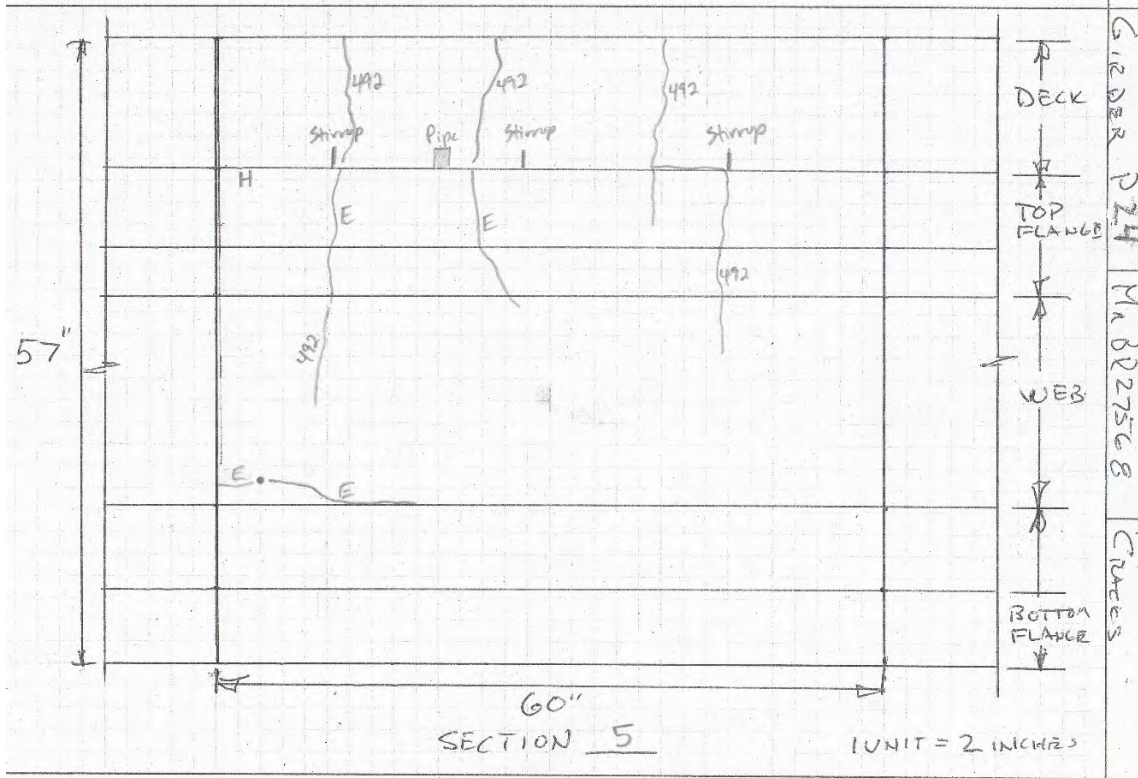
Figure 4.36 Girder P24 crack pattern – Section 5

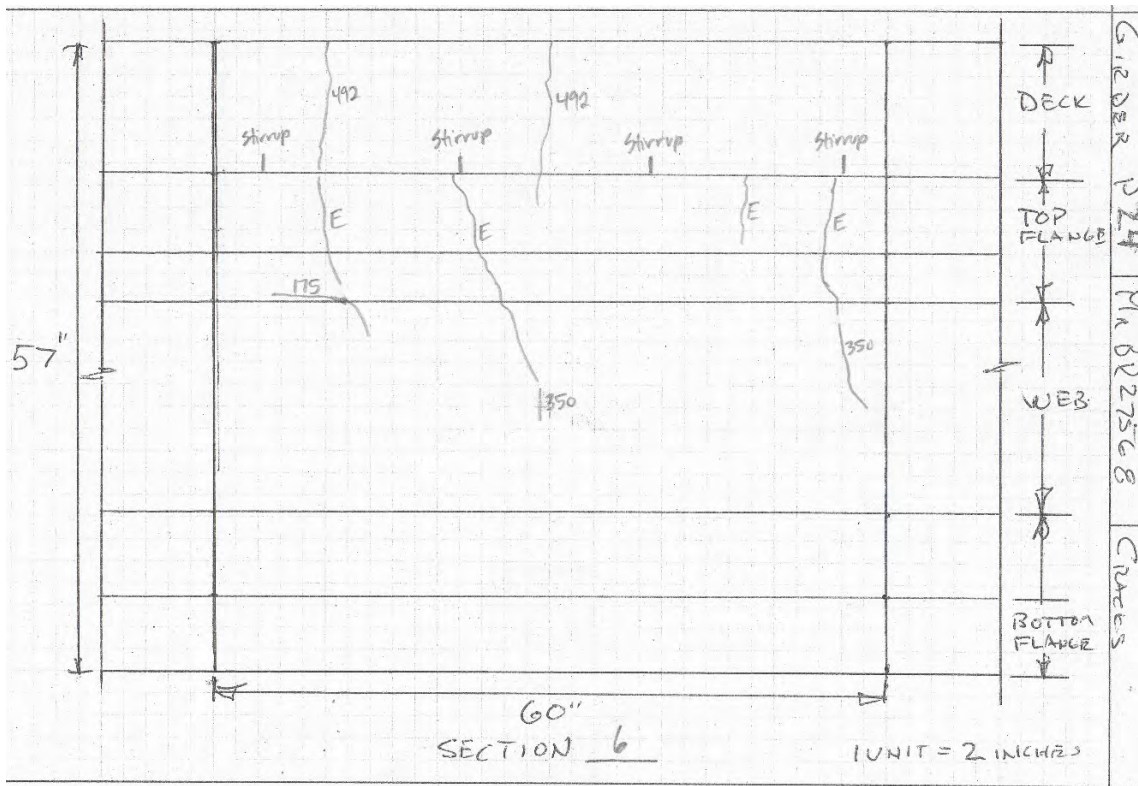
Figure 4.37 Girder P24 crack pattern – Section 6

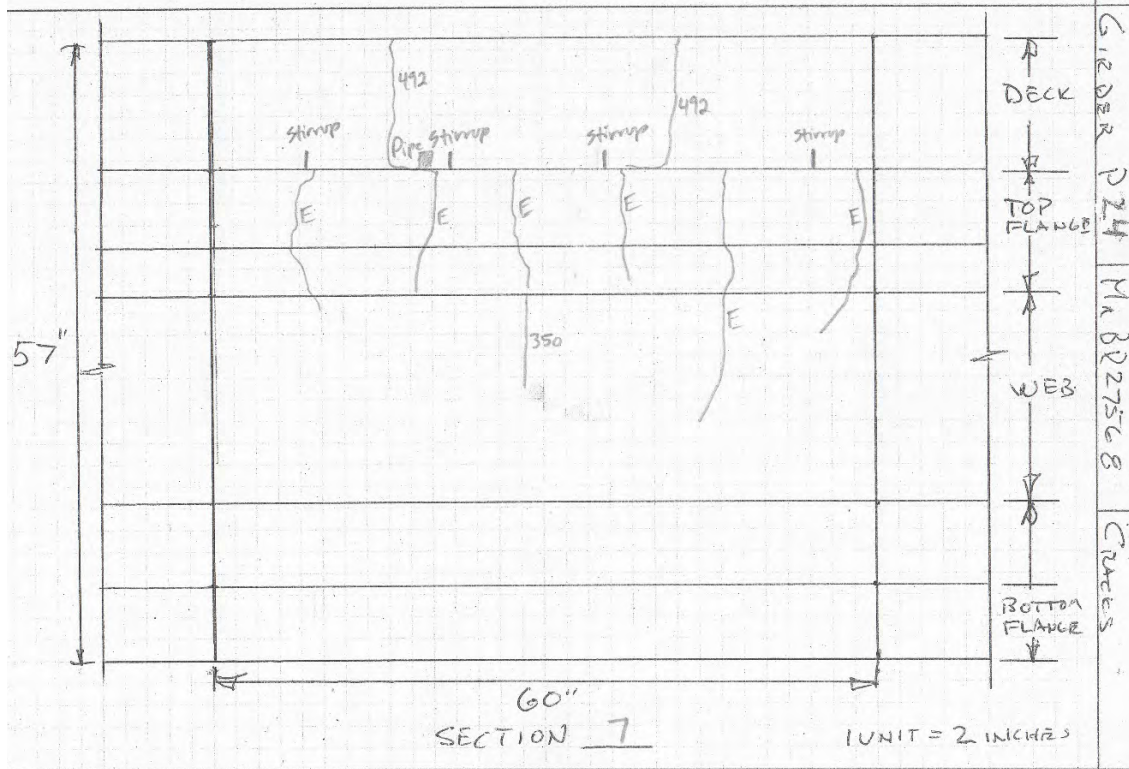
Figure 4.38 Girder P24 crack pattern – Section 7

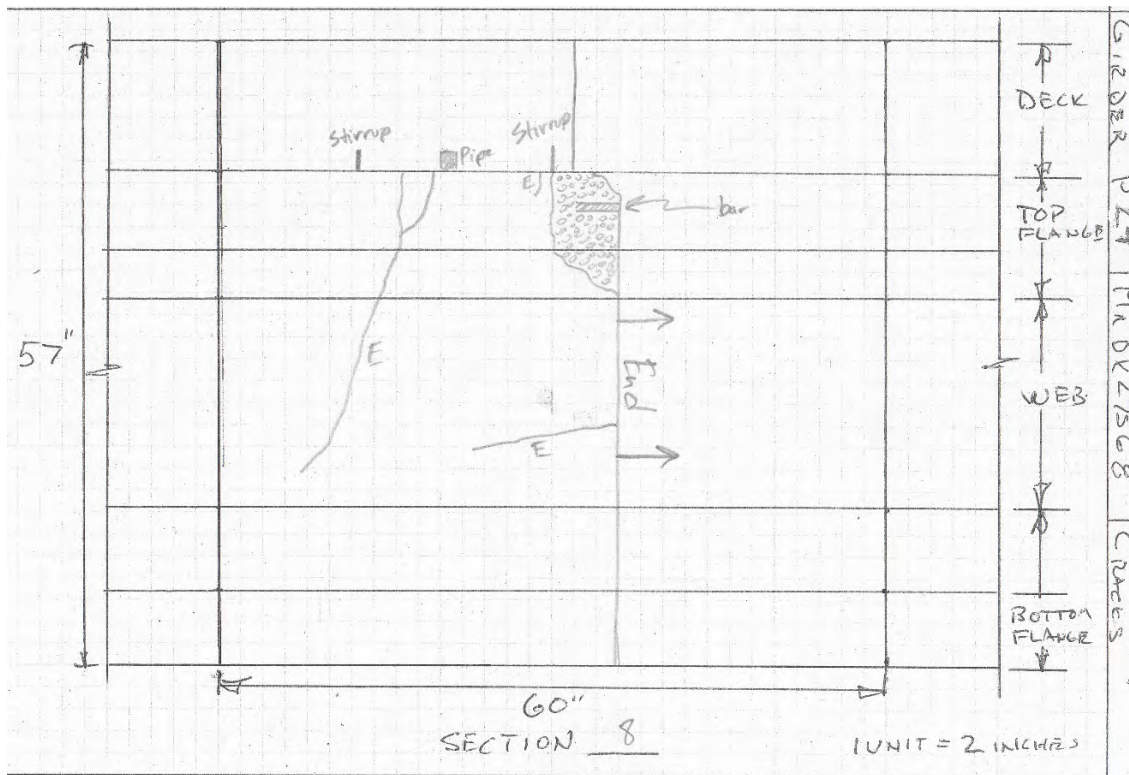
Figure 4.39 Girder P24 crack pattern – Section 8

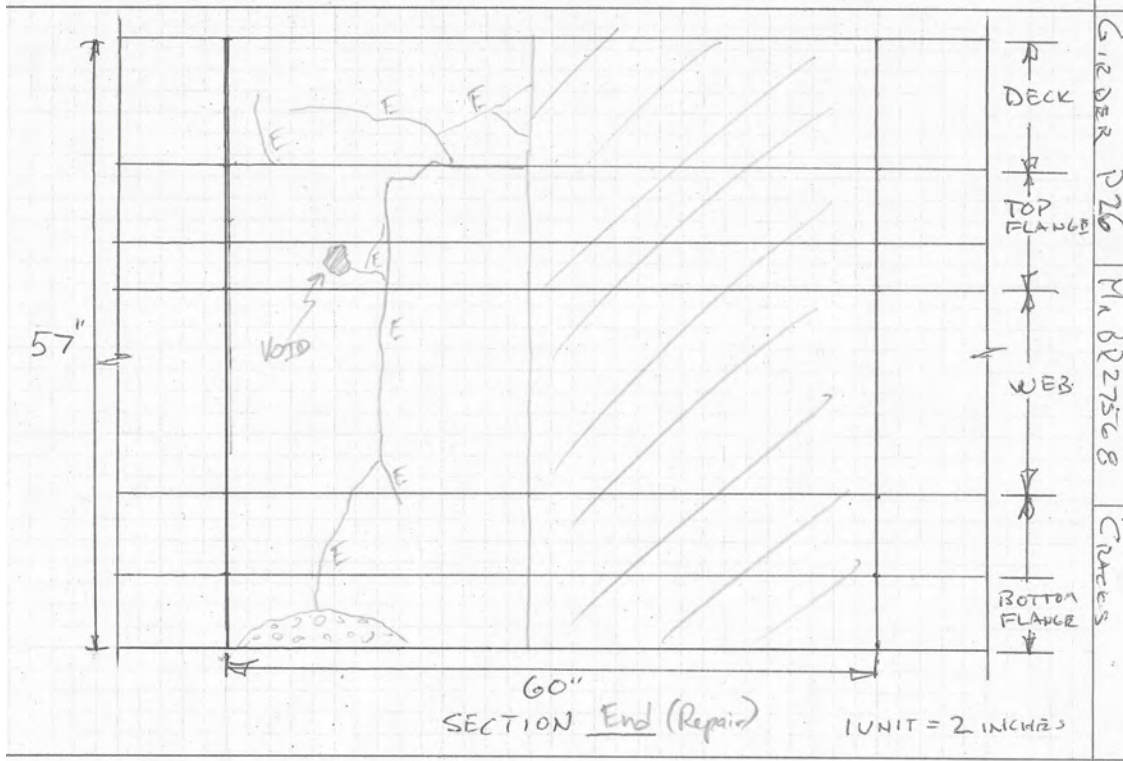
Figure 4.40 Girder P26 crack pattern – repair end view

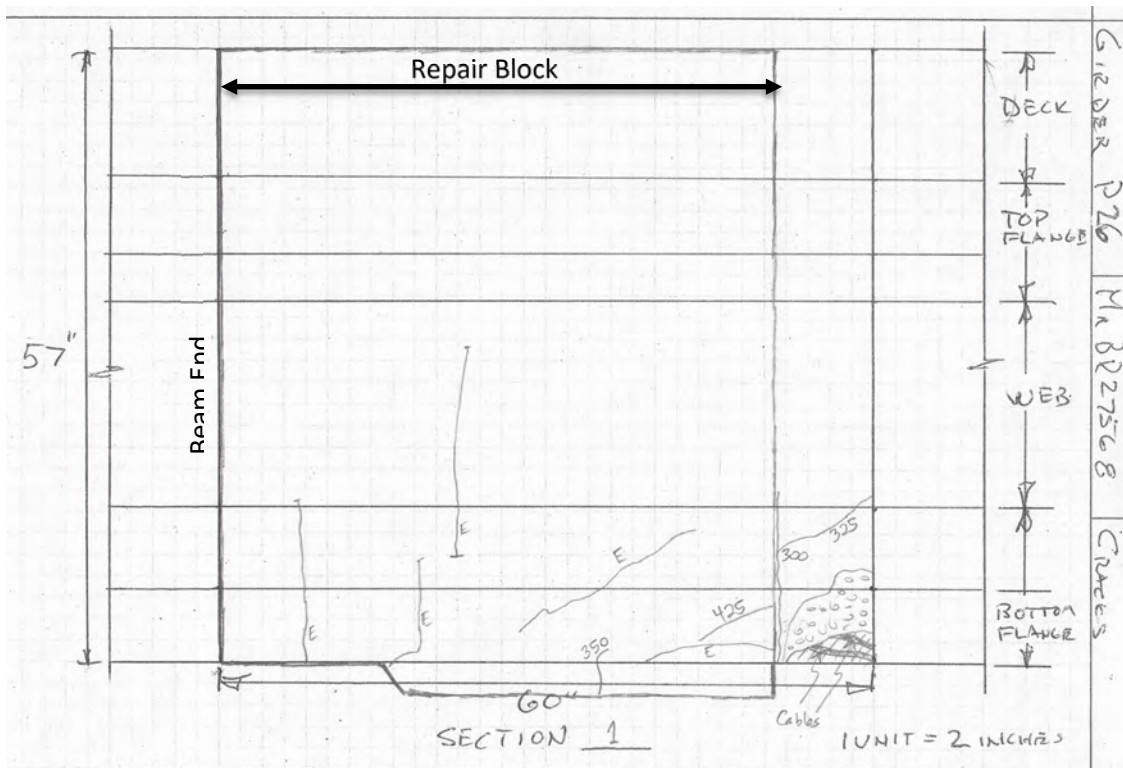
Figure 4.41 Girder P26 crack pattern – Section 1 (See Figure 3.4 for Section limits)

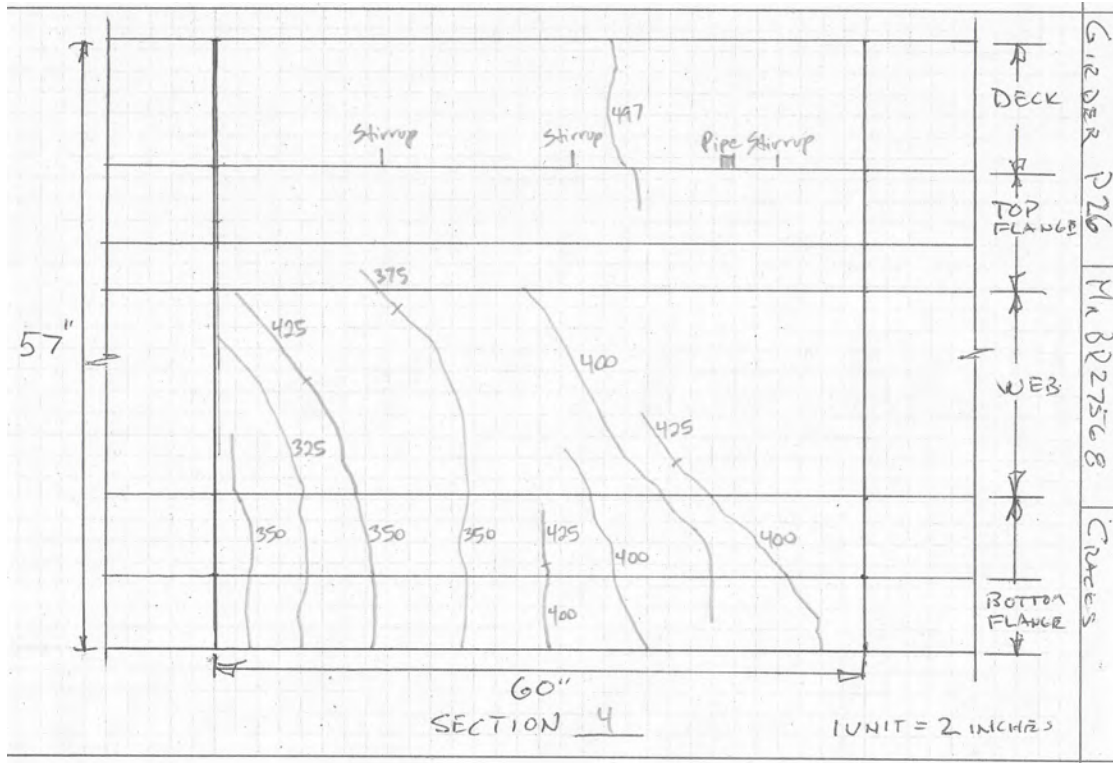
Figure 4.44 Girder P26 crack pattern – Section 4
