BR27568 – Experimental Shear Capacity Comparison Between Repaired and Unrepaired Girder Ends

Carol Shield, Principal Investigator

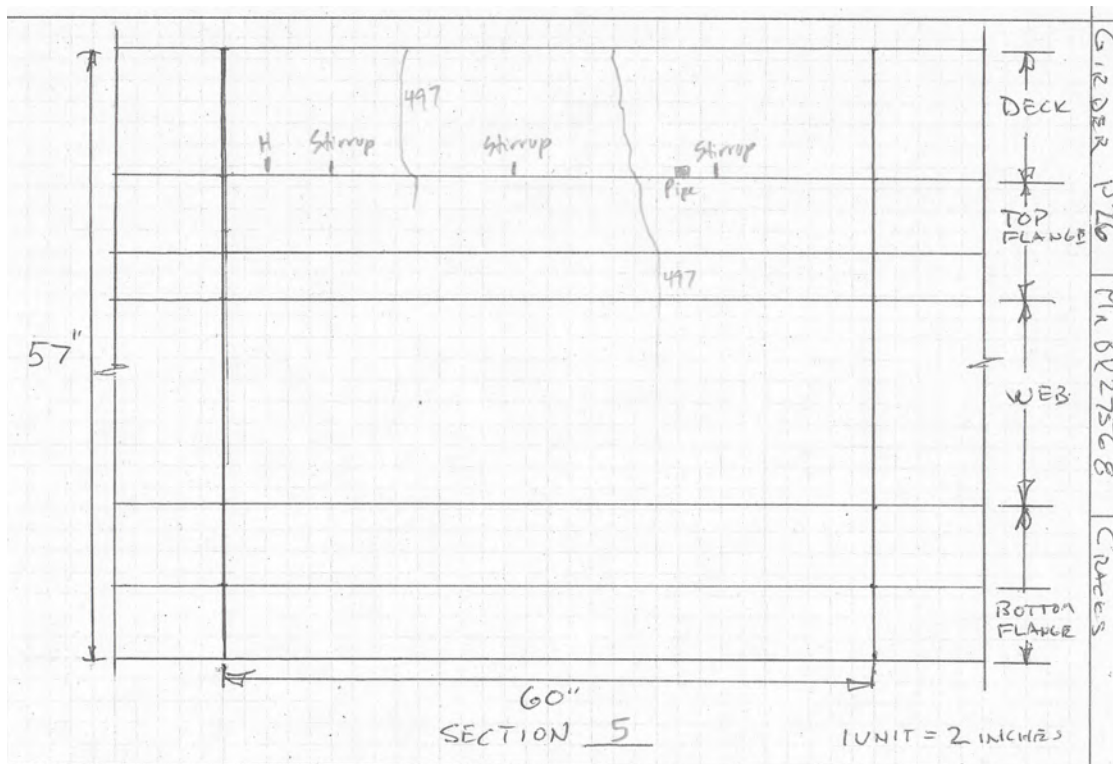
Figure 4.45 Girder P26 crack pattern – Section 5

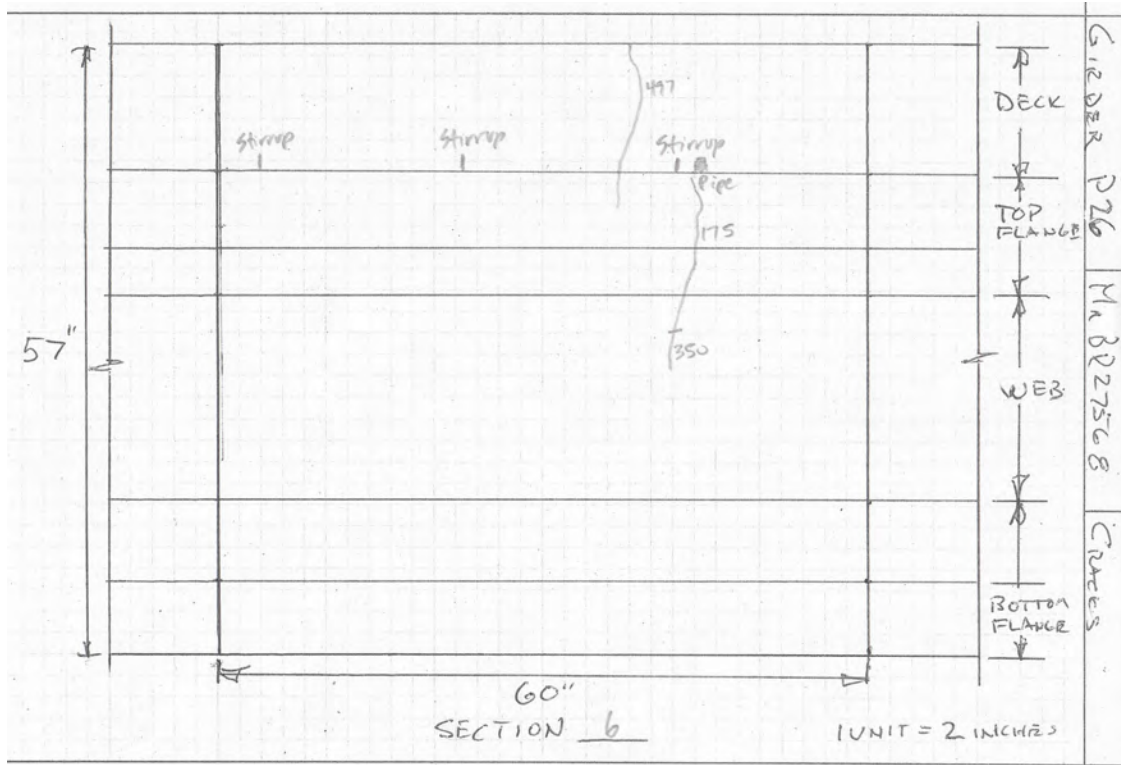
Figure 4.46 Girder P26 crack pattern – Section 6

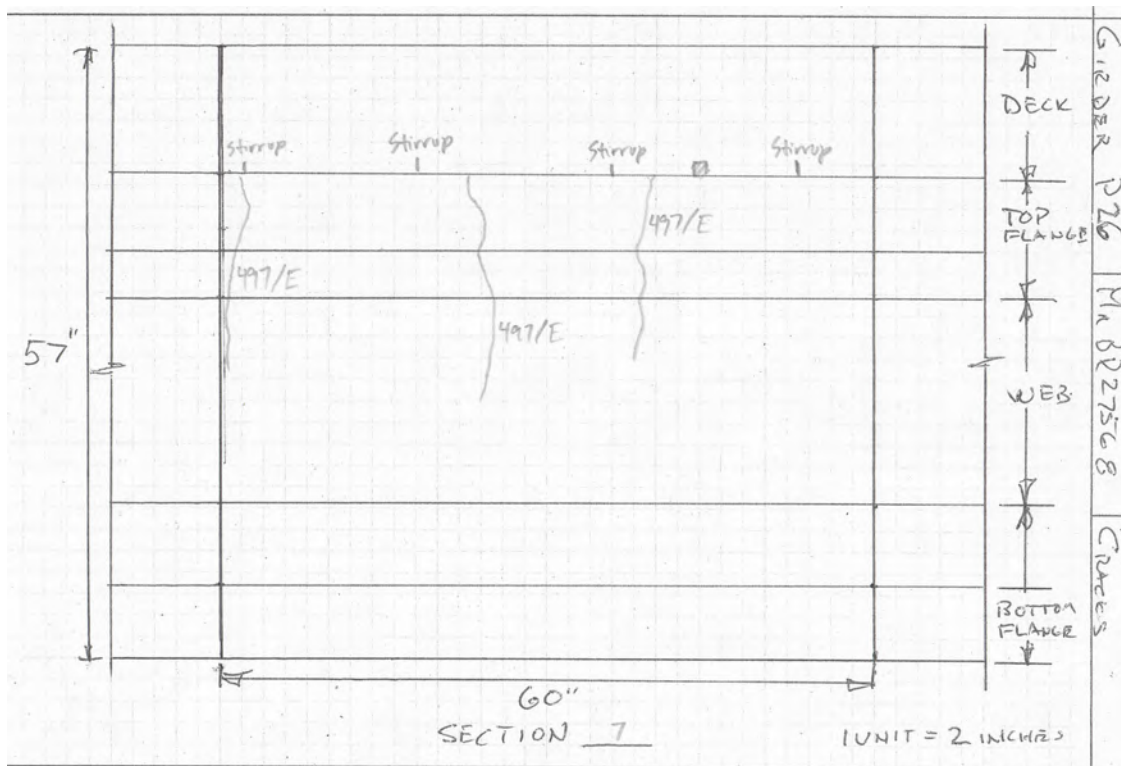
Figure 4.47 Girder P26 crack pattern – Section 7

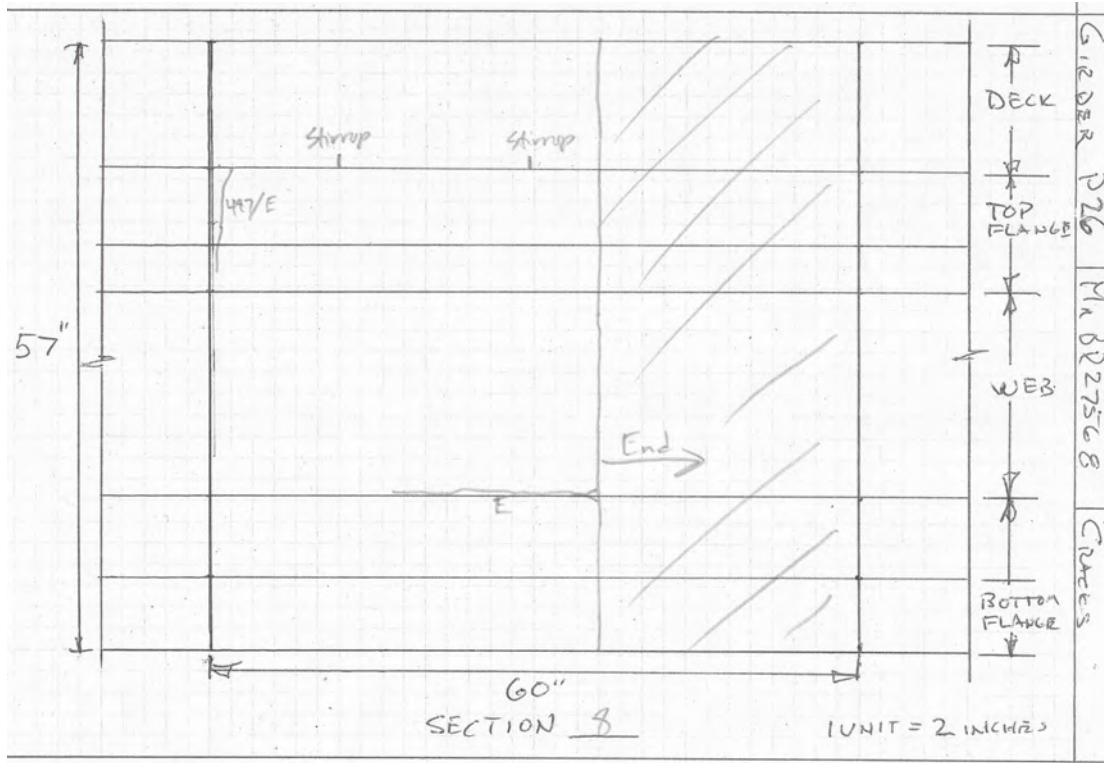
Figure 4.48 Girder P26 crack pattern – Section 8

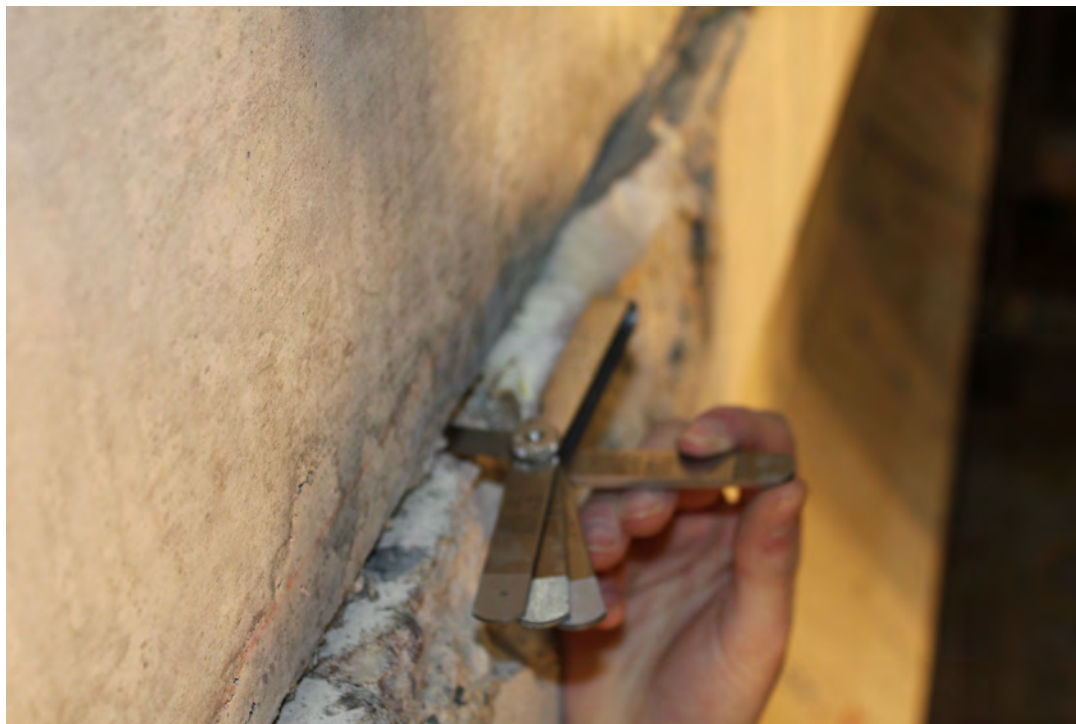
Figure 4.49 Separation between the deck and top flange of Girder P26.

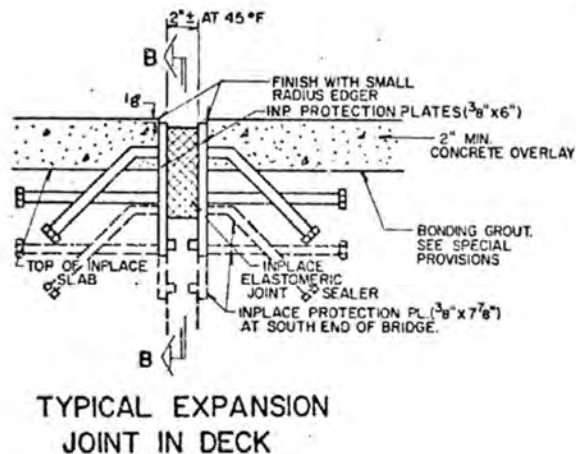
Figure A.1: Original expansion joint in service until 1995.

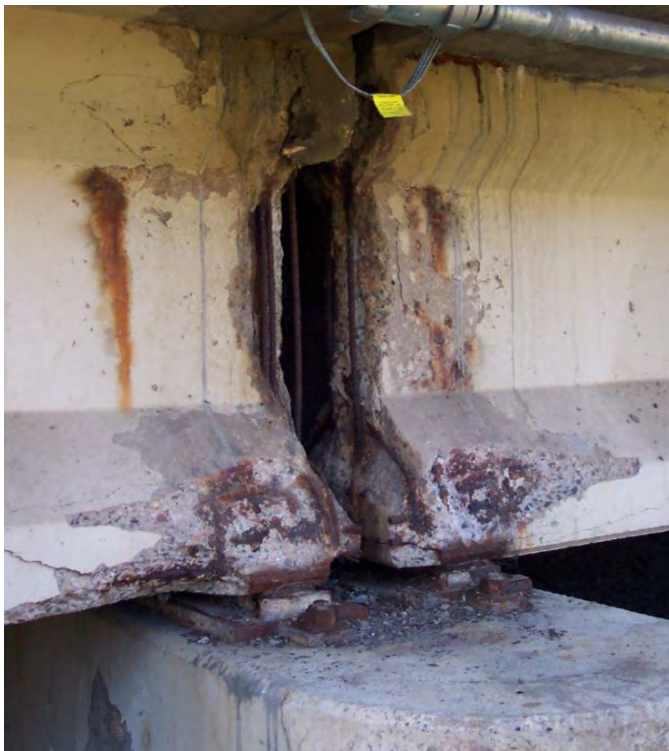
Figure A.7: Photo from October 2010 of Pier 4 beam end prior to final scoping

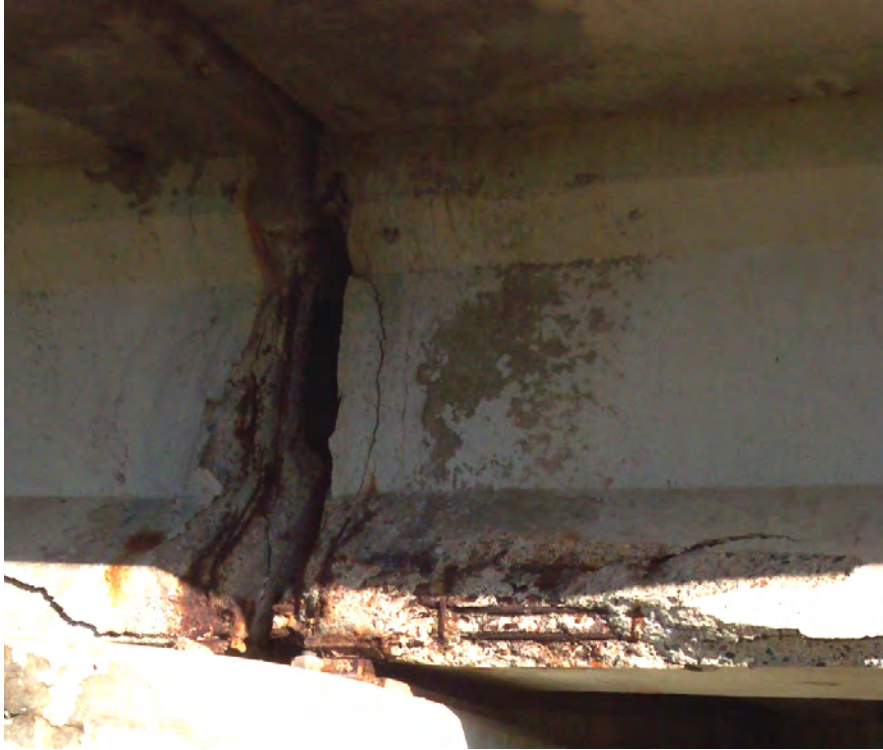
Figure A.8: Photo from October 2010 of Pier 26 beam end prior to final scoping

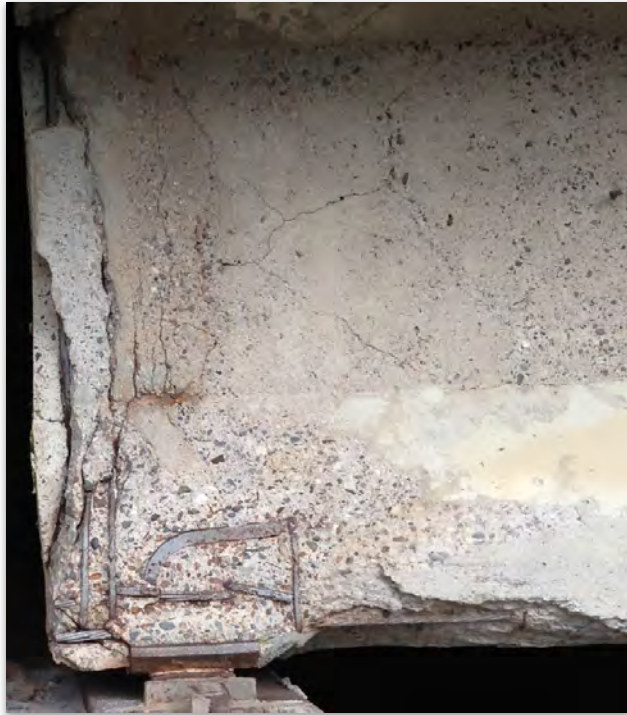
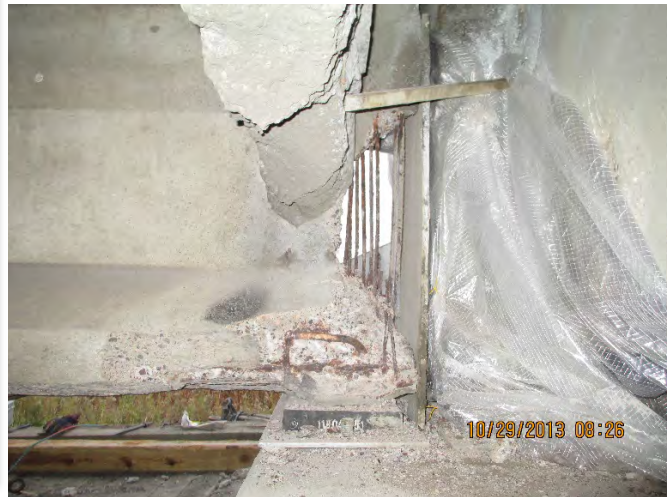
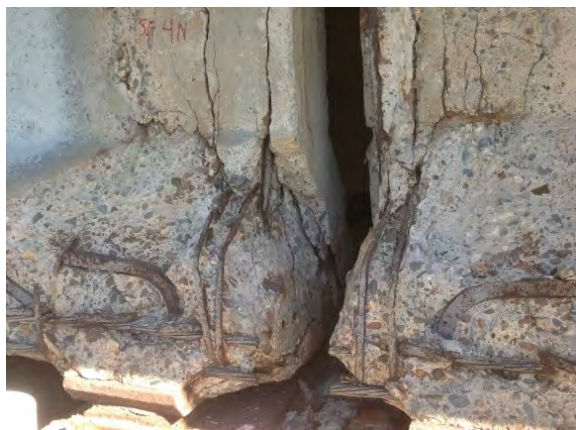
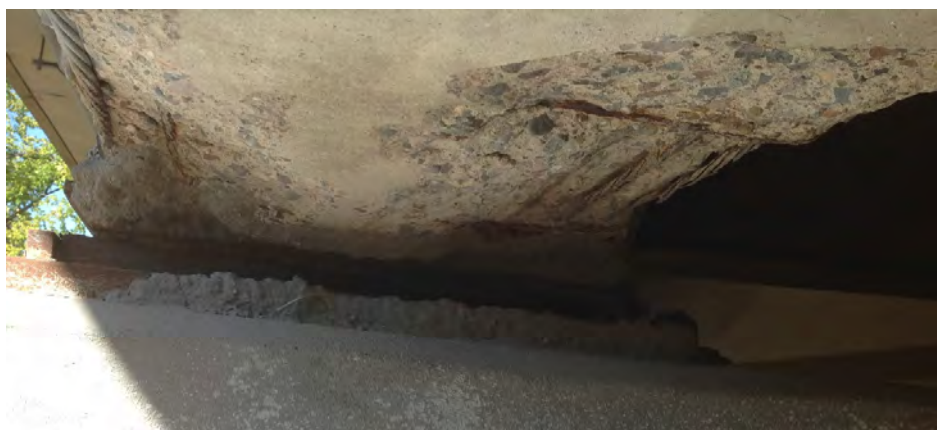
Figure A.9: Beam end at Pier 4 prior to preparation.

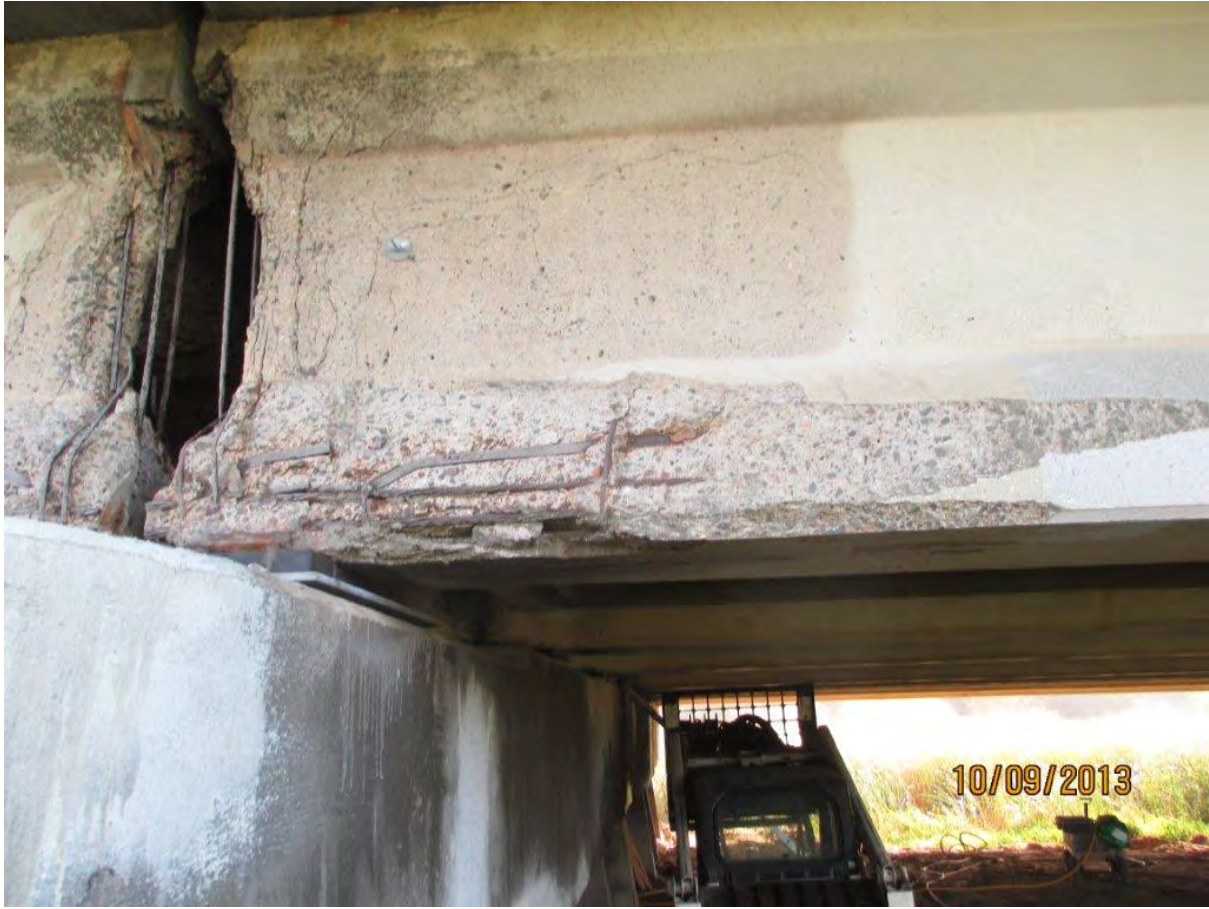
Figure A.12: Sandblasted beam end at Pier 26 prior to issuing box-style repair design details.

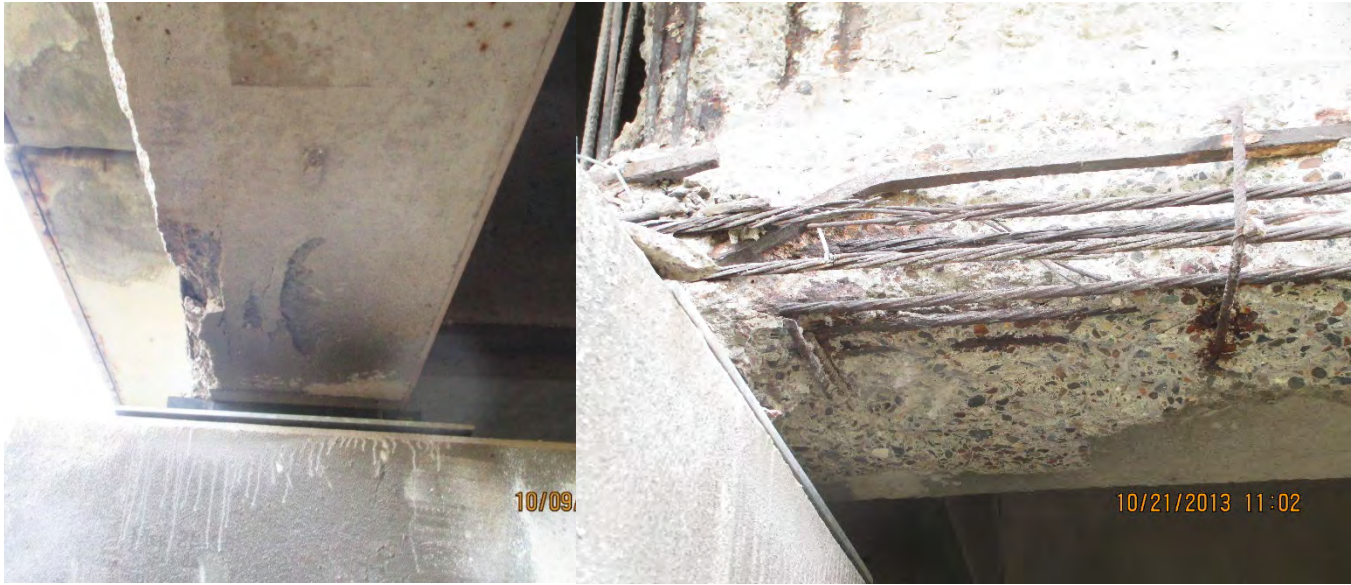
Figure A.13: Underside of Pier 26 beam prior to preparation.

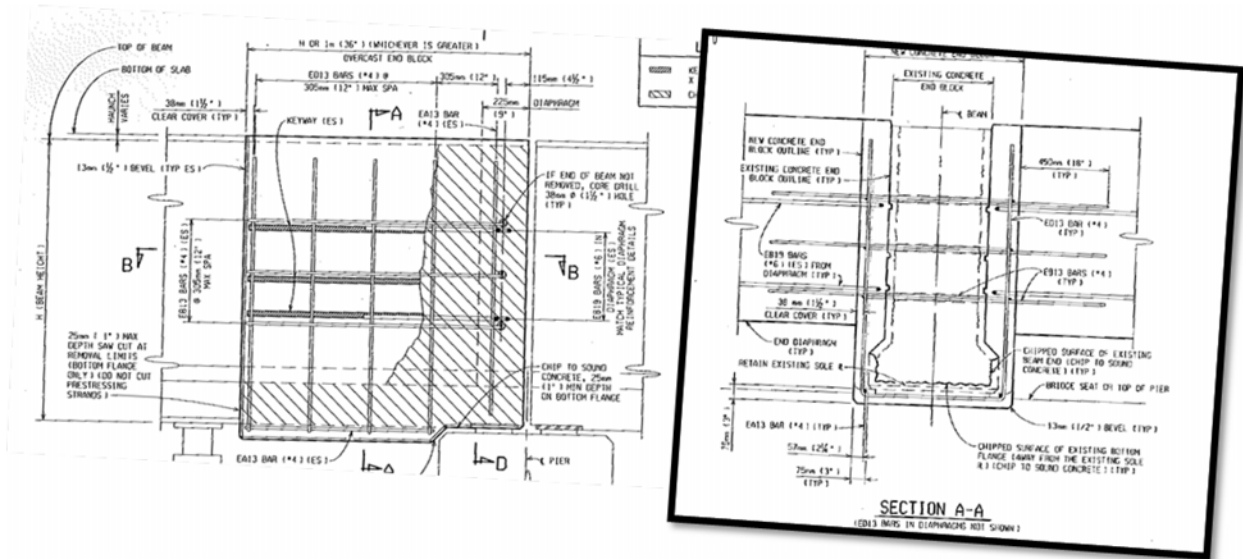
Figure A.16: Details from 1999 Michigan Report R-1373.

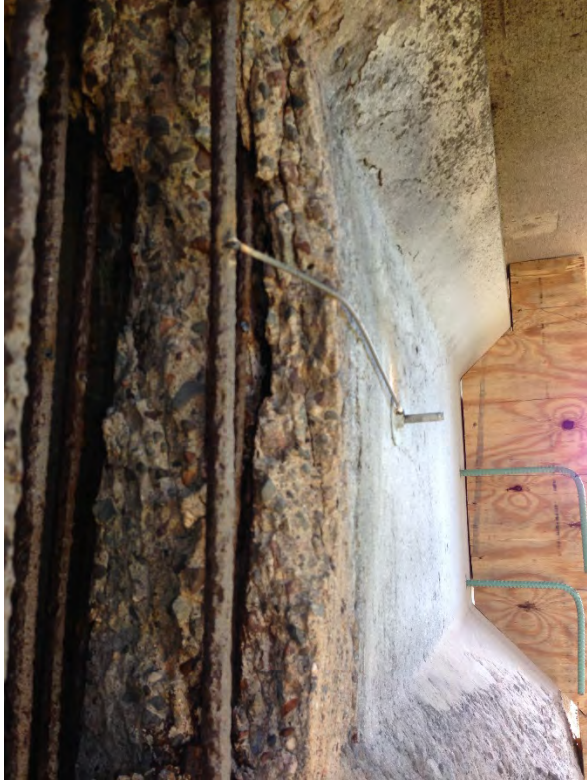
Figure A.17: Separation of concrete web concrete upon slow jacking from temporary support location. Separation was likely due to rebalancing of internal prestress forces. After the separation was reported the jacking pressure was immediately reduced to 50% dead load take-up from 100% dead load. The repair proceeded under 50% dead load take-up.

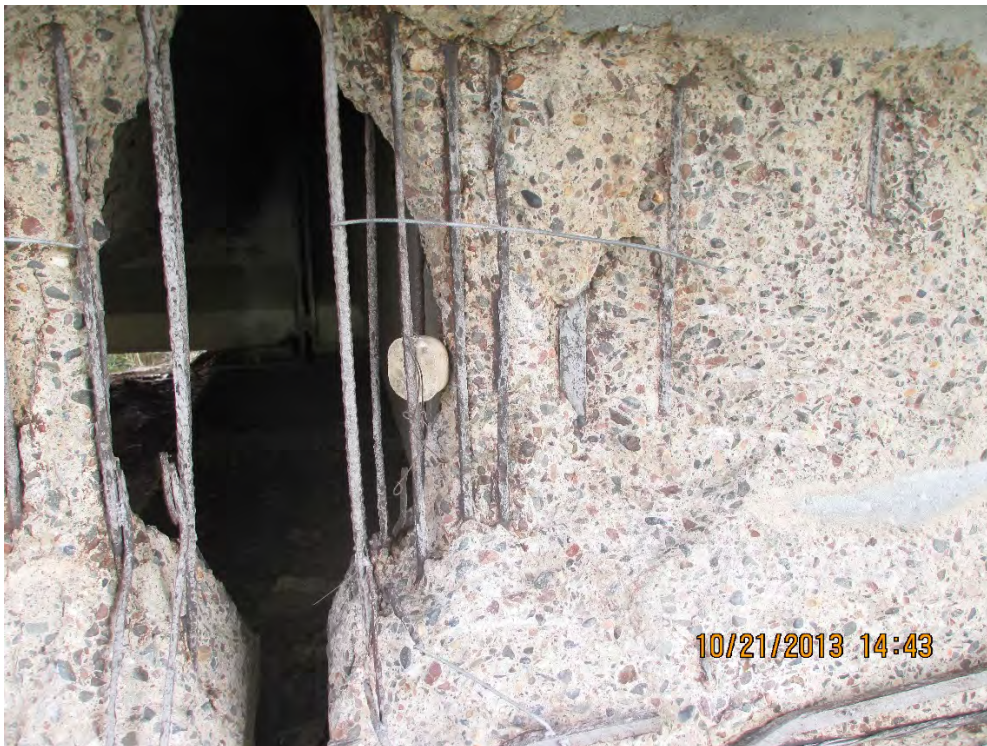
Figure A.18: Prepared beam end at Pie 26 prior to installation of mild rebar.

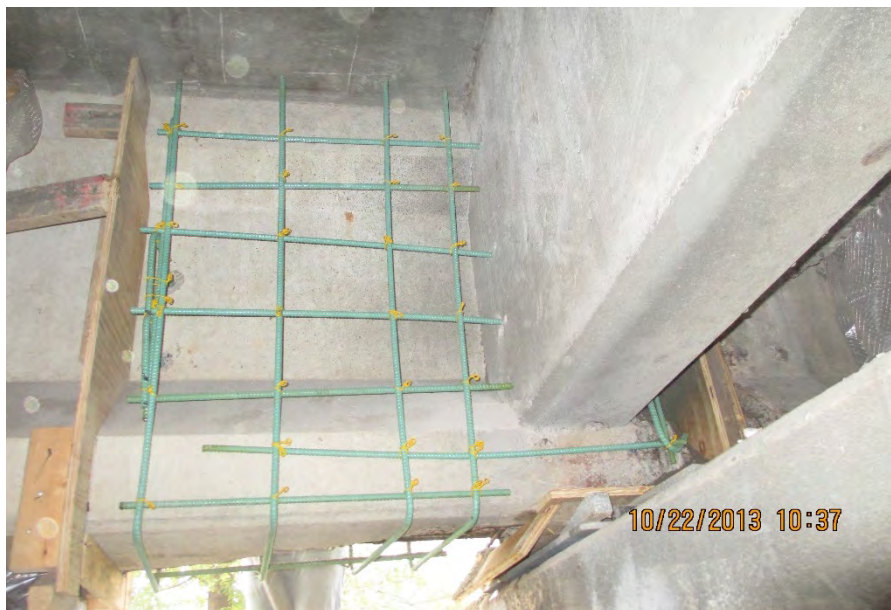
Figure A.20: Inside face view of P26 beam end just prior to shotcreting.

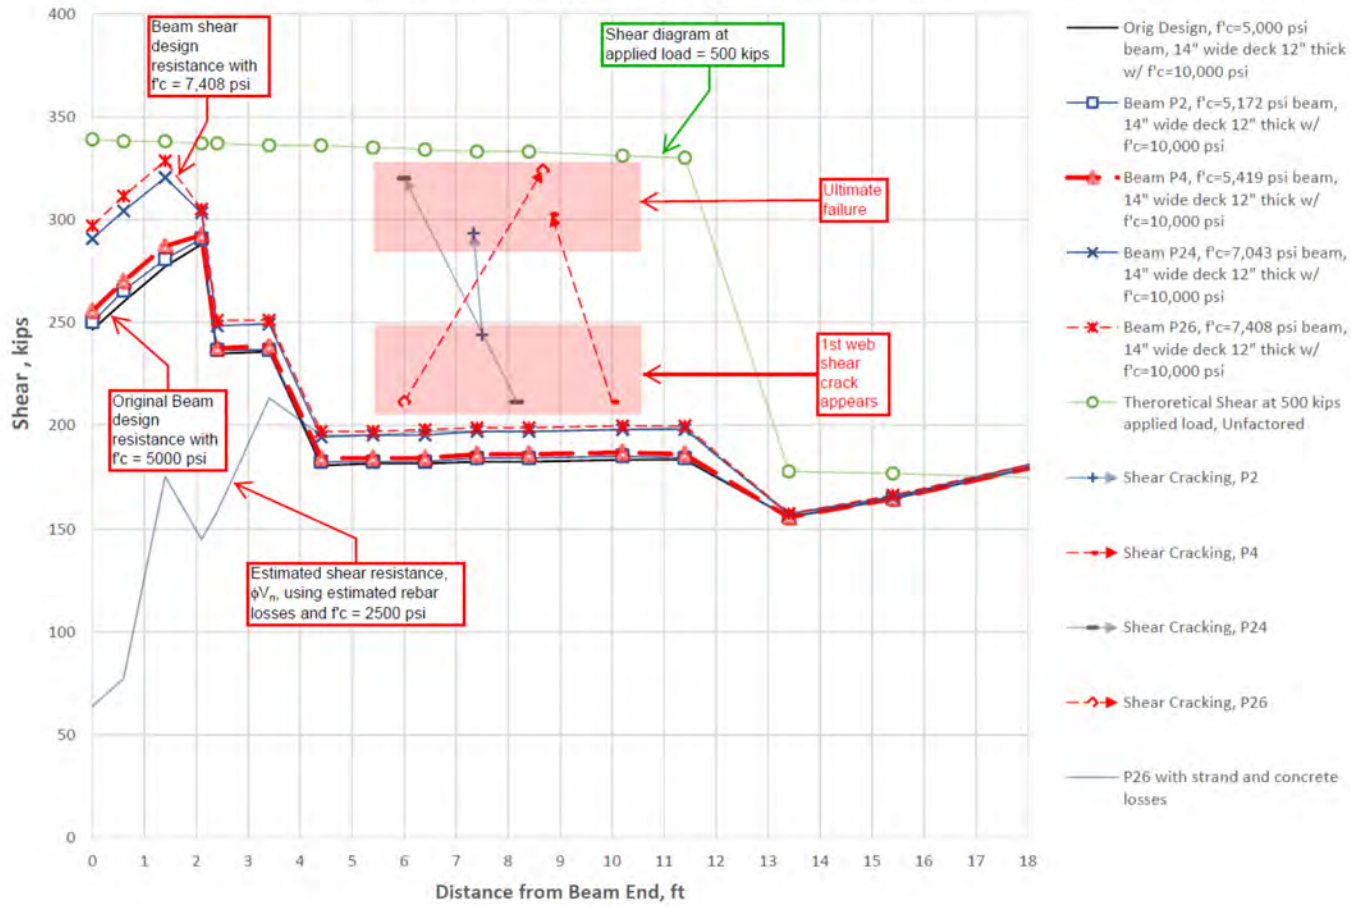
Figure A.21: Shear design resistance as compared to testing results.

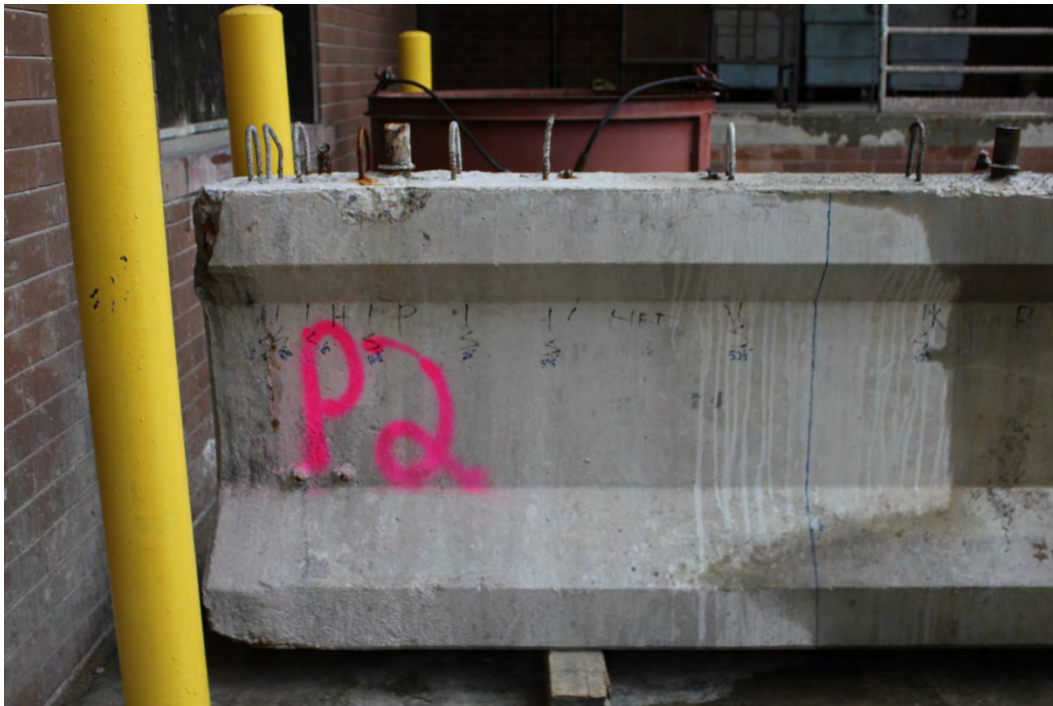
Figure B.1 Girder P2 Prior to Casting – Section 1

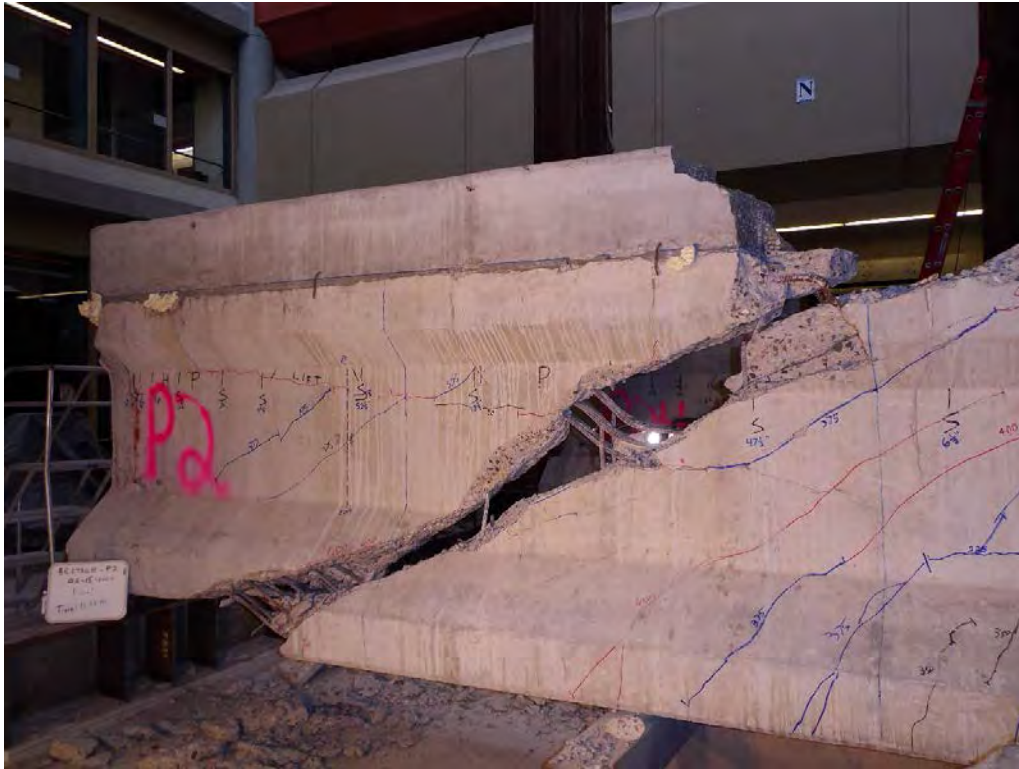
Figure B.16 Girder P2 Southside Section 1-Section 2 Failure

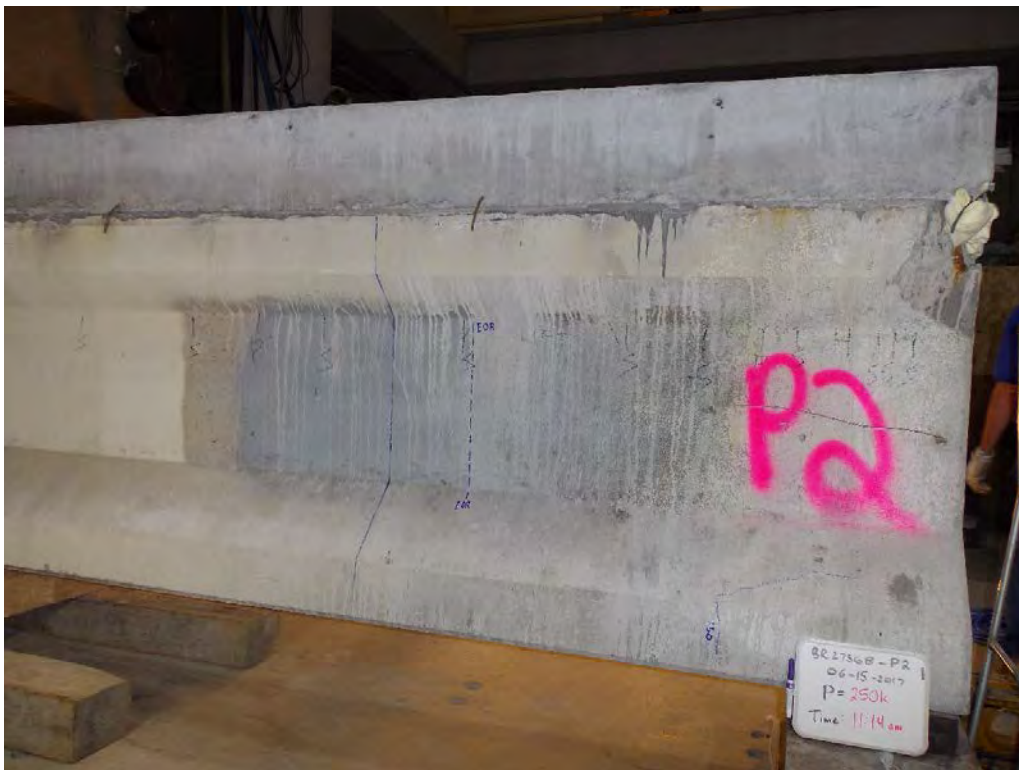
Figure B.17 Girder P2 Northside Section 1-Section 2 $P=250$ kips

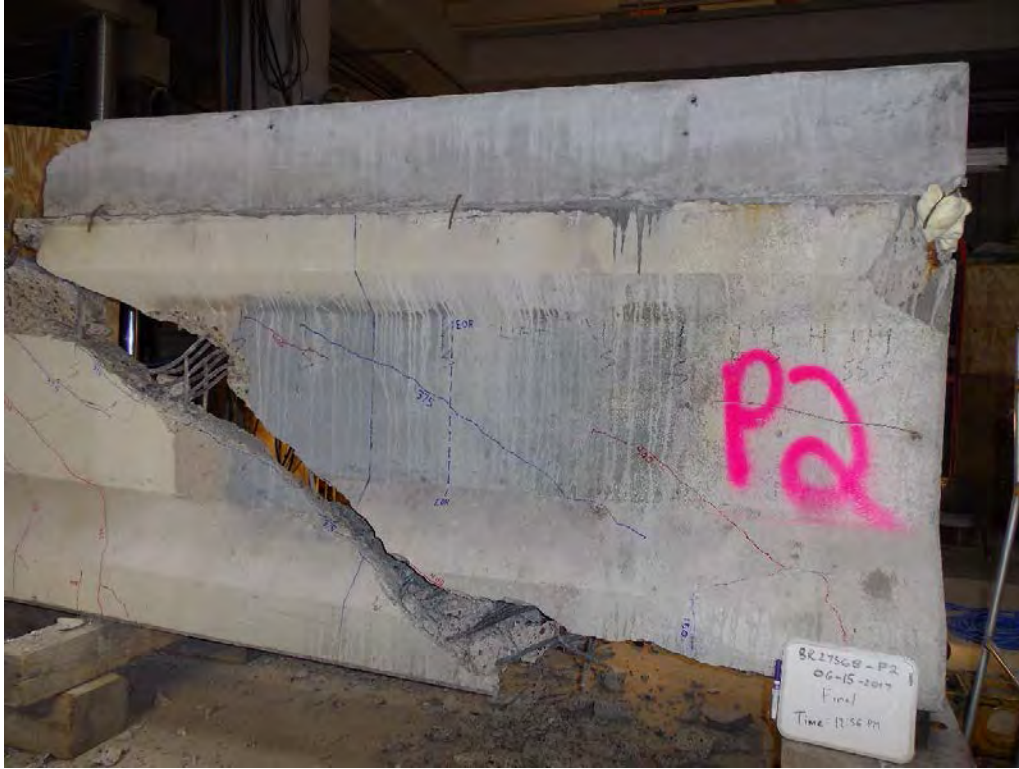
Figure B.24 Girder P2 Northside Section 1-Section 2 Failure

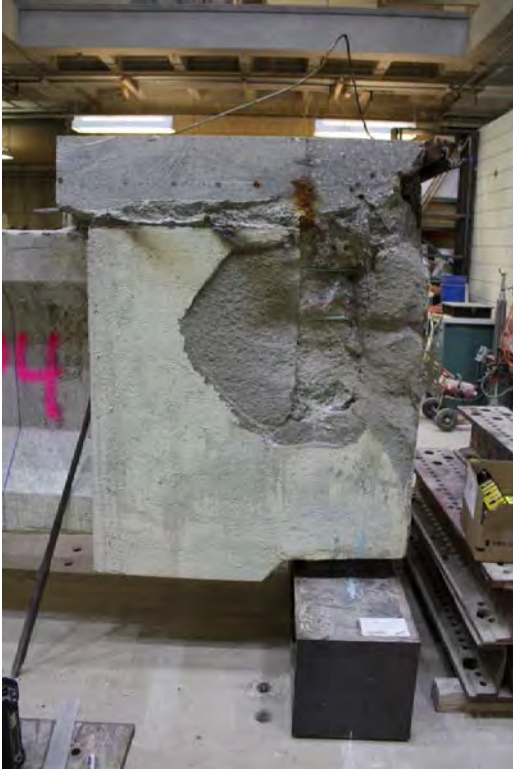
Figure B.25 Girder P4 Prior to Casting – Section 1 (Northside)

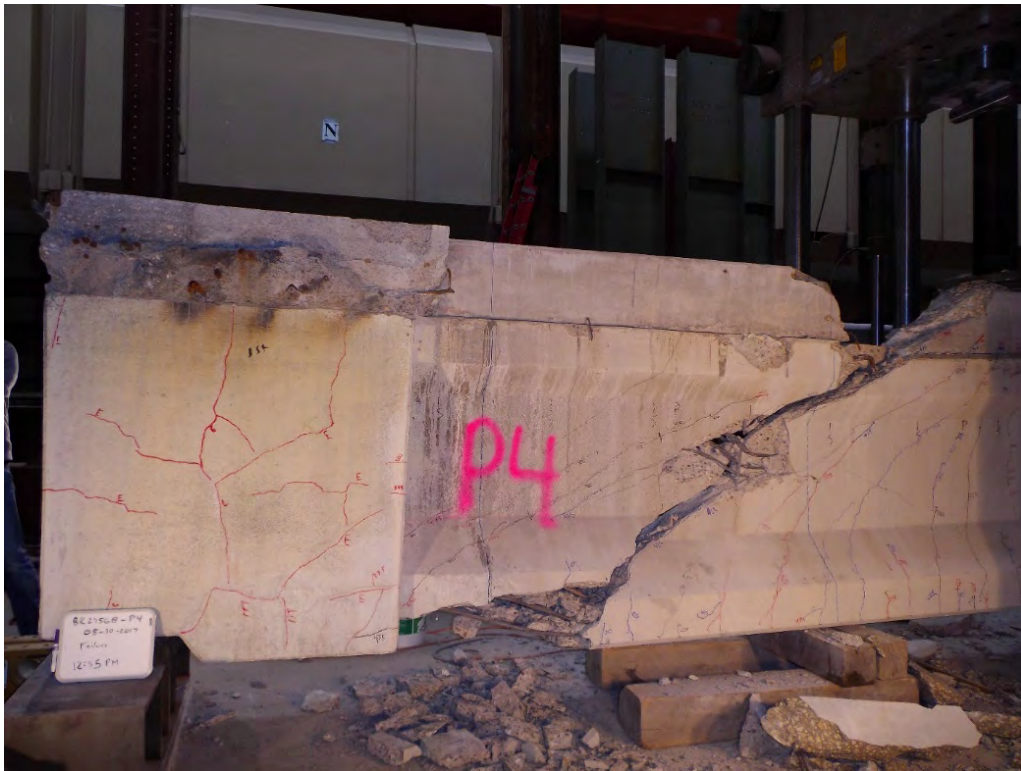
Figure B.42 Girder P4 Southside Section 1-Section 3 Failure

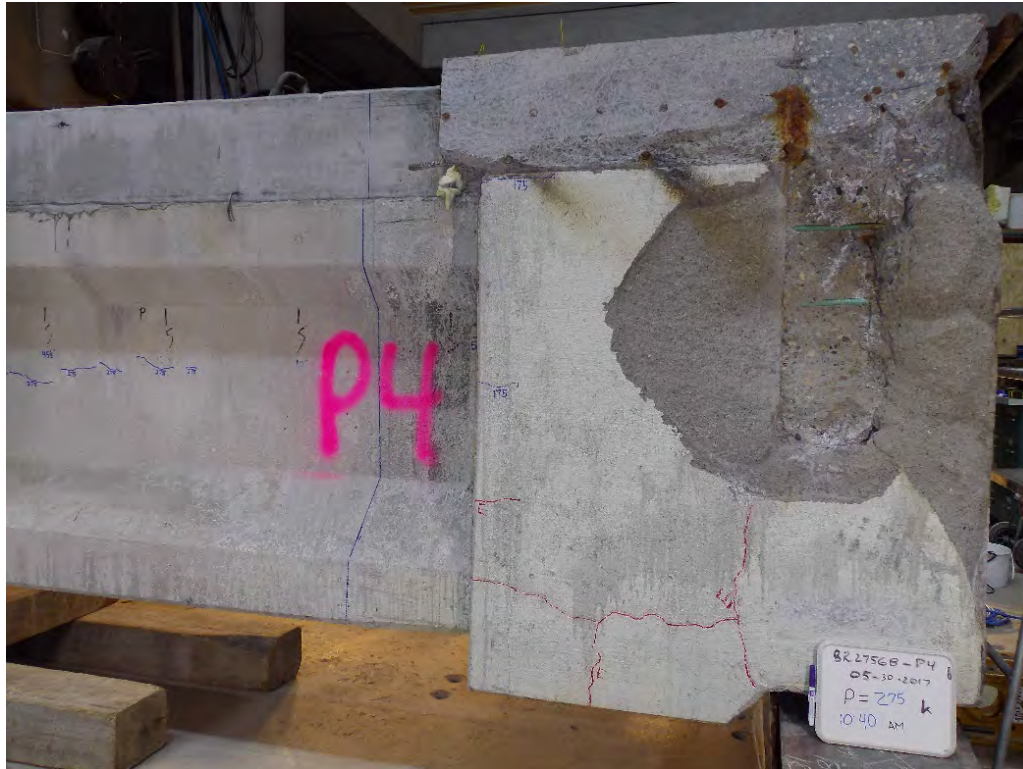
Figure B.43 Girder P4 Northside Section 1-Section 2 $P=275$ kips

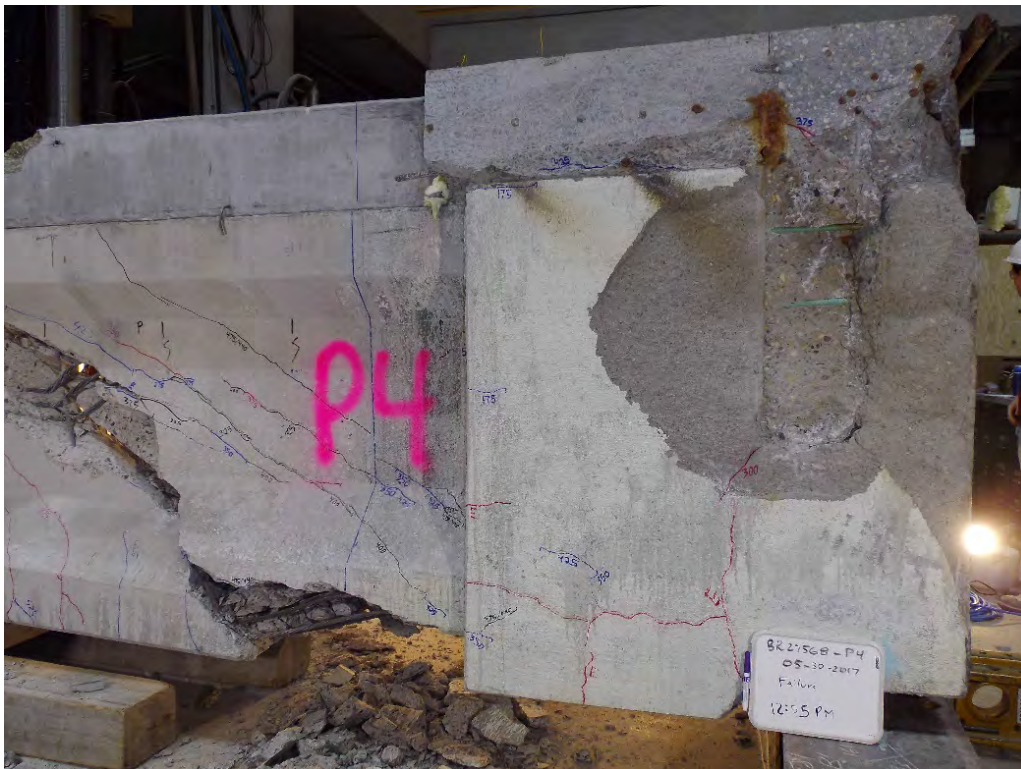
Figure B.52 Girder P4 Northside Section 1-Section 2 Failure

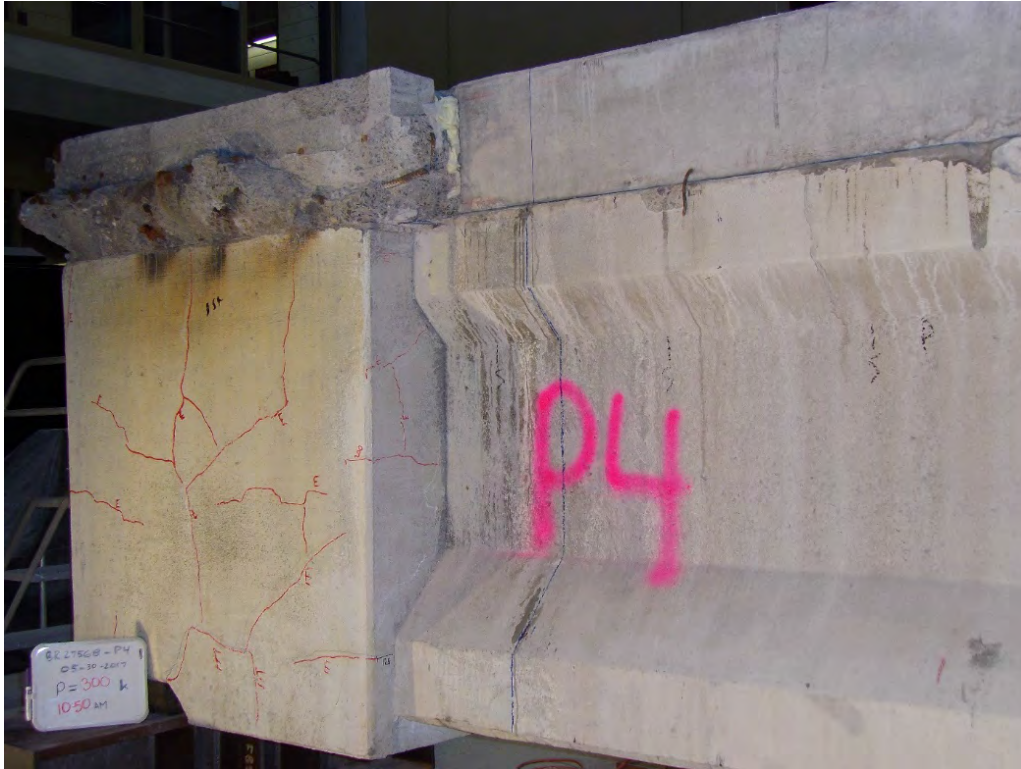
Figure B.53 Girder P4 Repair Section 1 $P=300$ kips

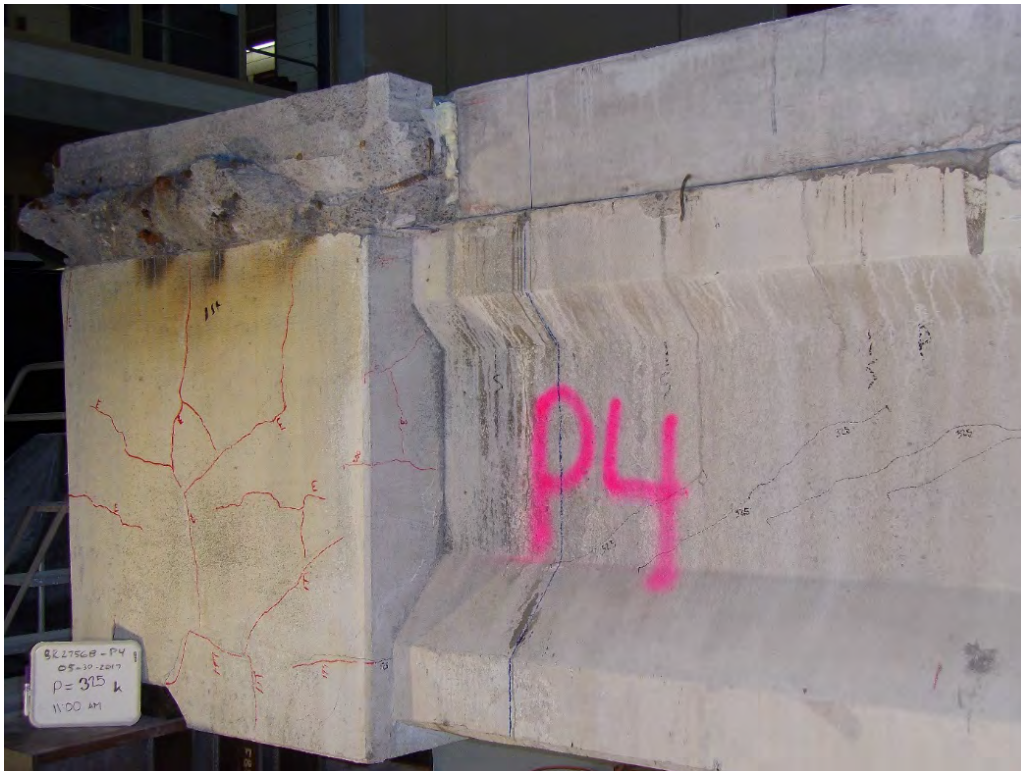
Figure B.54 Girder P4 Repair Section 1 $P=325$ kips

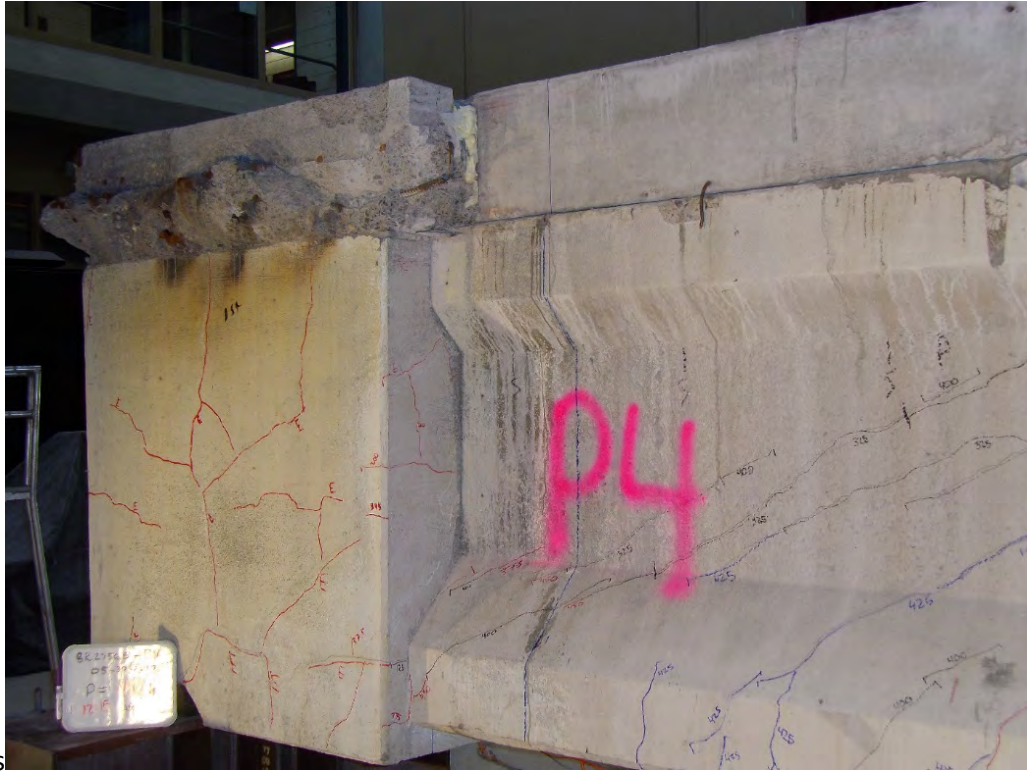
Figure B.55 Girder P4 Repair Section 1 $P=450$ kips

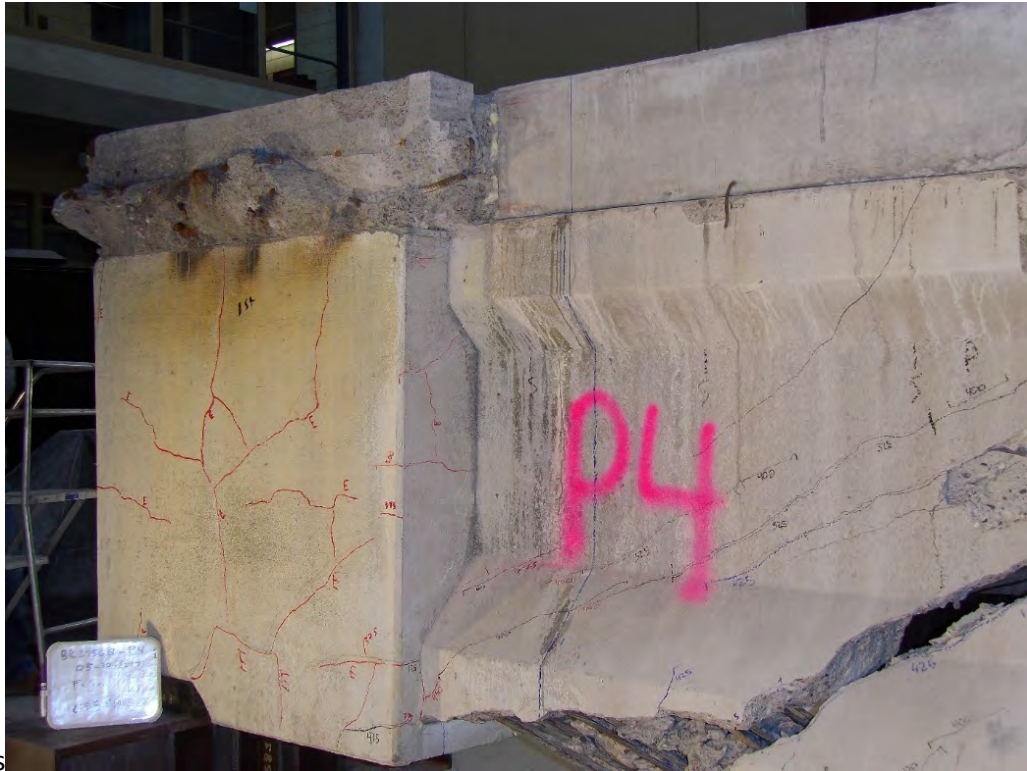
Figure B.56 Girder P4 Repair Section 1 Failure

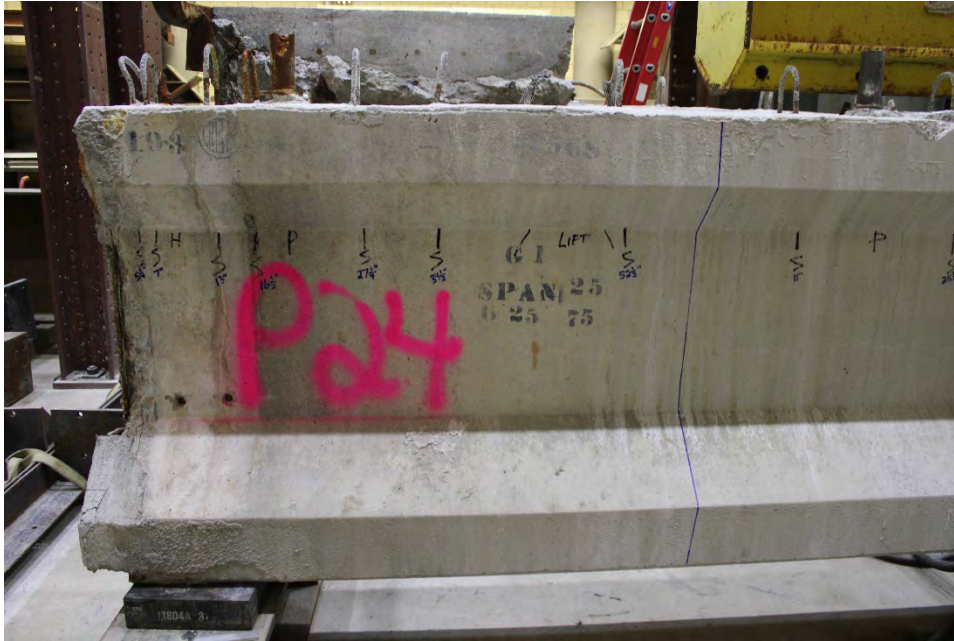
Figure B.57 Girder P24 Prior to Casting – Section 1
