BR27568 – Experimental Shear Capacity Comparison Between Repaired and Unrepaired Girder Ends

Carol Shield, Principal Investigator

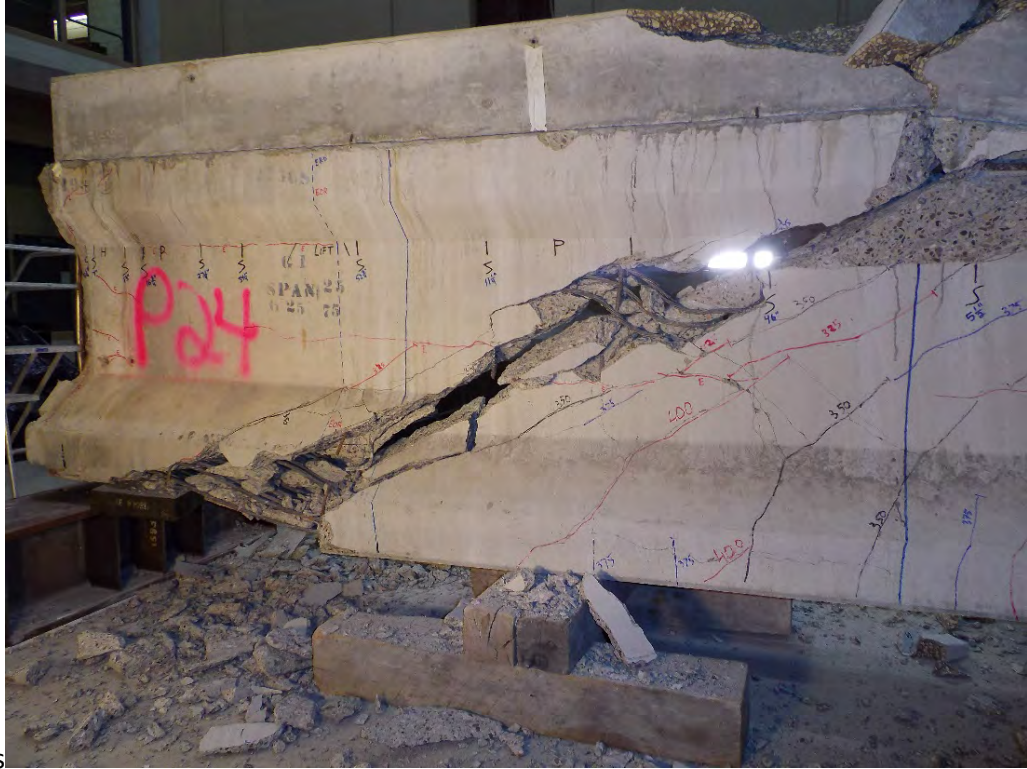
Figure B.73 Girder P24 Southside Section 1-Section 2 Failure

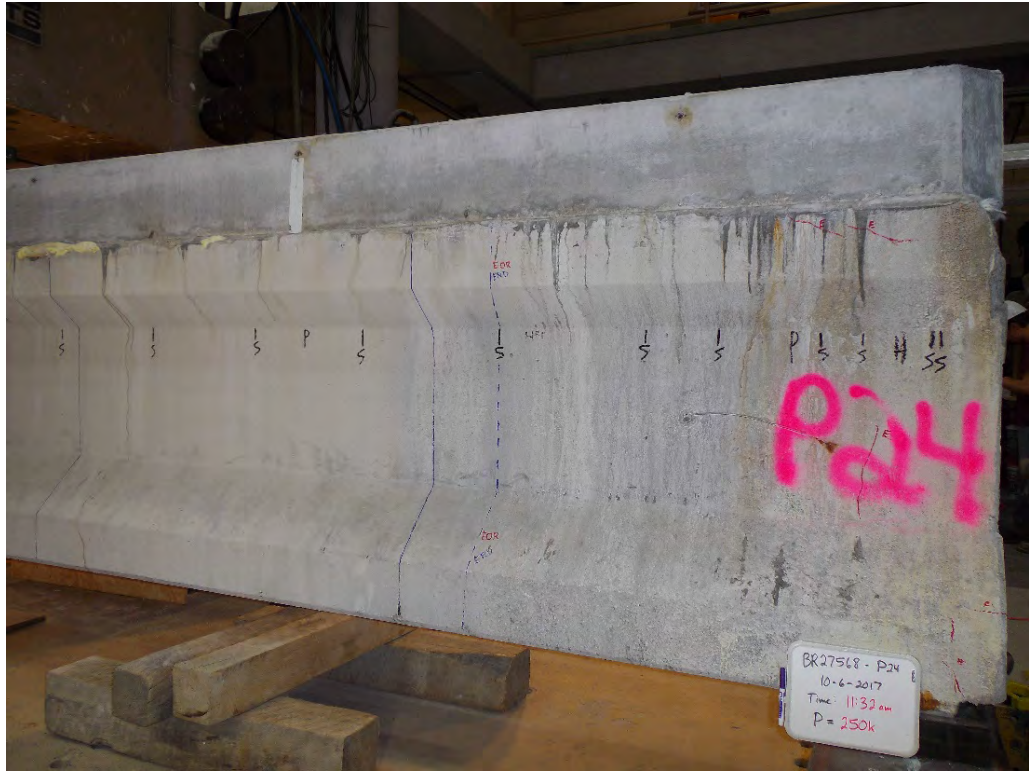
Figure B.74 Girder P24 Northside Section 1-Section 2 P=250 kips

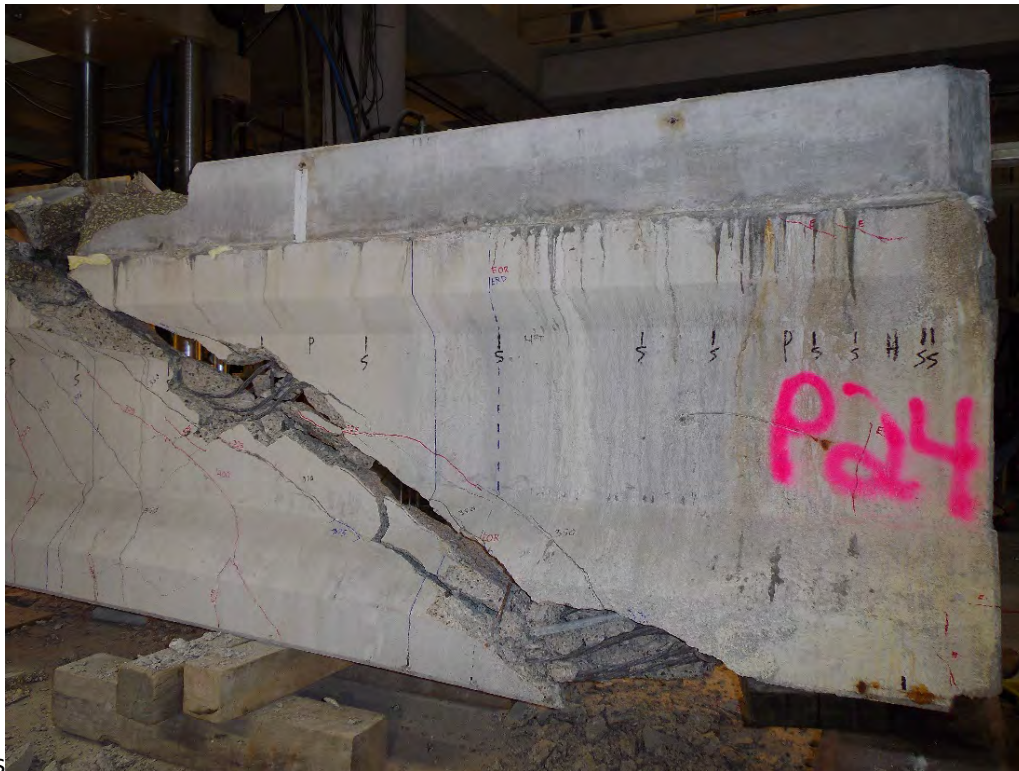
Figure B.82 Girder P24 Northside Section 1-Section 2 Failure

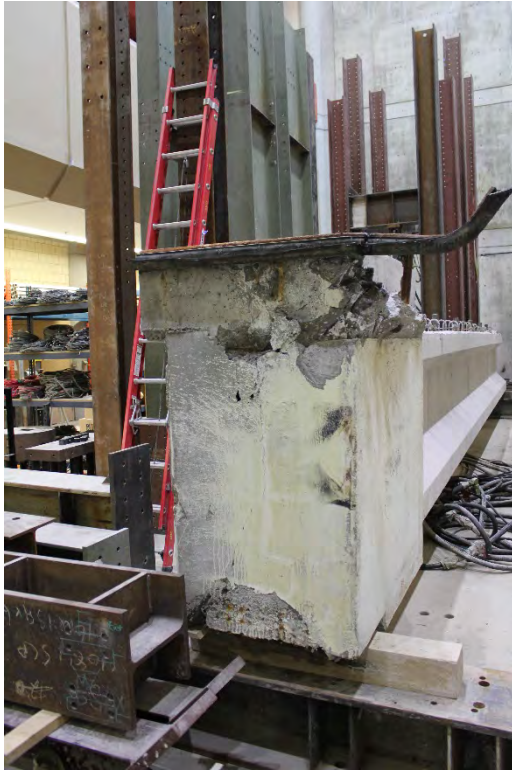
Figure B.83 Girder P26 Prior to Casting – Repair End View

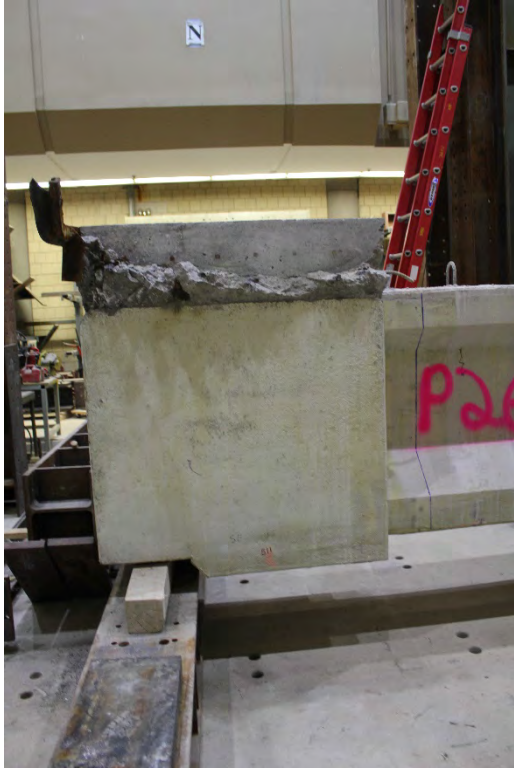
Figure B.84 Girder P26 Prior to Casting – Section 1

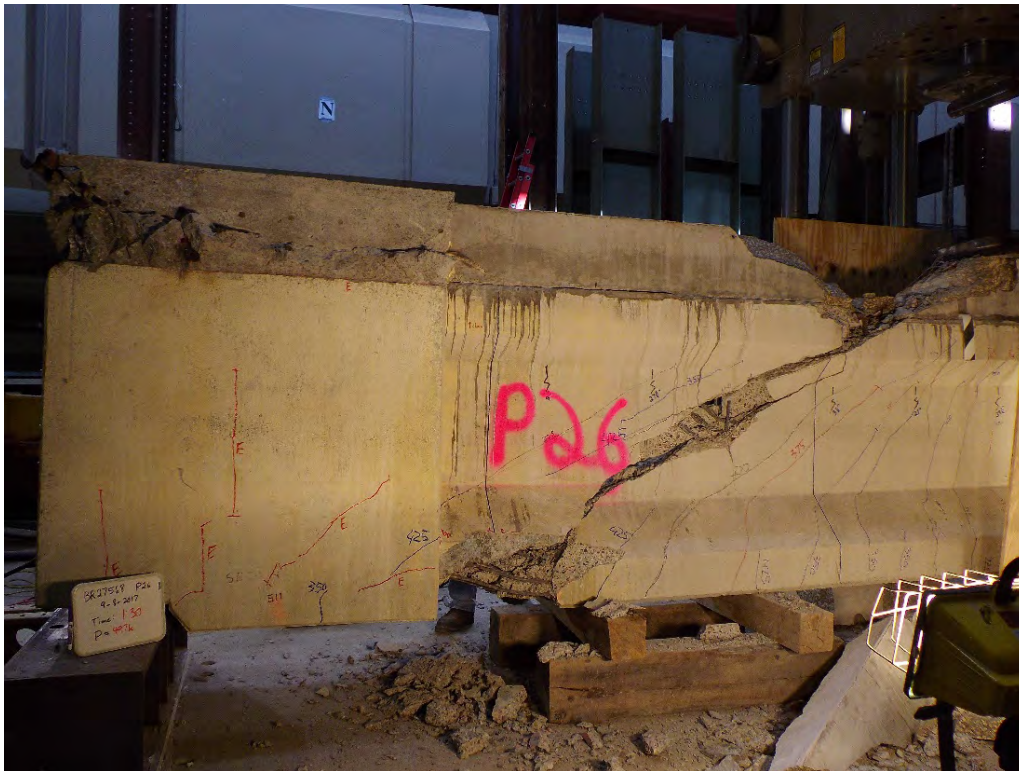
Figure B.99 Girder P26 Southside Section 1-Section 3 Failure

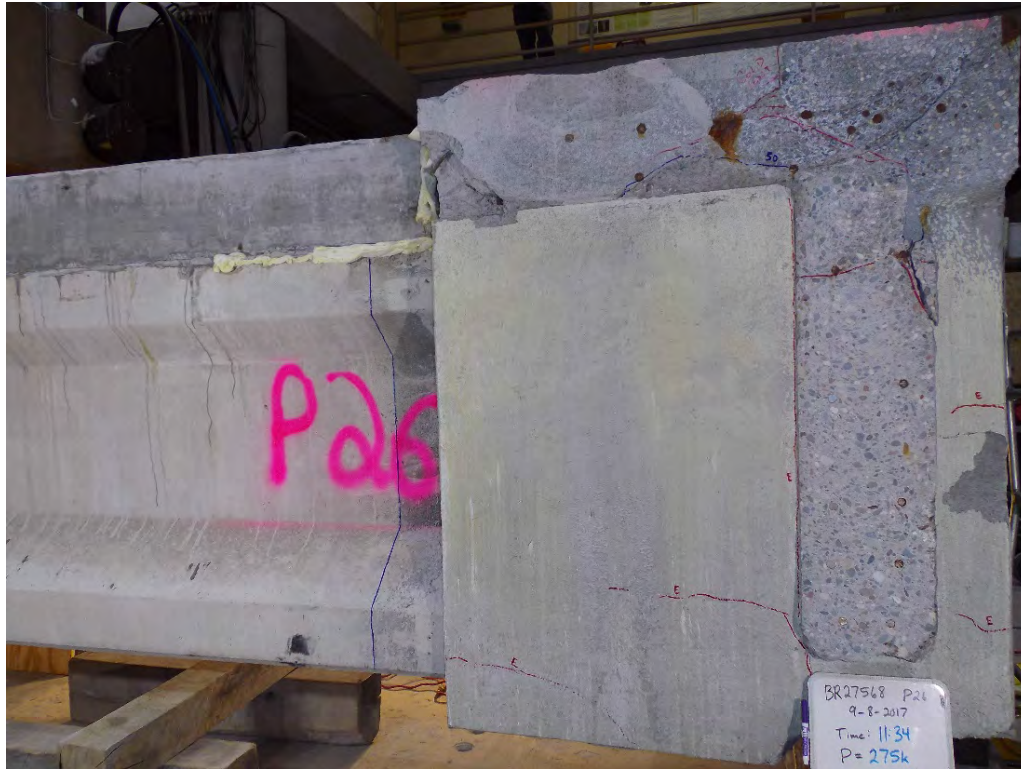
Figure B.100 Girder P26 Northside Section 1-Section 2 $P=275$ kips

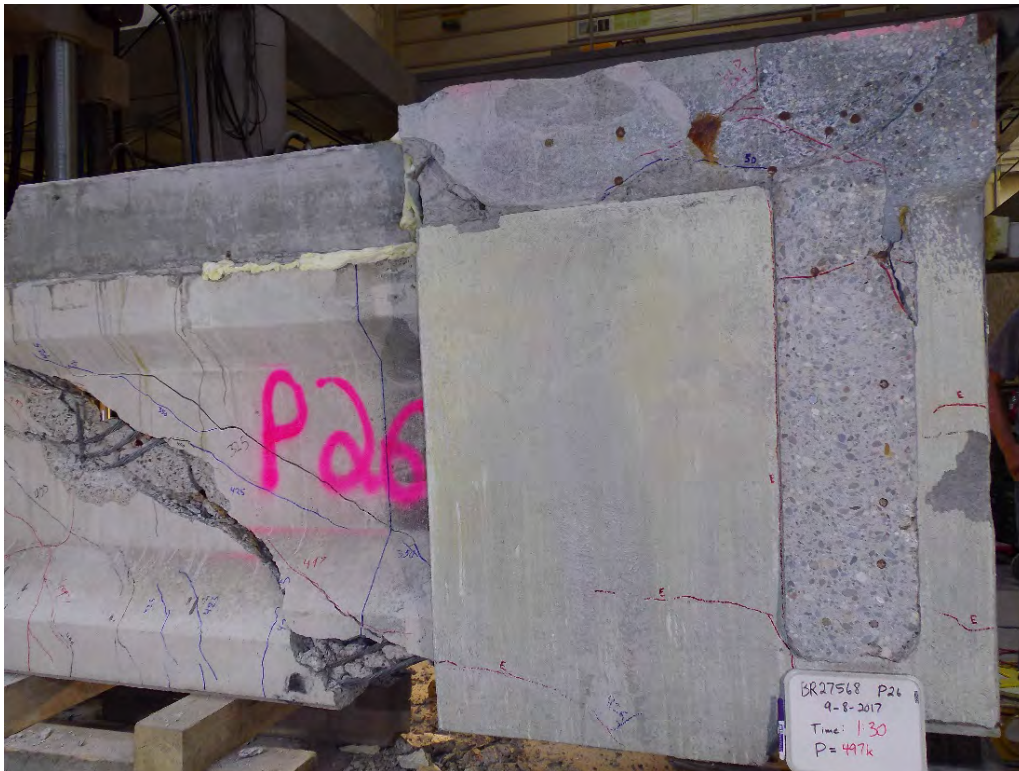
Figure B.107 Girder P26 Northside Section 1-Section 2 Failure

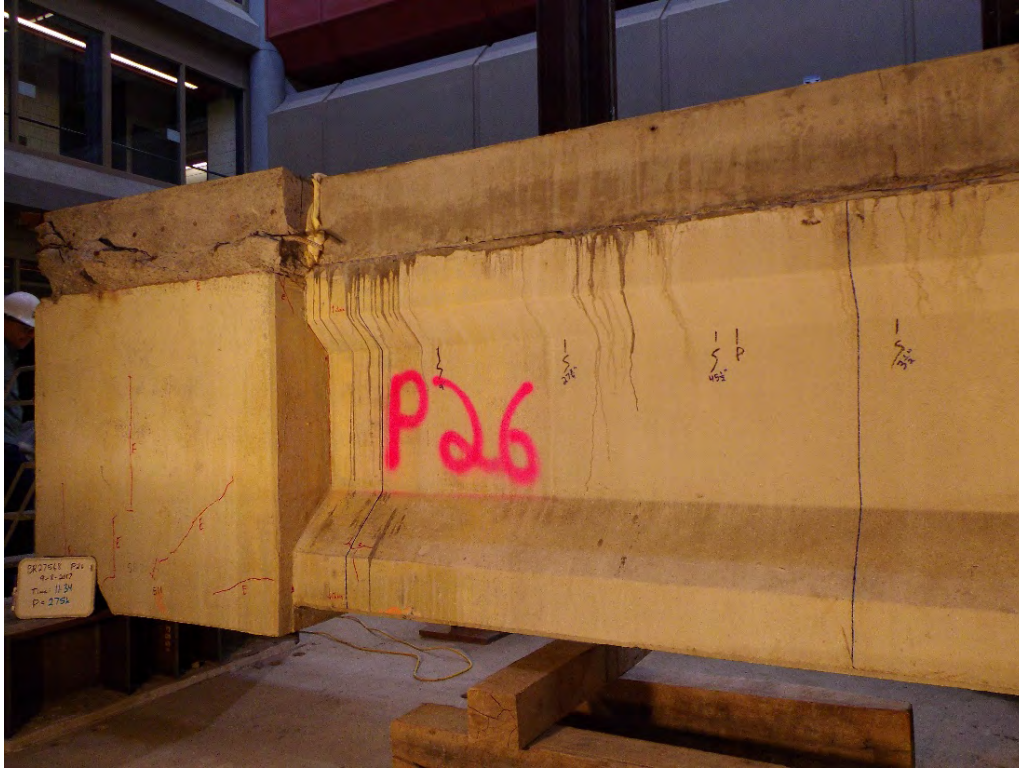
Figure B.108 Girder P26 Repair Section 1 – Section 2 $P=275$ kips

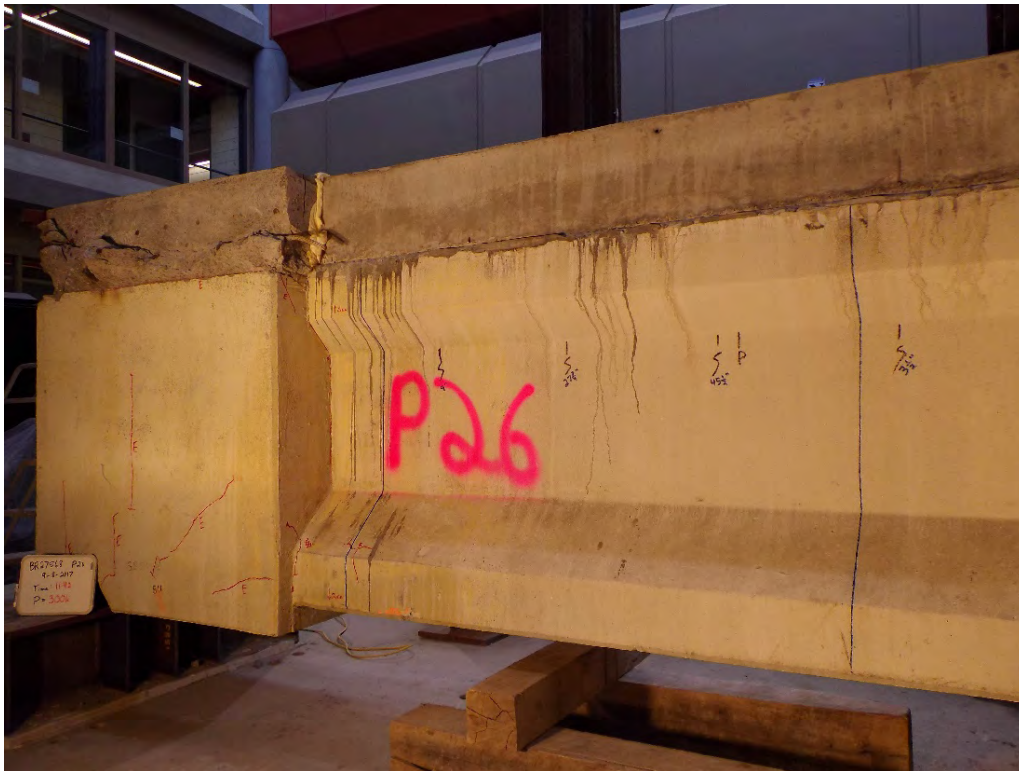
Figure B.109 Girder P26 Repair Section 1 – Section 2 $P=300$ kips

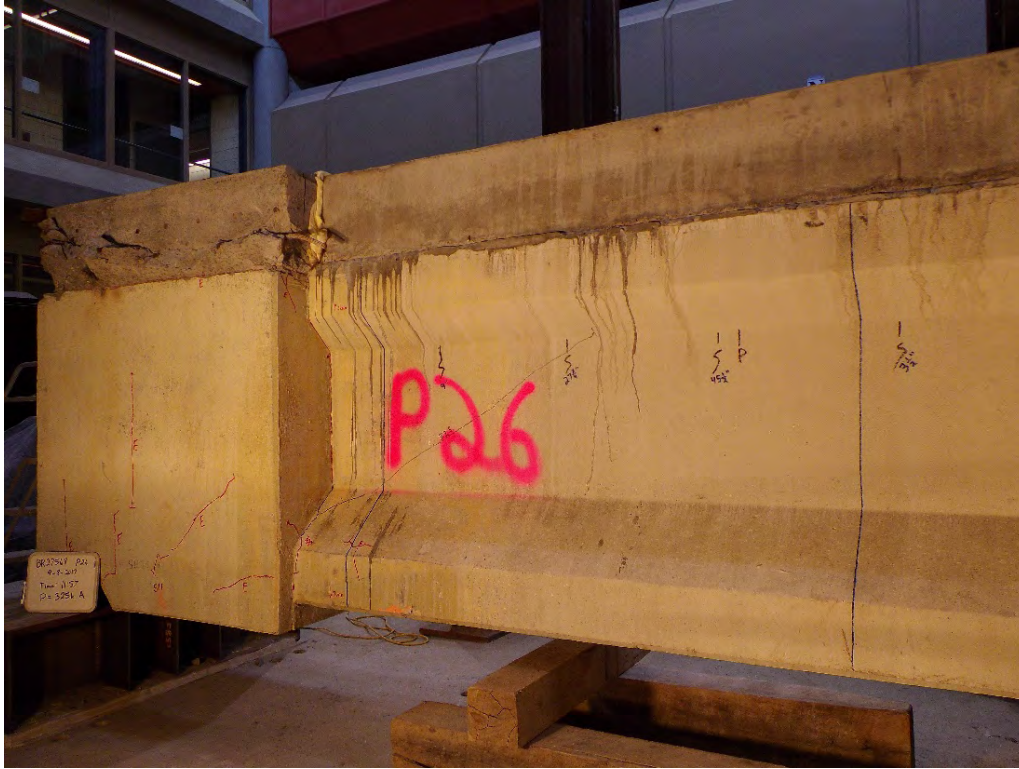
Figure B.110 Girder P26 Repair Section 1 – Section 2 $P=325$ kips

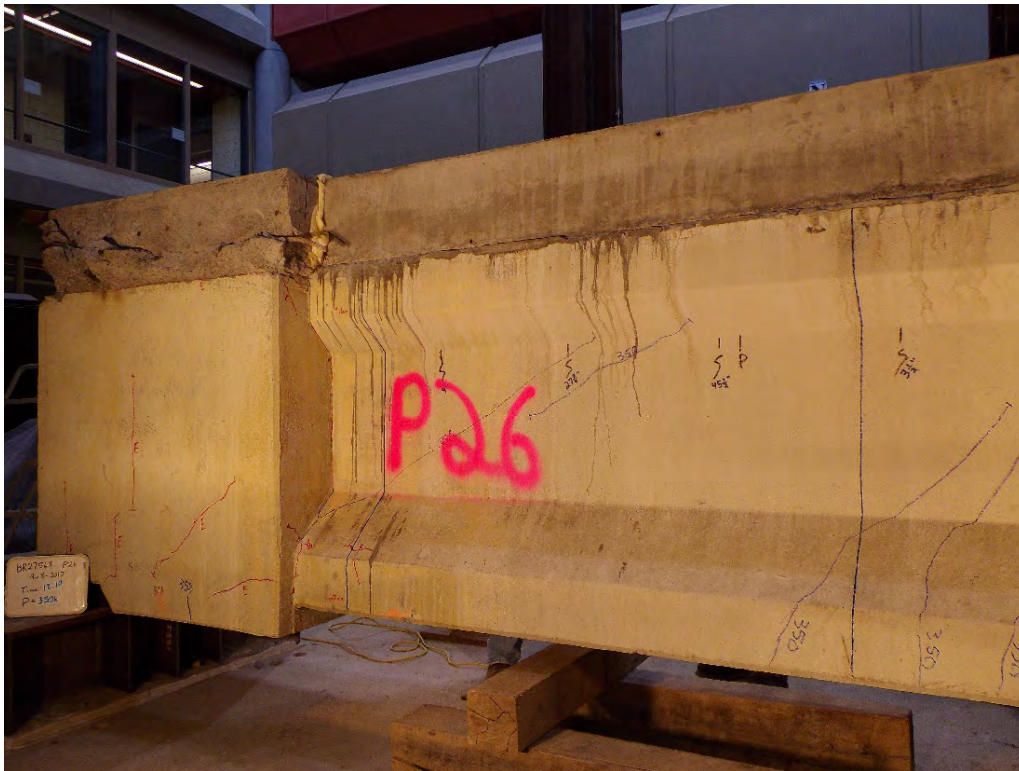
Figure B.111 Girder P26 Repair Section 1 – Section 2 $P=350$ kips

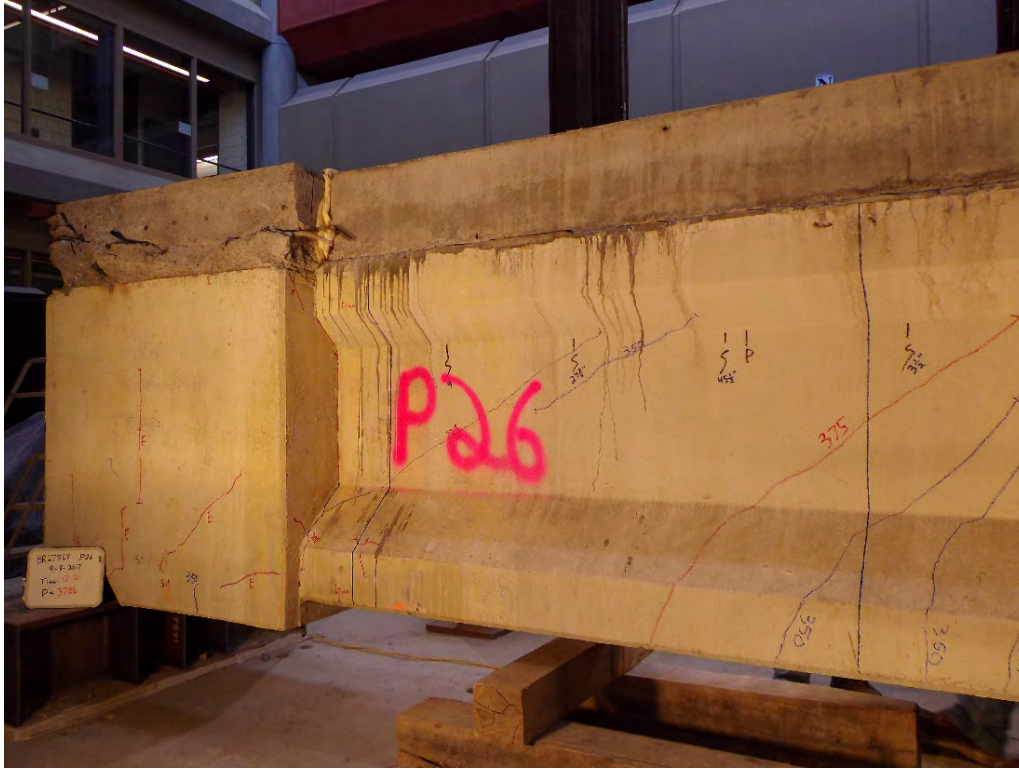
Figure B.112 Girder P26 Repair Section 1 – Section 2 $P=375$ kips

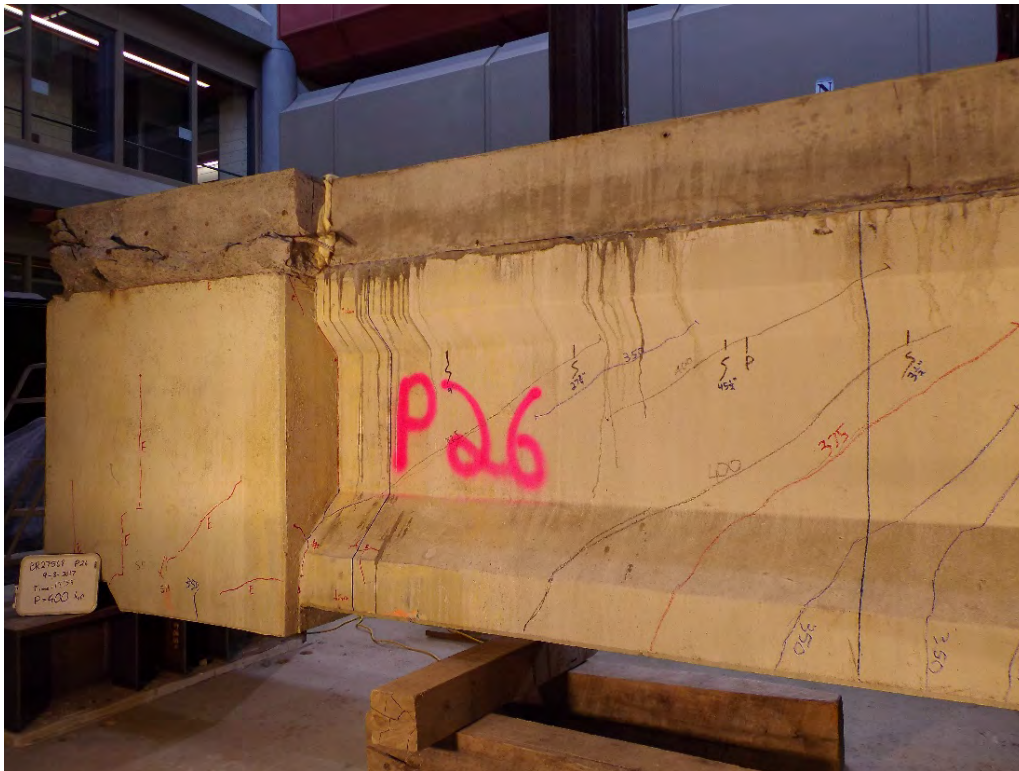
Figure B.113 Girder P26 Repair Section 1 – Section 2 $P=400$ kips

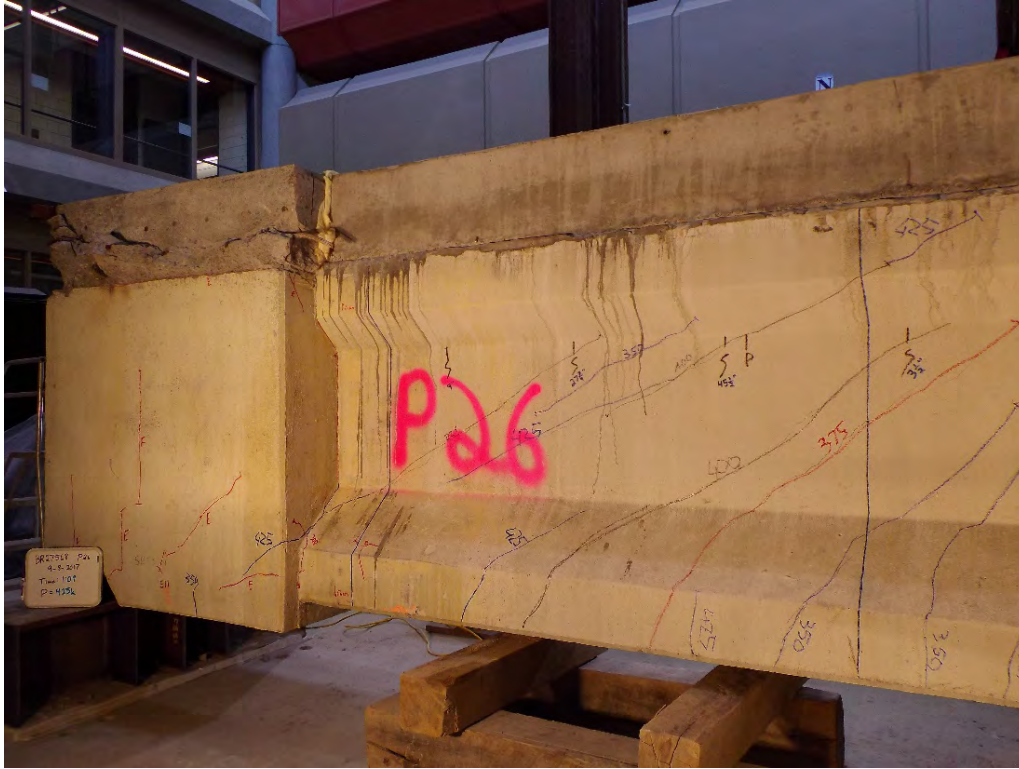
Figure B.114 Girder P26 Repair Section 1 – Section 2 $P=425$ kips

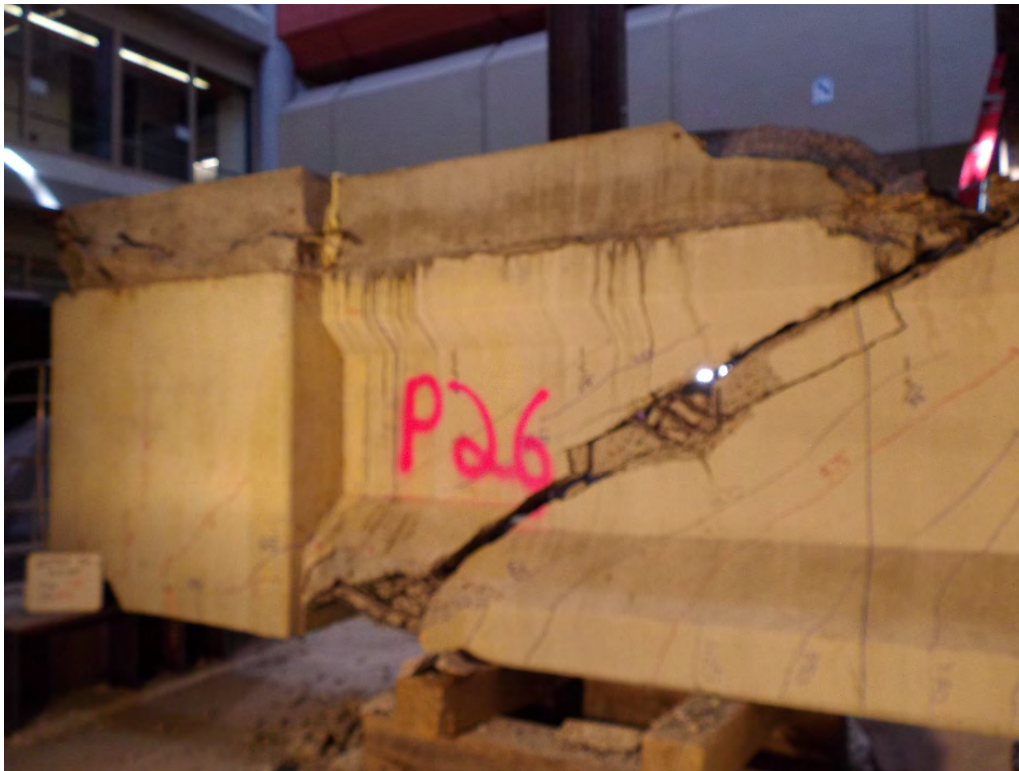
Figure B.115 Girder P26 Repair Section 1 – Section 2 Failure
