*The Ohio Department of Transportation
Office of Research & Development
Executive Summary Report*

Evaluation of Stay-in-Place Metal Forms

Report Number: FHWA/OH – 2006/13

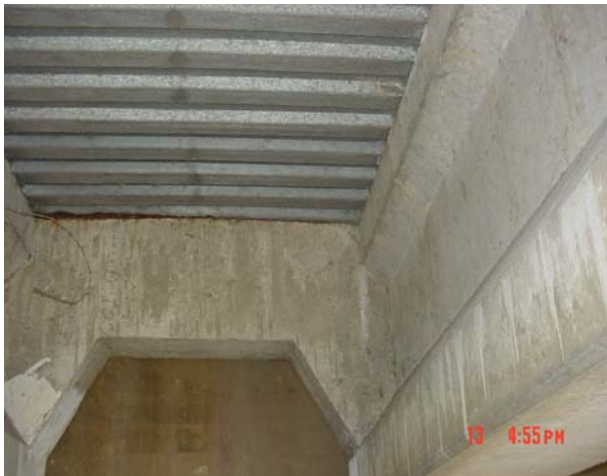
SIPMF near expansion joints and SIPMF with holes in it experienced localized rusting near these water sources. It is recommended the number of holes be minimized and steps be taken to prevent water from flowing around the edges of the SIPMF. It has also been reported that SIPMF on underpasses in urban areas experienced deterioration from water being continually thrown on the bottom of the bridge. Localized rusting is illustrated in the following figures.

Figure 1. 40-year old SIPMF on Precast Girders. Note Localized Rusting Near Expansion Joint

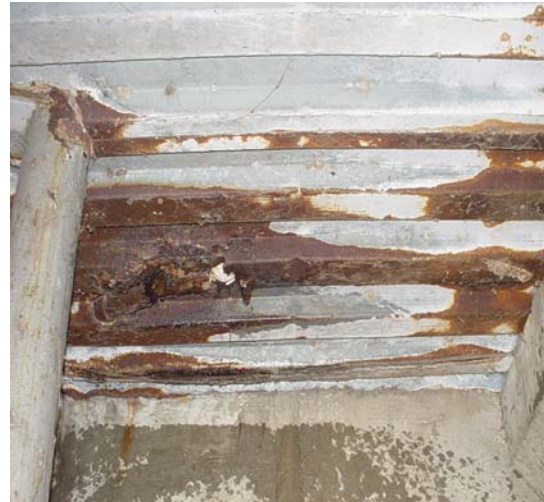
Figure 2. Localized Rusting Near a Scupper Hole and Drain Pipe

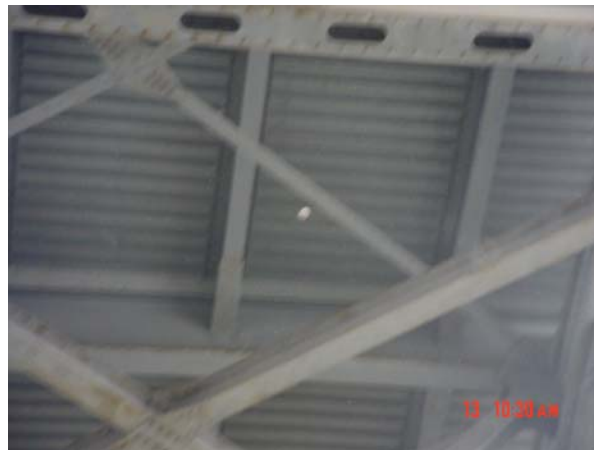
Figure 3. 40-year old SIPMF on Steel Girders

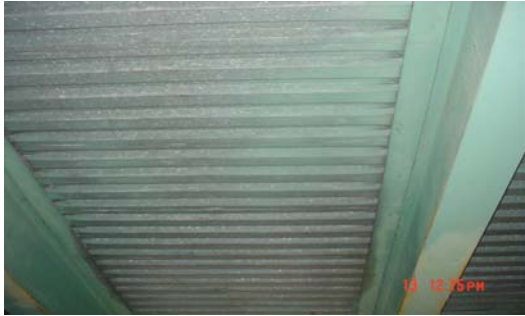
Figure 4. 40-year old SIPMF on Steel Girders

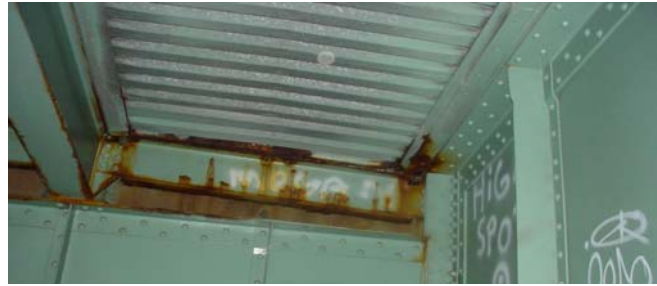
Figure 5. Localized Rusting Near Expansion Joint

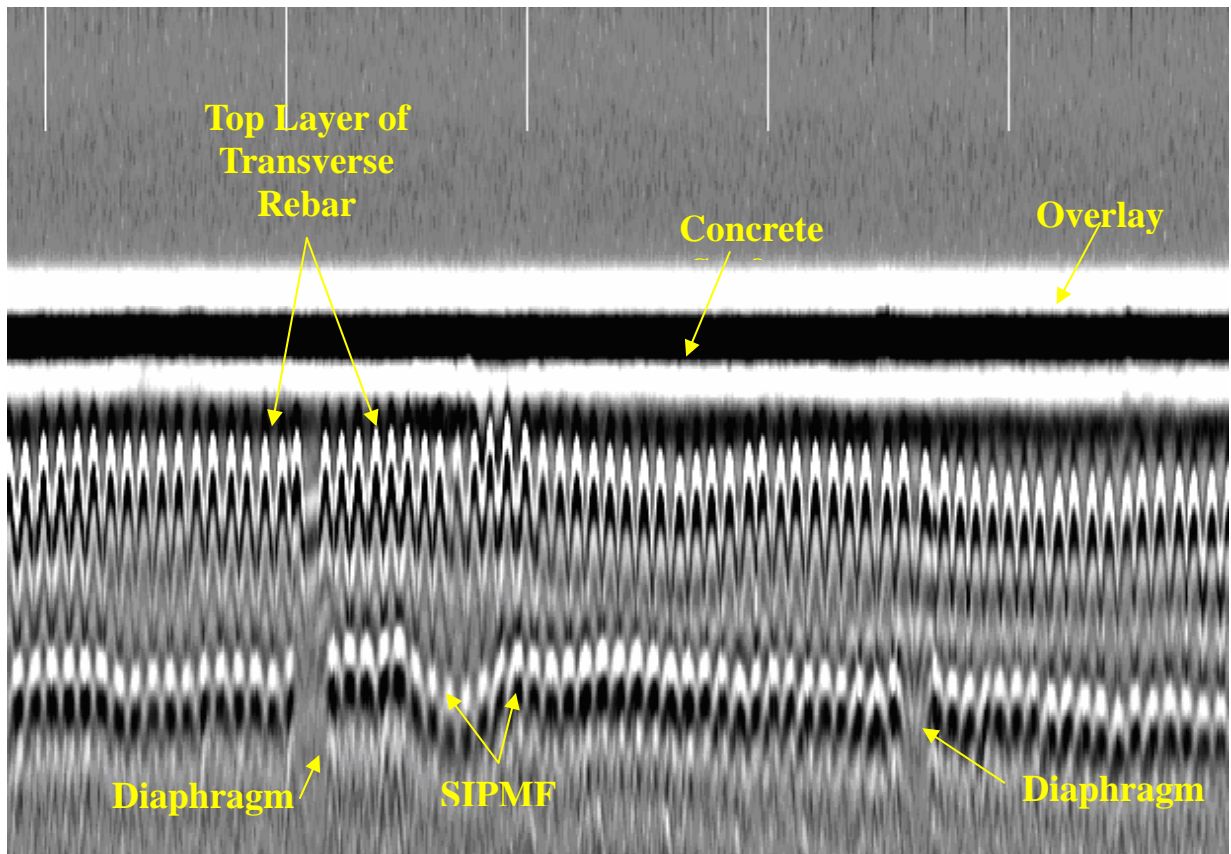
Figure 6. Ground Coupled GPR Image

- b) A GPR survey was carried out on a bridge constructed with SIPMF. Figure 6 is a ground coupled GPR image. A GPR signal attenuation map was developed to predict the quality of the concrete in the bridge. This attenuation map was also used to select the locations of the verification (ground truth) cores to be harvested.

Analysis of the data showed that the GPR system used was not an effective inspection tool for the concrete immediately above the SIPMF. The GPR was effective in locating delaminations above the top layer of rebar. However, the GPR gave false indications of delaminations for the concrete below the top rebar.
