# Evaluation of Dowel Bar Retrofit for Long-Term Pavement Life in Washington State

WA-RD 727.1

May 2009

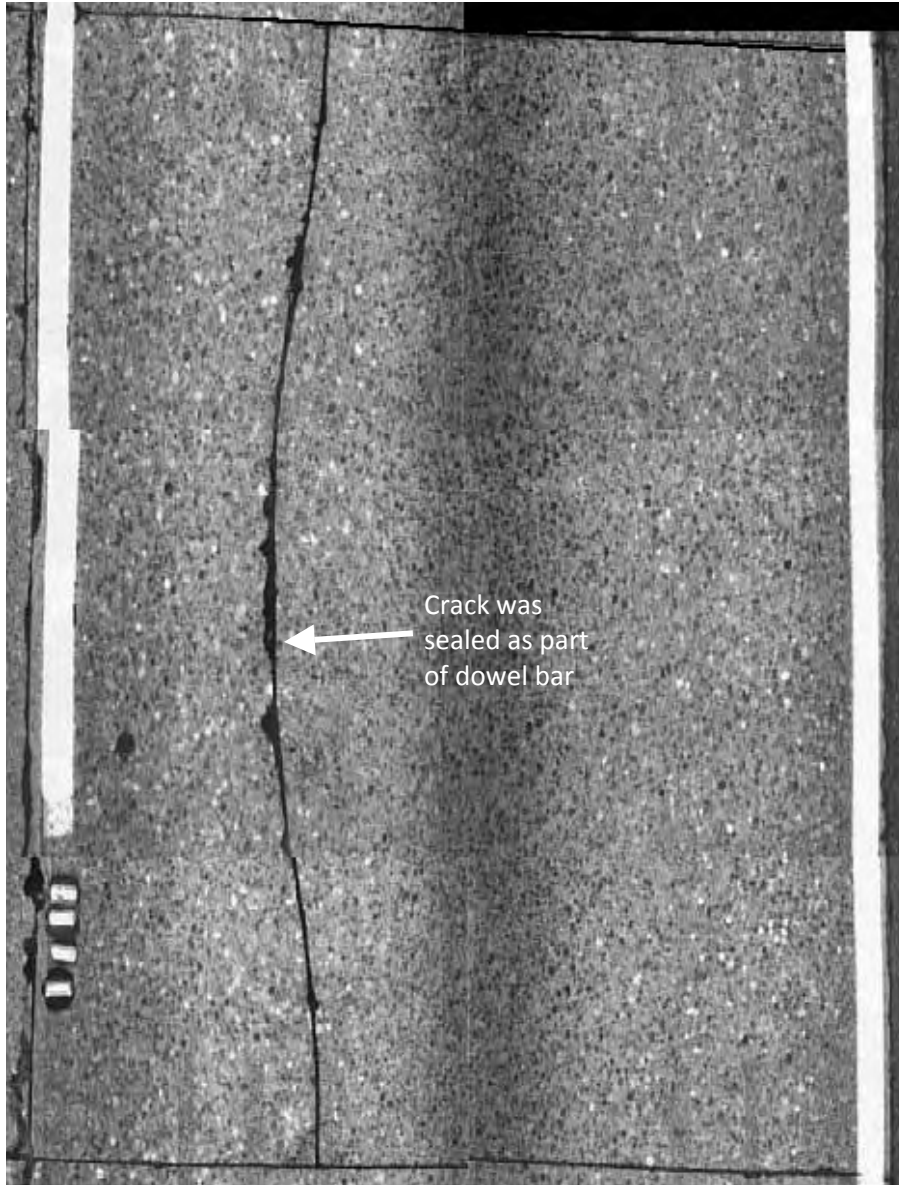
For longitudinal cracking, the determination of crack development before or after dowel bar retrofit was not as clear as it was with transverse cracking. WSDOT practice, at a minimum, may only seal the longitudinal crack. In many cases the longitudinal crack will receive no treatment. Therefore, if the longitudinal crack had not been sealed (Figure 196) and a narrow crack width (Figure 197) was noted it was assumed that the longitudinal crack occurred after dowel bar retrofit.

**Figure 196 Pre-existing sealed longitudinal crack.**

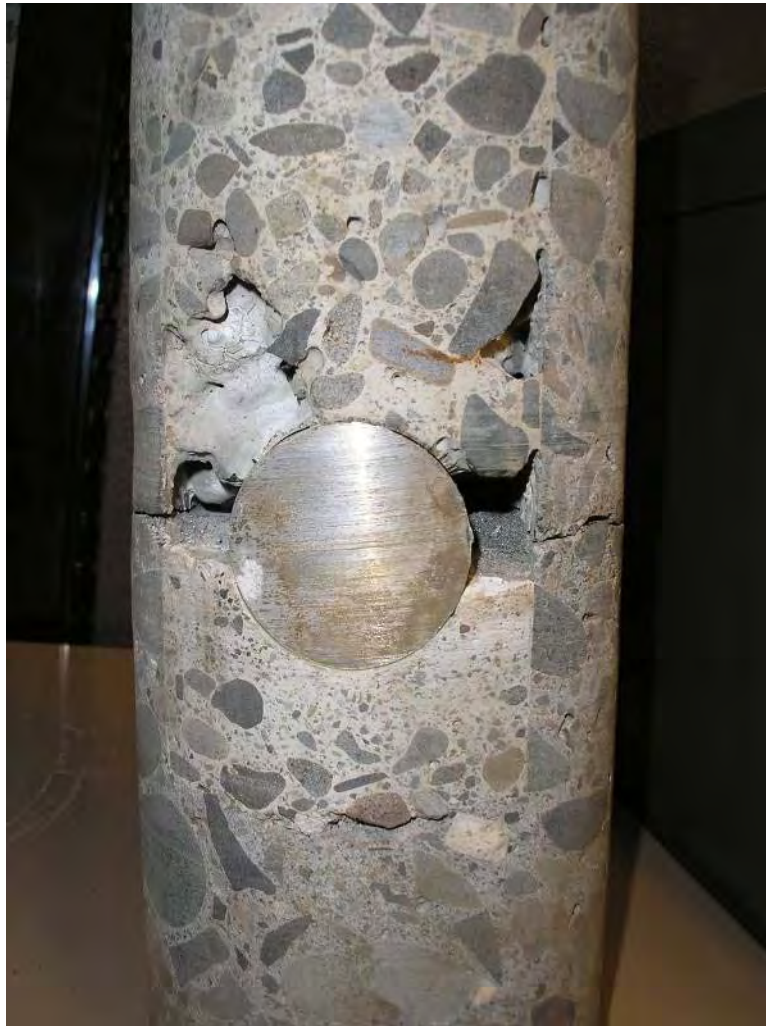
**Figure 213 Poor consolidation of patching material around dowel bar.**

WSDOT modified the Standard Specification to require that the aggregate meet AASHTO Grading No. 8.

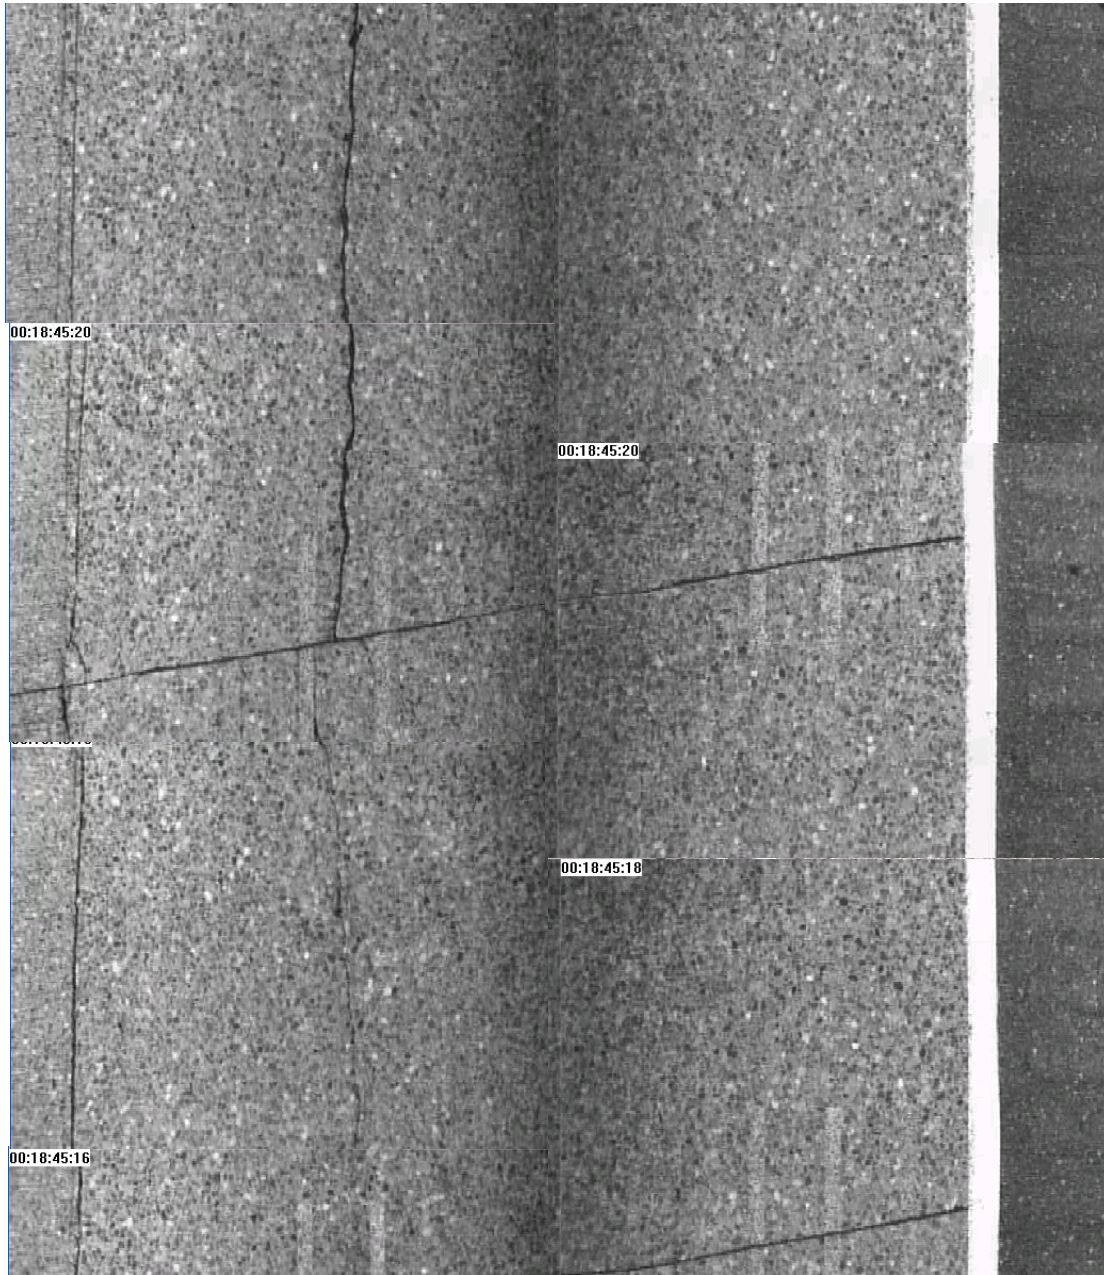
**Figure 221 Propagation of existing longitudinal crack after dowel bar retrofit.**

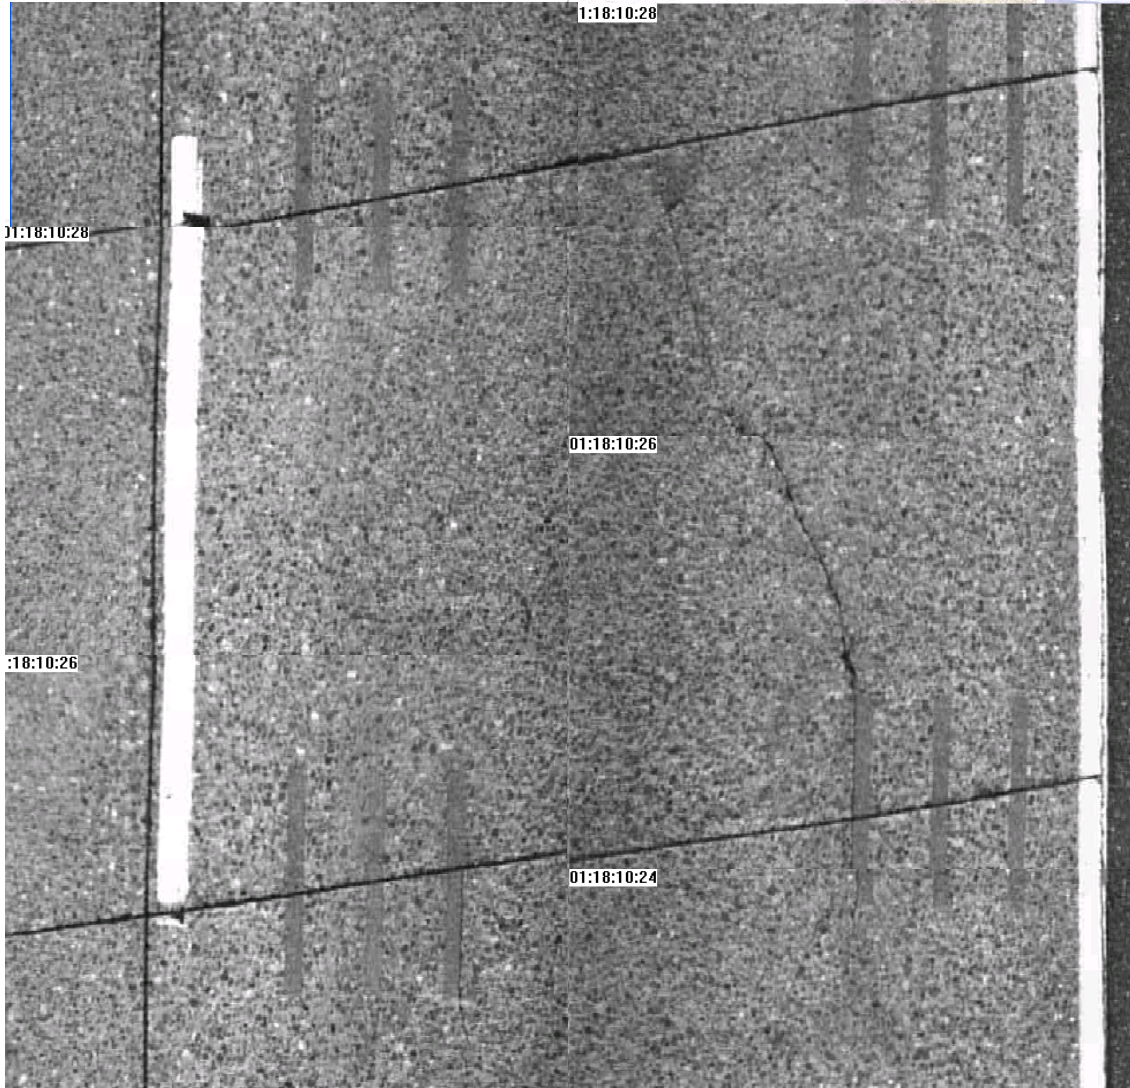
**Figure 222 Longitudinal cracking after dowel bar retrofit.**

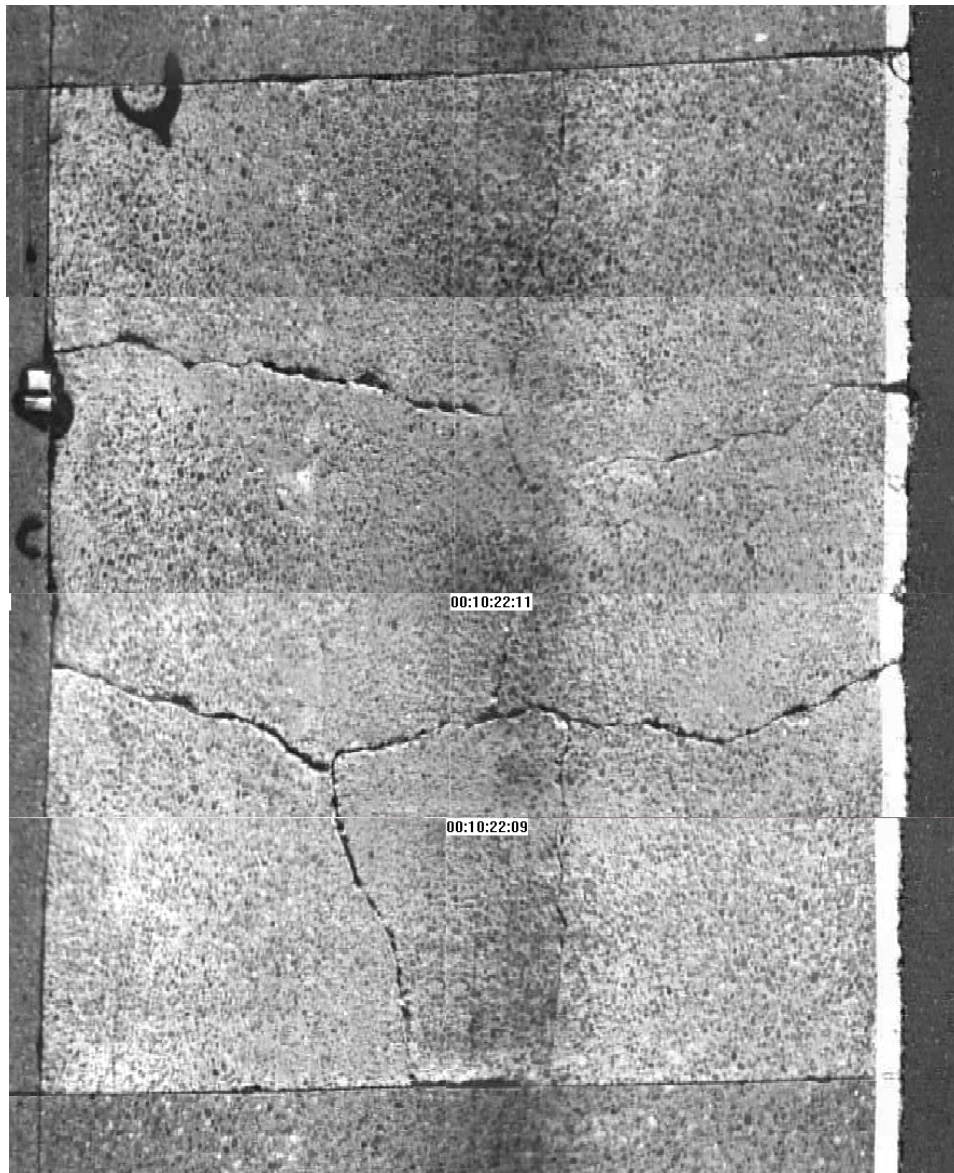
**Figure 232 Panel replacement with multiple cracks.**

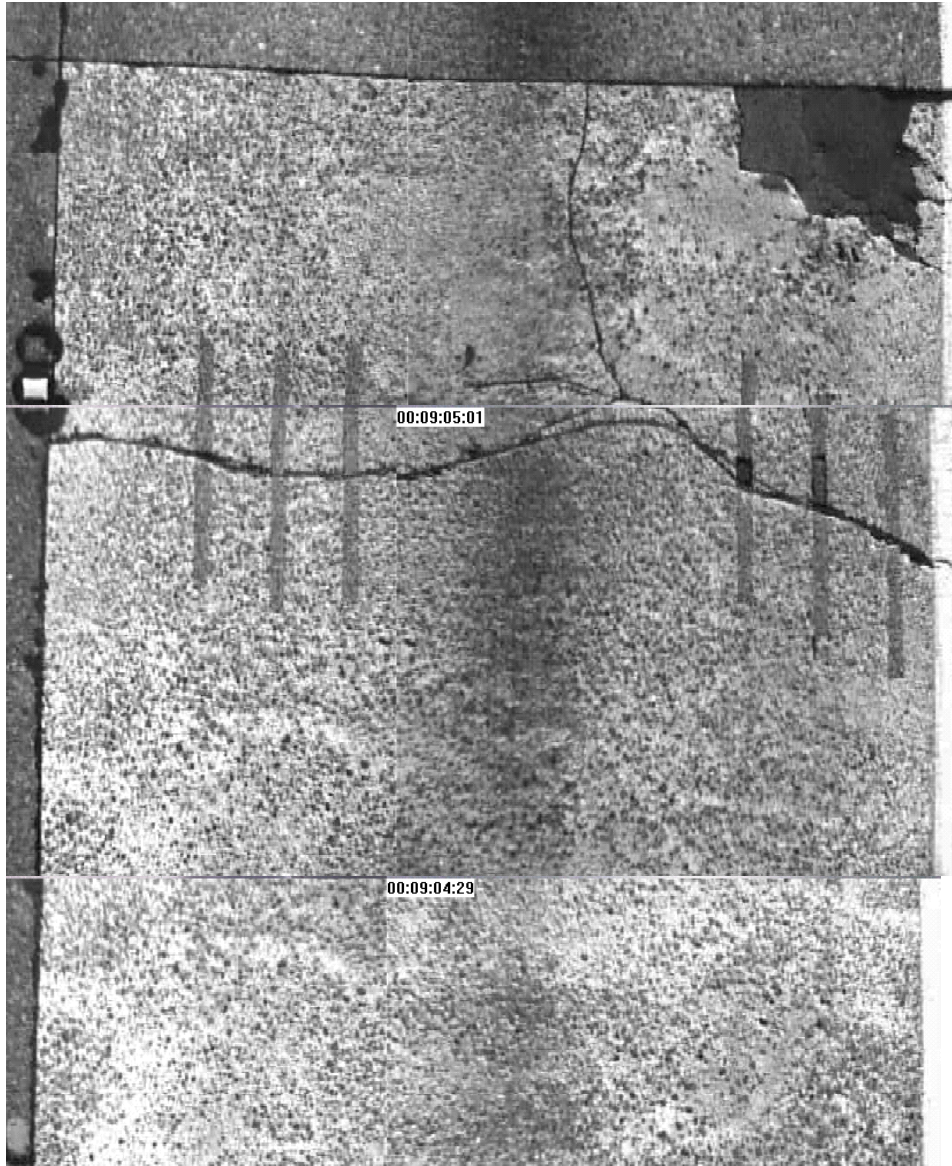
**Figure 233 Panel replacement that cracked immediately after construction.**

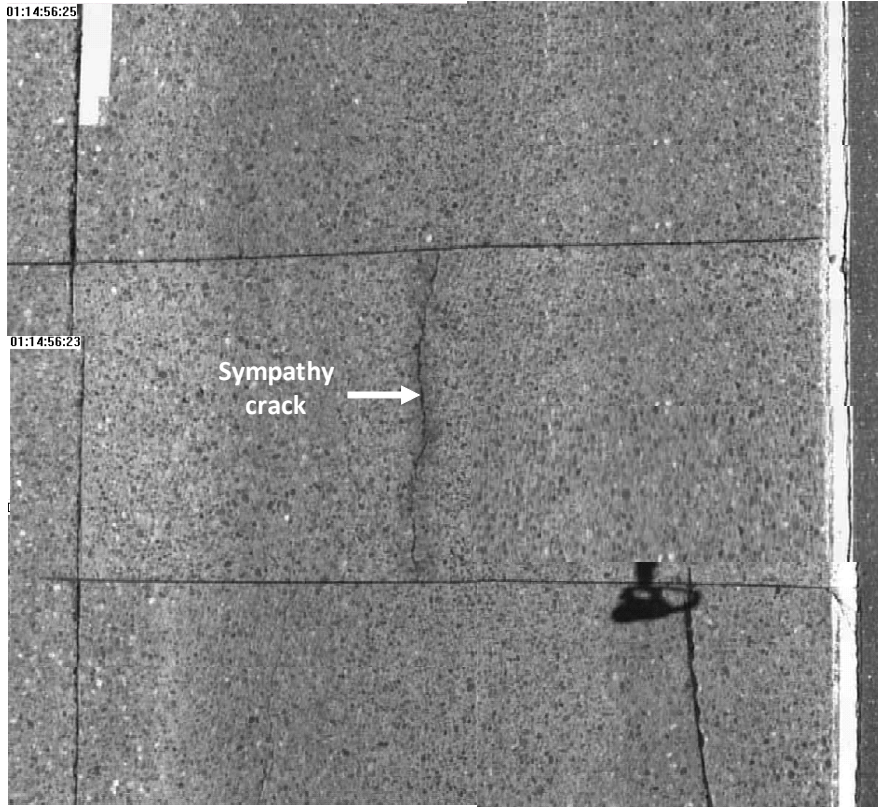
**Figure 234 Panel replacement with sympathy crack from adjacent panel.**

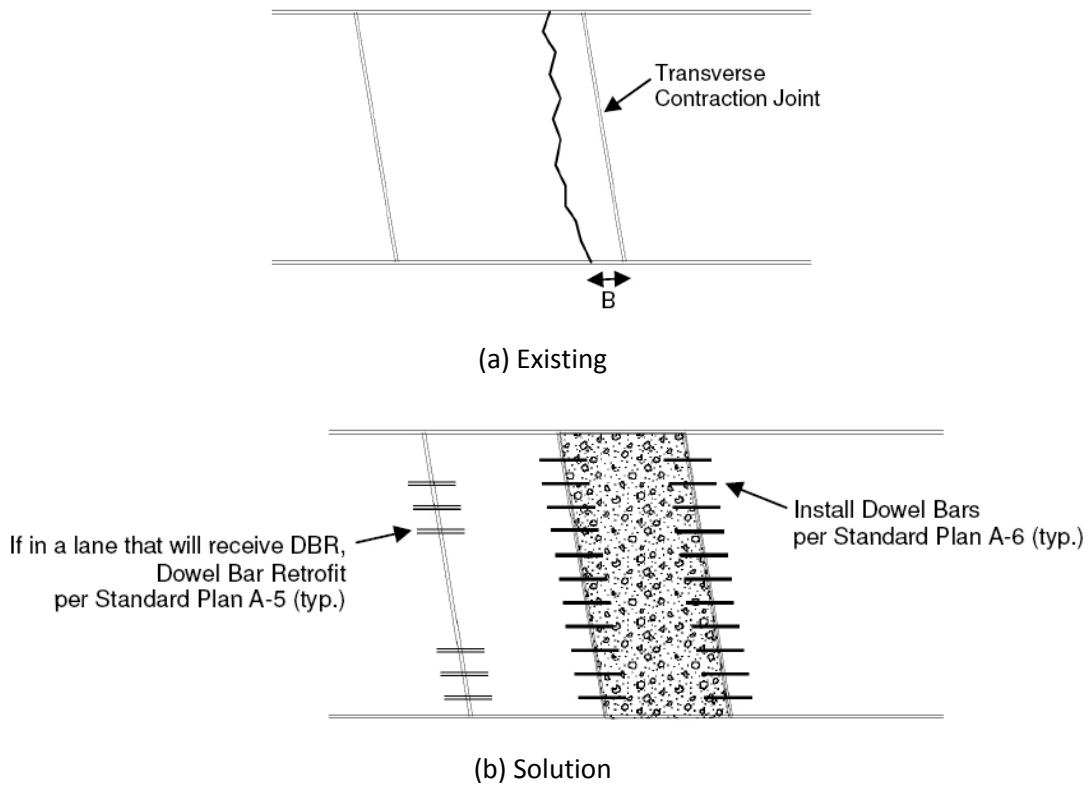
Figure A-2. Existing transverse crack ( $B < 3$  feet).

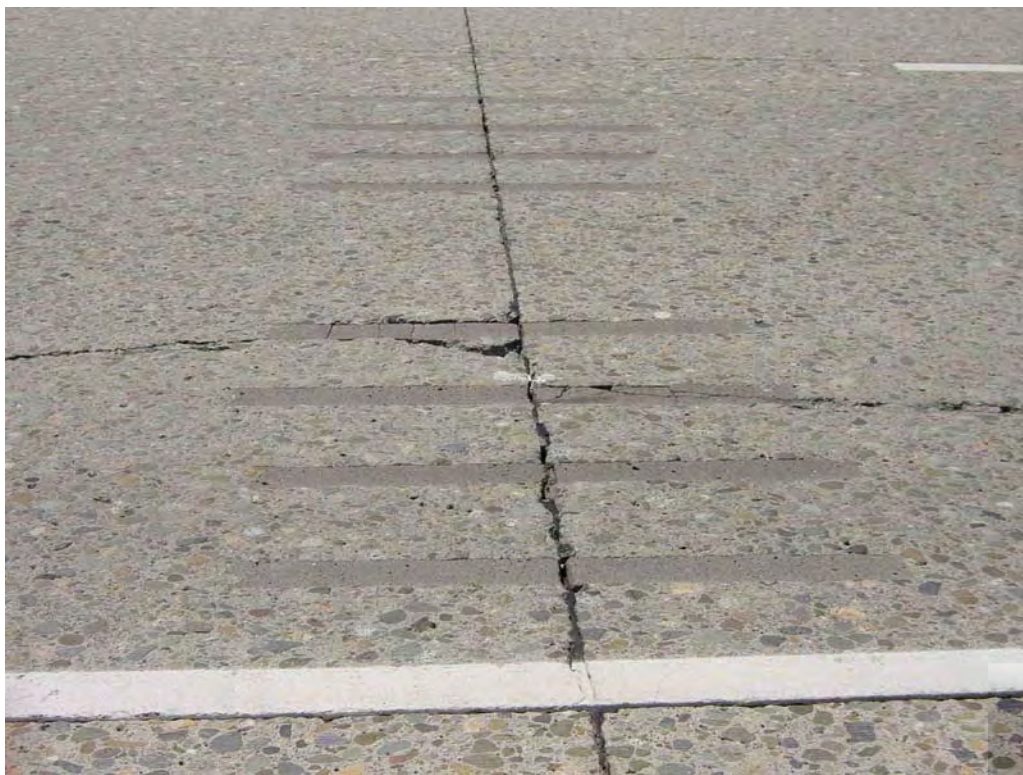
**Figure A-20. Failure of dowel bar slot placed over existing longitudinal crack.**

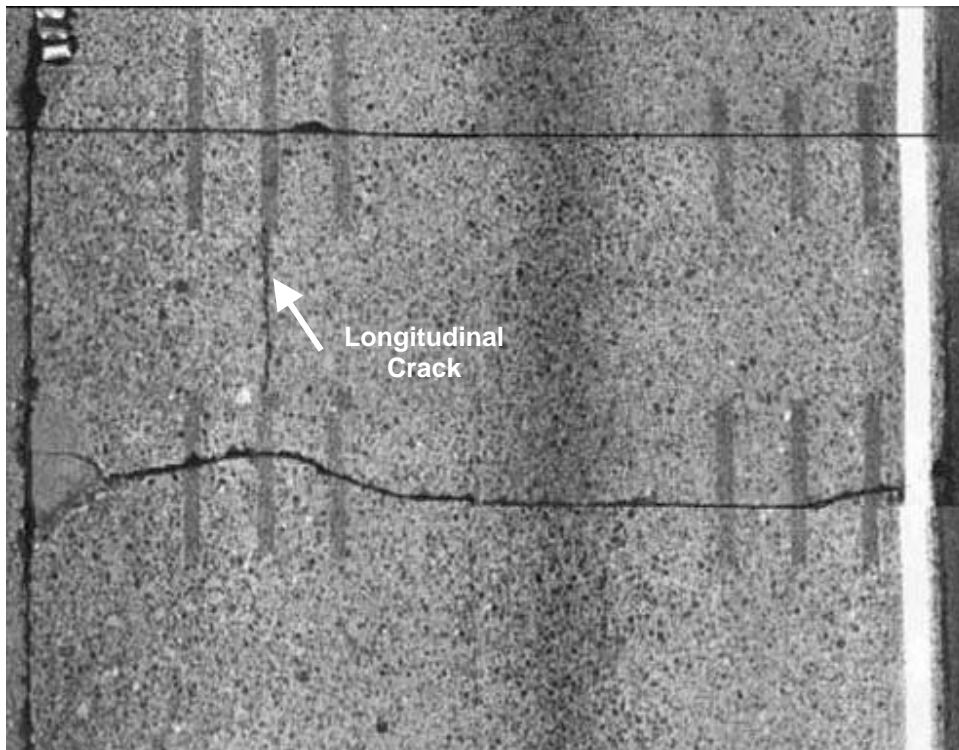
**Figure E-8 Dowel bar retrofitted transverse crack and longitudinal crack.**

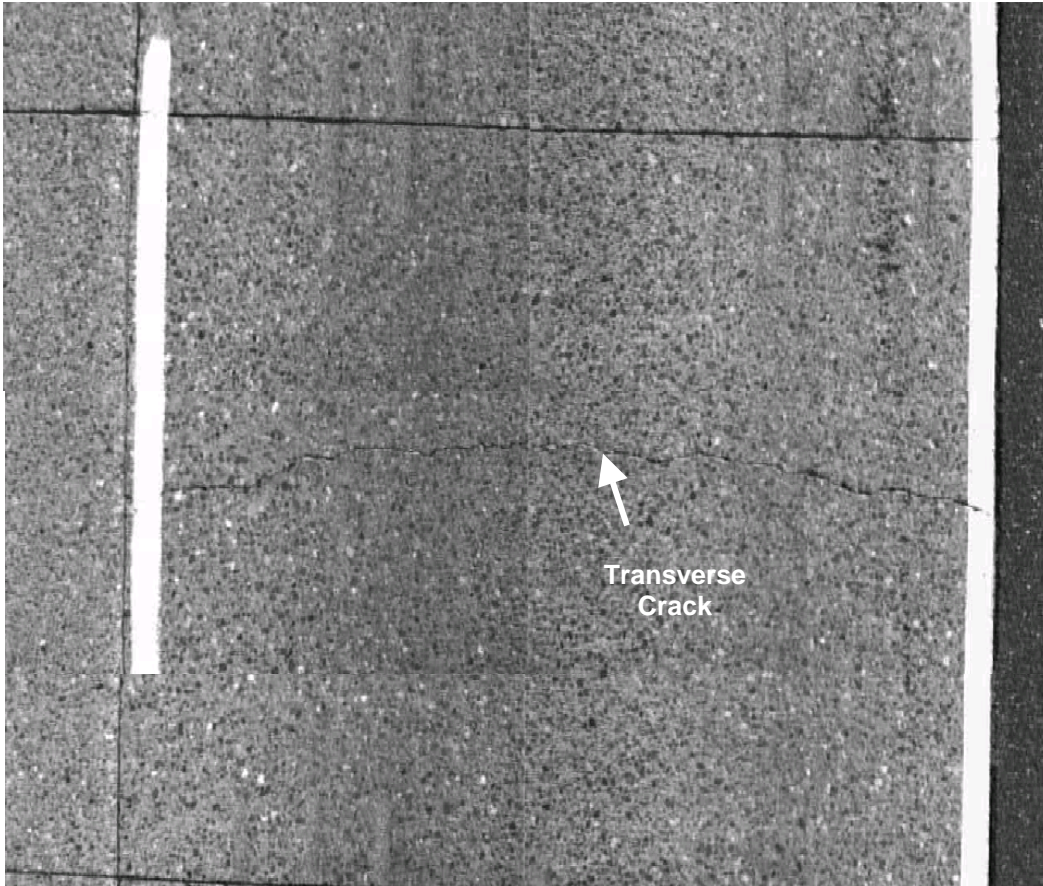
**Figure E-9 Transverse crack after dowel bar retrofit.**

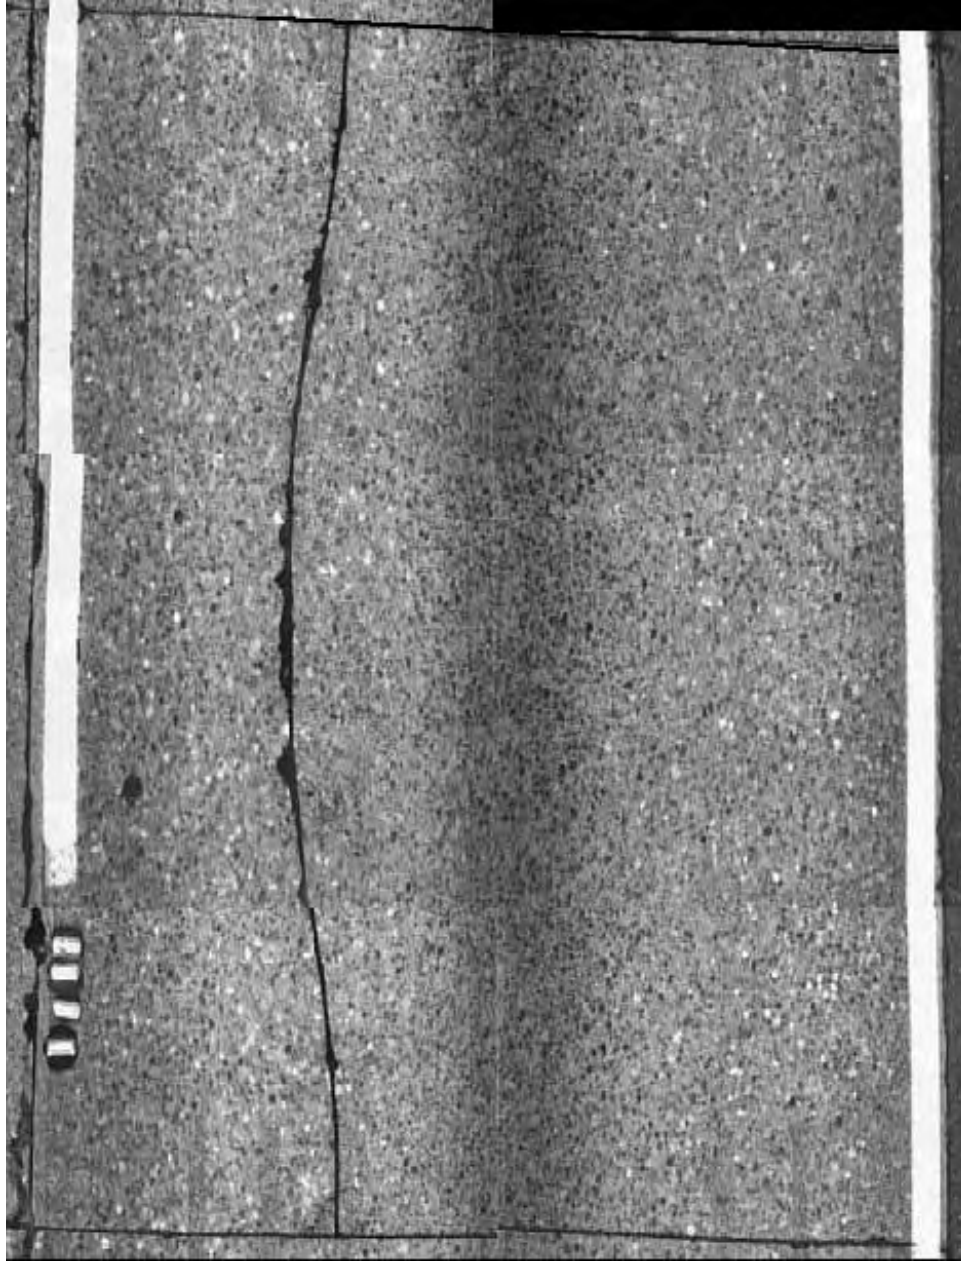
**Figure E-12 Pre existing longitudinal crack.**

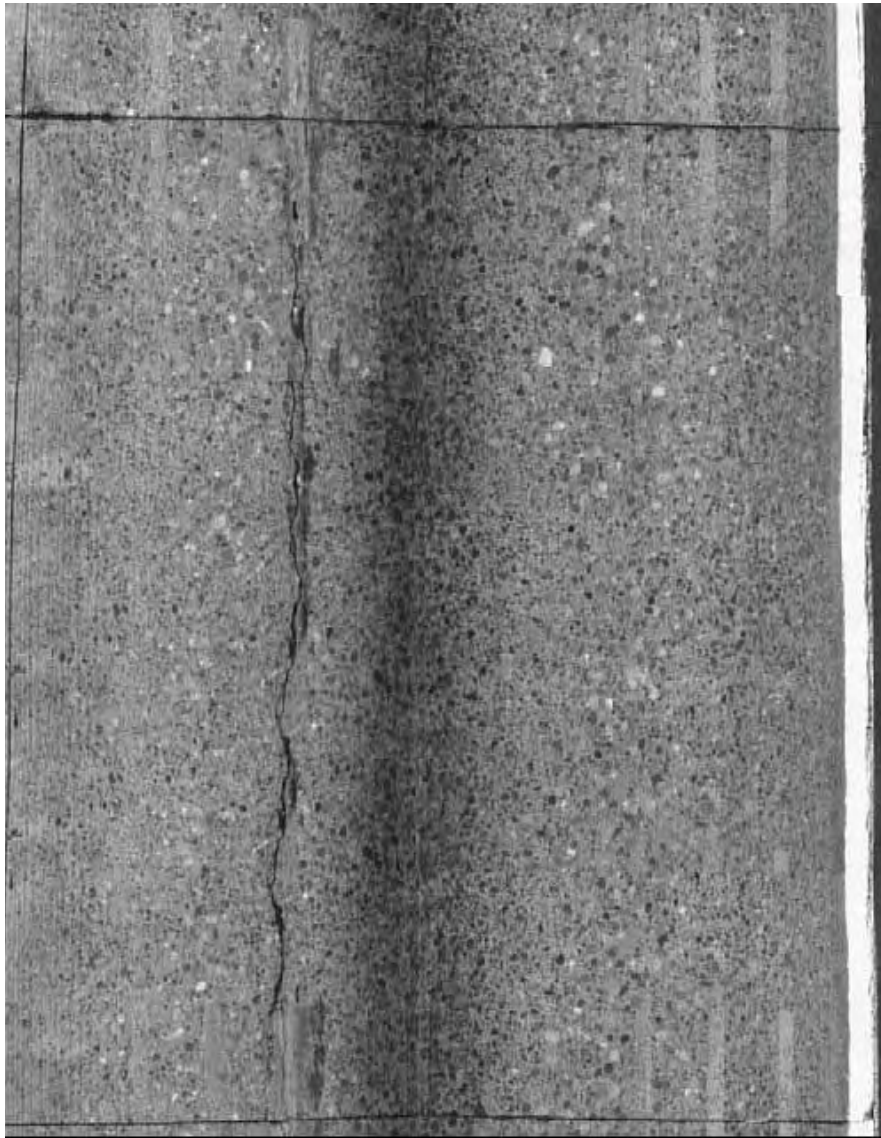
**Figure E-13 Longitudinal crack after dowel bar retrofit.**

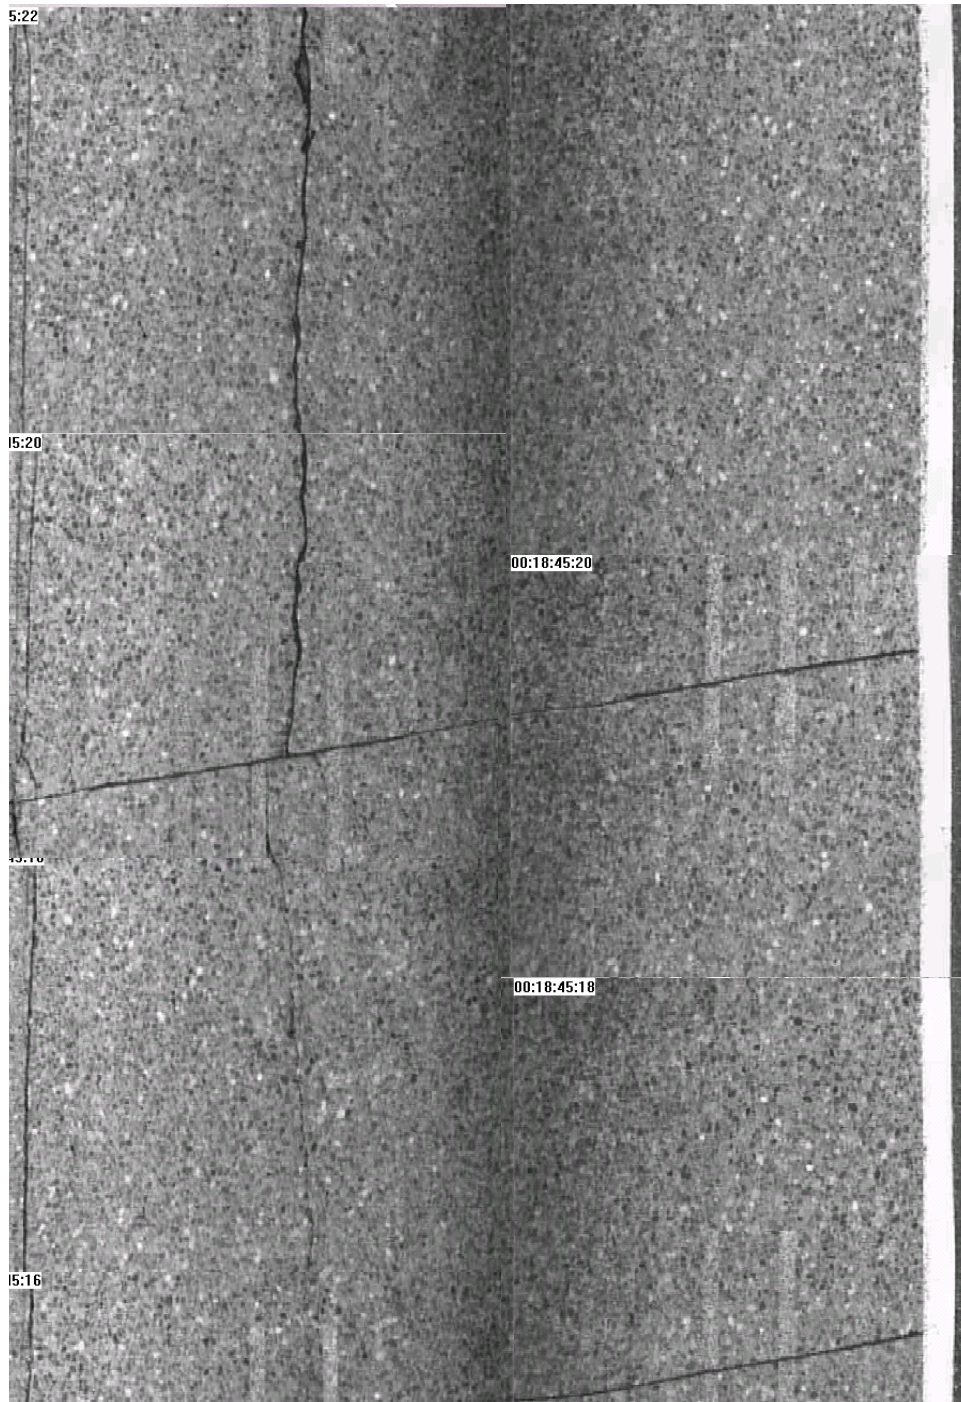
**Figure E-15 Existing sealed longitudinal crack (top panel) and longitudinal crack after dowel bar retrofit (lower panel).**

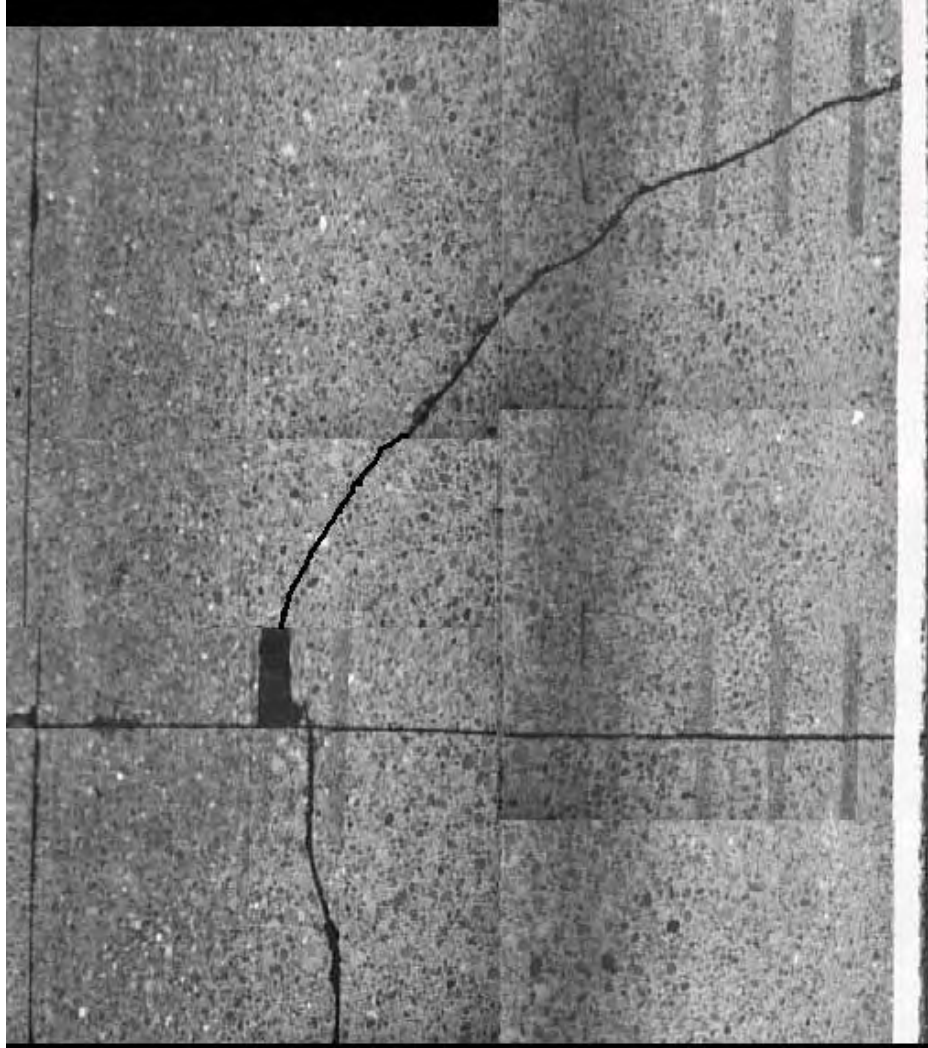
**Figure E-17 Dowel bar retrofit of existing longitudinal to transverse crack.**

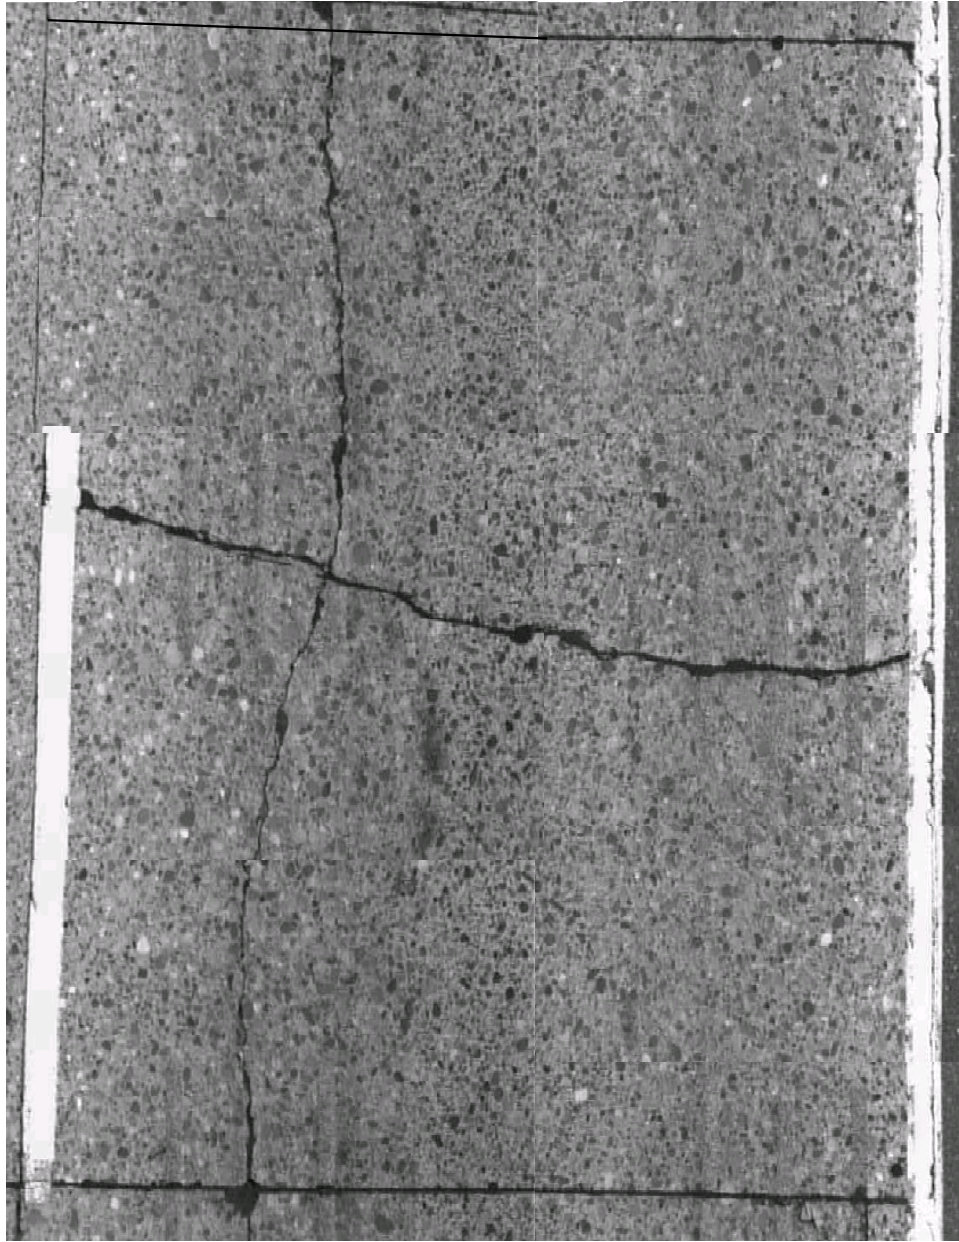
**Figure E-27 Retrofitted transverse crack and new longitudinal crack.**
