1. Report No. FHWA/TX-11/0-4562-4		2. Government Accession No.		3. Recipient's Catalog No.	
4. Title and Subtitle Evaluation of Corrosion Resistance of Improved Post-tensioning Materials after Long-term Exposure Testing			5. Report Date October 2011

CTR Technical Report:	0-4562-4
Report Date:	October 2011
Project:	0-4562
Project Title:	Corrosion Resistance of Grouted Post-Tensioning Systems
Sponsoring Agency:	Texas Department of Transportation
Performing Agency:	Center for Transportation Research at The University of Texas at Austin

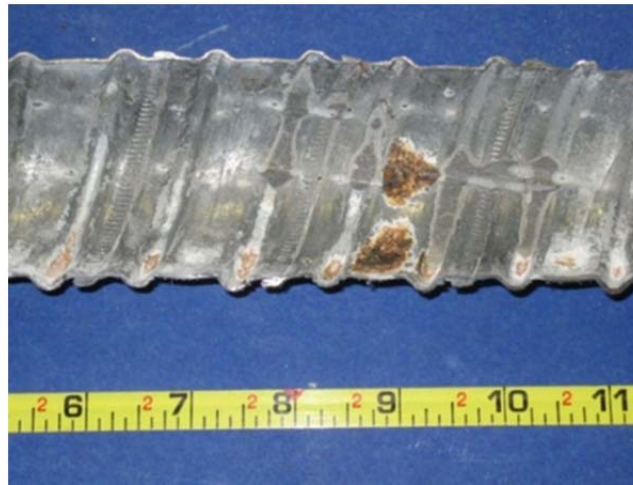
The north and south ducts both had localized severe corrosion damage as shown in Figure 5.10. Most damage on the north duct occurred at midspan and at the live end quarter point. Pitting and corrosion were more extensive on the inside of the duct. The shape and extent of the damage indicate the presence of small grout voids along the top of the entire duct. Significant corrosion and pitting also extended along the bottom inside surface. Here, the location of damage suggests that voids may have formed under the strands during grouting (see Figure 5.9).

Figure 5.9: Specimen T.1, Corrosion Along Gouges on Bottom Half of North Duct

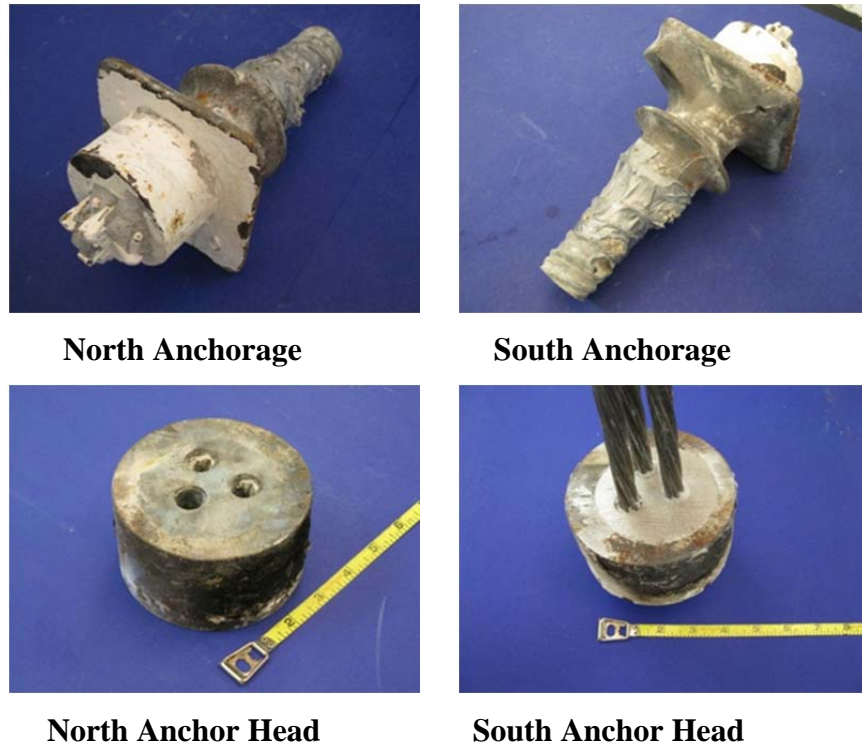
Figure 5.12: Specimen T.1 Anchorages and Anchor Heads

discoloration on all epoxied surfaces. The duct tape used to seal the bearing plate-duct connection was intact on both anchorages. Extensive surface corrosion was found on the surfaces covered by the duct tape. The north and south anchorages and anchor heads are shown in Figure 5.12 and corrosion ratings are given in Table 5.6.

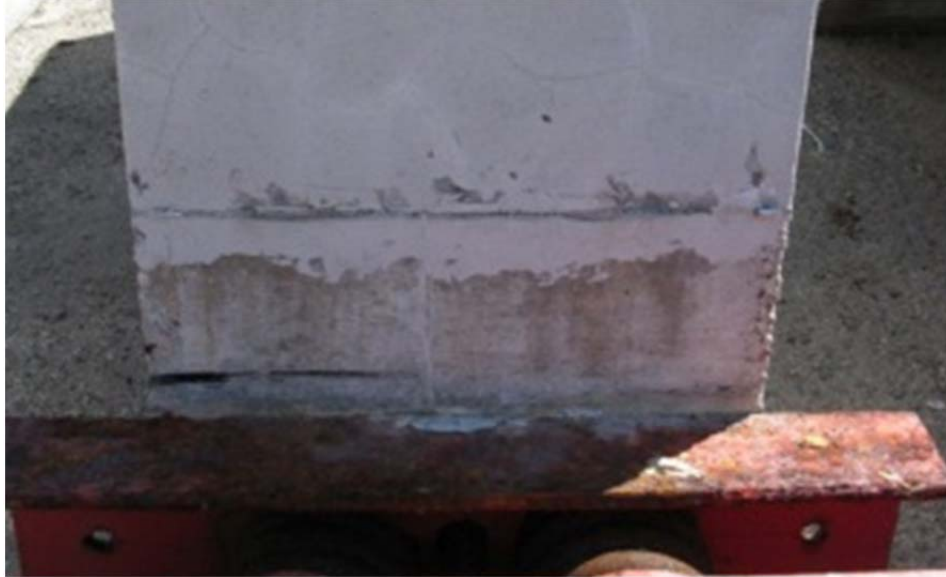
The specimen had two large transverse cracks running along its top face and down its north and south faces, each with an average width of 0.03 inches. The epoxy used to seal the vertical portions of these cracks to prevent leakage was intact. The dead end anchorage pourback showed significant separation as well as some delamination near its interface with the rest of the specimen. This is shown in Figure 5.15. The crack diagram is shown in Figure 5.19.

*Figure 5.15: Specimen T.2, Separation and Delamination Around Dead End Pourback*

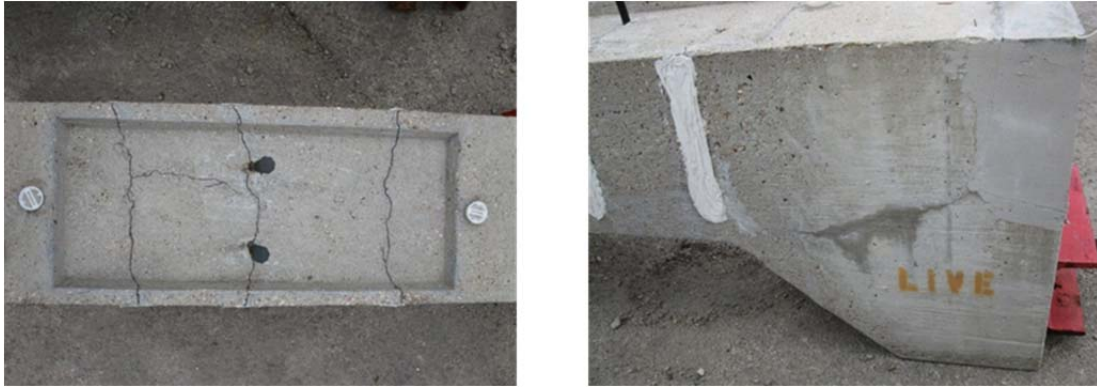
Figure 5.22: Specimen 1.2 Top Surface (Left) and Leakage at Live End Corbel Crack (Right)

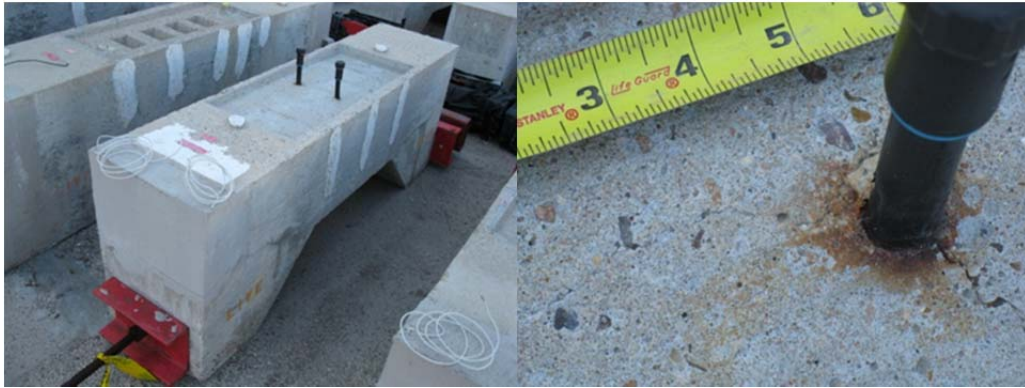
Figure 5.29: Specimen 2.2 Overall (Left) and Corrosion Stains Near Grout Vent (Right)

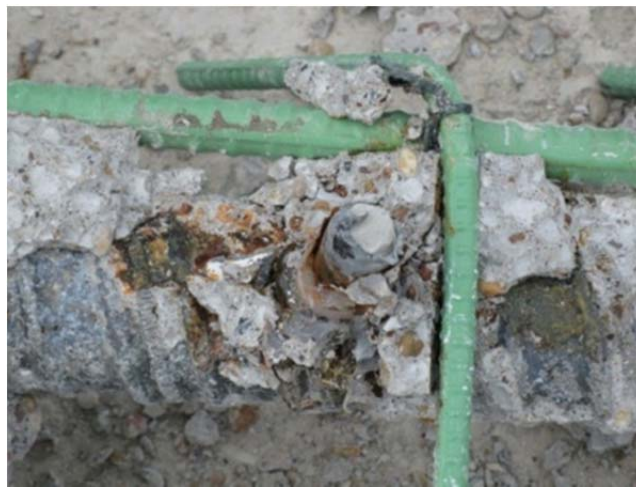
Figure 5.30: Specimen 2.2, Corrosion Staining Under North Grout Vein

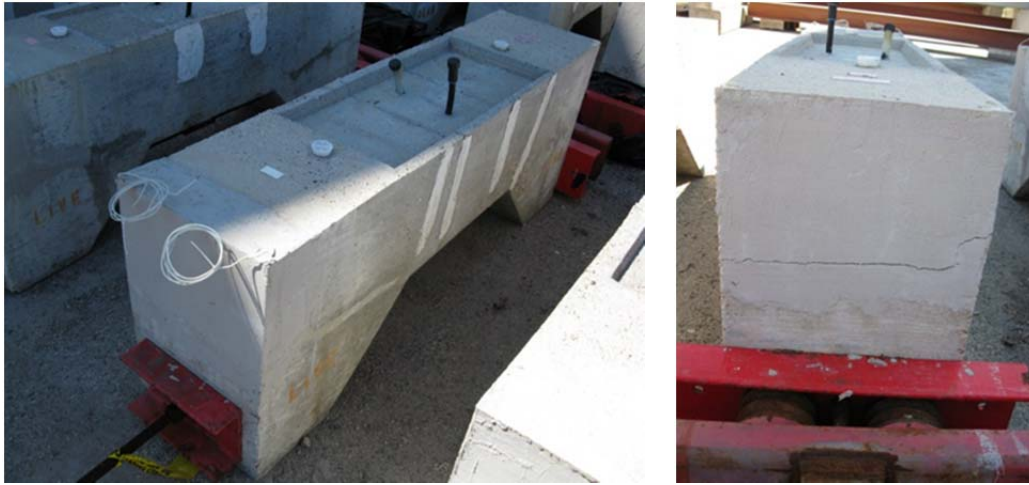
Figure 5.34: Specimen 2.4 Overall (Left) and Cracking at Dead End Pourback (Right)

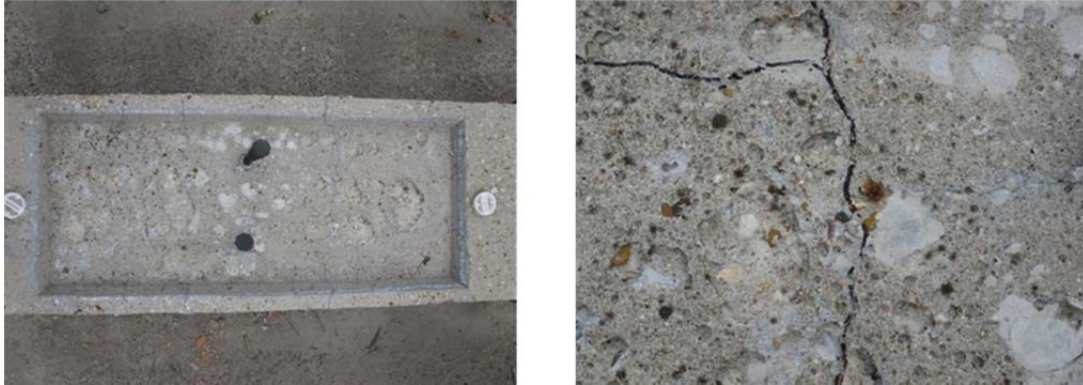
Figure 5.41: Specimen 3.1 Top Surface (Left) and Corroded Wire Tie at Top Surface (Right)

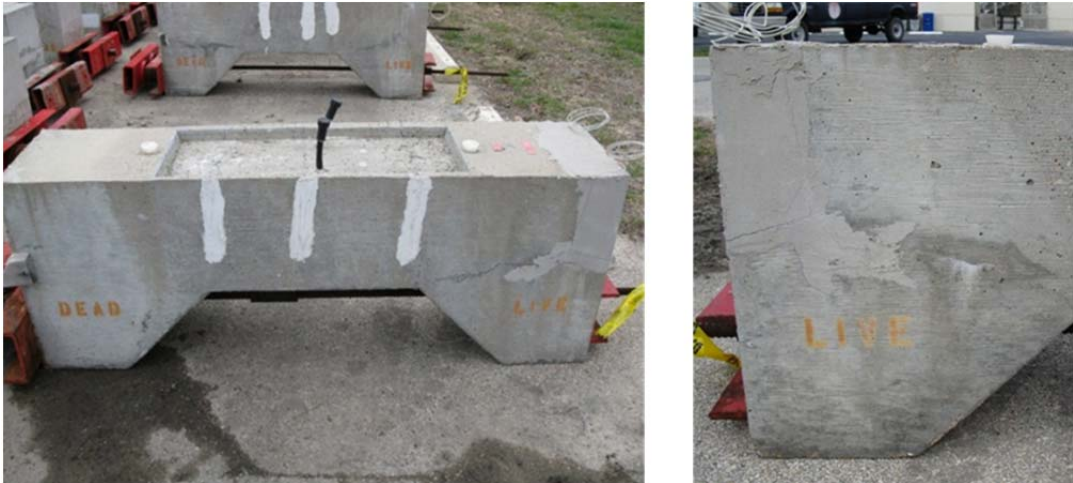
*Figure 5.50: Specimen 3.2 Overall (Left) and Efflorescence at Live End Corbel Crack*

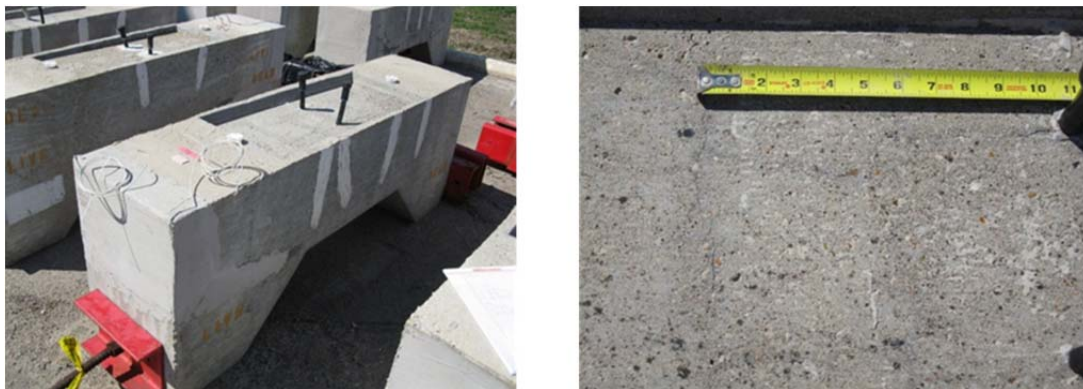
*Figure 5.59: Specimen 3.4 Overall (Left) and Discoloration around Surface Cracks (Right)*

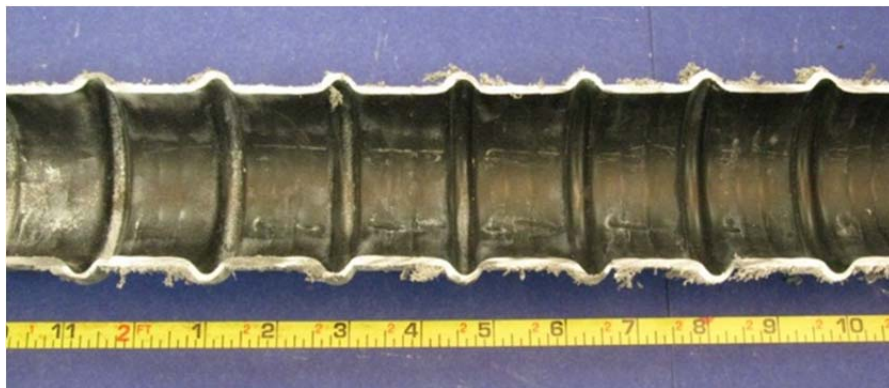
Figure 5.60: Specimen 3.4 Strand Gouging on Bottom of North Duct

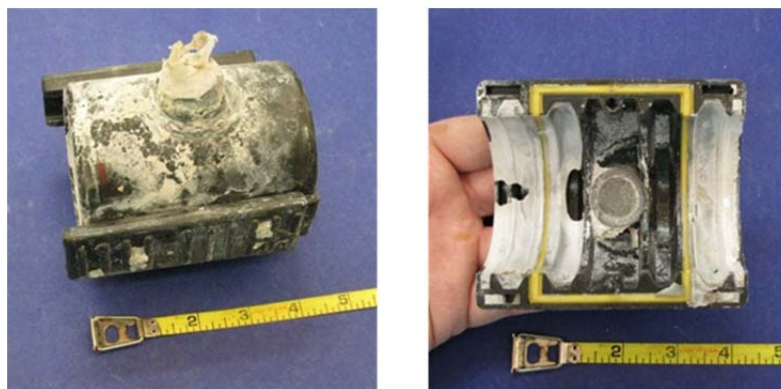
*Figure 5.61: Specimen 3.4 North Duct Coupler Outer Surface (Left) and Breach in Upper Gasket (Right)*

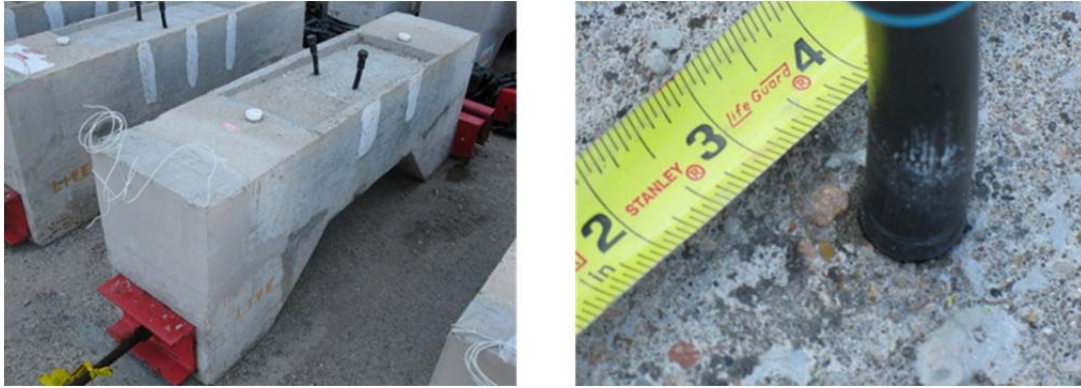
Figure 5.65: Specimen 4.2 Overall (Left) and Discoloration around North Grout Vent (Right)

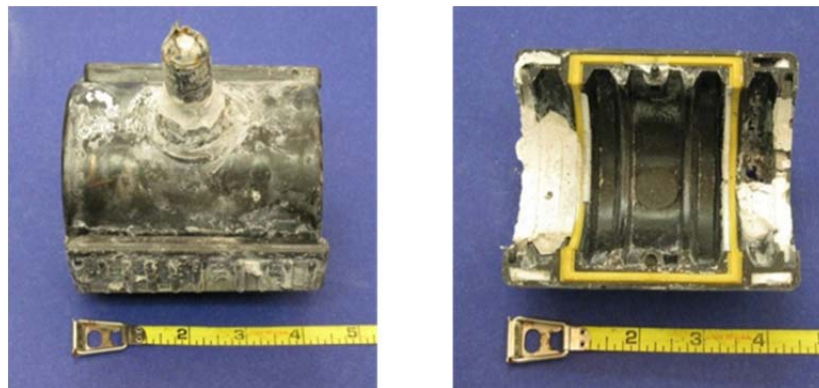
*Figure 5.66: Specimen 4.2 Coupler Outer Surface (Left) and Lower Gasket Breach (Right)*

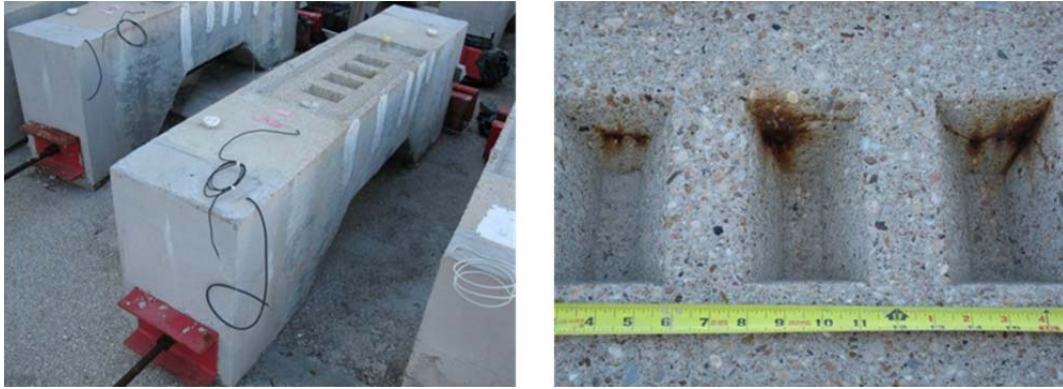
Figure 5.71: Specimen 7.1 Overall (Left) and Corrosion Staining in Saltwater Tray Wells (Right)
