# Evaluation of Tyregrip® High-Friction Surfacing -- Final Report

WA-RD 788.2

SR-14

SE 164<sup>th</sup> Ave Southbound to SR 14 Westbound

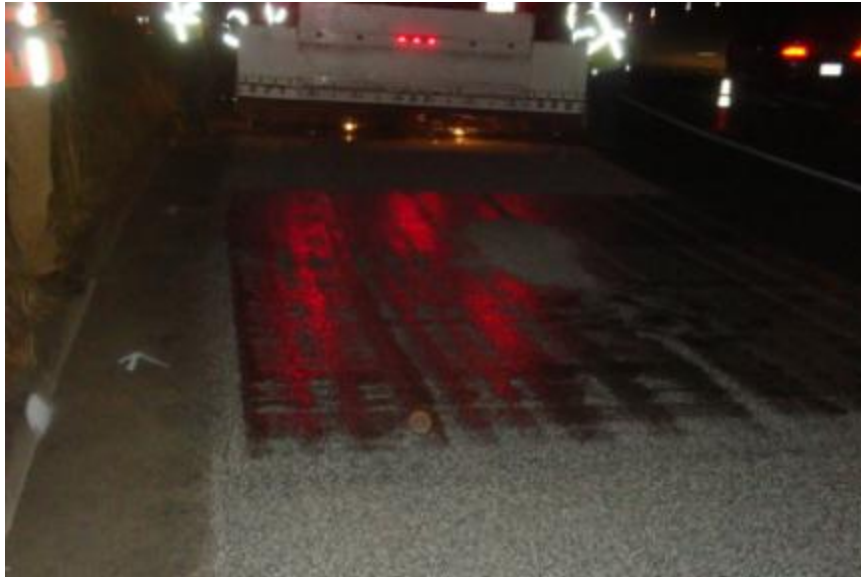
Figure 9. Location where aggregate spreader limited placement of material.

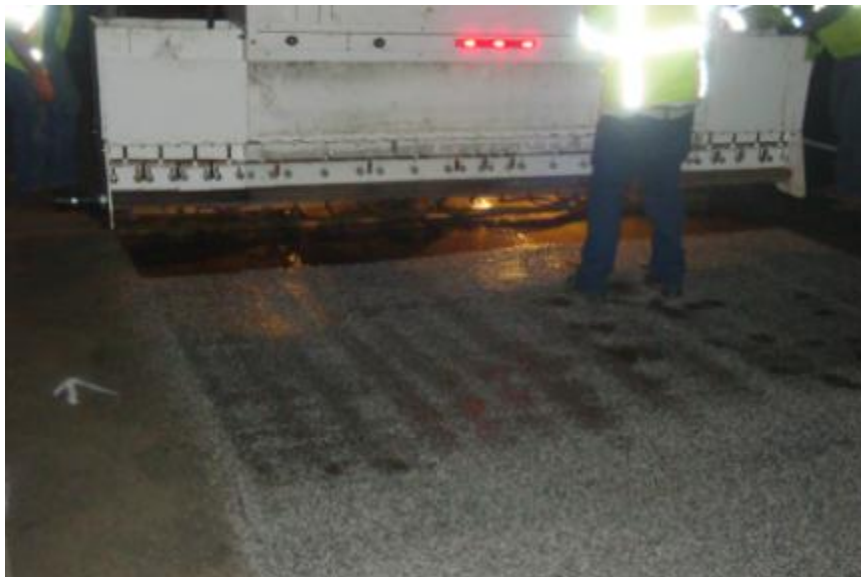
Figure 10. Streaking surface caused by inconsistency of the aggregate spreader.

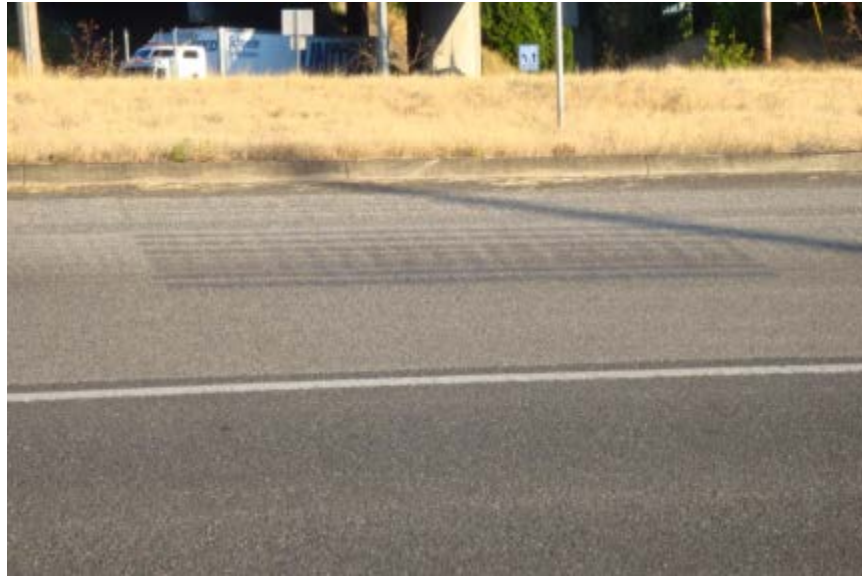
The second lift of the first application was placed on September 1, 2010. Figures 12 and 13 illustrate the condition of the surface prior to the second application of the Tyregrip®. The biggest problem with the first lift was the lack of aggregate coverage mainly at the beginning of the project. The remaining areas of insufficient aggregate cover resulted in only slight surface irregularities as shown in Figure 13.

Figure 13. Streaking in aggregate coverage.

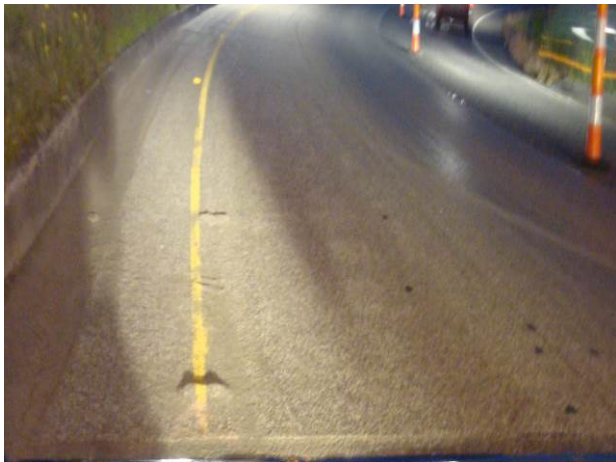
Figure 25. Excess aggregate on overlay.

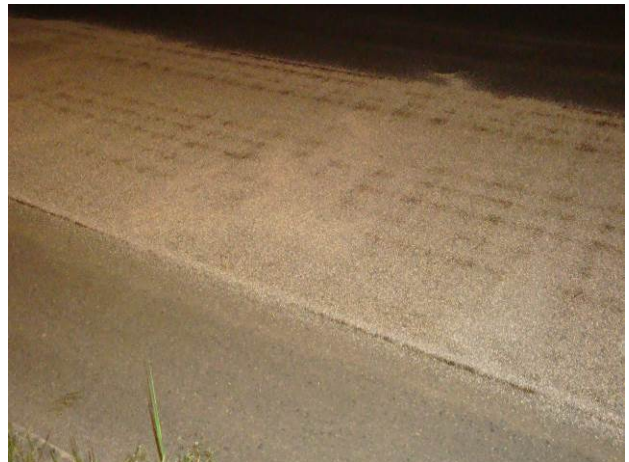
Figure 26. Streaky final product.

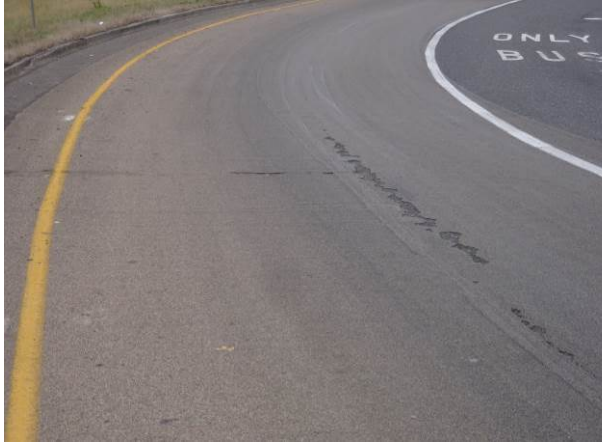
Figure 27. Longitudinal joint delamination.

The problems with cracking and delamination of the Tyregrip® may have been caused in part by the poor condition of the underlying pavement. A FHWA brochure on high friction surface treatments (HFST) indicates that they can be installed on both asphalt and concrete surfaces. The pavement must be in good structural condition with no or few cracks that are correctable by remedial sealing (FHWA, 2016). AASHTO PP 79-14, Standard Practice for High-Friction Surface Treatment for Asphalt and Concrete Pavements, recommends that all cracks greater than 1/4 inch in width and depth be filled with the mixed resin binder to be used for the overlay (AASHTO, 2016).

The delamination problem may also have been caused by placing the overlay on a pavement that was contaminated by oils dripping from vehicles. The Contractor used a broom/sweeper to clean the pavement prior to the installation of Tyregrip® on this project. AASHTO recommends that surfaces that are contaminated with oils, greases, or other deleterious materials be washed with a mild detergent solution, rinsed with clean water, and dried prior to a general cleaning with mechanical sweepers and high pressure air. There is no proof one way or the other regarding contamination but merely mentioned as a possibility.

The cause of the cracking and delamination of the HFST has not been positively determined but the evidence points to a substrate failure caused either by the accumulation of moisture in the underlying HMA or high shear forces developing in the HMA from vehicle tires on the HFST's higher friction surface.

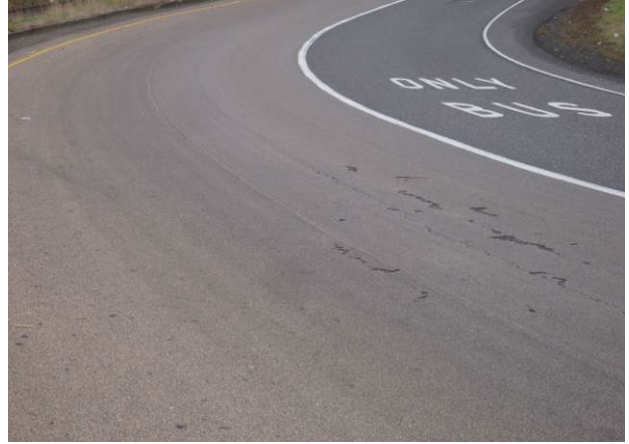
Figure 28. Random delamination.

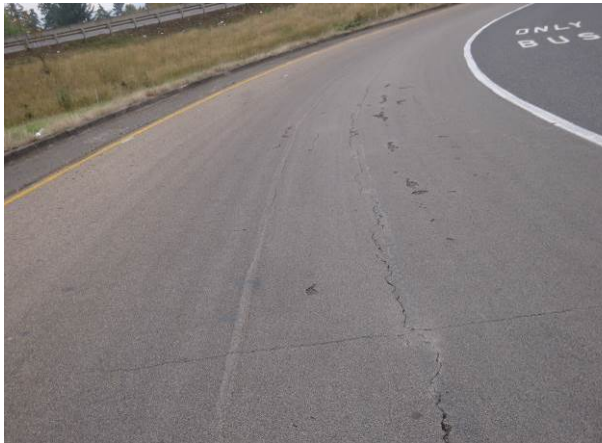
Figure 29. Longitudinal and transverse cracking and minor delamination.

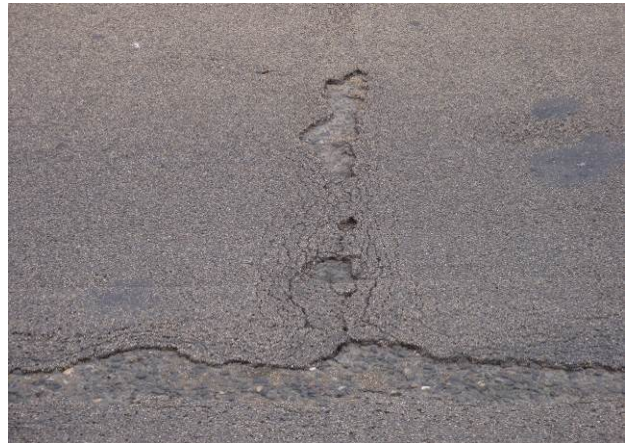
Figure 30. Transverse crack and delamination.

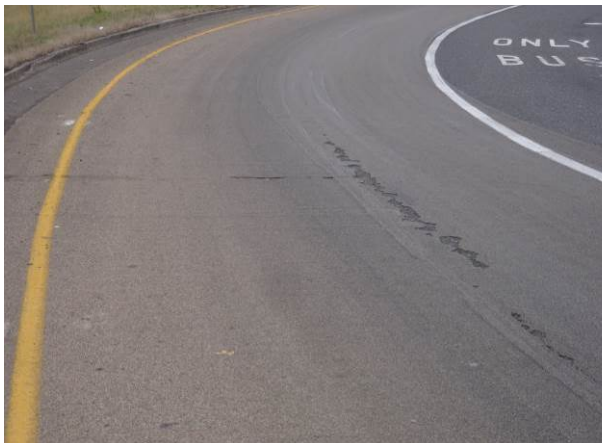
Figure 31. Wheel path delamination.

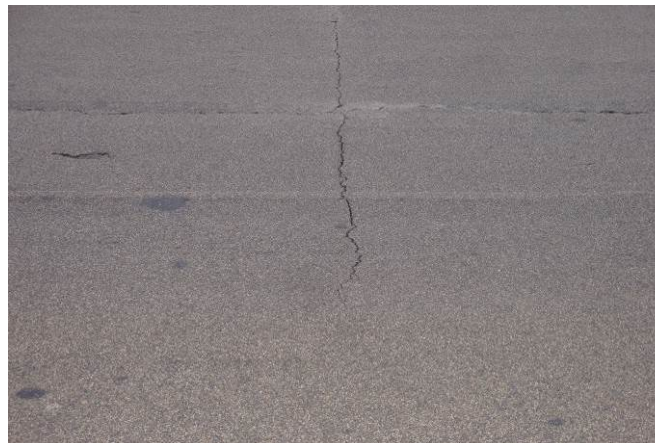
Figure 32. Transverse crack.

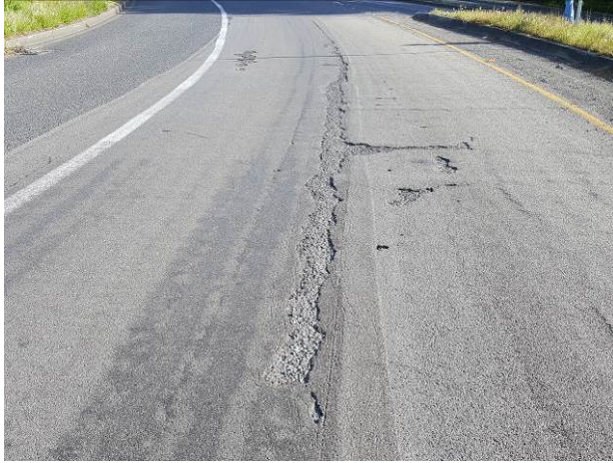
Figure 33. Wheel path delamination.

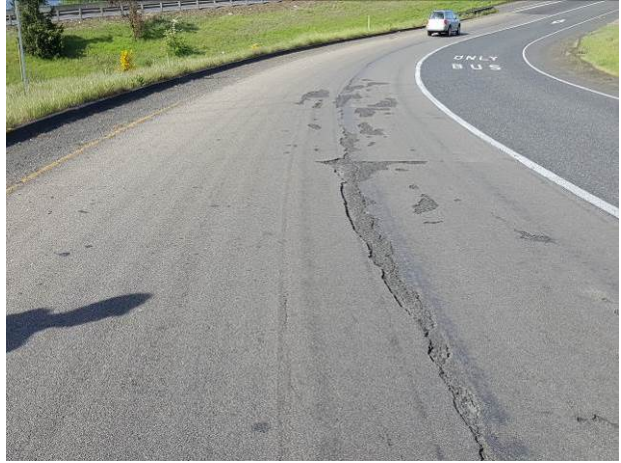
Figure 34. Wheel path delamination.

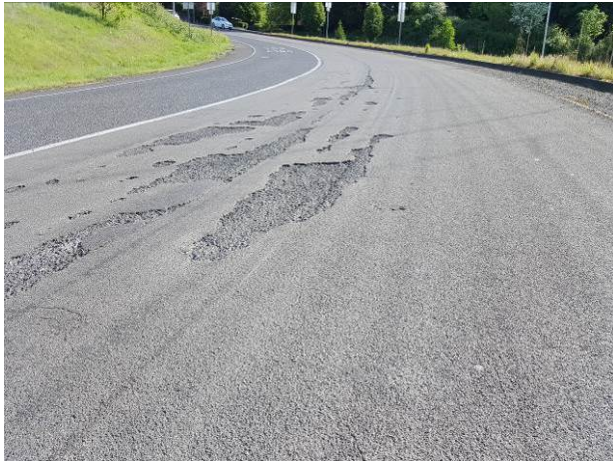
Figure 35. Delamination across lane.

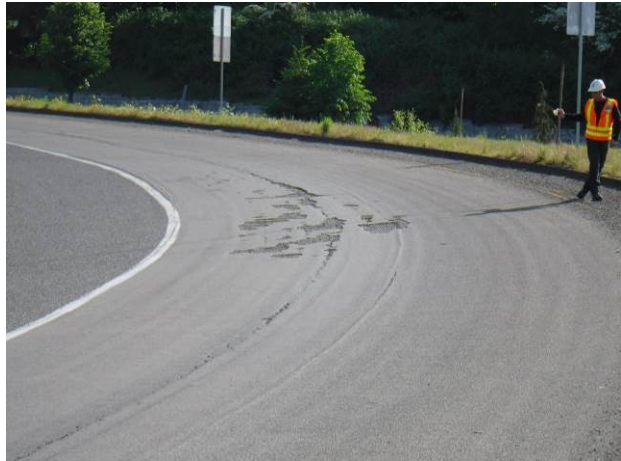
Figure 36. Delamination across lane.

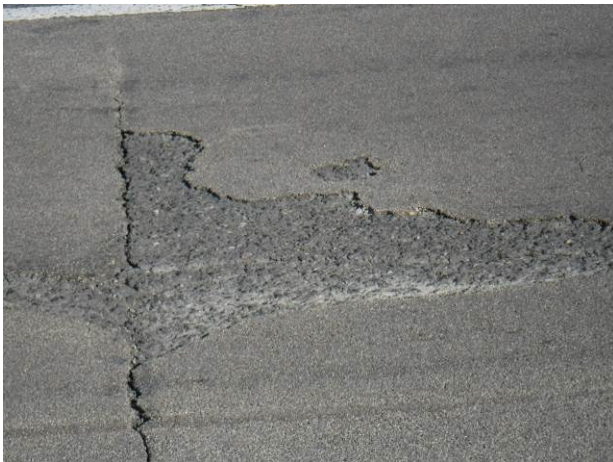
Figure 37. Delamination and transverse crack.

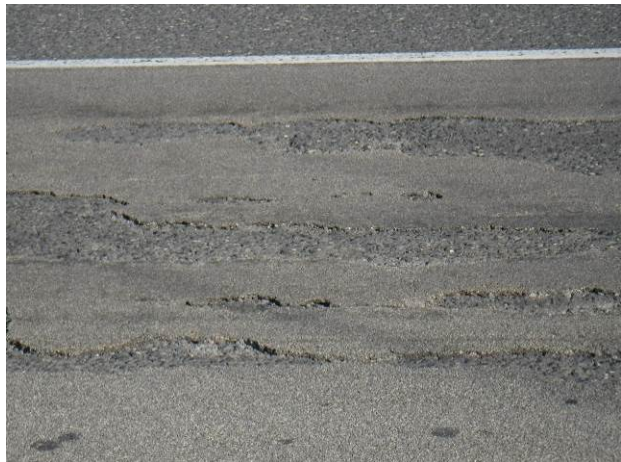
Figure 38. Delamination close-up.

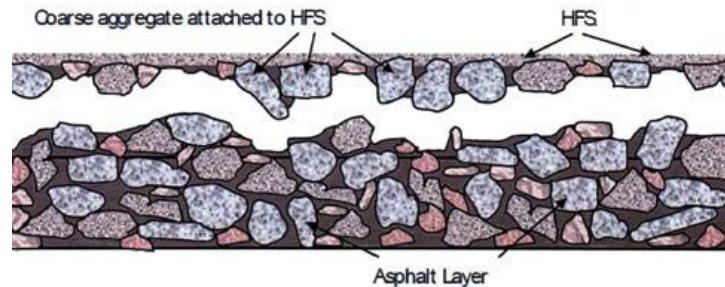
pavement resulting in shallow cracks. Shallow horizontal tearing (see Figure 39) can be caused by thermal incompatibility or stripping (moisture accumulation in the pavement)

Figure 39. Shallow tearing (Wilson and Mukhopadhyay, 2016).
