RDT 03-010

Signal Mast Arm Failure Investigation

RI 97-019

July, 2003

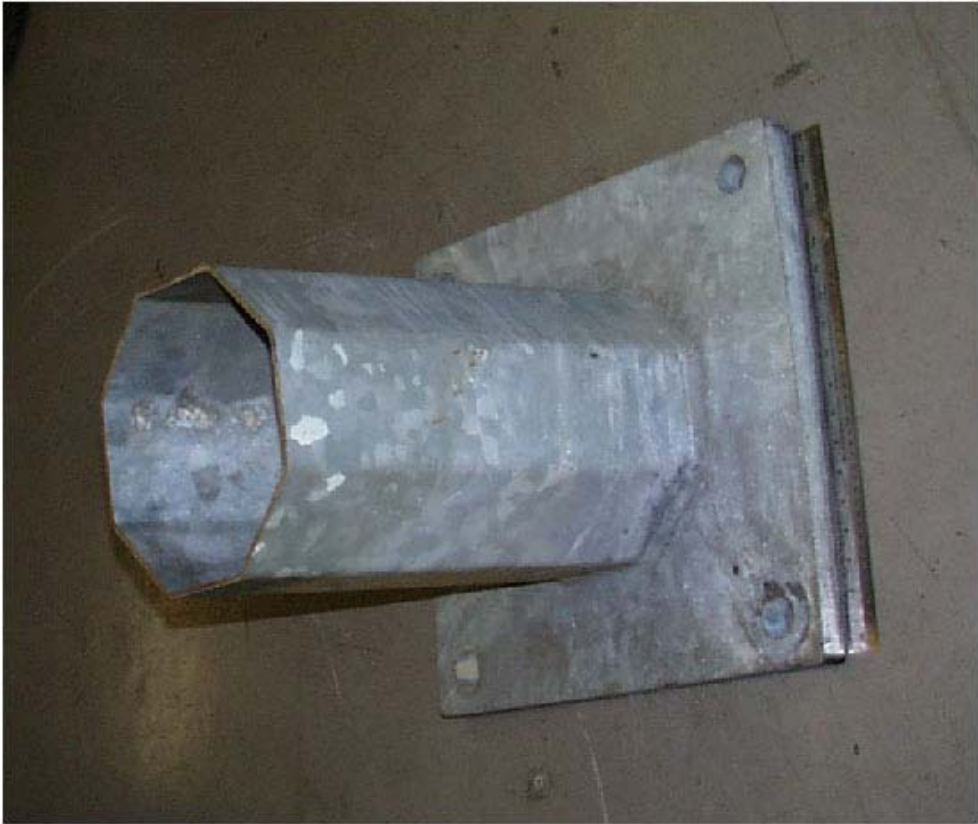
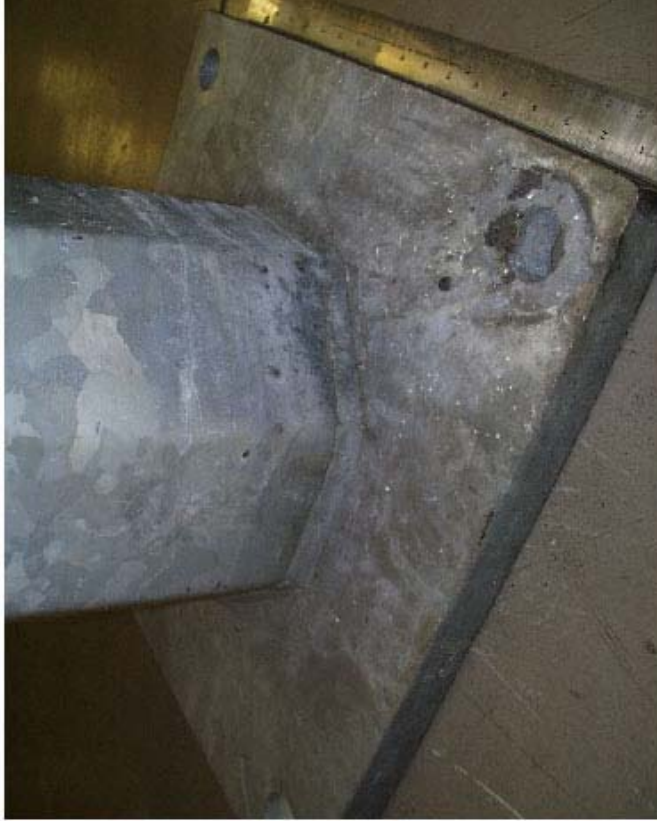
Figure 2.3 Overview of the failed arm-to-plate connection

A cursory visual examination of a signal mast arm failure was also performed. The fracture showed lack of fusion in several places, and had the characteristic blue temper colors showing exposure to heat. Several locations on the fracture had a morphology that suggested fatigue that had initiated at multiple locations at the outer surface at the toe of the weld. Initiation and propagation of cracking was through the base metal. No beachmarks were observed. However, this is not unusual in weldments. No effort was made to confirm the presence of fatigue using the scanning electron microscope.

It is clear that the weld quality is poor. There is lack of fusion and lack of penetration. This can be improved by proper joint preparation and preheating the weld. Better penetration of the weld could be achieved by creating a small 45° bevel at the edge of the base plate where the mast arm meets the base plate. This bevel could be readily achieved by grinding immediately prior to welding. This would improve the amount of weld fusion and penetration. It would also provide a concave weld bead shape that is more conducive to fatigue service. This would reduce the sharp radius produced by the convex weld shape, reducing the high stress concentration.

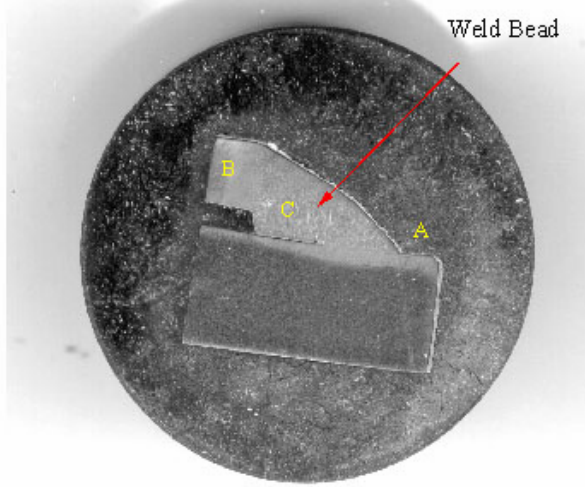
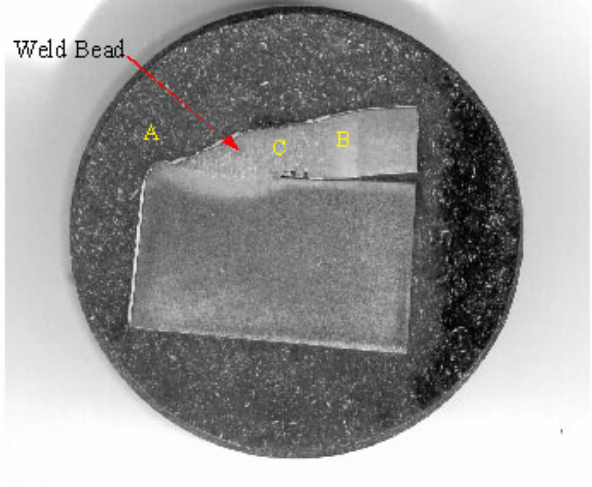
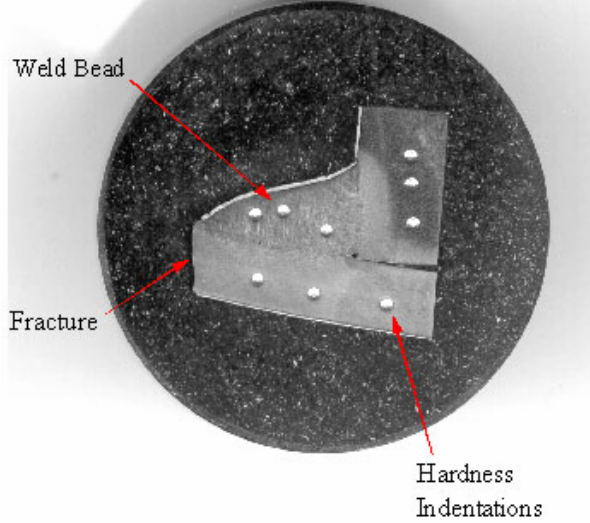
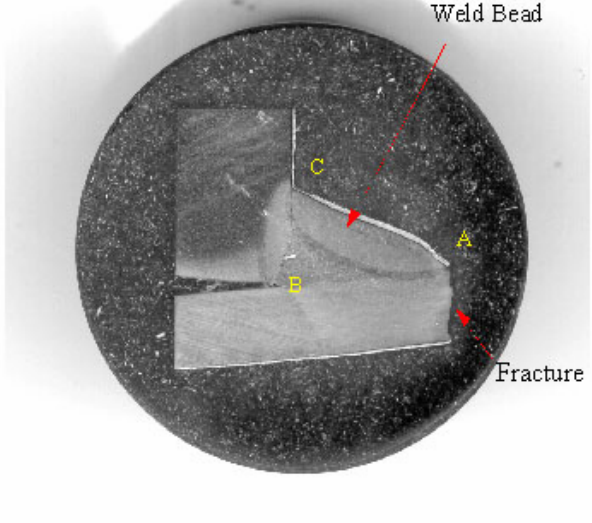
e Figure 2.5 Metallographic specimens examined, showing locations of photomicrographs

Four metallographic specimens were taken from a variety of locations in the mast arm assembly shown in Figure 2.2. Specifically, two specimens were cut from the outside weld in cracked and uncracked regions, which are respectively designated “CT” and “ET”. The other two specimens were cut from the inside weld in cracked and uncracked regions, respectively denoted as “BC” and “BE”. The metallographic sections were polished to remove any oxidation and were then etched using 2% Nital (2ml HNO₃, 98 ml CH₃OH). The resulting sections are shown in Figure 2.5.

Examination of these sections showed a lack of fusion in any of the metallographic sections. There is no evidence of any weld preparation. On the inside welds, the weld bead in Figures 2.6 and 2.7 showed a typical microstructure of acicular ferrite. The heat affected zone (HAZ) showed evidence of banded spheroidized pearlite. The base material was also banded, and exhibited distinct regions of very fine pearlite. This structure is not unusual for A36 steel that has been hot rolled. The radius at the toe of the weld is sharp. A sharp undercut of the weld is also evident. The undercut is approximately 50 to 100 μ m deep, and 200 μ m wide. This is a very sharp notch, and occurs where the base material is the softest, and least resistant to fatigue.

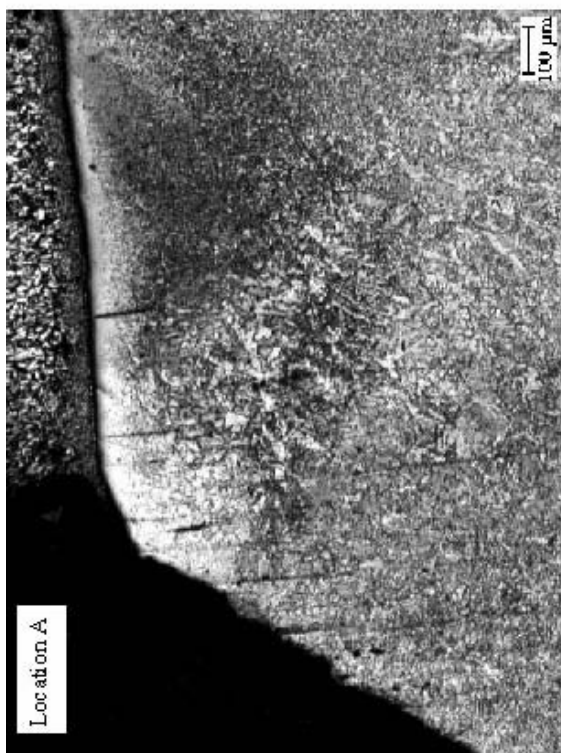
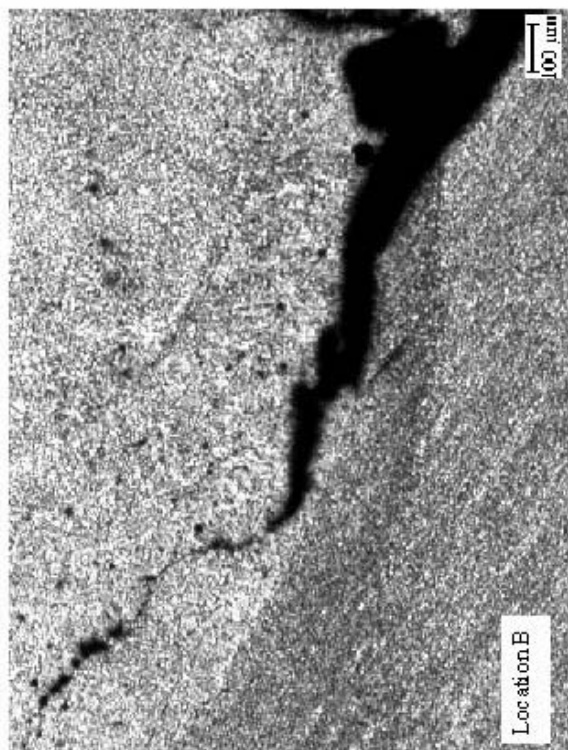
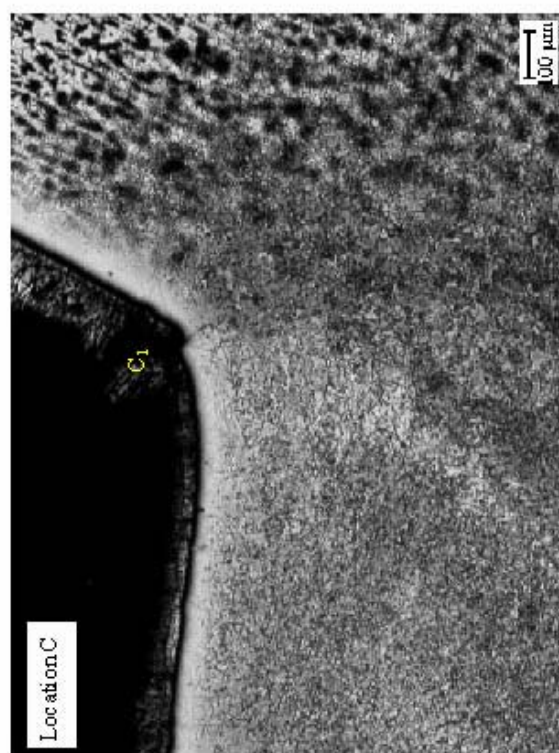
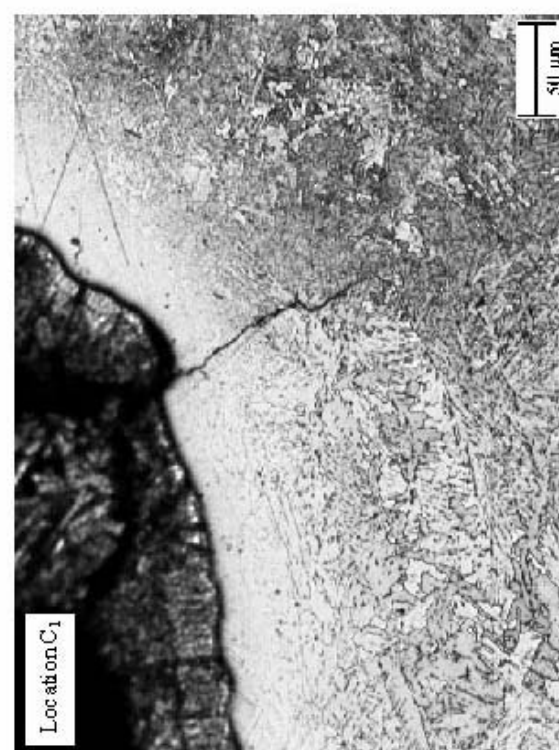
3 Figure 2.8 Selected photomicrographs from Specimen ET

In the outside weld (Specimen ET), the weld bead shown in Figure 2.8 at three locations presented evidence of undercutting at the site of crack initiation of the fracture surface. The close-up view at location C1 confirmed the cracking. The small size of the shear lip indicates that the stress levels were small in comparison to the overall section size. At the region of the root of the fillet, evidence of porosity, and cracks linking regions of porosity, was observed. This probably occurred by overload, possible during the final failure. This is indicated by the direction of cracking, perpendicular to the fracture. However, this could have also occurred because of residual stresses in the weld.
