BREAK AND SEAT OF JOINTED  
REINFORCED CONCRETE PAVEMENTS

INTERIM CONSTRUCTION REPORT  
BY

RESEARCH REPORT NO. 287

STATE PROJECT NO. DTFH71-91-SP202-LA-10

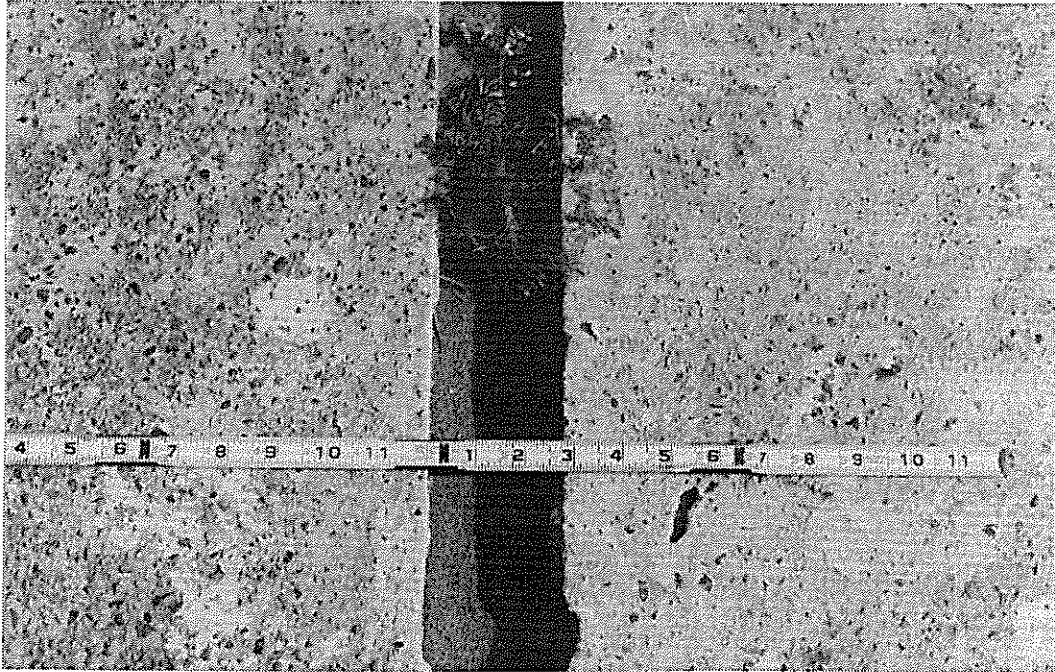
An initial visual distress survey was conducted on the SP-202 sections prior to breaking operations. Crack positions were measured and a crack map produced. In addition, a hand held videotape recording of each section was taken to permanently record the pre-rehabilitation distress for future reference. The initial distress survey for the SP-202 test sections is shown in Figure 13 of Appendix A. Figures 2 and 3 are sample photographs of the existing joint conditions.

Figure 2. Crack width of existing joint.

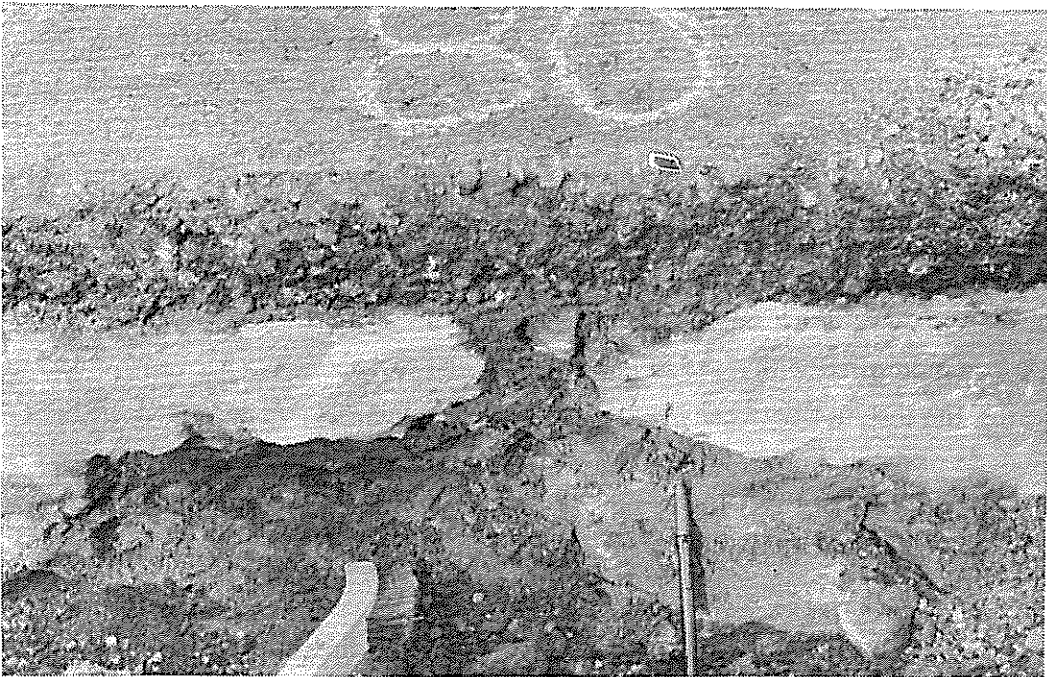
Figure 3. Condition of slab edge at the joint.

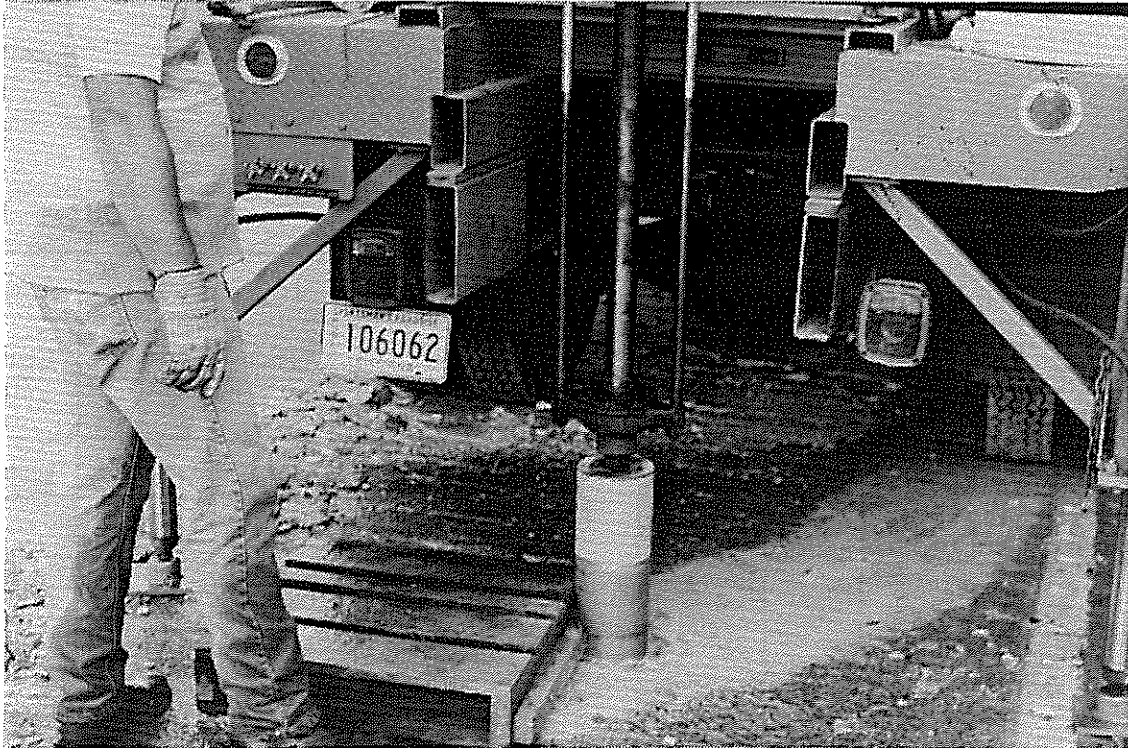
The six inch diameter cores taken within the test sections as shown in Figure 7 were to verify full depth breaks and determine the degree of debonding of the wire mesh reinforcing from the PCC. These cores were taken to coincide with selected post-break, mid-panel, FWD test locations. Information on these core locations are shown in Table 7.

Full-depth cracks were evident in each of the cores after breaking, however, in every case the steel was only partially debonded from the concrete. Coring operations and extracted cores were videotape recorded.

Figure 7. After Break Core, 6" Break Pattern.

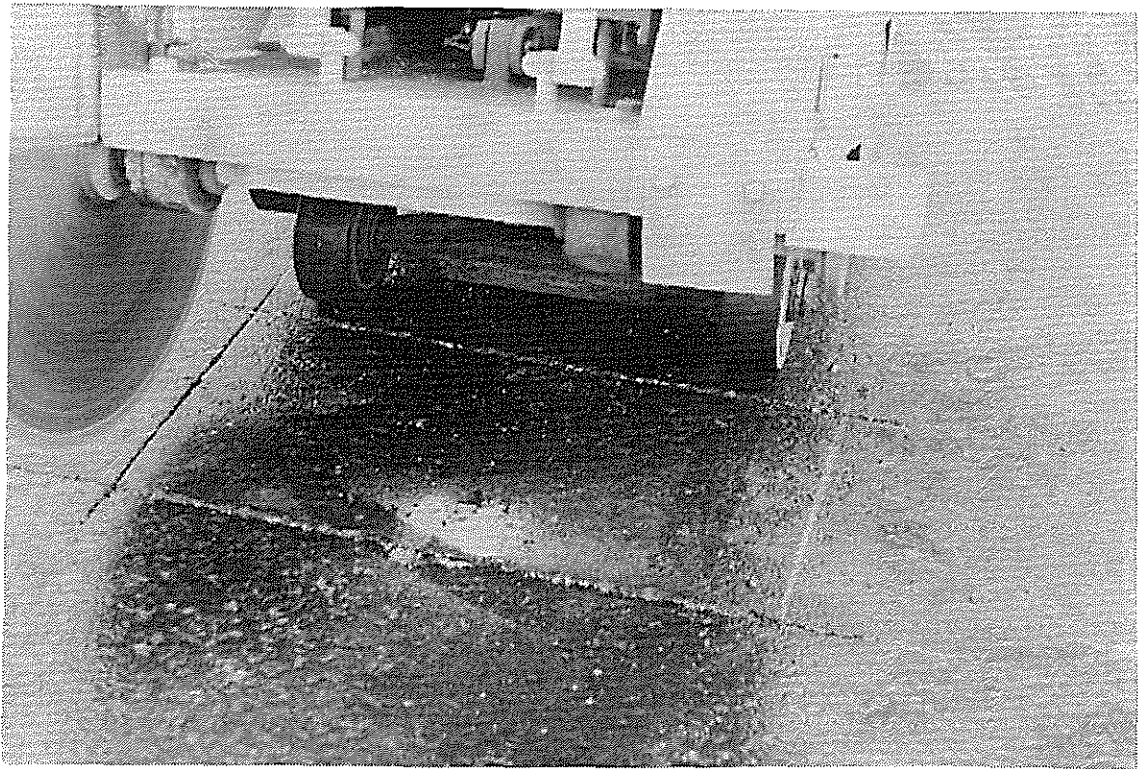
Figure 9. Saw Cut for Utility Box Installation.

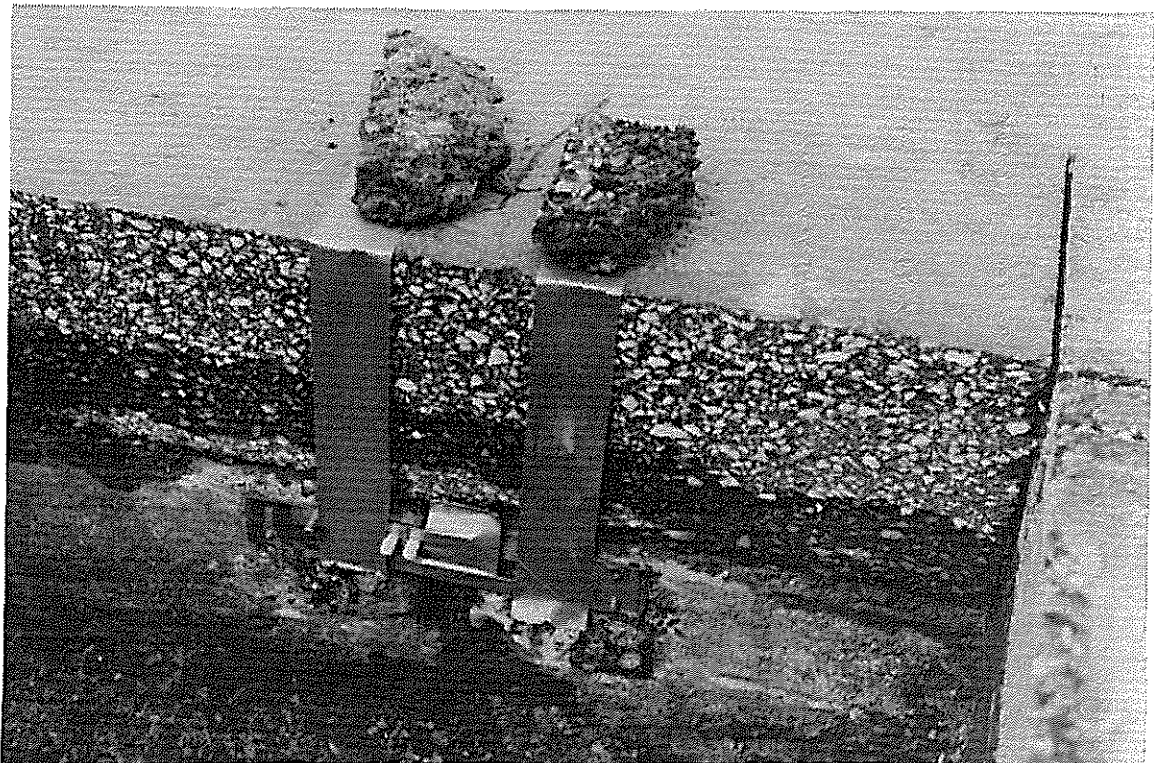
Figure 10. Installation of Monitoring Gauge.

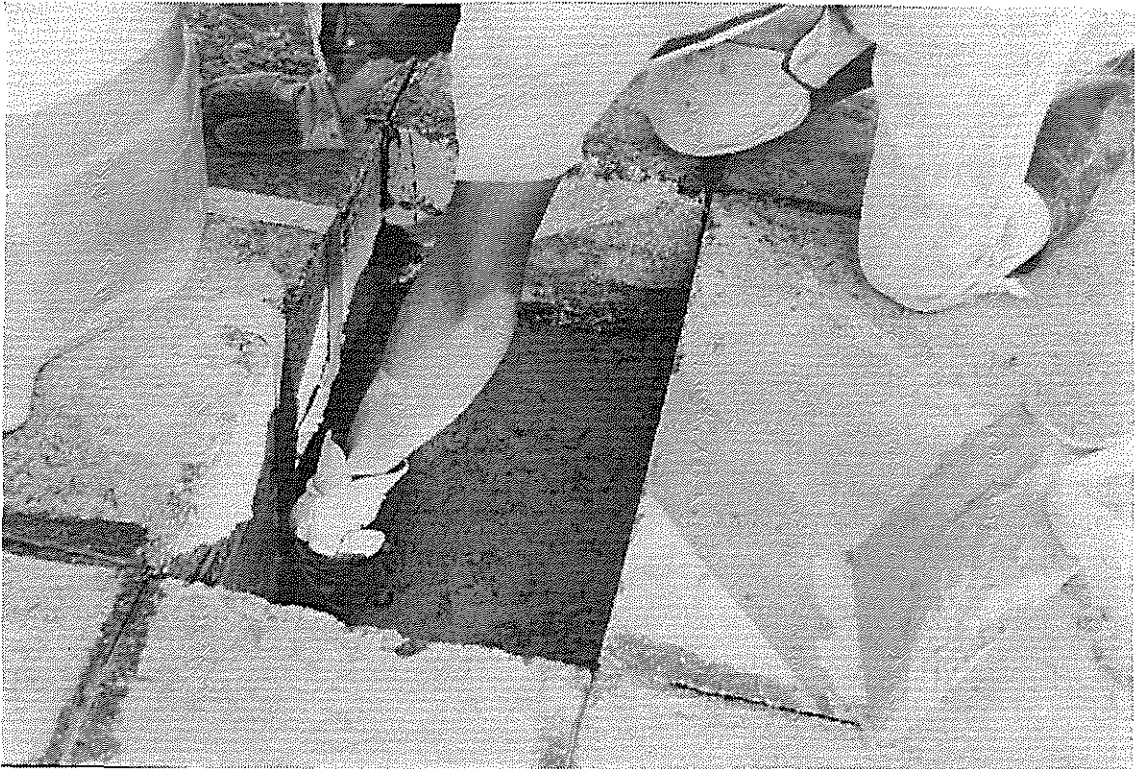
Figure 11. Preparing Base for Utility Box.

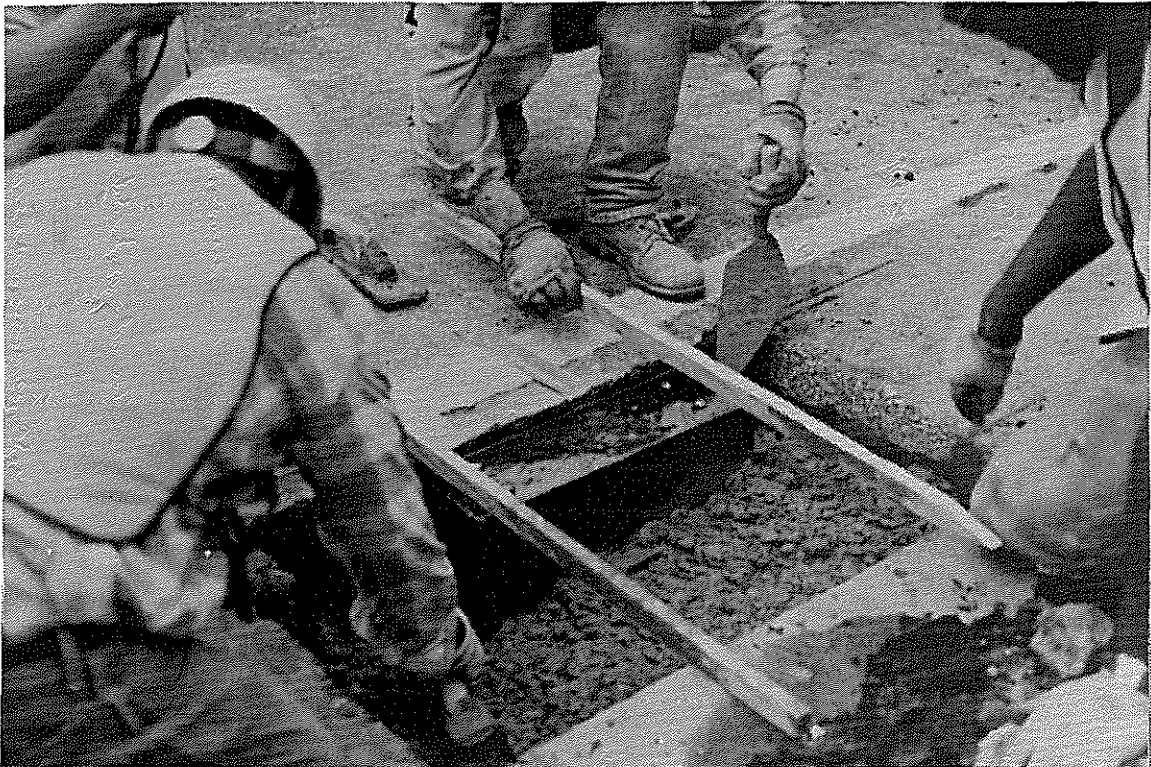
Figure 12. Installation of Utility Box..

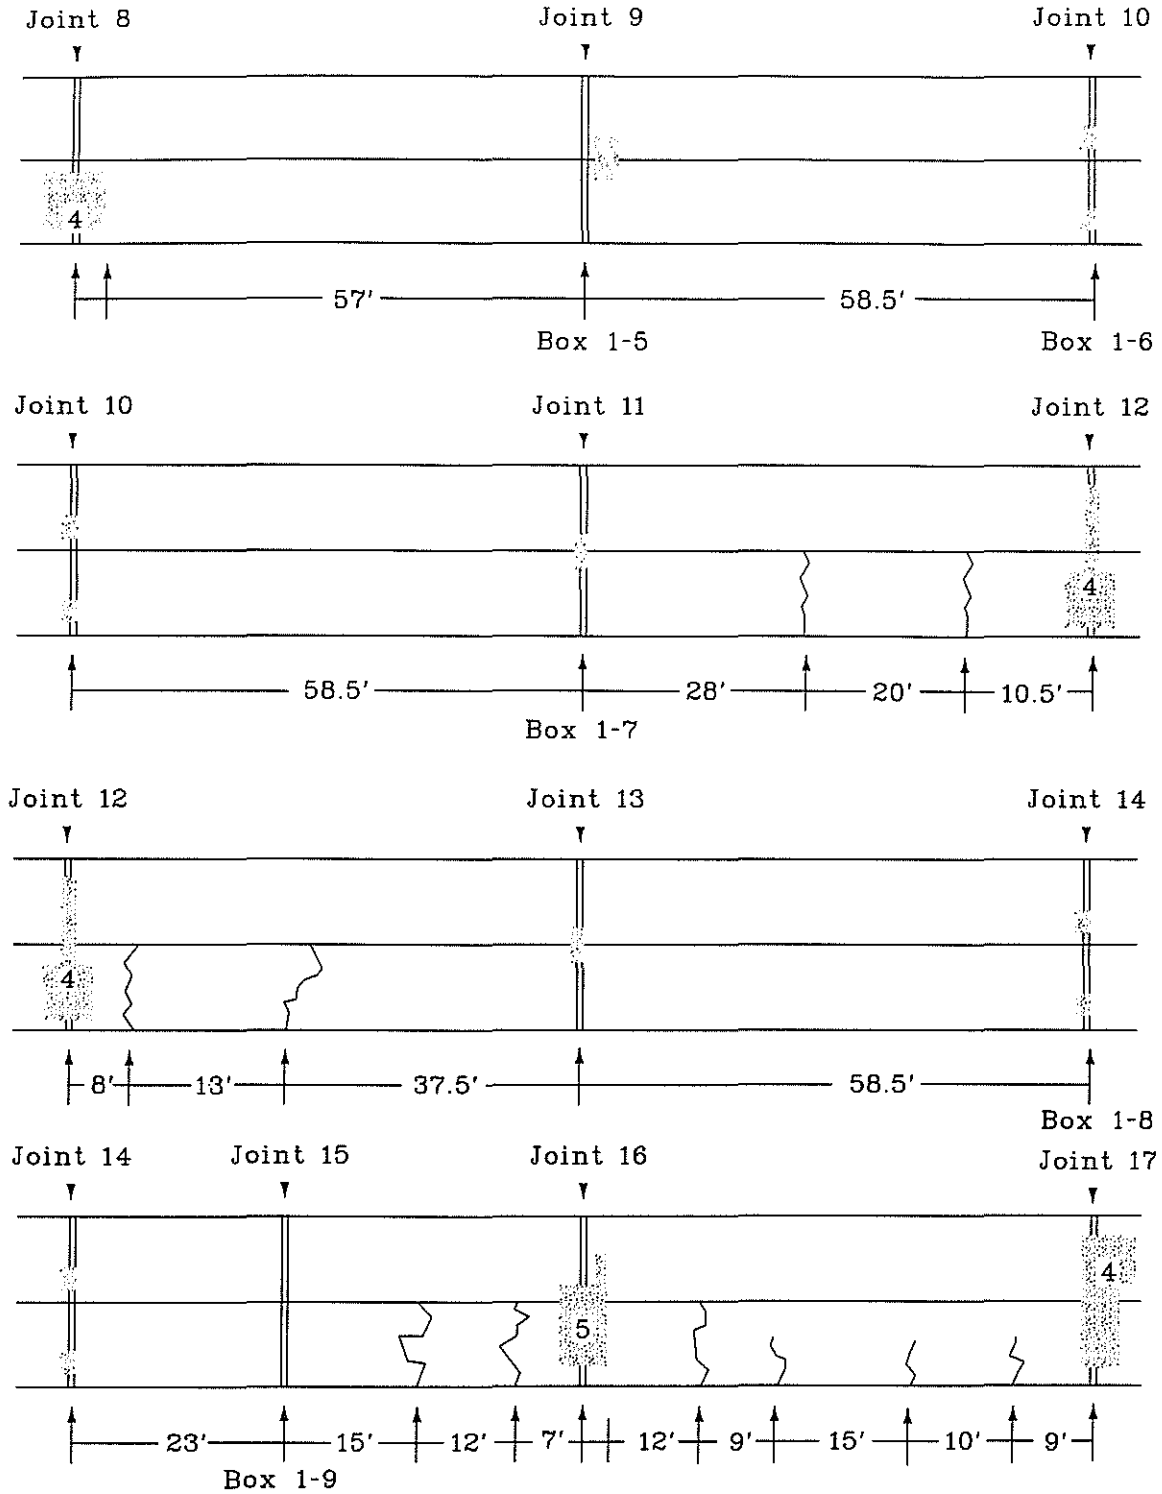
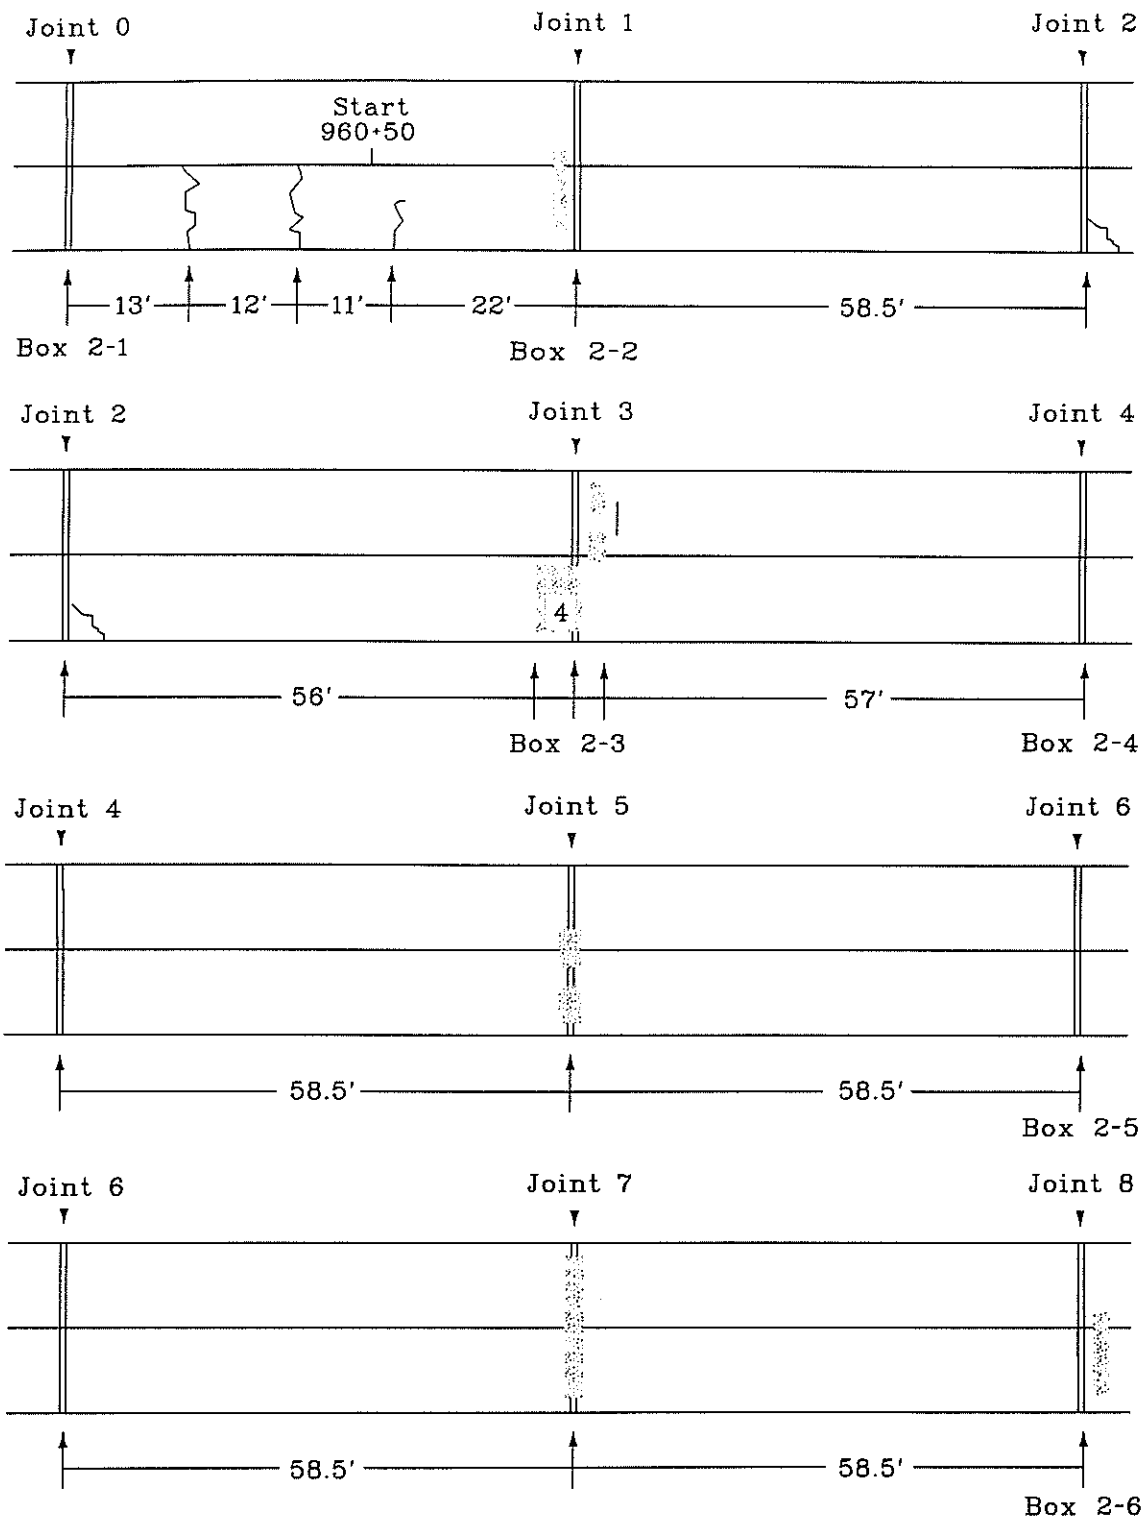
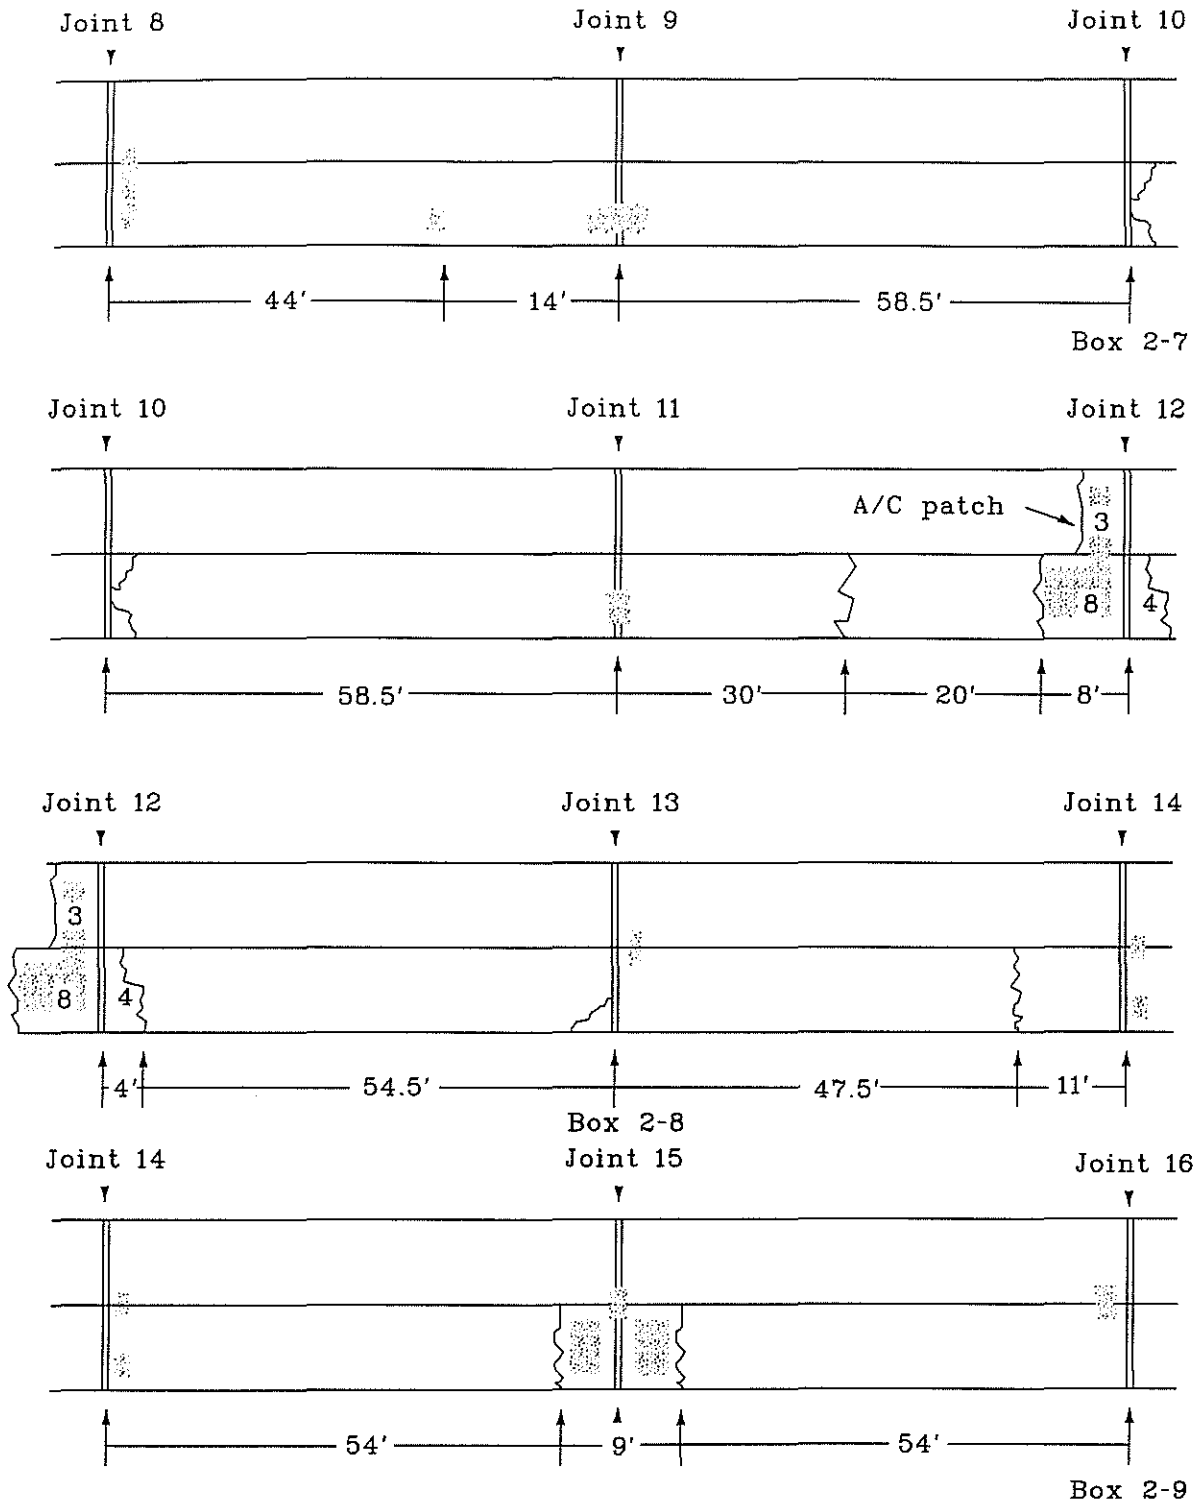
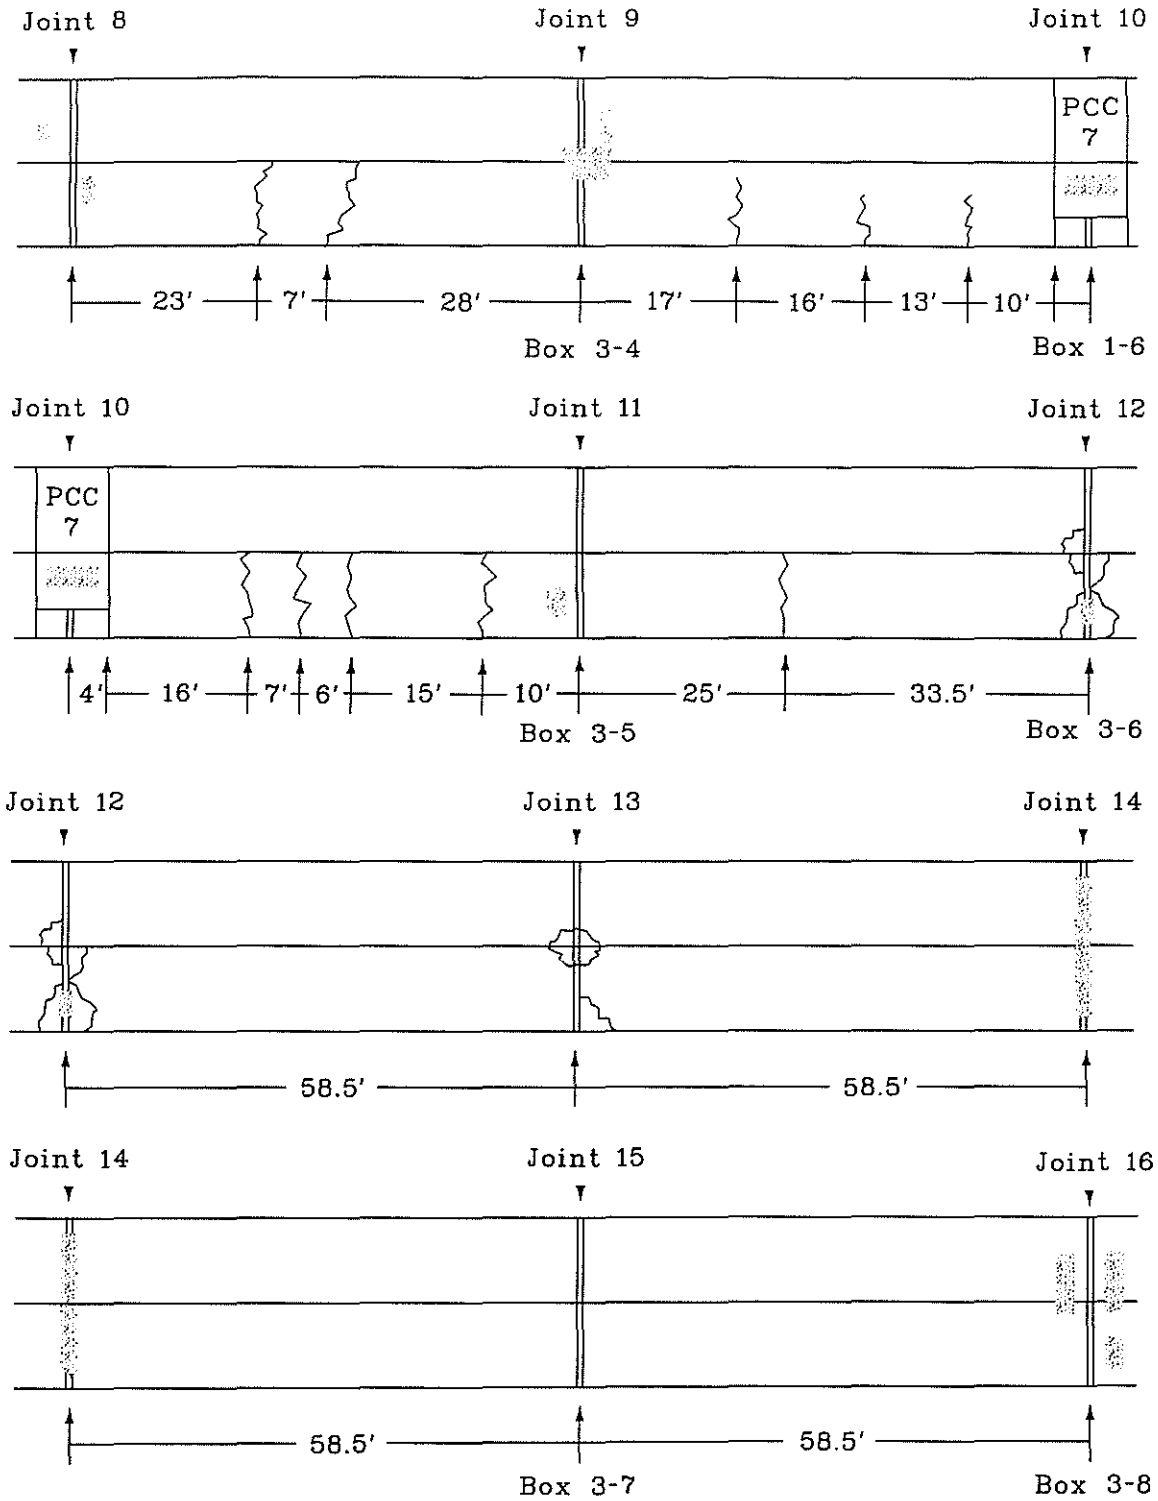
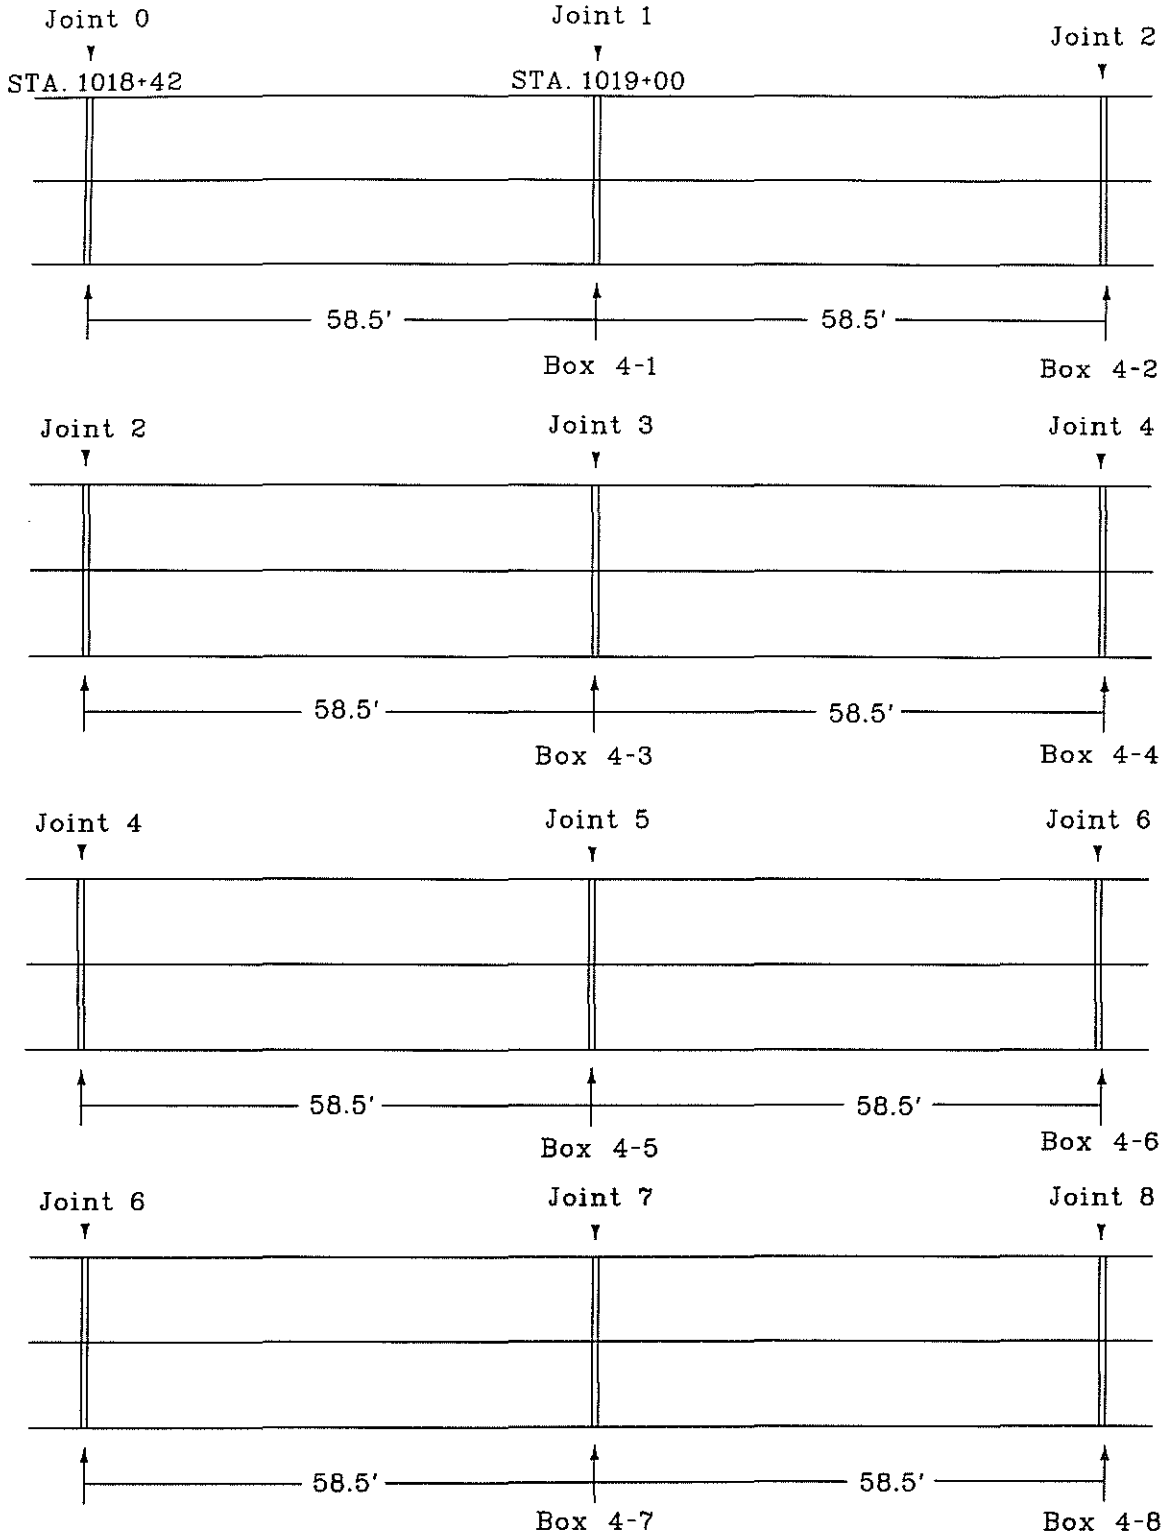
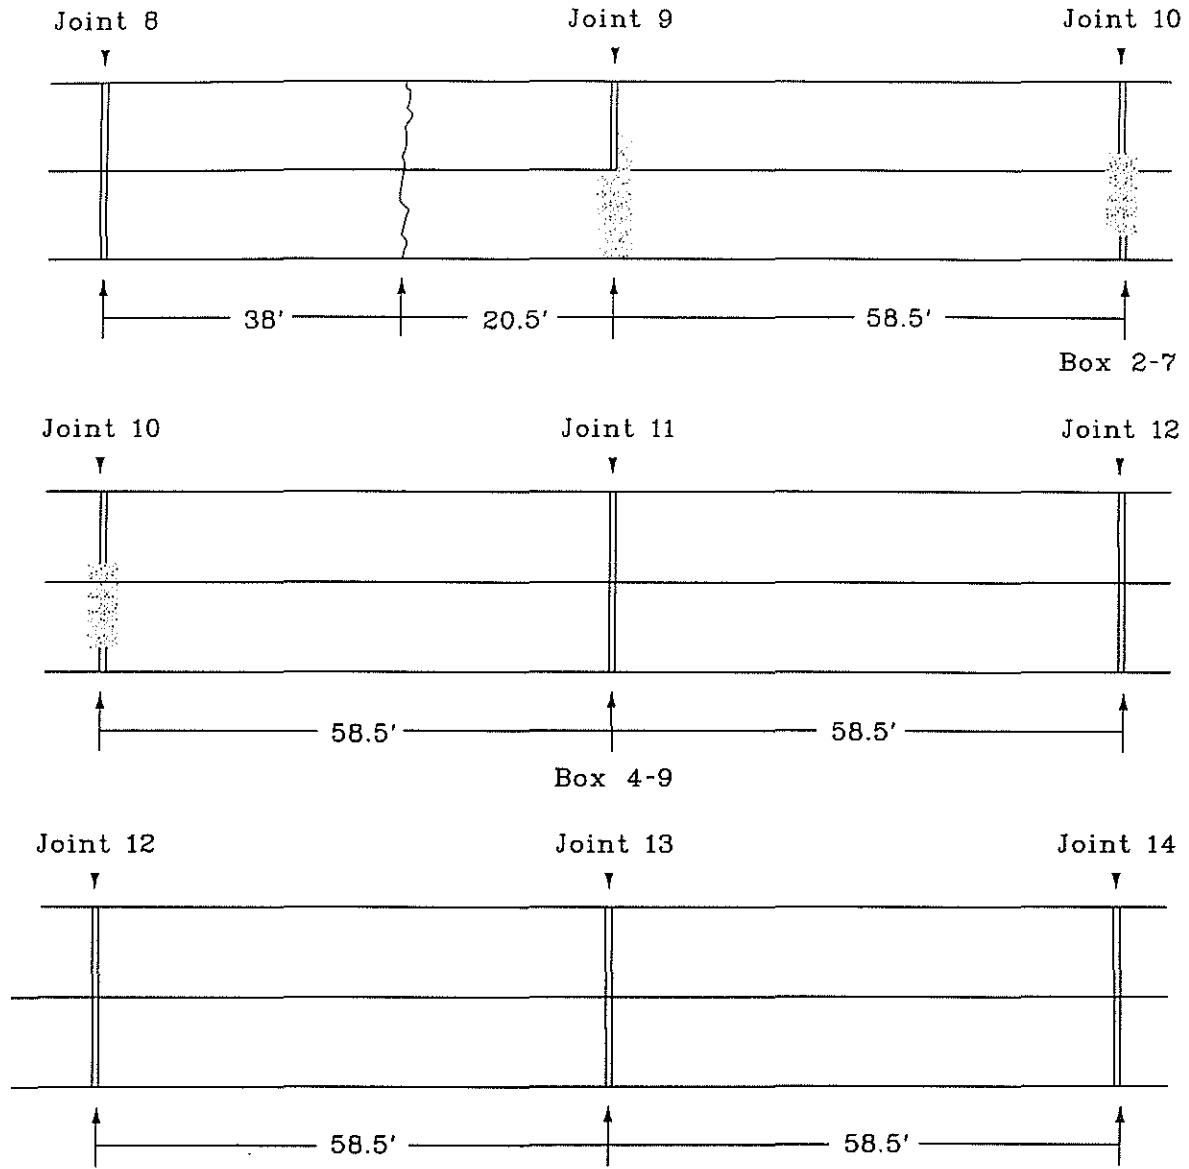
Figure 13 (Cont'd). La. Initial Distress Survey and Gauge Location.

The exact location of instrumented joints/cracks are graphically depicted on the pre-construction distress survey is also shown in Figure 9 of Appendix A. This survey also displays the distance to the nearest crack/joint on either side of the instrumented crack/joint.
