# JOINT TRANSPORTATION RESEARCH PROGRAM

## Pack Rust Identification and Mitigation Strategies for Steel Bridges

Patel, C. H., & Bowman, M. D. (2018). *Pack rust identification and mitigation strategies for steel bridges* (Joint Transportation Research Program Publication No. FHWA/IN/JTRP-2018/16). West Lafayette, IN: Purdue University. <https://doi.org/10.5703/1288284316788>

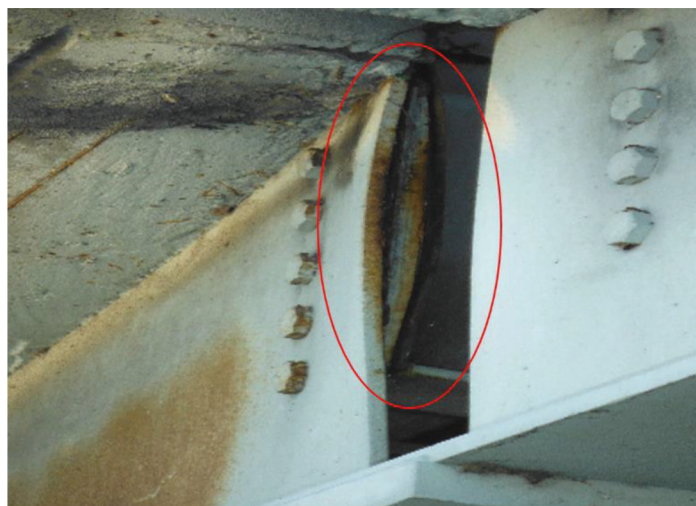
Figure 4.2 shows pack rust in bridge number (I465) 31-49-04449 B. Pack rust is evident between beam web and the leg of the angle member used to connect the diaphragm. This is the most severe condition of pack rust found in a diaphragm in Indiana. Paint has been applied over pack rust without removing and cleaning it. Taking a closer look at the pack rust, distinctive layers of rust built up over the years can be observed. The bridge was built in 1962 and last painted in 1993. Pack rust was first reported in 1998 and the image presented was taken in 2014. The images for the progression of pack rust are not available. It is difficult to judge if the pack rust thickness is large near the bolts. If the

**Figure 4.2** Most severe pack rust in the diaphragm found in Indiana.

thickness of pack rust at the line of bolts is roughly 1 inch, the bolts will have enormous additional stress in them.

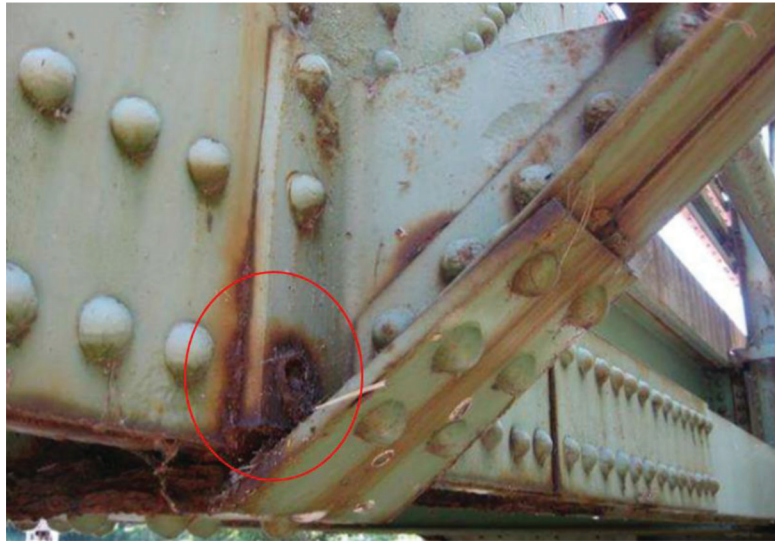
Figure 4.3 Rivet failed due to pack rust.

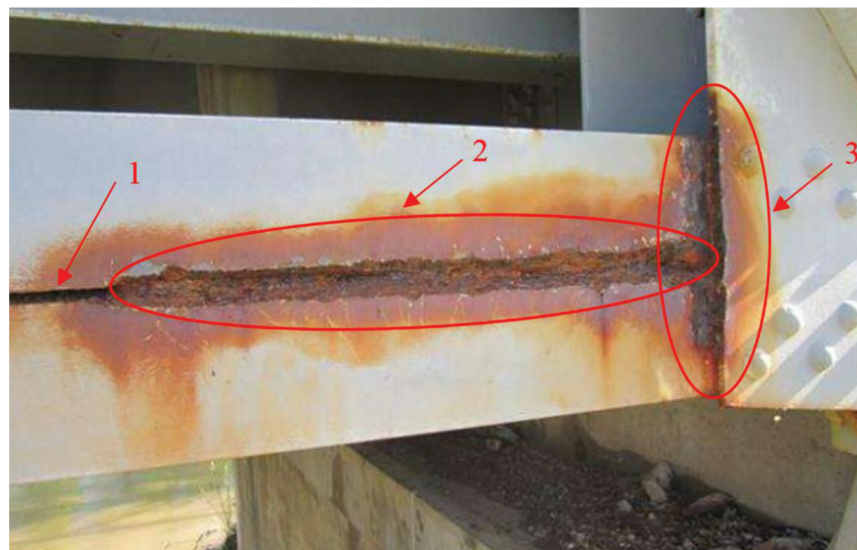
Figure 4.4 shows the bottom chord of the truss. The members visible are the angle members connected back to back with a small gap in between (marked as 1). There are two locations in the image where pack rust is present. The pack rust has filled the gap between the members over the years, and there is severe section loss at location 2 circled in the image. The second location is the connection between the gusset plate and the angle members is also affected by the pack rust marked as 3.

Figure 4.4 Pack rust in the lower chord and gusset plate.

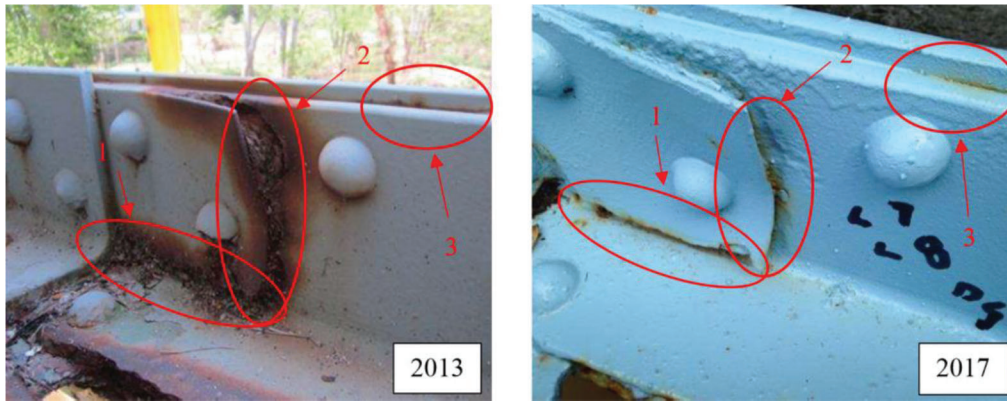
**Figure 4.5** Pack rust in connections of the bottom chord.

Figure 4.5 shows same connection detail after four years. The image on the left was taken in 2013, and the connection had severe pack rust causing section loss and bending of plate. The bridge was painted in 2016. The image on the right is of the same connection in 2017. From the post painting image it looks like some of the rust product has been removed but not completely. It is seen that just after one year of painting, rust bleeding is visible at the locations 1, 2 and 3 marked in the right image in Figure 4.5. There are chances that this is not an active corrosion it could be just rust coloration from the already present rust due to rain. No field testing was conducted for this study.

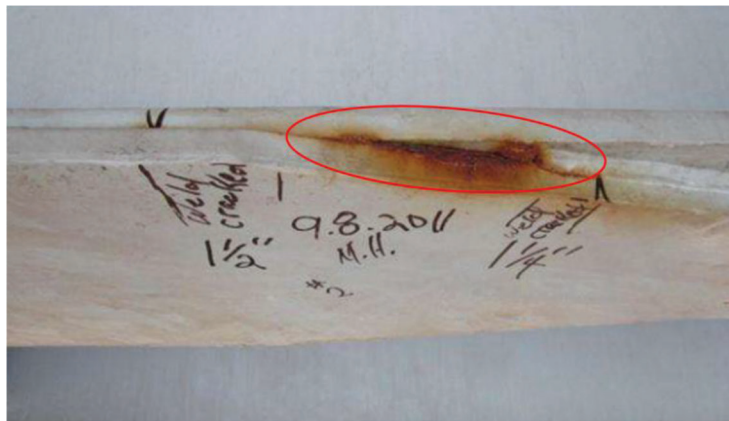
**Figure 4.6** Pack rust at the tapered location for wider cover plates (location 1).

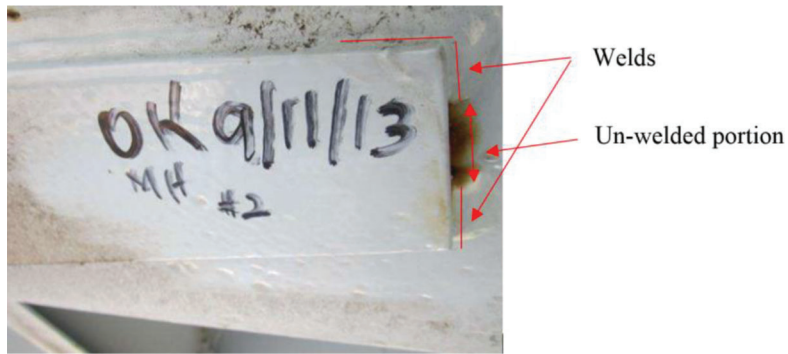
**Figure 4.7** Un-welded portion at the end of cover plate (location 2).

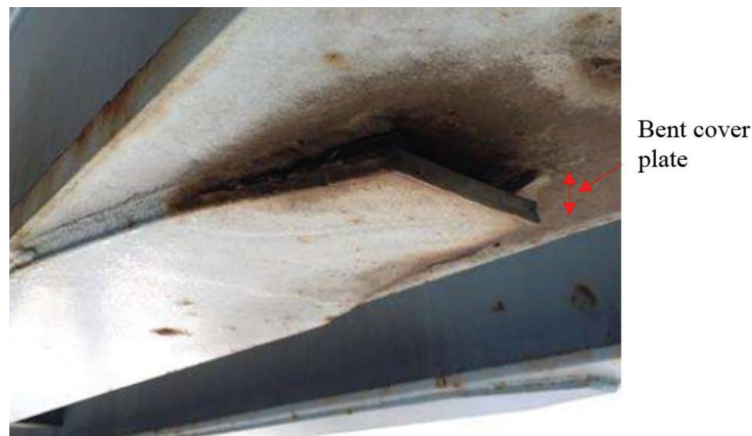
**Figure 4.8** Pack rust at the end of the cover plate (location 2).

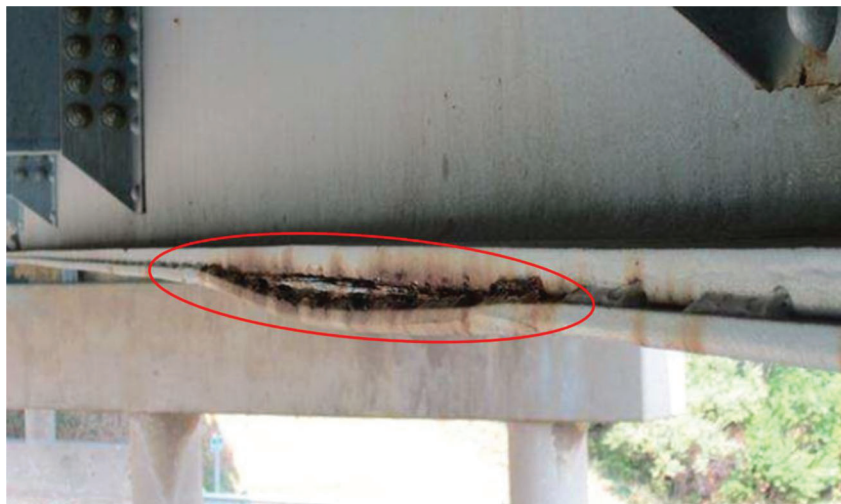
The third case in which the pack rust is formed in the cover plates is when the welds are not continuously made as shown in Figure 4.9. The causes for the pack rust formation are the same, non-continuous welds give an entry point to moisture. If the bridges intersect roads, the salt spray created by the moving vehicles gets deposited inside the crevice. Figure 4.9 shows bowing of the cover plate due to pack rust and failure of the welds.

**Figure 4.9** Non-continuous welds between the cover plate and bottom flange (location 3).

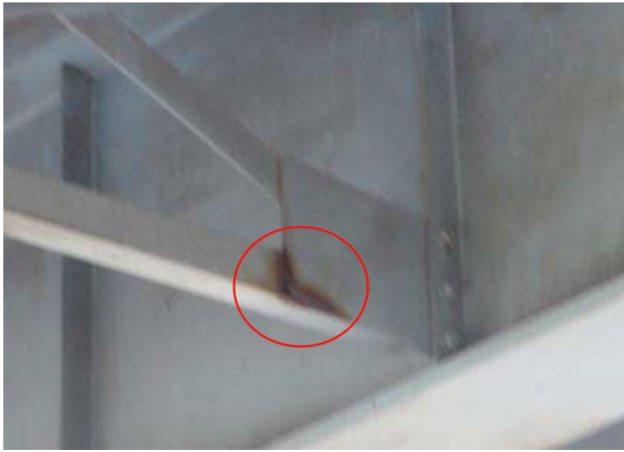
Figure 4.10 shows moderate corrosion between the cross-bracing members and the connection plate. The connection plate seems to have bent at the end due to

**Figure 4.10** Example of pack rust in cross bracing.

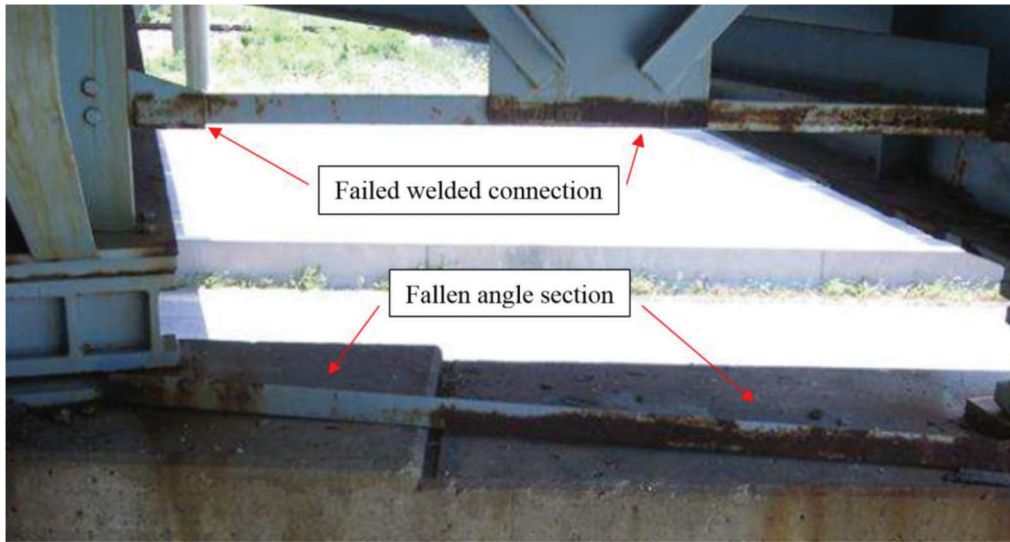
the development of pack rust. A case was observed where the whole angle section came off and fell on the pier, as shown in the Figure 4.11. The welds undoubtedly cracked due to pack rust.

**Figure 4.11** Angle connection failed due to pack rust.

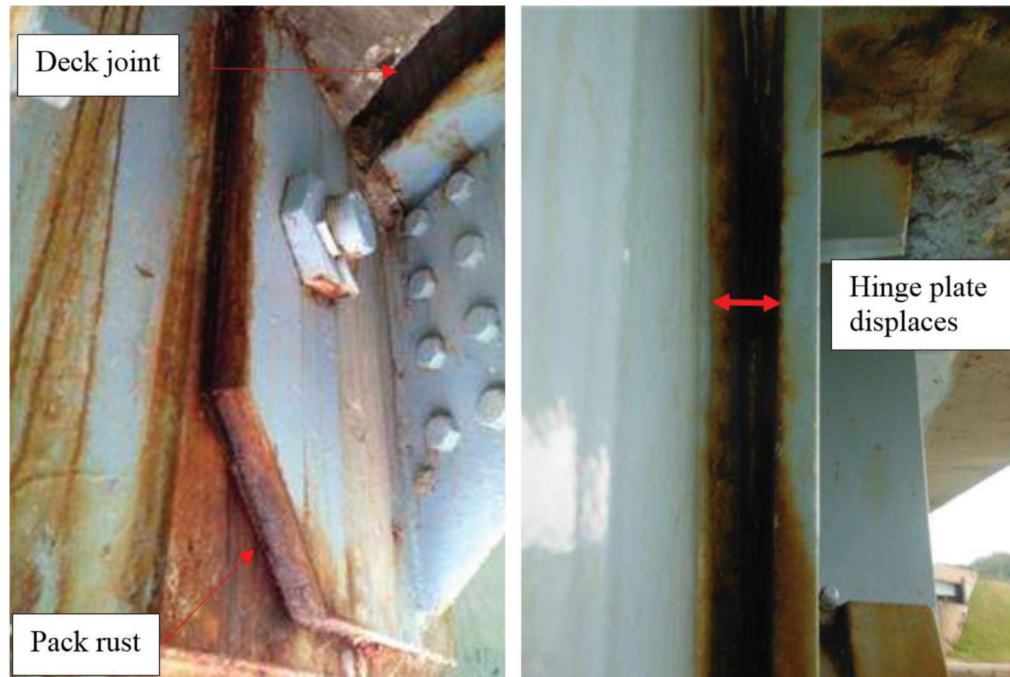
**Figure 4.13** Pack rust in the hinge-pin connection.

section loss in pins. Depending on the severity of the section loss of the pin, a severe decrease in the shear capacity could occur. Pack rust between the hinge plates and the girder web causes an out of plane bending of the hinge plate, and it also displaces the hinge plates as seen on the right of Figure 4.13. The out of plane bending will introduce eccentric loading onto the pins for which they are not designed. It was suspected that this was the reason for the collapse of the Minus River Bridge.

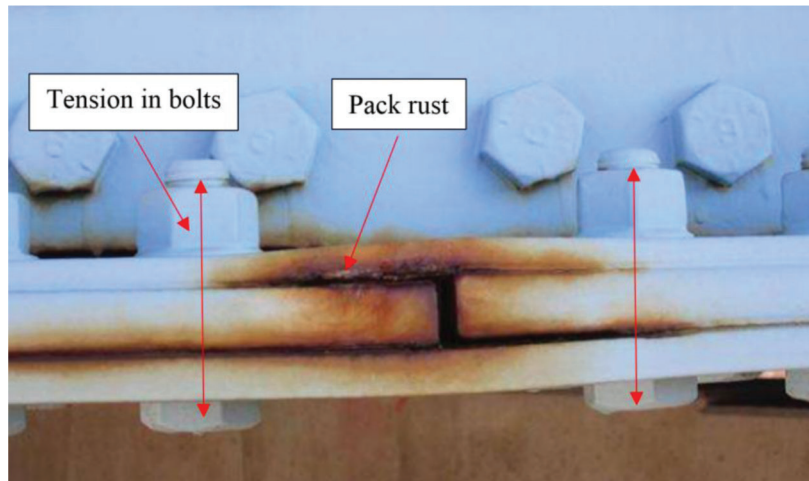
**Figure 4.14** Pack rust in the middle of the splice plate (location 1).

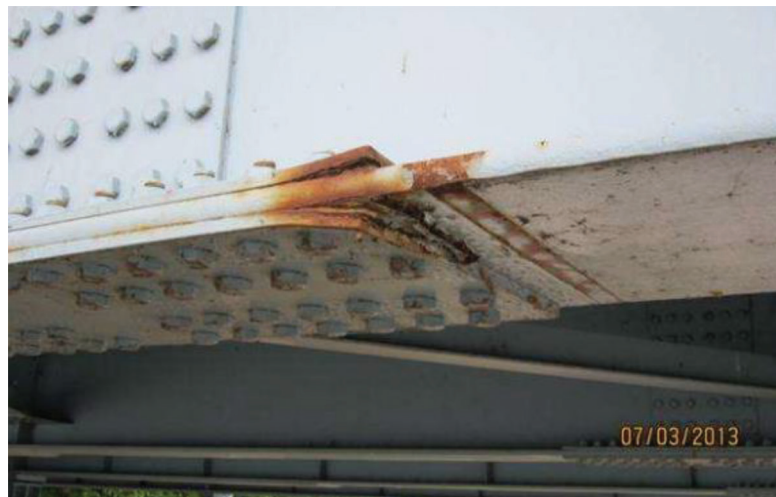
**Figure 4.15** Pack rust in the corners of the splice plate (location 2).

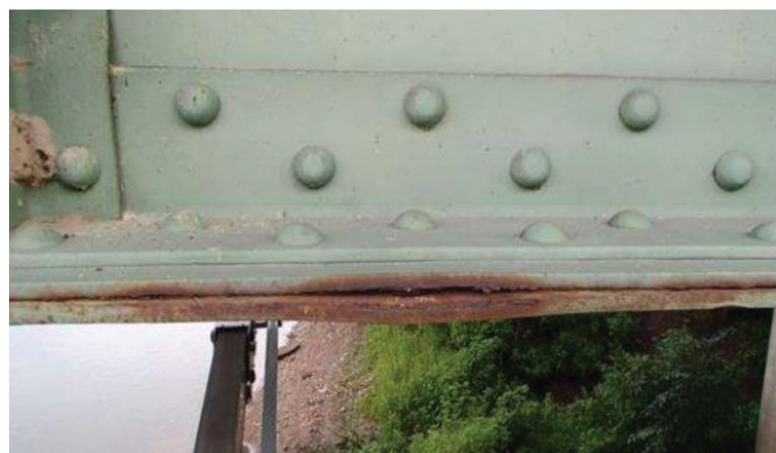
Figure 4.16 shows a riveted built-up bridge girder. It has a staggered rivet arrangement. It is evident that at

**Figure 4.16** Pack rust in the edges of the splices (location 3).

the locations where the rivet is positioned away from the edge, pack rust and rust bleeding is visible at those locations only. Figure 4.16 sets a clear example that

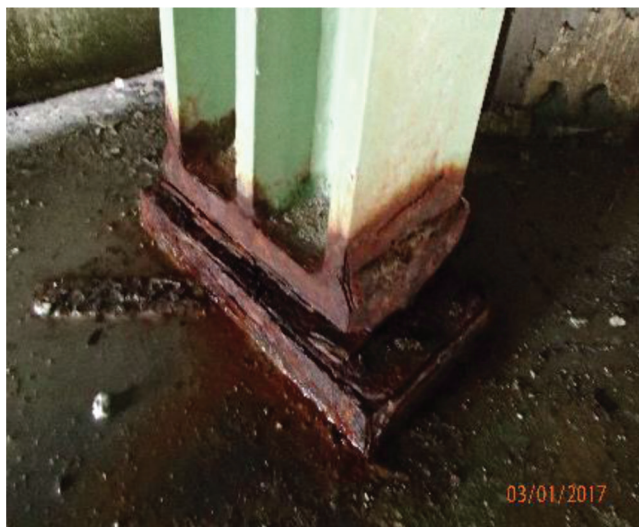
Figure 4.17 Pack rust in the rocker bearings.

Even though pack rust in rocker bearings occurs quite frequently, mitigating pack rust in rocker bearings is not a high priority since INDOT plans to eventually

reconstruct all the rocker bearings with semi-integral bearings, which are not prone to pack rust formation.

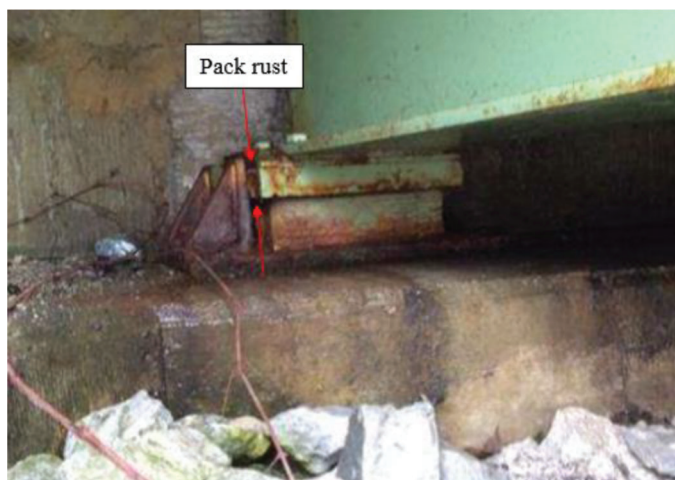
Figure 4.18 Pack rust in elastomeric bearings.
