Monitoring of Bridge Abutment Walls at SR 33 Over East State St. (Athens, OH)

Teruhisa Masada
ORITE, Ohio University

Final Report
FHWA/OH-2007/02
March 2007

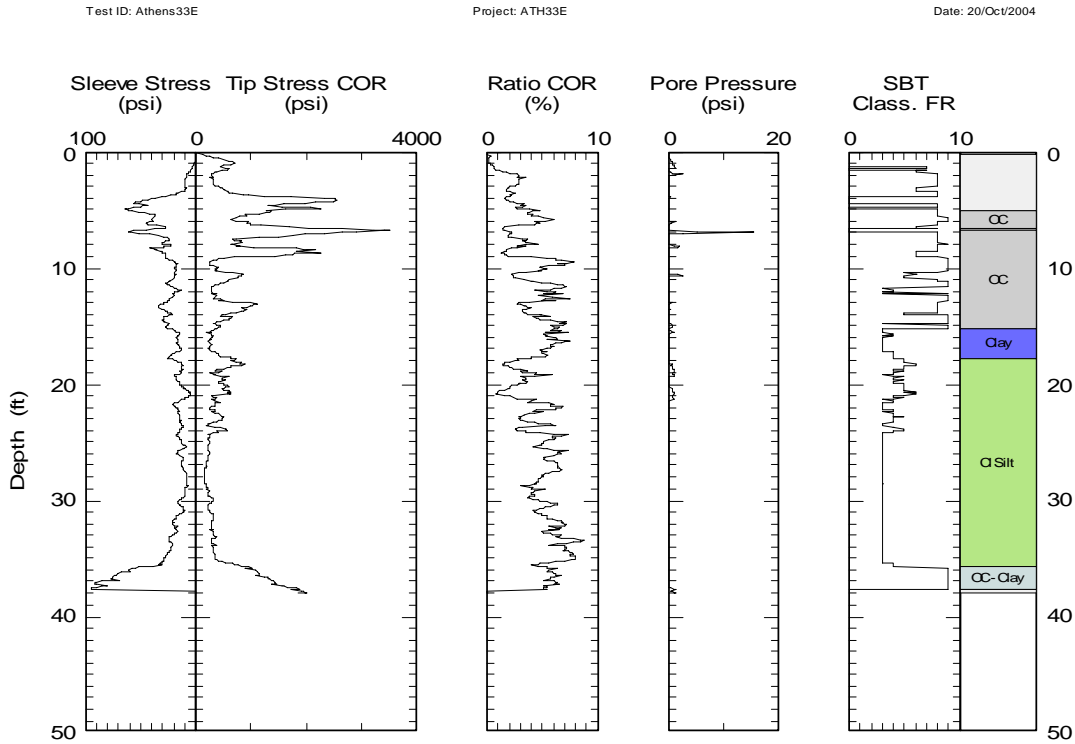
- Encountered stiff materials from 0' to 10.0' (0 to 3.1 m) depth.
- Soil (mostly clayey silt) soft and wet from 10.0' to 36.0' (3.1 to 11.0 m) depth.
- Encountered a very stiff layer at 38.0'(11.6 m); started lifting the truck (end of penetration).
- Encountered no apparent water table.

Figure 3.2: Standard CPT Log for CPT Hole #1 @ Sta. 808+60

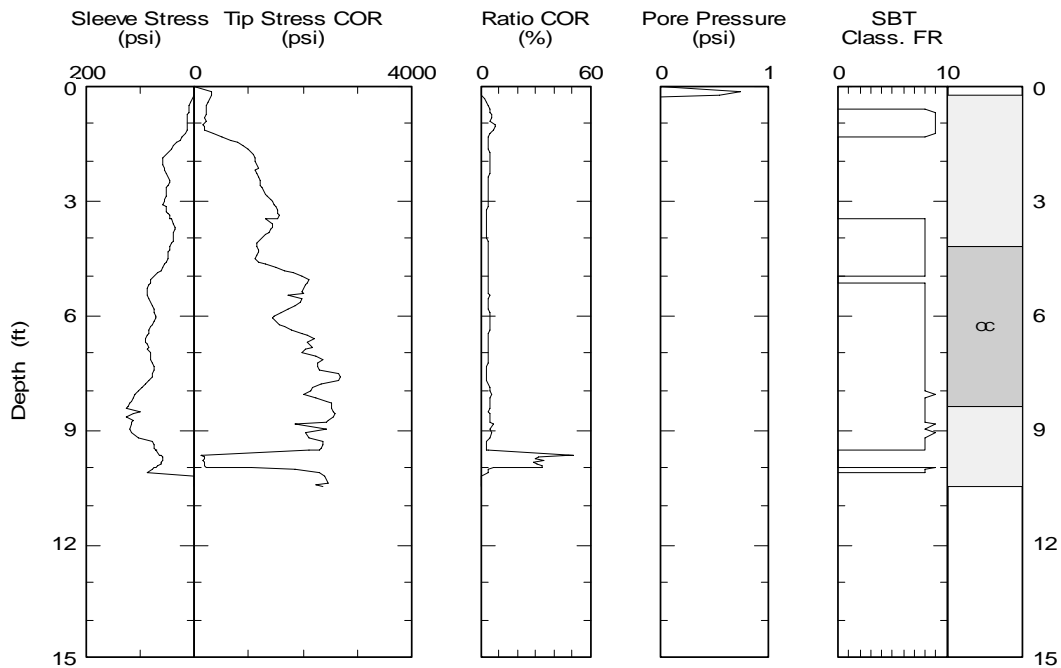
- [Notes]
- Hit a large boulder at 9.7' (3.0 m).
 - Managed to reach a depth of 11.5' or 3.5 m (end of penetration).
 - Soil overall dry in this hole.

Figure 3.4: Standard CPT Log for CPT Hole #2 @ Sta. 812+60

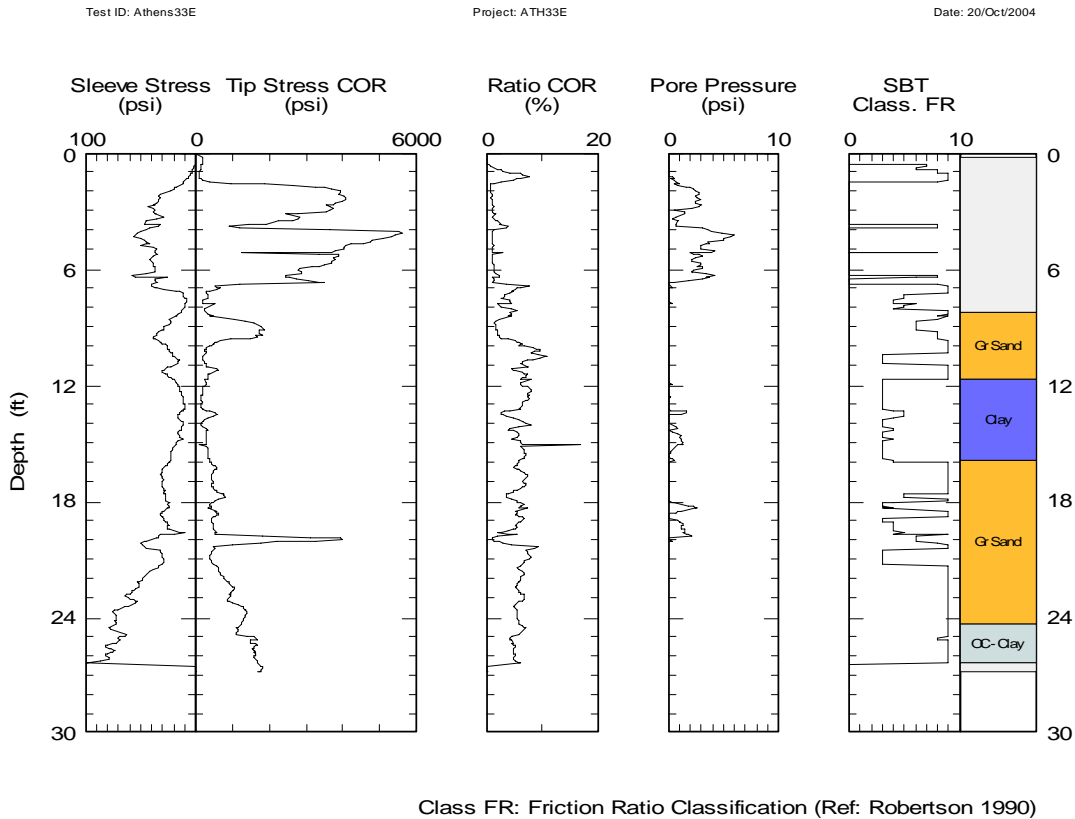
- [Notes]
- Soil soft and wet from 8.0' to 20.0' (2.4 to 6.1 m).
 - Encountered a very stiff layer at 27.0' (8.2 m); started lifting the truck (end of penetration).

Figure 3.5: Standard CPT Log for CPT Hole #3 @ Sta. 816+60

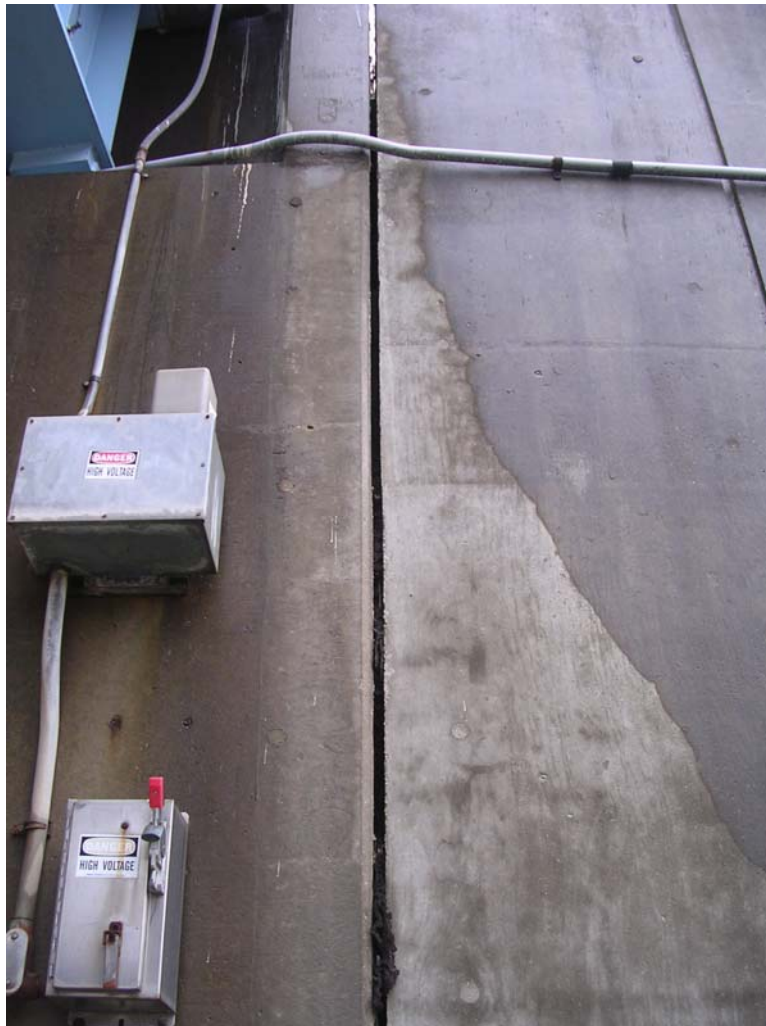
Figure 3.6: General View of Panel S-1 and SW Wingwall

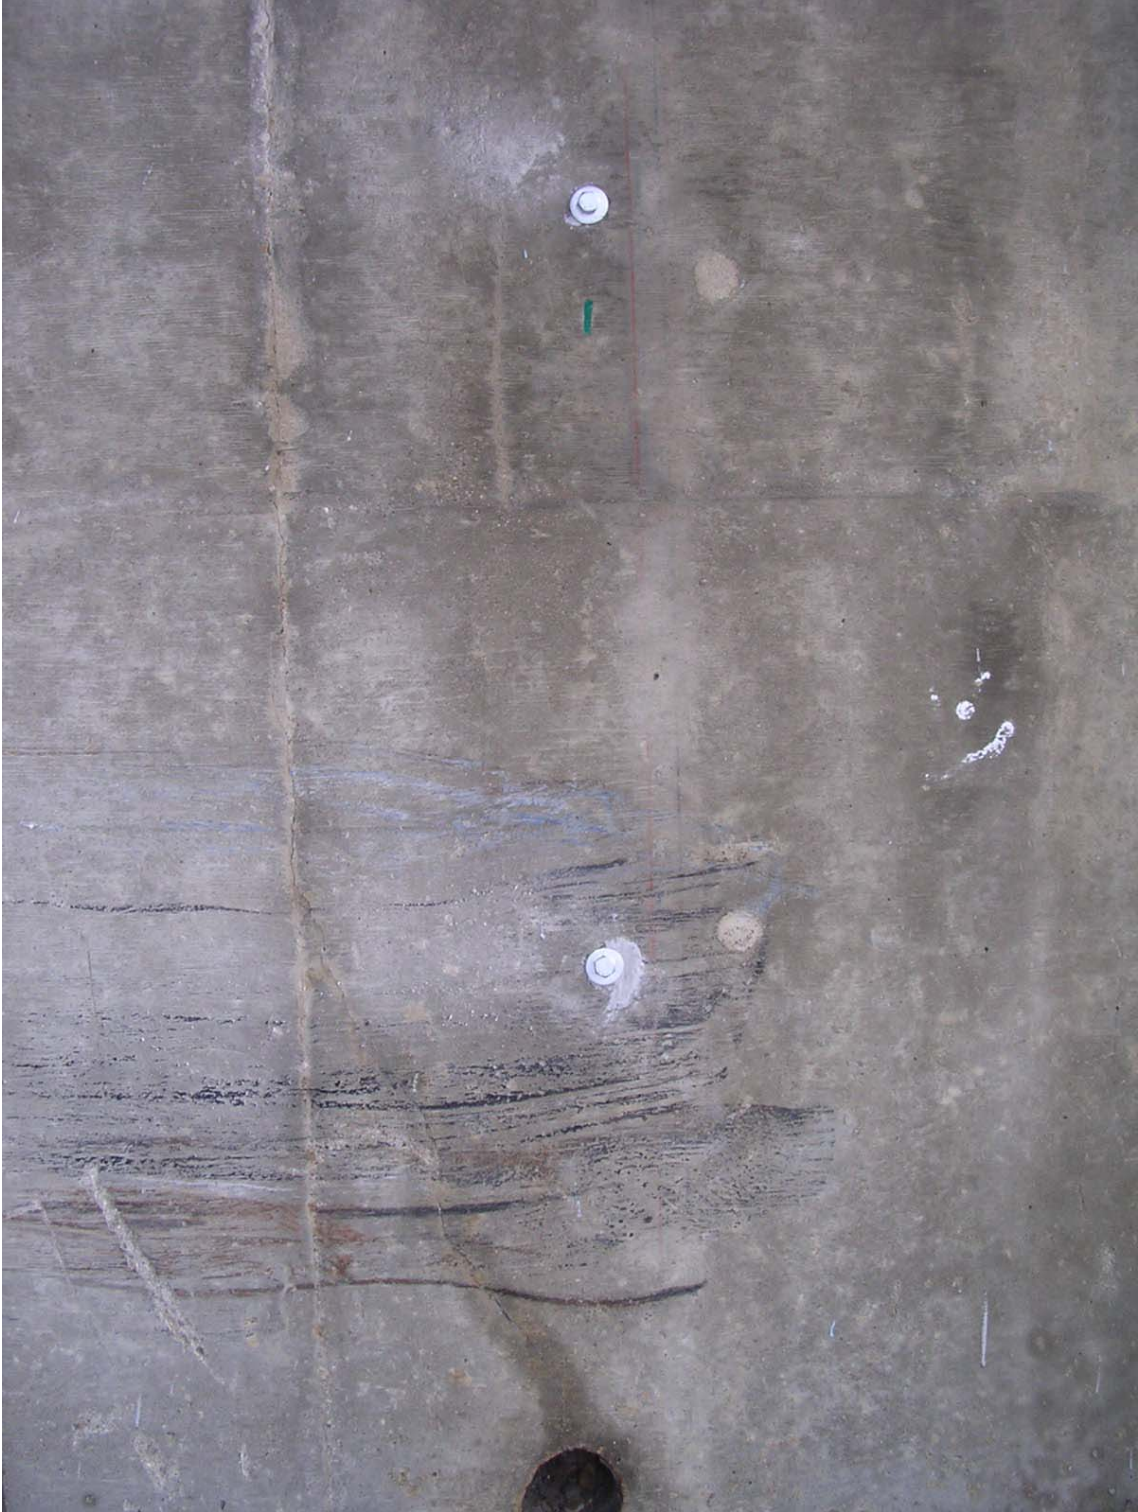
Figure 3.7: General View of Panel S-1

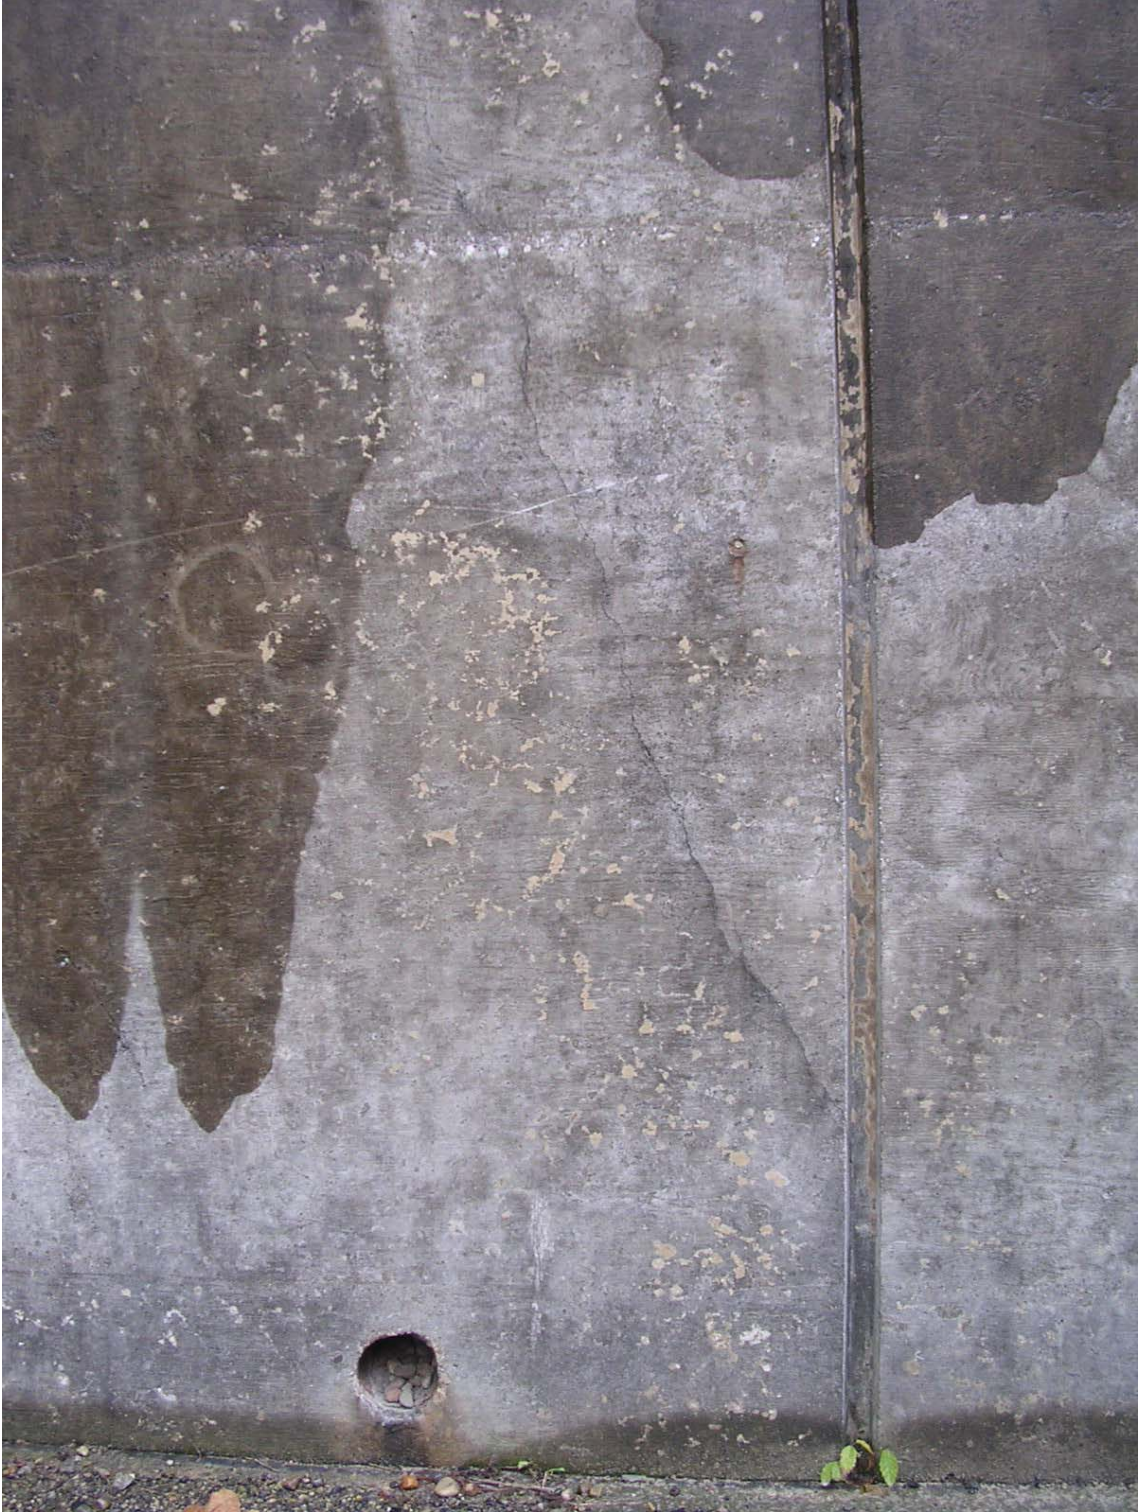
Figure 3.8: General View of Panel S-3

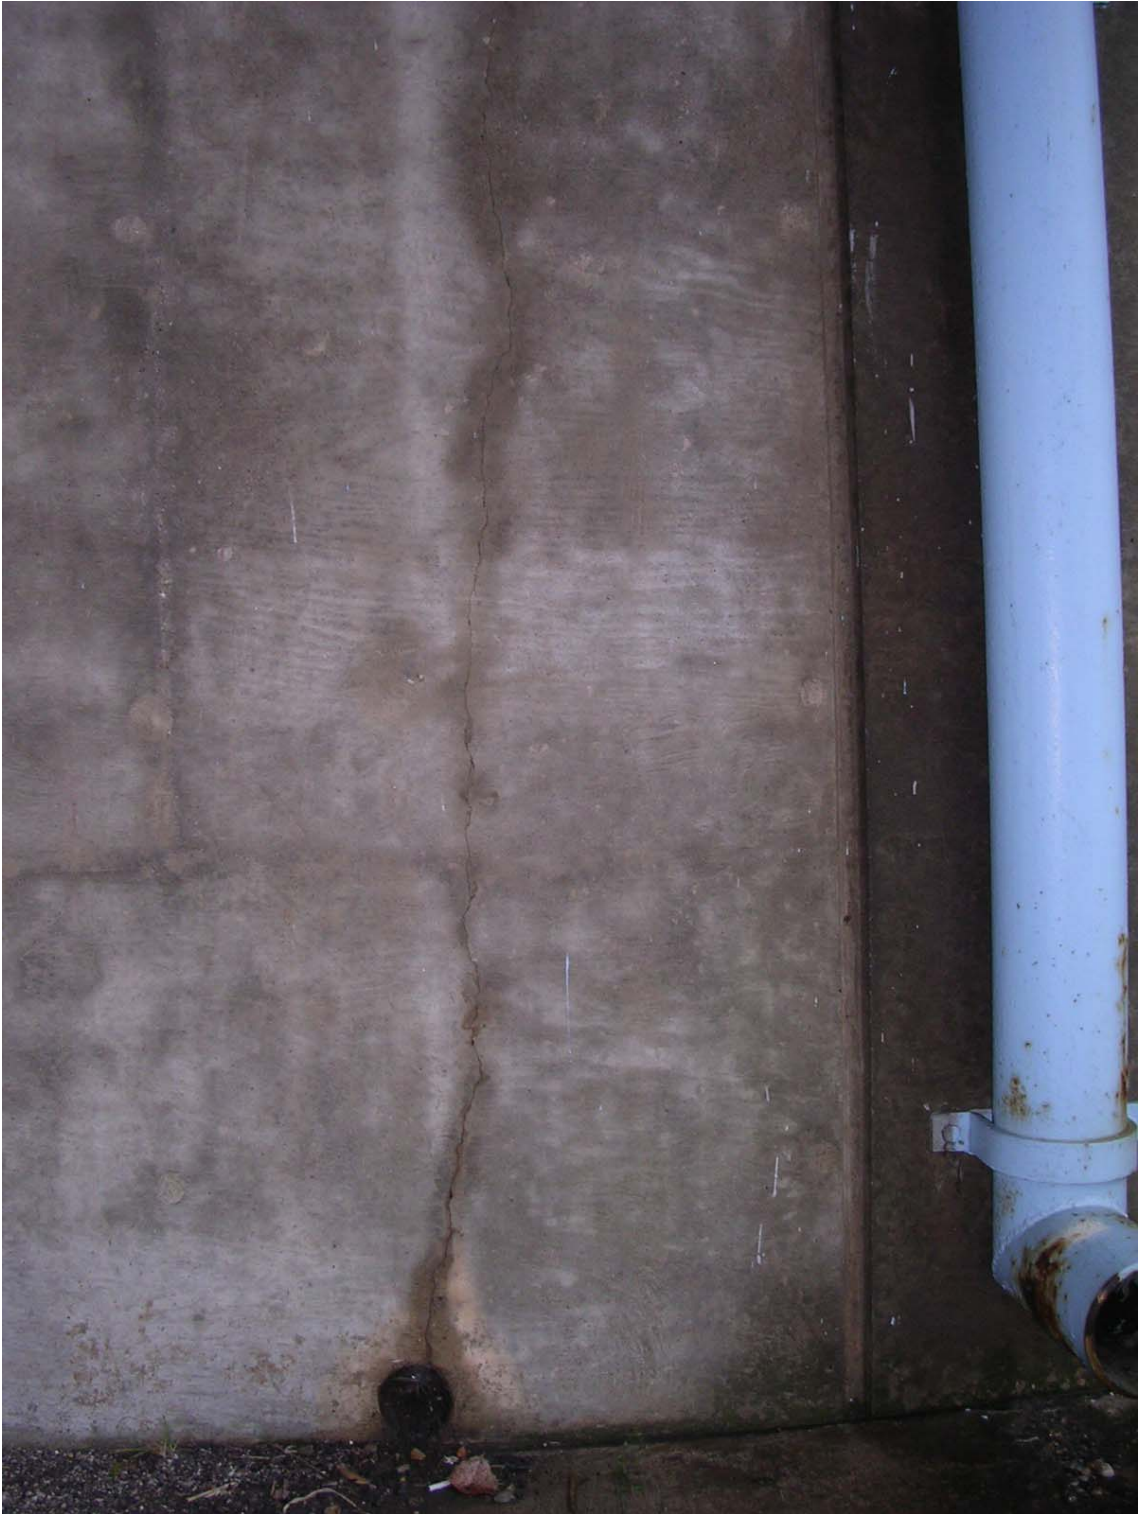
Figure 3.9: General View of Panel S-4

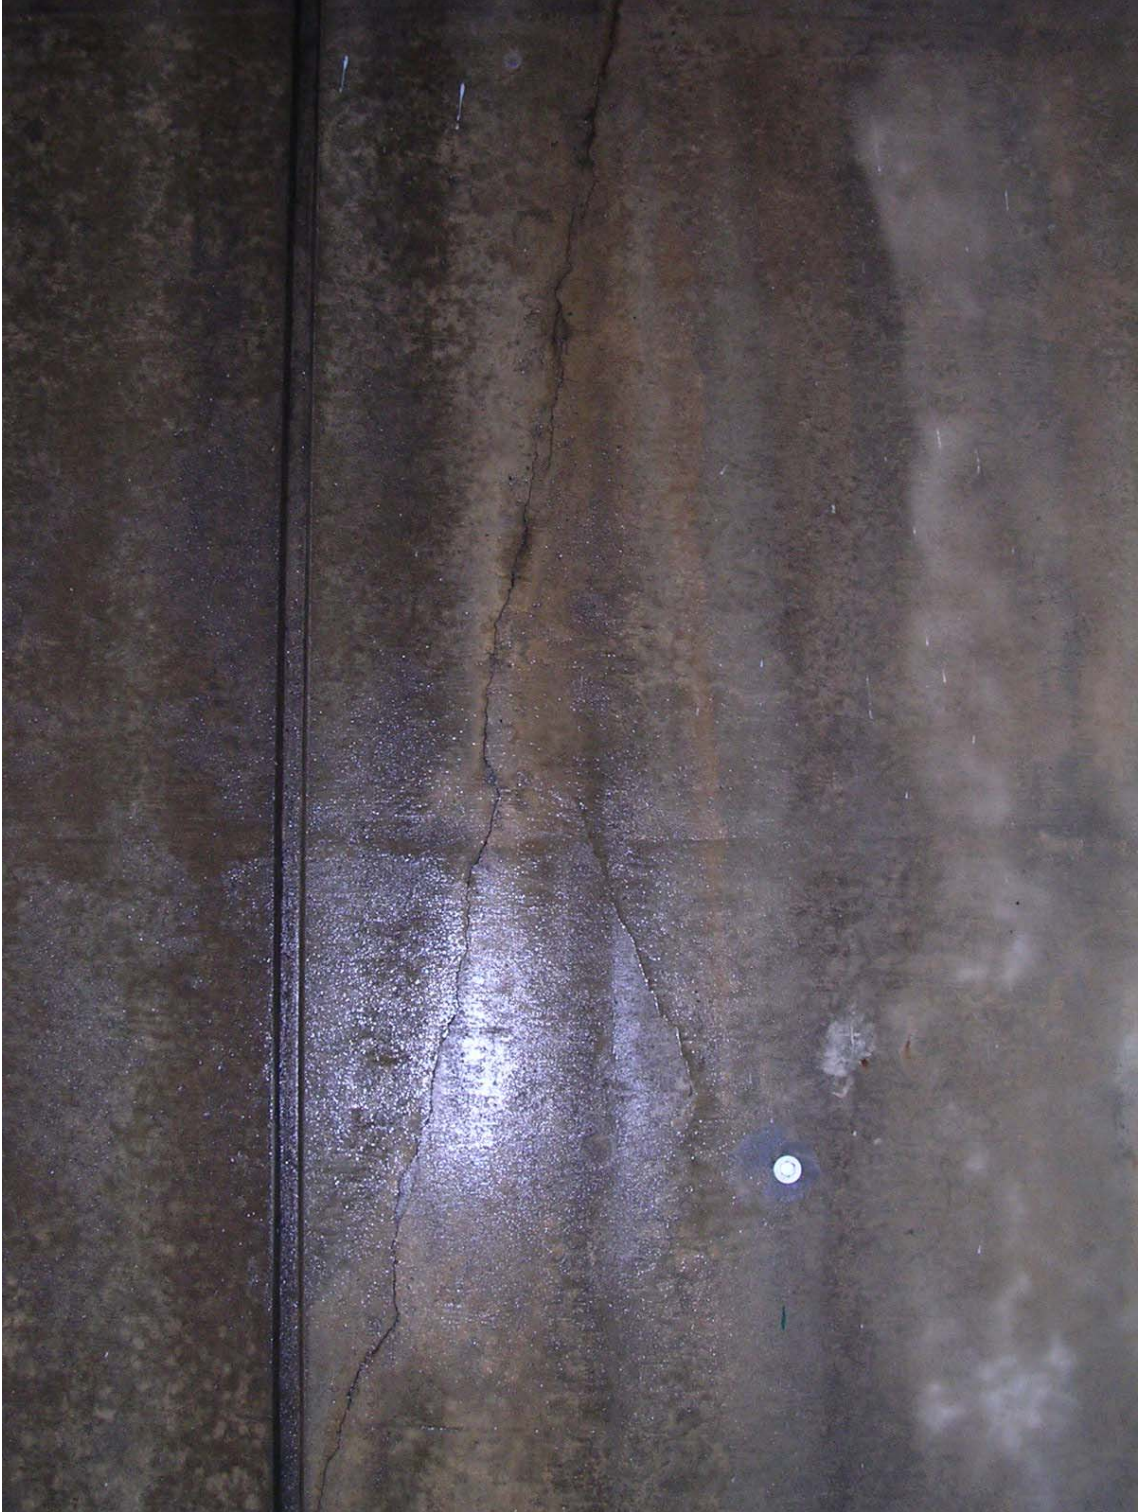
Figure 3.10: General View of Panel S-5

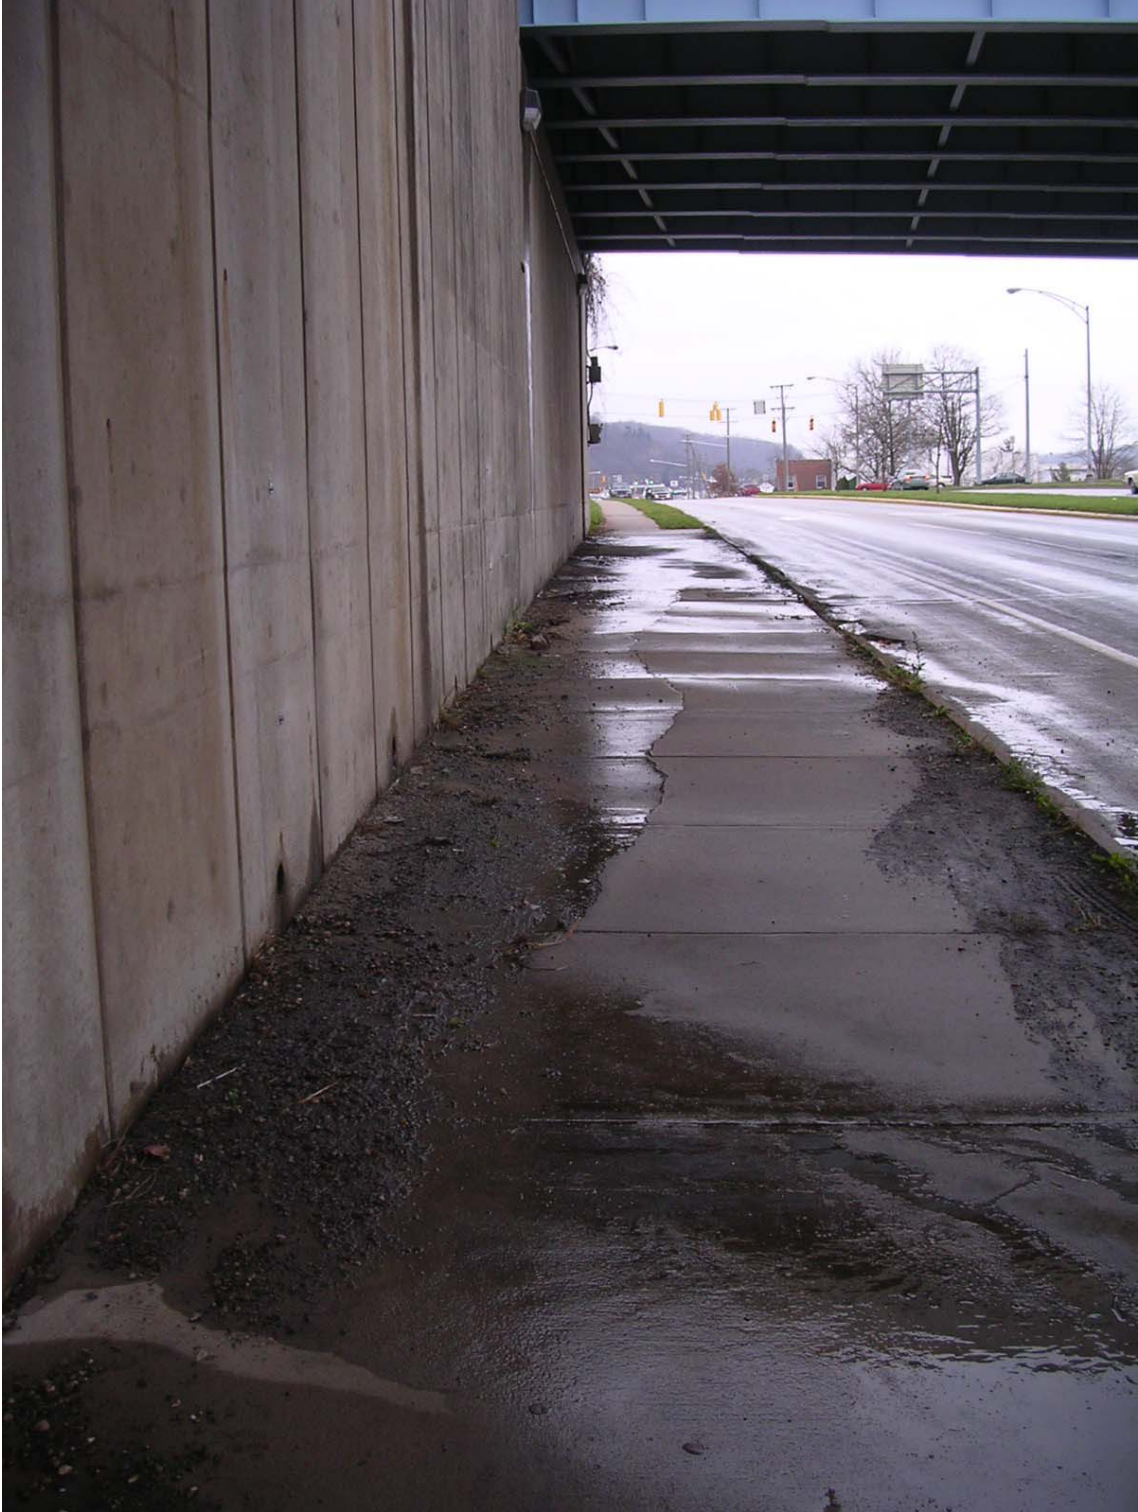
Figure 3.11: Cracked Sidewalk on North Side of E. State St.

The rehabilitation project was completed during the first week of September 2006. The last action taken by the Contractor was the reconstruction of the sidewalk on the north side of East State Street and installation of drainage channel along the edge where the abutment wall and the new sidewalk meet.

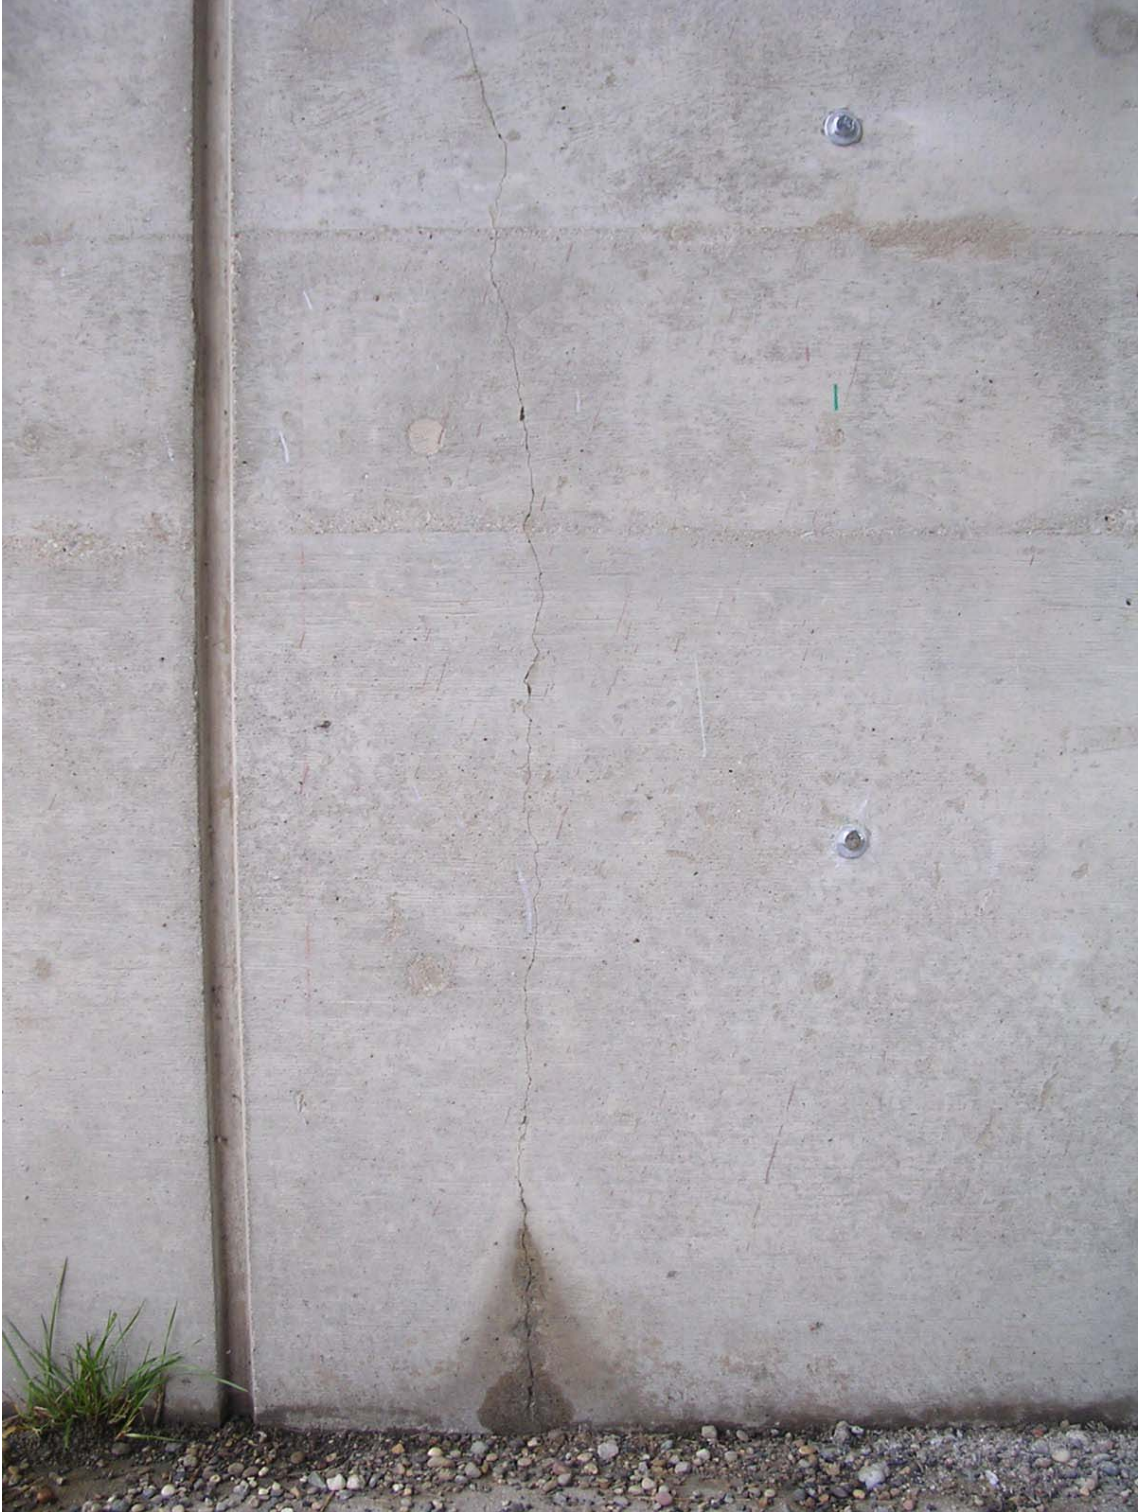
Figure 3.12: General View of Panel N-1

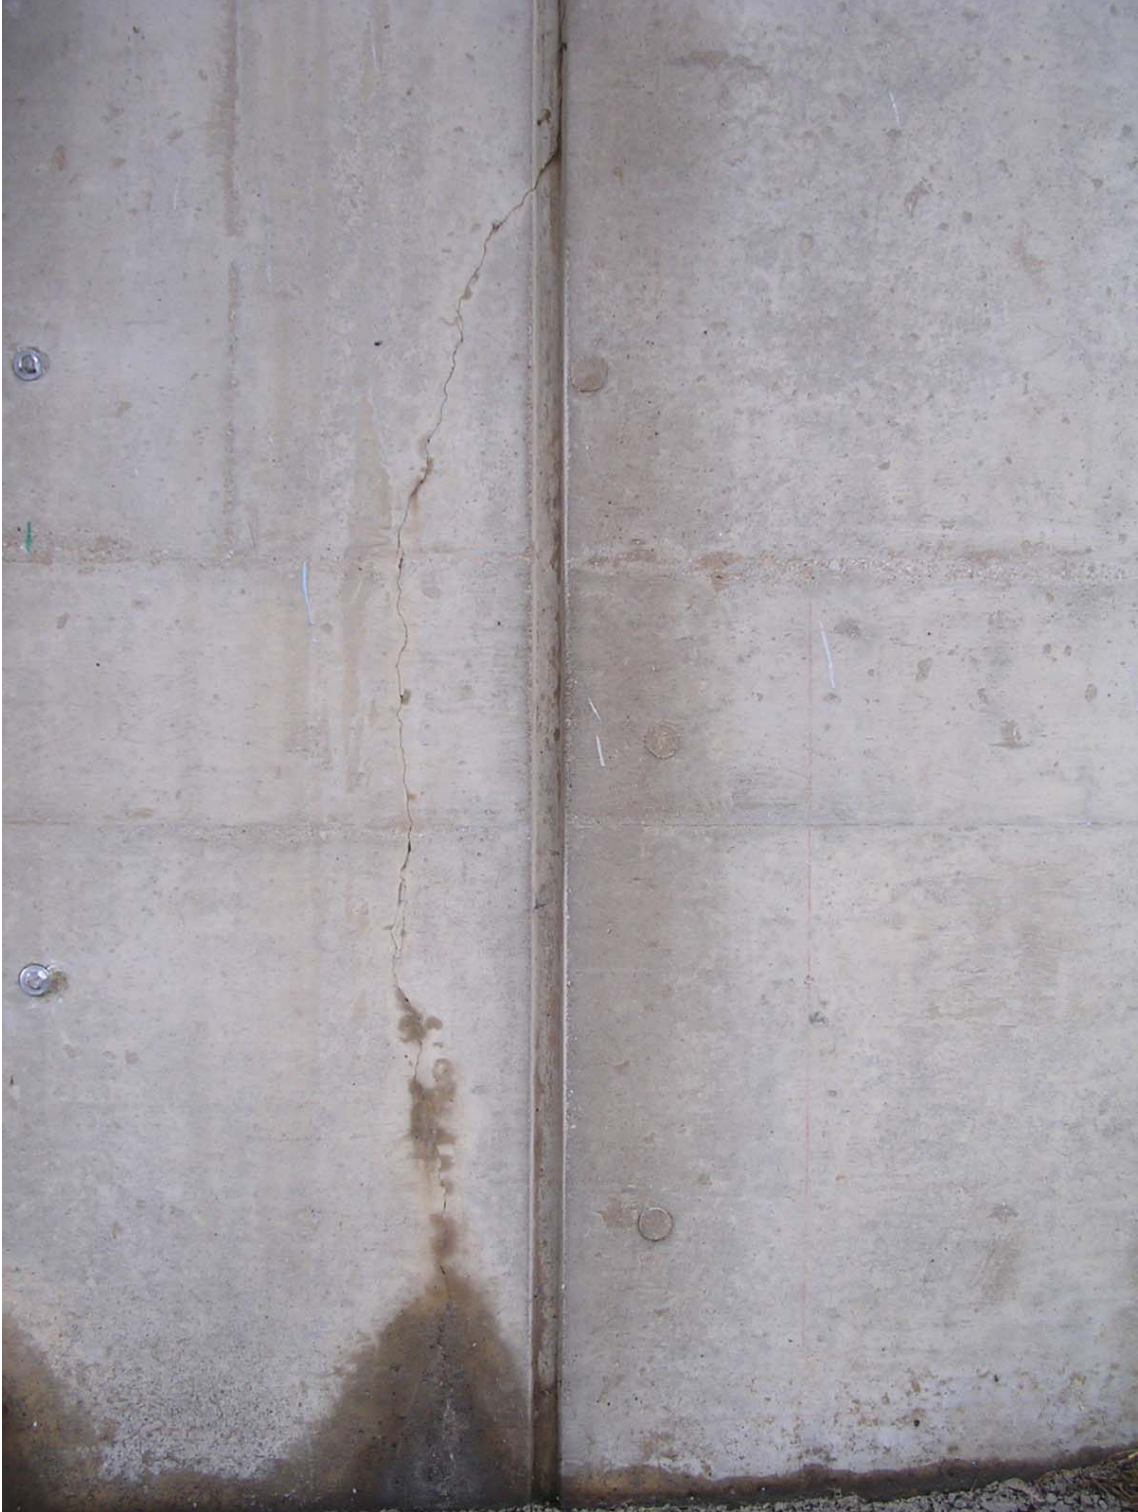
Figure 3.13: General View of Panel N-2

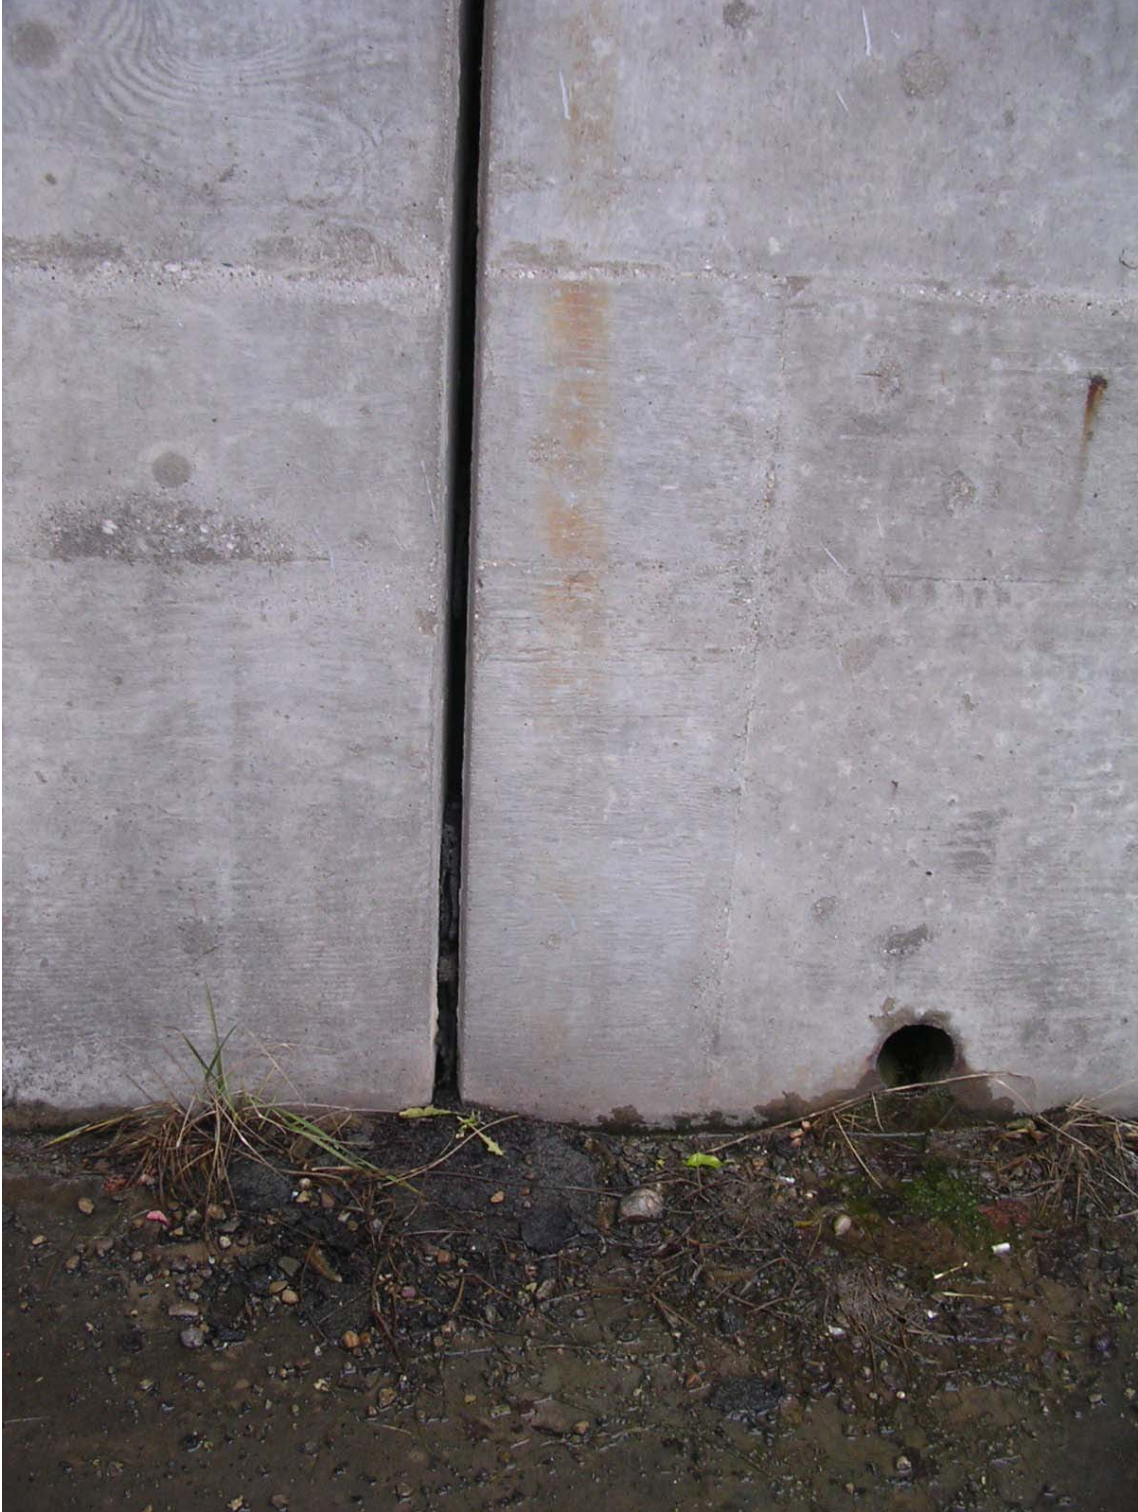
According to the initial site visit, some of the panels had cracks that were slightly wider than hairline cracks. Also, a sign of backfill infiltration existed at some of the panel joints that had opened up slightly. Contrary to the initial speculation, no major horizontal cracks were detected anywhere in the lower half of the walls. Figures 3.6 through 3.22 present digital pictures taken at the project site on Dec. 6, 2004. Most of the panel facing had at least one crack running almost vertically. Signs of soil infiltration were visible at the construction joints between Panels N-2 and N-3, Panels N-3 and N-4, and Panel N-5 and NE Wingwall.

Figure 3.14: Signs of Soil Infiltration Between Panels N-2 and N-3

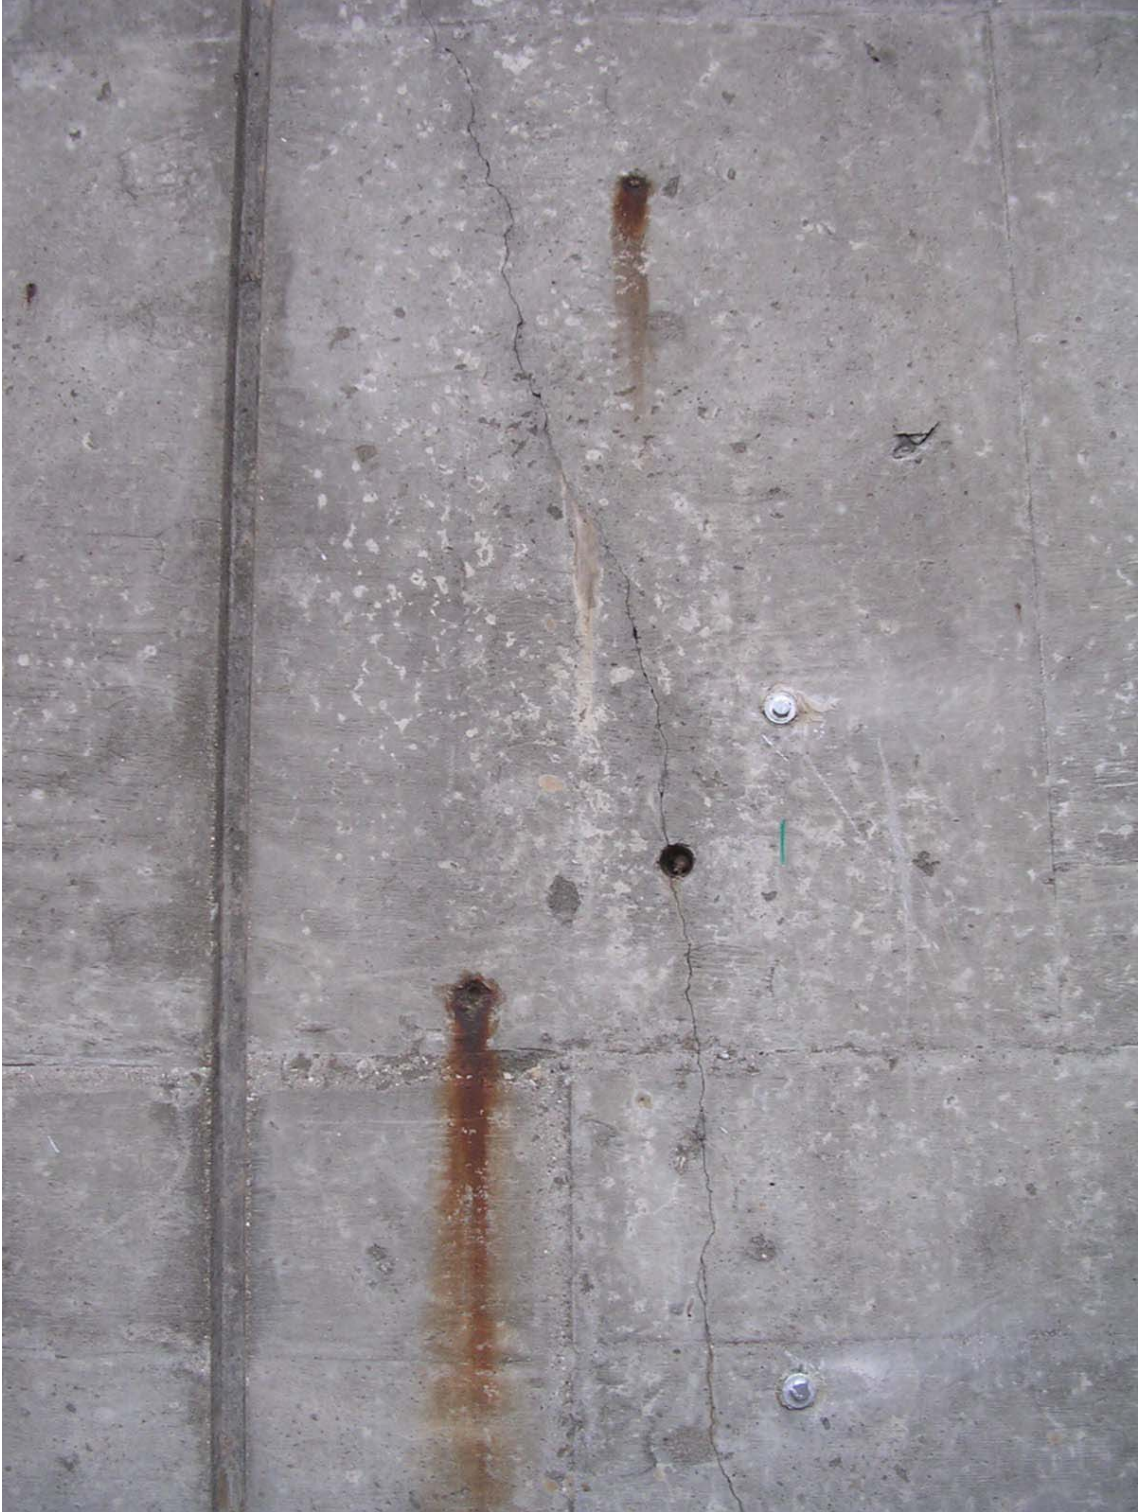
Figure 3.15: General View of Panel N-3

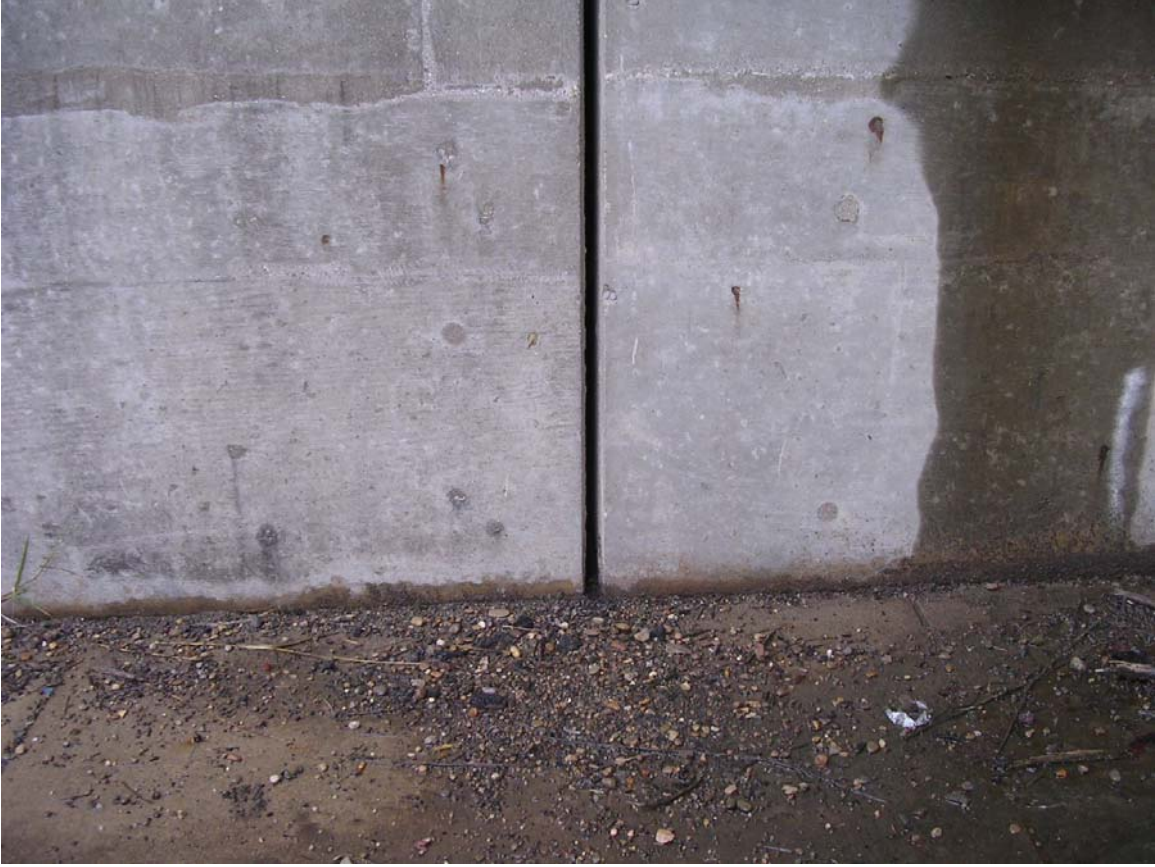
Figure 3.16: Signs of Soil Infiltration Between Panels N-3 and N-4

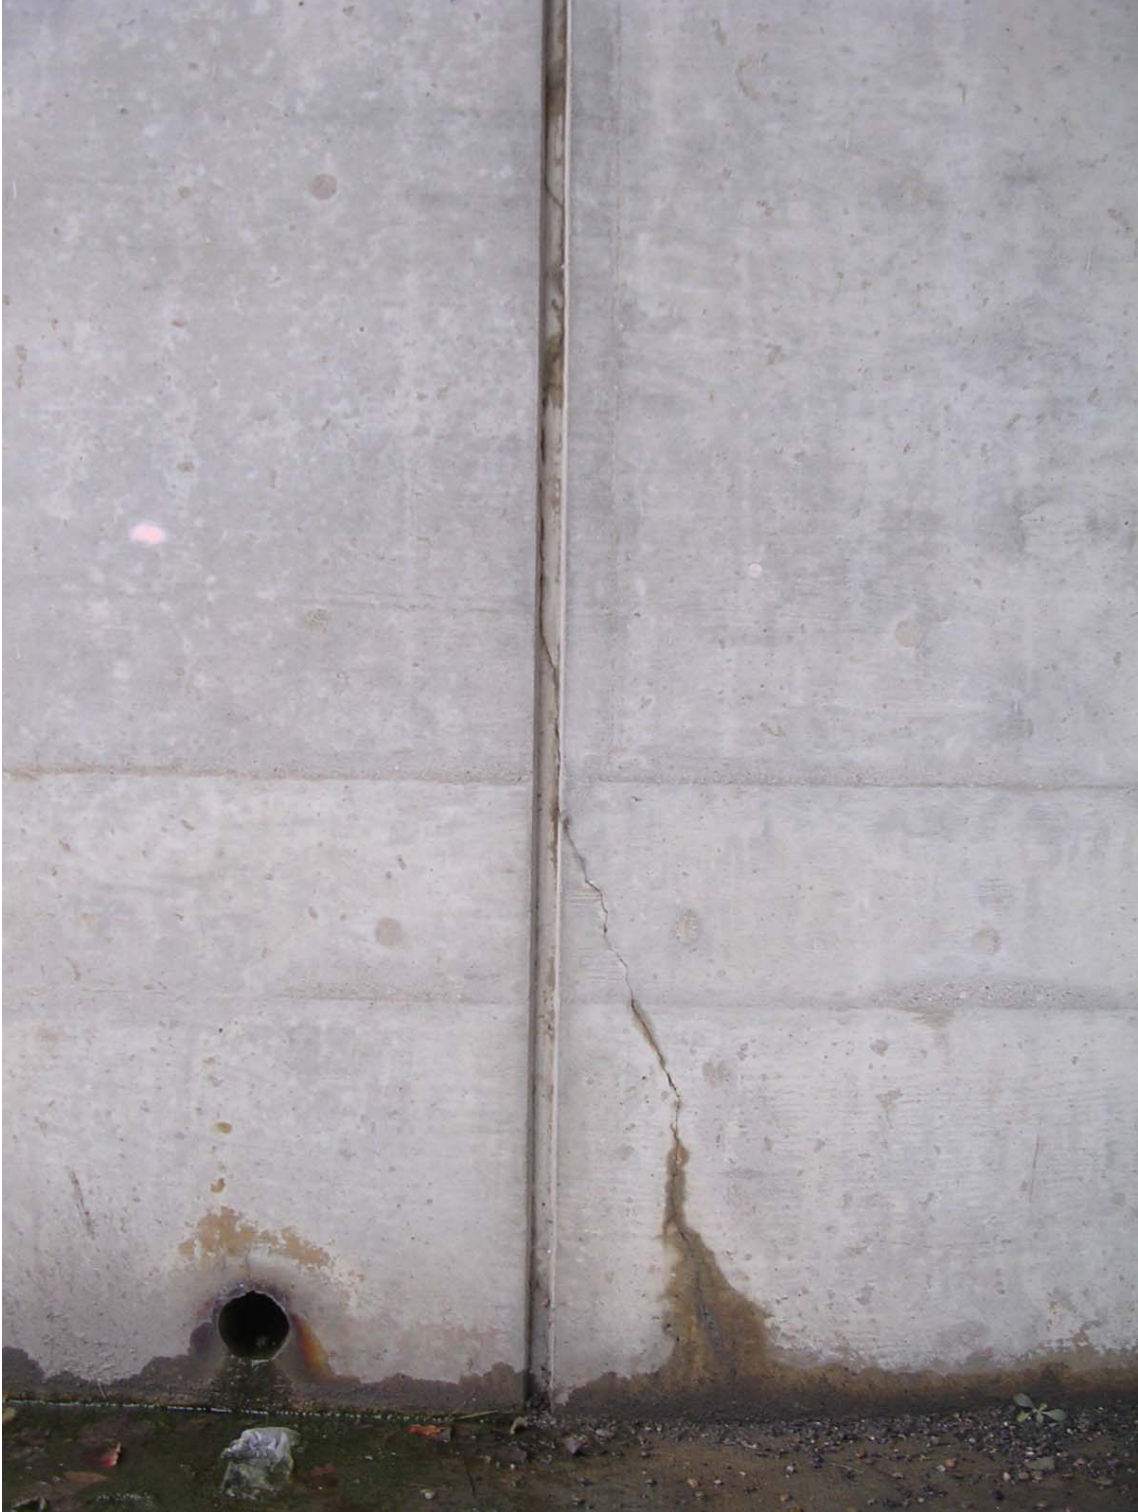
Figure 3.17: General View of Panel N-4 (Photo A)
