Monitoring of Bridge Abutment Walls at SR 33 Over East State St. (Athens, OH)

Teruhisa Masada
ORITE, Ohio University

Final Report
FHWA/OH-2007/02
March 2007

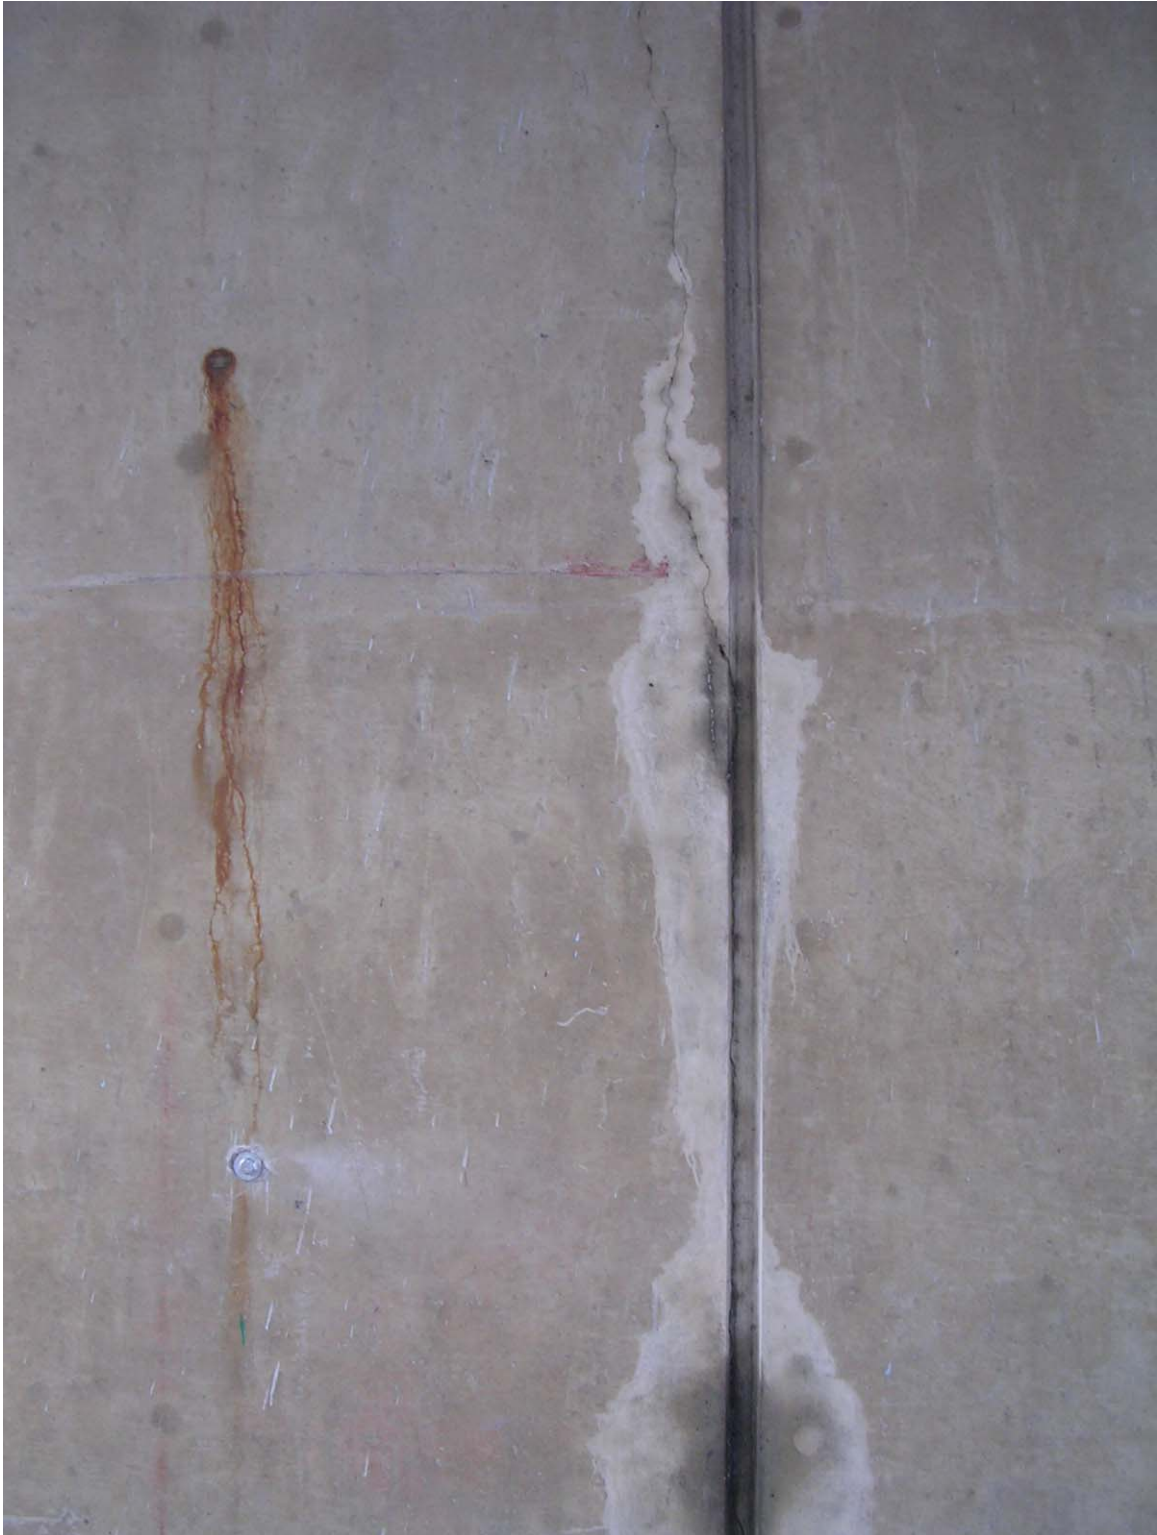
Figure 3.18: General View of Panel N-4 (Photo B)

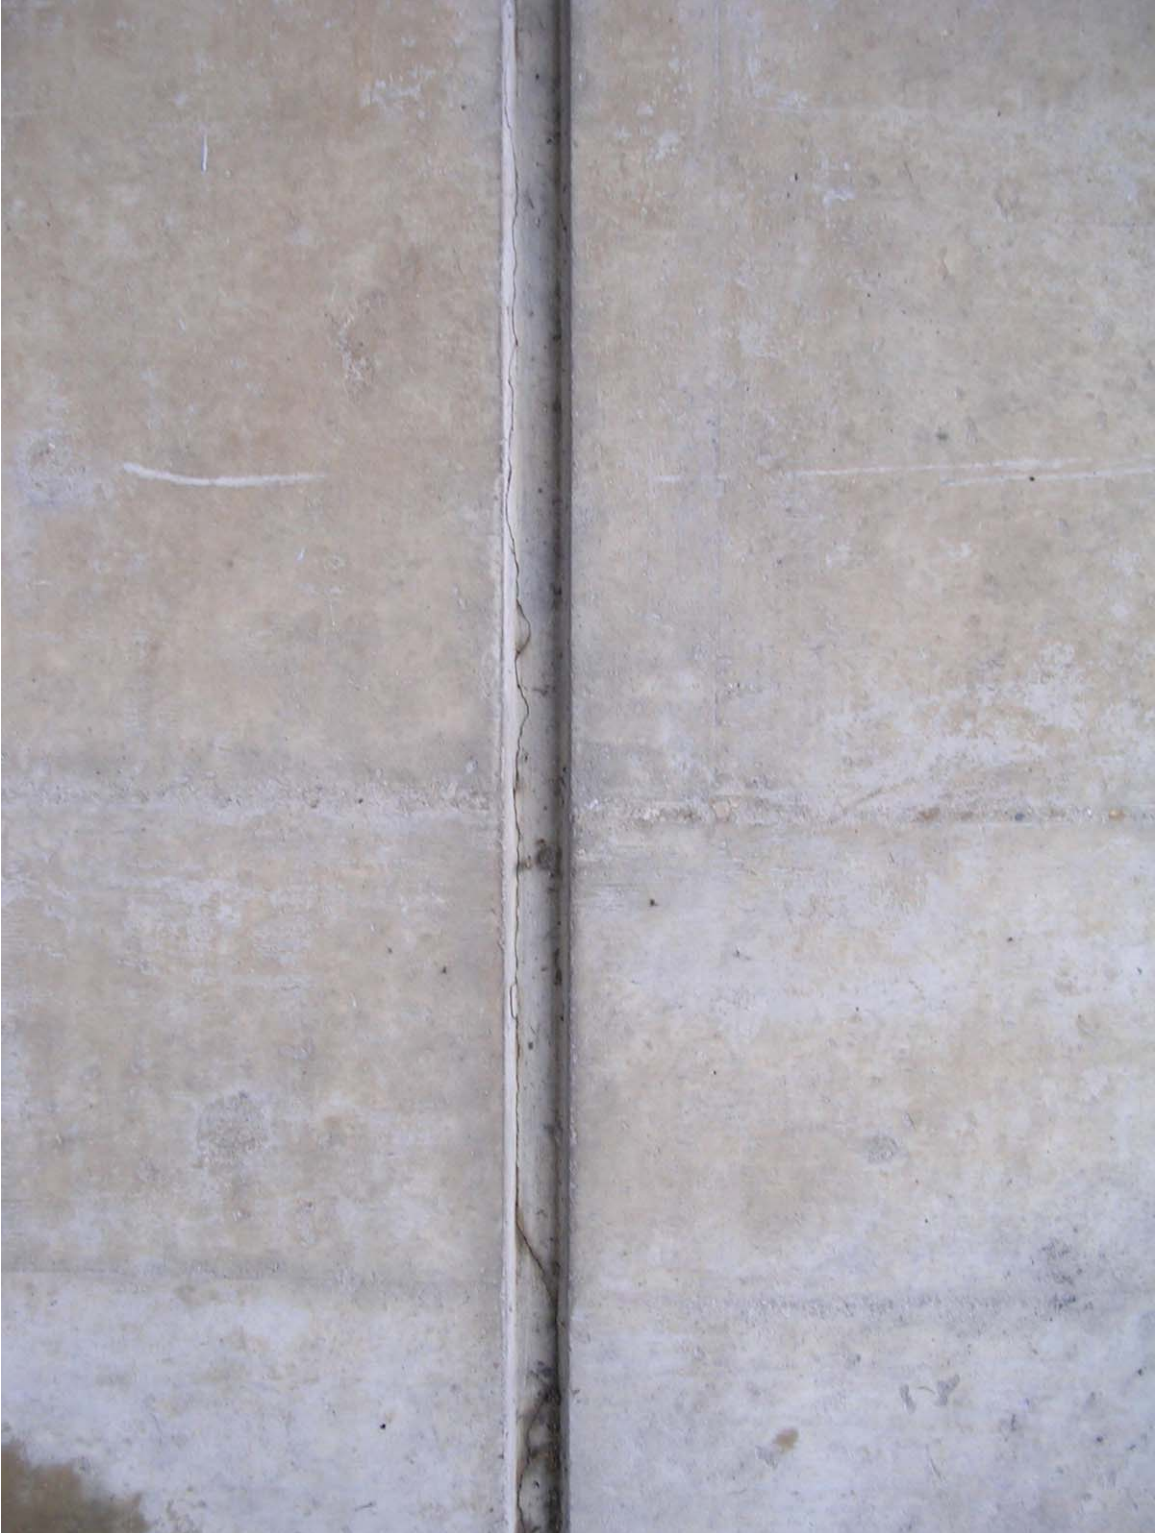
Figure 3.19: General View of Panel N-5 (Photo A)

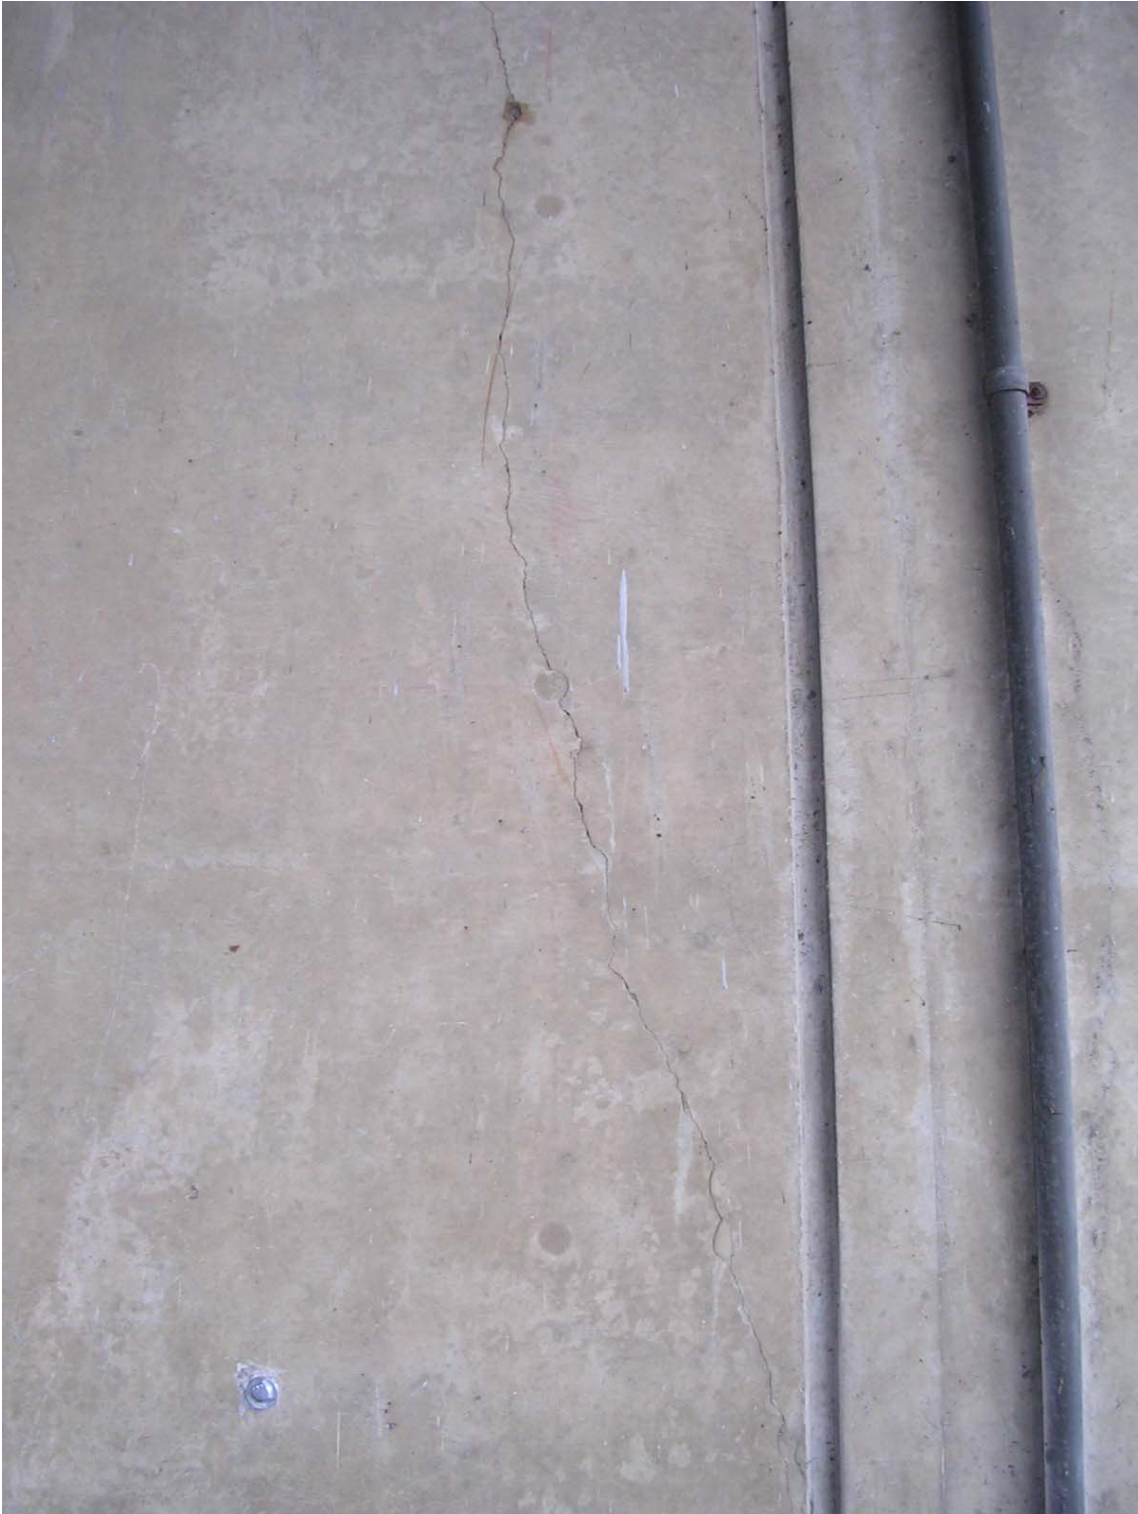
Figure 3.20: General View of Panel N-5 (Photo B)

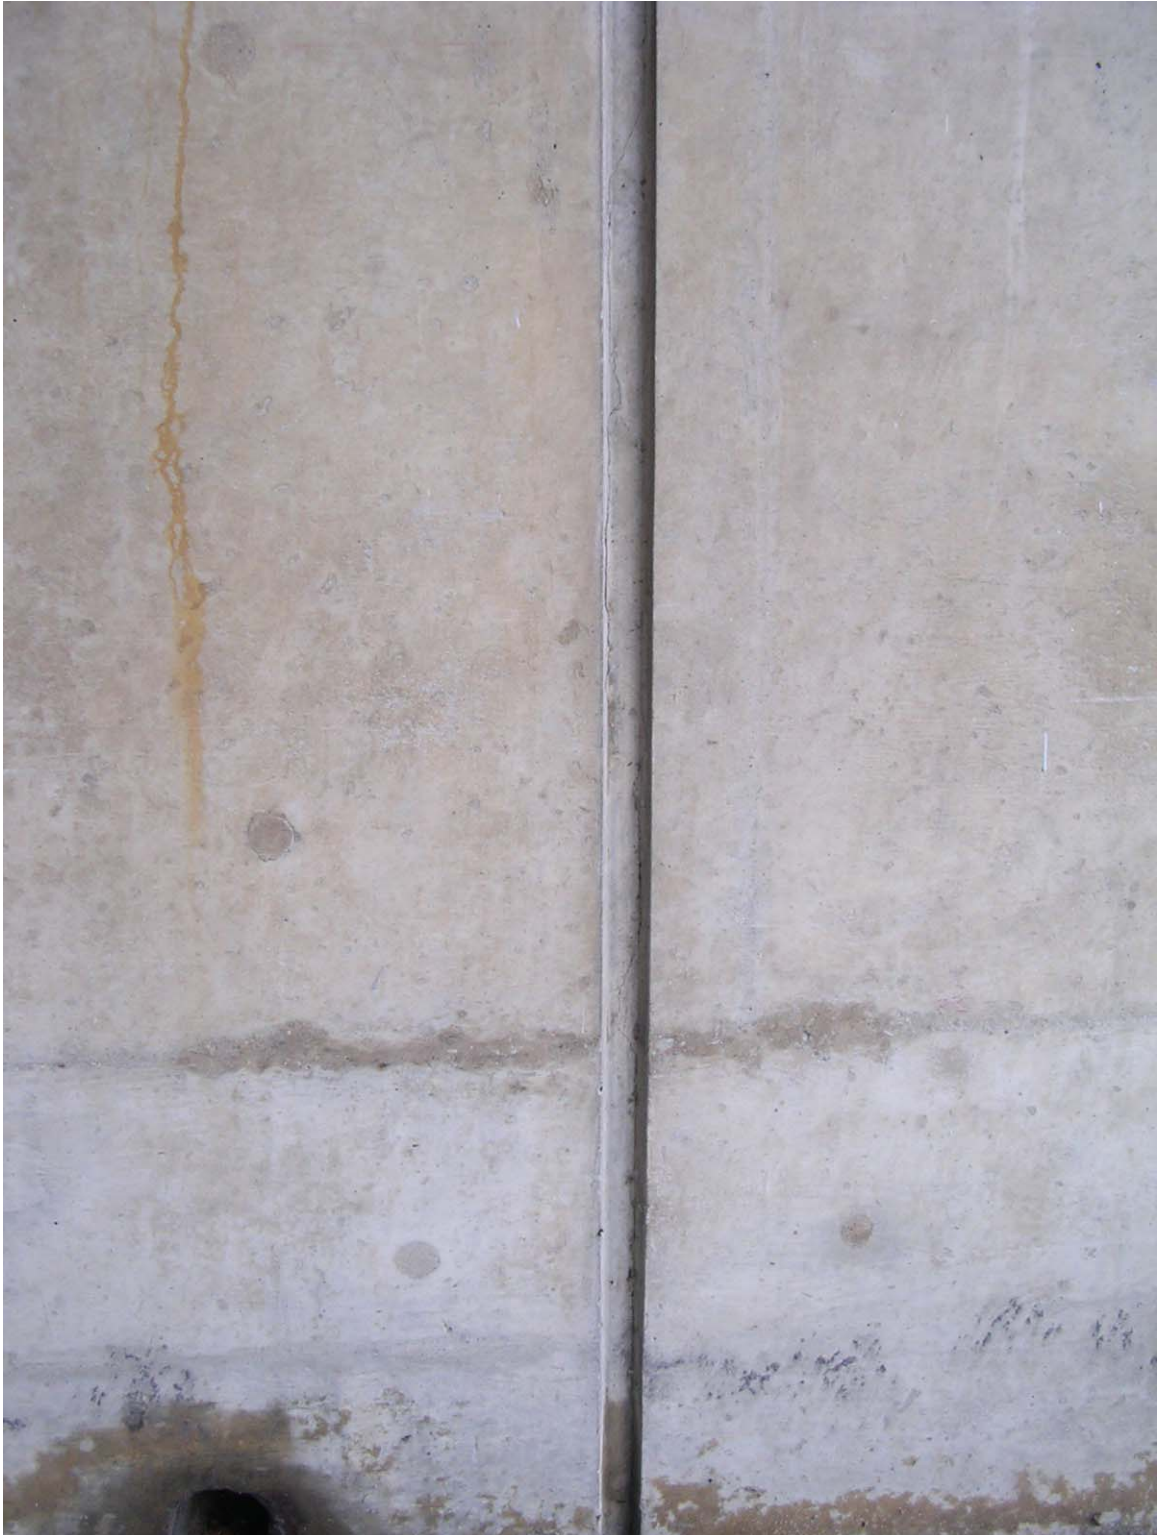
Figure 3.21: General View of Panel N-5 (Photo C)

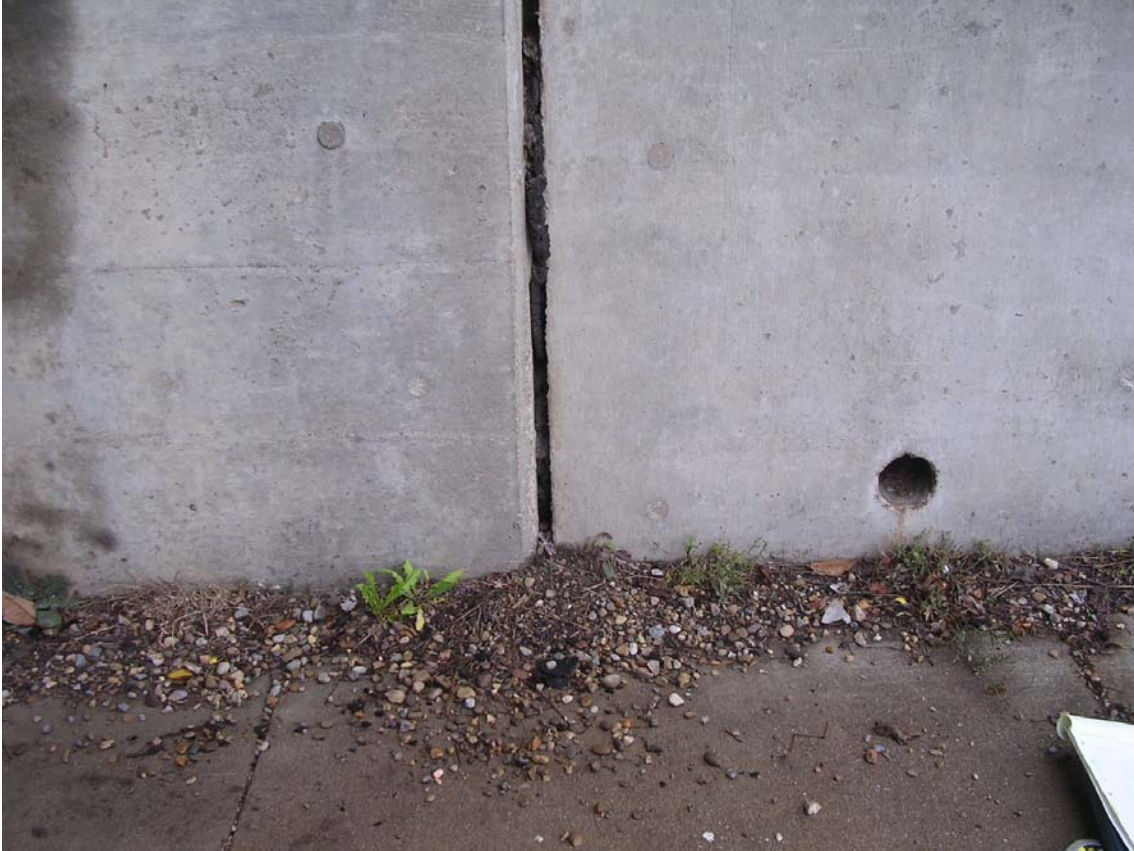
According to the initial site visit, some of the panels had cracks that were slightly wider than hairline cracks. Also, a sign of backfill infiltration existed at some of the panel joints that had opened up slightly. Contrary to the initial speculation, no major horizontal cracks were detected anywhere in the lower half of the walls. Figures 3.6 through 3.22 present digital pictures taken at the project site on Dec. 6, 2004. Most of the panel facing had at least one crack running almost vertically. Signs of soil infiltration were visible at the construction joints between Panels N-2 and N-3, Panels N-3 and N-4, and Panel N-5 and NE Wingwall.

Figure 3.22: Signs of Soil Infiltration Between Panel N-5 and NE Wingwall

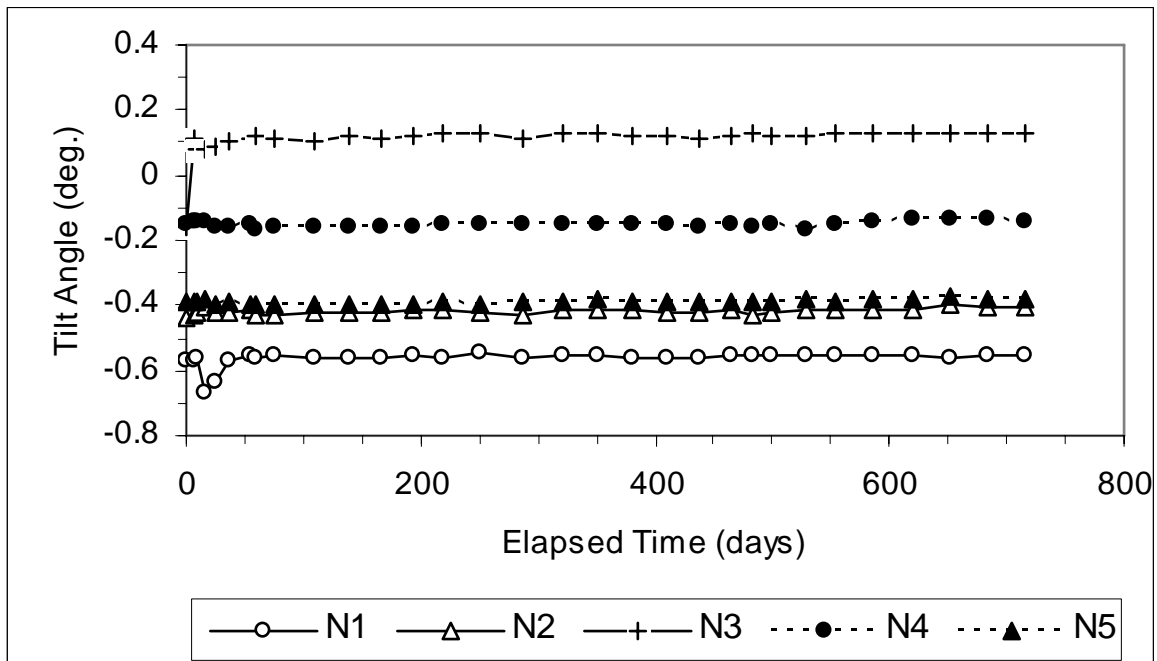
Figure 3.23: Changes in Tilt Angles vs. Time (North Side)

According to these tables and plots, the vertical positions of wall panels N-2, N-4, N-5, S-2, S-3, S-4, and S-5 changed little during the monitoring period (Dec. 2004 to April 2006). Wall Panel N-1 experienced about 0.1° rotation toward the backfill in the second half of December 2004. Since then, it has rotated back close to the original position and remained stable for more than 15 months. Wall Panel N-3 has been stationary, except during December 2004 in which it experienced about 0.2° rotation away from the backfill. Wall Panel S-1 rotated about 0.25° away from the backfill in December 2004. It experienced some movements again in July 2005. Since then, it has changed its position very little.

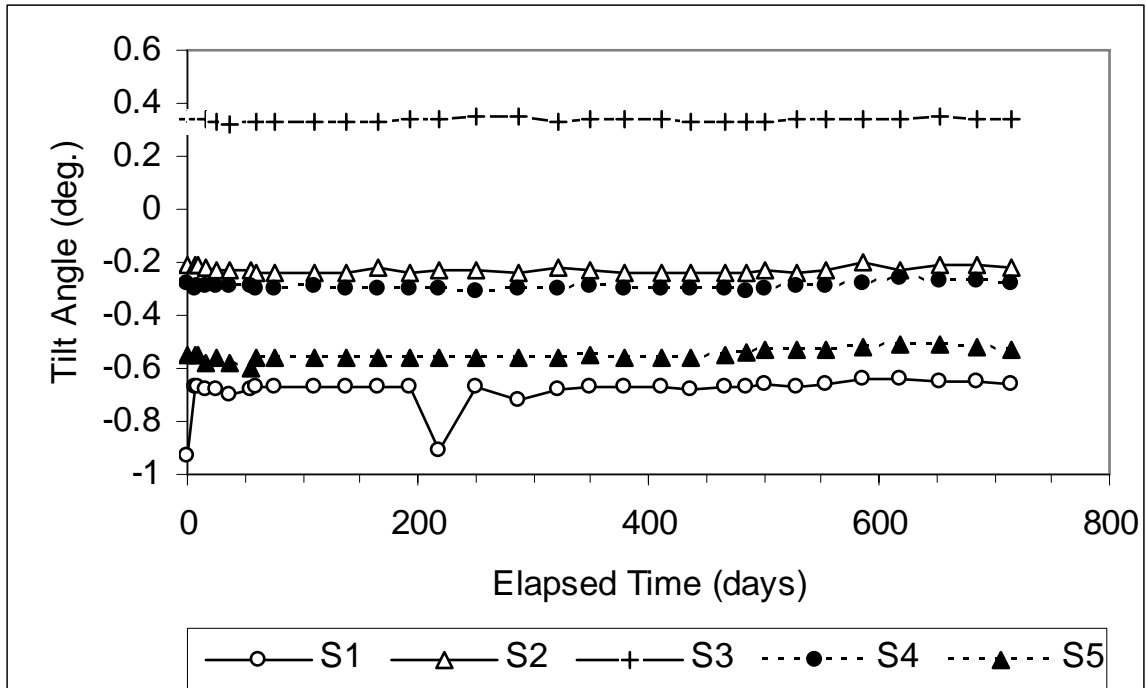
Figure 3.24: Changes in Tilt Angles vs. Time (South Side)
