## AIRCRAFT ACCIDENT REPORT

UNCONTROLLED COLLISION WITH TERRAIN  
AMERICAN INTERNATIONAL AIRWAYS FLIGHT 808  
DOUGLAS DC-8-61, N814CK  
U.S. NAVAL AIR STATION  
GUANTANAMO BAY, CUBA  
AUGUST 18, 1993

Adopted: May 10, 1994  
Notation 6182A

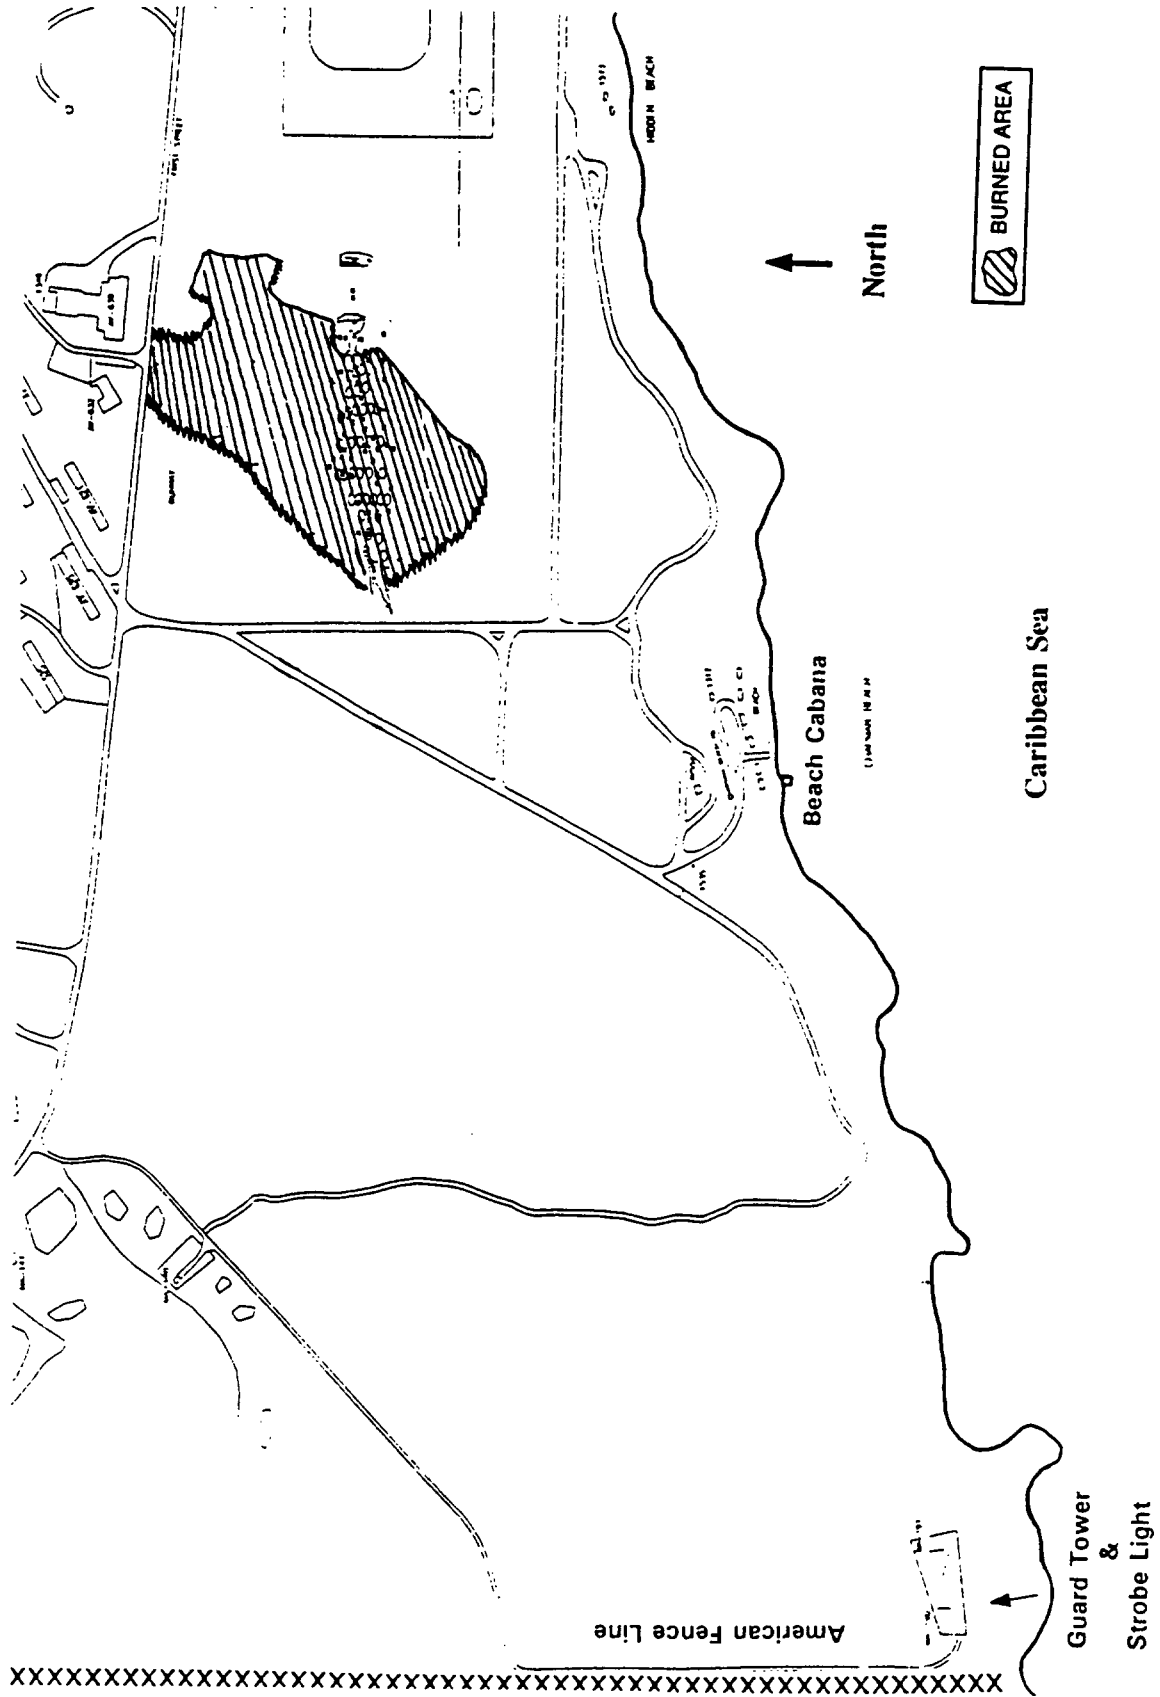
Figure 2.--Location of airplane wreckage.

The airplane initially struck the ground 200 feet north of the extended runway centerline and 1,400 feet west of the runway 10 threshold (see figure 2). The wreckage debris was oriented on a magnetic heading of approximately 100 degrees and extended for a distance of about 1,000 feet from the initial impact point. The debris found at the farthest point from the runway consisted primarily of right wing structure and skin, as well as parts from the Nos. 3 and 4 engines.

The initial impact mark was a thin, shallow trough that fanned outward to about 25 feet wide and extended 150 feet in the direction of flight. The right wing tip, found 200 feet north of the first impact point, exhibited compression damage and scratch marks that were consistent with the airplane in a roll attitude of 51 degrees at the point of initial ground impact.

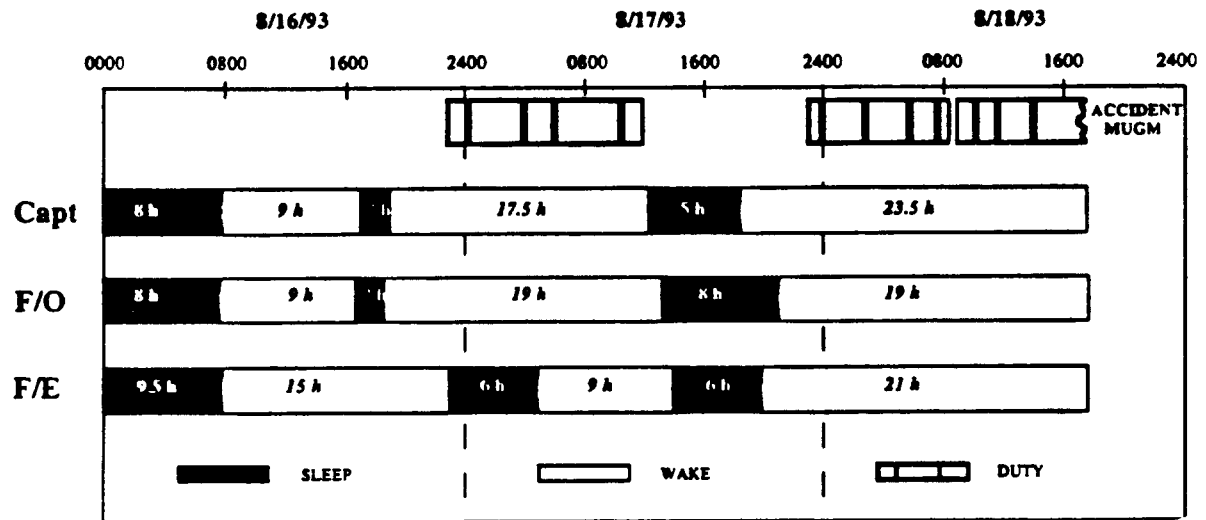
Figure 3.--Flightcrew sleep/wake histories.

The researchers found in their study of the crewmembers' sleep/wake periods that in the 28.5 hour period prior to the accident, the cumulative totals for sleep and wakefulness for the captain, first officer, and flight engineer were: 23.5 hours awake with 5 hours of sleep, 19 hours awake with 8 hours of sleep, and 21 hours awake with 6 hours of sleep, respectively. (See figures 3 and 4).

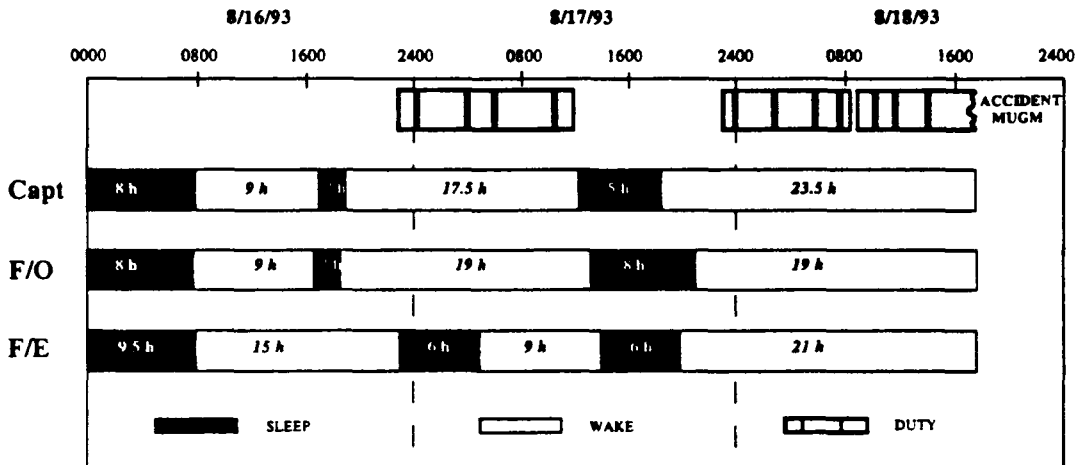
Figure 1. AIA Flight 808 Crew Sleep/Wake Histories

The first horizontal bar in Figure 1 displays the sleep/wake history of the Captain. He reported a typical sleep requirement of 8 hours. The Captain awakened on 8/16/93 after 8 hours of sleep and was awake for 9 hours before taking a 2-hour nap prior to his all-night duty period. Following his nap, the Captain was awake for 17.5 hours. He reported a 5-hour sleep period during a daytime sleep opportunity in a Dallas-Ft. Worth Airport hotel during layover. The Captain was then awake for 23.5 hours until the accident occurred at Guantanamo Bay. This 23.5 hour period included an all-night duty period after which the Captain was released from duty. However, he was called back to operate Flight 808 prior to his return home, and therefore was continuously awake until the accident.

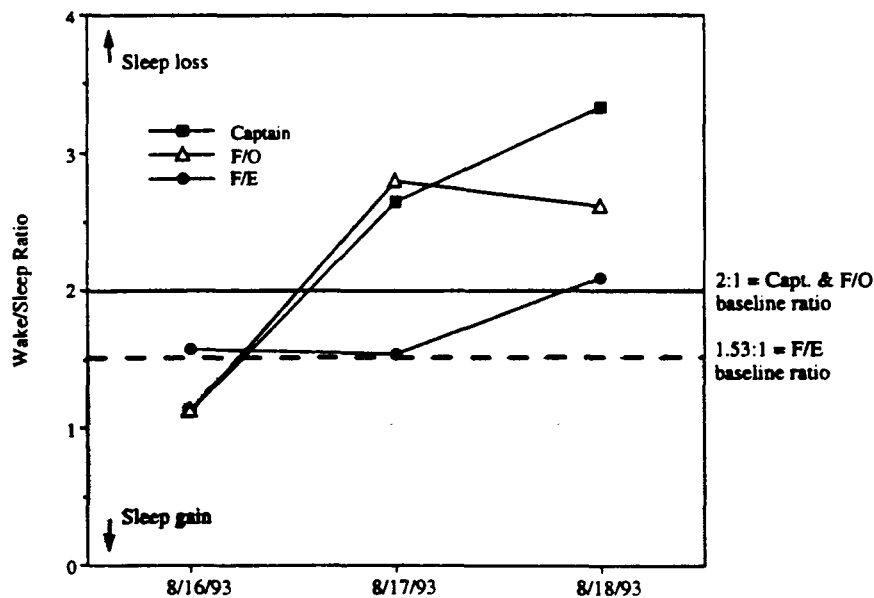
Figure 2. Cumulative Sleep/Wake Debt

The Captain and First Officer reported a usual sleep requirement of 8 hours and therefore, a wake/sleep ratio of 2 would be their appropriate self-defined norm. As evidenced in Figure 2, the wake/sleep ratio for both the Captain and First Officer is greater than 2 (indicated by the solid line) over the two days prior to the accident, reaching greater than 3 for the Captain. The Second Officer reported a usual sleep requirement of 9.5 hours. This represents a wake/sleep ratio of 1.53 as his self-defined norm (indicated by the dashed line). He approximates this on 8/16 and 8/17 and exceeds a ratio of 2 prior to the accident.
