REPORT NOS. DOT-TSC-NHTSA-79-47

ULTRASONIC INSPECTION OF TEN RETREADED TIRES  
AND THIRTY-TWO CASINGS

Stephen Bobo

FINAL REPORT

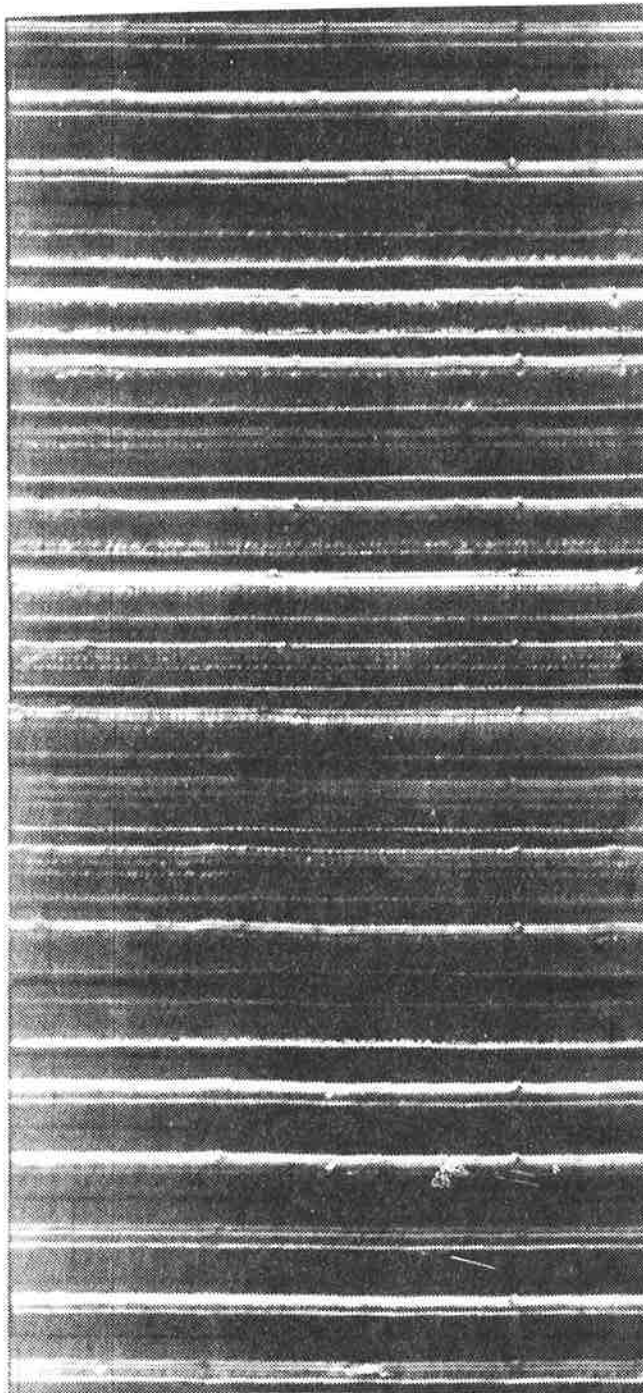
FIGURE 3-3. POOR QUALITY DATA PRINTOUT

Degree of clarity and focus of traces, black and white detail and gray shades (good quality - Figure 3-2; poor quality, Figure 3-3).

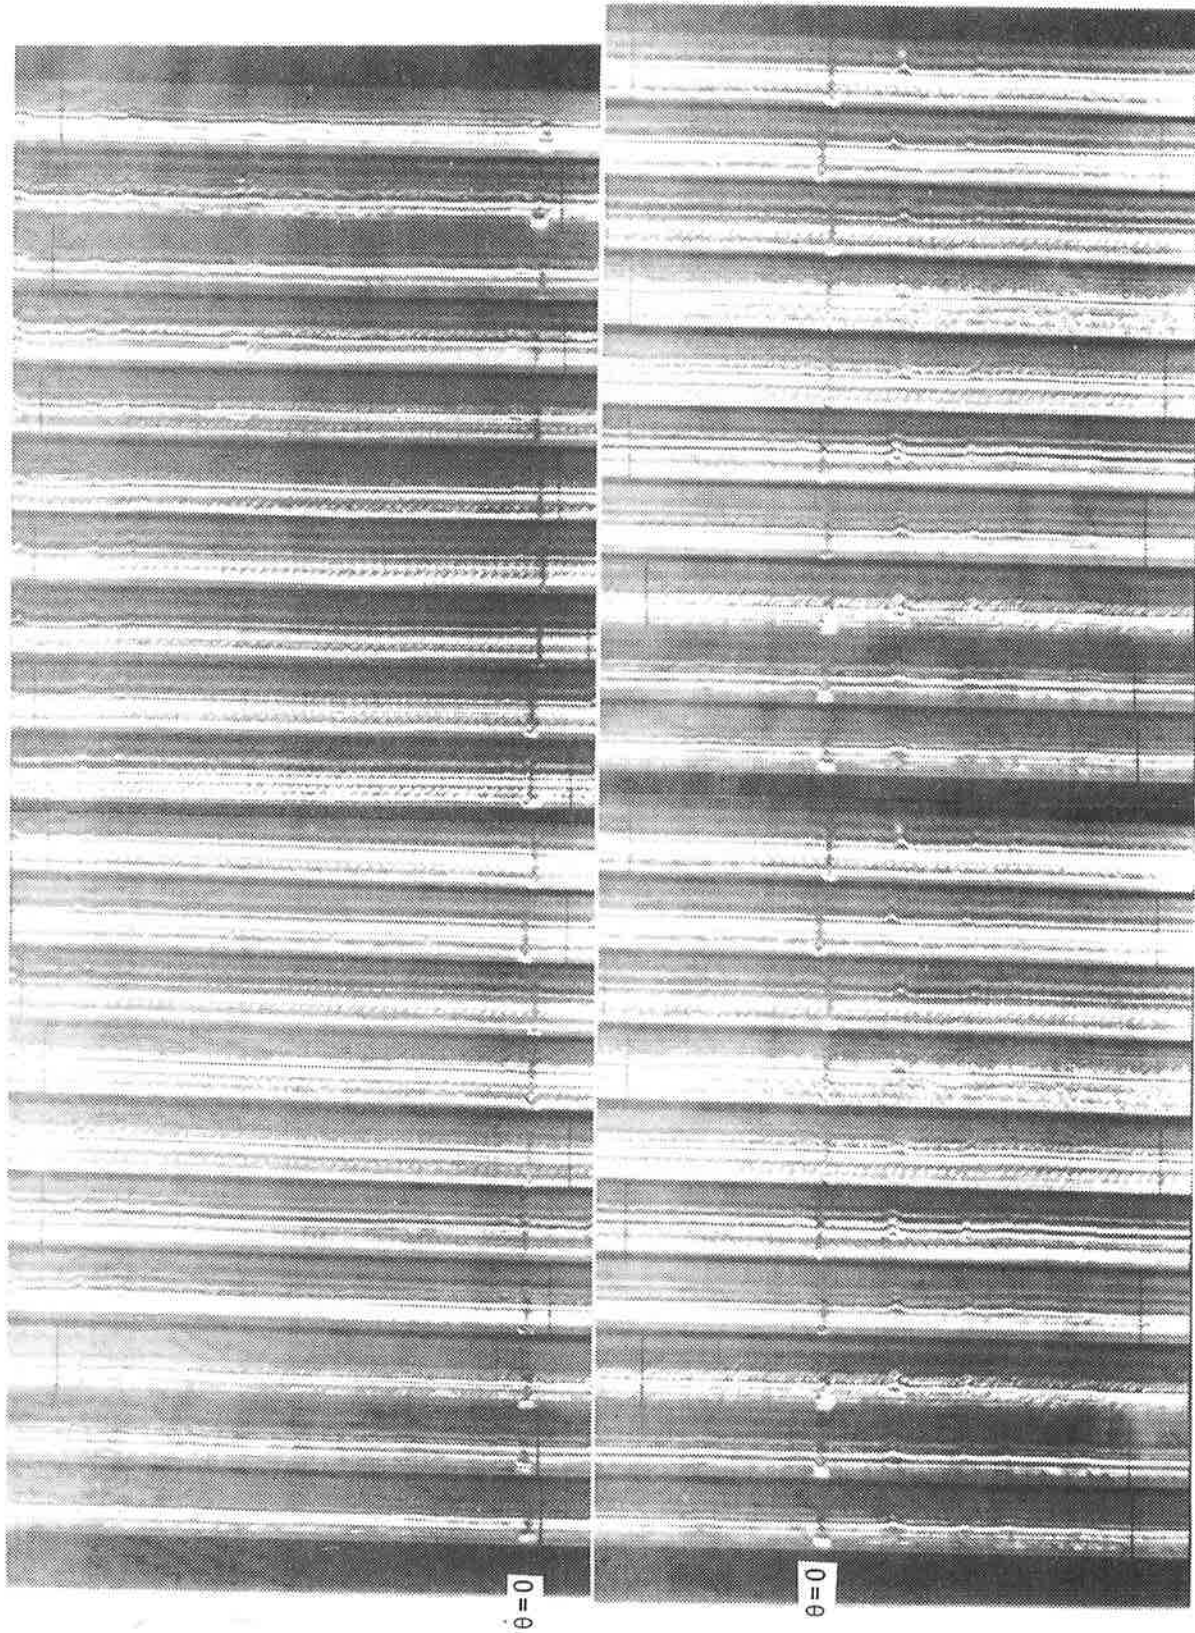
FIGURE 3-4. EXAMPLE OF POOR REGISTRATION

The line-up accuracy of the 20 data channels. The complete printout consists of two pages placed side by side, channels 2 - 11 on the first page, channels 12 - 21 on the second page (Figure 3-4). The  $\theta=0^\circ$  location is different on the two traces, thereby preventing superposition for comparison purposes (poor registration).

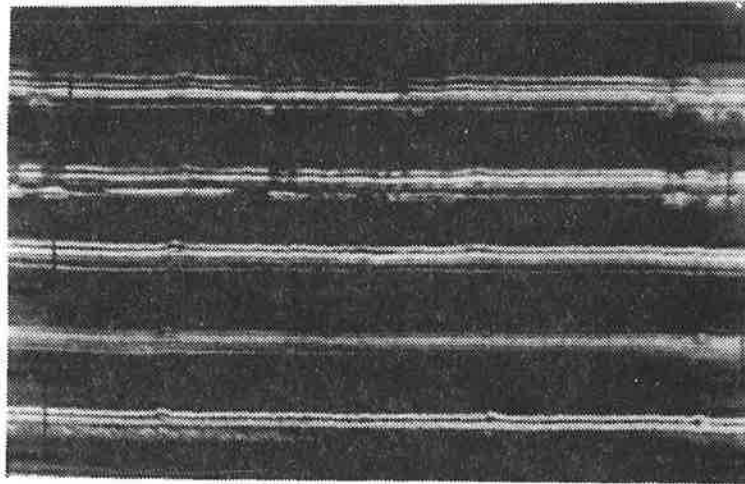
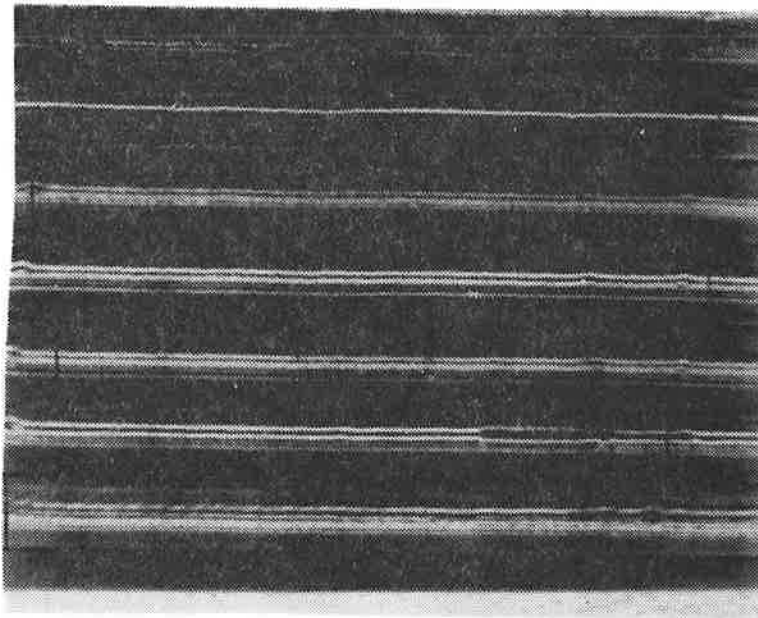
FIGURE 3-5. TURN-UP AREA

Abrupt brightness change (Figure 3-5). It is caused by overlapping or separation of material near the tire beads.

SEVERE TURNUP  
MODULATION

LITTLE OR NO  
TURNUP MODULATION

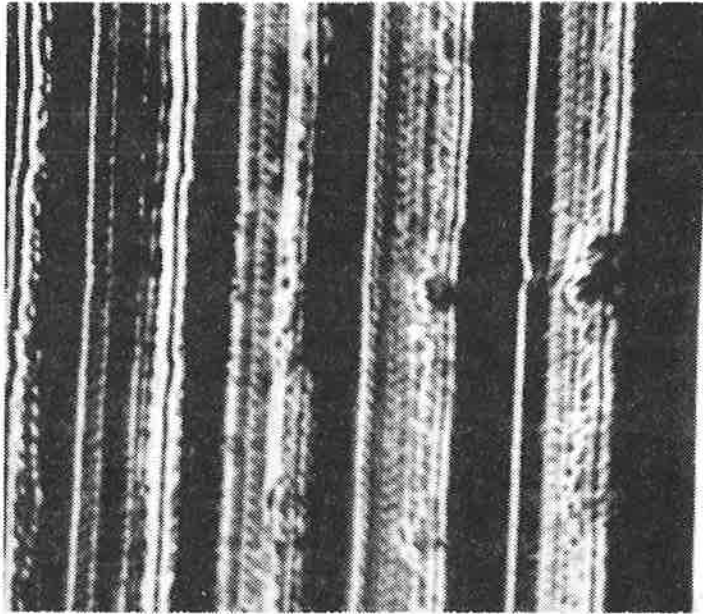
FIGURE 3-6. EXAMPLE OF INCLUSION

A reflection from several depths and generally present in more than one channel (See Figure 3-6), not to be confused with a single trace separation or fading of a trace. It is caused by a hole or foreign material in the tire structure.

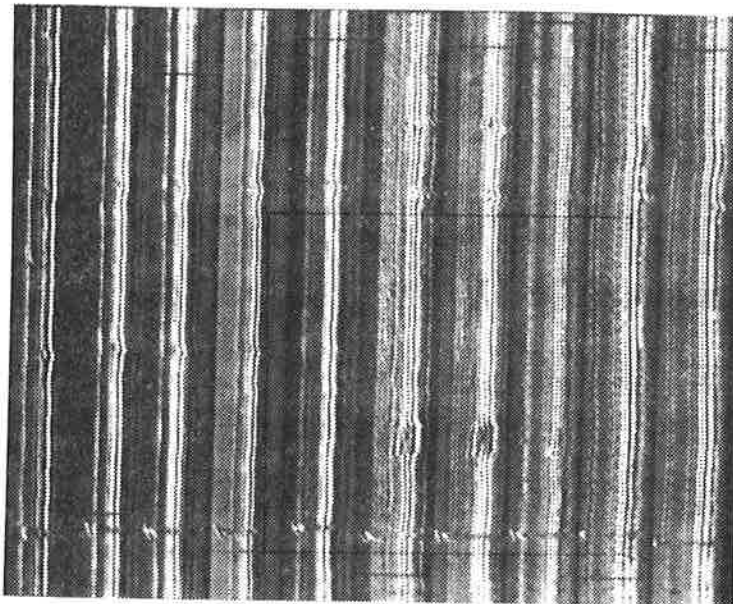
FIGURE 3-7. EXAMPLE OF SINGULARITY/SHADOW

A bright spot adjacent to a shadow (Figure 3-7). It is

caused by a separation or other discontinuity.\*

\*The figure shows an example of typical belt-edge separations in Channels 7 and 8.

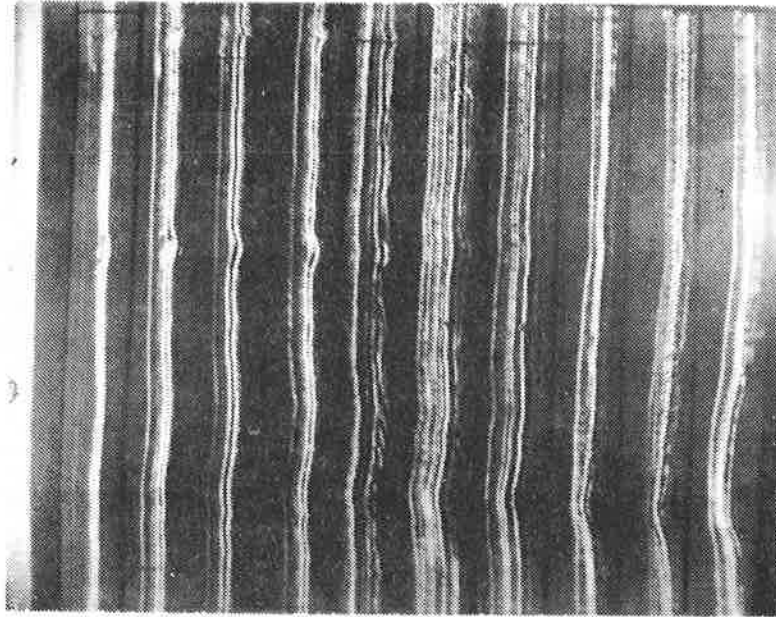
FIGURE 3-8. RADIAL RUNOUT

Skewed or wavy trace (Figure 3-8). Caused by "out of roundness"; the resulting "high spot" passes closer to transducer #10 than the remainder of the tire.

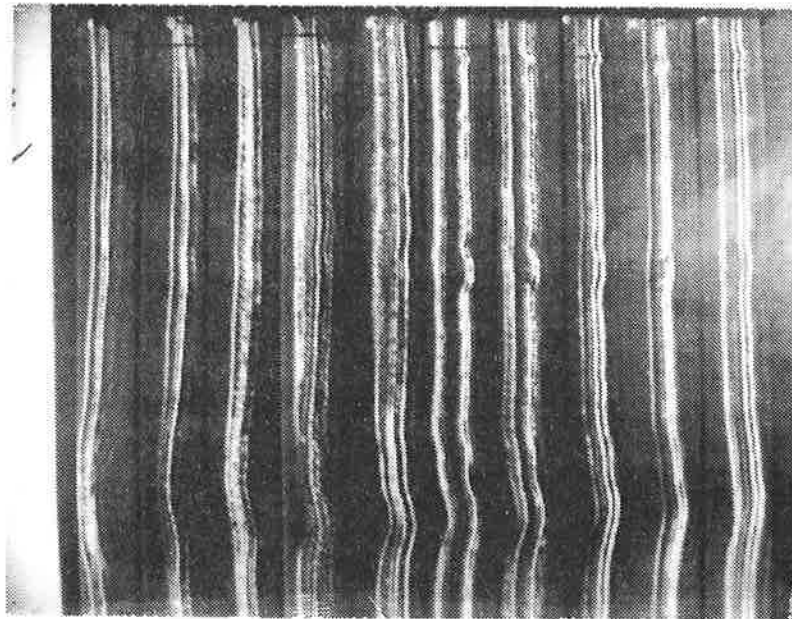
FIGURE 3-9. LATERAL RUNOUT

Wavy trace (Figure 3-9). Caused by a change in tire width.

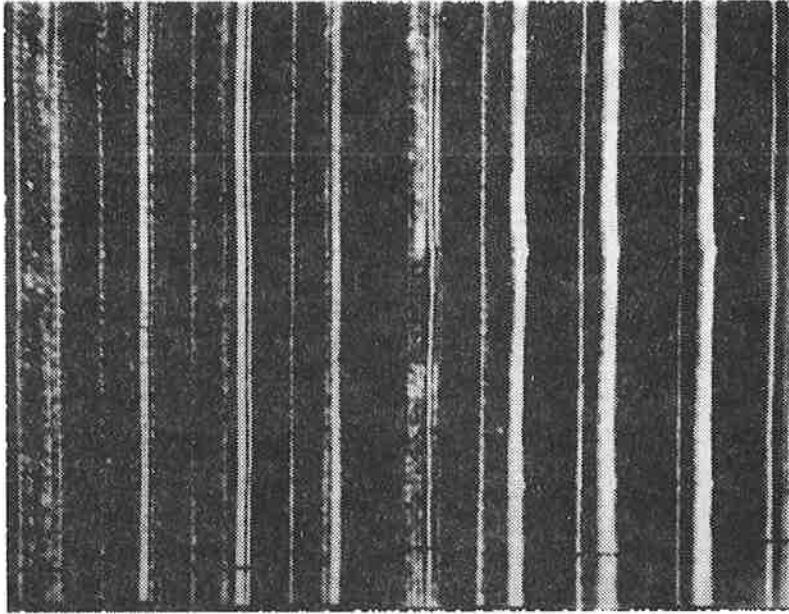
FIGURE 3-10. INTENSITY CHANGE

Abrupt brightness change (Figure 3-10). Caused by a change of material thickness.

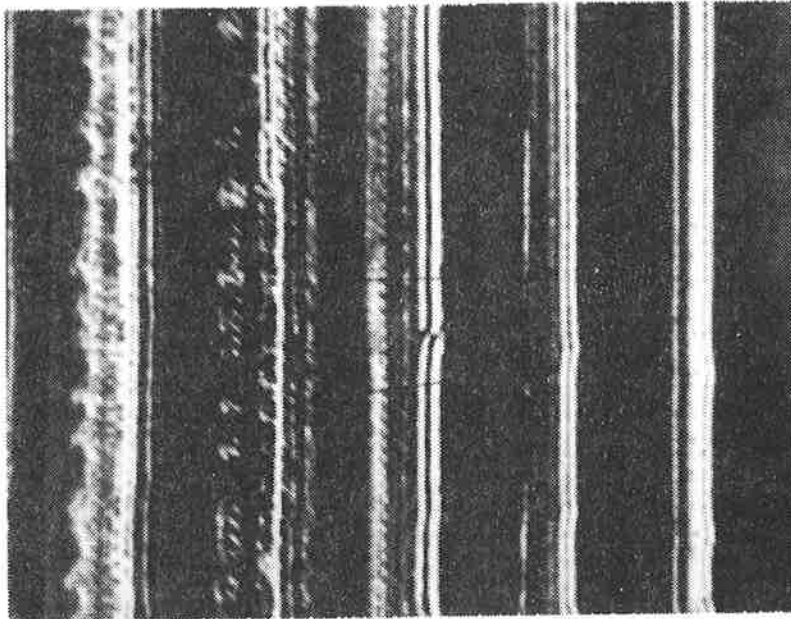
FIGURE 3-11. TRACE DISCONTINUITY

Interruption of a trace (Figure 3-11); not to be confused with an inclusion which is usually indicated in more than one channel. It is caused by abnormal displacement of material.

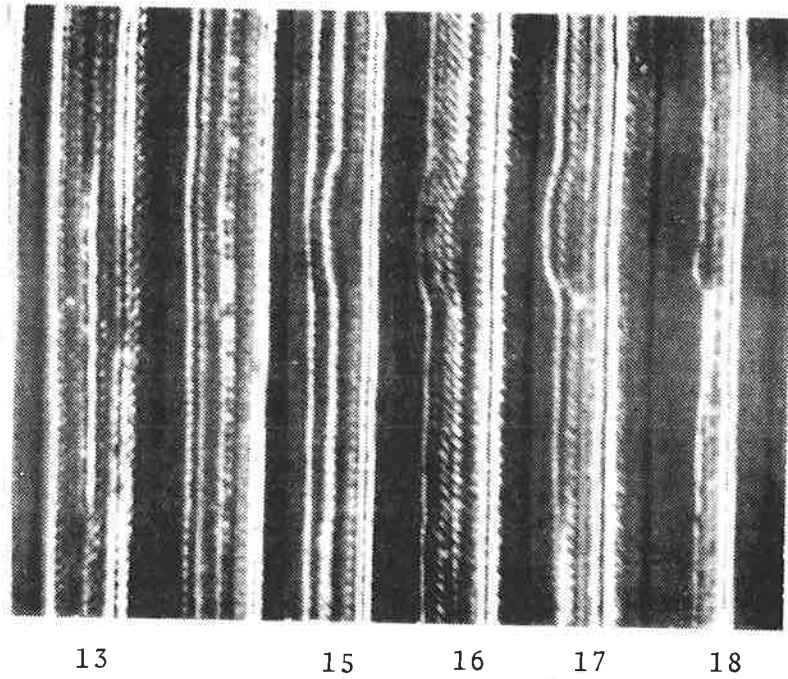
FIGURE 3-12. SHAPE DISCONTINUITY

Abrupt change of shape of trace (Figure 3-12). It is caused by excess of material or distorted ply structure.
