Florida Department of Transportation Research

Develop Epoxy Grout Pourback Guidance and Test Methods to Eliminate Thermal/Shrinkage Cracking at Post-Tensioning Anchorages, Phase 2

December 2015

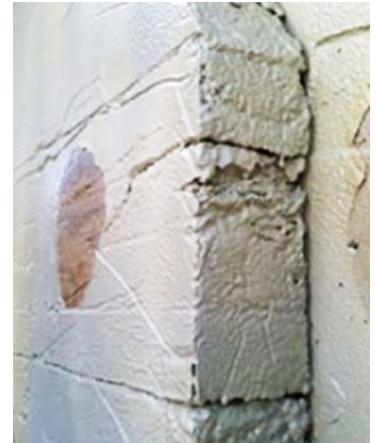
Based on the full-scale test data and observation, full-depth cracks were found on specimens with V/S ratio of 0.37 ft and on the S-type specimen with V/S ratio of 0.32. The cracks appeared within the first 24 hours and concentrated in regions with high exothermic temperature, suggesting that these cracks were caused by exothermic temperature rather than shrinkage. A finite element analysis was used to perform a parametric study to clarify the cracking mechanism of epoxy grout pourback systems and the influence of V/S ratio. The model was calibrated and validated using full-scale test data. Behavior of the full-scale pourbacks and the simulated pourbacks was correlatable, showing a general correspondence. Study results led to recommendations for the design and construction of epoxy grout pourbacks.

Serious cracking can be observed in this epoxy pourback, which encases a post tensioning anchorage (marked by the dark spot).
