# **DEVELOPMENT OF THE MIDWEST GUARDRAIL SYSTEM (MGS) W-BEAM TO THRIE BEAM TRANSITION ELEMENT**

## **MIDWEST ROADSIDE SAFETY FACILITY**

MwRSF Research Report No. TRP-03-167-07

November 26, 2007

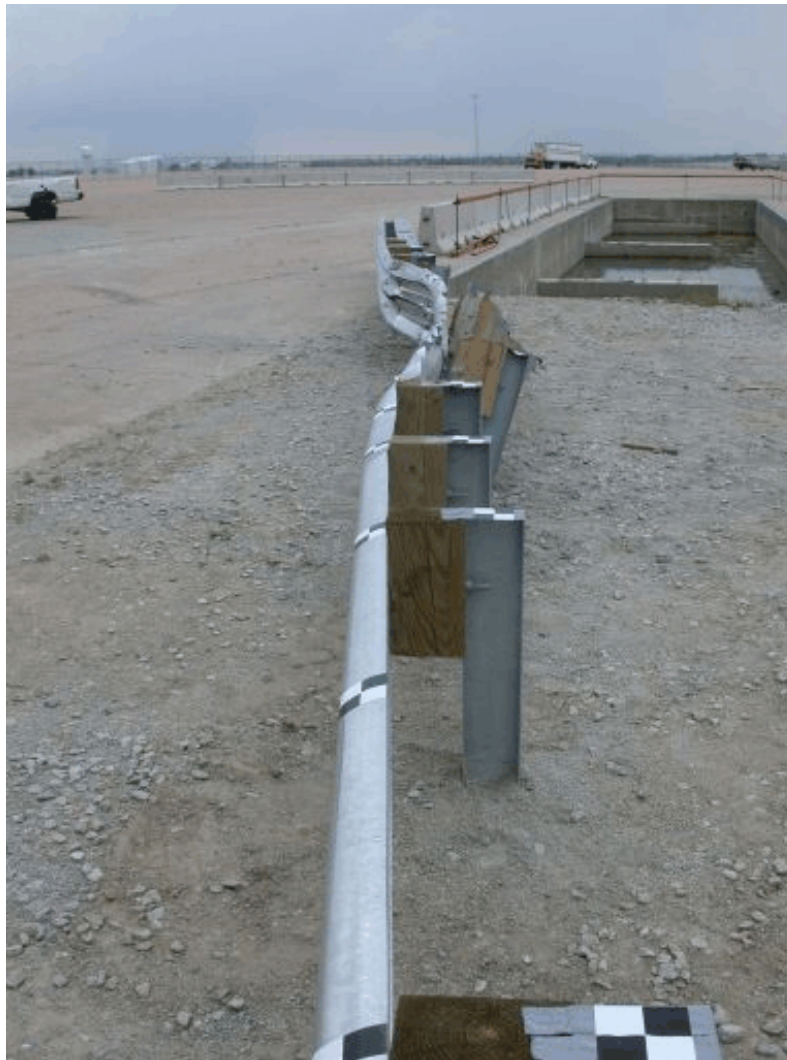
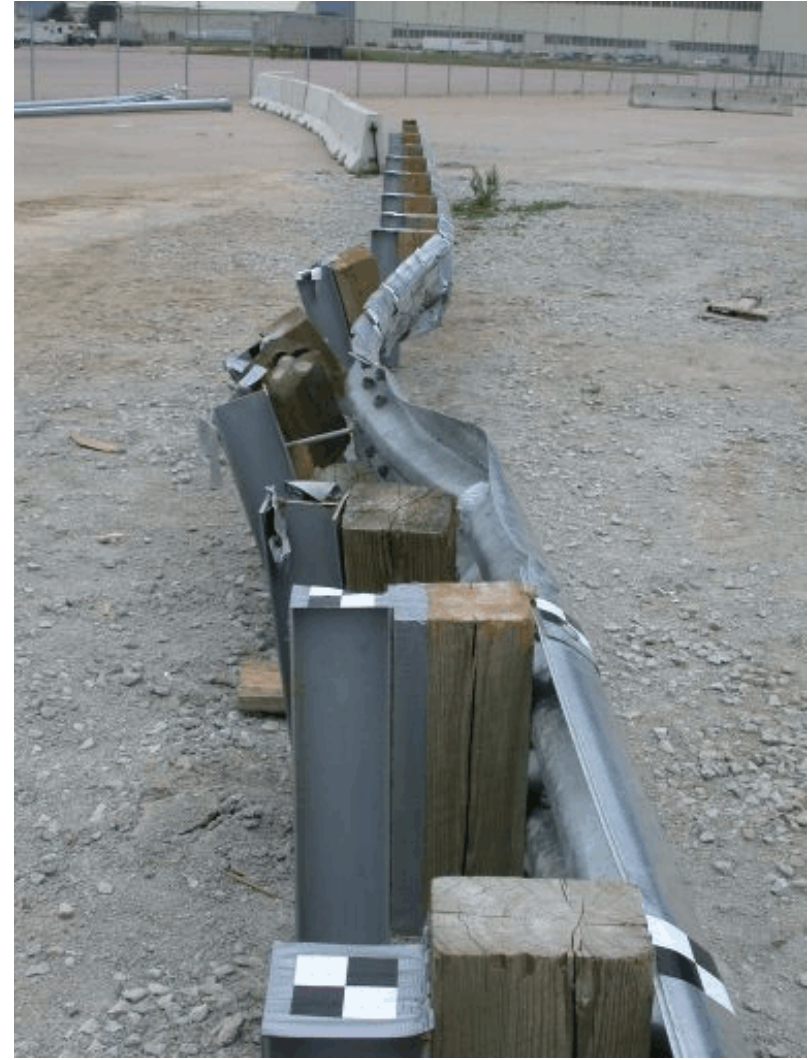
Figure 39. System Damage, Test MWT-3

Buckling in the upper and lower portions of the rail was found 102 mm (4 in.) upstream of post no. 8. Two buckle points were evident on the top portion of the rail at the leading edges of the blockouts at post nos. 16 and 17. Between post nos. 9 and 12, the bottom portion of the W-beam was

The permanent set of the barrier system is shown in Figure 39. The maximum lateral permanent set rail and post deflections were 389 mm (15.3 in.) at the centerline of post no. 12 and 556 mm (21.9 in.) at the centerline of post no. 11, respectively, as measured in the field. The maximum lateral dynamic rail and post deflections were 620 mm (24.4 in.) at the centerline of post no. 12 and 649 mm (25.5 in.) at the centerline of post no. 11, respectively, as determined from the high-speed film analysis. The working width of the system was found to be 785 mm (30.9 in.).

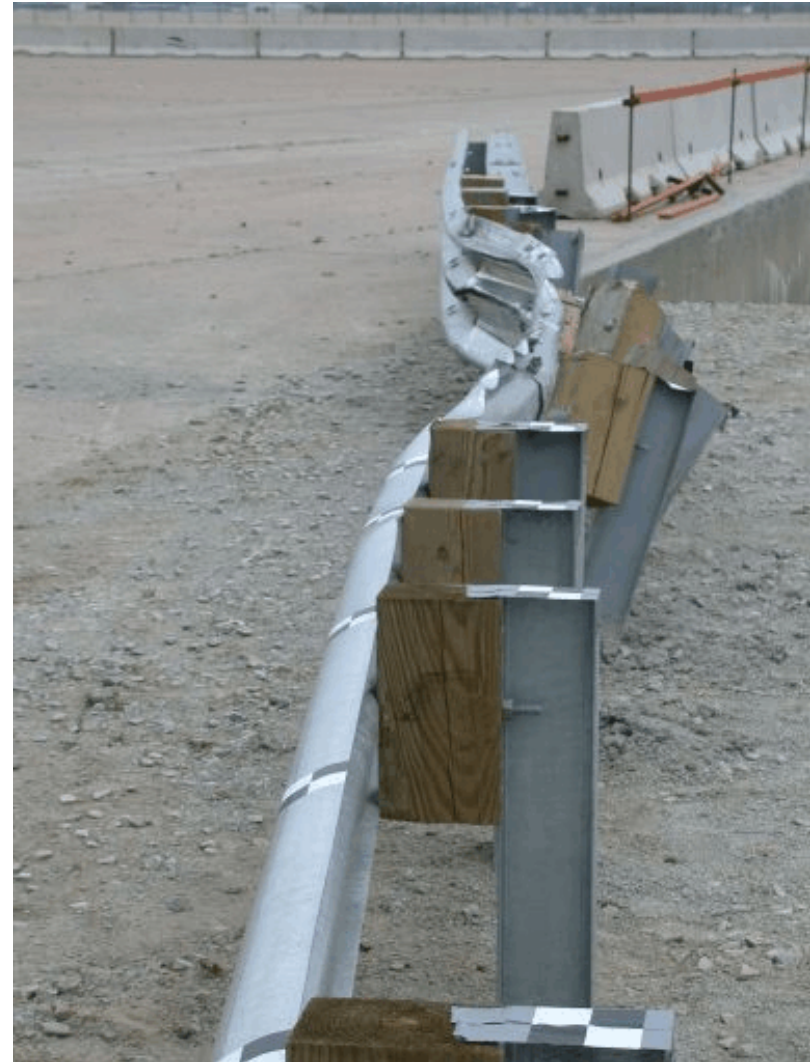
Figure 40. System Damage, Test MWT-3

Damage to the barrier was moderate, as shown in Figures 39 through 45. Barrier damage consisted of deformed guardrail and posts, contact marks on a guardrail section, and fractured wooden spacer blockouts. The length of vehicle contact along the approach guardrail system was approximately 5.7 m (18.75 ft), which spanned from 203 mm (8 in.) upstream from the centerline of post no. 9 through 203 mm (8 in.) upstream from the centerline of post no. 15.

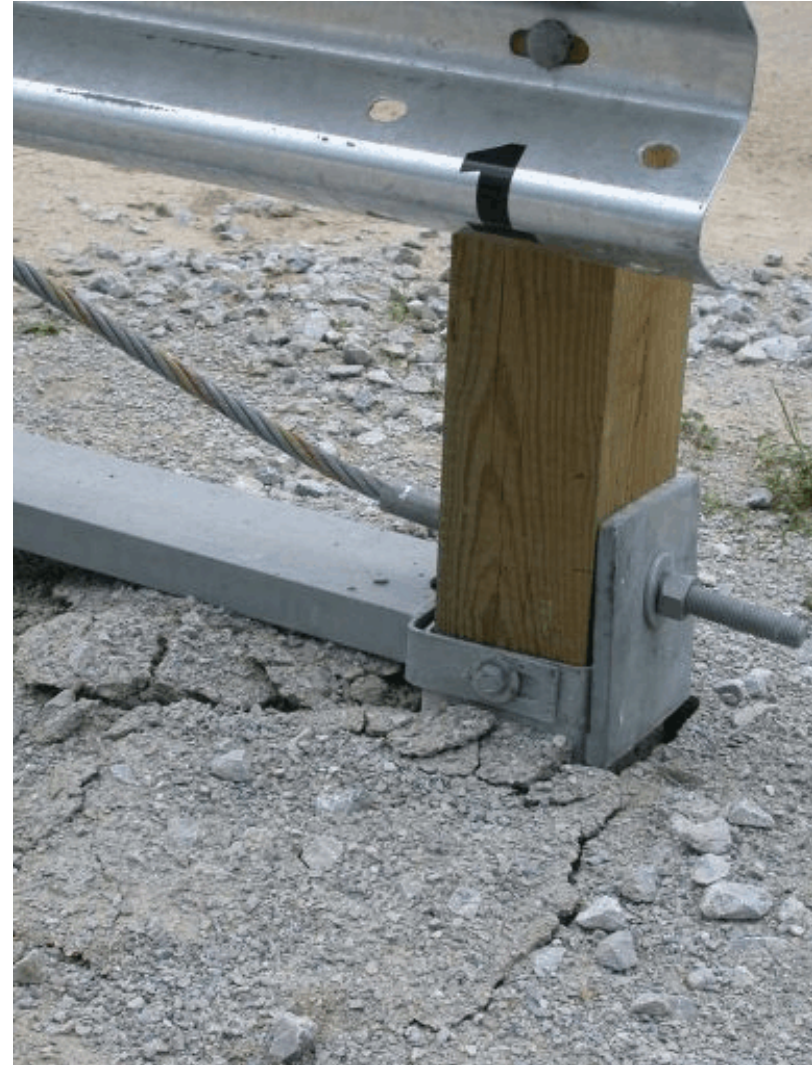
Figure 41. Anchorage Damage, Test MWT-3

Post nos. 1 and 2 deflected downstream slightly causing soil cracks to radiate from both soil foundation tubes. The soil became amassed on the upstream side of post no. 1. Soil gaps were visible on the upstream and downstream sides of post nos. 1 and 2. Post nos. 3 through 7 twisted approximately 25 mm (1 in.) at the back of the rail and were rotated downstream. Minor soil gaps occurred around post nos. 3 through 7. Post no. 8 remained undamaged with no major twisting nor deflection. Soil gaps of 3 mm (0.125 in) and 6 mm (0.25 in.) were evident on the traffic and back sides of post no. 8, respectively. Post no. 9 encountered 19 mm ( $\frac{3}{4}$  in.) of twist. Soil gaps of 25.4 mm (1 in.) were found on both the traffic and back sides of post no. 9. Post no. 10 encountered severe deflections backward and downstream. Post no. 10 also twisted approximately 30 degrees counter-clockwise. A tire mark was visible on post no. 10 beginning on the upstream corner 102 mm (4 in.)

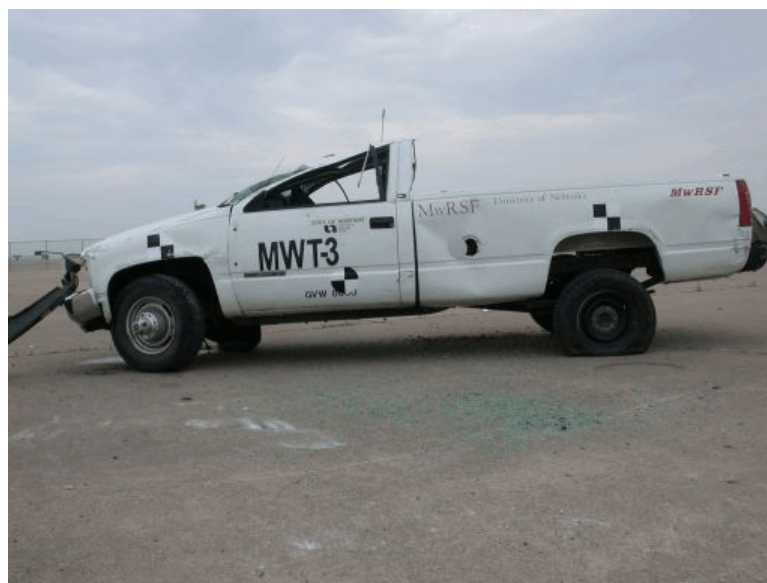
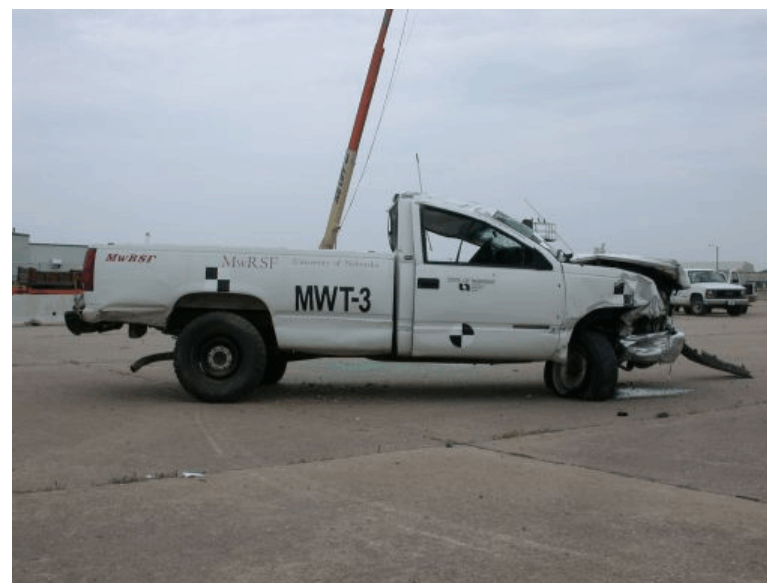
Figure 46. Vehicle Damage, Test MWT-3

Most of the damage was concentrated on the front, both the left and right sides, and the roof of the vehicle due to rollover, as shown in Figure 46. The right-front corner of the vehicle was

crushed inward toward the engine with the bumper buckling near its center. The roof of the vehicle was crushed downwards due to vehicle roll. The right-front tire was deflated and removed from the steel rim, and the inside of the steel rim encountered deformations. The right-front outer tie rod was disengaged, while the ball joints, stabilizer bar, and shock mount remained intact. The right-side A-frame was deformed. The right-rear fender behind the tire, the right-side end of the rear bumper, and the tail pipe encountered significant damage.

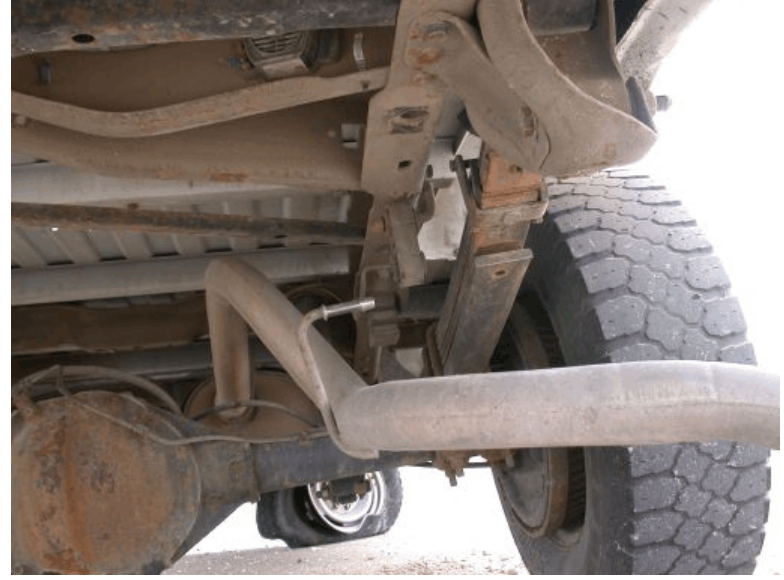
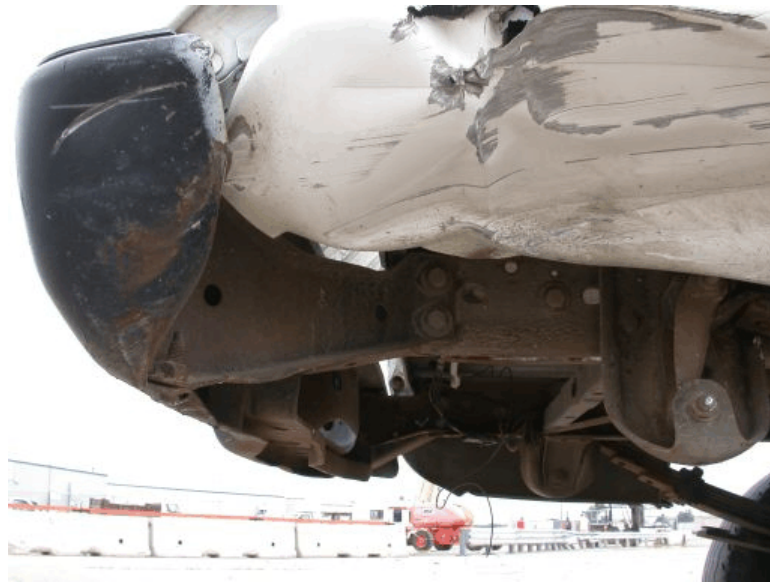
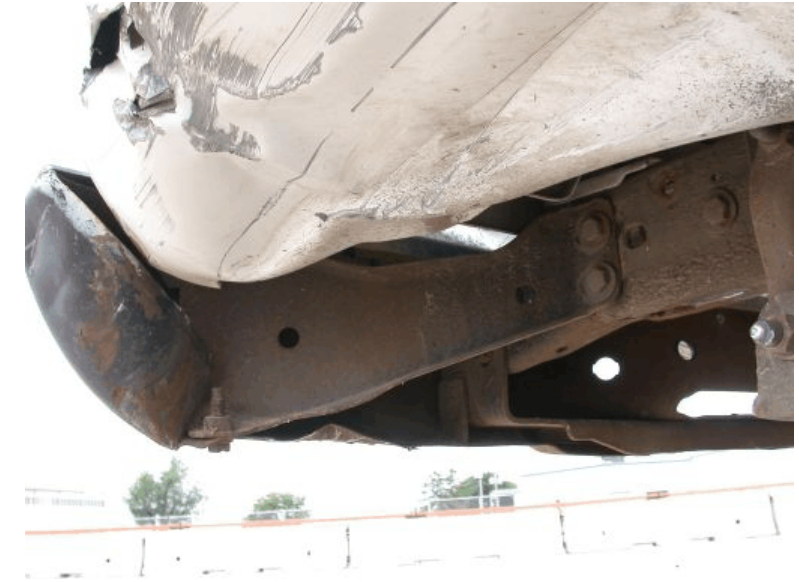
Figure 48. Vehicle Damage, Test MWT-3

The damage to the frame was minimal and focused mainly around the bumper bracket and frame horns. Deformations to the vehicle's body were evident on the right side in the shape of the guardrail. Left-side damage was limited to light scraping and box deformations due to rollover. The windshield was shattered but remained intact due to the safety layer, as shown in Figure 48. All other window glass shattered and was removed from the system.

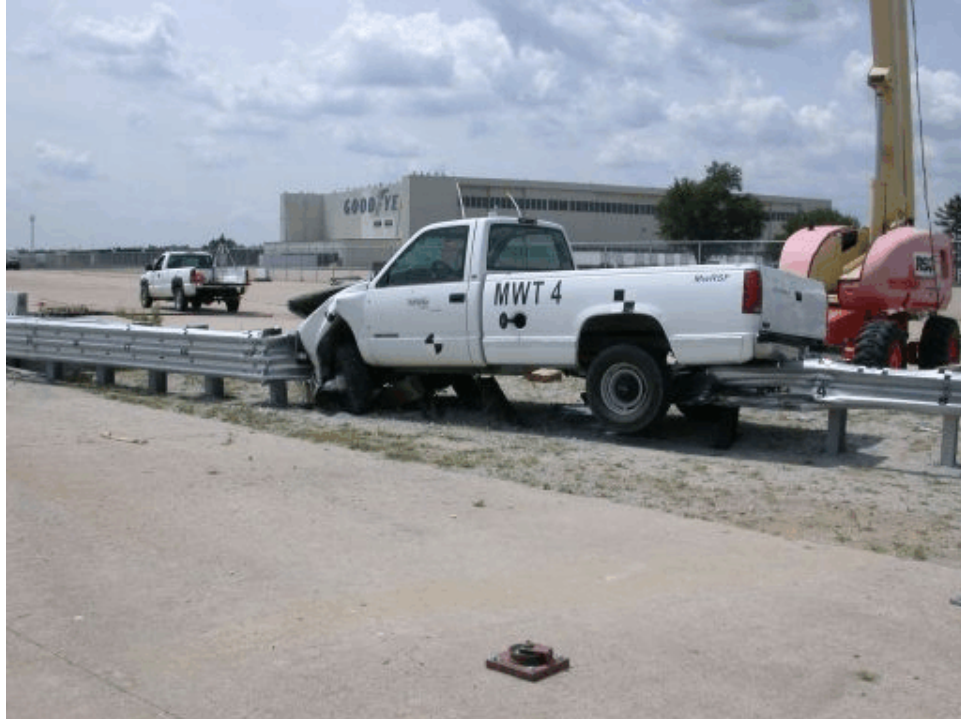
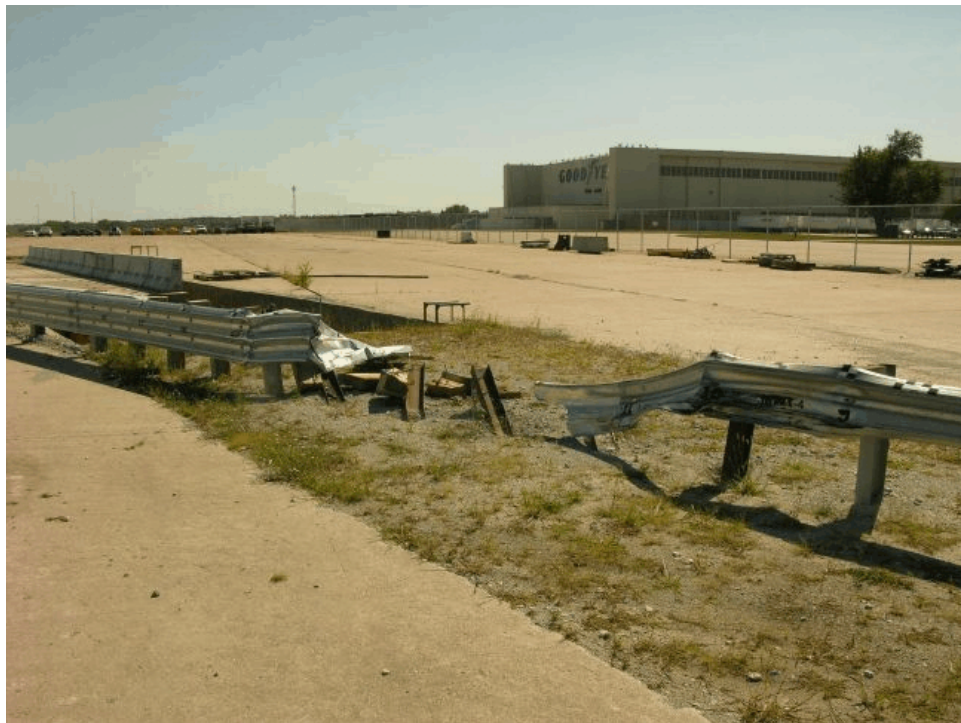
Figure 70. System Damage, Test MWT-4

Barrier damage was extensive as shown in Figures 70 through 76. Barrier damage consisted of deformed guardrail and posts, ruptured guardrail, fractured blockouts, and contact marks on a guardrail section. The length of vehicle contact along the approach guardrail system was approximately 5.9 m (19.5 ft), which spanned from 229 mm (9 in.) upstream from the centerline of post no. 9 through the centerline of post no. 15.

The guardrail damage consisted of significant contact marks and moderate deformation and flattening of the impacted section of W-beam and thrie beam rail between post nos. 9 and 14. The guardrail buckled at post nos. 8, 9, 14, 15, and 16 and 89 mm (3.5 in.) downstream of post no. 10. The guardrail bent around the blockouts at post nos. 9 and 10. The W-beam guardrail was torn

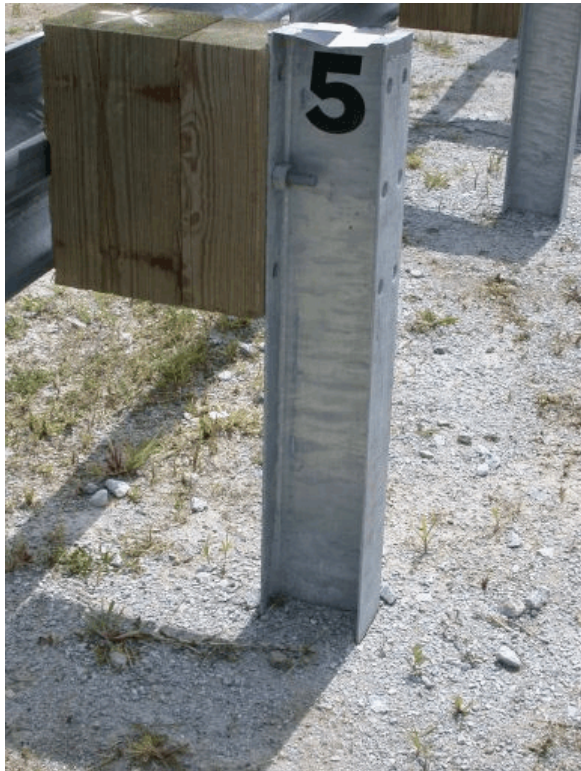
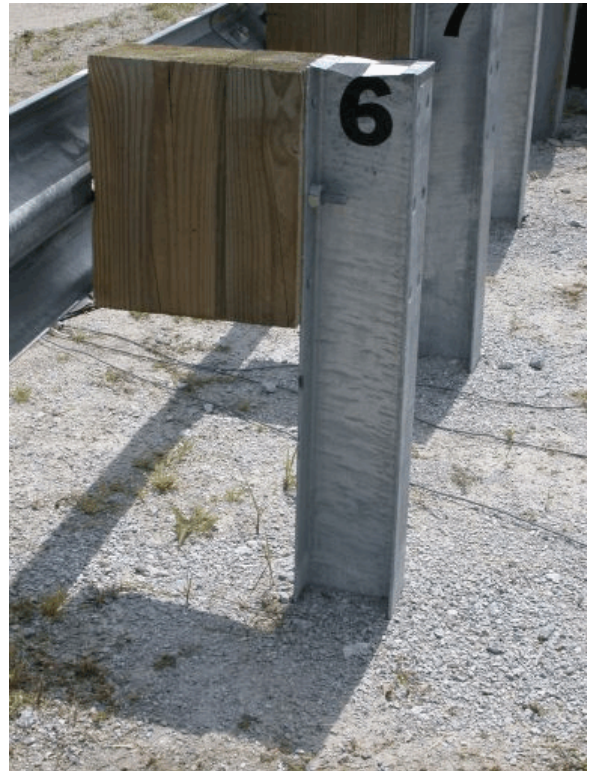
Figure 73. Post Nos. 1, 2, 5, and 6 Damage, Test MWT-4

Steel post nos. 3 through 7 twisted and rotated slightly downstream. Post nos. 8 through 10 rotated backward slightly and bent longitudinally downstream. Post nos. 11 through 14 rotated backwards and bent longitudinally downstream. Post nos. 11 and 12 also encountered contact marks on the upstream front flange and rear flange, respectively. Post nos. 15 through 21 bent slightly downstream, and post nos. 15 through 18 also rotated backward slightly. The upstream anchorage system moved slightly longitudinally, but the posts were not damaged.

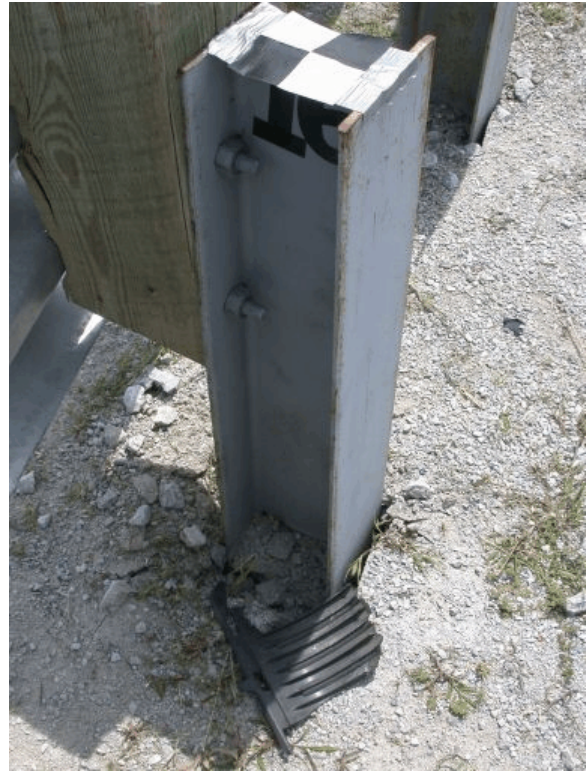
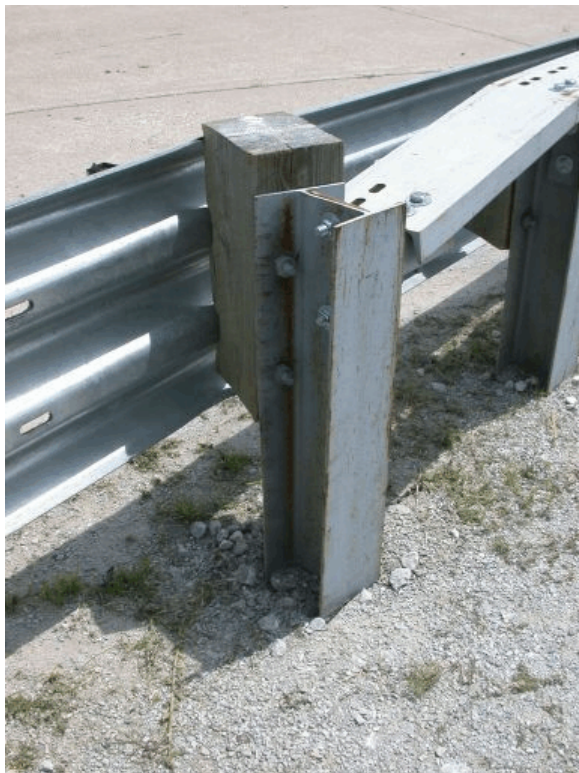
Figure 76. Post Nos. 16 and 17 Damage, MWT-4

The wooden blockouts at post nos. 9 and 15 through 17 encountered minor deformations due to rail interaction, while the wooden blockout at post no. 10 encountered more significant deformations. The wooden blockout at post no. 14 encountered moderate damage due to the post bolt pulling partially through the blockout. The wooden blockouts at post nos. 13 and 18 were fractured but remained attached to the post. The wooden blockouts at post nos. 11 and 12 disengaged from the system. The steel blockouts at post nos. 19 through 21 twisted slightly downstream. The blockouts at post nos. 3 through 8 remained undamaged.

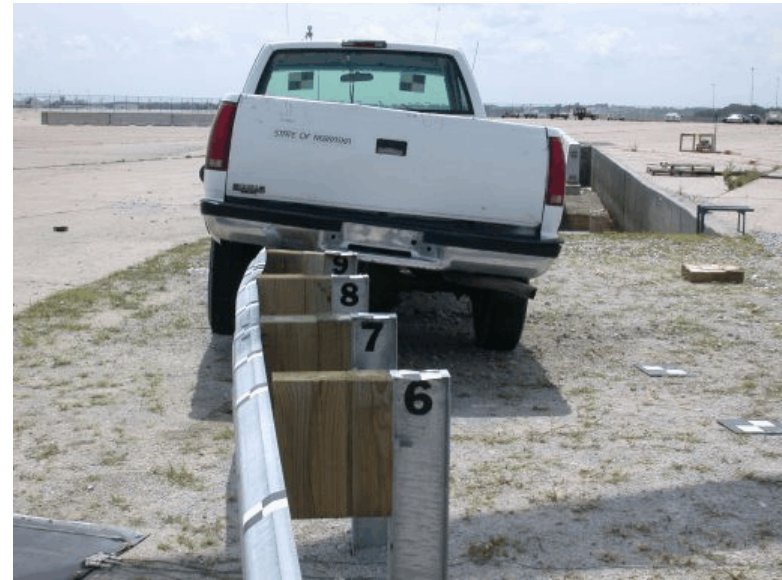
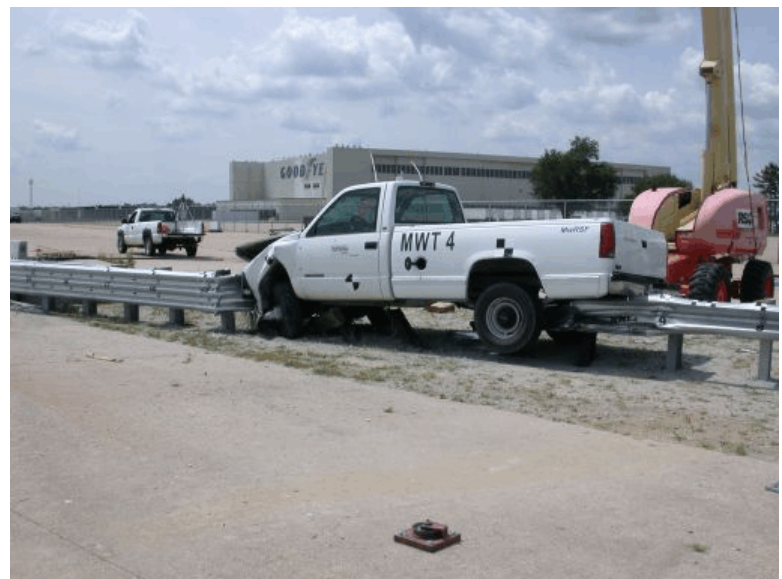
Figure 77. Vehicle Damage, Test MWT-4

Exterior vehicle damage was moderate, as shown in Figures 77 and 80. Extensive occupant compartment deformations occurred with the penetration of the center of the floorboard, as shown in Figure 80. The drive shaft U-joint penetrated through and caused a 178-mm (7-in.) slice in the floorboard. A 64-mm (2.5-in.) dent was also found in the floorboard. Complete occupant compartment deformations and the corresponding locations are provided in Appendix C.

Damage was concentrated on the front third of the vehicle. The front of the vehicle through the front quarter panels buckled inward. The right-front and left-front quarter panels and right-side door encountered significant contact and scratch marks along with buckling and numerous dents. The right-side frame rail buckled near the cab portion. The hood deformed downward and inward under itself. The front bumper encountered significant tears, dents, and buckling. The front grill was fractured and removed from the vehicle. The radiator encountered contact marks and was punctured. Contact marks were visible on the right side of the rear bumper. The right-front and left-front wheel wells sustained contact and scratch marks, and the right-front wheel well also encountered significant dents. Both of the front wheel assemblies were severely deformed and damaged.
