Performance of Modified Class D HMA Pavements in Washington State

WA-RD 711.1

December 2008

Special Report

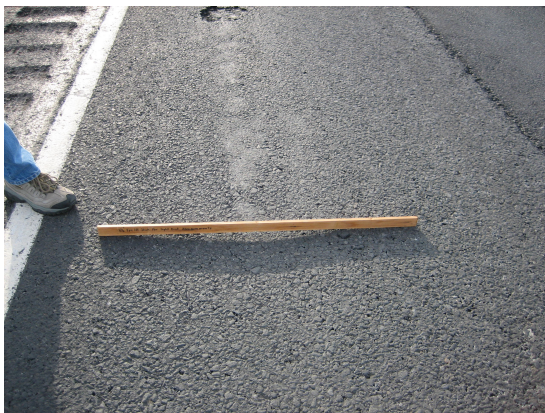
WSDOT documented two failures of Modified Class D on Interstate 90. The first was Contract 4254 which placed 0.15 feet of Modified Class D HMA between MP 191.89 and MP 208.16. Two years after placing the Modified Class D HMA the section exhibited areas of potholing, flushing, rutting and shoving. An investigation revealed that stripping was occurring primarily in the underlying layer of HMA leading to the distress. The report concluded that traffic consolidated the Modified Class D HMA in the left wheel path of the truck lane making it impermeable. The roadway cross slope ran from the left shoulder downward to the right shoulder, so surface water would flow through the Modified Class D HMA from left to right

Figure 7. Fat spots and rutting in wheel path resulting from stripping.

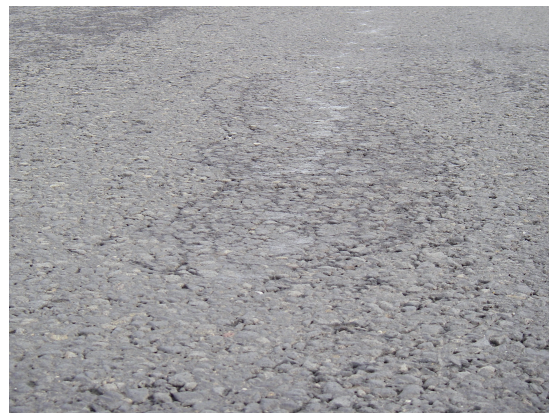
Figure 8. Area with fat spots beginning to crack.

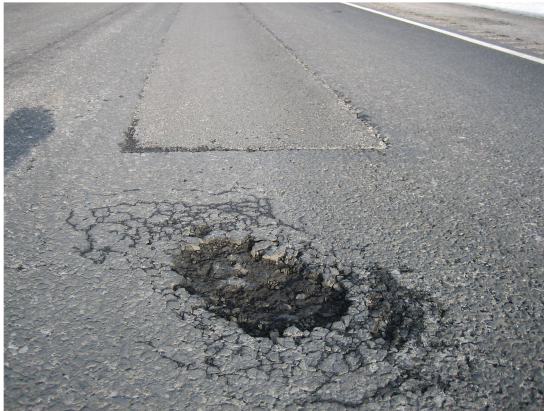
Figure 9. New pothole developing ahead of a previously patched area.

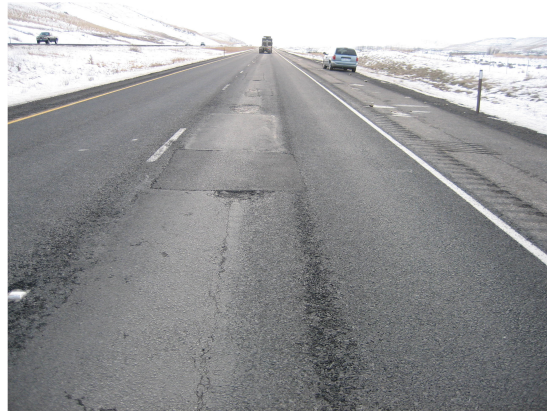
Figure 10. String of patches typical to distressed areas.

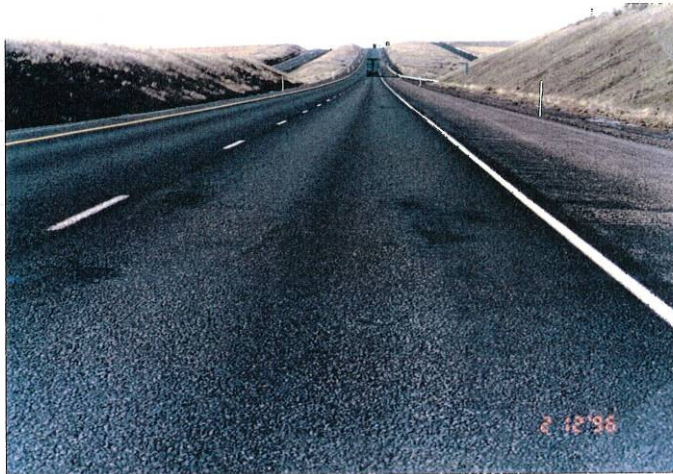
Photo 1, MP 208.09, Westbound Lanes
Failing Modified Class D (MCD) surface. The wheel paths first appear fat, second push and shove, and finally potholes develop. This location shows several areas have almost progressed to potholes.

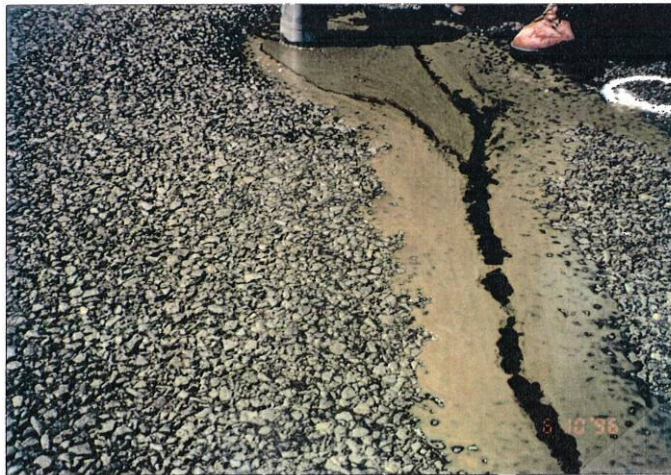
Photo 2, MP 202.49, Westbound Truck Lane
Left wheel path where the MCD surface has become fat.

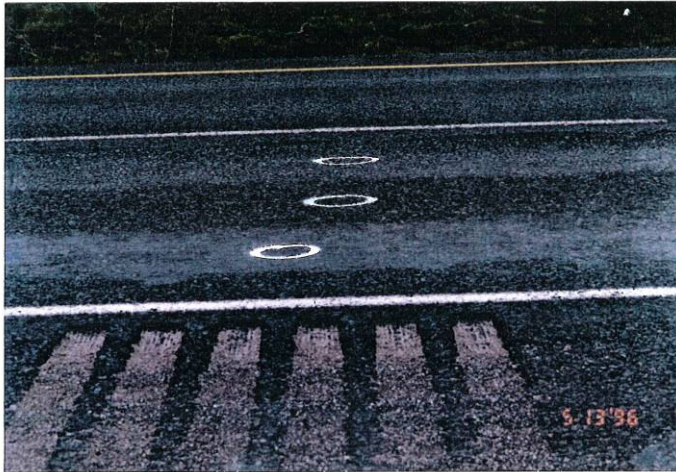
Photo 3, MP 208.01, Westbound Lanes
Wheelpaths in the truck lane where the MCD has turned fat.

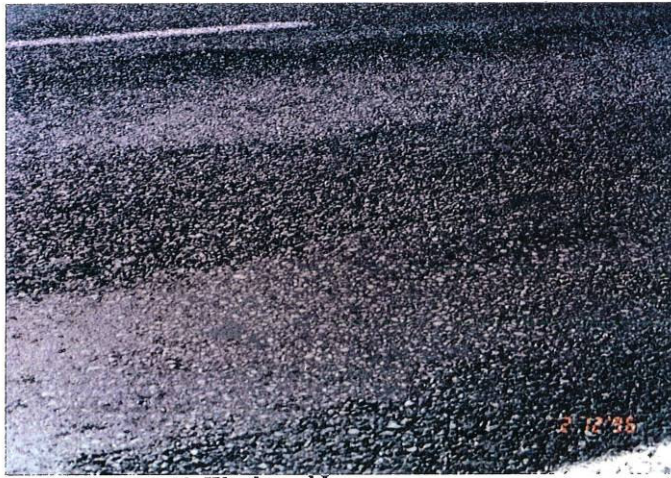
Photo 4, MP 208.09, Westbound Lanes
Wheelpaths in the truck lane where the MCD has turned fat.

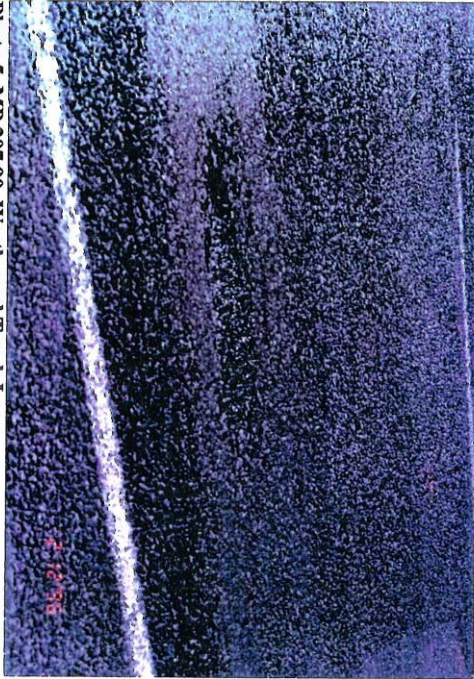
Photo 5, MP 207.90, Westbound Truck Lane
Typical infancy stage of potholing of the MCD surface.

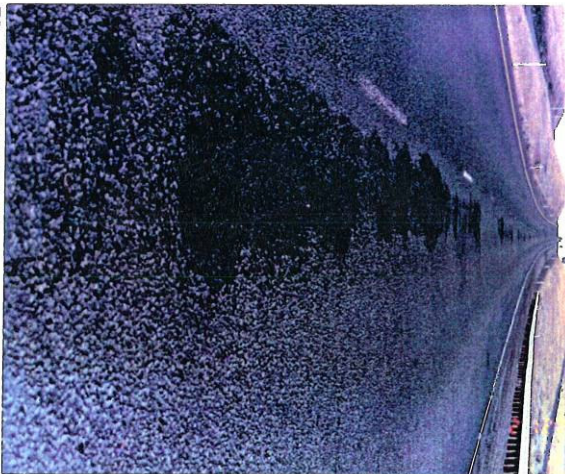
Photo 6, MP 207.91, Westbound Truck Lane
Potholes that have required maintenance patching.

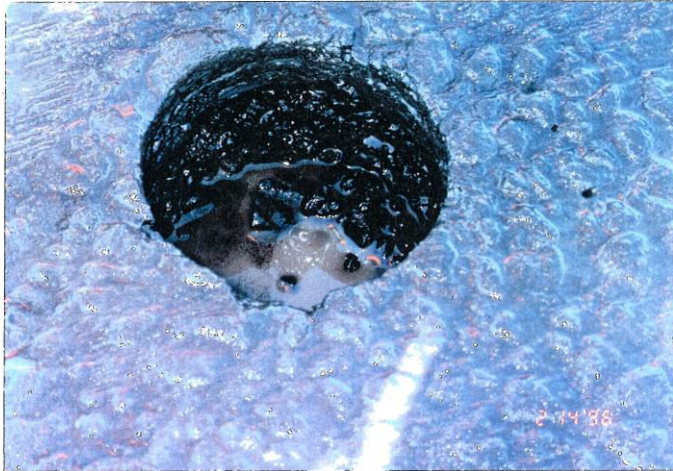
Photo 7, MP 207.87, Westbound Truck Lane
Stripped Asphalt Class B beneath the MCD surface in the left wheelpath. The MCD surface appears fat and the core appears very dense.

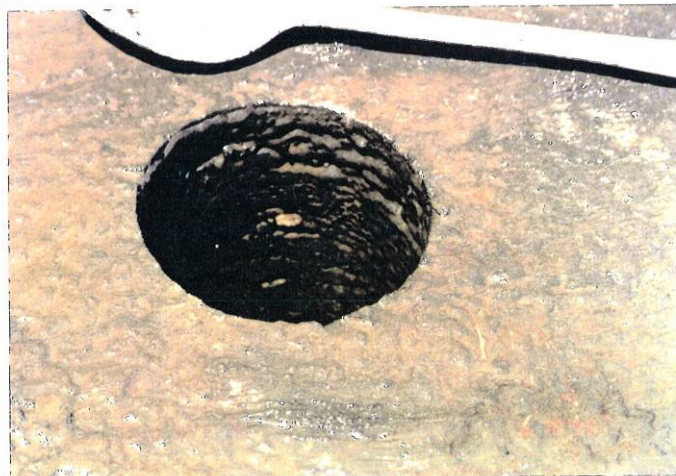
Photo 8, MP 202.49, Westbound Truck Lane
Stripped Asphalt Class B beneath the MCD surface in the left wheelpath. The MCD surface appears fat and the core appears very dense.

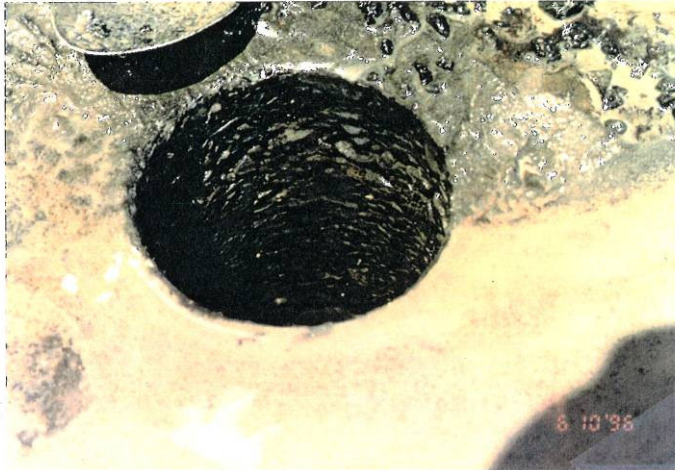
Photo 9, MP 205.73, Westbound Truck Lane
Stripped Asphalt Class B beneath the MCD surface in the left wheelpath. The MCD surface appears fat and the core appears very dense.

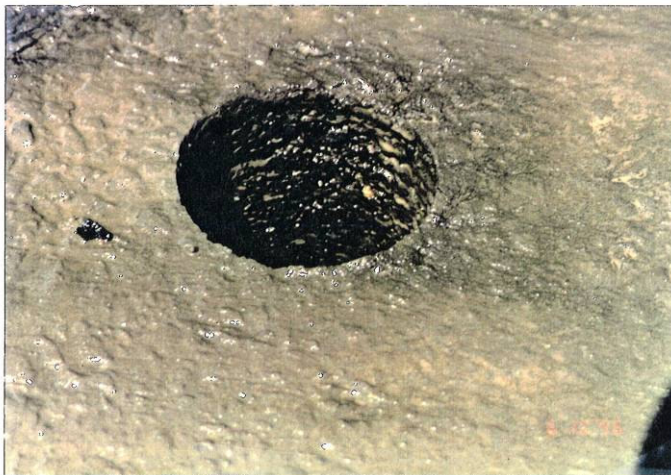
Photo 10, MP 206.69, Westbound Truck Lane
Stripped Asphalt Class B beneath the MCD surface in the left wheelpath. The MCD surface appears fat and the core appears very dense.

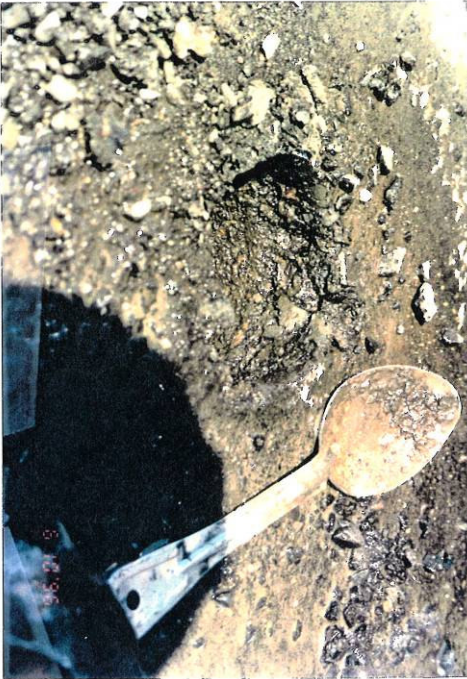
Photo 11, MP 206.62, Westbound Truck Lane Stripped Asphalt Class B beneath the MCD surface in the left wheelpath. The MCD surface appears fat and the core appears very dense.

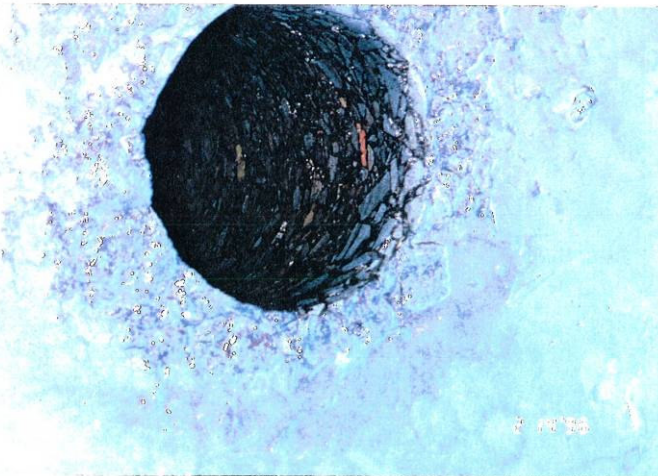
Photo 12, MP 207.87, Westbound Truck Lane Core taken in the center of lane. The underlying asphalt Class B looks good.

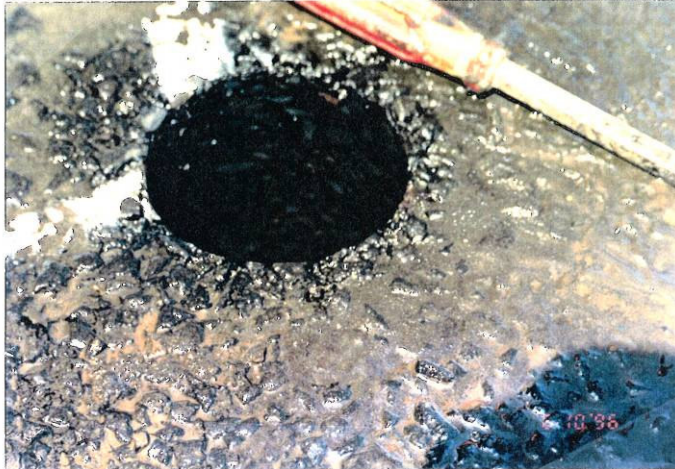
Photo 13, MP 202.37, Westbound Truck Lane
Core taken in the center of lane. The underlying asphalt
Class B looks good.

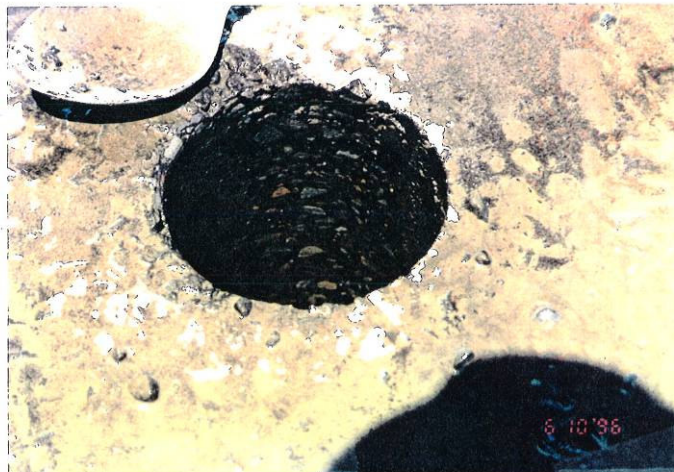
Photo 14, MP 205.73, Westbound Truck Lane
Core taken in the center of lane. The underlying Asphalt
Class B looks good.

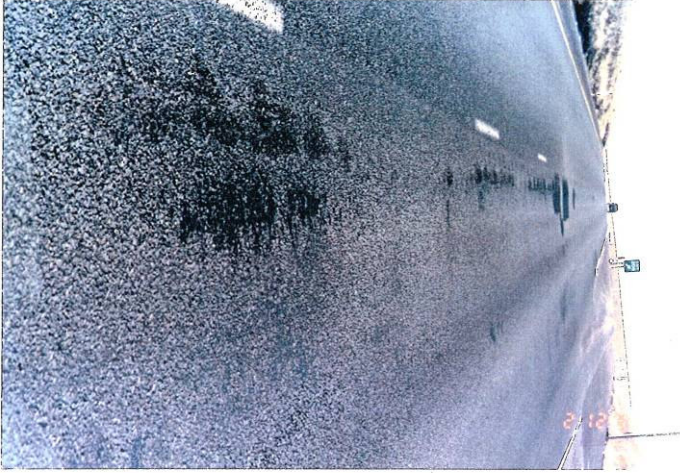
Photo 15, MP 207.19, Westbound Truck Lane
This section of I-90 is built with a shed section that drains to the outside shoulder. Water is "dammed" left of the left wheelpath for westbound traffic.

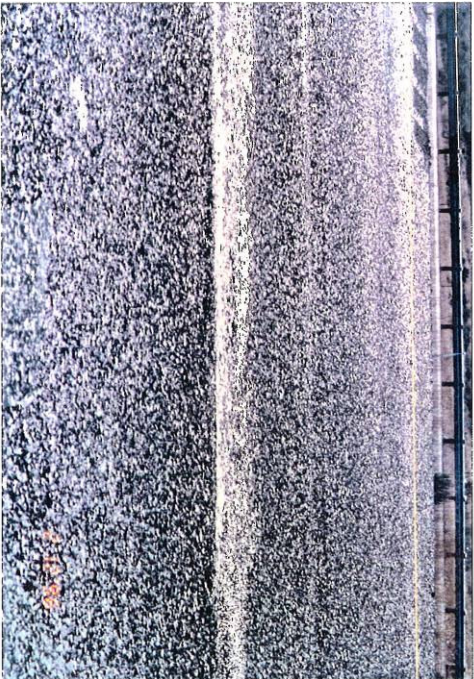
Photo 16, MP 208.84, Westbound Truck Lane
Water "dammed" by compressed MCD on the high side of the wheel rut.

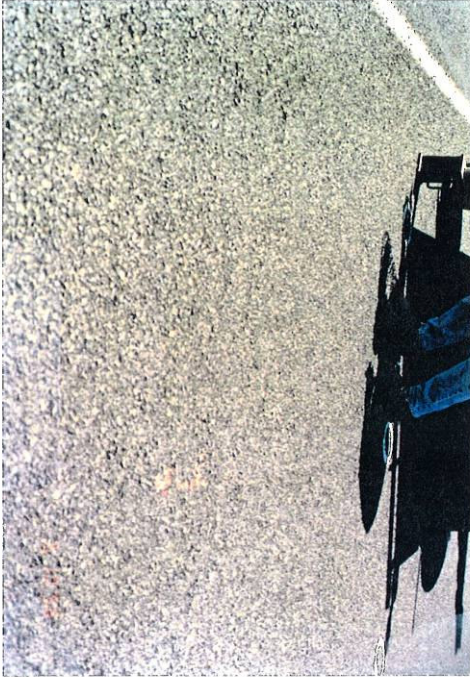
Photo 17, MP 195.00, Westbound Lanes
This MCD was overlaid over an existing Asphalt Class D. The pavement looks good.

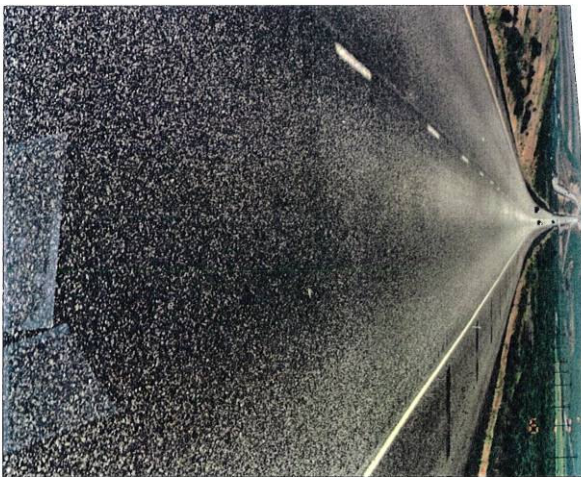
Photo 18, MP 195.00, Eastbound Truck Lane
Flushing appearing in the eastbound truck lane.

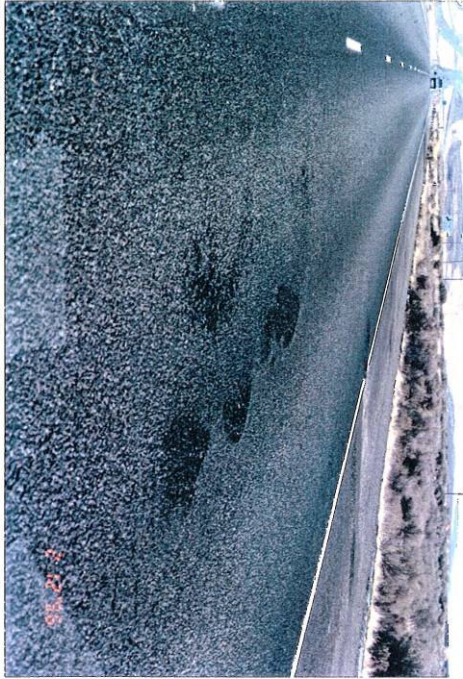
**Photo 19, MP 195.85, Eastbound Truck Lane
Isolated area of pushing and shoving.**

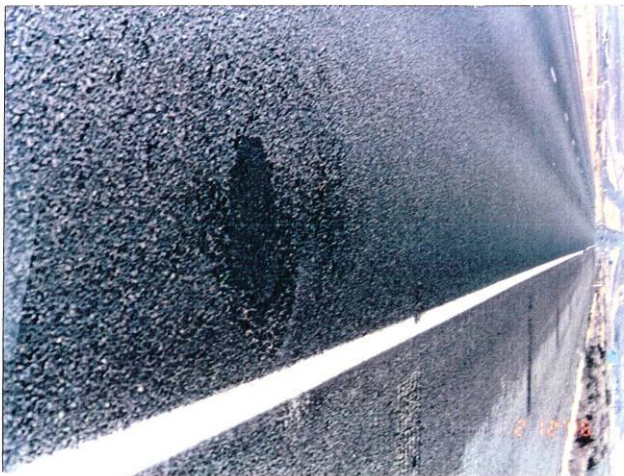
**Photo 20, MP 195.75, Eastbound Truck Lane
Isolated pothole. Stripping occurs almost full
thickness.**

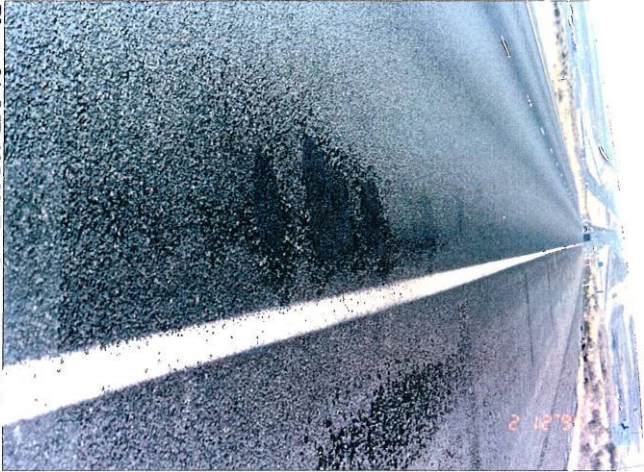
Photo 21, MP 195.90, Eastbound Truck Lane
Isolated pothole. Stripping occurs almost full thickness.

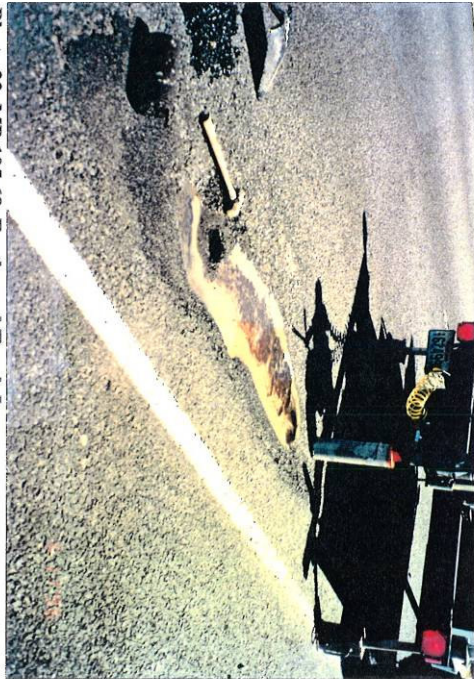
Photo 22, MP 195.68, Eastbound Truck Lane
Isolated pothole. Stripping occurs almost full thickness

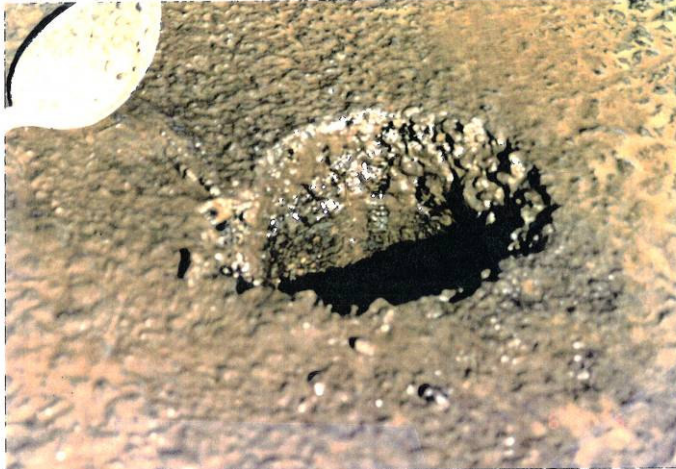
Photo 23, MP 194.88, Eastbound Truck Lane
Stripping occurring within the top 0.25 to 0.30 ft of MCD and Class D.

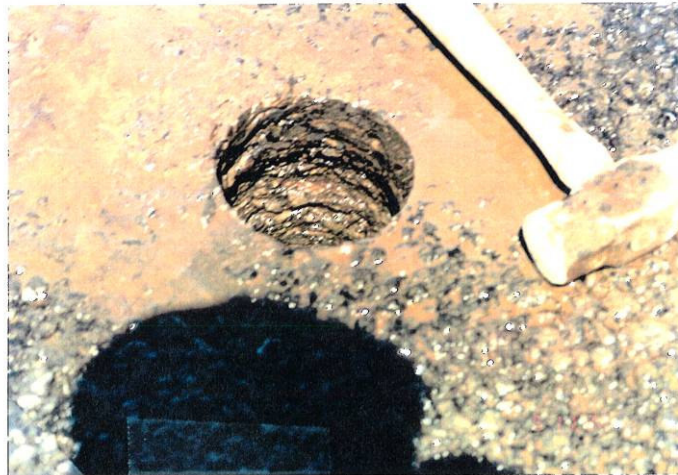
Photo 24, MP 195.68, Eastbound Truck Lane
Core taken within a pothole. Stripping is deep seated.

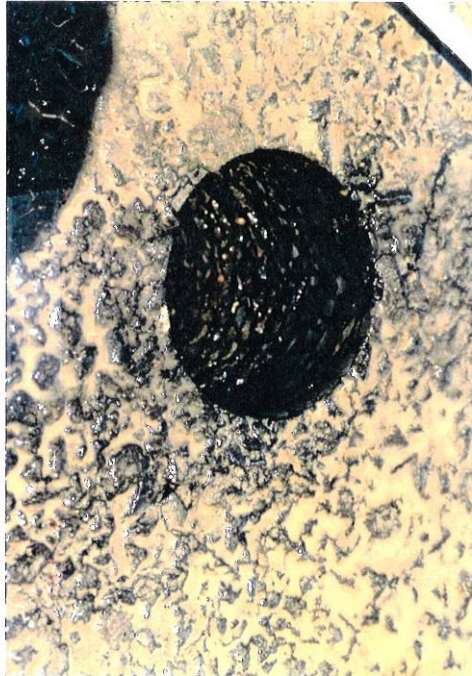
**Photo 25, MP 195.79, Eastbound Truck Lane
Core taken within a pothole. Stripping is deep seated.**
