Revisiting Aloha Airline Flight 243: Corrosion Engineer's Stand point

Mr Nauman Hashmi

School of chemical and materials engineering, National University of
Science and technology, Islamabad, Pakistan

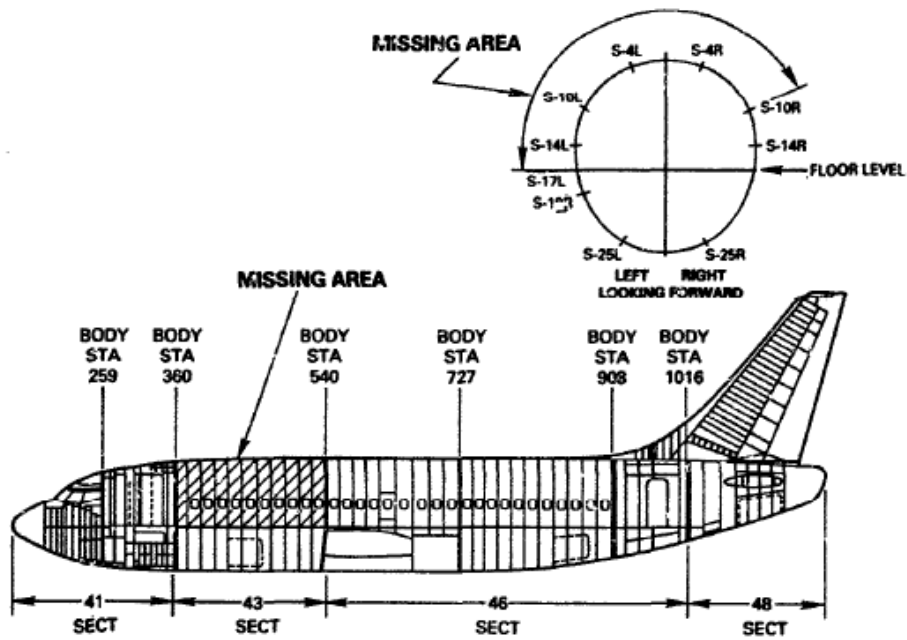
7. As per (National Transportation Safety Board, 1989, p. 5), a major portion of upper crown skin and structure of section 43 separated in flight causing an explosive decompression of the cabin. From NTSB stand point, explosive decompression in this case refers to violent expansion and noise from cabin air released under pressure rather than the effect of a chemical explosive device. From (National Transportation Safety Board, 1989, p. 5) point of view, the damaged area extended from aft of main cabin entrance door, rearwards about to 18 feet to the area just forward of the wing and from left side at the cabin floor level to the right side window level. The airplane was worth at an estimated cost of 5 million US dollars. As a result of accident it was determined as damaged beyond economic repair and was dismantled and sold in scraps and parts. The visual illustrations of the damage are depicted below in the figures.

Figure 2: Schematics of Damage Cause to Aloha Airline Flight 243 (Source: (National Transportation Safety Board, 1989, p. 6)

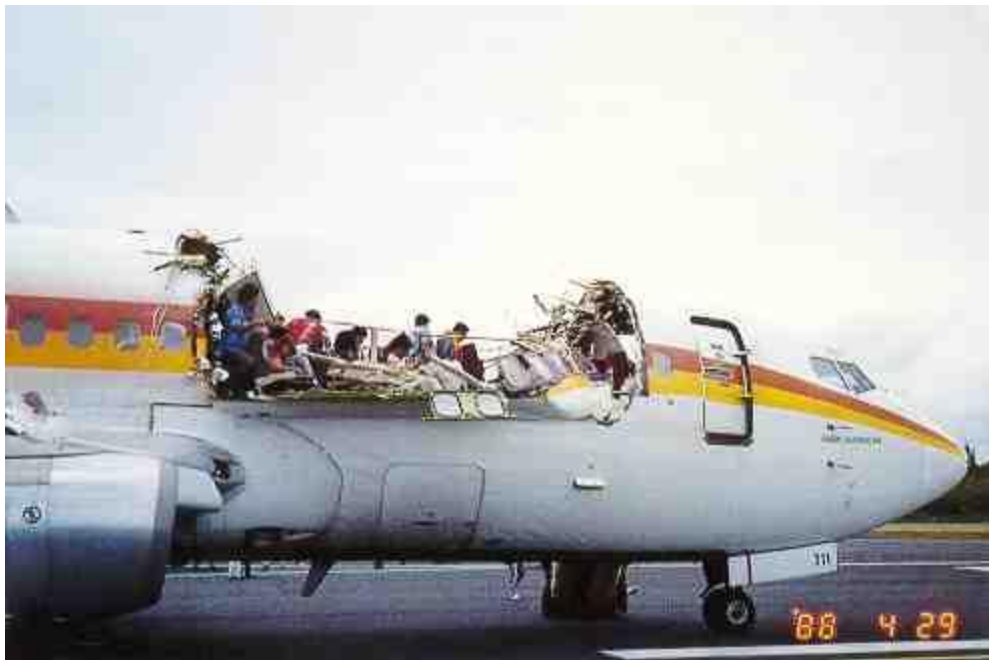
Figure 3: Damage to the right hand side of Fuselage of Aloha Airline Flight 243

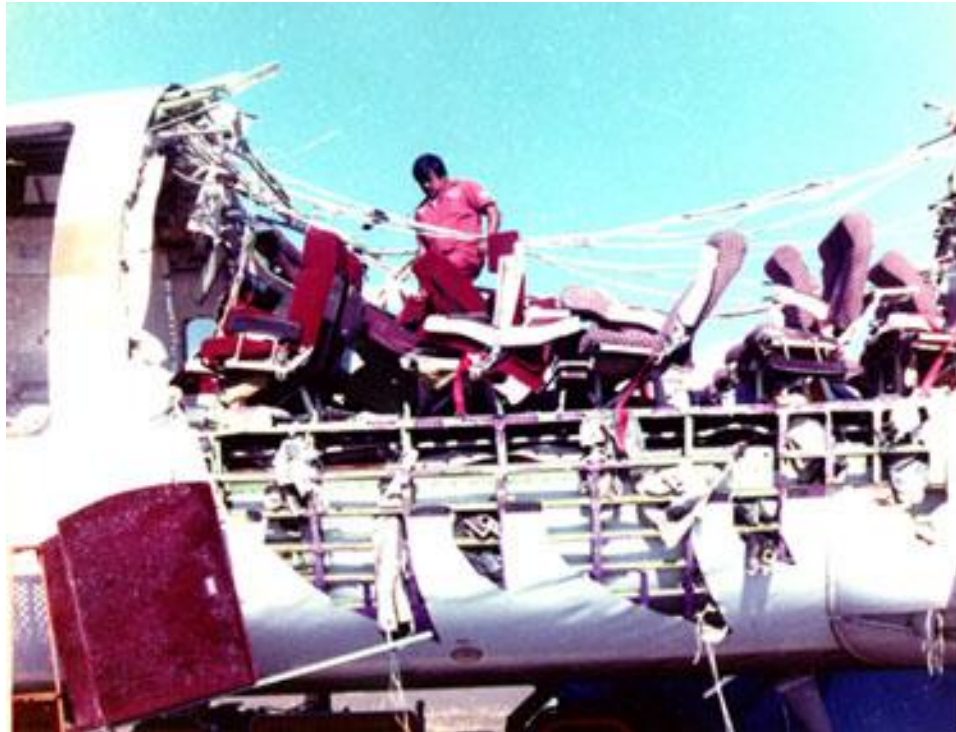
Figure 4: Damage to the Left Hand Side of Aloha Airline Flight 243

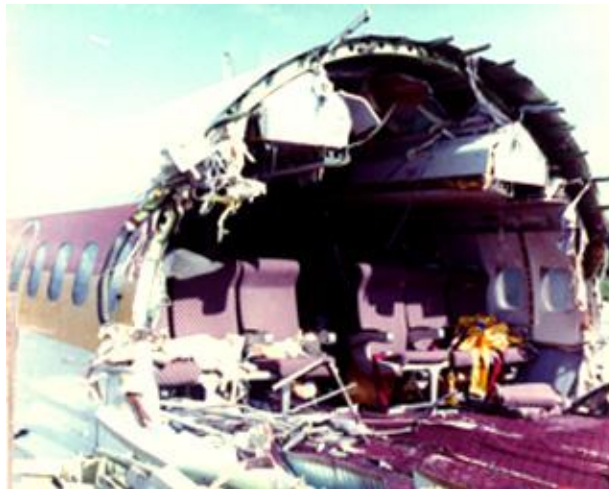
Figure 5: Front view of Damaged Aloha Airline Flight 243 fuselage

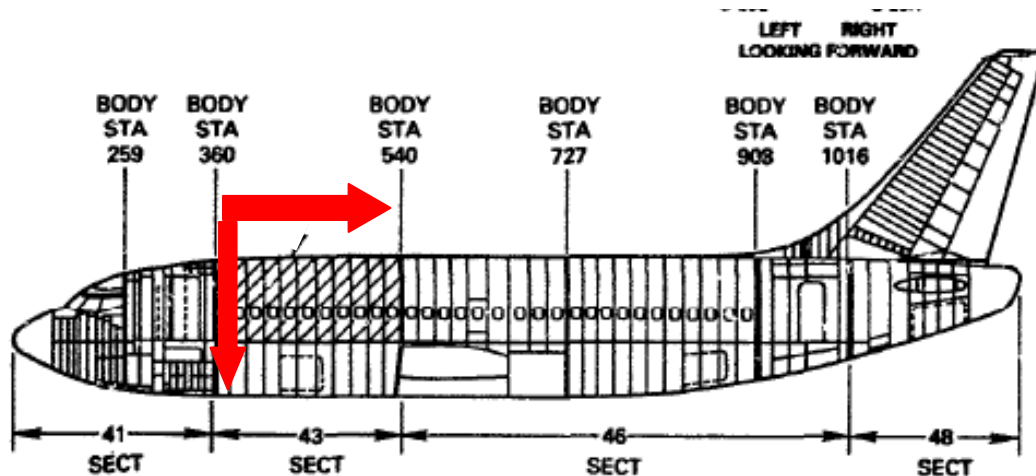
8. As per (National Transportation Safety Board, 1989, pp. 8-10), the skin of the aircraft from body station 360 till body station 540 was peeled from the structure in down and aft direction. The direction of damage on aircraft station is illustrated below in the figure.

Figure 6: Damage Direction between Body station 360 & 540

9. According to (National Transportation Safety Board, 1989, p. 9), indications of pre-existing cracks were found in lap joints of S-10L forward of body station 540 and on side of each rivet holes in body station 360 butt strap near S-7R. All other fractures adjacent to the separation area were typical of overstress application.

10. As per (National Transportation Safety Board, 1989, p. 10), fracture surface and the immediate areas surrounding the separation perimeter were generally corrosion free. However, areas of corrosion and dis-bonded surface were noted in joints at body station 360 and 540.

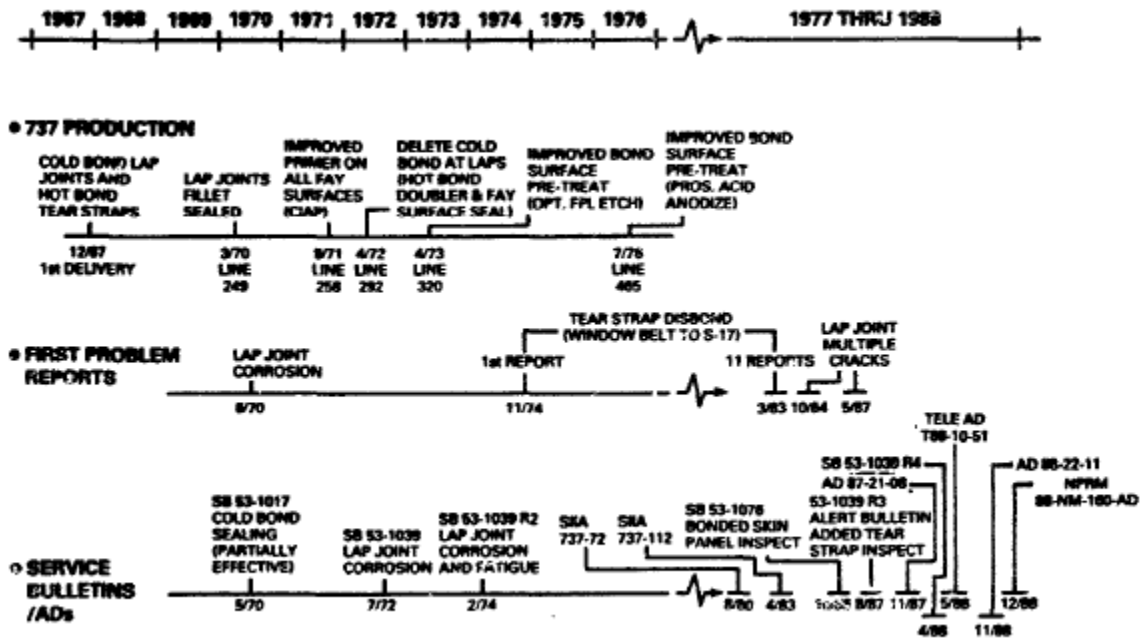
to premature curing of the bond. The presence of such discrepancies can trigger corrosion which can get worst during service due to accumulation of water on these vulnerable sites. The cold bond production process was dis-continued in 1972. The riveted joints were replaced by using chromated polysulfide sealing compound without any bonding. The production process was implemented from production serial number 292 onwards. From Boeing's point of view, the dis-bonding caused direct transfer of fuselage hoop stresses to the counter sunk rivet holes and ultimately triggers fatigue crack initiation and propagation. In cylindrical fuselage like 737 the amplitude of circumferential hoop stresses is greater than the longitudinal stresses, the crack propagation takes place perpendicular to the direction of hoop stresses. In case of Boeing 737, the fatigue cracks were expected to initiate in the outer layer of skin and not to the underlying skin panels due to absence of counter-sunk holes. Random cracking of lap joints were reported by Boeing 737 users. The rate of crack propagation was dependant on degree of dis-bonding, accumulation of full pressurization cycles and environment of operation. The reports of cracks appearance is illustrated in a historic time line in figure illustrated below.

Figure 9: Historic Time line of Lap joints crack appearance on Boeing 737 fuselage

18. According to (National Transportation Safety Board, 1989, p. 20), Boeing issued several service bulletins (SB's) to address the issue. The earliest of which was issued in May 13, 1970 under the heading of "Sealing of Cold Bonded structure for Corrosion Protection" bearing SB 737-53-1017. A follow up SB, bearing number SB 737-53-1039 was issued on July 19, 1972 which addressed the area of lap joint corrosion and repair in the first 291 produced planes. In 1974, a revision was issued which stated, "In most instances these areas are identified only after corrosion caused exterior bulges, cracks on missing fasteners" and prolonged operations with de-lamination (dis-bonded) would lead to fatigue cracking. The details of corrosion and fatigue inspections were also stipulated. However, the Federal Aviation Authority (FAA) never classified it as mandatory. In 1987, the status was upgraded to alert and was to be complied before

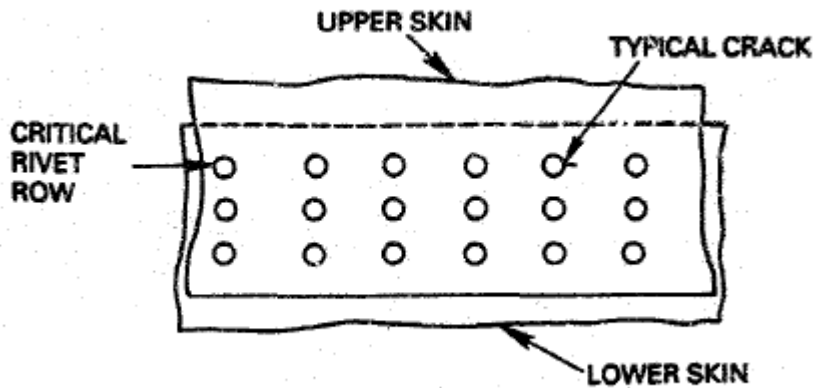
22. According to (National Transportation Safety Board, 1989, p. 30), the lap joint sample S-4R between BS 360 and 420 was found having extensive fatigue cracking. The longest crack was found to be of 0.27 inches. The entire cold bonded lap joint had become dis-bonded. Light to moderate and severe corrosion was noticed on different areas. The lap joint of S-4L from BS-727 to 747 and 847 and 867 also showed fatigue cracking in the skin adjacent to rivet holes. The laboratory examination further revealed that only a crack larger than 0.08 inch can be detected by stipulated eddy current contrary to Boeing's claim of 0.04 inch. Boeing also performed the striation counts on seven crack samples. The data acquired from these counts is illustrated below in the figure.

Figure 12: Typical Crack Appearance on Lap joint (Source: **(National Transportation Safety Board, 1989, p. 32)**)

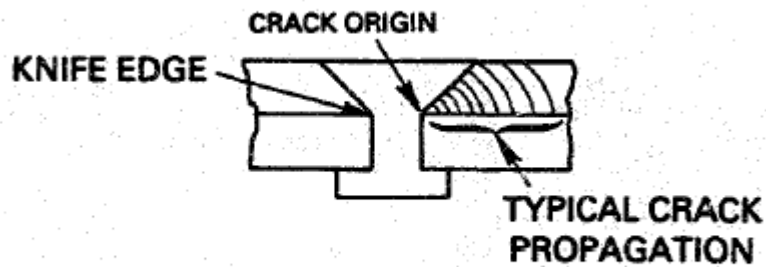
Figure 13: Typical Crack origination site on Lap joint (Source: **(National Transportation Safety Board, 1989, p. 32)**)

24. According to (National Transportation Safety Board, 1989, p. 47), the accident sequence initiated with the separation of the pressurized fuselage skin. This separation led to an explosive decompression which further caused the separation of upper lobe of section 43 of the cabin. The post accident examination of the structure revealed that the remaining intact structure did not contain the origin of the failure. The main exhibit was not recovered despite the extensive sea and ground search. The origins of failure were deliberated on the basis of remaining structure and the air worthiness history of the airplane. The available evidence suggested that the origin of the fuselage separation was initiated from lap joint S-10L near BS-440. NTSB also concluded that the tear strap dis-bonding also resulted in failure of expected controlled decompression of the airplane which was anticipated by designers. The multiple sit damage (MSD) also resulted in multiple cracks. The dis-bonding of cold lap joints would result into transfer of loads

directly to the counter sunk rivets holes. The presence of knife edge in these rivet holes would result in to a stress concentration area making it susceptible to fatigue cracking.

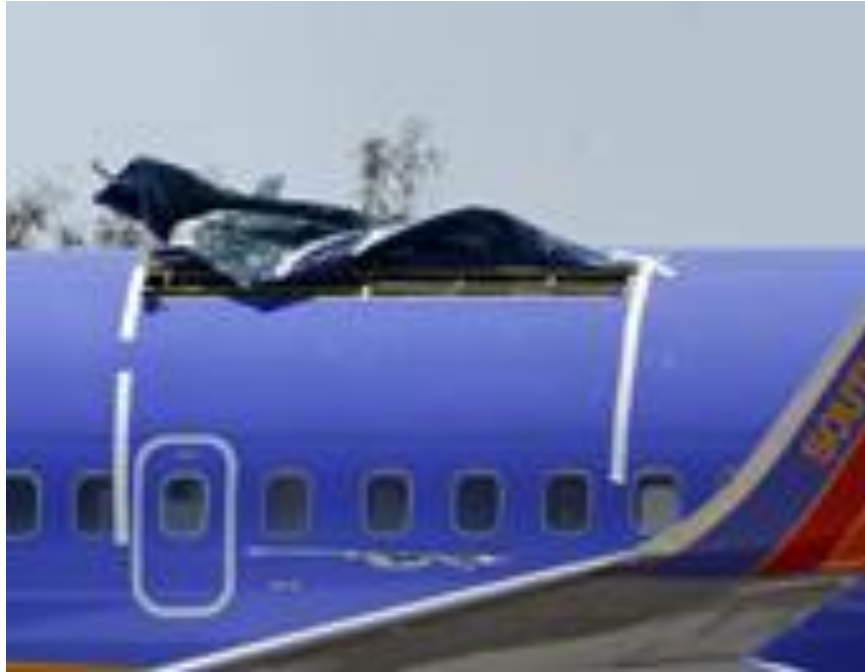
fuselage skin panel on South West Airline Flight 812. As per (Dubios, 2011), Boeing has further reduced the inspection cycle to 30000 flight cycles.

Figure 14: South West Airline Flight 812 with fractured skin on fuselage (Source: **(Boylan, 2011)**)

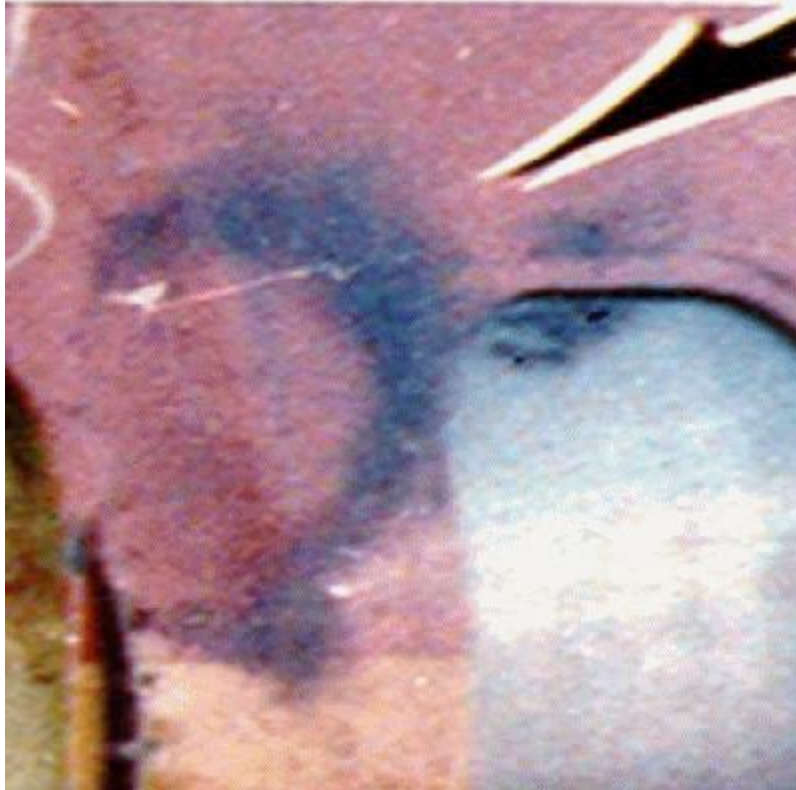
Figure 15: Blood Stains photograph that forms the Basis of Austin's fluid hammer theory
(Source: **(Austin, 2001)**)

34. According to (Austin, 2001), these blood stains are a tell tale story of what might had happened at Aloha airline flight 243. These stains were actually the silhouette of the only casualty of the flight, C B Lansing's skull. From Austin's point of view, these stains are not explained properly in the inquiry and are misunderstood. Due to these reasons the NTSB investigation cause is out rightly wrong. From Austin's point of view, the separation sequence started at BS 500 instead of BS 340. The flight attendant standing at row 5 was sucked in the tear opening, blocking the controlled decompression. This blockage led to the increase of the pressure inside the hull and eventually its failure. A pictorial illustration of Austin's theory is illustrated below.

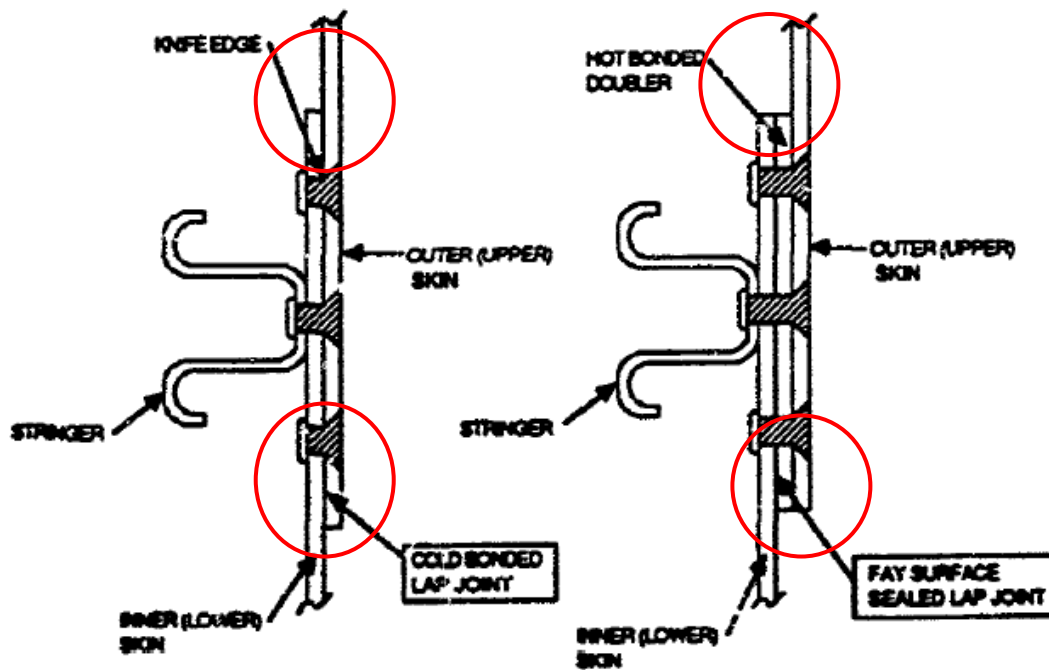
Figure 26: Boeing Lap joint design and proposed point of protection

52. Boeing may like to consider sealing of the lap joints by using either a sealant or some rubber covering. The configuration used by Boeing in lap joints is susceptible to moisture accumulation and stagnation conditions which can trigger localized corrosion. During the design of these protective covers/sealing, a curvature may also be given to these surfaces to enable a better water drainage. The lap joints used on Boeing and their proposed protective covering point is illustrated below.
