Investigation of Steel-Stringer Bridges: Superstructures and Substructures, Volume II

Final Report
October 2007

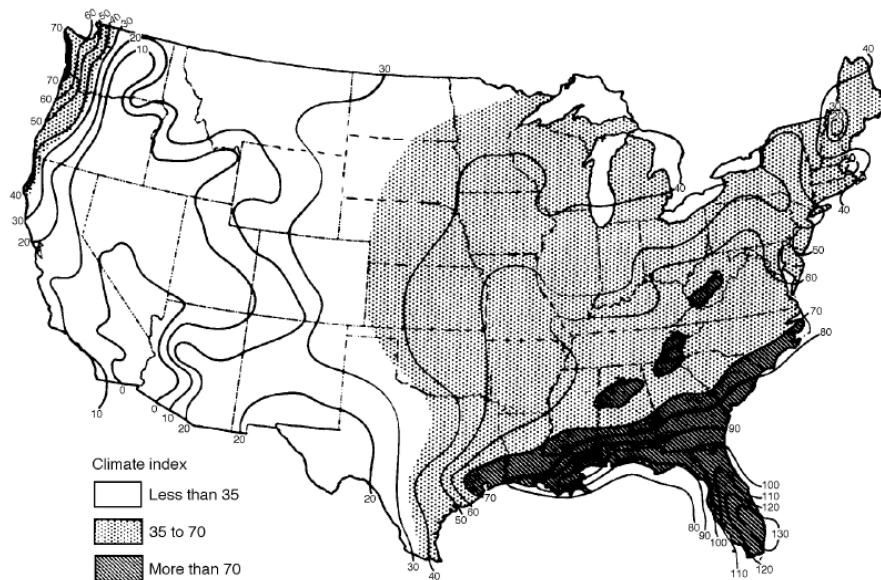
Figure 2.1. Climate index for decay hazard. Higher numbers indicate greater decay hazard (USDA 1999)

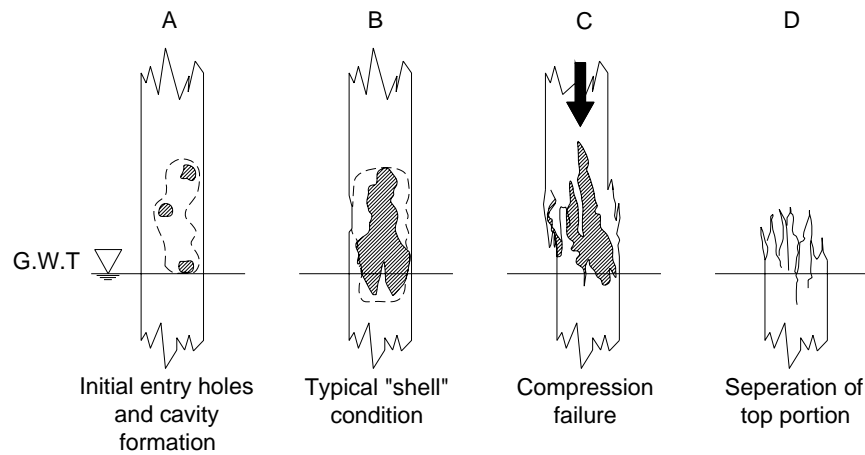
Figure 2.2. Stages of timber pile deterioration by overloading (reproduced from Buslov and Scola 1991)

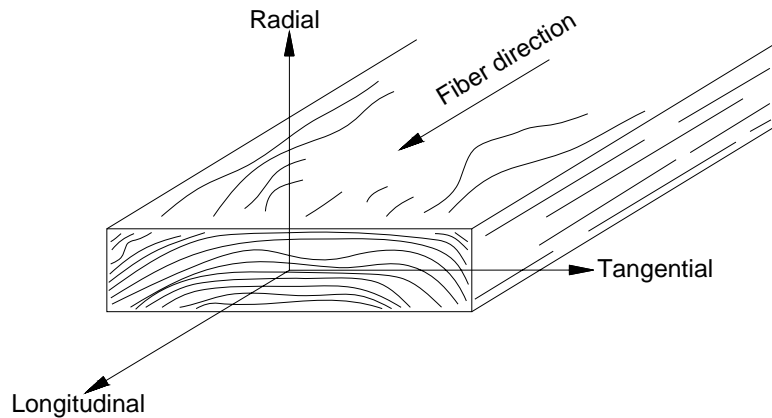
Figure 2.3. Three principal axes of wood with respect to the grain and growth rings (modified from USDA 1999)

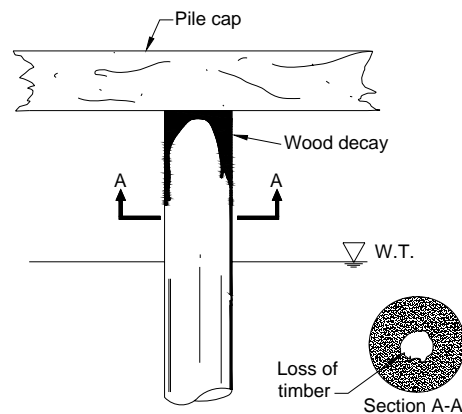
Typical rot and fungi damage

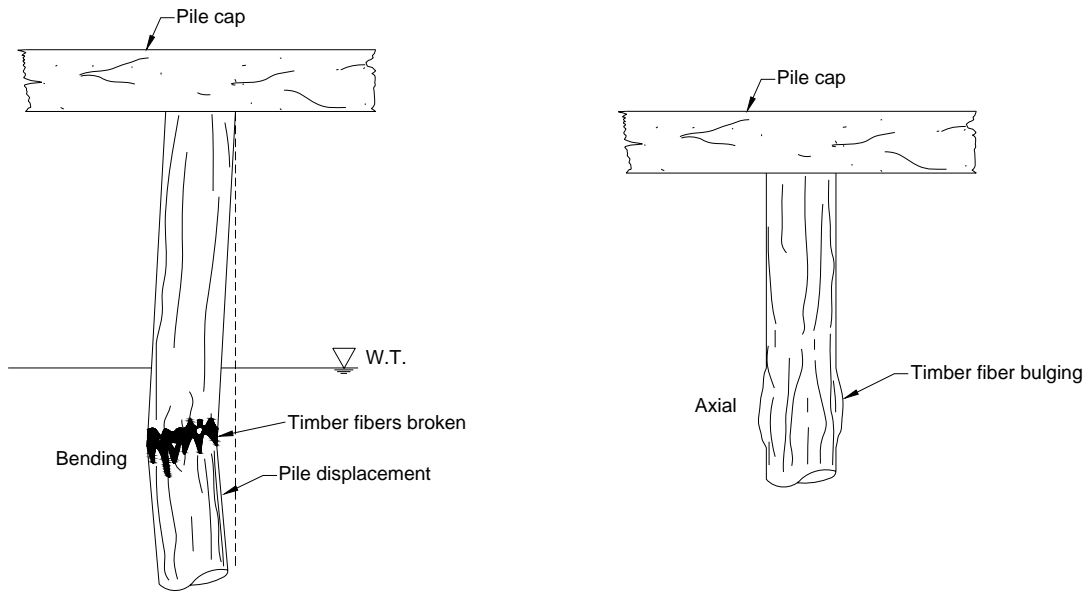
(a) Typical damage due to overloading of piles

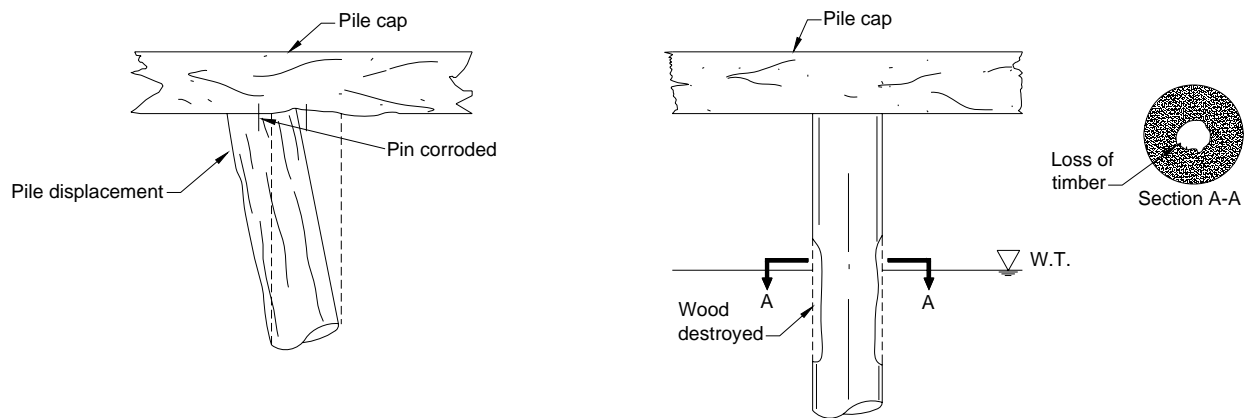
(b) Typical movement caused by failure of connection

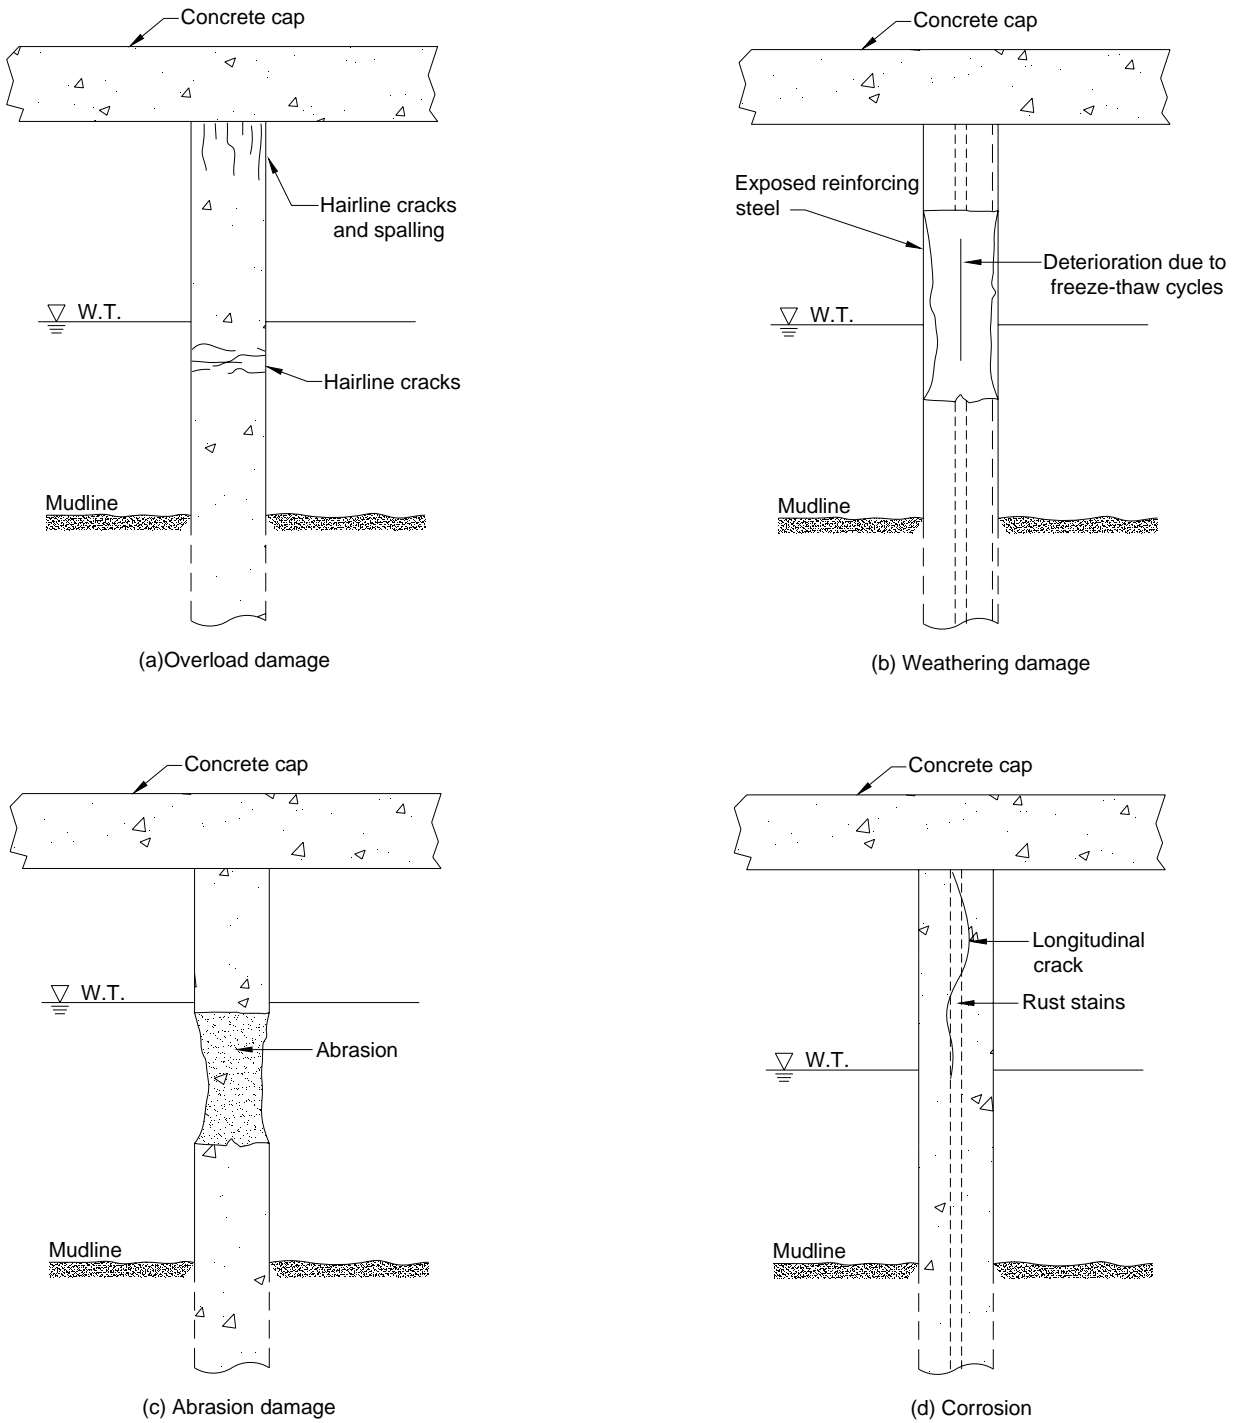
Figure 2.6. Typical damage of concrete piles from physical sources (reproduced from U.S. Army Corps. Of Engineering et al. 2001)

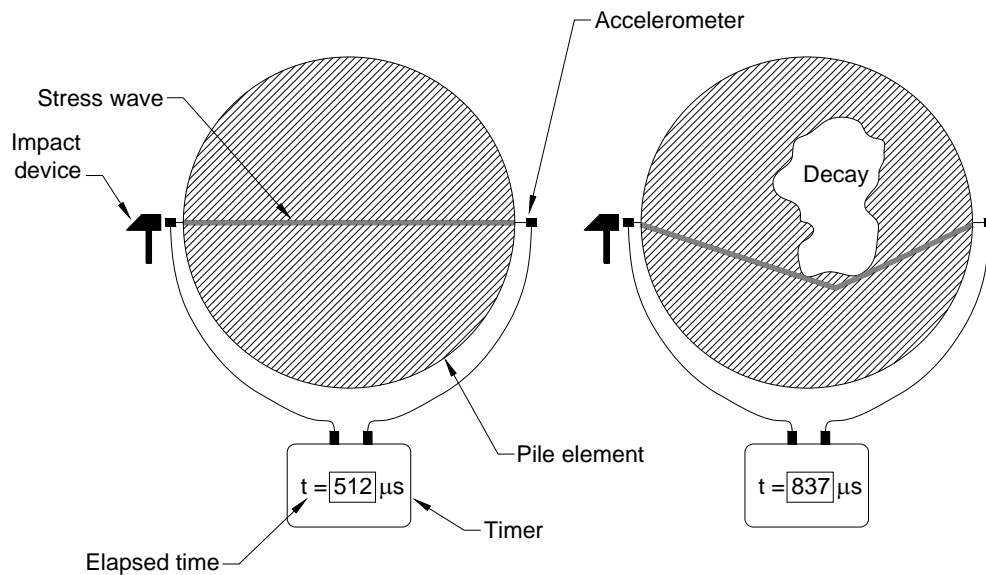
Figure 2.7. Concept of stress wave timing for detecting internal decay (modified from Wang et al. 2004)

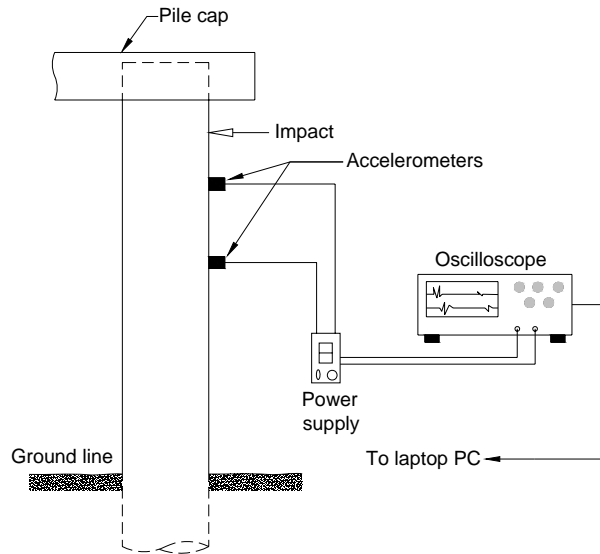
Figure 2.8. Dispersive wave propagation field test setup

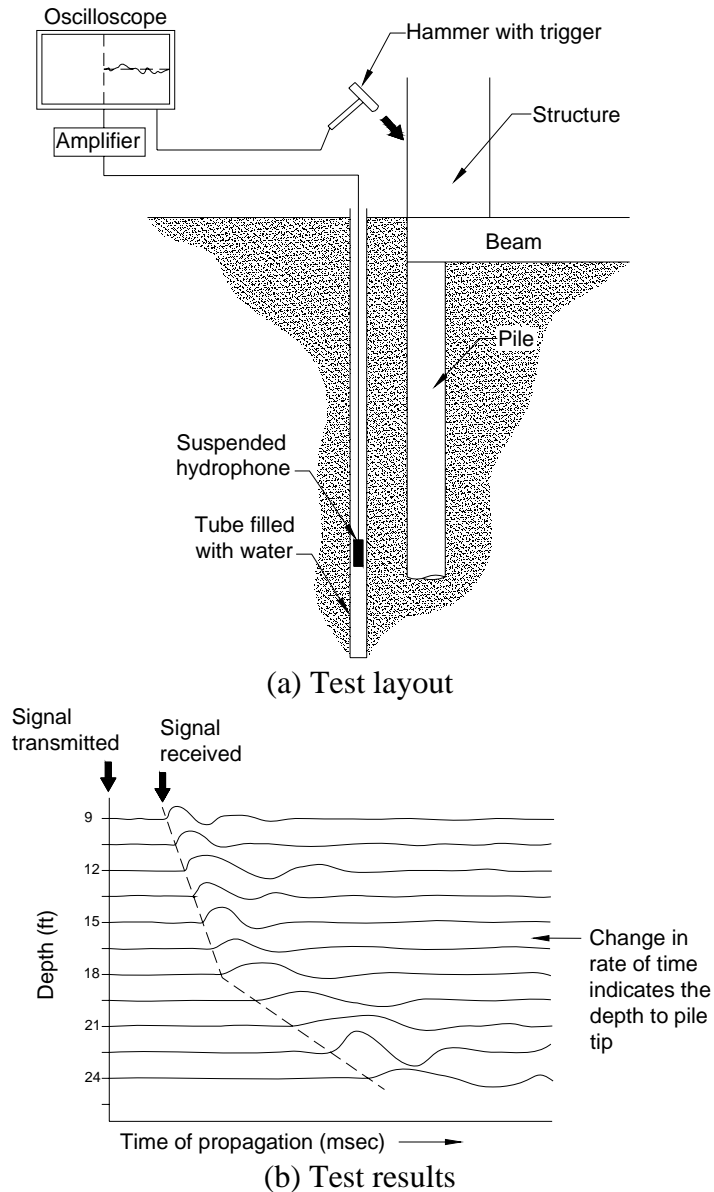
Figure 2.10. Principle of parallel seismic test (reproduced from Davis 1995)

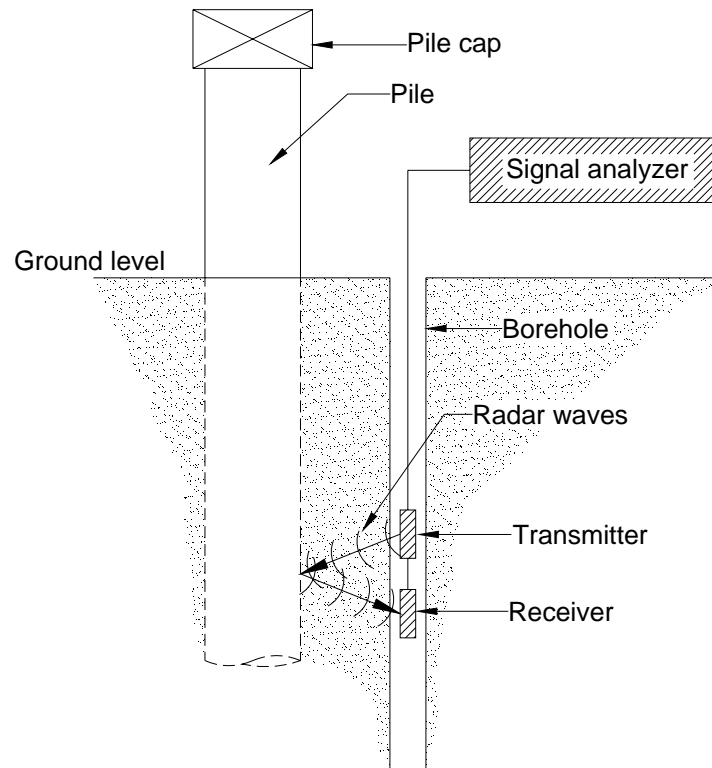
Figure 2.11. Borehole radar system (reproduced from Wightman et al. 2003)

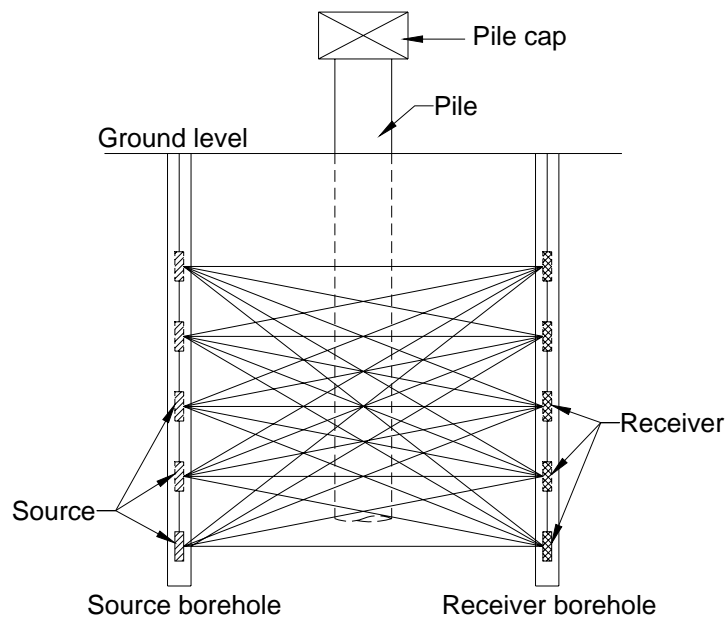
Figure 2.12. Tomographic survey design (reproduced from Wightman et al. 2003)

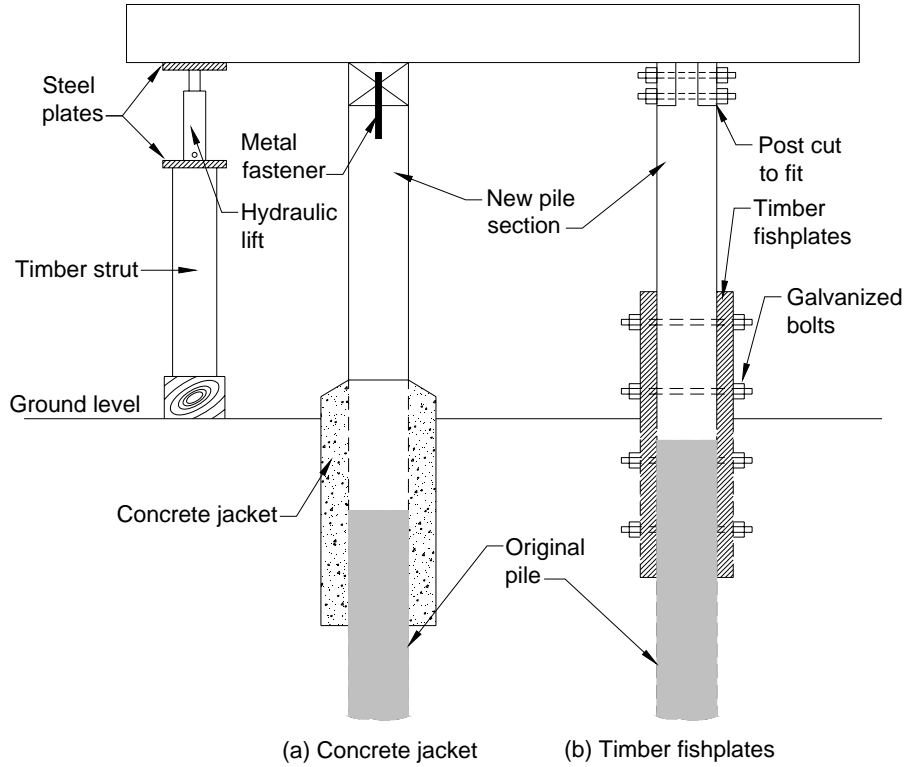
Figure 2.14. Splicing timber piles using concrete jacket or timber fishplate (Wipf et al. 2003a, and U.S. Army Corps. of Engineers et al. 2001)

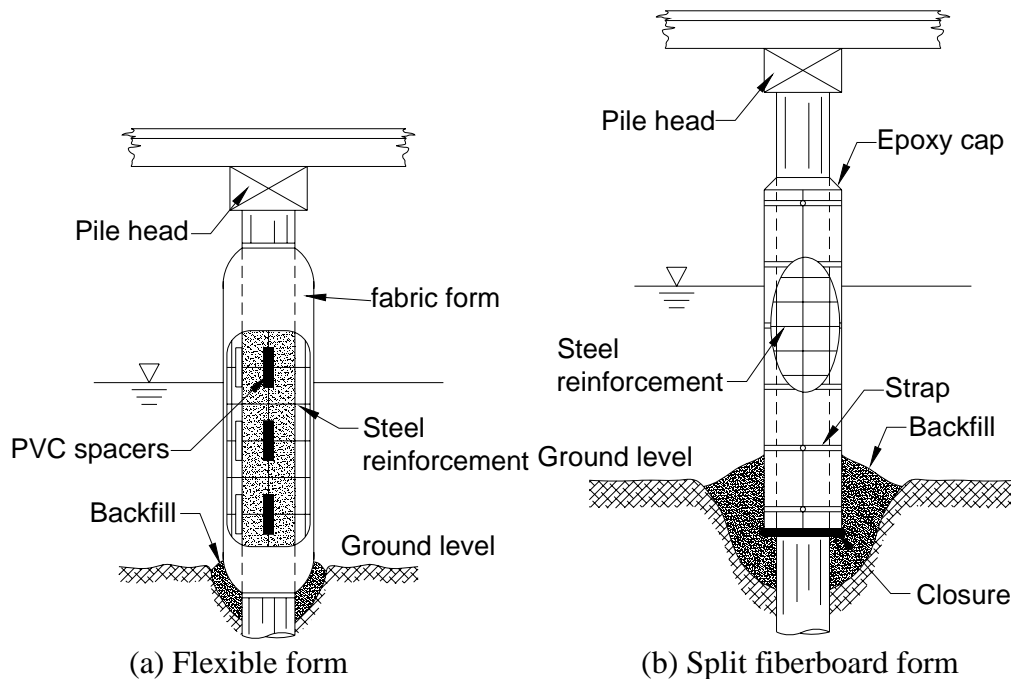
Figure 2.16. Concrete encasement repairs to timber, steel or concrete piles (U.S. Army Corps. of Engineers et al. 2001)

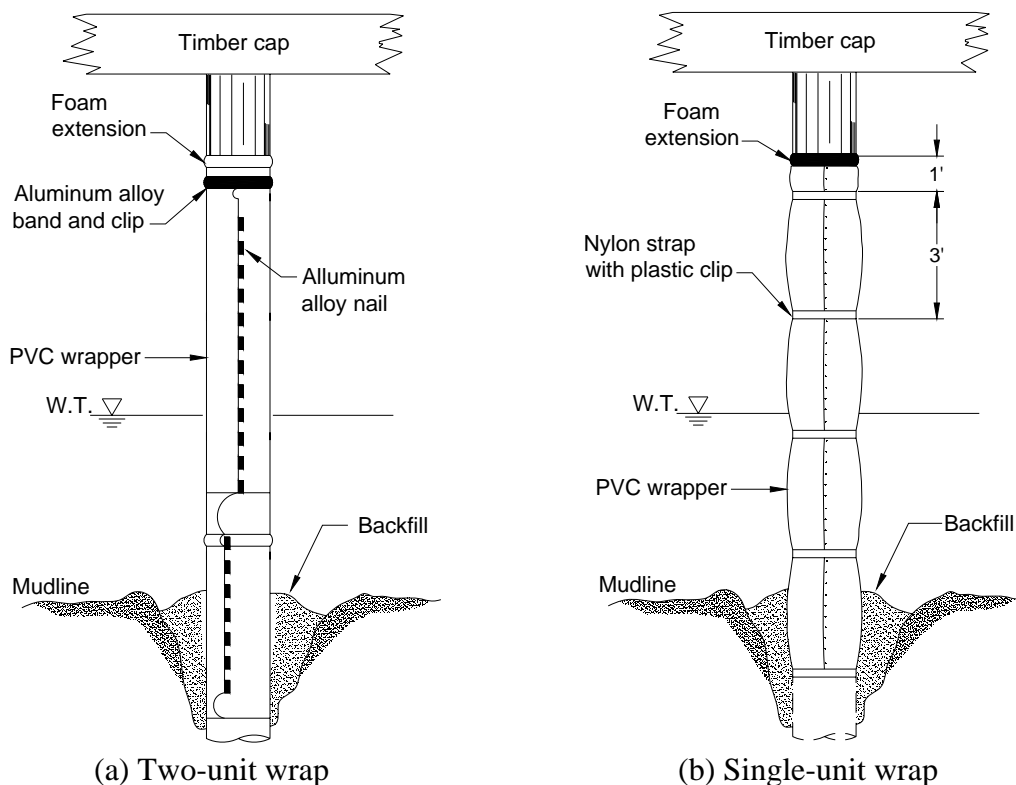
Figure 2.17. Wrapping timber piles with polyvinyl chloride (U.S. Army Corps. Of Engineers et al. 2001)

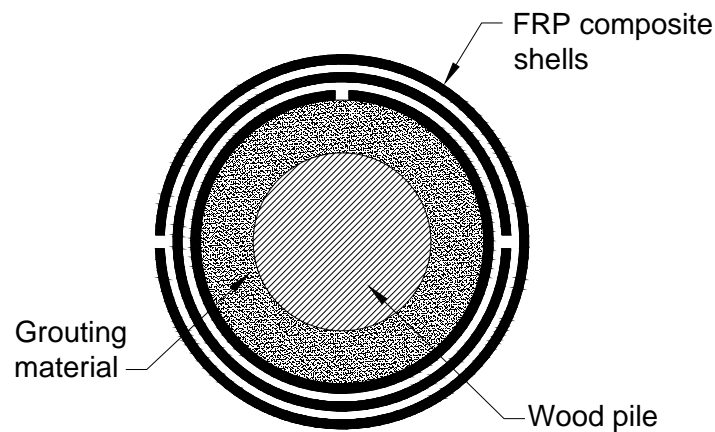
Figure 2.18. Cross section of timber pile repaired with fiber reinforced polymer composite shells (Lopez-Anido et al. 2005)

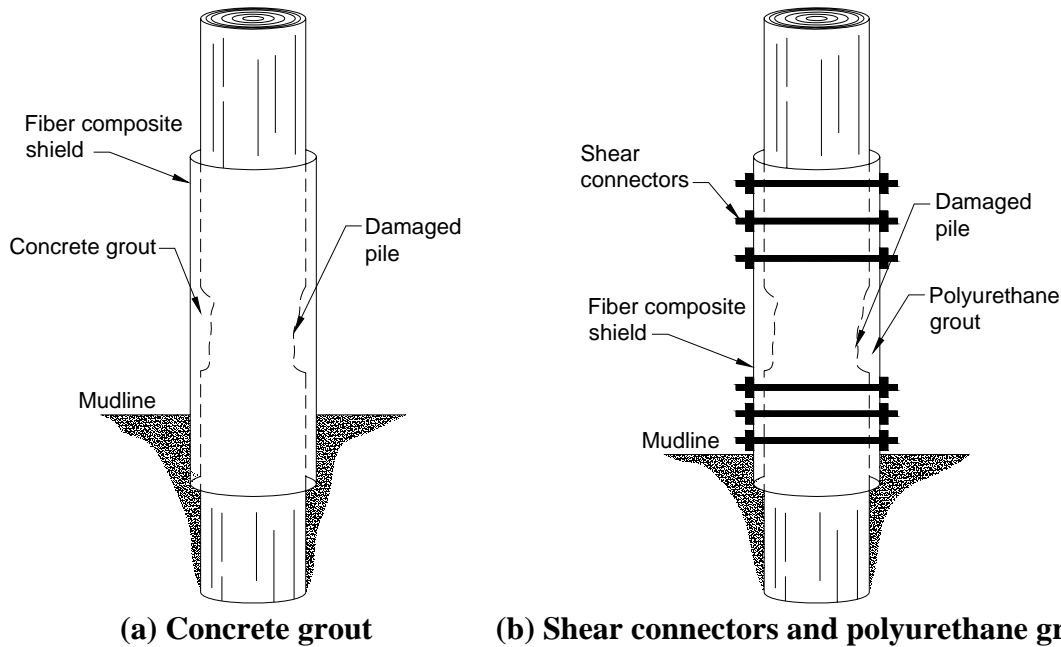
Figure 2.19. Fiber reinforced polymer composite repair system with (reproduced from Lopez-Anido et al. 2005)

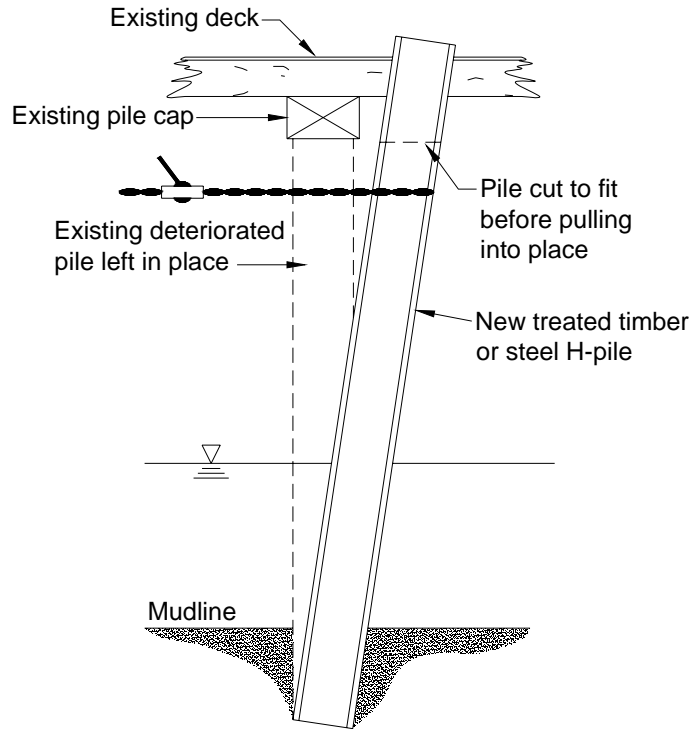
Figure 2.20. Addition of supplemental timber or steel piles (reproduced from U.S. Army Corps. of Engineers et al. 2001)

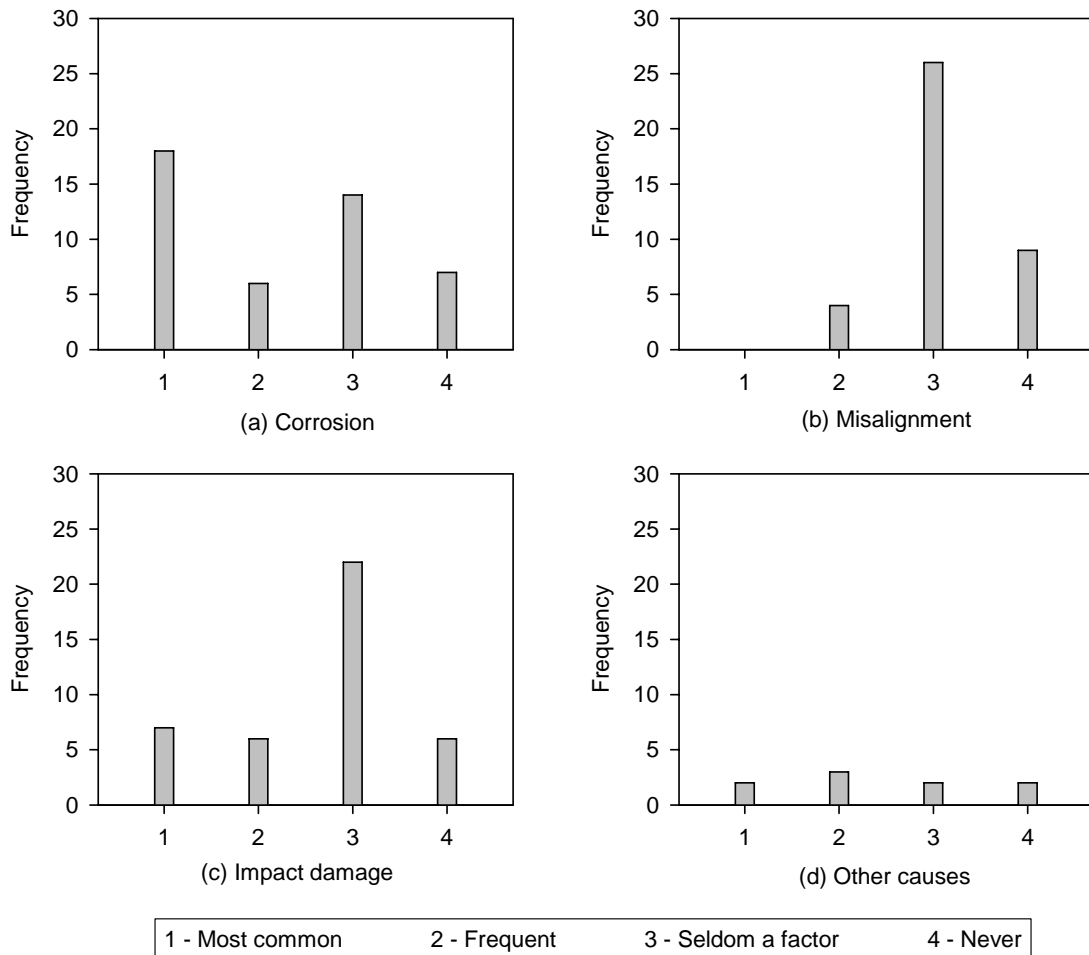
Figure 3.1. Iowa County Engineers rating of common steel pile problems

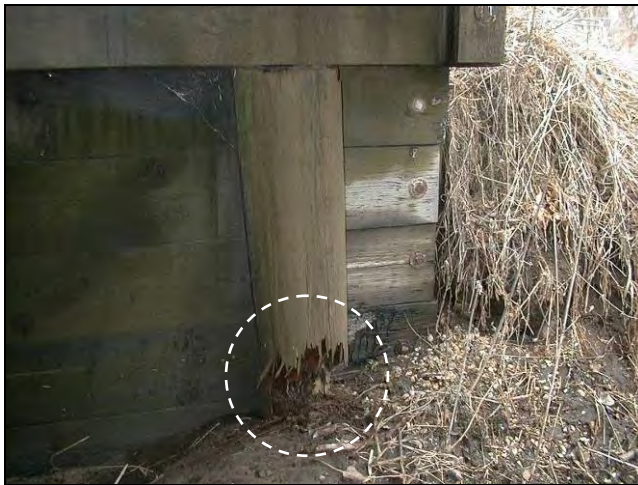
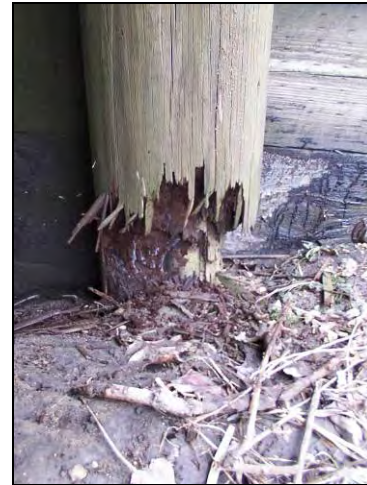
(a) Reduction of pile cross section (Bridge No. 13-42-06 Buchanan County – February 16 2005)

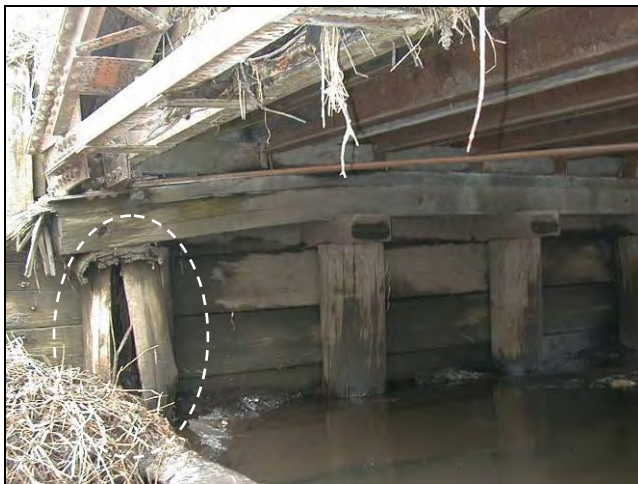
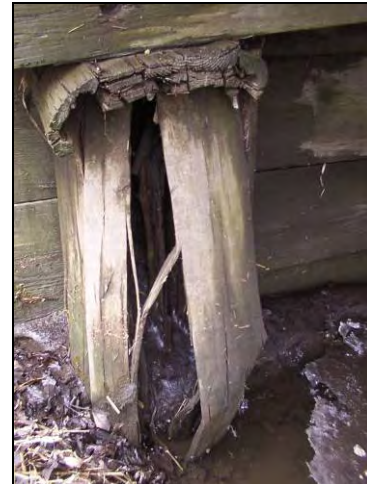
(b) Complete deterioration of pile section (Bridge No. 27-42-00 Buchanan County – February 16 2005)

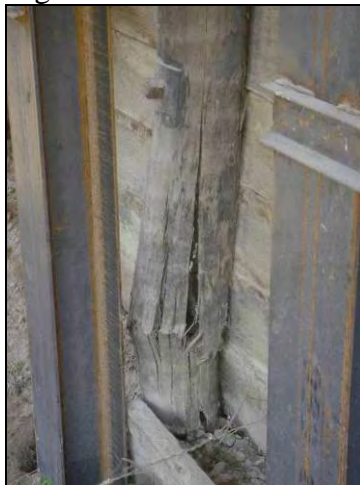
(c) “Mushrooming” of fibers at a hollow section (Bridge No. 23-70-00 Mahaska County – July 8 2005)

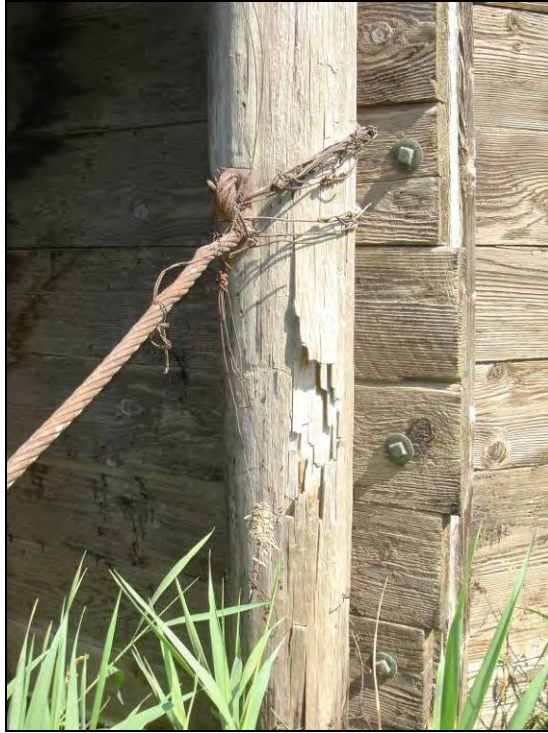
Figure 4.5. Ultraviolet degradation of a timber pile (Bridge No. 23-73-50 Mahaska County – July 8 2005)

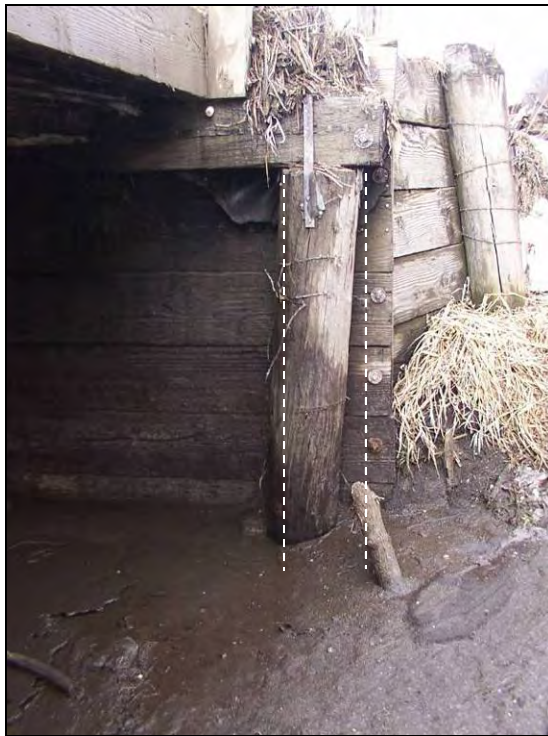
Figure 4.6. Misalignment of a timber pile (Bridge No. 22-00-44 Buchanan County – February 15 2005)

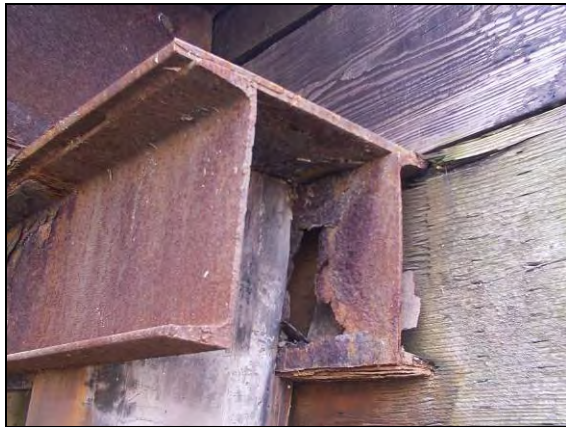
(a) Corroded steel
(Bridge No. 1045 Black Hawk County
– April 2 2005)

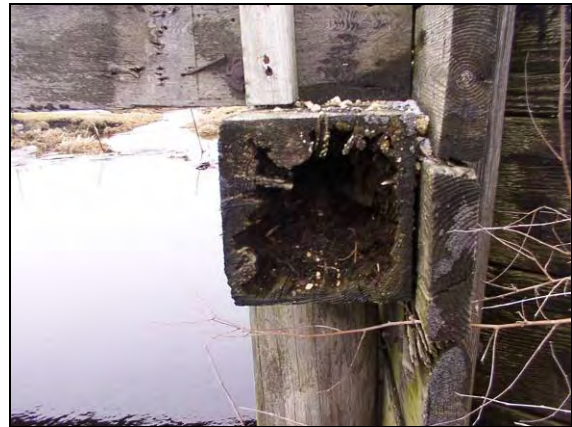
(b) Biologically degraded timber cap
(Bridge No. 15-00-62 Buchanan County
– February 15 2005)

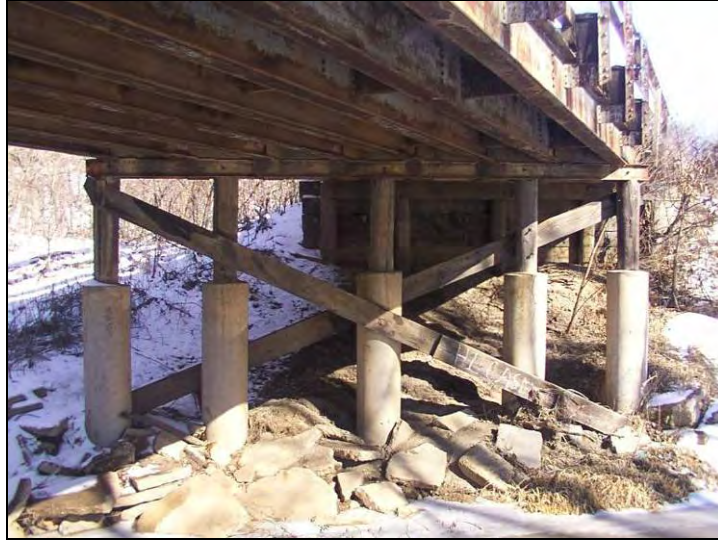
Figure 4.8. Encasing the center piers with concrete for pile restoration (Bridge No. 149 Boone County – February 11 2005)

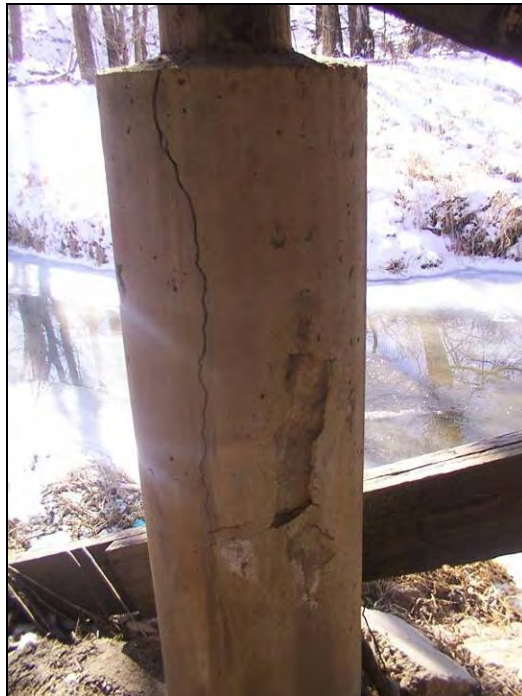
Figure 4.9. Spalling and cracking of concrete casing (Bridge No. 149 Boone County – February 11 2005)

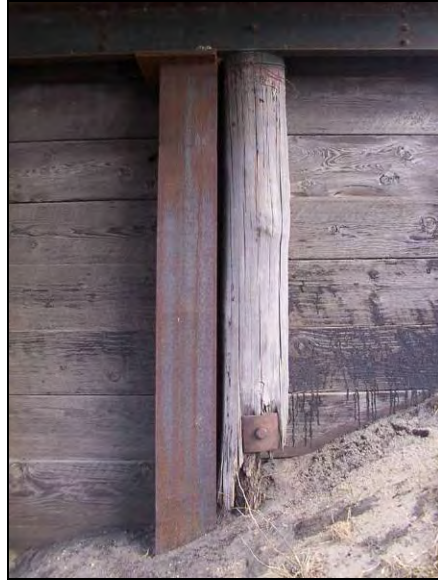
Figure 4.10. New steel pile driven adjacent to defective pile (Bridge on Indian Creek Road Black Hawk County – April 2 2005)

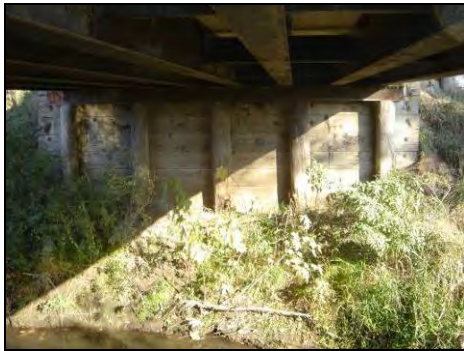
(a) Overview of the north abutment before replacement

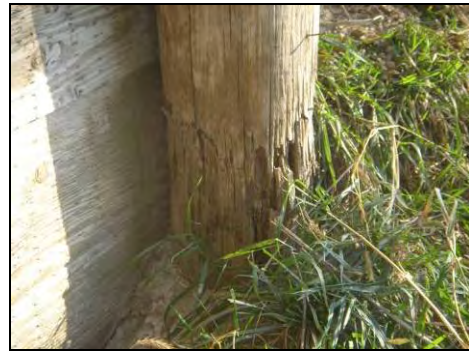
(b) Brooming of pile at the east end of the north abutment

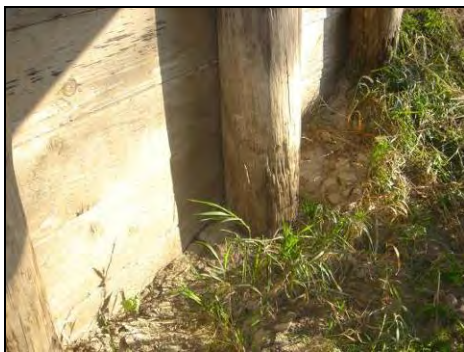
(c) Soft pile section with high moisture near the ground level

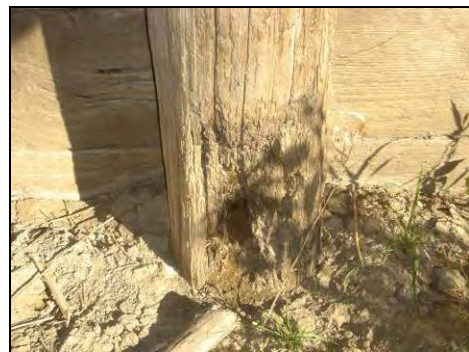
(d) hollow pile section near the ground level

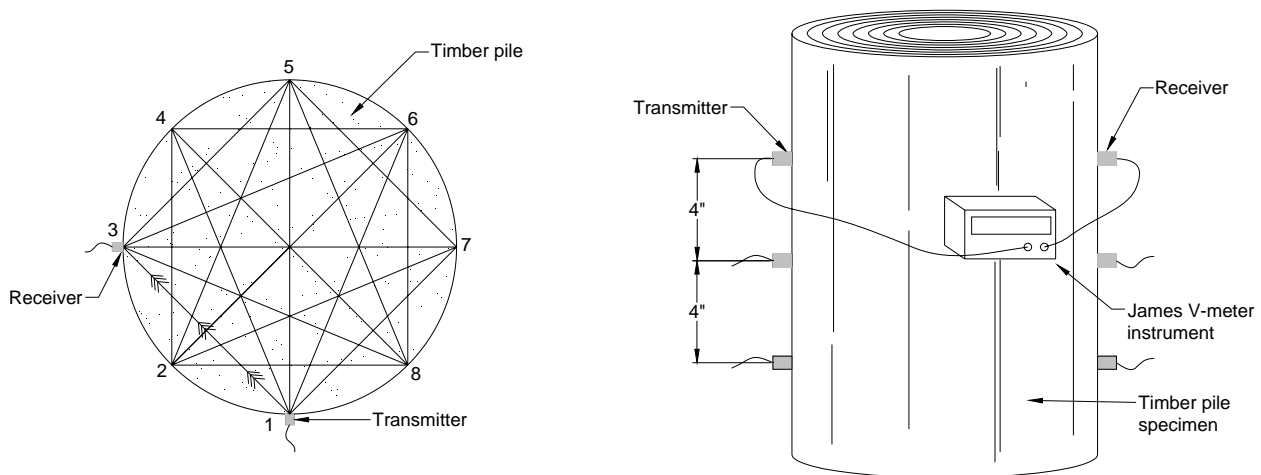
Figure 5.5. Incremental testing to obtain multiple 2 dimensional images

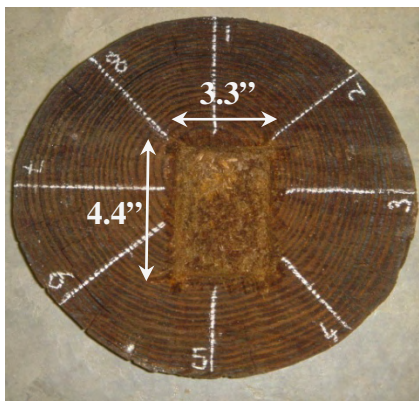
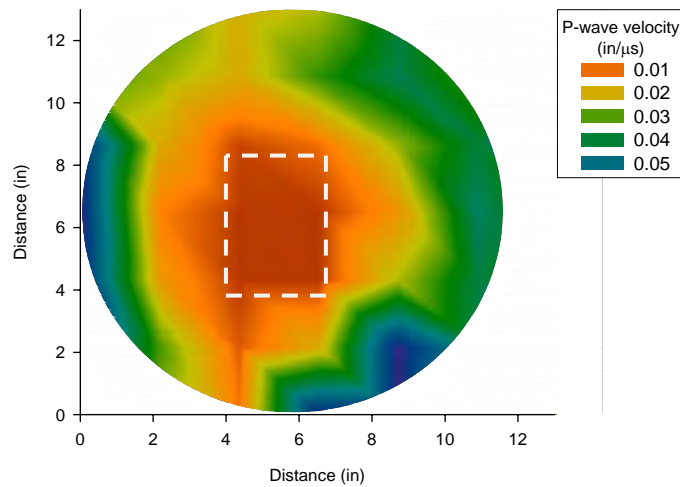
(a) Square cavity; 3.3"x4.4"

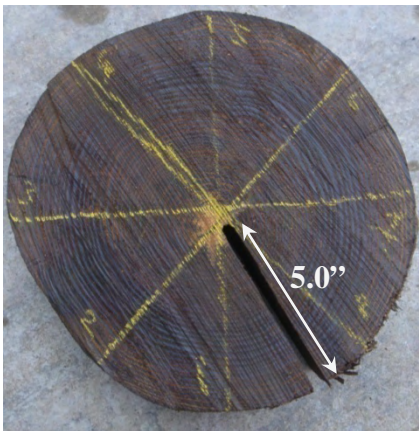
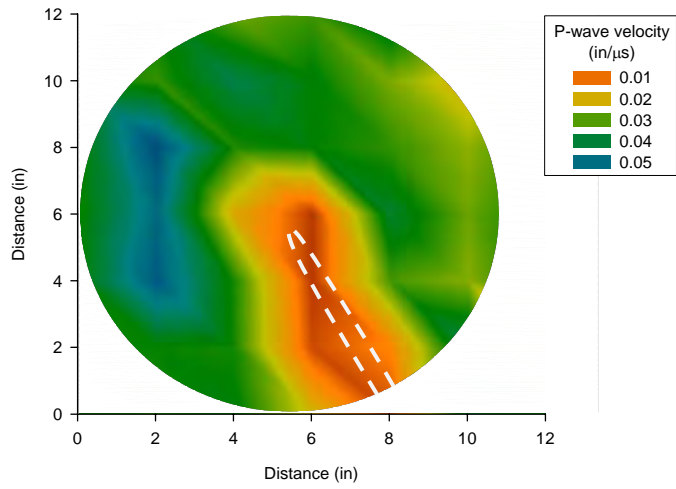
(d) Squared cavity; 3"x3"

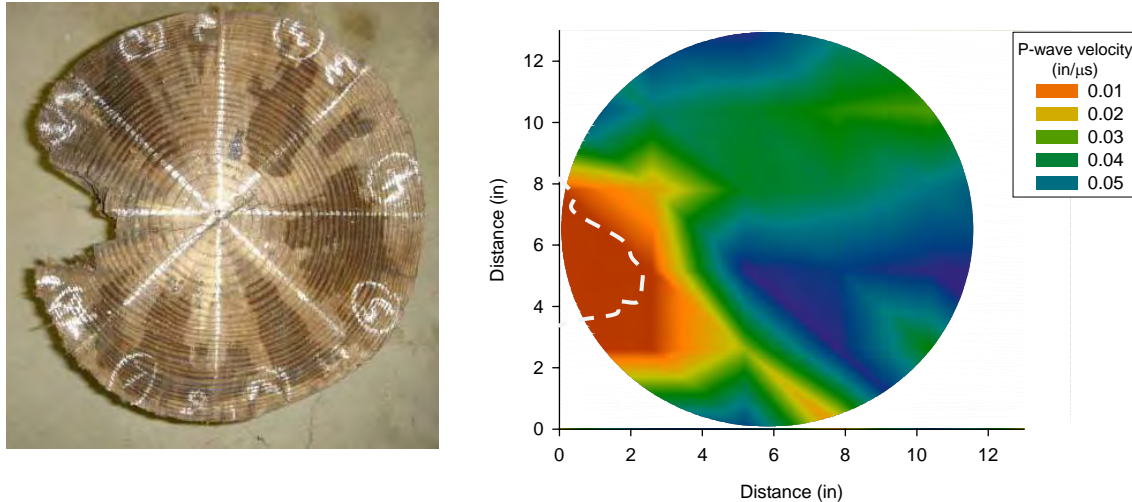
(f) Irregular outer cavity

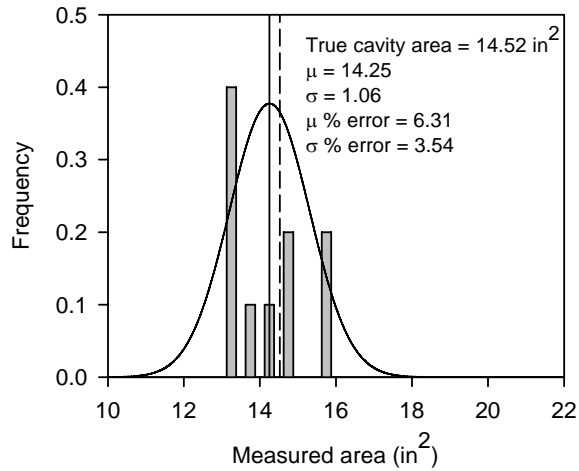
(a) Squared cavity; 3.3"x4.4"

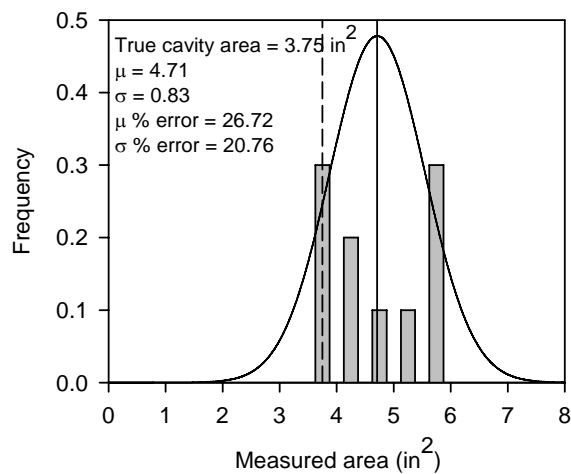
(d) Squared cavity; 3"x3"

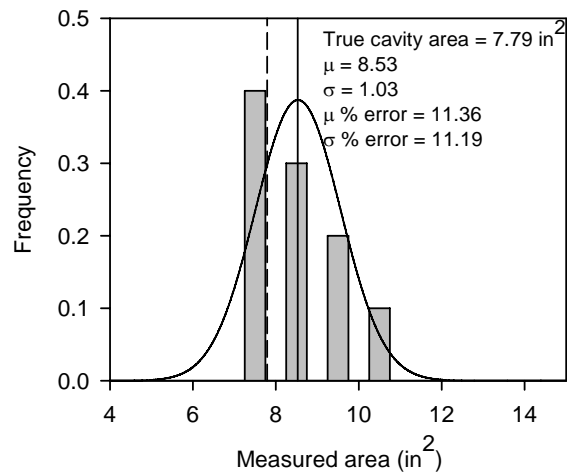
(f) Irregular outer cavity

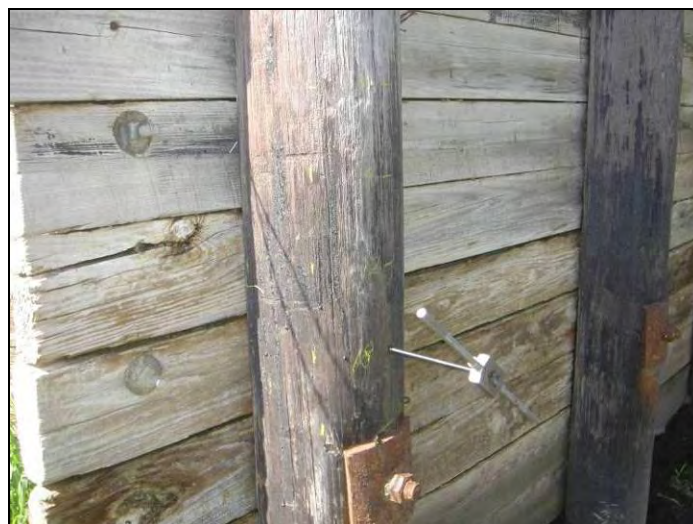
Figure 6.10. Increment borer used to obtain a pile core (Bridge No. 09-46-80 Carroll County – May 12 2006)

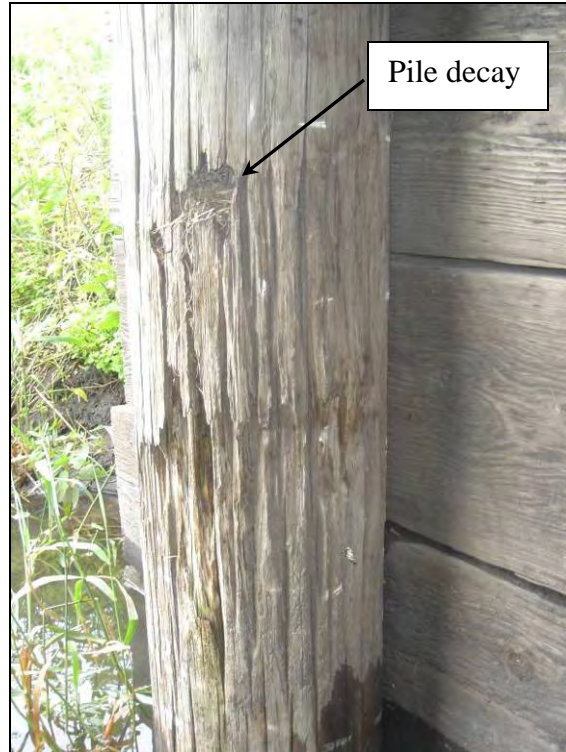
Figure 7.6. Deterioration at pile No. 1 (Bridge No. 7710 Boone County – July 1 2005)

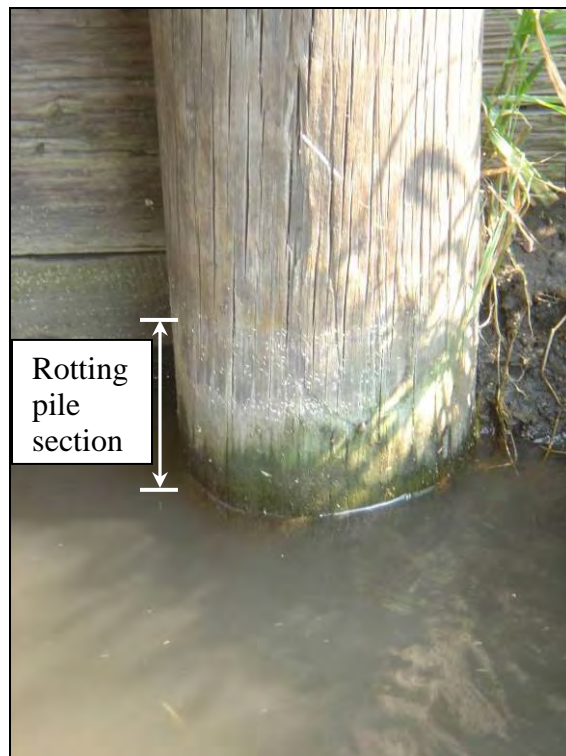
Figure 7.7. Soft section at pile No. 7 above the water level (Bridge No. 7710 Boone County – July 1 2005)

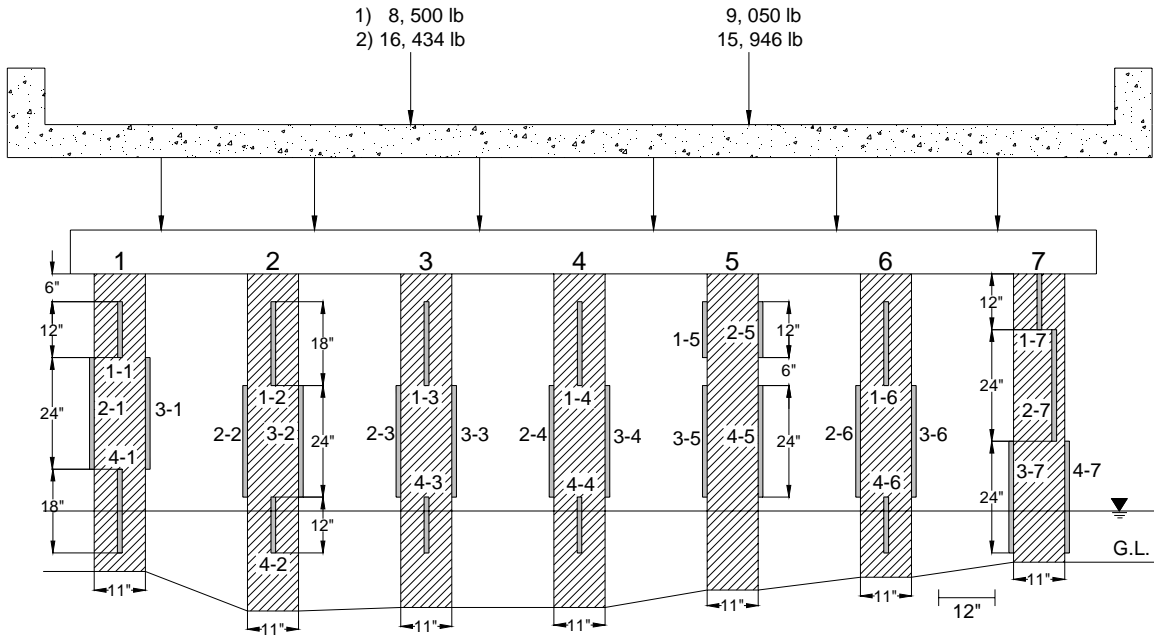
(a) Location of strain transducers and axial loads

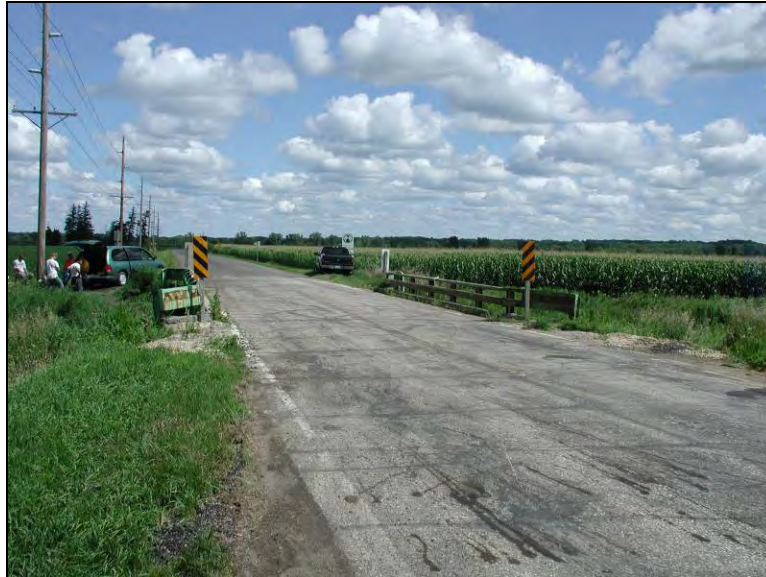
Figure 8.1. North view of Marshall County Bridge No. 243470 (July 22 2005)

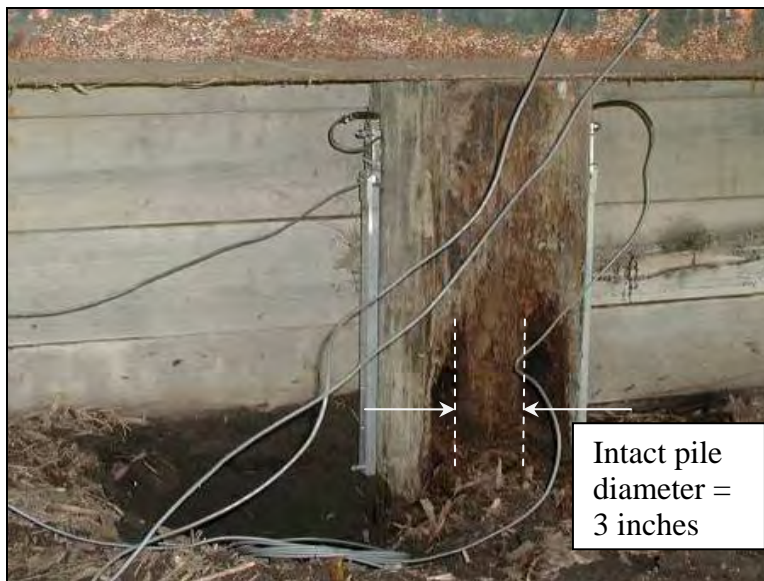
Figure 8.7. Pile no. 4 at the north abutment undergoing biological deterioration (Bridge No. 243470 Marshall County – July 27 2005)

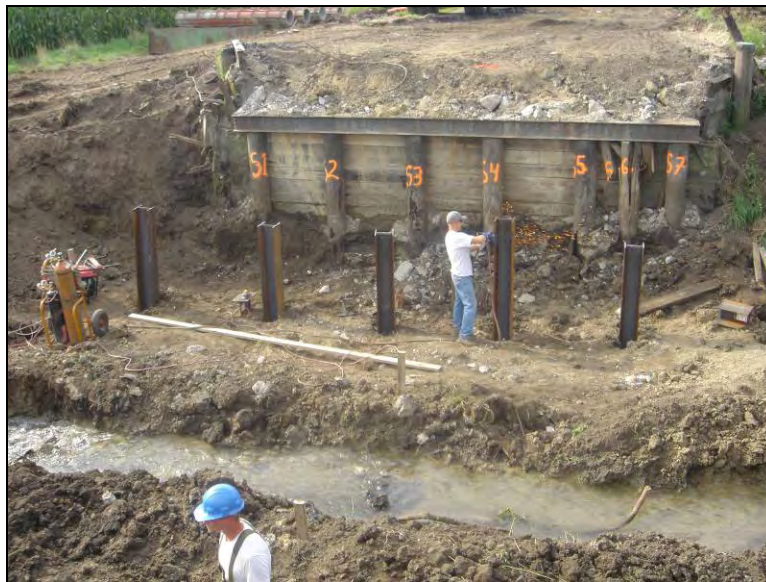
Figure 8.9. Construction of the new bridge foundation (Bridge No. 243470 Marshall County – August 19 2005)
