Investigation of Steel-Stringer Bridges: Superstructures and Substructures, Volume II

Final Report
October 2007

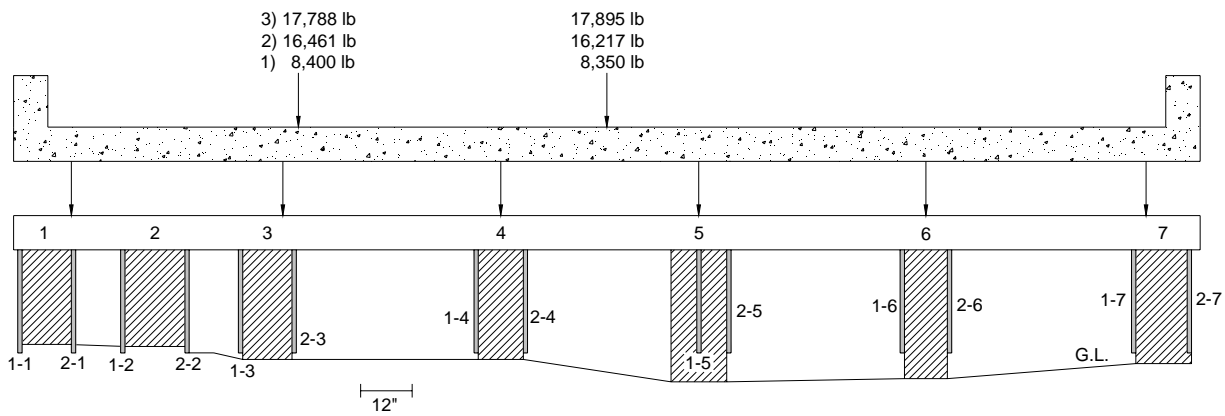
(a) Location of strain transducers and axial loads

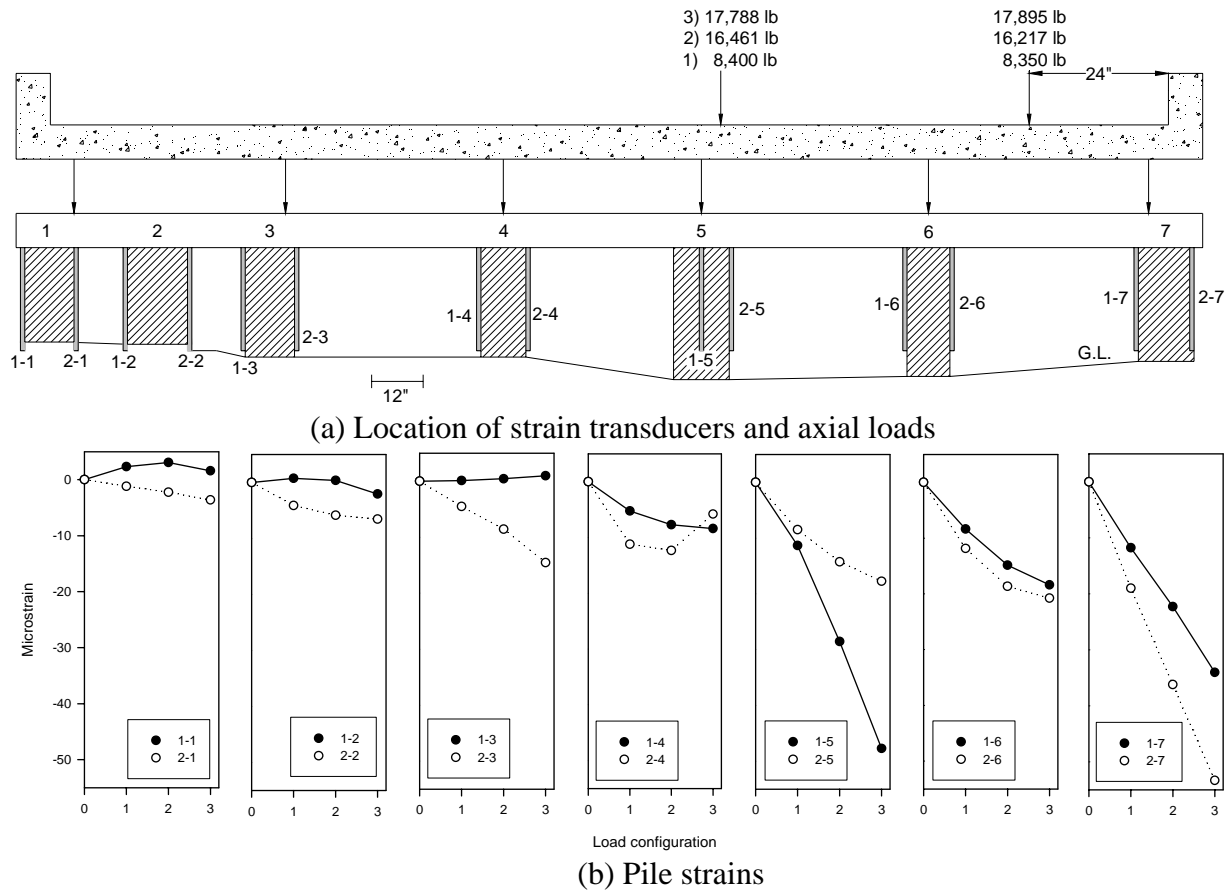
Figure 8.13. Static load test at the east edge (Bridge No. 243470 – Marshall County)

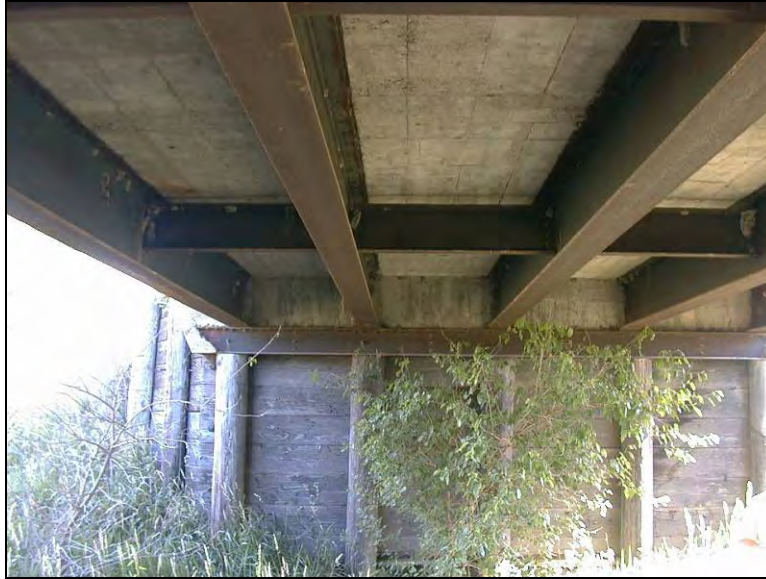
Figure 9.2. North abutment (Bridge No. 237350 Mahaska County – October 25 2005)

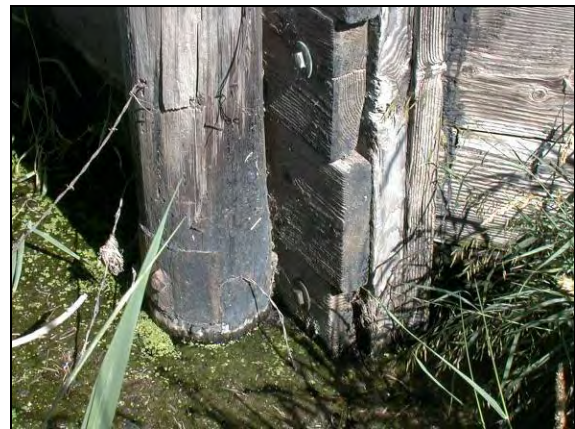
(b) Soft section near the water level

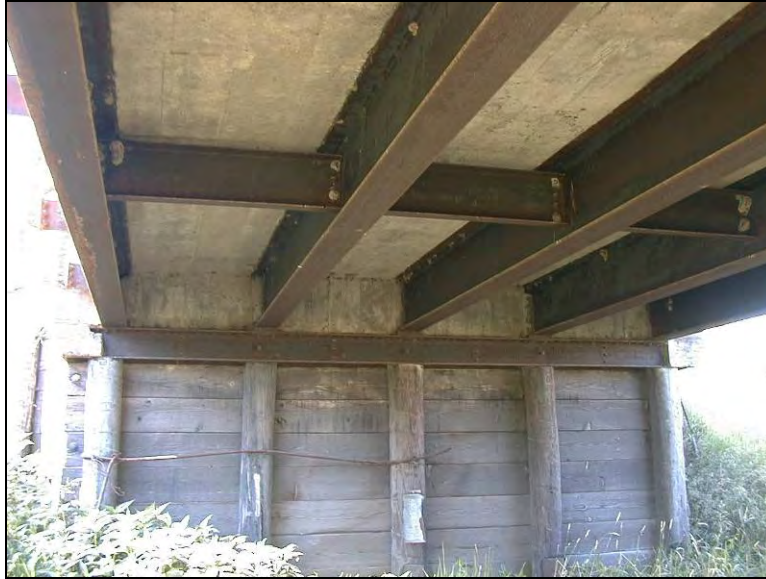
Figure 9.6. South abutment (Bridge No. 237350 Mahaska County – October 25 2005)

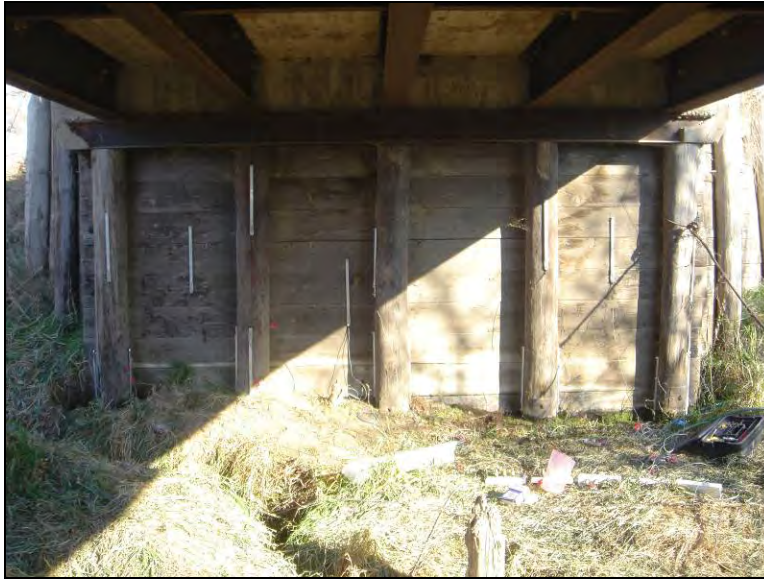
The backwall strains were highest near the applied load, and decreased with increasing distance from the location of the loads. For load configurations 2 and 3, the recorded strain decreased due to reduction in axial load. Negative strains were recorded at load configuration 3 because of the partial bearing of the pile cap on the backwall (See Figure 9.13).

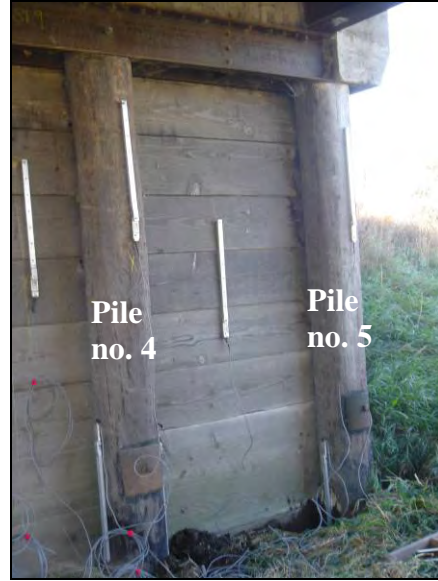
(b) Pile nos. 4 and 5 at the south abutment

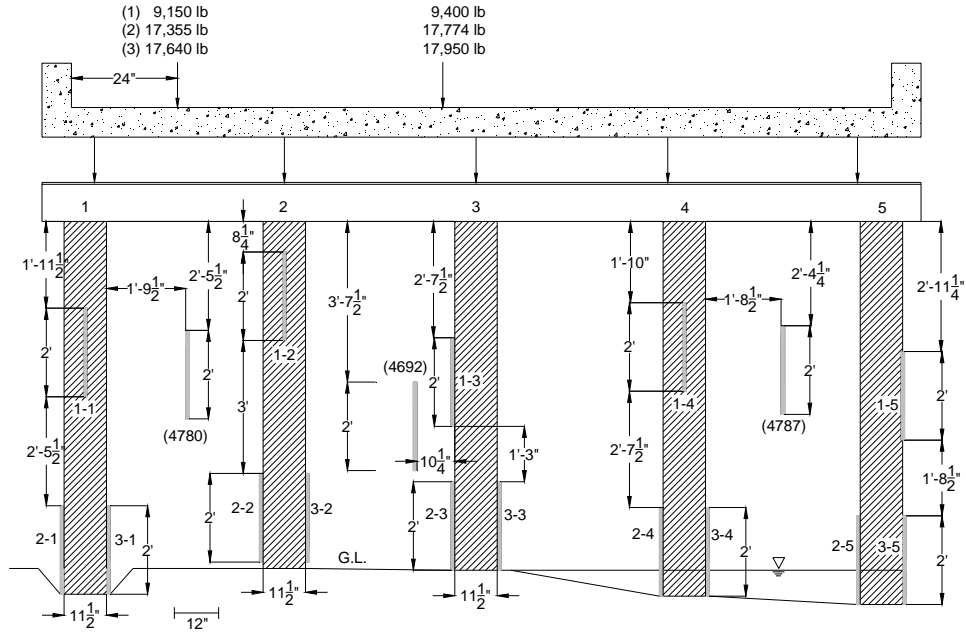
(a) Location of strain transducers and axial loads

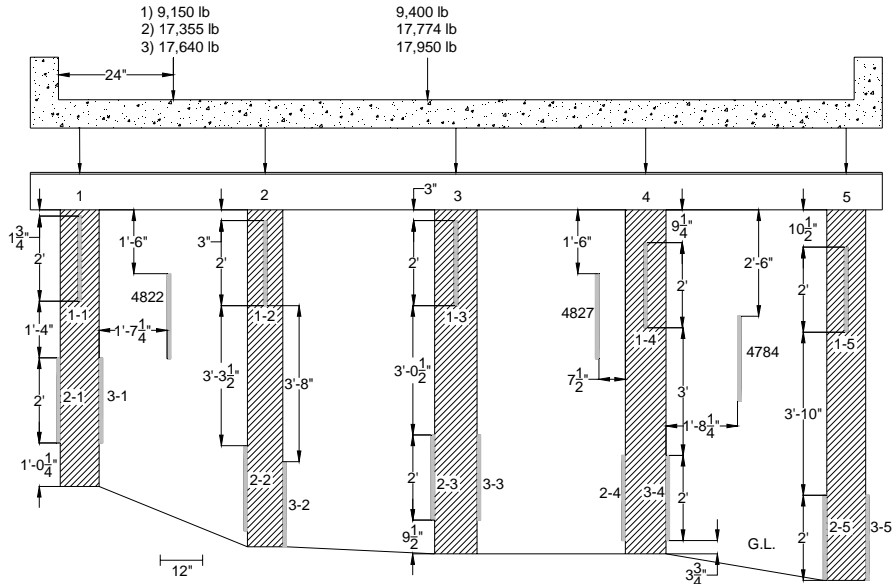
(a) Location of strain transducers and axial loads

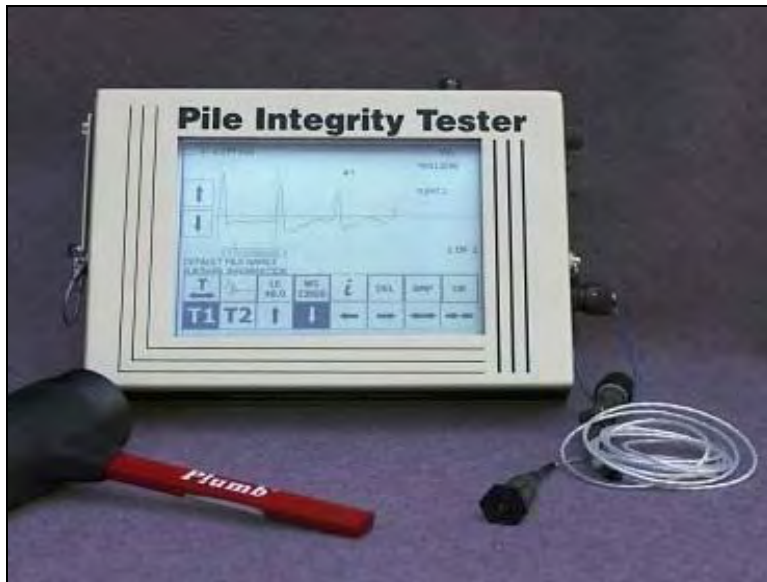
Figure 9.21. Equipment used in Pile Integrity Testing

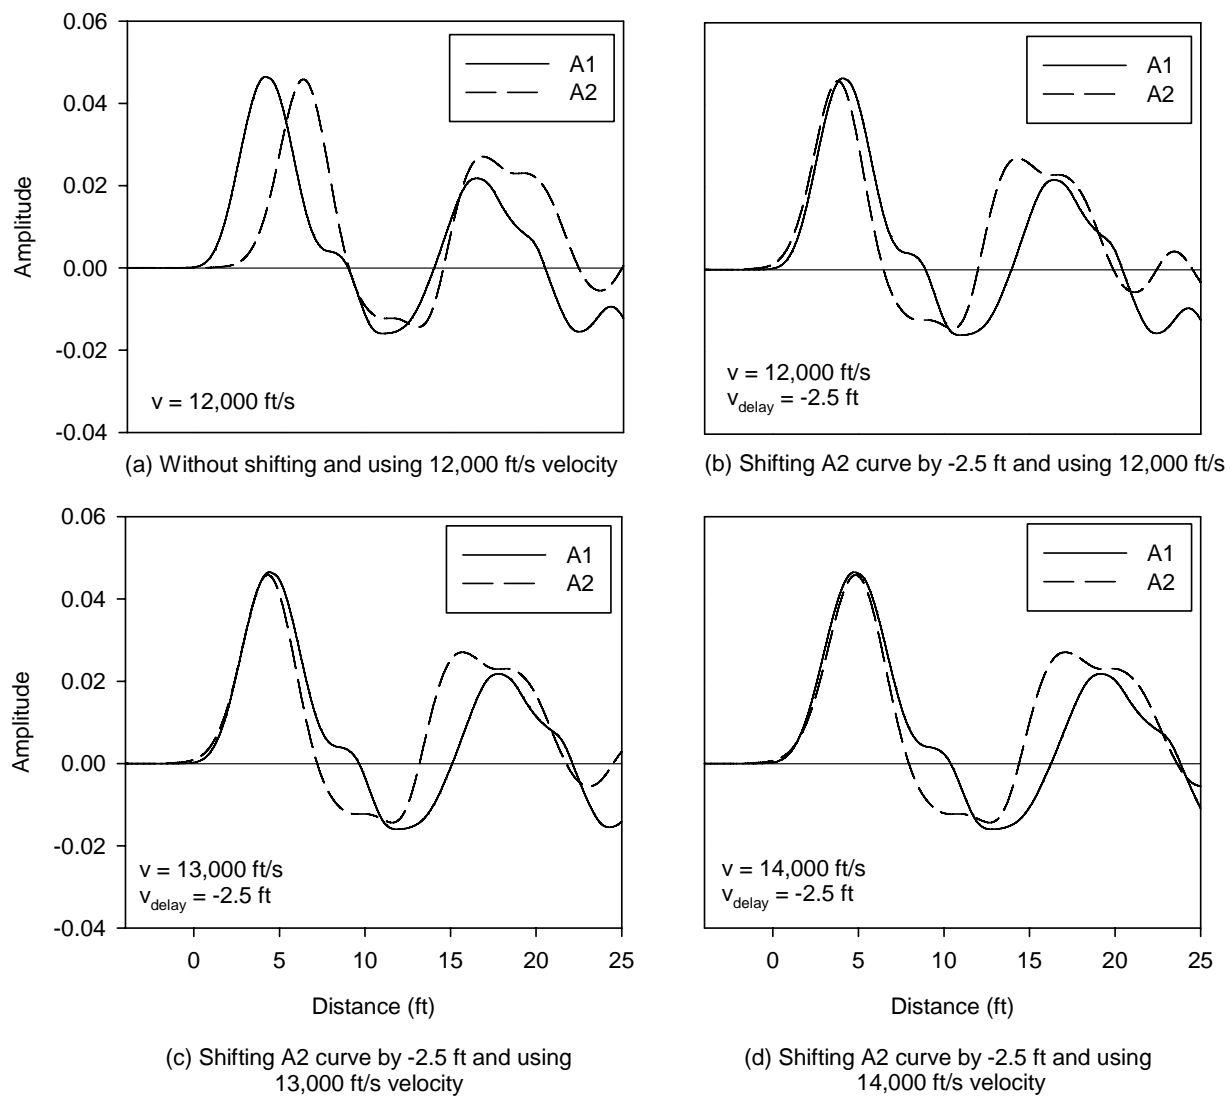
Figure 9.25. Determination of wave speed by matching the rising slope of two input pulses

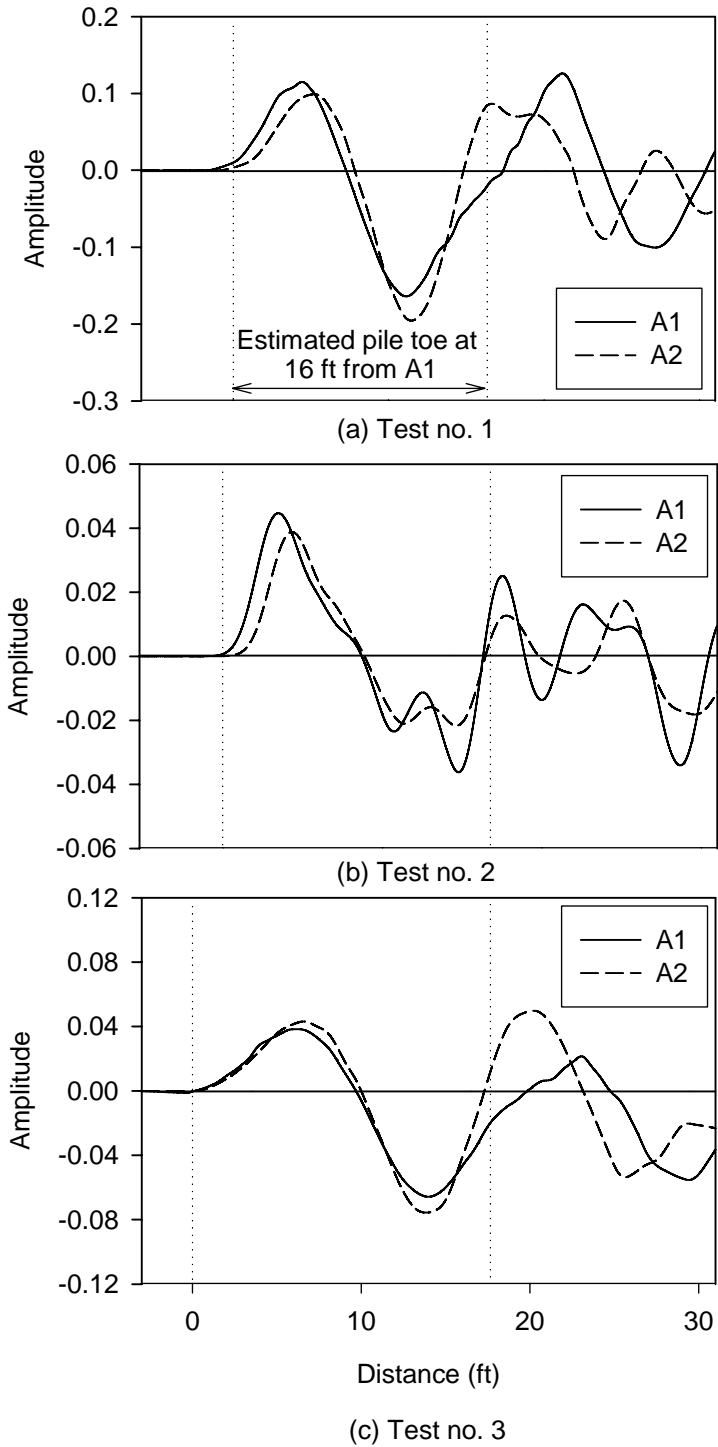
Figure 9.26. Results of PIT on pile no. 2 at the north abutment (Bridge No. 237350 – Mahaska County)

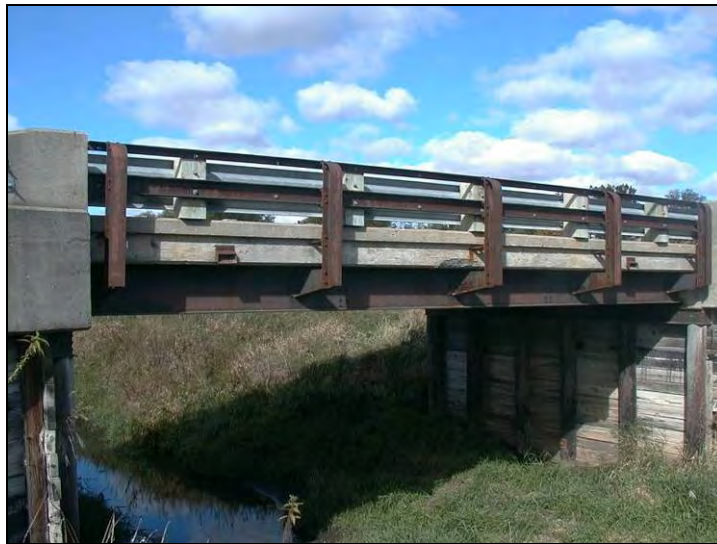
Figure 10.1. Side view of the bridge looking northwest (Bridge No. 094680 Carroll County – May 16 2006)

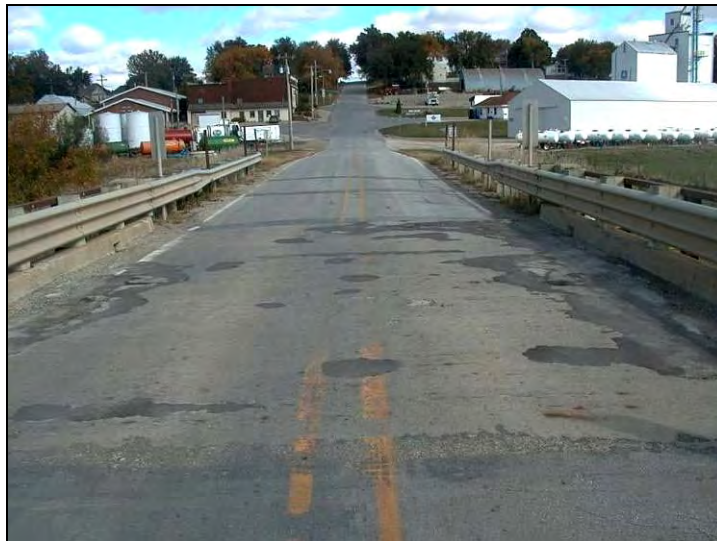
Figure 10.2. Concrete deck patched with asphalt (Bridge No. 094680 Carroll County – May 16 2006)

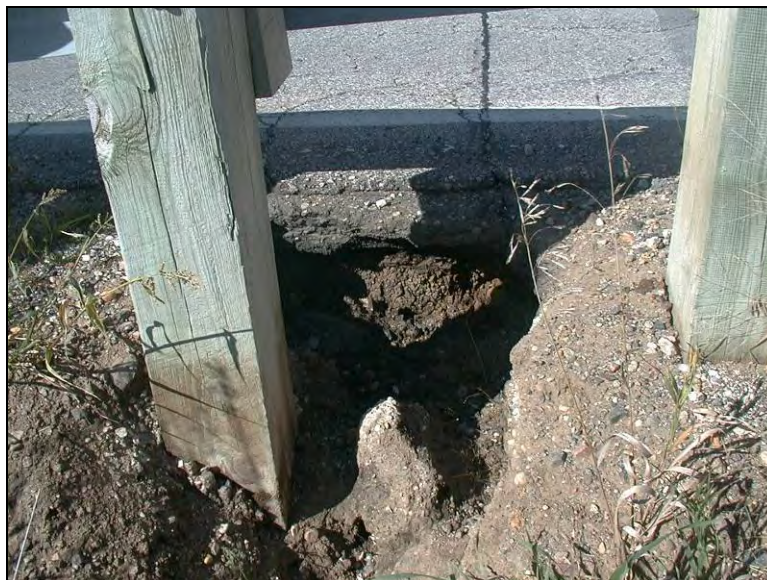
Figure 10.3. Soil erosion near the north abutment (Bridge No. 094680 Carroll County – April 15 2006)

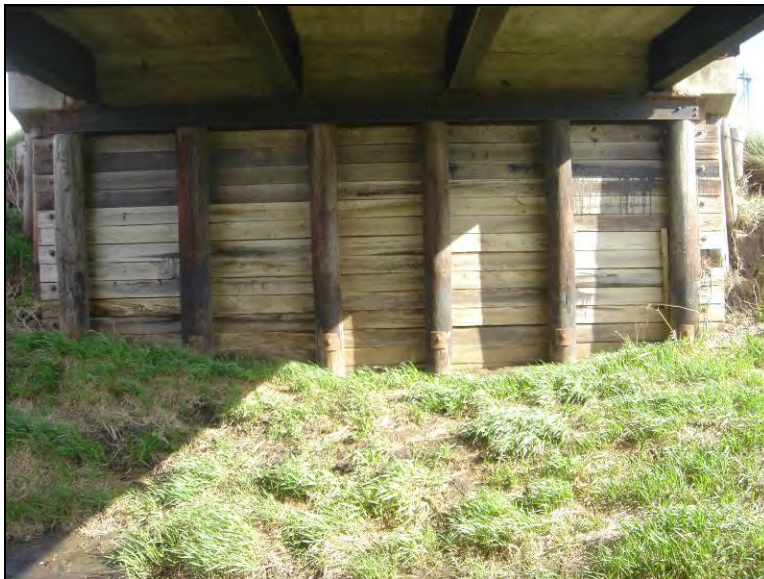
Figure 10.5. North abutment (Bridge No. 094680 Carroll County – April 15 2006)

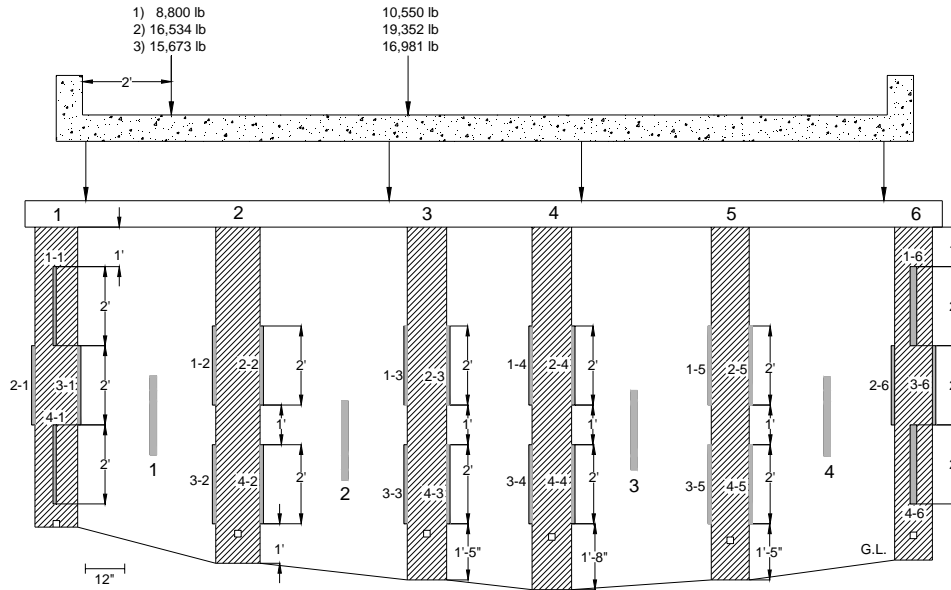
(a) Location of strain transducers and axle loads

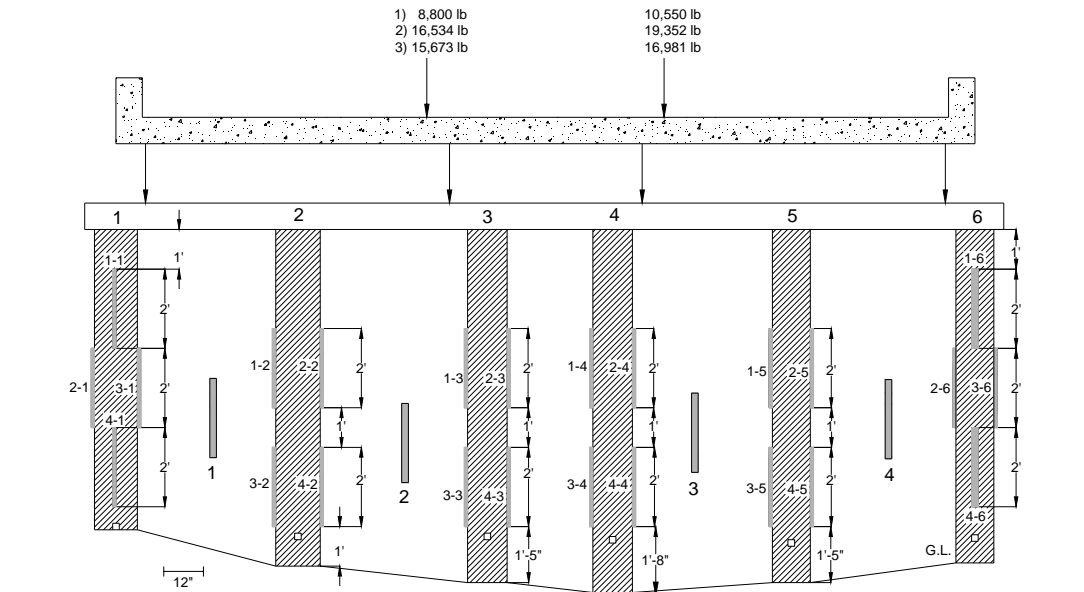
(a) Location of strain transducers and axle loads

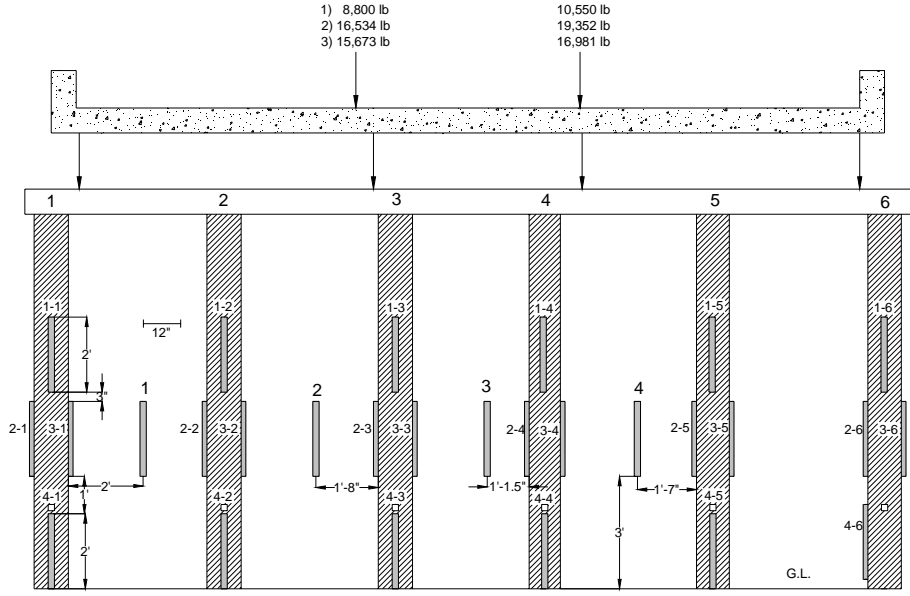
(a) Location of strain transducers and axle loads

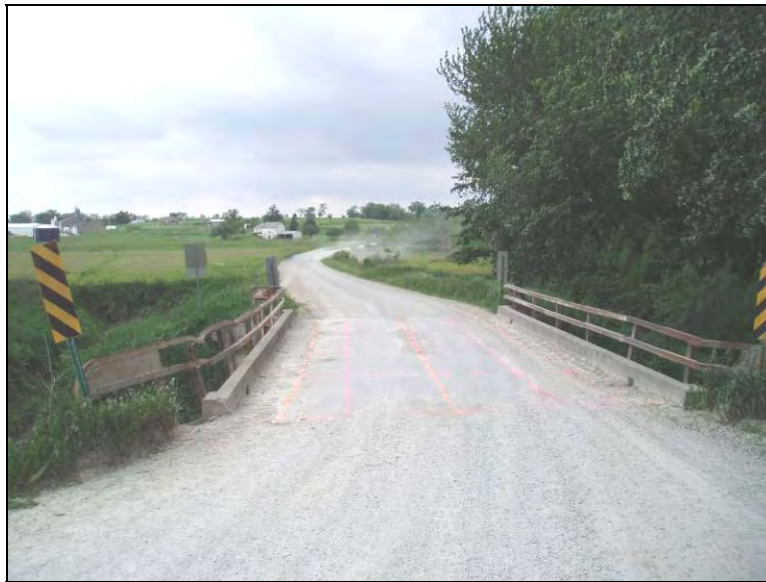
Figure 11.1. Bridge No. 237380 – Mahaska County (April 16 2006)

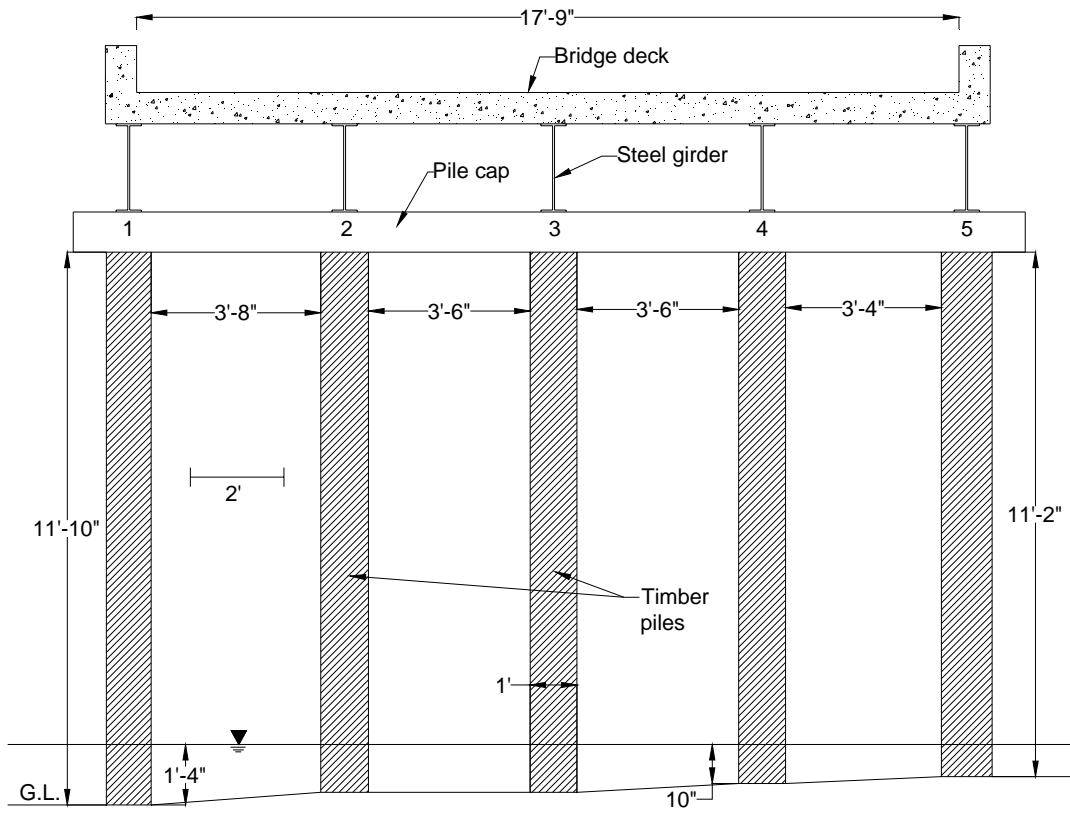
Figure 11.2. Schematic diagram of the northwest abutment (Bridge No. 237380 – Mahaska County)

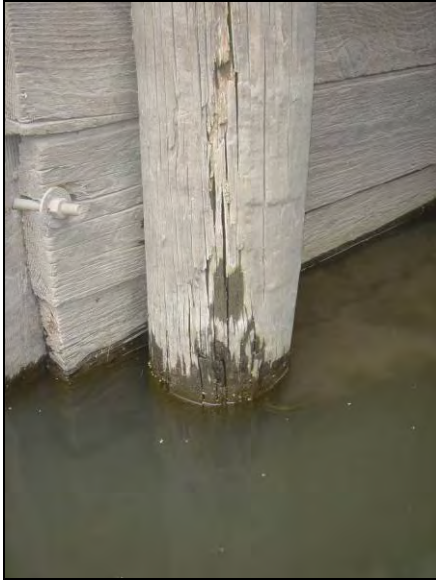
(a) Biological deterioration near the water level

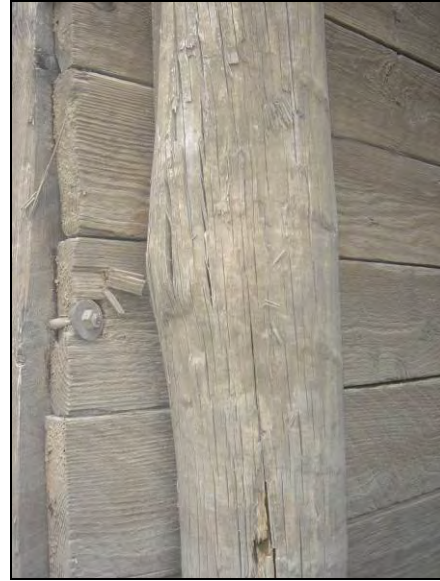
(b) Bulging of timber fibers

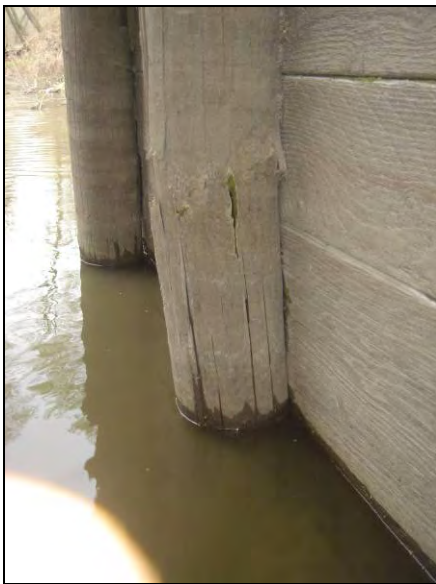
Figure 11.4. Deterioration of pile no. 1 (Bridge No. 237380 Mahaska County – April 16 2006)

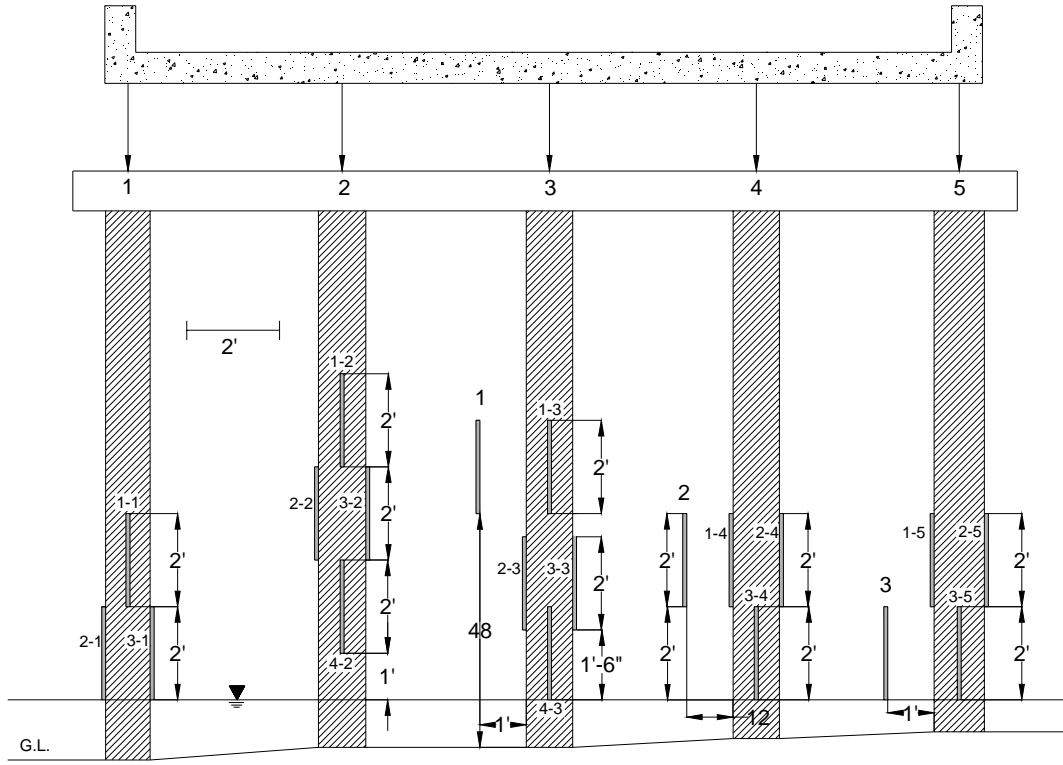
(a) Northwest abutment

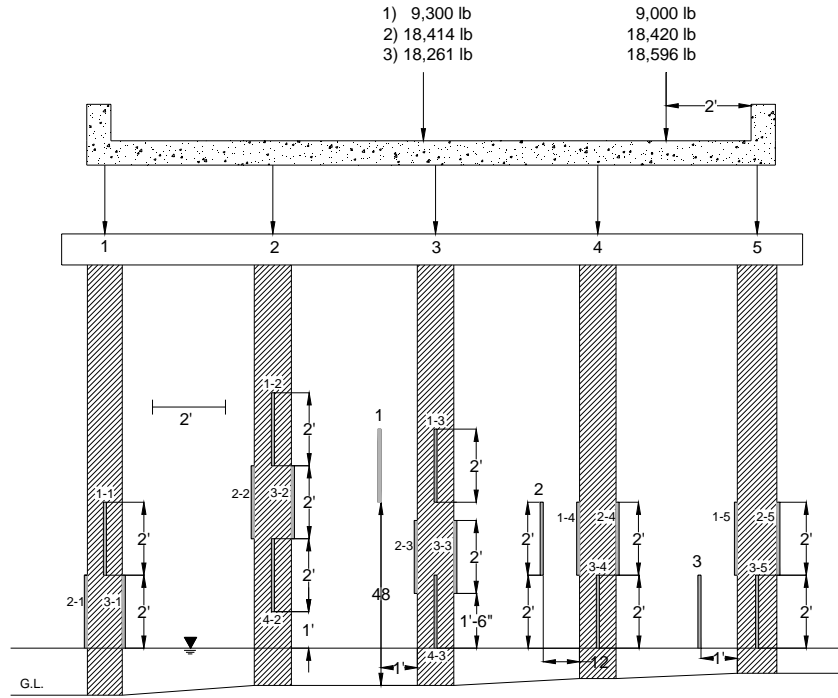
(a) Location of strain transducers and axle loads

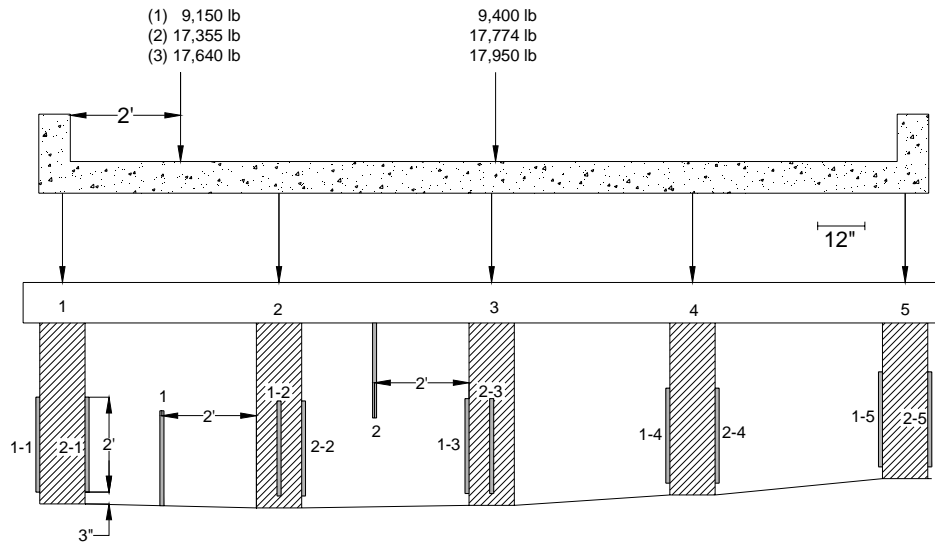
(a) Location of strain transducers and axle loads

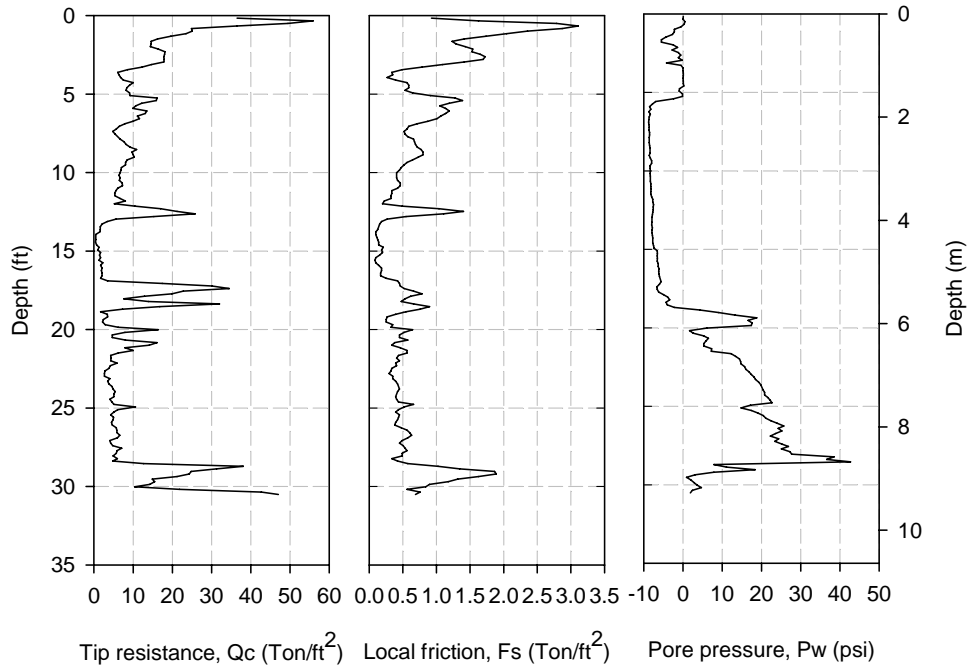
Figure 11.16. CPT carried out 100 ft north of the north abutment (Bridge No. 237380 – Mahaska County)

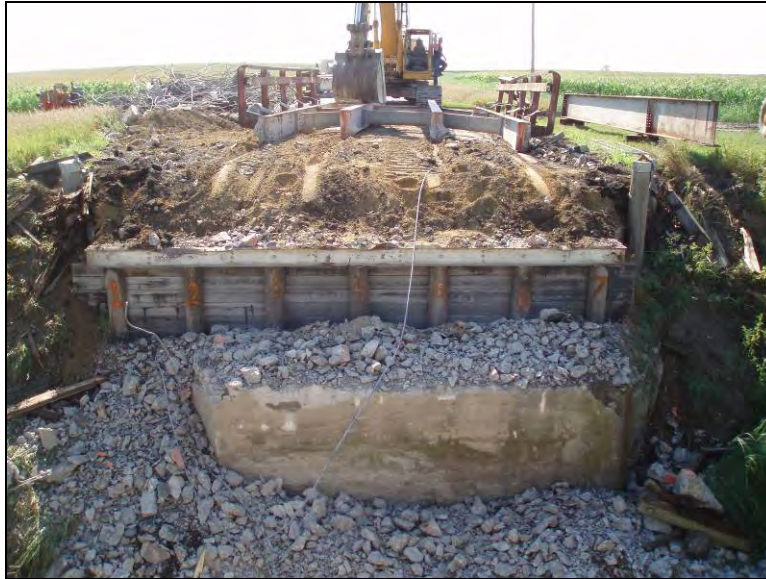
Figure 12.12. Removing the bridge super structure – looking west (Bridge No. 029070 Humboldt County – July 28 2006)

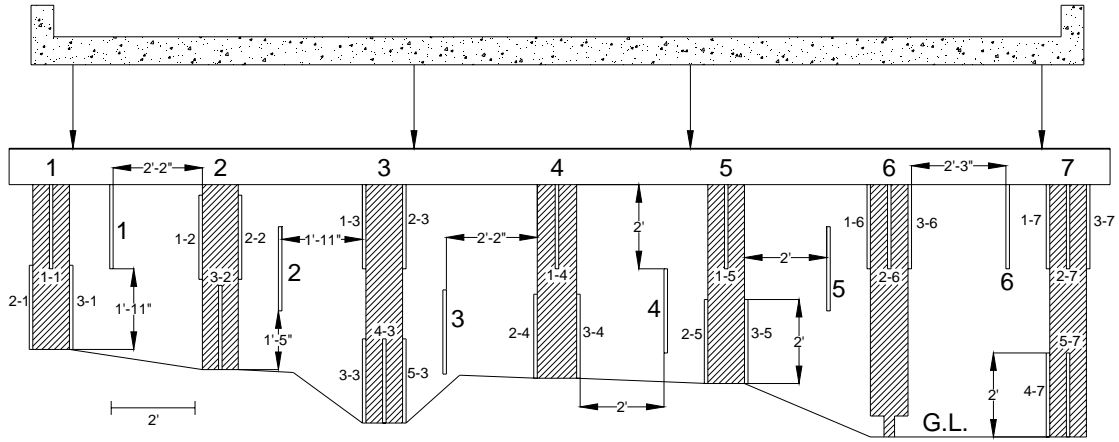
To determine the feasibility of repairing localized deteriorated sections in timber piles, pile no. 7 was repaired using a splicing technique in which the percent restoration of pile capacity was measured. A new timber section was spliced and placed instead of the removed section as shown in Figure 12.21. The existing and new pile sections were connected by installing two metal screws at an angle as demonstrated in Figure 12.22. Once repaired, the bridge was load tested and the percentage of the restored capacity was evaluated.

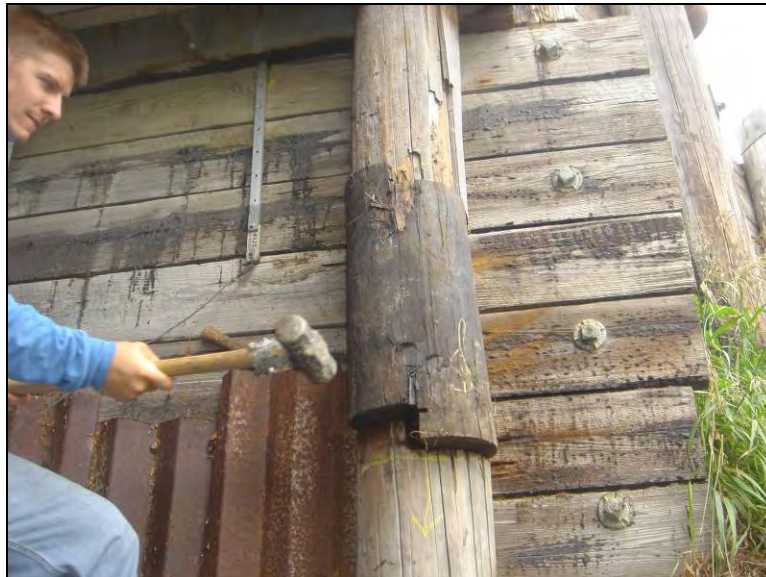
Figure 12.21. Installing a new timber section to repair pile no. 7 (Bridge No. 029070 Humboldt County – July 12 2006)

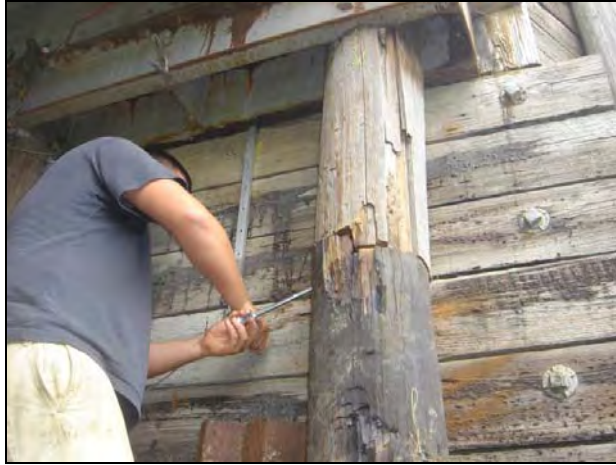
Figure 12.22. Metal screws used to connect the new section to the existing timber pile (Bridge No. 029070 Humboldt County – July 12 2006)

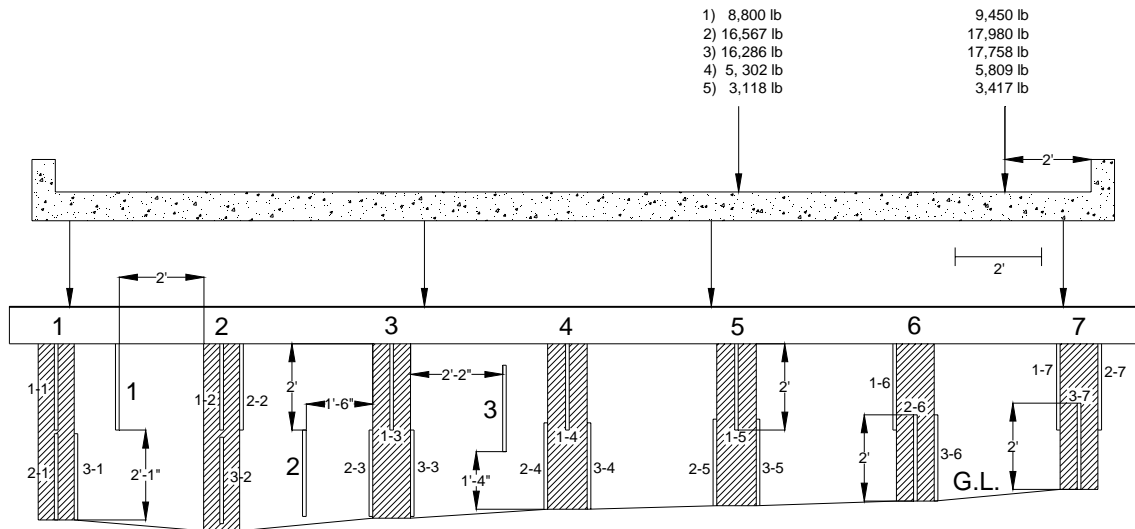
(a) Location of strain transducers and axle loads

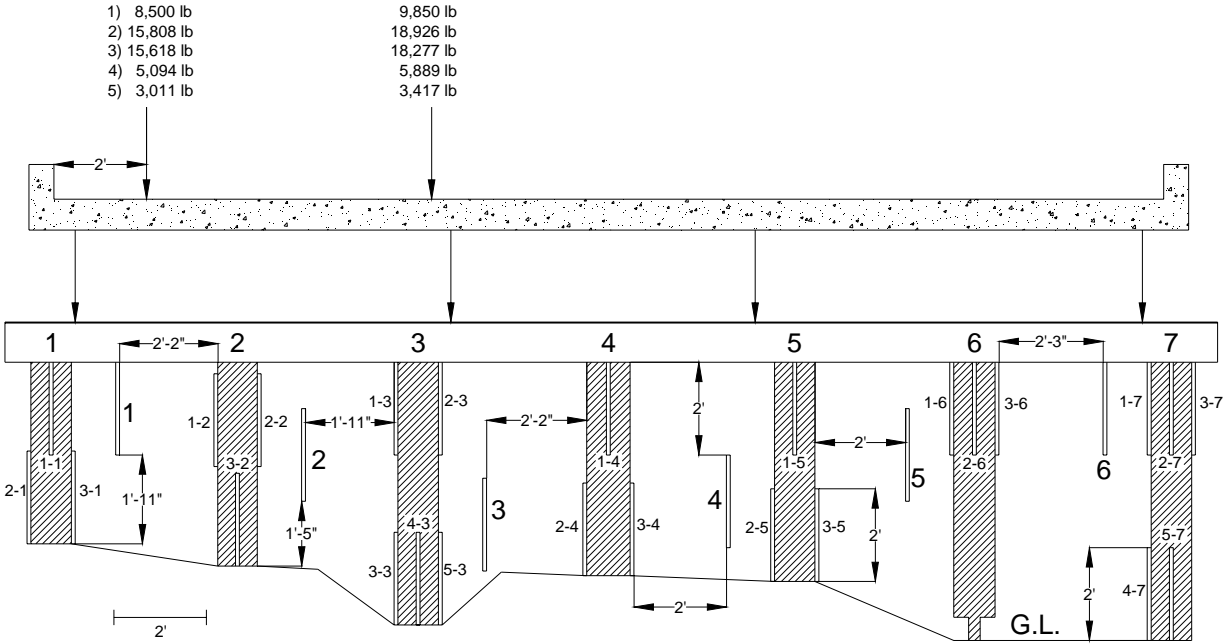
(a) Location of strain transducers and axial loads

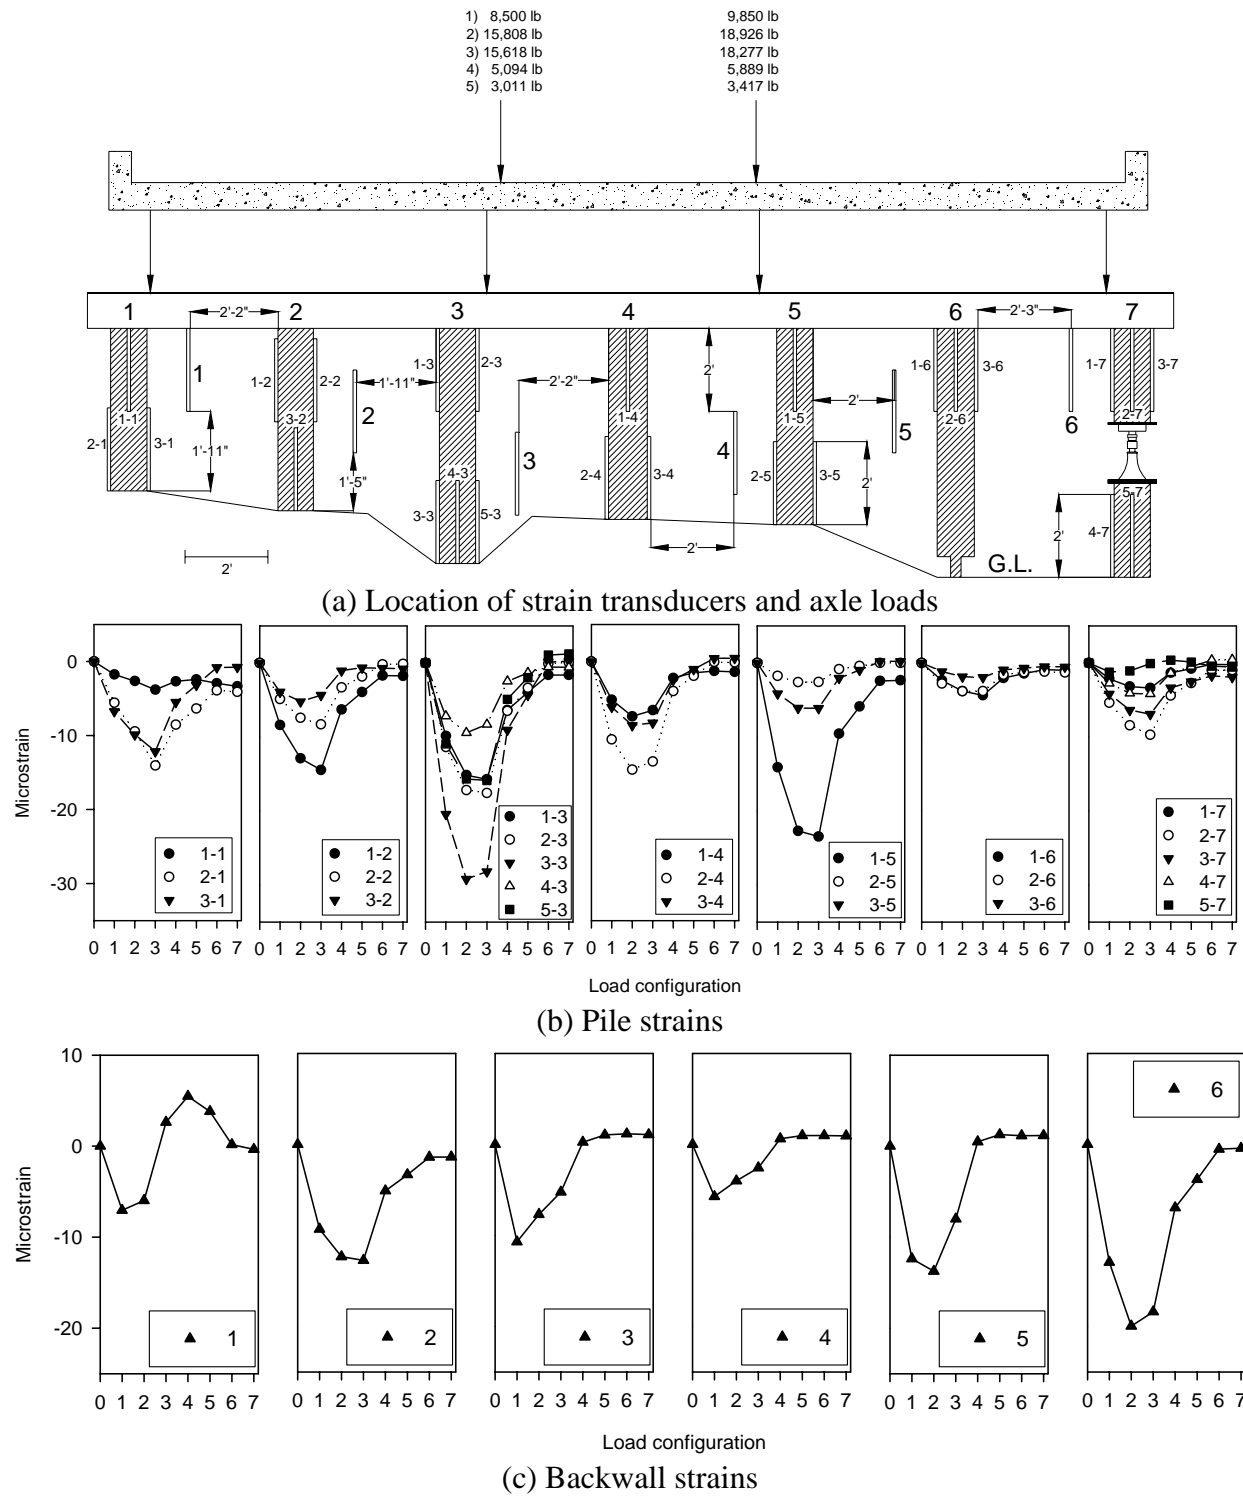
Figure 12.29. Static load test at the centerline with pile No. 7 jacked (Bridge No. 029070 – Humboldt County)

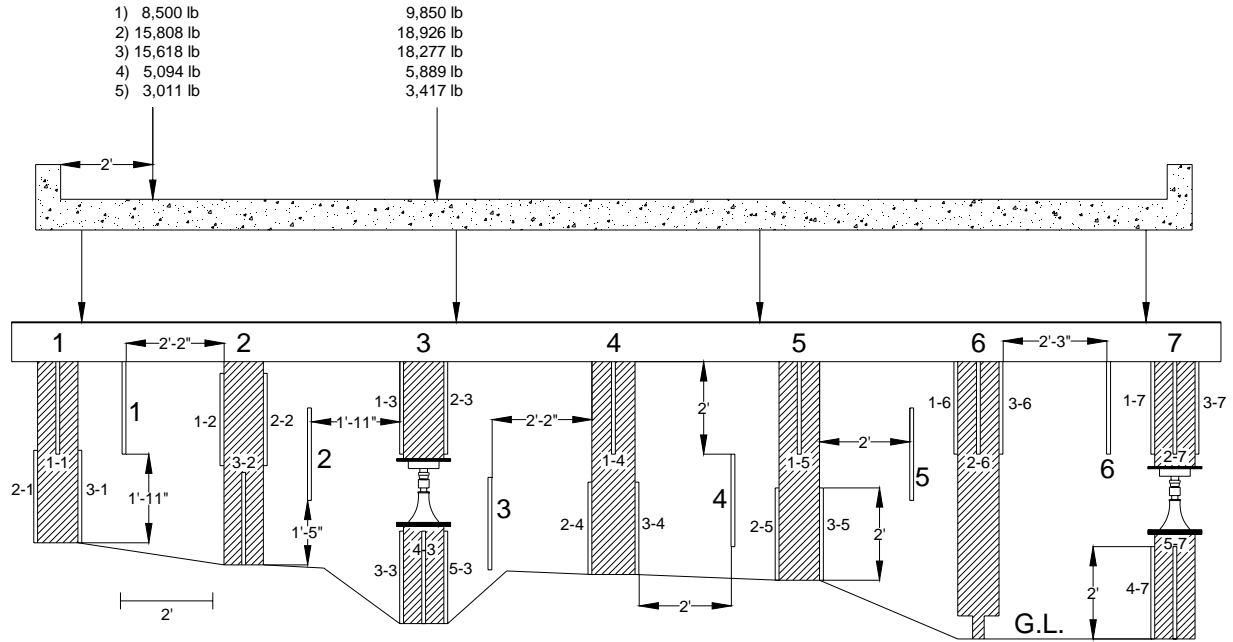
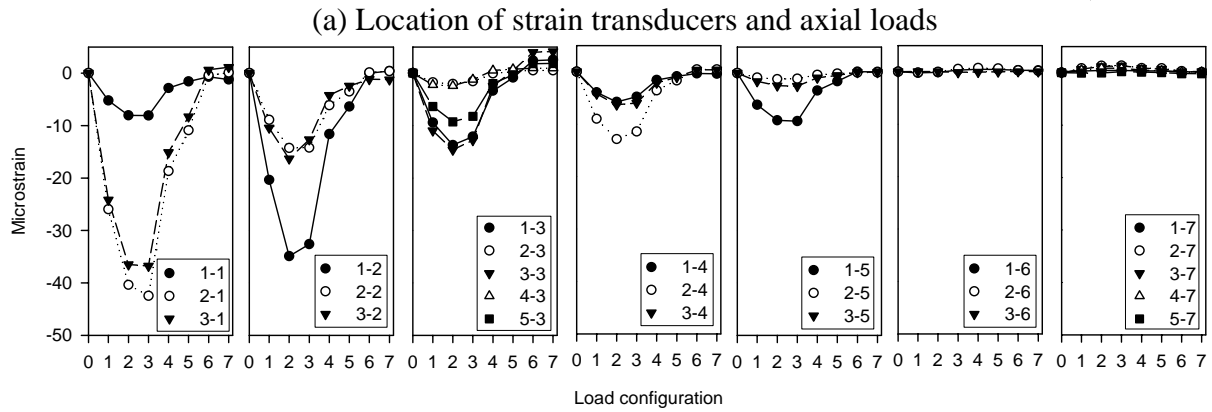
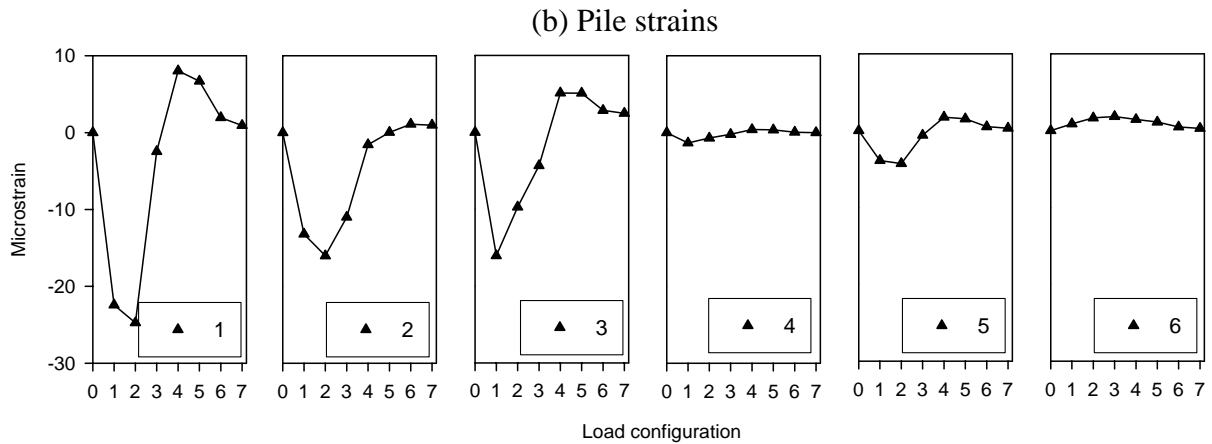
Figure 12.35. Static load test at the north edge with pile Nos. 7 and 3 jacked (Bridge No. 029070 – Humboldt County)
