Investigation of Steel-Stringer Bridges: Superstructures and Substructures, Volume II

Final Report
October 2007

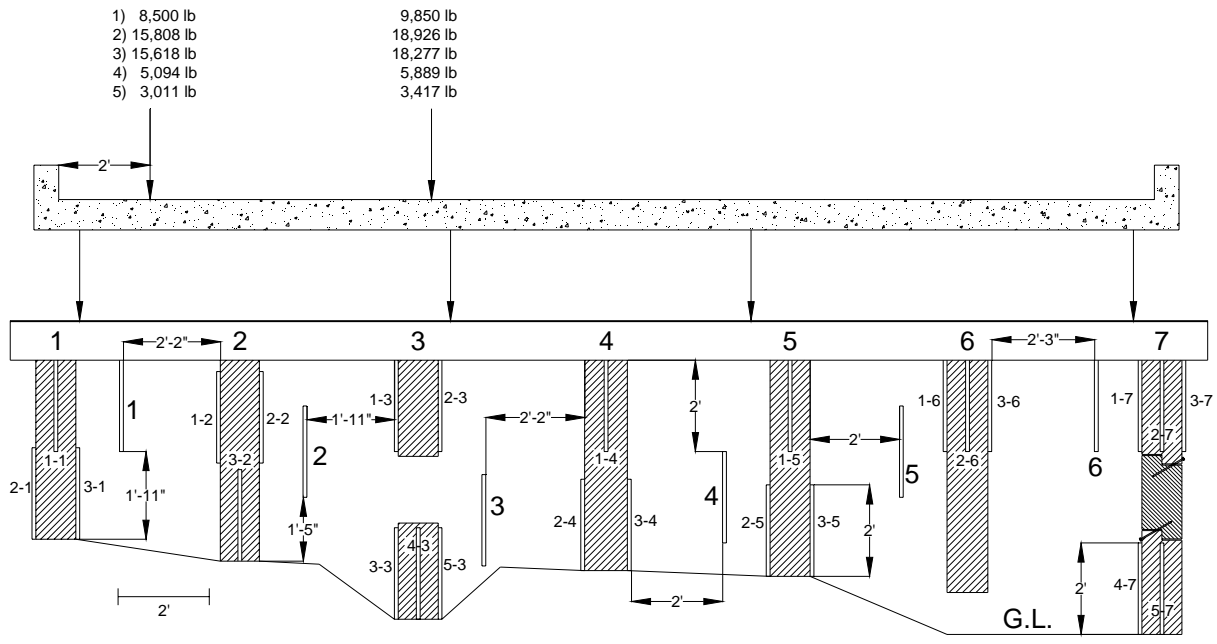
(a) Location of strain transducer and axial loads

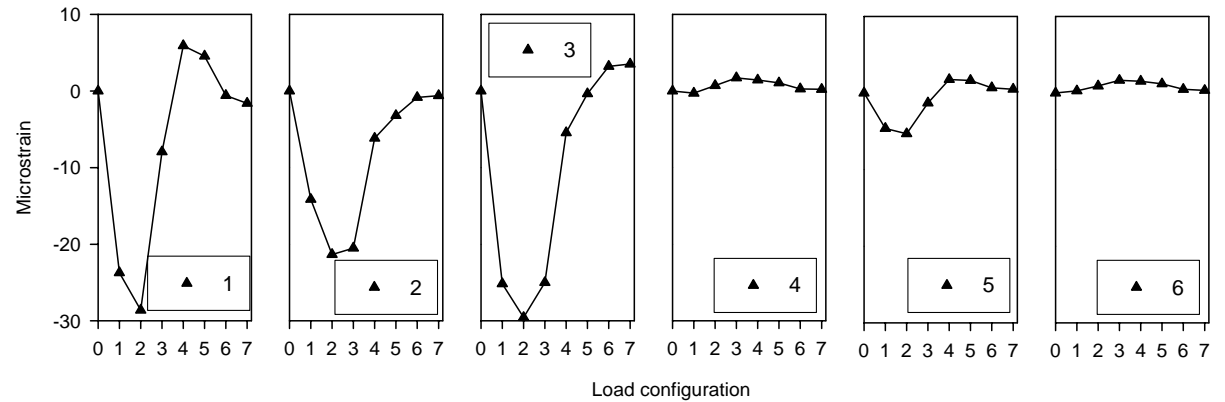
(c) Backwall strains

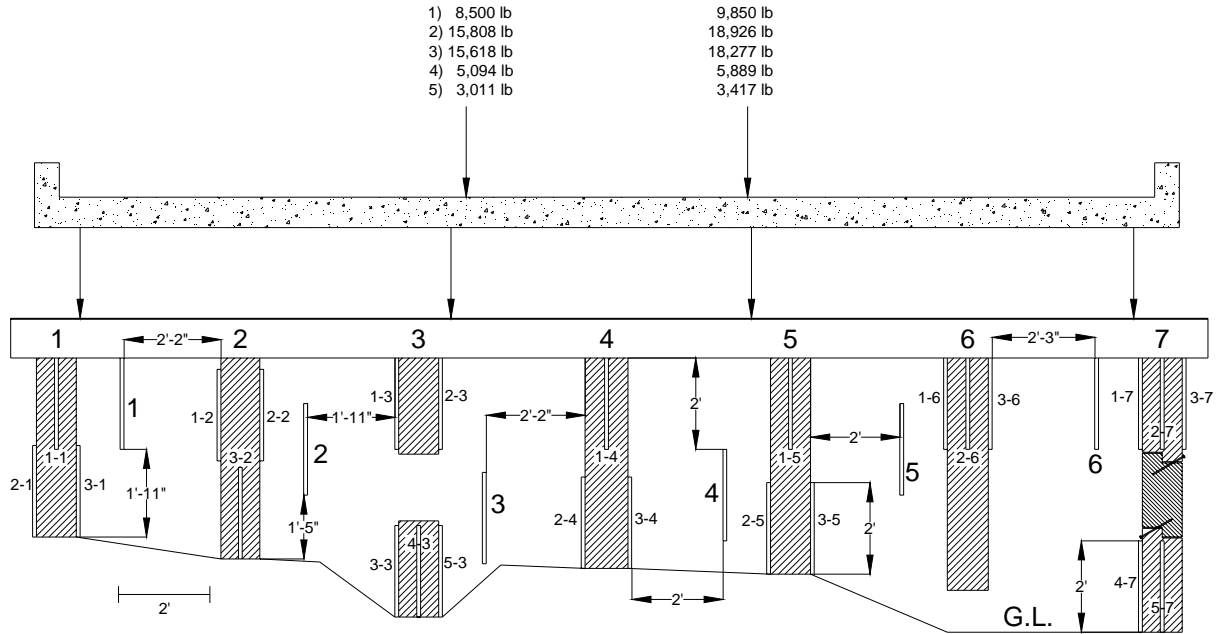
(a) Location of strain transducers and axial loads

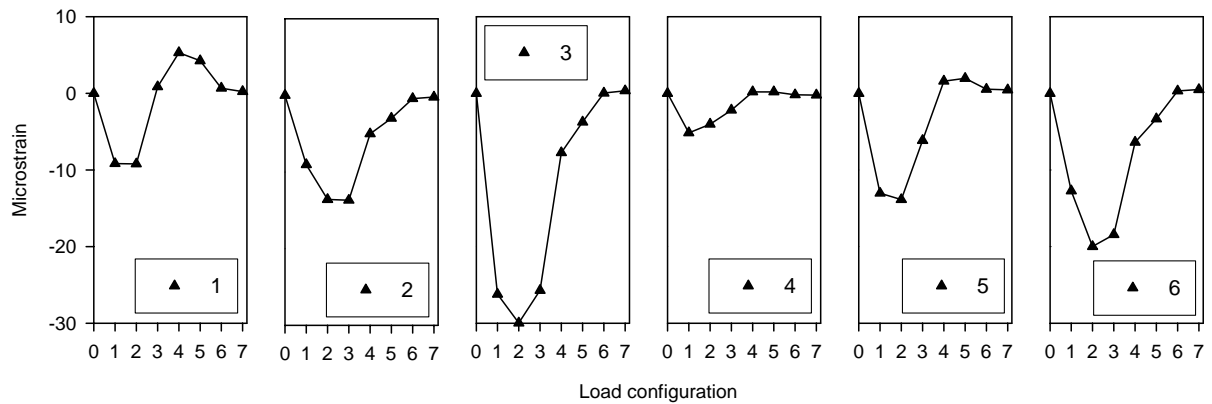
(c) Backwall strains

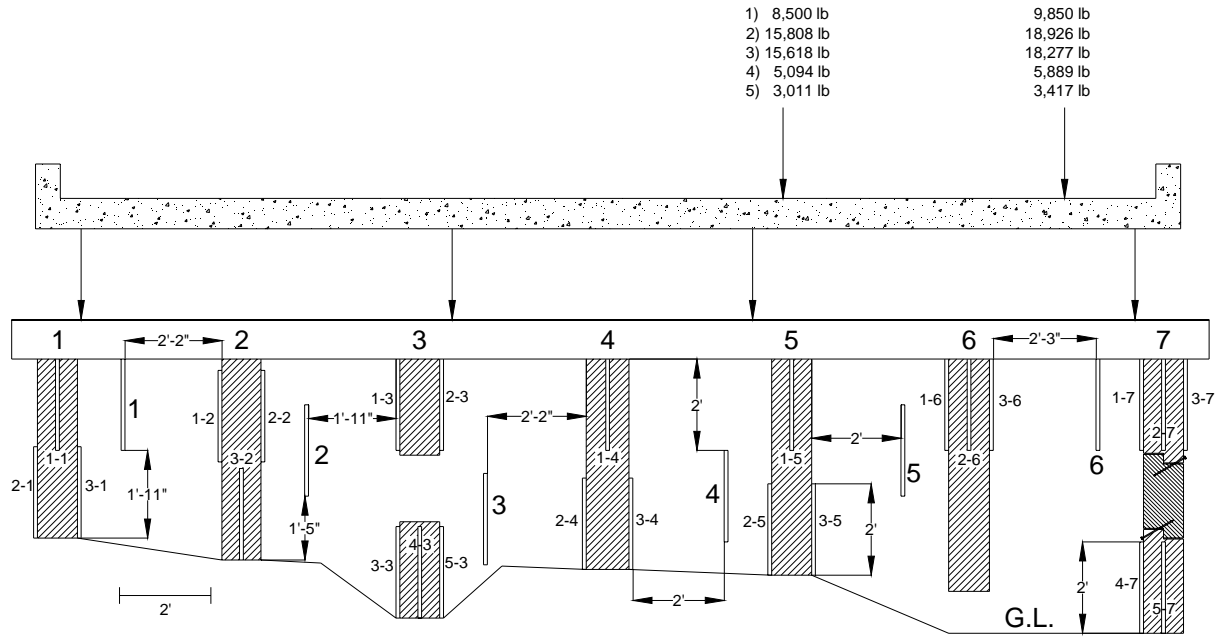
(a) Location of strain transducers and axial loads

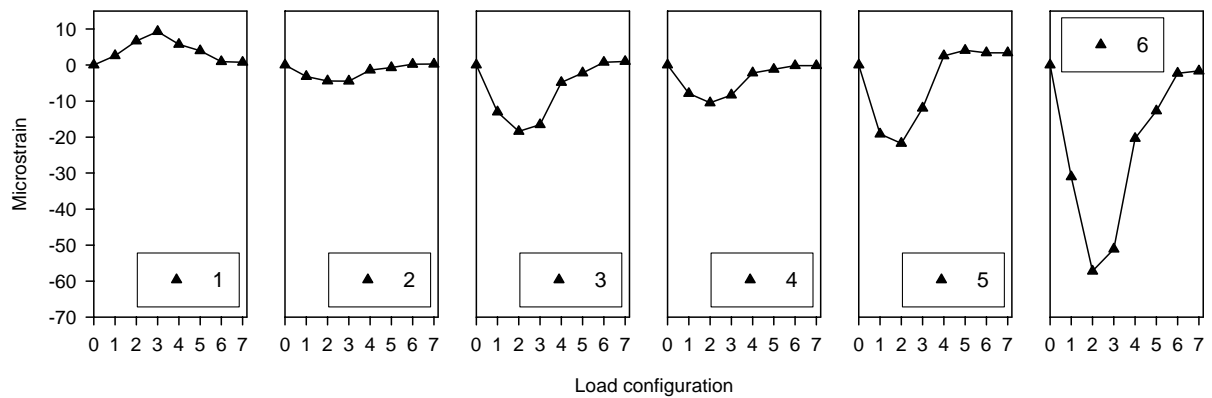
(c) Backwall strains

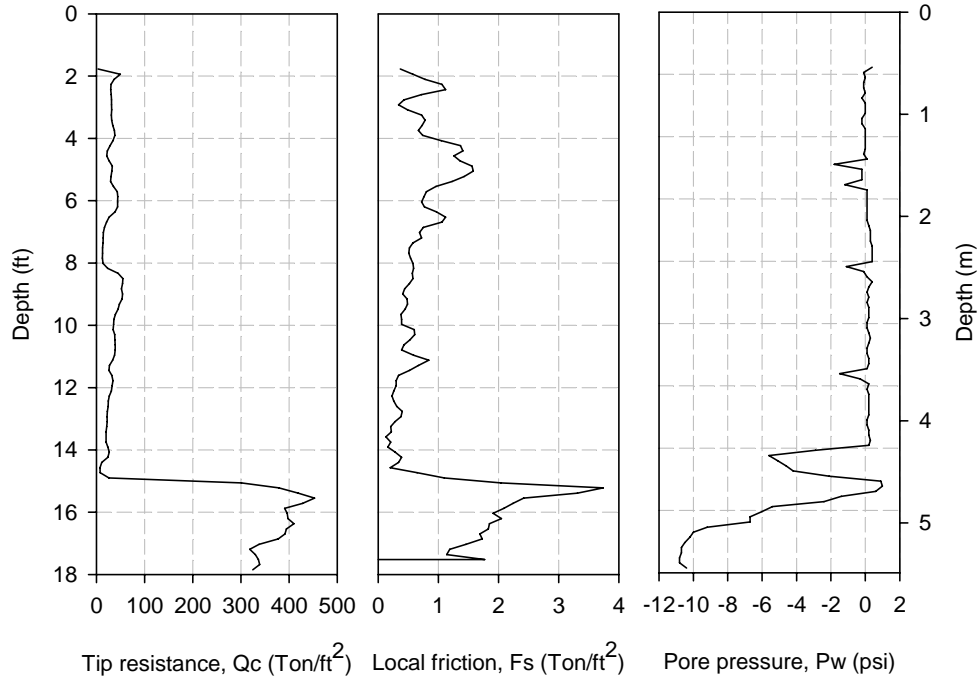
Figure 12.49. CPT test conducted near the east abutment (Bridge No. 029070 Humboldt County)

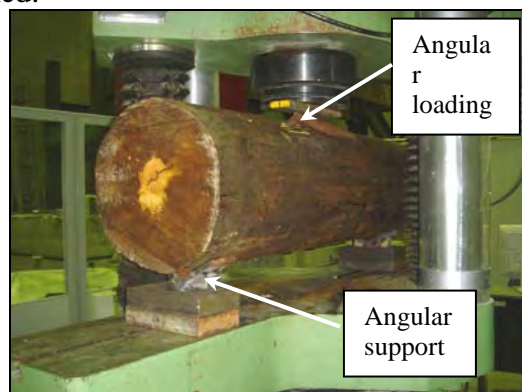
Figure 13.1. Angular supports and loading plate used during a trial bending test

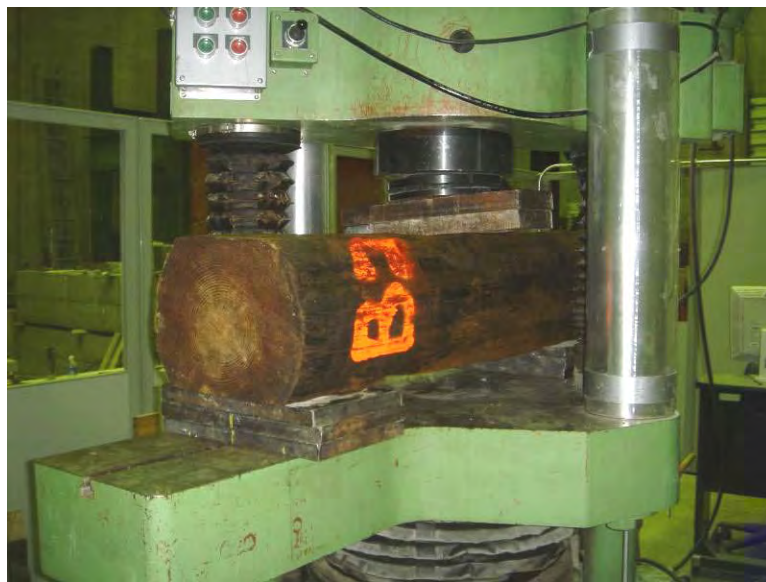
Figure 13.3. Pile sides flattened for conducting bending tests

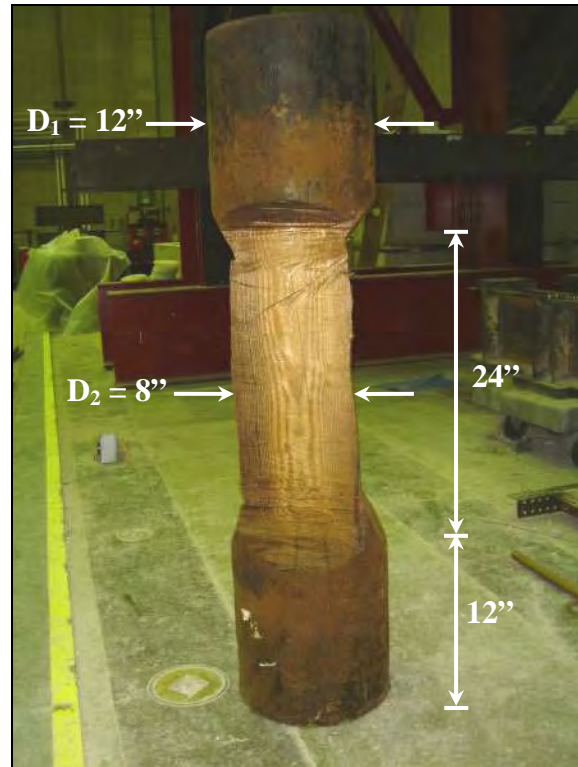
Figure 13.4. Reduced cross sectional area of control timber pile section

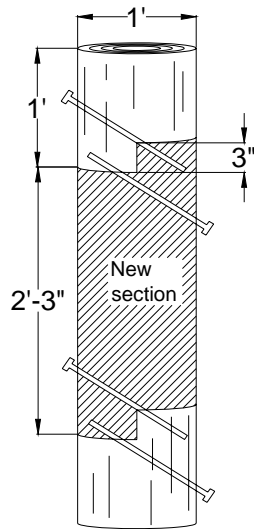
(a) Schematic diagram of the repair method

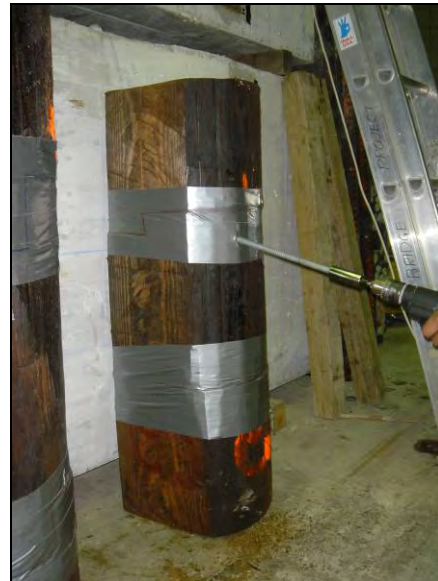
(b) Connecting the pile sections using a metal screw

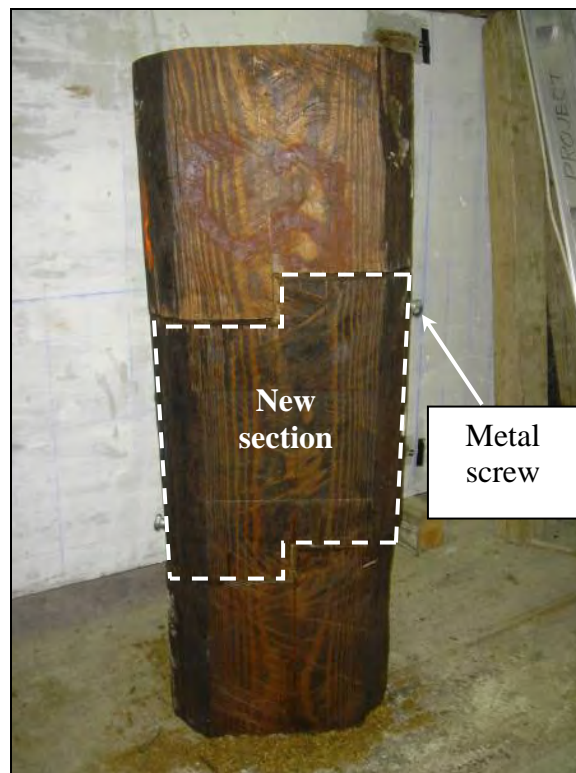
Figure 13.6. Pile section repaired using a mechanical splicing techniques

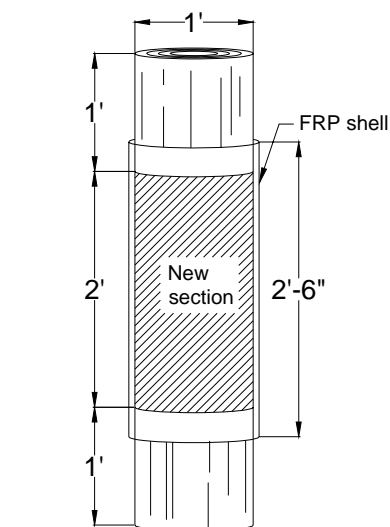
(a) Schematic diagram of the repair method

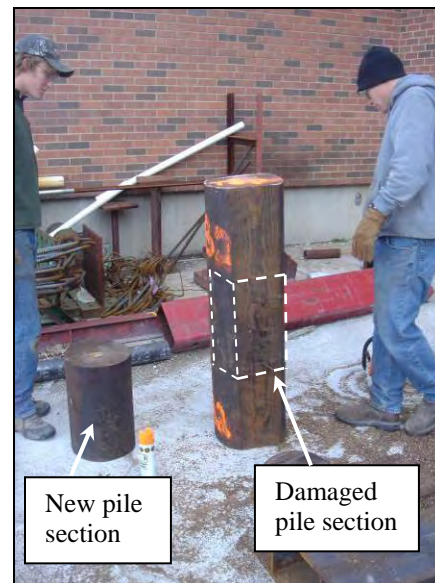
(b) Replacing old timber section with new one

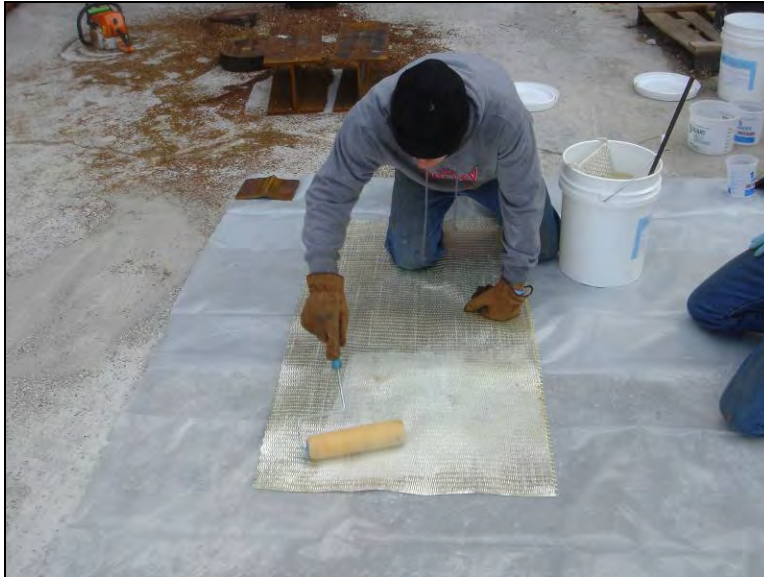
Figure 13.8. Applying the bonding epoxy using a paint roller

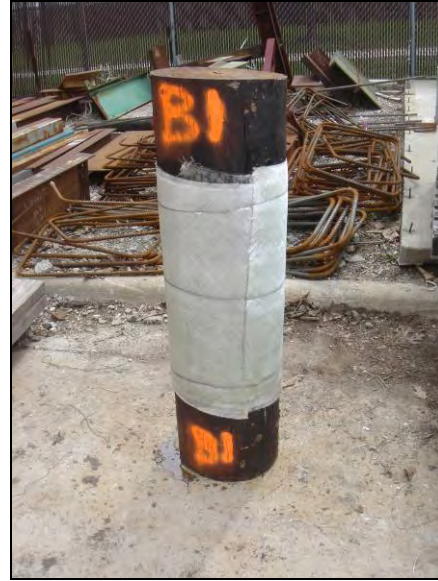
(b) Pile subjected to axial loading

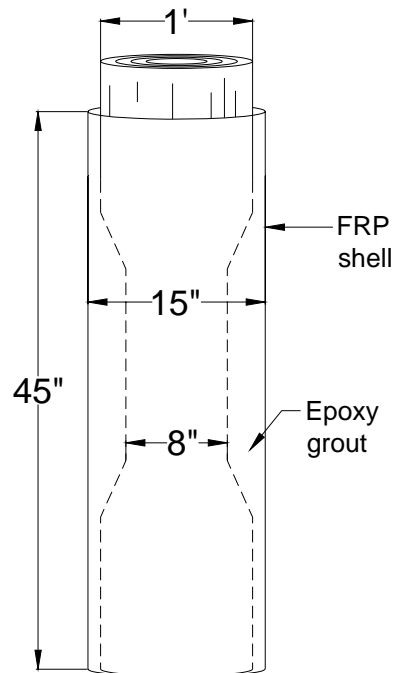
Figure 13.11. Schematic diagram of repair method C

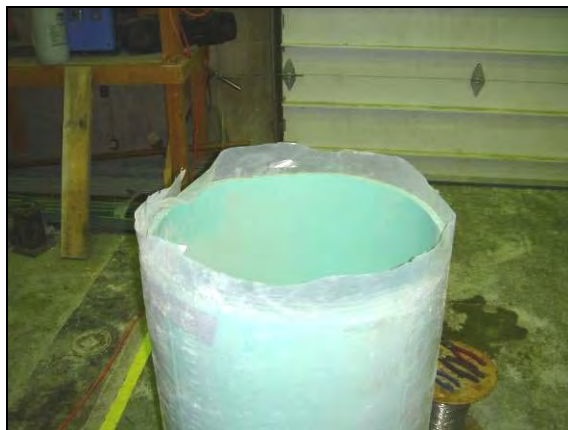
(a) PVC pipe used as a shell mold

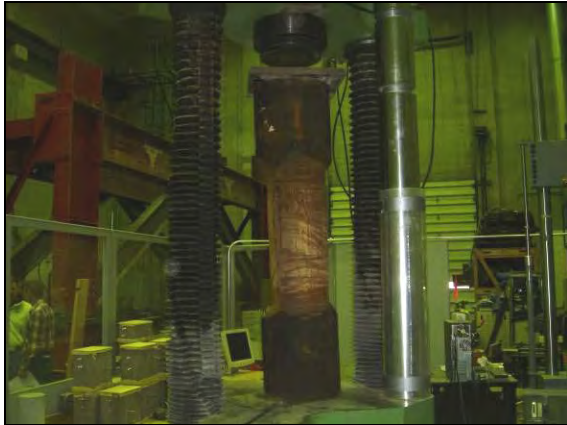
(a) Control pile section – axial

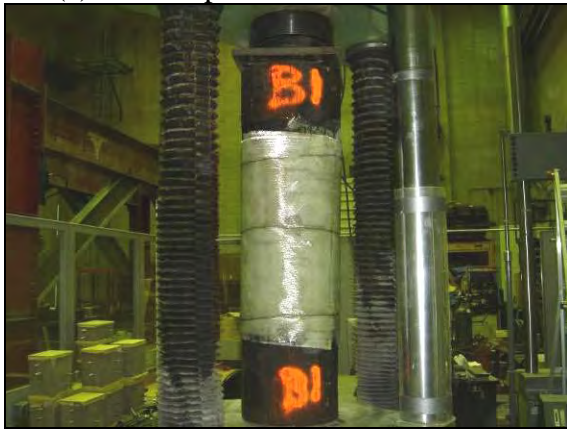
(c) Repair method B – axial

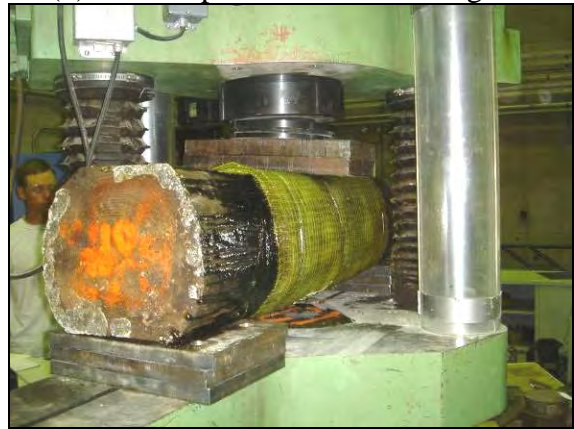
(d) Repair method B – bending

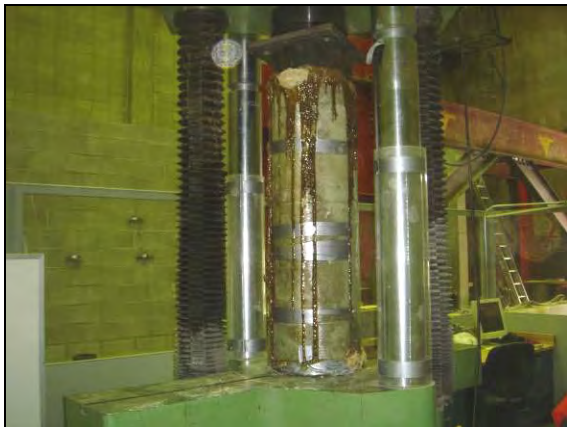
(e) Repair method C – axial

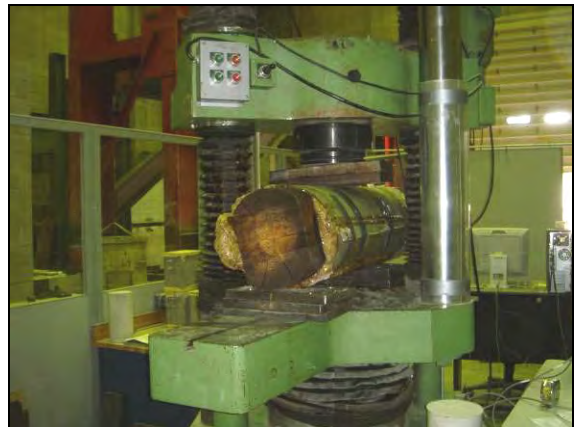
(f) Repair method C – bending

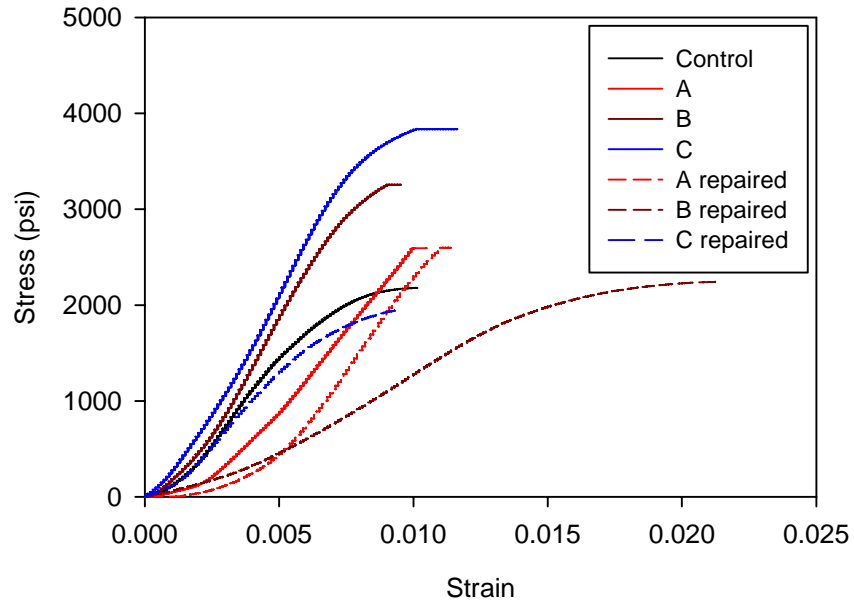
Figure 13.16. Summary of axial compression test results

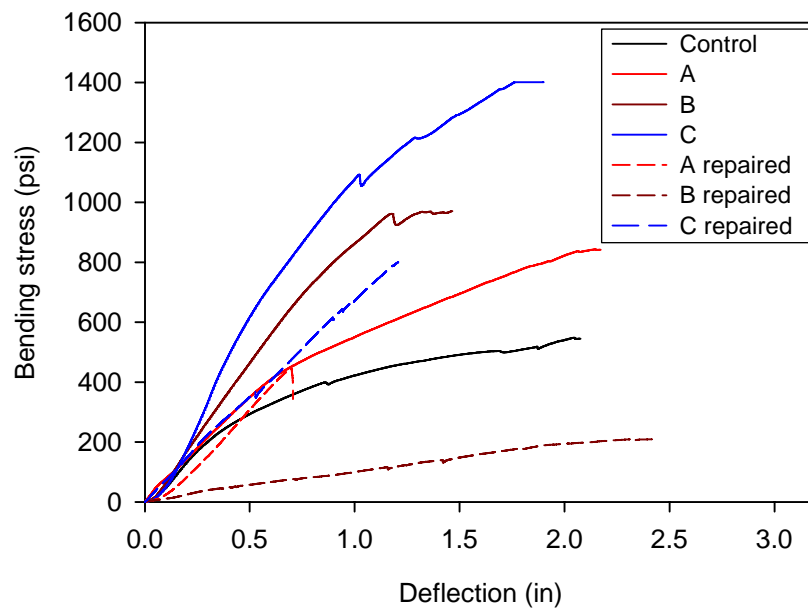
Figure 13.17. Summary of bending test results
