Detection of Voids in Prestressed Concrete Bridges using Thermal Imaging and Ground-Penetrating Radar

WA-RD 717.1

December 2008

**DETECTION OF VOIDS IN PRESTRESSED CONCRETE BRIDGES USING
THERMAL IMAGING AND GROUND-PENETRATING RADAR**

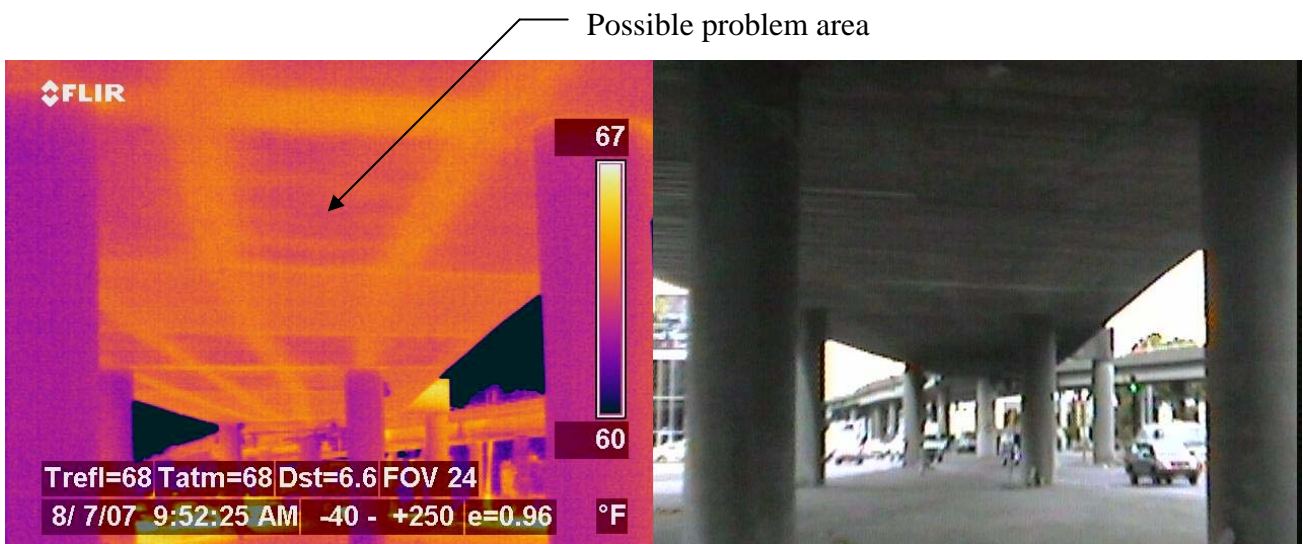
Figure 18 – Thermal image and photo of box girder bridge under ambient conditions

conditions from which a heating location might be determined. The arrow points to a location which should be a solid color inside a rectangle of yellow indicating a uniform temperature distribution. The yellow areas in the image signify locations of interior webs of the box girder. However, a closer look at the image reveals a few areas with higher surface temperatures than the surrounding concrete within the rectangle. This signal of inconsistency may indicate a problem area.

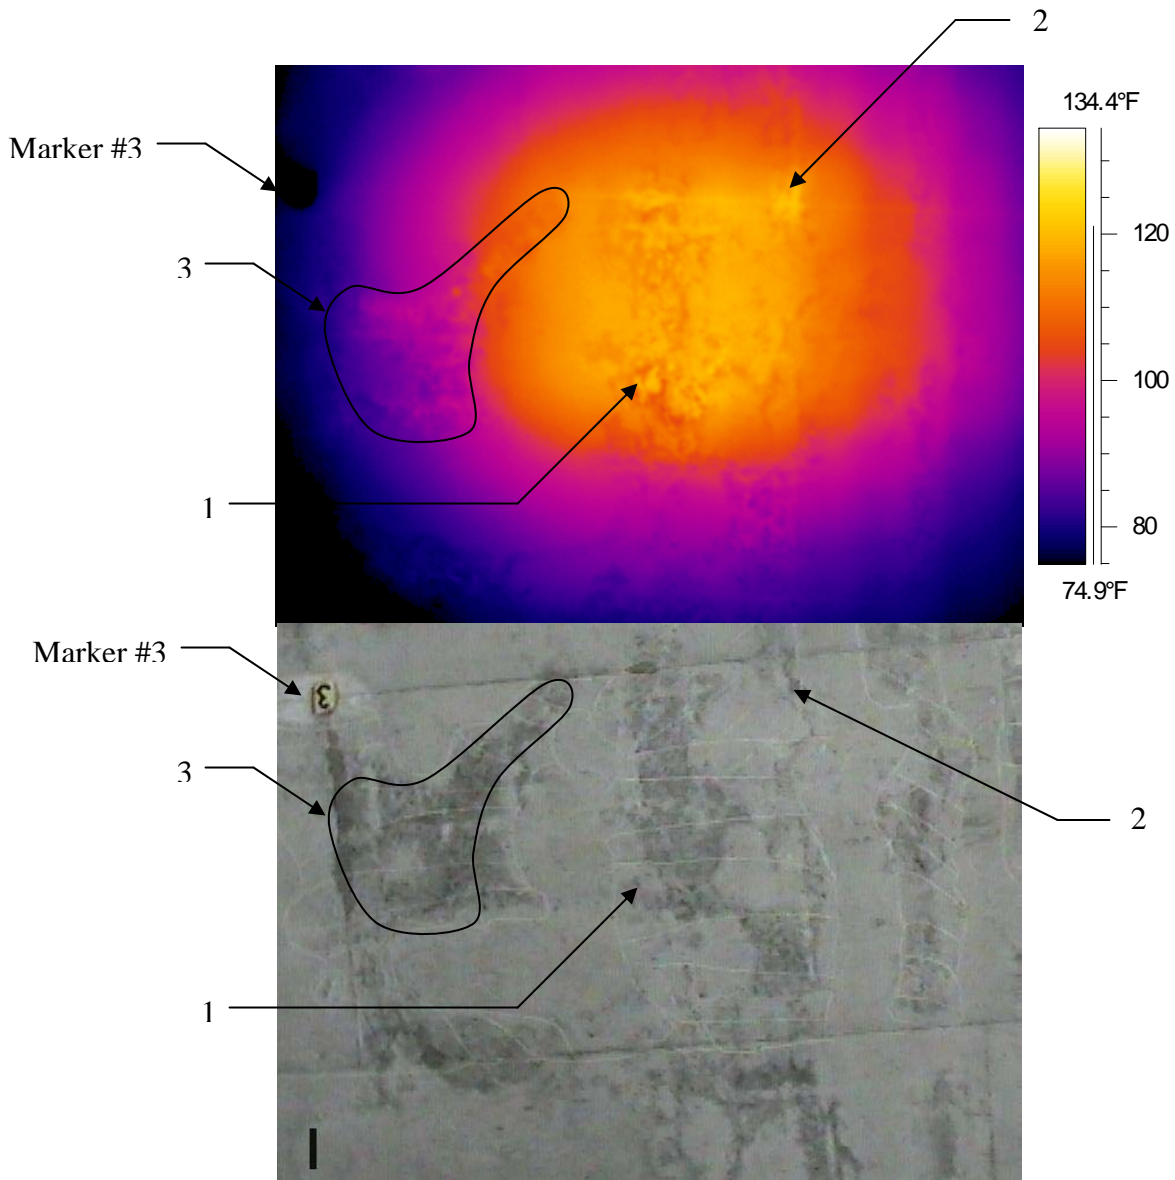
Figure 20 – Thermal image and photo of Heating Location # 1

Heating Location # 1 was inspected on August 6th, 2007 using inspection Method 2. The inspection position was in Span 11 between marker # 1 and marker # 3 (markers were attached to the surface during prior WSDOT inspections). The surface was heated for a time span of 1:45 (hh:mm). The top of the heater was placed approximately 76 cm (30 in.) from the heated surface, which was 7.1 m (23.2 ft.) from the ground. This location was chosen because it was an area that had already been inspected by WSDOT, as indicated by the white chalk in Figure 20. The objective was to see how the thermal images displayed what was previously discovered. Figure 20 shows a thermal image and a corresponding photo of the heated surface. The figure also shows three regions of interest on the heated surface. These regions are clearly shown in both the photo and the thermal image as locations with thermal anomalies.

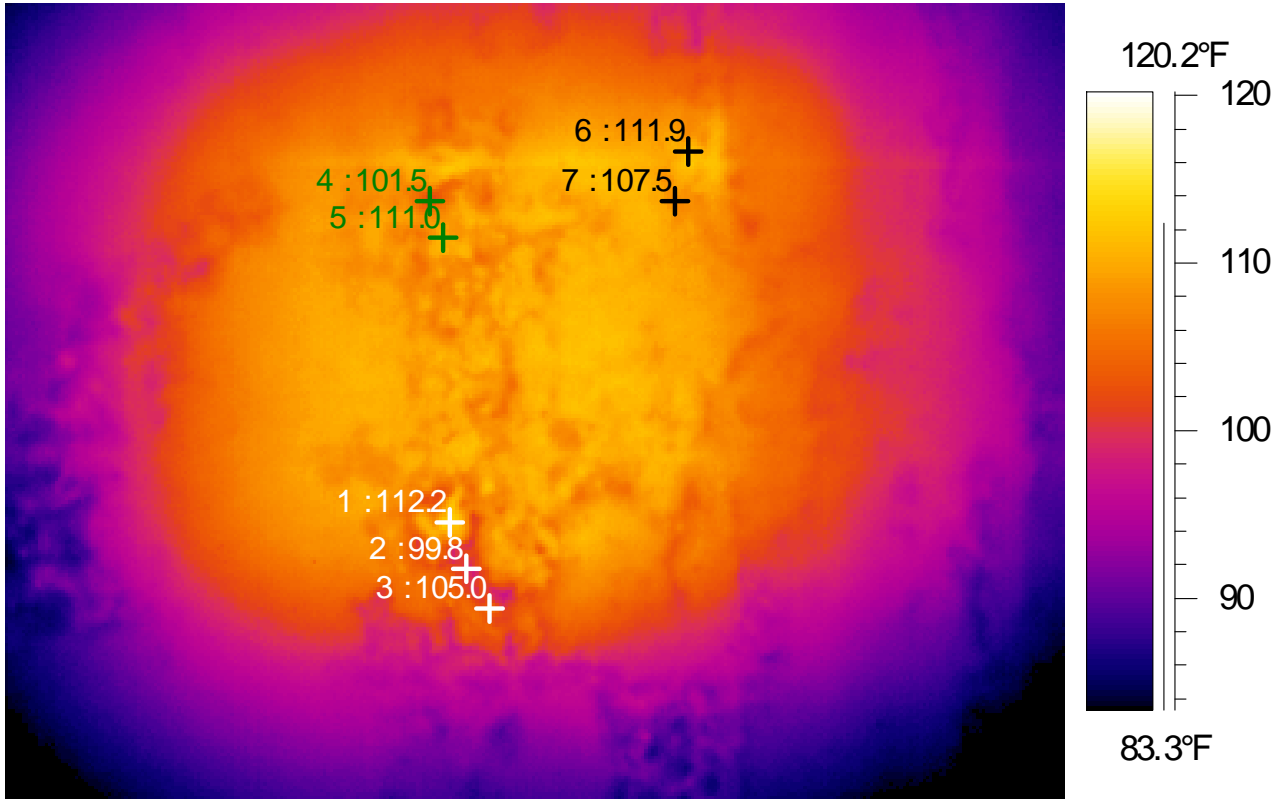
Figure 21 – Thermal image of Heating Location # 1

away from the heated center. This shows that there was an irregularity at this location, which was at approximately the same location as region 1 in Figure 20.

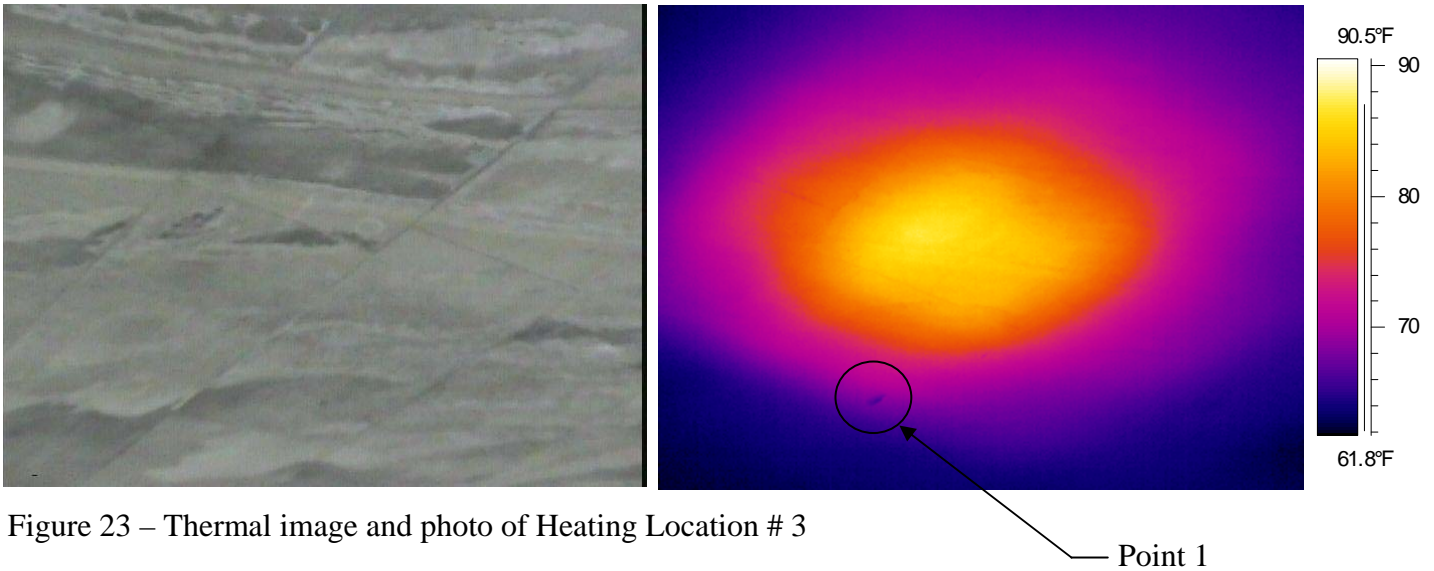
Figure 23 – Thermal image and photo of Heating Location # 3

small temperature change and the lack of other irregularities around the point, it would probably not be classified as a point of significance. Heating Location # 3 would therefore be a good example of a surface with no apparent problems after inspection.

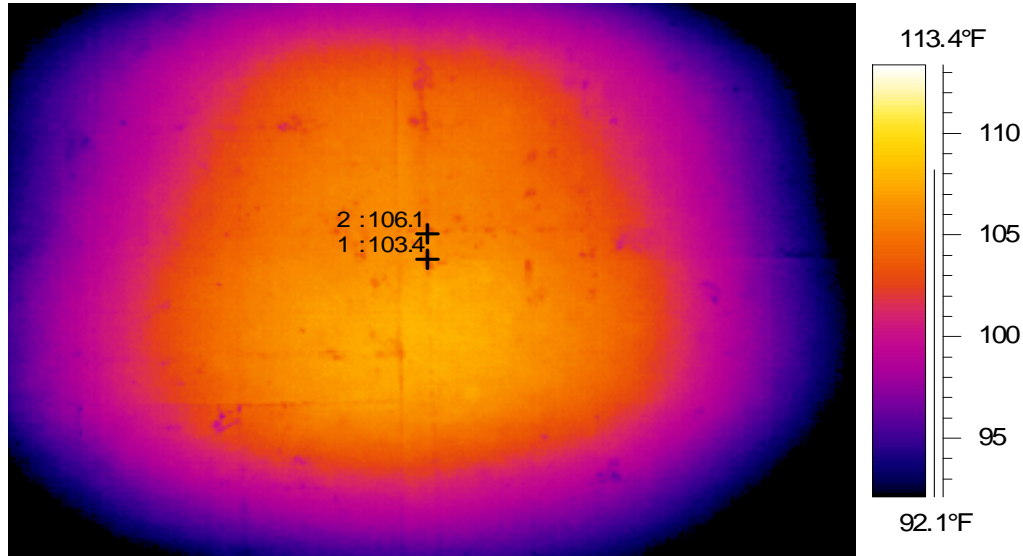
Figure 24 – Thermal image of Heating Location # 4

Figure 24 shows a thermal image of Heating Location # 4. Many small irregularities were detected in this image. An example is at points 1 and 2 in the middle of the image. Point 1 is closer to the heated center than point 2, but it is almost 3 °F cooler. Based on more analysis of the image with the thermal imaging software, most of the other irregularities were found to be approximately 2 to 3 °F cooler as well. Since the irregularities are not substantially different in

terms of temperature, one can conclude that they are just surface marks or areas where a small amount of concrete has spalled off.

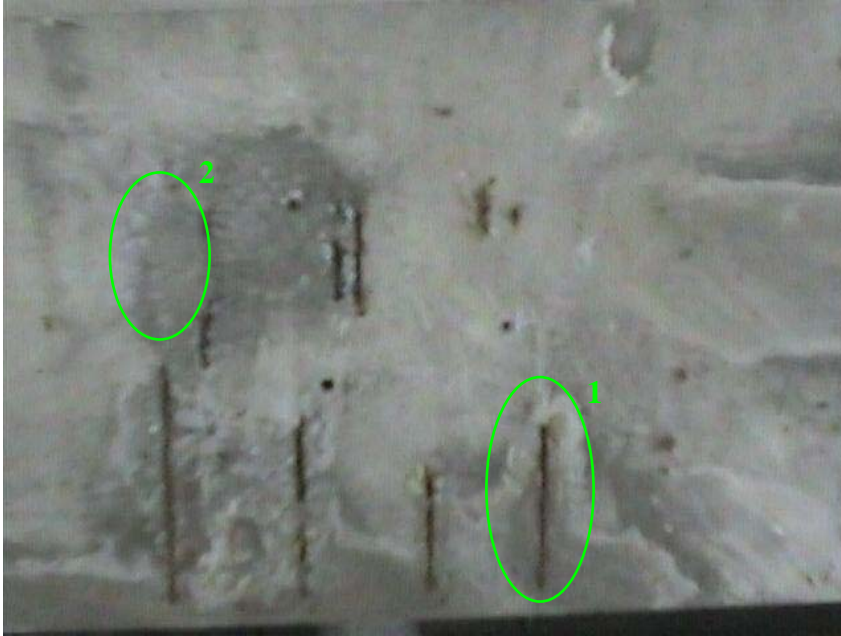
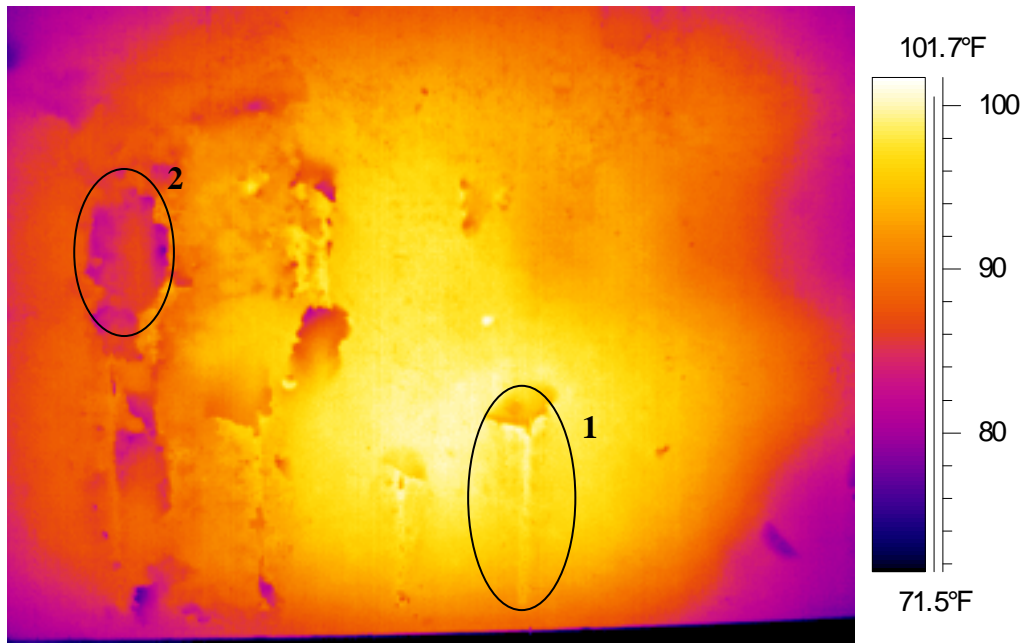
Figure 26 –Thermal image and photo of Heating Location # 5

Figure 26 shows both a photo and thermal image of Heating Location # 5. This figure is helpful because one can see exactly how each area in the photo appears in the thermal image. An example is the steel reinforcement. It is seen exposed in the photo, and then as a warmer line in the image, designated by circled area 1 in the figure. Most of the longitudinal rebar can be traced in a similar manner.

Circled area 2 in Figure 26 shows an interesting irregularity. The area doesn't display anything significant in the photo except a small amount of discoloration, but the thermal image demonstrates inconsistencies in the material in the form of great temperature differences. The thermal imaging software showed an approximate 5 °F difference between areas within the circle. This may be due to delamination, poorly consolidated concrete, or another irregularity, but there is no way to be certain of the specific cause until further tests are completed (either "sounding" with a hammer, or chipping out the loose concrete). This does, however, reveal that there may be a problem at this location. There are also a few other areas in the figure that exhibit similar temperature anomalies.

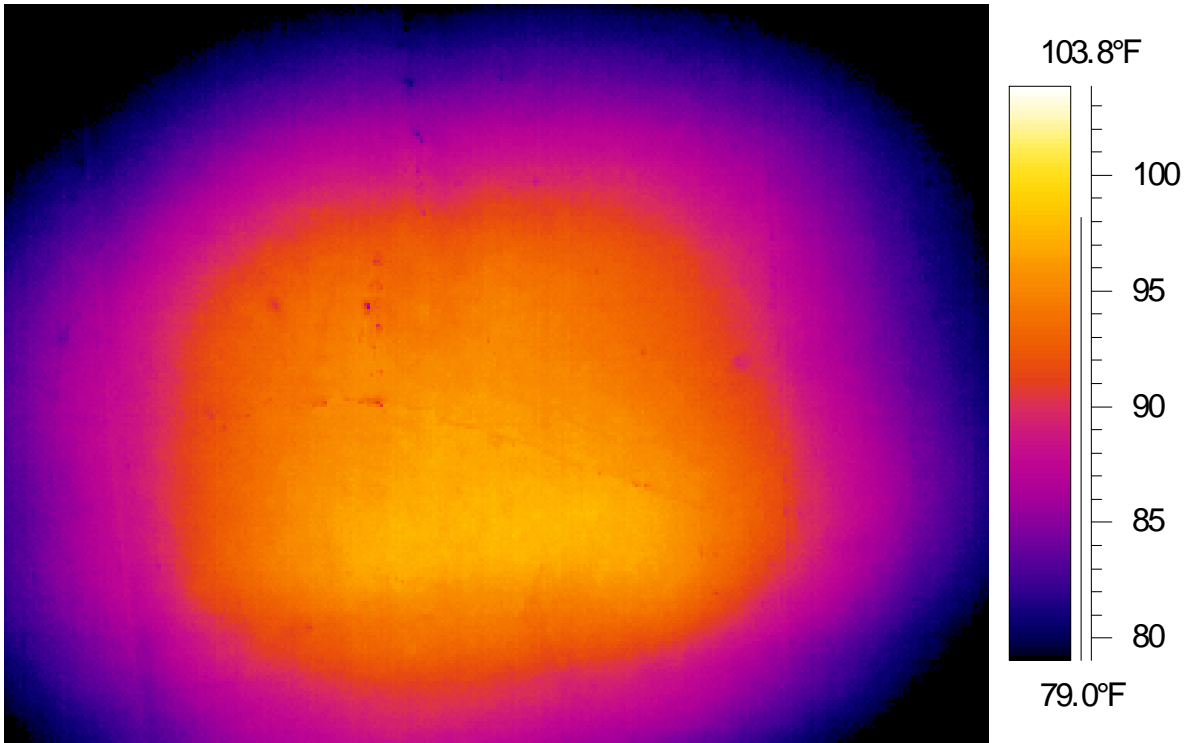
Figure 27 – Thermal image of Heating Location # 6

Figure 27 shows a thermal image of Heating Location # 6. This inspection did not detect any irregularities. The concrete surface seems to have no flaws. However, the inspection does show some of the surface texture characteristics. In the center of the thermal image, for example, is an area where concrete protrudes a very short distance beyond the flat surface. The surface feature looks like a line with a downward slope. The thermal image also demonstrates how very small surface defects can be detected.

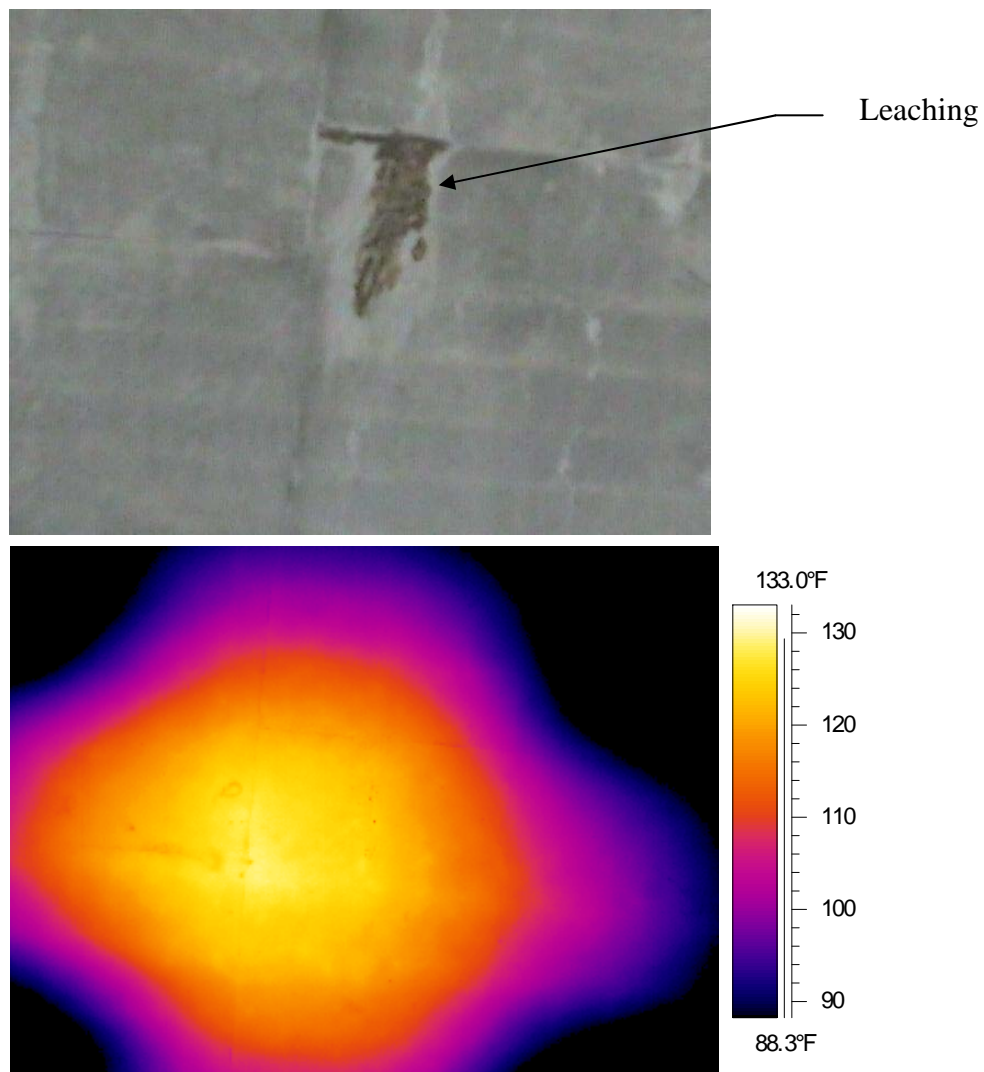
Figure 28 – Thermal image and photo of Heating Location # 7

Figure 28 shows a thermal image and photo of the unheated surface from Heating Location # 7. This area was chosen because of discoloration due to leaching on the bottom surface of the box girder. The leaching may have been caused by water pooling inside the box girder at this location, and then leaching through. However, the thermal image in Figure 28 does not show any irregularities. This indicates that there are no delaminations or air voids near the surface of the concrete.

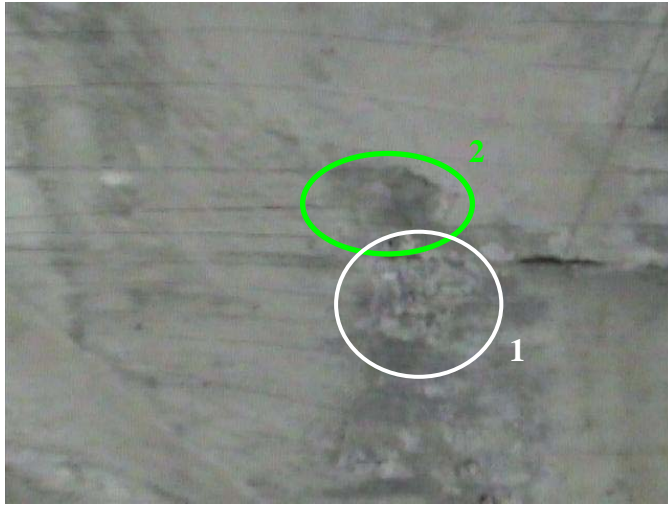
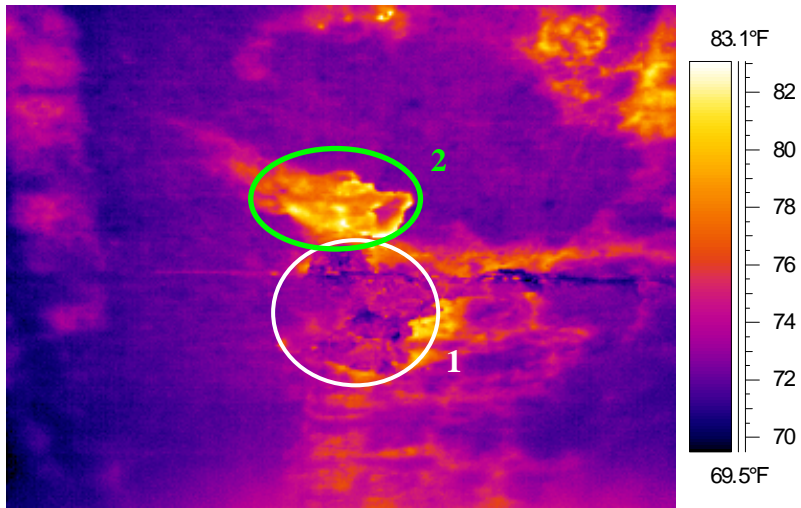
Figure 32 – Thermal image and photo of Heating Location # 11 approximately 10 minutes after heating began

Figure 32 shows a thermal image and photo of Heating Location # 11 that were taken approximately 10 minutes after heating began. Visible flaws were present on the heated surface and temperature differences between warm and cool areas were approximately 7 °F. The thermal image shows that not much heat time is needed to detect surface irregularities and obtain a significant temperature variation. Figure 32 also shows what looks like spalled concrete (denoted by circle 1) and an area of delamination (denoted by circle 2).

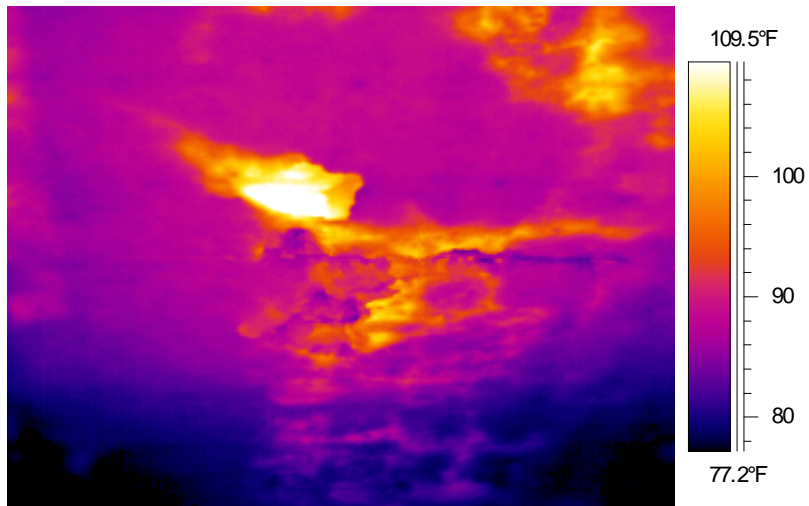
Figure 33 – Thermal image of Heating Location # 11 approximately 40 minutes after heating began

Figure 33 shows a thermal image of Heating Location # 11 taken approximately 40 minutes after heating commenced. When comparing Figures 32 and 33, it is evident that a lot of surface detail was lost as the heating time increased. This is likely due to the camera's automatic adjustment to a broader temperature range. Broader temperature ranges result in less detailed images.

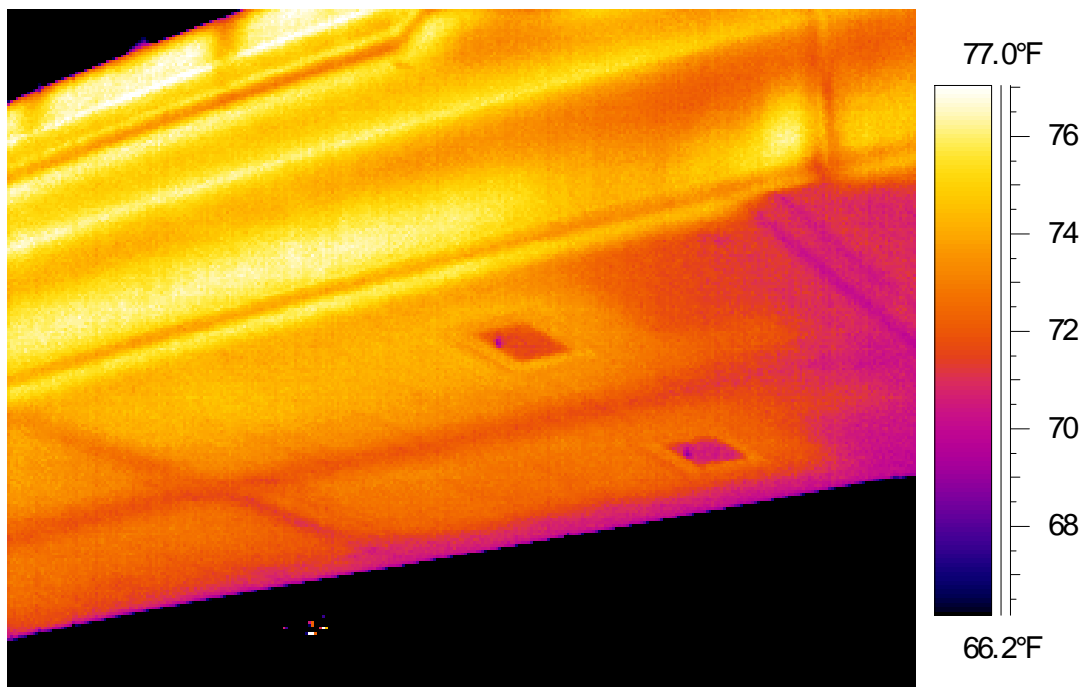
Figure 34 – Thermal image of Bridge 5/537E-N under ambient conditions

Before any inspections took place, thermal images of the bottom surface of the box girder under ambient conditions were analyzed to see if problem areas could be identified. Figure 34 shows a thermal image of the bridge under ambient conditions that encompasses most of Span 4. This thermal image displays the access hatches used during one inspection (Heating Location # 2). However, it does not reveal any specific problem areas. Without thermal identification to locate problem areas, visual analysis was used, in conjunction with access limitations, to determine heating locations. The positioning limits were based on access provided by WSDOT

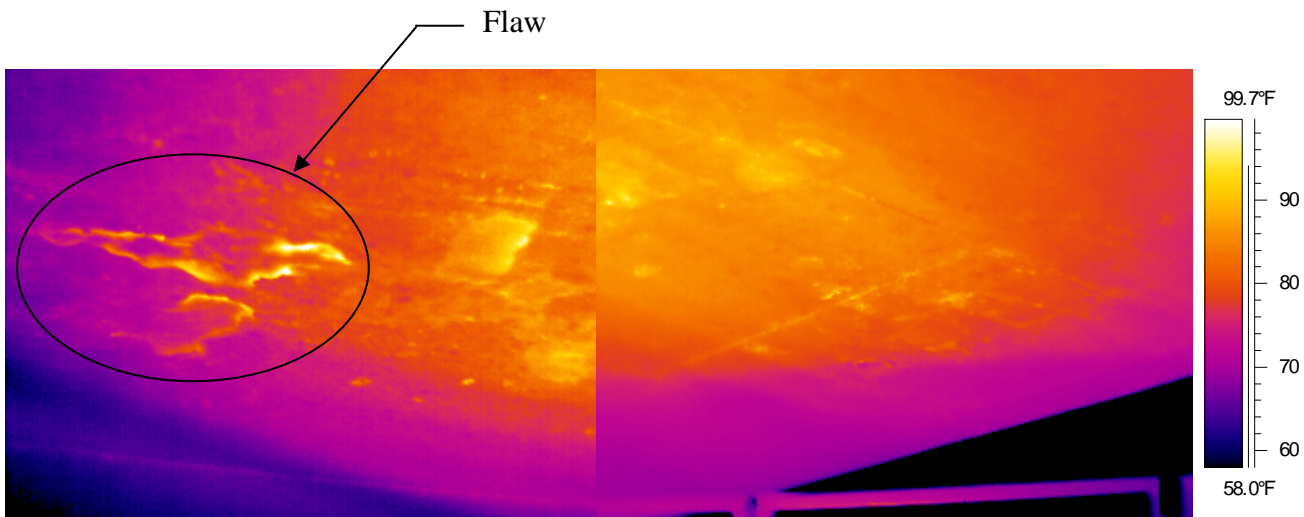
Figure 36 – Thermal images of Heating Location # 1, side by side

With this inspection, thermal images were taken throughout the heating process. The camera was placed on the lift platform approximately 3 m (10 ft.) to one side of the heater. Figure 36 shows two thermal images side by side that were taken approximately four minutes after heating began. The circled region demonstrates that after a fairly short heat time, surface characteristics and flaws were visible in thermal images. There were also other visible irregularities in the middle of the figure.

The thermal images in Figure 36 were taken in order to help locate areas that, with further heat input, might reveal subsurface flaws. The circled region shows what looks like a flaw, so the heater was moved so that its center was directly underneath this region, and then heating commenced again. From here, thermal images were taken every two minutes. Figure 37 shows a typical image progression during heating, or what one would see from the camera display. Figure 38 shows a single image from the progression.

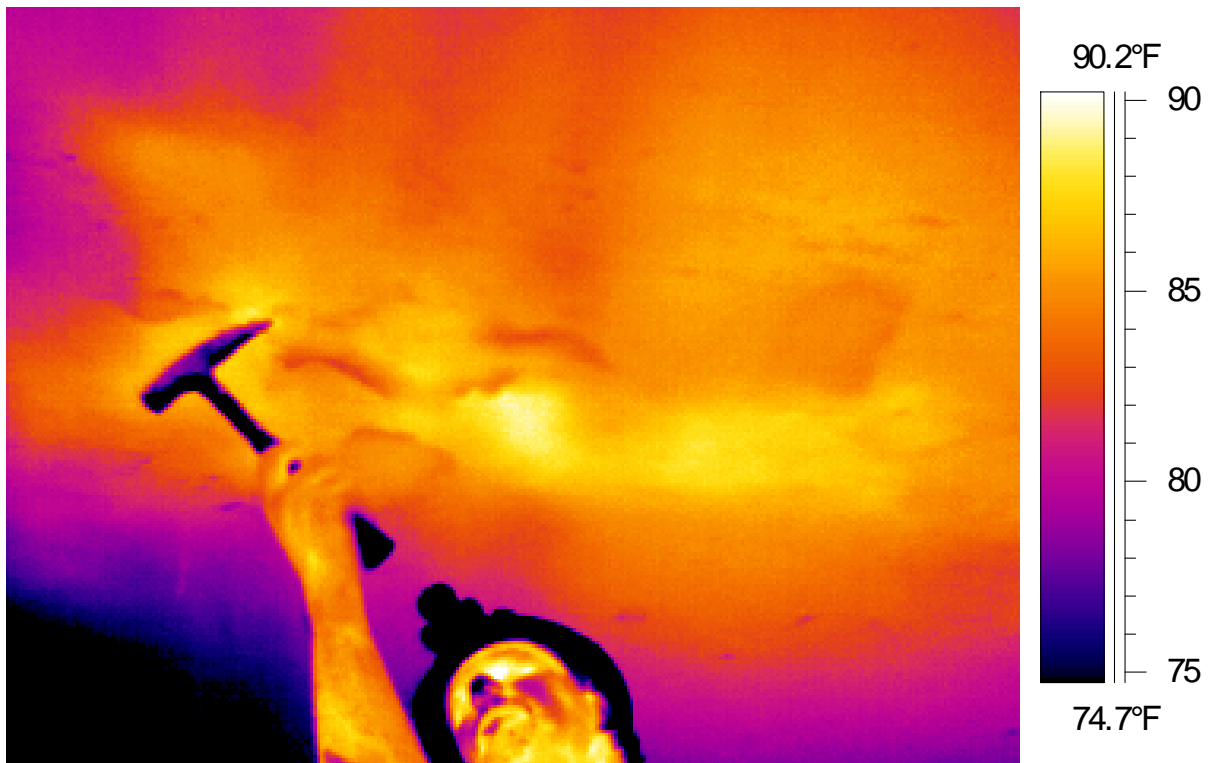
Heating Location # 1 was a very important inspection because, after heating was stopped, the surface was examined with a rock hammer. Tapping confirmed what was seen in the thermal images. A WSDOT inspector tapped part of the surface that had no apparent flaws (either visually or thermally) and then tapped at suspected flaw locations. Sound differences were easily discernable between the two locations, and then the pick end of the hammer was used to remove surface concrete and excavate the flaw. Delamination and poorly consolidated concrete (small air voids) were discovered. Figure 39 shows a thermal image of a WSDOT employee excavating the delaminated concrete at the flaw location shortly after thermal imaging inspection. This was the first inspection location where flaws discovered thermally were confirmed using physical means (tapping and excavation).

Figure 39 – Thermal image of Heating Location # 1: excavating a detected flaw

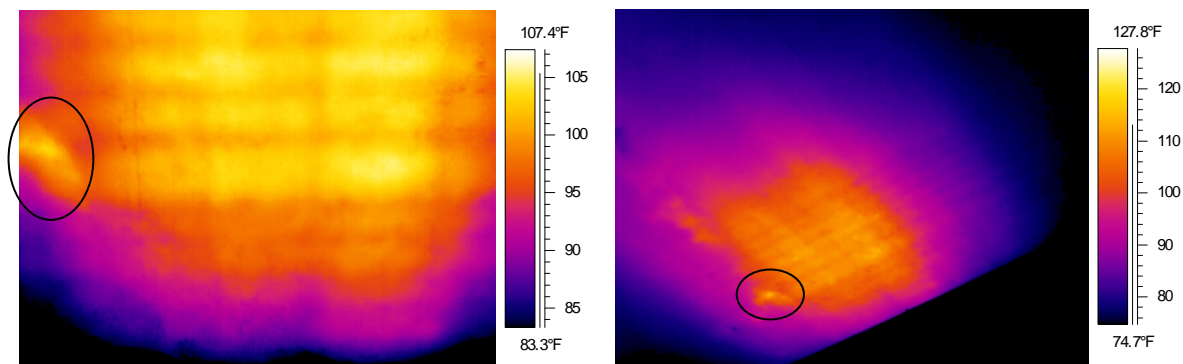
Figure 40 – Thermal images of Heating Location # 2

Thermal images from Heating Location # 2 do not reveal anything about the leaching or the unheated surface. Steel reinforcement inside the concrete is the only thing shown in the images. Figure 40 is comprised of two thermal images that show the reinforcing steel as cool lines between warmer regions. There is one hot spot, which is located inside the circled region in both thermal images.
