# **DEVELOPMENT AND EVALUATION OF THE MIDWEST GUARDRAIL SYSTEM (MGS) PLACED ADJACENT TO A 2:1 FILL SLOPE**

## **MIDWEST ROADSIDE SAFETY FACILITY**

MwRSF Research Report No. TRP-03-185-10

February 24, 2010

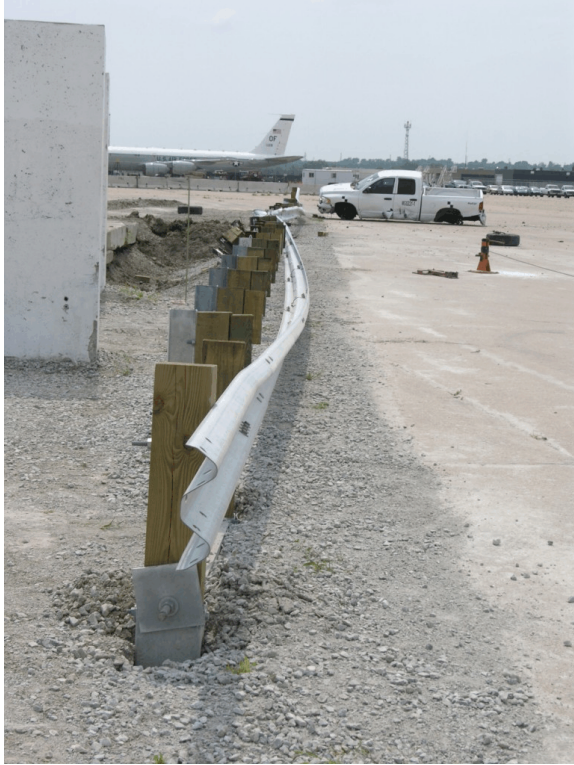
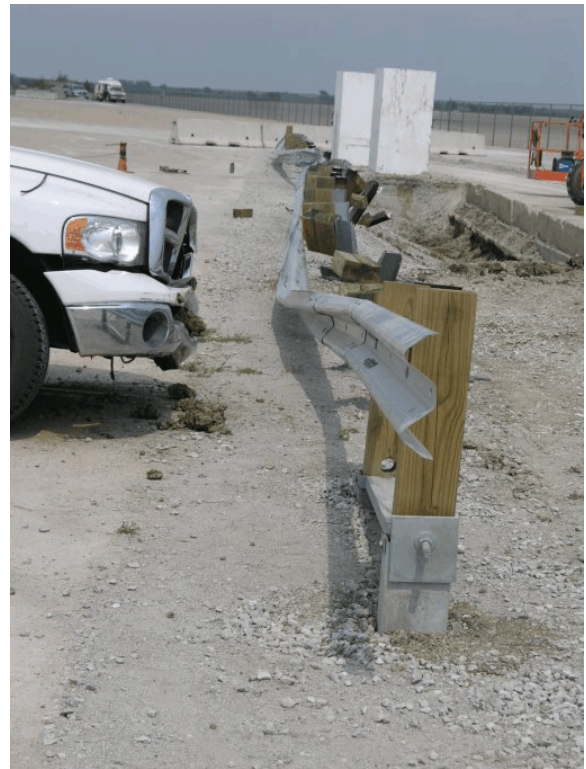
Figure 33. System Damage, Test No. MGS221-1

Damage to the barrier was moderate, as shown in Figures 33 through 41. Barrier damage consisted of deformed guardrail posts, disengaged wooden blockouts, contact marks on a guardrail section and posts, and deformed and fractured W-beam rail. The length of the vehicle contact along the MGS system was approximately 8.8 m (29 ft - 1½ in.), which spanned from 305 mm (12 in.) upstream from the centerline of post no. 13 through the midspan between post nos. 17 and 18.

Moderate deformation and flattening of the impacted section of W-beam rail occurred between post nos. 13 through 17. Contact marks were found on the guardrail between post nos. 12 and 18 and on the backside of the W-beam between post nos. 23 and 26. A 686-mm (27-in.) long diagonal tear in the rail occurred 127 mm (5 in.) downstream of post no. 5. A 25-mm (1-in.) long

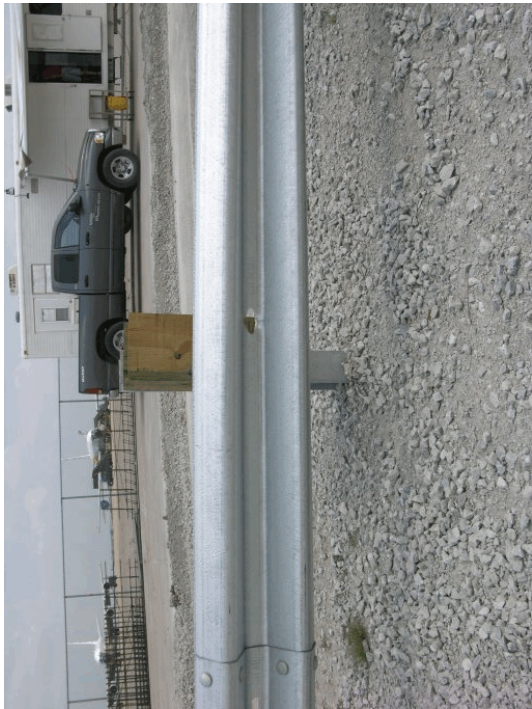
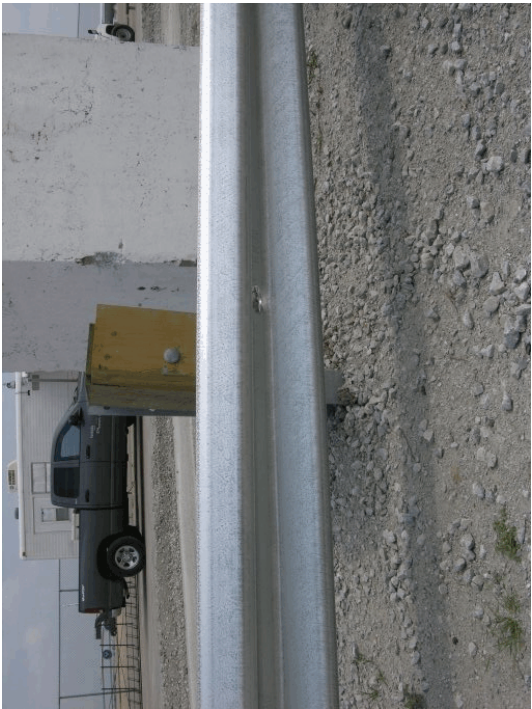
Figure 34. Post Nos. 3 through 6 Damage, Test No. MGS221-1

Steel post nos. 3 through 12 encountered minor twisting. Steel post nos. 13 through 17 twisted and rotated backward with major soil failure visible at the ground level. Steel post nos. 18 through 20 were undamaged. Steel post nos. 21 and 22 bent slightly, while post no. 23 bent downstream and rotated clockwise. The rear flange of post no. 23 was bent toward the web due to vehicle contact. Steel post nos. 24 through 26 bent downstream and backward and twisted counter-clockwise. The front and back flanges were bent backward at the top of steel post nos. 24 and 25. The upstream and downstream anchorage systems moved longitudinally. For the upstream anchorage, soil gaps of 102 mm (4 in.) and 38 mm (1½ in.) were found on the upstream and downstream sides of post no. 1, respectively, and for post no. 2, soil gaps of 64 mm (2½ in.) and 51 mm (2 in.) were found on the upstream and downstream sides, respectively. For the downstream anchorage, soil gaps of 13 mm (½ in.) and 51 mm (2 in.) were found on the downstream side of post nos. 28 and 29, respectively, while no soil gaps were found on the upstream sides of these posts. In addition, post no. 28 and 29 were uplifted out of the ground 102 mm (4 in.) and 229 mm (9 in.), respectively. However, the wooden posts in both anchorage systems were not damaged.

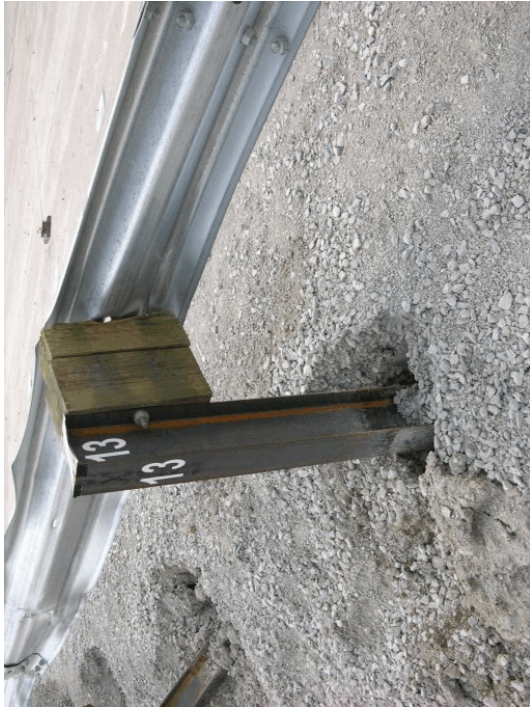
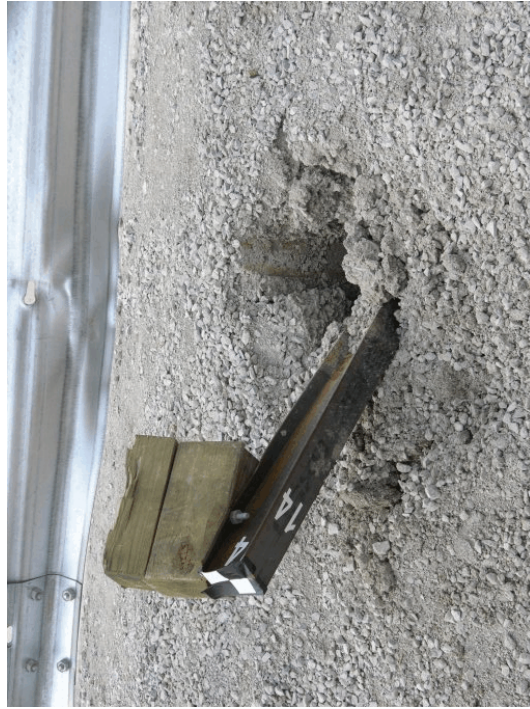
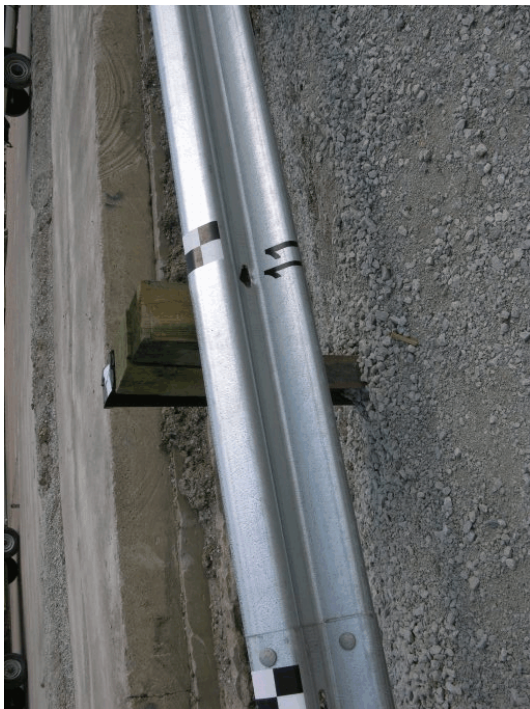
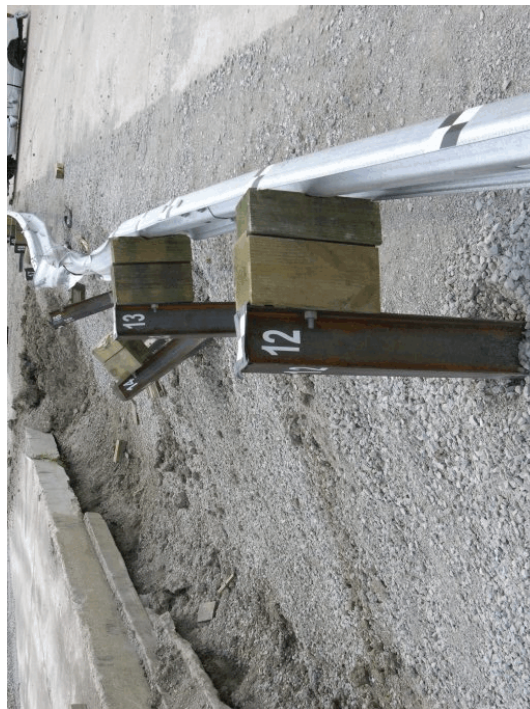
Figure 36. Post Nos. 11 through 14 Damage, Test No. MGS221-1

The wooden blockout at post no. 14 encountered damage on the front face, but it remained attached. The wooden blockouts at post nos. 15 through 17 were fractured and mostly removed from the post. All other wooden blockouts remained undamaged.

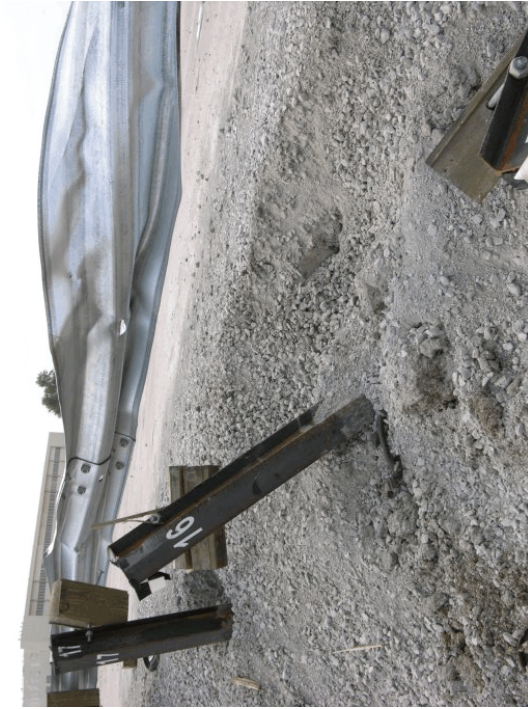
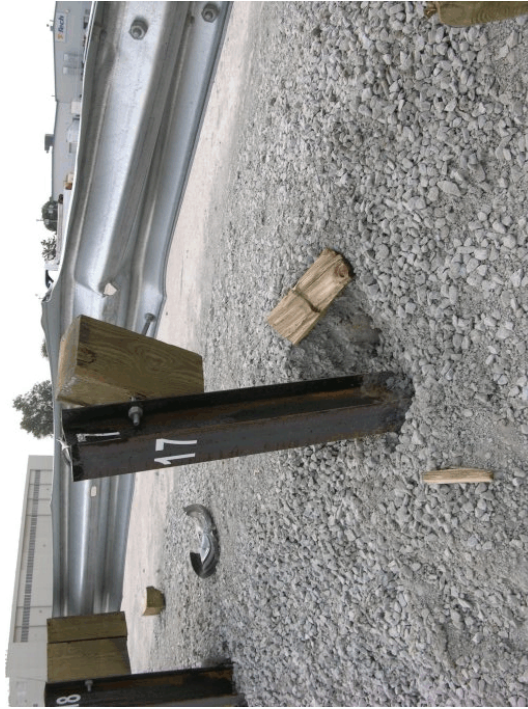
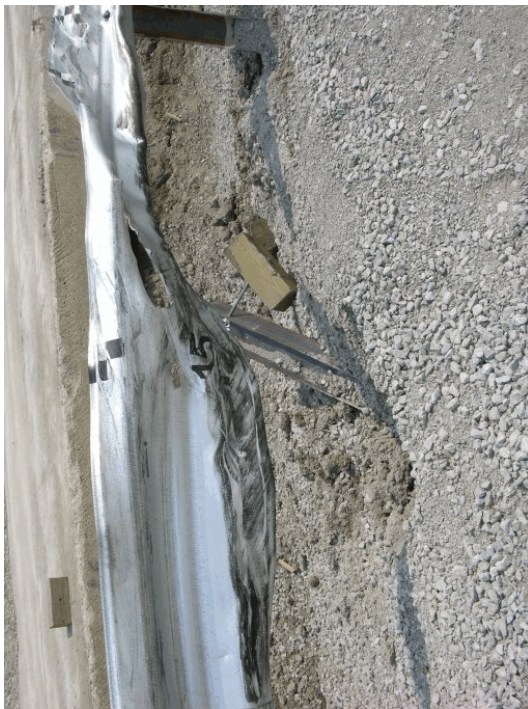
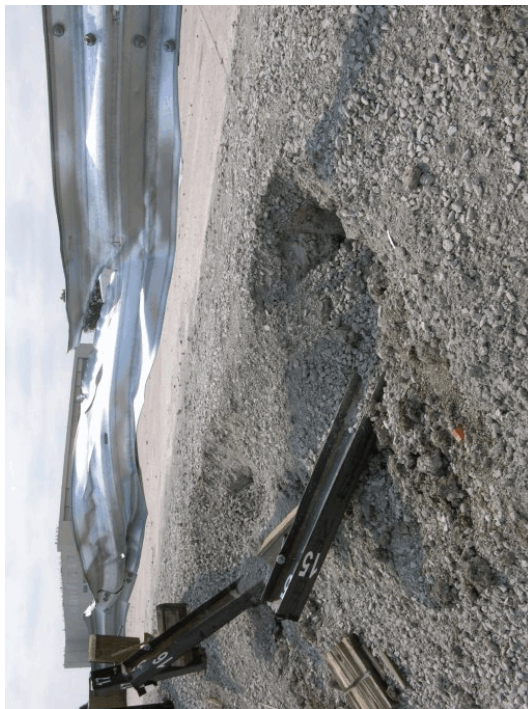
Figure 37. Post Nos. 15 through 17 Damage, Test No. MGS221-1

The vehicle override was attributed to the slow release of post no. 15 from the guardrail, thus causing the W-beam to be pulled downward. In addition, the vehicle override was also attributed to the failure of the vehicle's front suspension shortly after impact, thus preventing the guardrail from capturing the pickup truck's left-front tire.

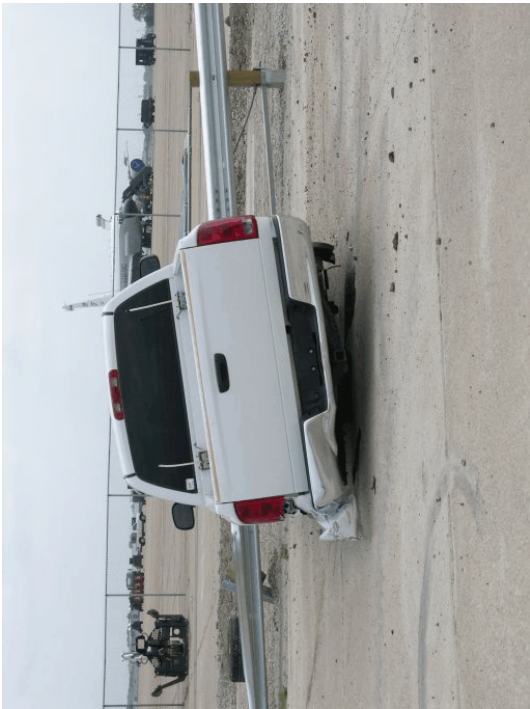
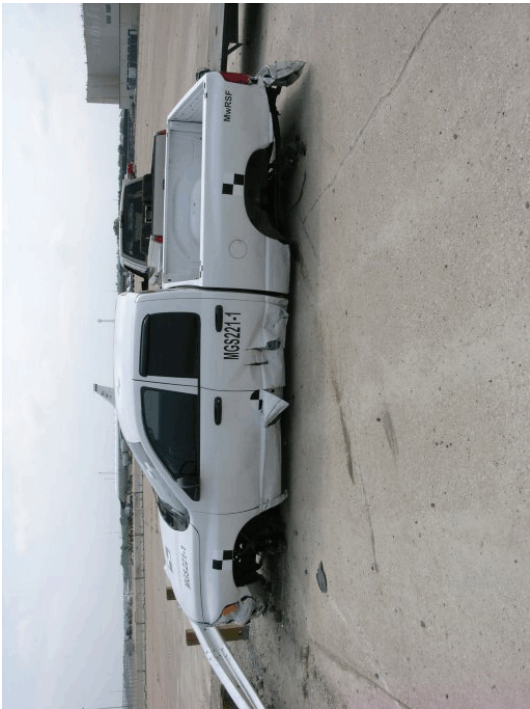
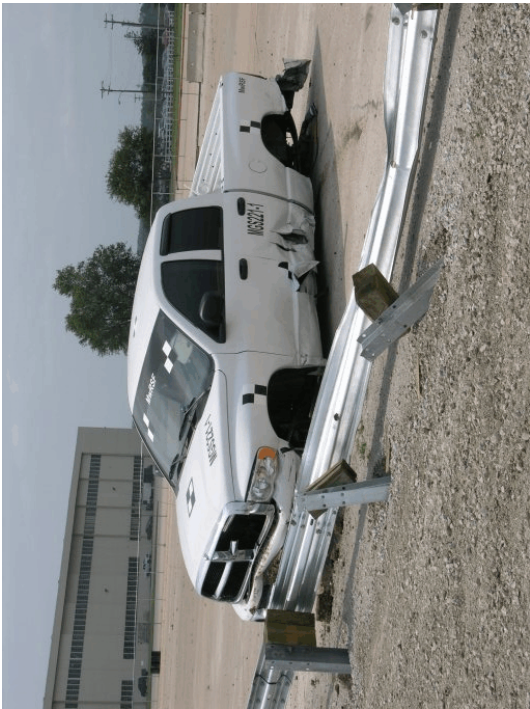
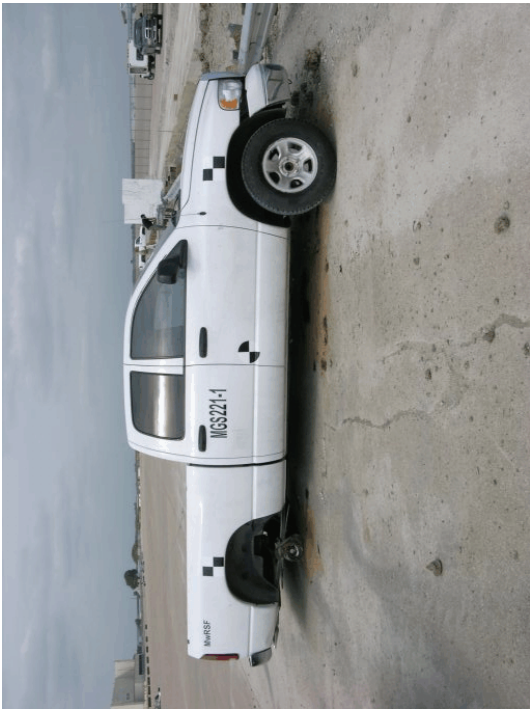
Figure 42. Vehicle Damage, Test No. MGS221-1

Exterior vehicle damage was moderate, as shown in Figures 42 through 44. Occupant compartment deformations to the left side and center of the floor pan were judged insufficient to cause serious injury to the vehicle occupants, as shown in Figure 45. Maximum longitudinal deflections of 6 mm ( $\frac{1}{4}$  in.) were located throughout the left-side floor pan. Maximum lateral deflections of 13 mm ( $\frac{1}{2}$  in.) were located at the rear-center of the left-side floor pan. Maximum vertical deflections of 13 mm ( $\frac{1}{2}$  in.) were located on the floor pan near the left-side door. Complete occupant compartment deformations and the corresponding locations are provided in Appendix E.

Damage was concentrated on the left-front corner of the vehicle. The left-front corner was deformed inward toward the engine compartment. The left side of the grill was fractured and removed. The center of the front bumper buckled. The left-front, left-rear, and right-rear tires disengaged from the vehicle. Sheet metal tearing and major deformations were found along the lower portion of the left-side doors and the left-rear fender. The left side of the rear bumper was deformed upward. The left-side taillight was fractured, while the right-side taillight was slightly dislodged. The left-front, right-front, and right-rear brake lines were severed. The left-rear and right-rear shocks were fractured. The left-front upper control arm and left-front tie rod were fractured. The drive shaft was fractured and separated at the transmission yoke. The left-front sway bar linkage was

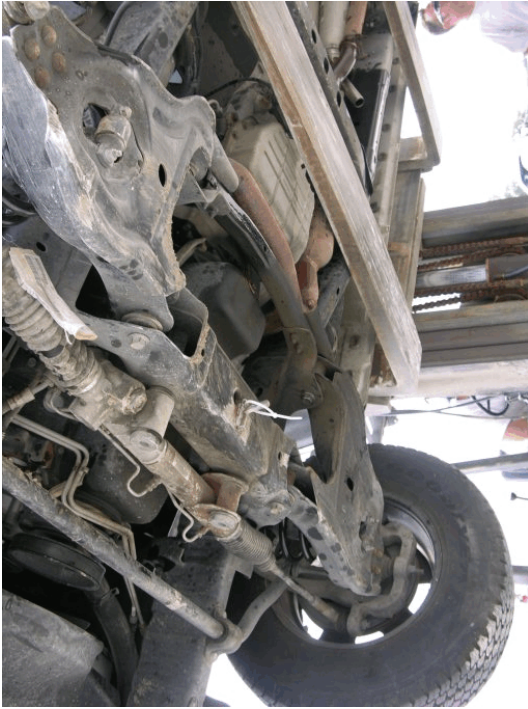
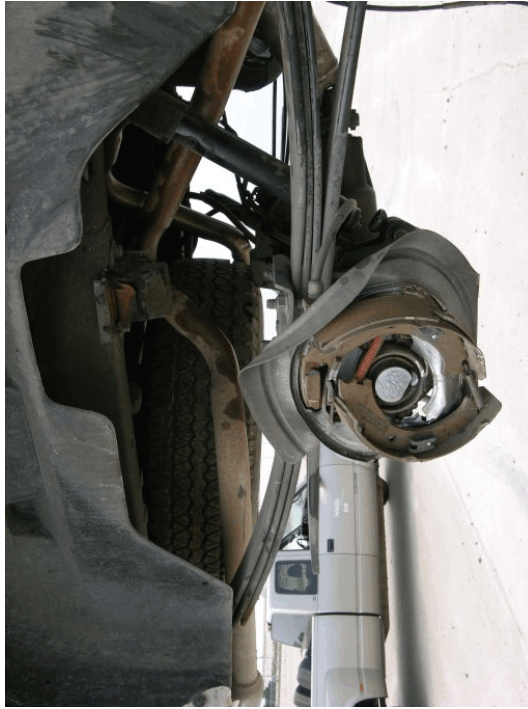
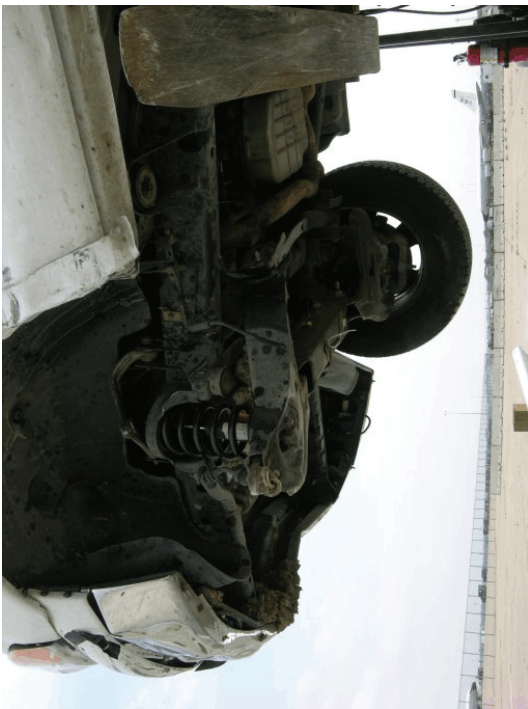
Figure 44. Undercarriage Damage, Test No. MGS221-1

bent. Both ends of the rear axle fractured before the brake housing. The gas tank heat shield was deformed and bent. The roof, hood, and right side of the vehicle and all window glass remained undamaged.

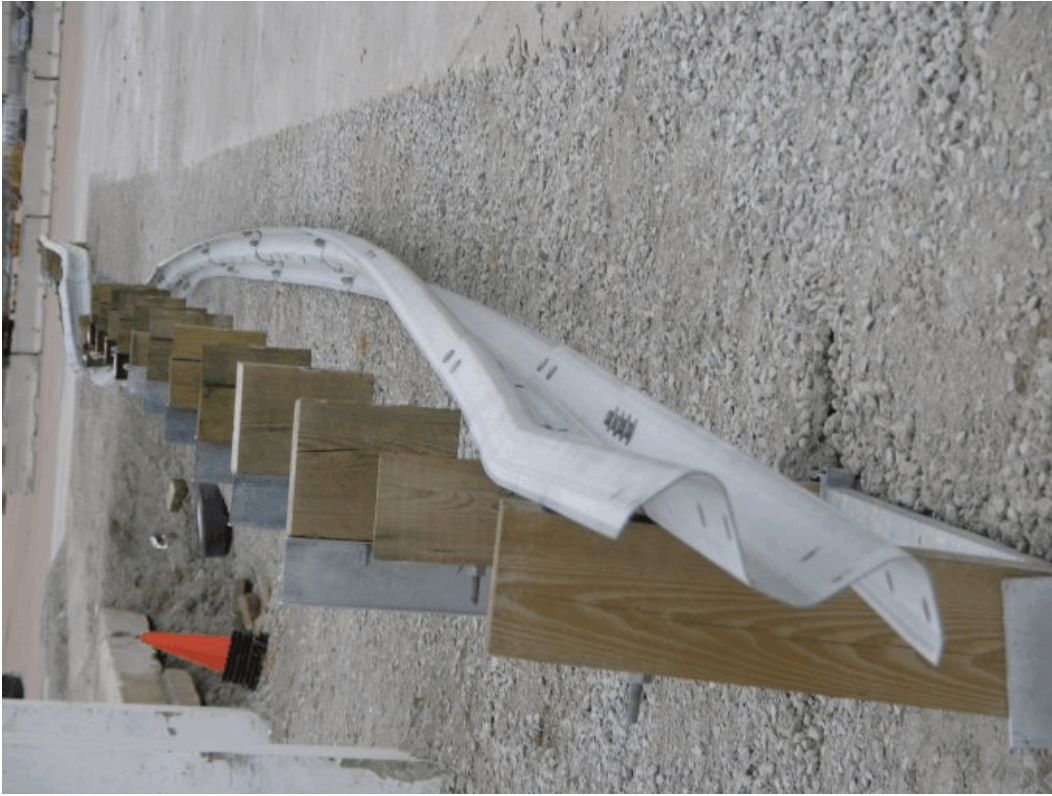
Figure 58. System Damage, Test No. MGS221-2

Damage to the barrier was moderate, as shown in Figures 58 through 64. Barrier damage consisted of deformed W-beam and guardrail posts, disengaged wooden blockouts, and contact marks on a guardrail section and posts. The length of the vehicle contact along the MGS system was approximately 12.42 m (40 ft - 9 in.), which spanned from 394 mm (15½ in.) upstream of the centerline of post no. 13 through 597 mm (23½ in.) downstream from the centerline of post no. 19.

Moderate deformation and flattening of the impacted section of W-beam rail occurred between post nos. 14 through 17. Contact marks were found on the guardrail between post nos. 12 and 20. Buckling in the rail occurred around the upstream cable anchor bracket. The guardrail buckled at post nos. 12 through 18. Rail buckle points also occurred at the midspans between post nos. 13 and 14, 14 and 15, and 15 and 16, at 229 mm (9 in.) and 508 mm (20 in.) downstream from post no. 15, at 330 mm (13 in.) downstream from post no. 16, and at 508 mm (20 in.) upstream from post no. 19. The W-beam rail sustained yielding around the post bolt slots at post nos. 2 through 19. The W-beam was pulled off post nos. 2 through 18.

The permanent set of the barrier system is shown in Figure 58. The maximum lateral permanent set rail and post deflections were 1,067 mm (42 in.) at the midspan between post nos. 15 and 16 and 864 mm (34 in.) at post no. 14, respectively, as measured in the field. The maximum lateral dynamic rail and post deflections were 1,463 mm (57.6 in.) at the centerline of post no. 15 and 805 mm (31.7 in.) at post no. 14, respectively, as determined from high-speed digital video analysis. The working width of the system was found to be 1,631 mm (64.2 in.).

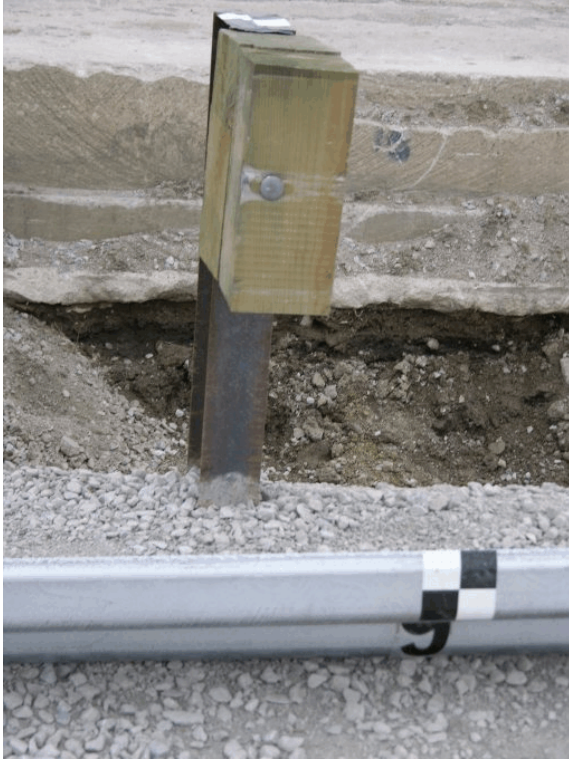
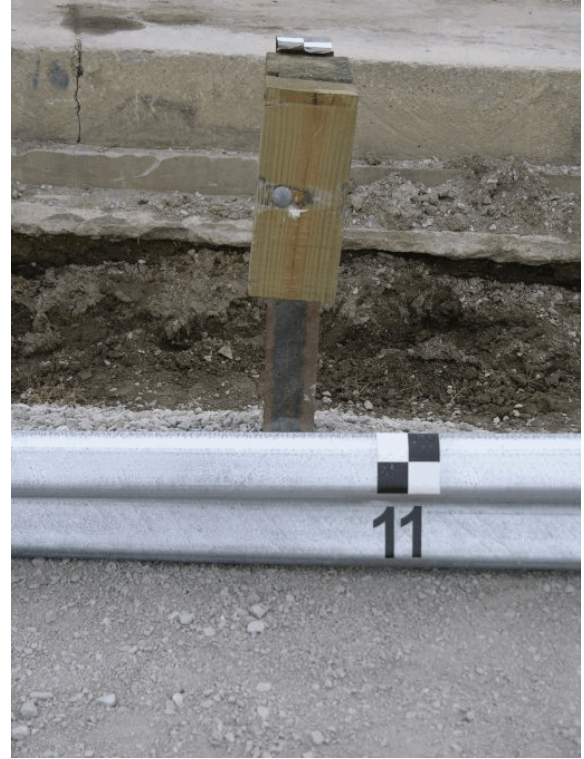
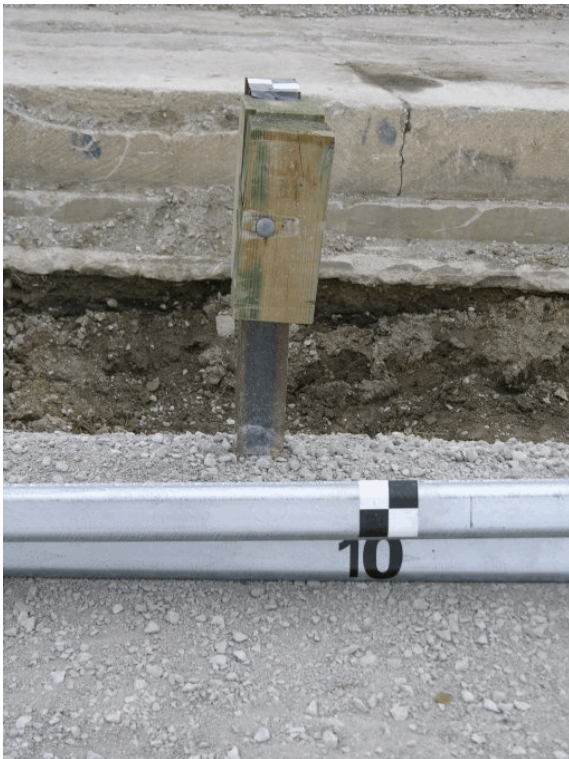
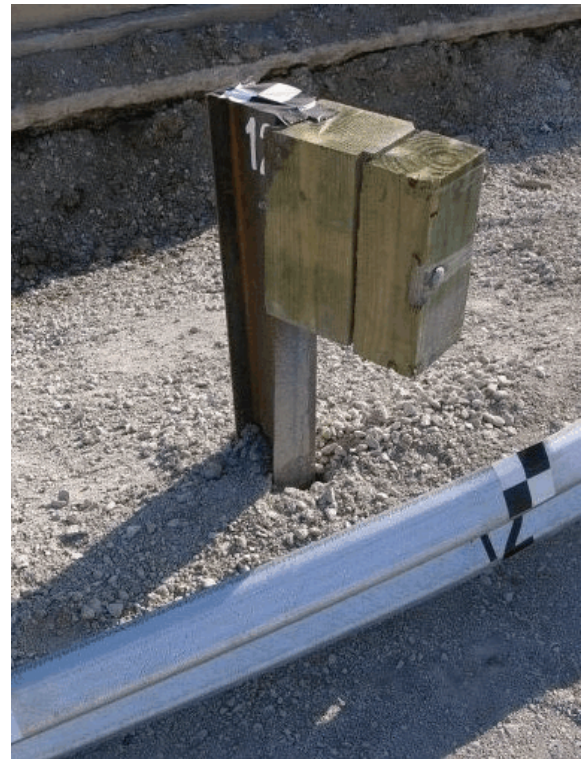
Figure 60. Post Nos. 9 through 12 Damage, Test No. MGS221-2

Steel post nos. 12 through 14 twisted and rotated backward. Post no. 14 also bent downstream to the ground. Post nos. 15 through 18 are bent and twisted downstream in the soil. Post no. 15 also encountered minor scraping and denting on the traffic face of the post. Post no. 16 encountered tearing in the flange at the bolt hole. The upstream and downstream anchorage systems moved slightly longitudinally. For the upstream anchorage, soil gaps of 121 mm (4¾ in.) and 89 mm (3½ in.) were found on the upstream sides of post nos. 1 and 2, respectively. For the downstream anchorage, a soil gap of 25 mm (1 in.) was found on the downstream side of post no. 29. However, the wooden posts in both anchorage systems were not damaged.

The wooden blockouts at post nos. 12, 13, and 18 encountered minor crush on the upstream traffic-side face. The wooden blockouts at post nos. 15 through 17 were fractured and removed from the posts. All other wooden blockouts remained undamaged.

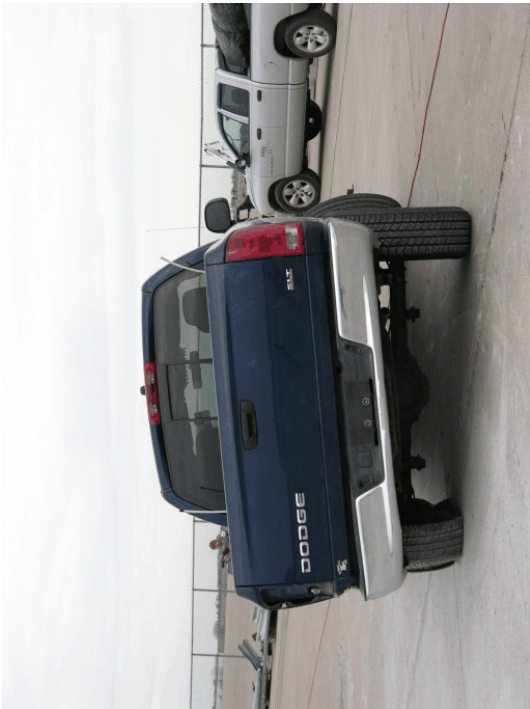
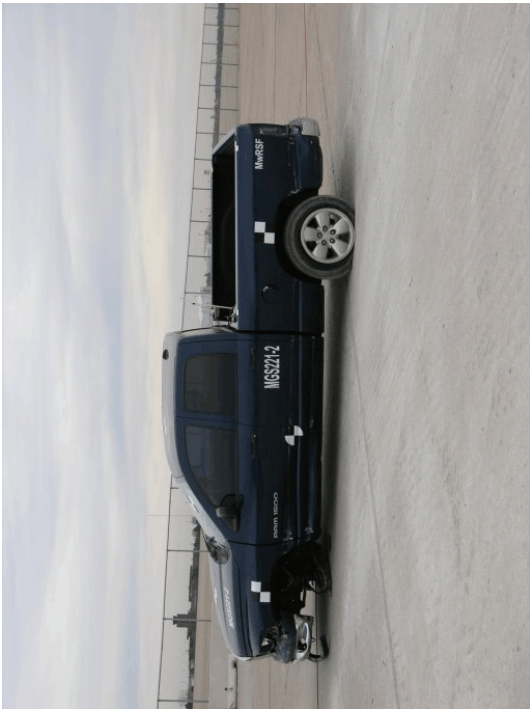
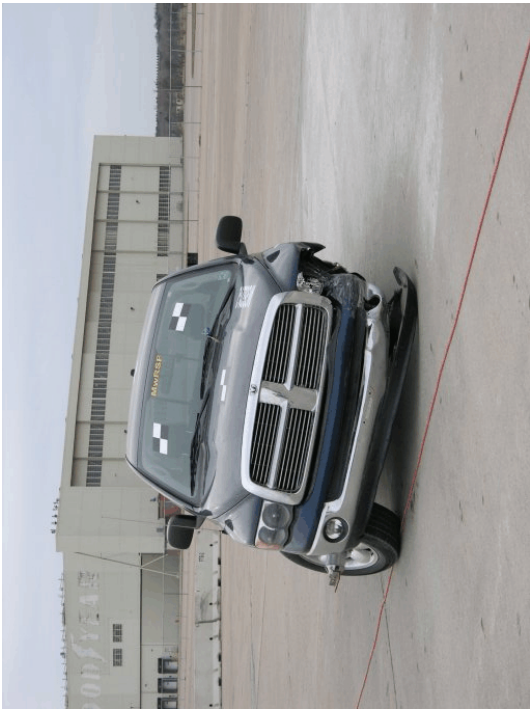
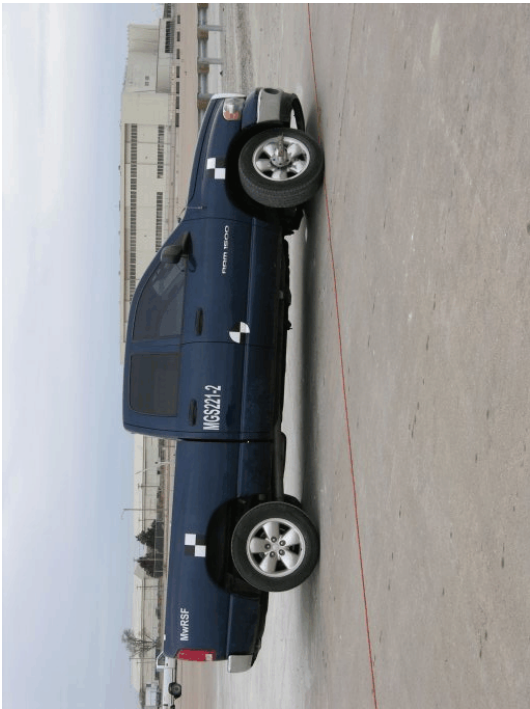
Figure 65. Vehicle Damage, Test No. MGS221-2

Exterior vehicle damage was moderate, as shown in Figures 65 and 66. Occupant compartment deformations to the left side and center of the floor pan were judged insufficient to cause serious injury to the vehicle occupants. Maximum longitudinal deflections of 6 mm (¼ in.) were located throughout the left-side floor pan. Maximum lateral deflections of 13 mm (½ in.) were

Damage was concentrated on the left-front corner of the vehicle. The left-front corner was deformed inward toward the engine compartment. The left-front tire disengaged from the vehicle. The left-rear tire was deflated. Sheet metal tearing and major deformations were found along the lower portion of the left-side doors and the left-rear fender. The left-side taillight was fractured, while the right-side taillight was slightly dislodged. The roof, hood, and right side of the vehicle and all window glass remained undamaged.
