EVALUATION OF CRITICAL FLARE RATES FOR THE MIDWEST GUARDRAIL SYSTEM (MGS)

MIDWEST ROADSIDE SAFETY FACILITY

MwRSF Research Report No. TRP-03-191-08

July 15, 2008

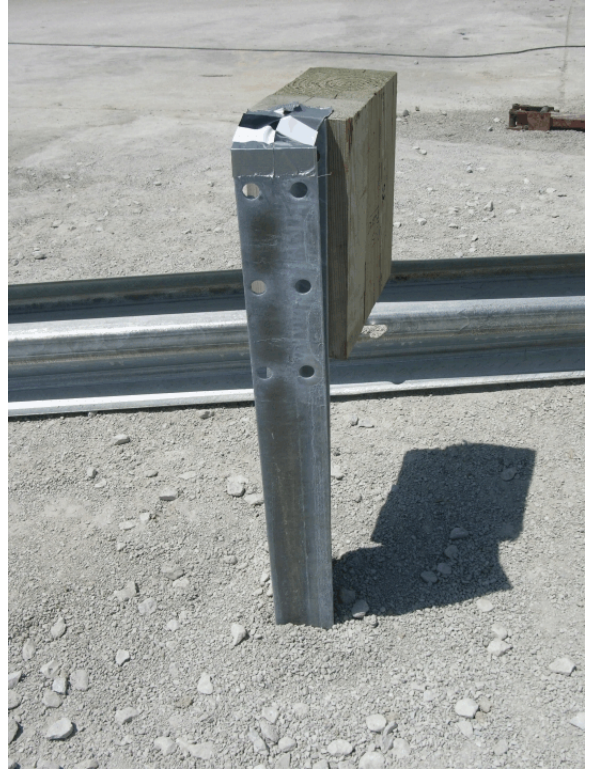
Figure 41. Post Nos. 11 and 12 Damage, Test No. FR-1

Moderate deformation and flattening of the impacted section of W-beam rail occurred between post nos. 12 and 18. Contact marks were found on the rail between post nos. 12 and 18. The guardrail buckled at nearly every post location between post nos. 12 and 18. Major buckling of the guardrail occurred at the upstream side of post no. 19. The W-beam was pulled off of post nos. 1 through 19. The W-beam rail sustained significant yielding around the post bolt slots at post nos. 1 through 11, 13, 14, 18, and 19. Minor tearing of the W-beam rail occurred around the post bolt slots at post nos. 12 and 15, while the tearing of the W-beam rail around the post bolt slots at post nos. 16 and 17 was very significant. No significant guardrail damage occurred downstream of post no. 20.

The wooden blockouts at post nos. 3 through 10 and 19 rotated slightly while still attached to the post. The wooden blockouts at post nos. 11, 12, and 18 encountered damage on the front face due to W-beam rail contact, but remained attached to the posts. The wooden blockouts at post nos. 13 through 17 were fractured and removed from the posts.

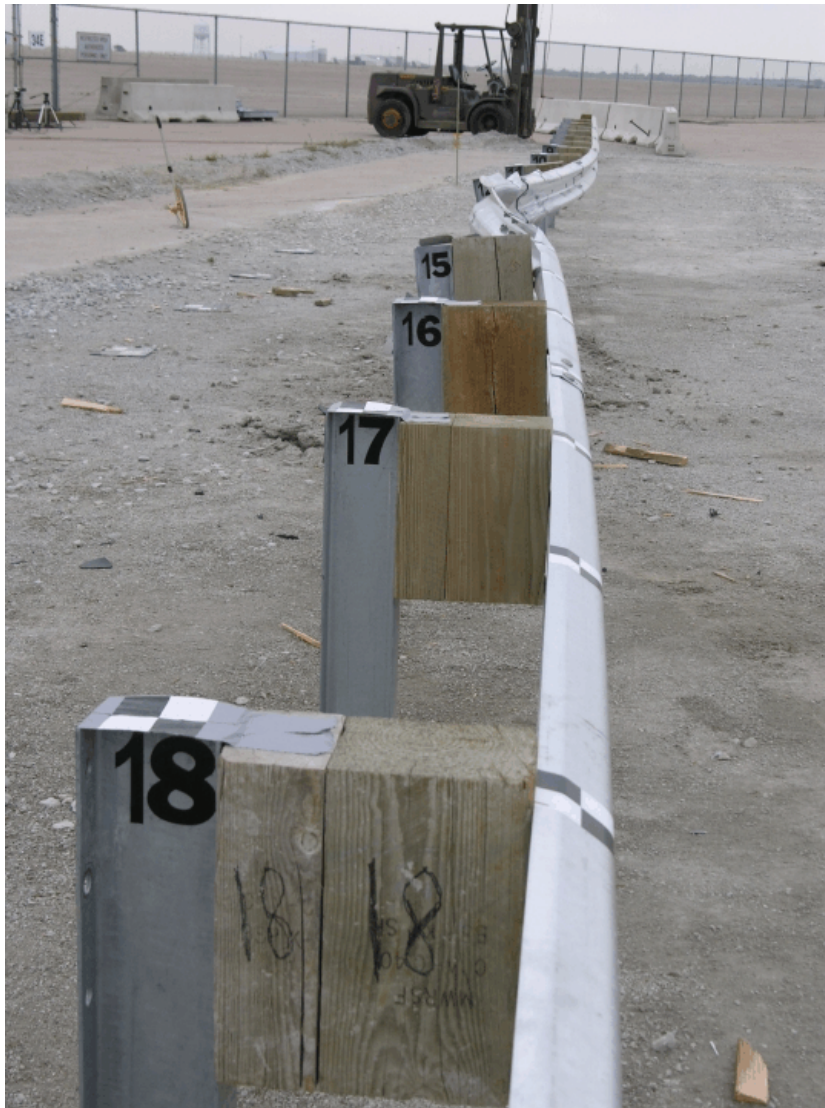
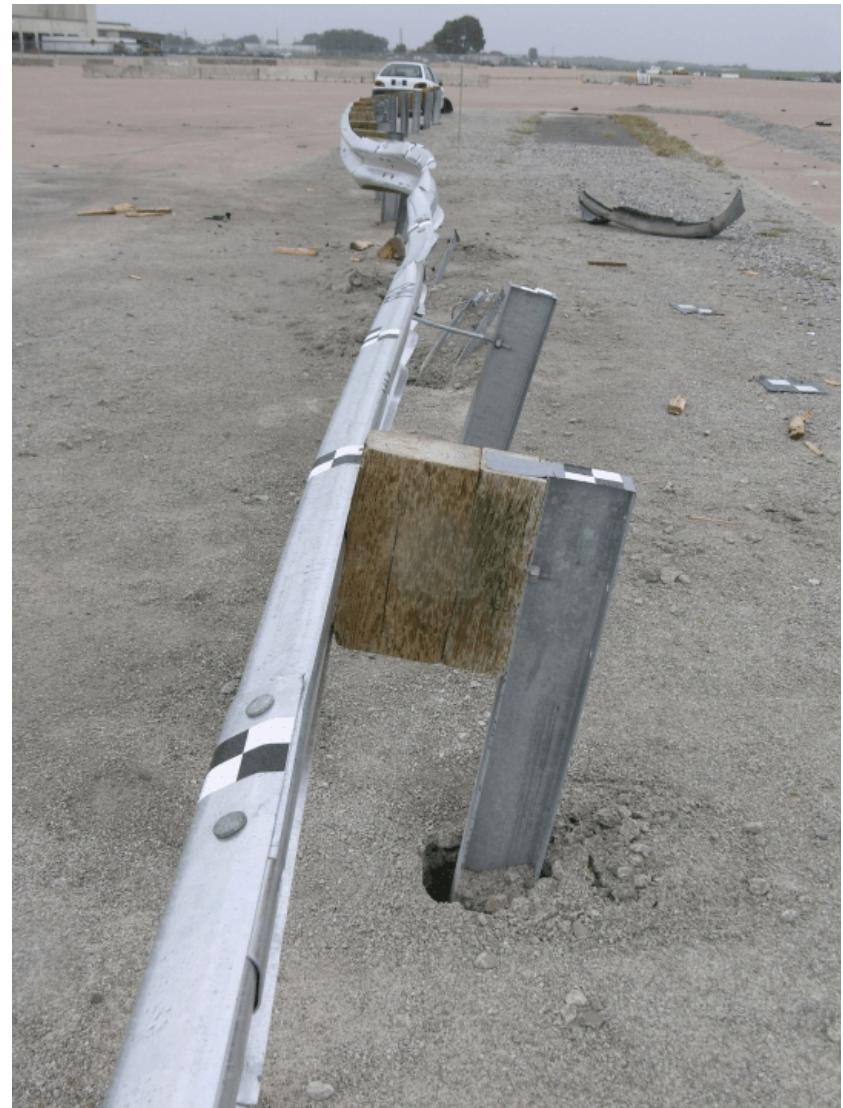
Figure 83. System Damage, Test FR-3

Barrier damage was moderate, as shown in Figure 83. Barrier damage consisted of deformed guardrail posts, deformed and disengaged blockouts, deformed W-beam guardrail, and contact marks on a guardrail section. The length of vehicle contact along the system was approximately 9.6 m (31 ft - 4.1875 in.), which spanned from 849 mm (33.4375 in.) downstream upstream from the centerline of post no. 12 through 1,086 mm (42.75 in.) downstream from the centerline of post no. 16.

Contact marks were found along the length of vehicle contact with the system. The W-beam rail was deformed and flattened between post nos. 11 and 15. The guardrail buckled at the midspan between post nos. 10 and 11, at post nos. 12 and 15, and at the midspan between post nos. 13 and 14. The guardrail also buckled at 648 mm (25.5 in.) downstream of post no. 12, at 254 mm (10 in.) and 356 mm (14 in.) upstream of post no. 13, and at 191 mm (7.5 in.) and 419 mm (16.5 in.) downstream of post no. 13. Guardrail buckle points were also found at 227 mm (9 in.) upstream of post no. 14, at 286 mm (11.25 in.) and 184 mm (7.25 in.) upstream of post no. 15, and 483 mm (19 in.) downstream of post no. 15. The W-beam was pulled off of post nos. 13 and 14. Minor yielding occurred around the post bolt slots at post nos. 12 through 15. No significant damage occurred downstream of post no. 16, except for slight deflection and minor contact marks between post nos. 25 and 28 due to the secondary vehicle contact with the system before coming to rest.

Post nos. 3 through 11 encountered minor twisting downstream, and post nos. 9 through 17 rotated backward in the soil. Post nos. 13 and 14 were also bent longitudinally downstream. The upstream and downstream end anchorage systems moved longitudinally approximately 13 mm (0.5 in.) downstream and 13 mm (0.5 in.) upstream, respectively, and the posts deflected downstream. However, all four wood BCT posts remained undamaged. The blockouts at post nos. 12 through 14 were fractured and removed from the system.

The permanent set of the barrier system is shown in Figure 83. The maximum lateral permanent set rail and post deflections were 527 mm (20.75 in.) at the midspan between post nos. 13 and 14 and 483 mm (19 in.) at the centerline of post no. 13, as measured in the field. The maximum lateral dynamic rail and post deflections 925 mm (36.4 in.) at the centerline of post no. 13 and 693 mm (27.3 in.) at the centerline of post no. 13, as determined from high-speed digital video analysis. The working width of the system was found to be 1,107 mm (43.6 in.).
