# **EVALUATION OF A MODIFIED THREE CABLE GUARDRAIL ADJACENT TO STEEP SLOPE**

## **MIDWEST ROADSIDE SAFETY FACILITY**

MwRSF Research Report No. TRP-03-192-08

March 4, 2008

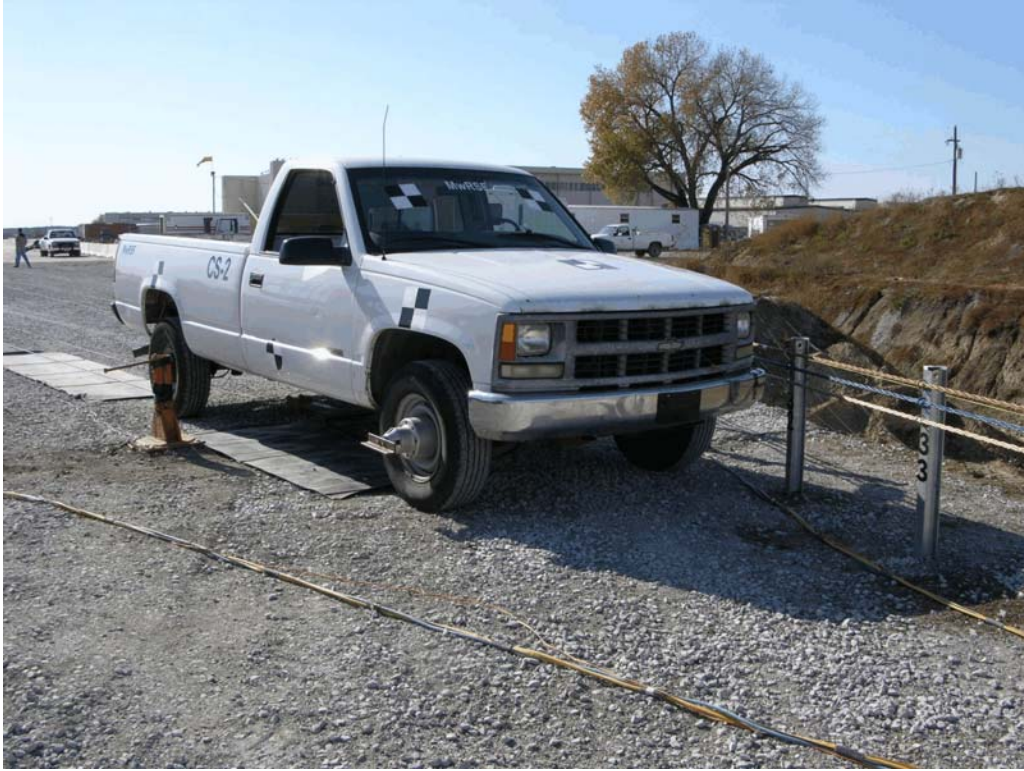
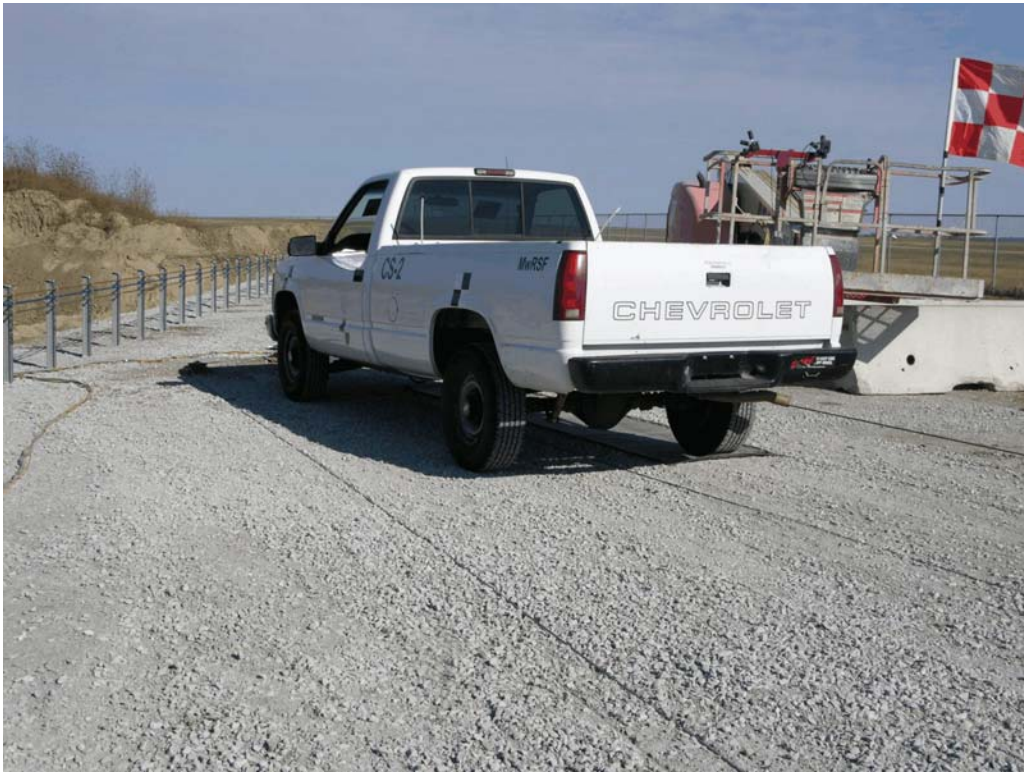
Figure 28. Impact Location, Test CS-2

Initial vehicle impact was to occur between post nos. 31 and 32, or 305 mm (1 ft) upstream from the centerline of post no. 32, as shown in Figure 28. Actual vehicle impact occurred at post no. 32. At 0.002 sec after impact post no. 32 deflected both laterally and longitudinally. At 0.020 sec, the vehicle contacted post no. 33. At 0.028 sec, the three cables wrap around the left-front corner of the truck. At 0.034 sec, the cables caused slight deformation to the left-front quarter panel of the truck. At 0.054 sec, post no. 34 deflected laterally and longitudinally. At 0.064 sec, the left-front tire of the vehicle completely traversed the original post line as the truck continued downstream. At 0.076 sec, the truck ran over post no. 33 with the front of the truck in contact with post no. 34. At 0.094 sec, post no. 35 deflected as the truck continued out over the slope breakpoint. At 0.124 sec, the right-front bumper of the truck contacted post no. 35. At 0.130 sec, post no. 36 deflected. At 0.150 sec, the truck yawed as it began to redirect out of the system. At this same time, post no. 37 deflected. At 0.154 sec, the top cable detached from post no. 36. At 0.156 sec, the front of the truck contacted post no. 36. At 0.160 sec, all three cables released from post no. 36. At 0.178 sec, post no. 38 deflected. At 0.180 sec, the left-front tire of the truck became airborne, and the front

The permanent set of the barrier system is shown in Figure 28. The upstream and downstream cable anchor ends encountered slight permanent set deformations. The maximum lateral permanent set post deflection was 578 mm (22.75 in.) at the centerline of post no. 36 as measured in the field. The maximum lateral dynamic cable deflection was 3,163 mm (124.5 in.), as determined from high-speed digital video analysis. The working width of the system was found to be 3,318 mm (130.6 in.).

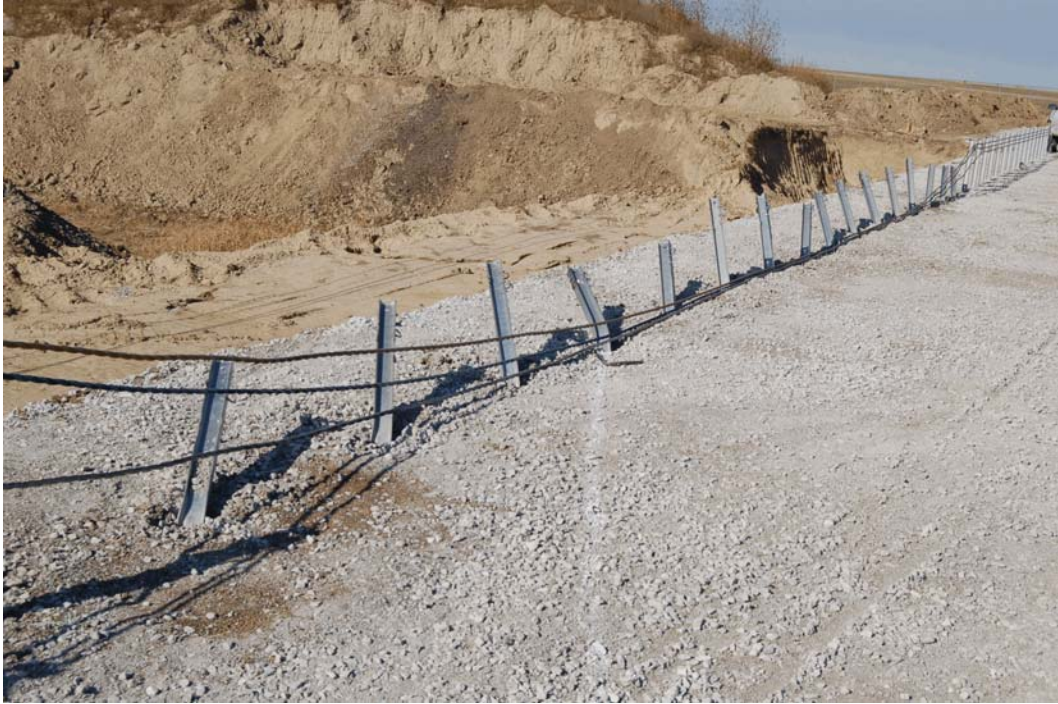
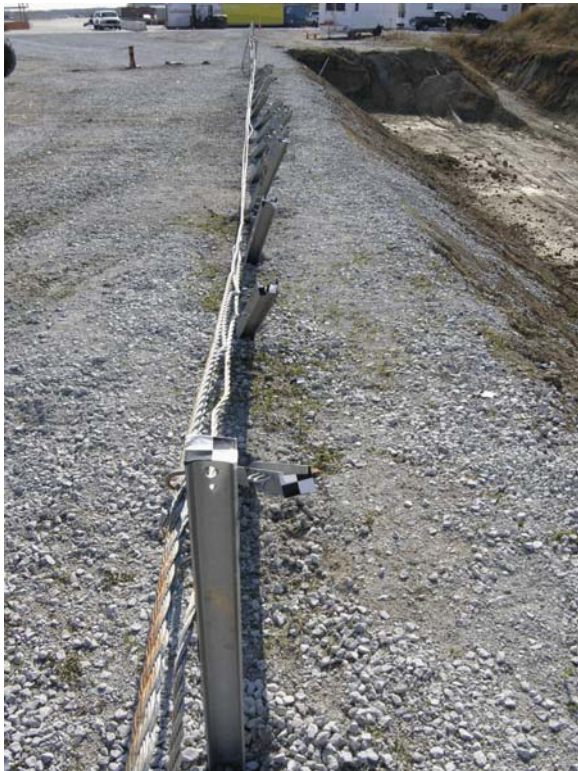
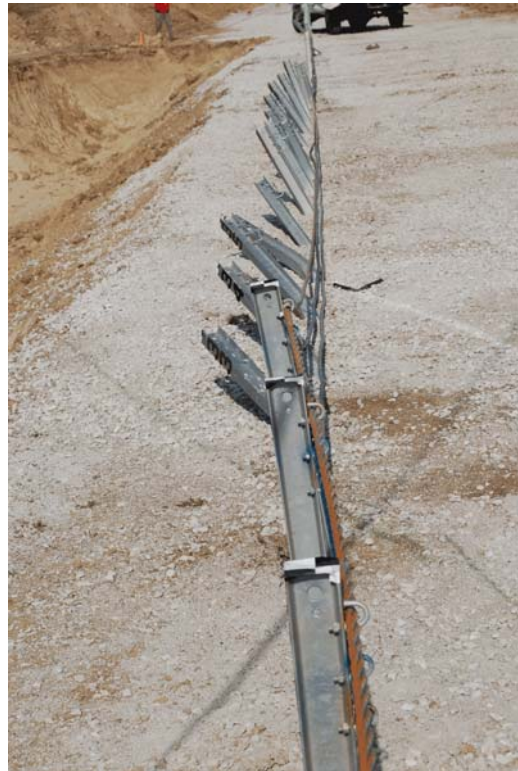
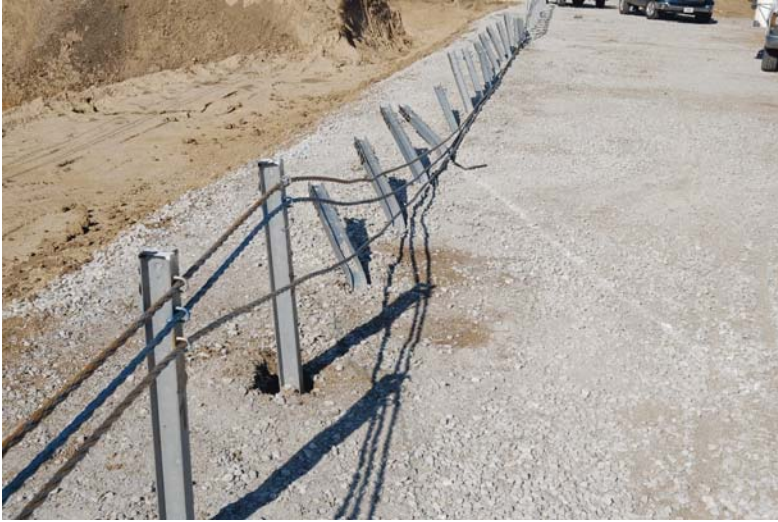
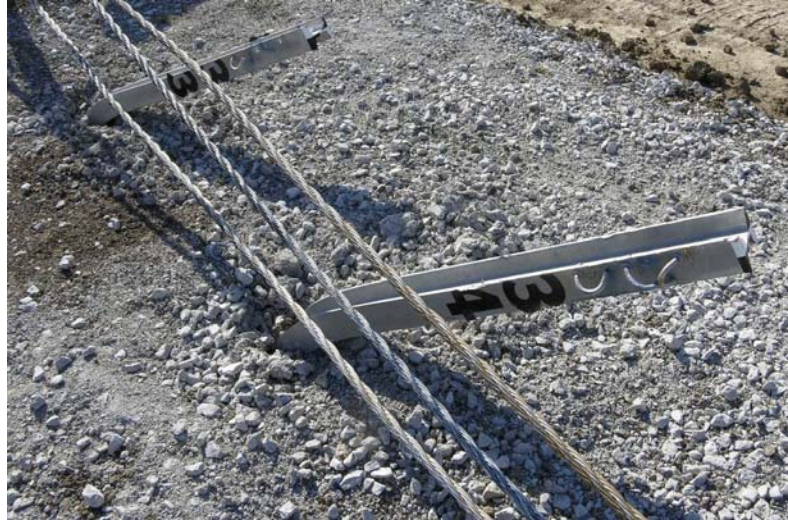
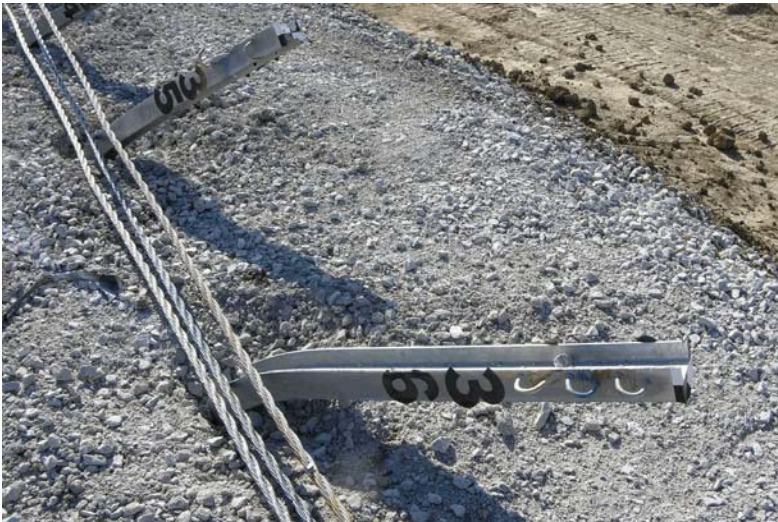
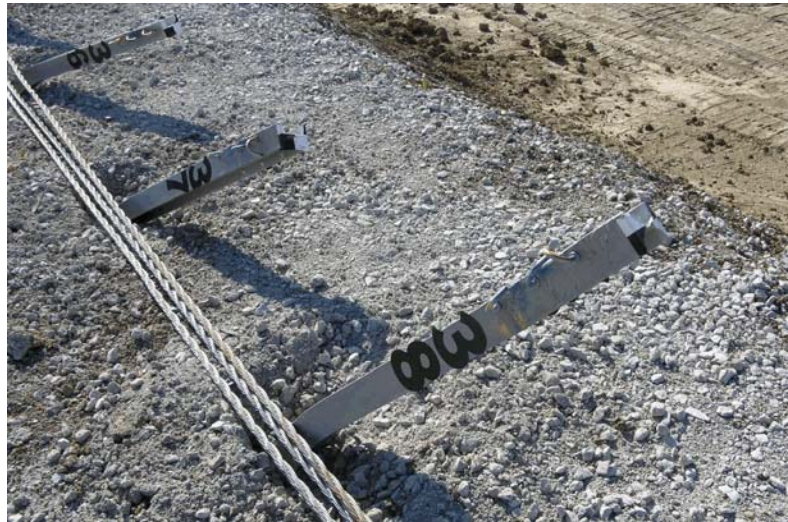
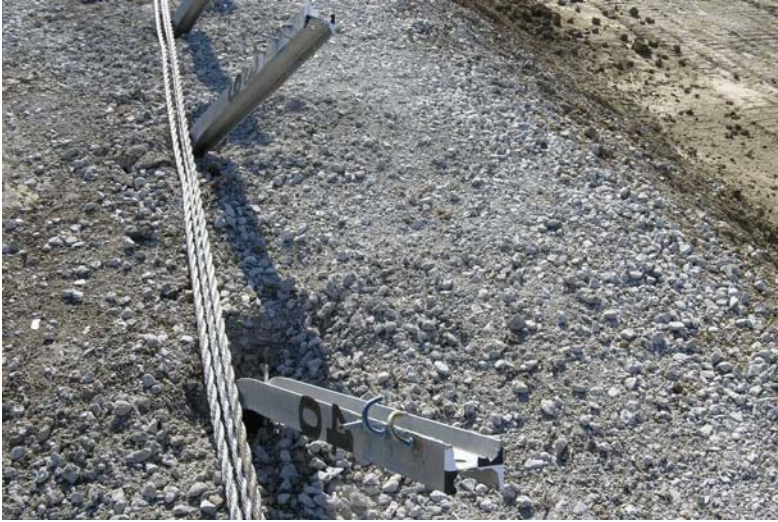
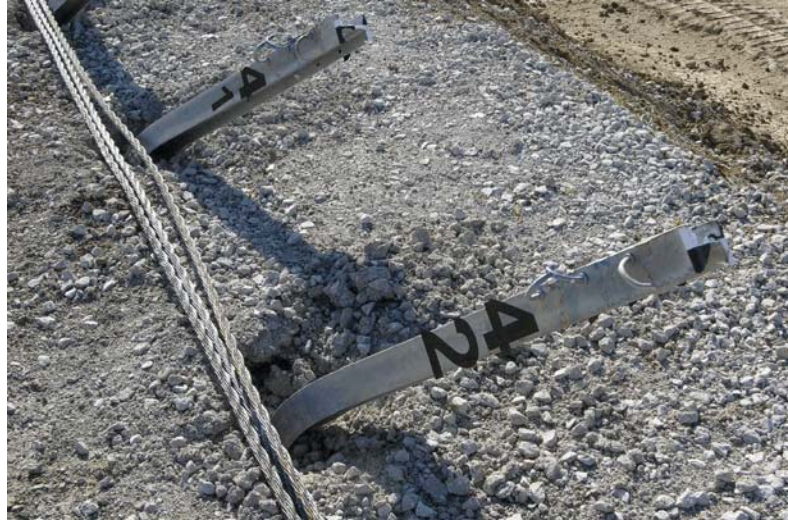
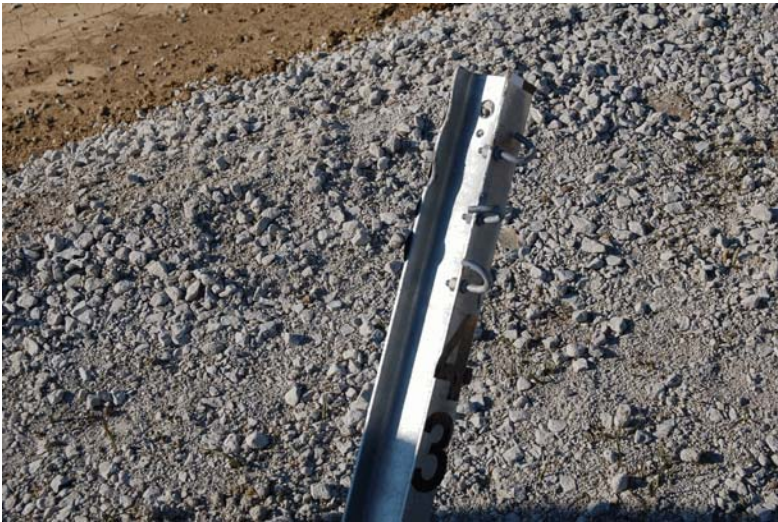
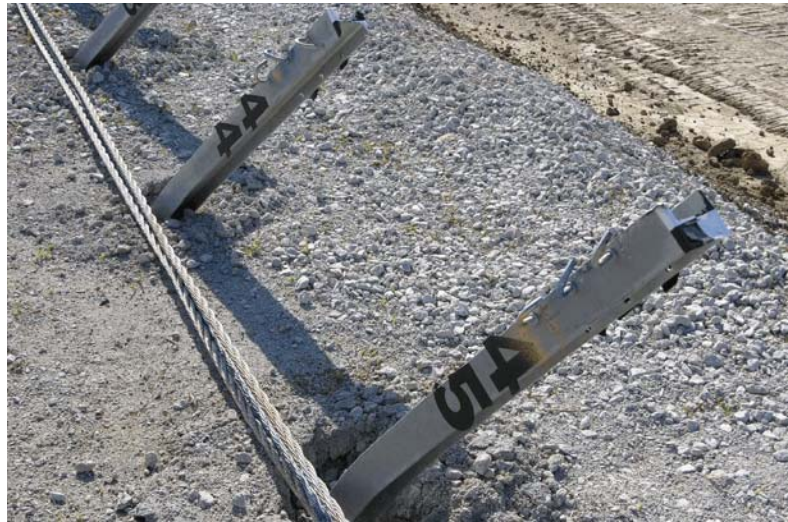
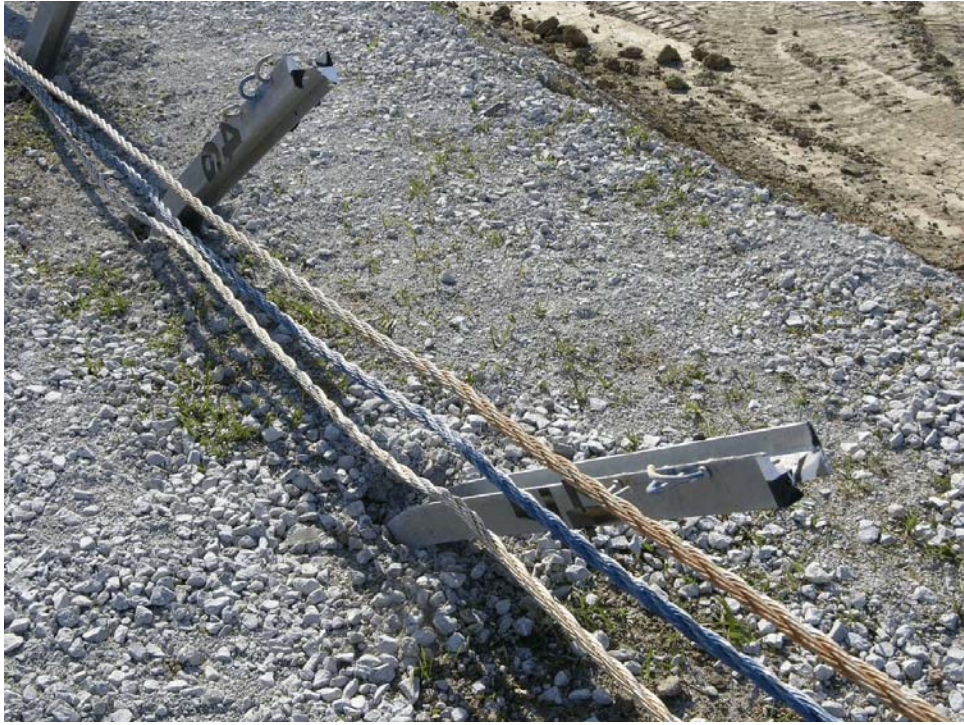
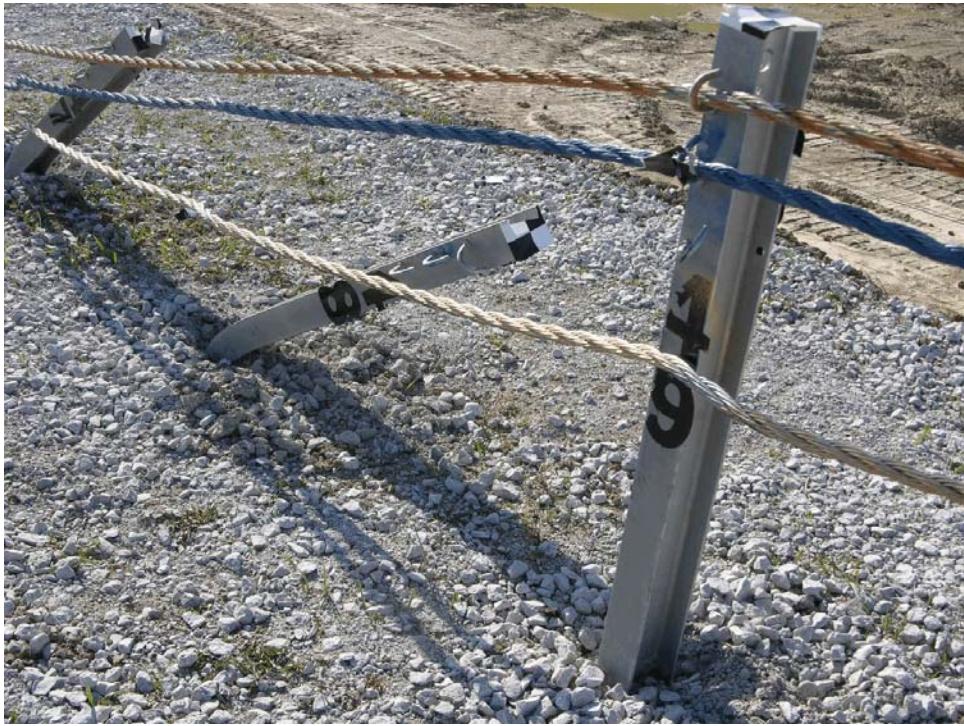
Damage to the barrier was moderate, as shown in Figures 30 through 34. Barrier damage consisted mainly of deformed line posts, stretched cable, and soil failure. The length of vehicle contact was approximately 19.7 m (64 ft - 8 in.), which spanned from the upstream edge of post no. 32 through the upstream edge of post no. 48.

nos. 34 and 35 were also rotated and bent backward with the tops of the posts 356 mm (14 in.) above the ground. Minor gouging was found on post no. 34. Post nos. 36 through 48 experienced weak axis bending. The tops of post nos. 36 through 48 were bent to 152 mm (6 in.), 305 mm (12 in.), 533 mm (21 in.), 533 mm (21 in.), 406 mm (16 in.), 419 mm (16.5 in.), 457 mm (18 in.), 533 mm (21 in.), 533 mm (21 in.), 610 mm (24 in.), 508 mm (20 in.), 470 mm (18.5 in.), and 406 (16 in.) above the ground respectively. Minor gouging was found on the upstream side of post nos. 37 and 41 through 44. Local buckling 279 mm (11 in.) from the top was found on the upstream side of post no. 38. Local buckling was found 305 mm (12 in.) from the top on the upstream-back flange of post no. 39. Minor gouging was found on the front face of post nos. 46 through 48. The remainder of the downstream posts were not damaged.

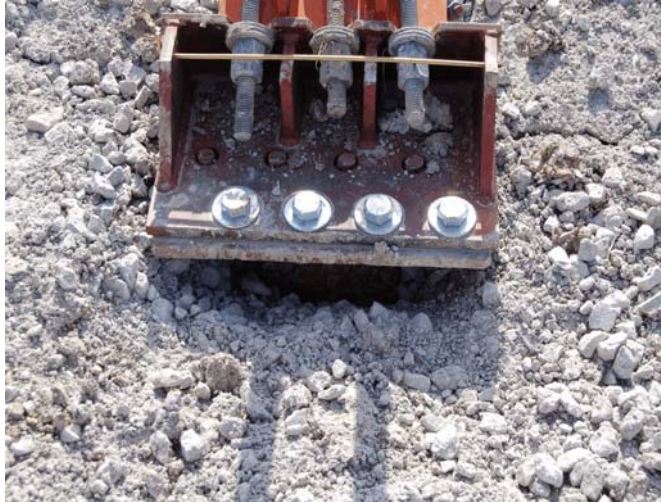
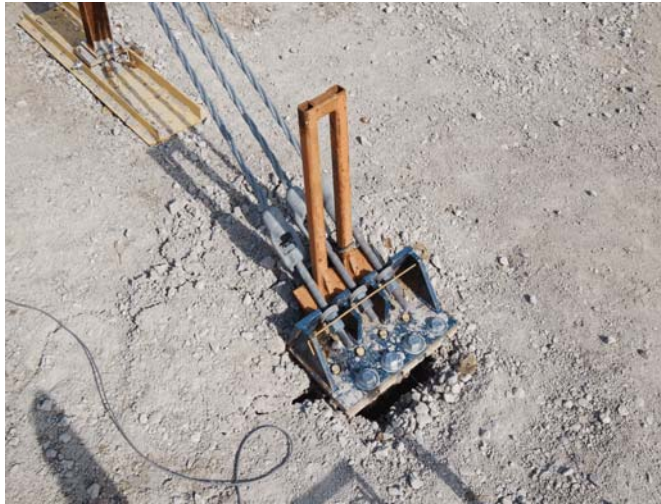
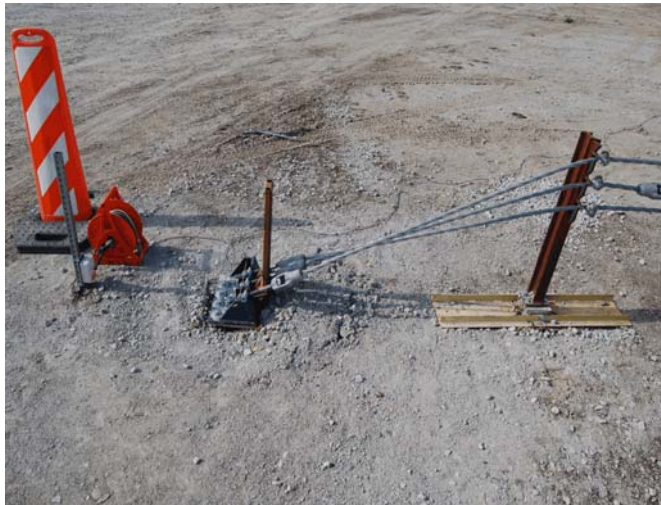
Figure 34. End Anchor Damage, Test CS-2

The system's upstream anchor deflected longitudinally 51 mm (2 in.) downstream. Soil cracking with a radius of 356 mm (14 in.) was found on the downstream side of the upstream anchor. The downstream anchor deflected upstream 38 mm (1.5 in.). All three cables were detached from post nos. 33 through 48. The bottom cable released from post nos. 32 and 49. Soil cracking was also found around post no. 7. Post no. 31 deflected backward 25 mm (1 in.). Post no. 32 deflected backward about 51 mm (2 in.). Post no. 33 was rotated and bent backward to where the top of the post was 279 mm (11 in.) above the ground. The top cable hook fractured off of post no. 33. Post

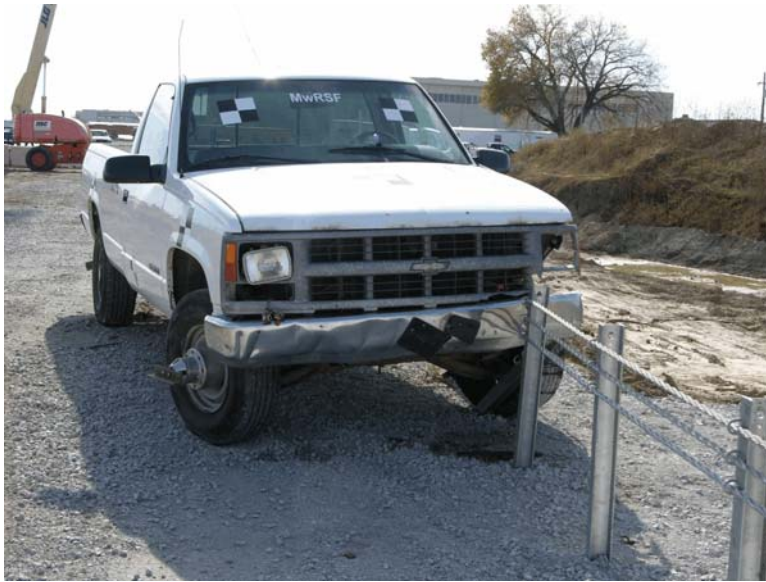
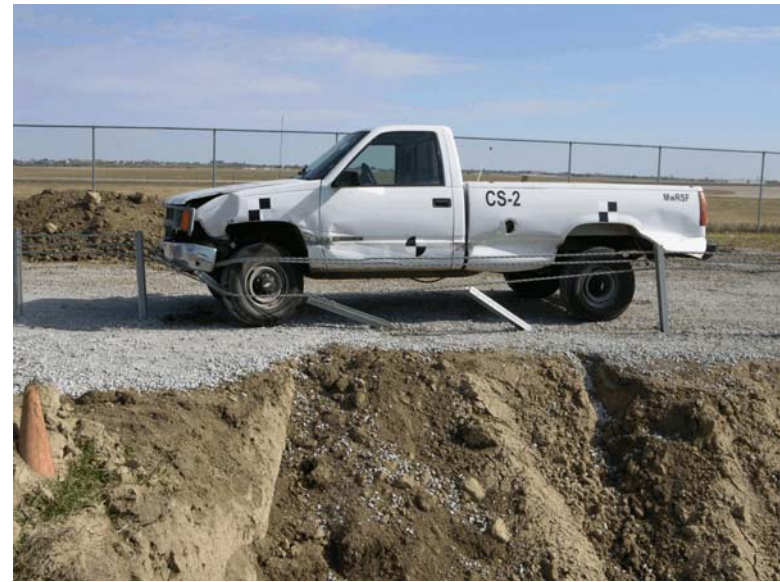
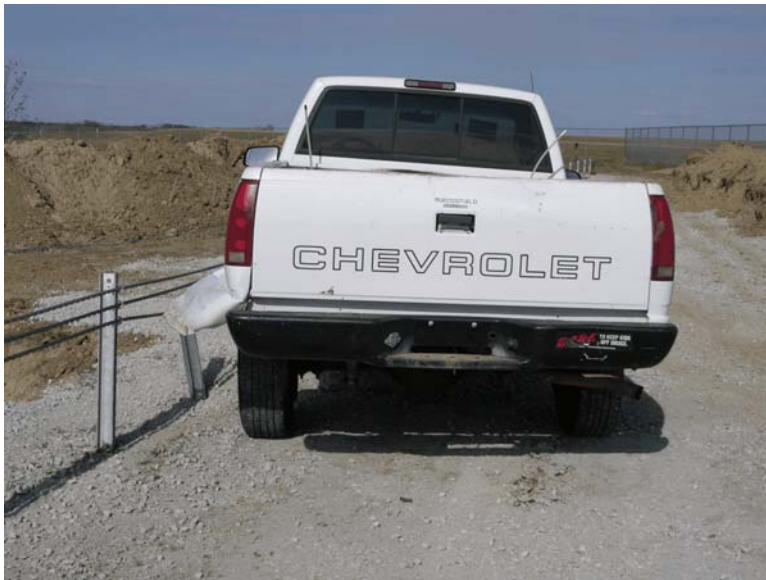
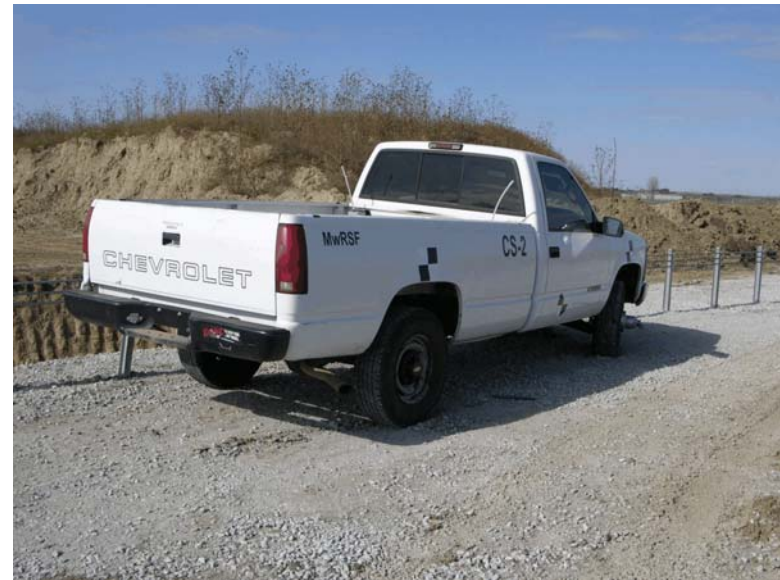
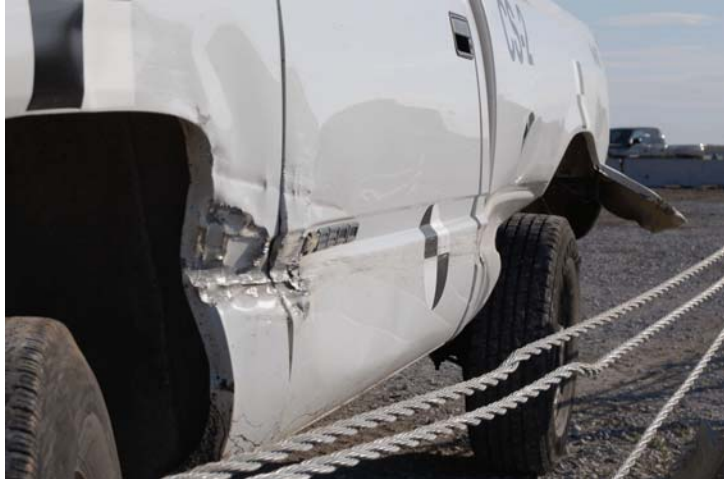
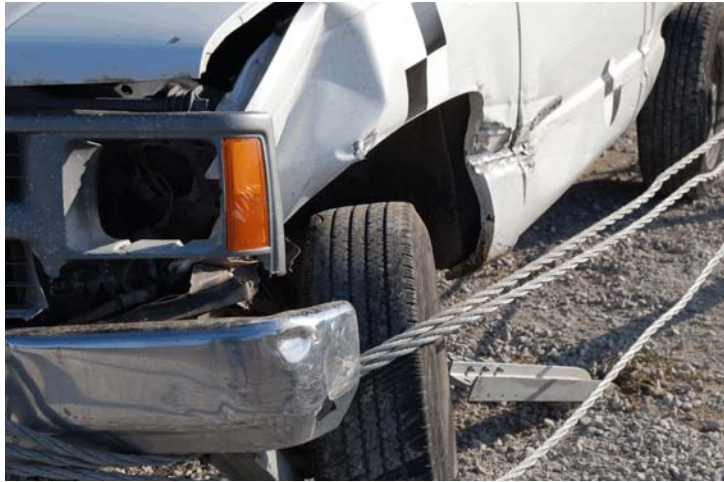
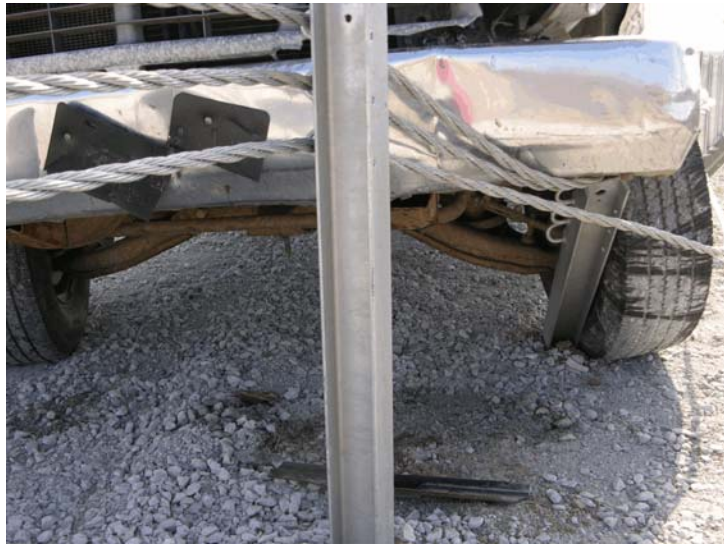
Exterior vehicle damage was moderate as shown in Figures 35 through 38. Occupant compartment deformations to the left side of the floorboard were judged insufficient to cause serious injury to the vehicle occupants as shown in Figure 38. Maximum longitudinal deflections of 6.35 mm (0.25 in.) were located along the front of the driver's side floor panel. A maximum lateral deflection of 13 mm (0.5 in.) was located on the right-front corner of the driver's side floor panel.

Damage was concentrated on the left-front corner and left side of the vehicle. The left-front quarter panel buckled inward. The left-front corner of the bumper was bent back toward the engine compartment. The inside wall of the left-front tire was punctured and the right-front wheel well was severely damaged. The steering knuckle was pushed into the strut frame. The front of the hood was deformed upward slightly. Significant cable friction damage was found on the entire left side of the vehicle. The left-rear quarter panel was deformed outward. Major denting and gouging was found on the exhaust pipe. The right side, rear, and top of the vehicle as well as all window glass remained undamaged.
