## **EVALUATION OF RIGID HAZARDS PLACED IN THE ZONE OF INTRUSION**

### **MIDWEST ROADSIDE SAFETY FACILITY**

MwRSF Research Report No. TRP-03-151-08

January 3, 2008

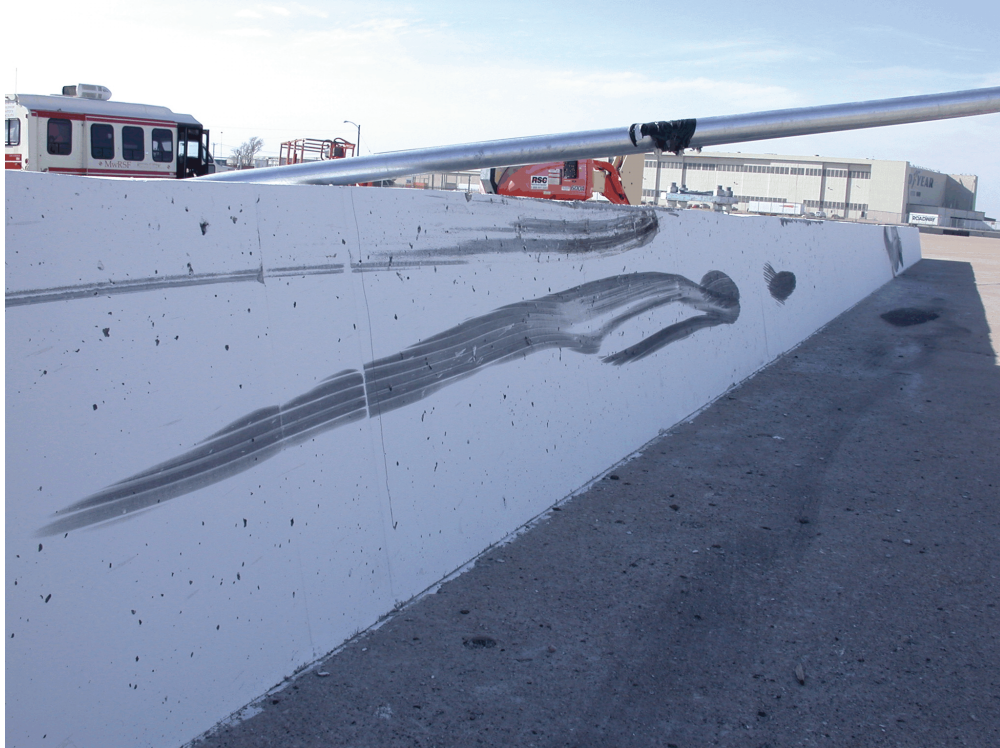
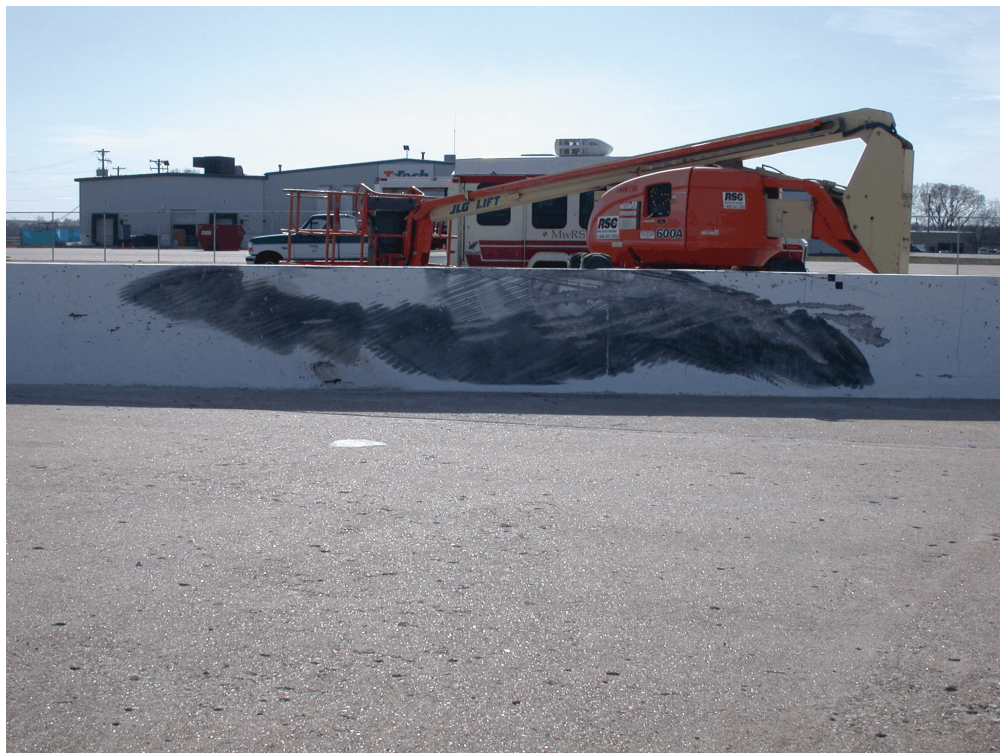
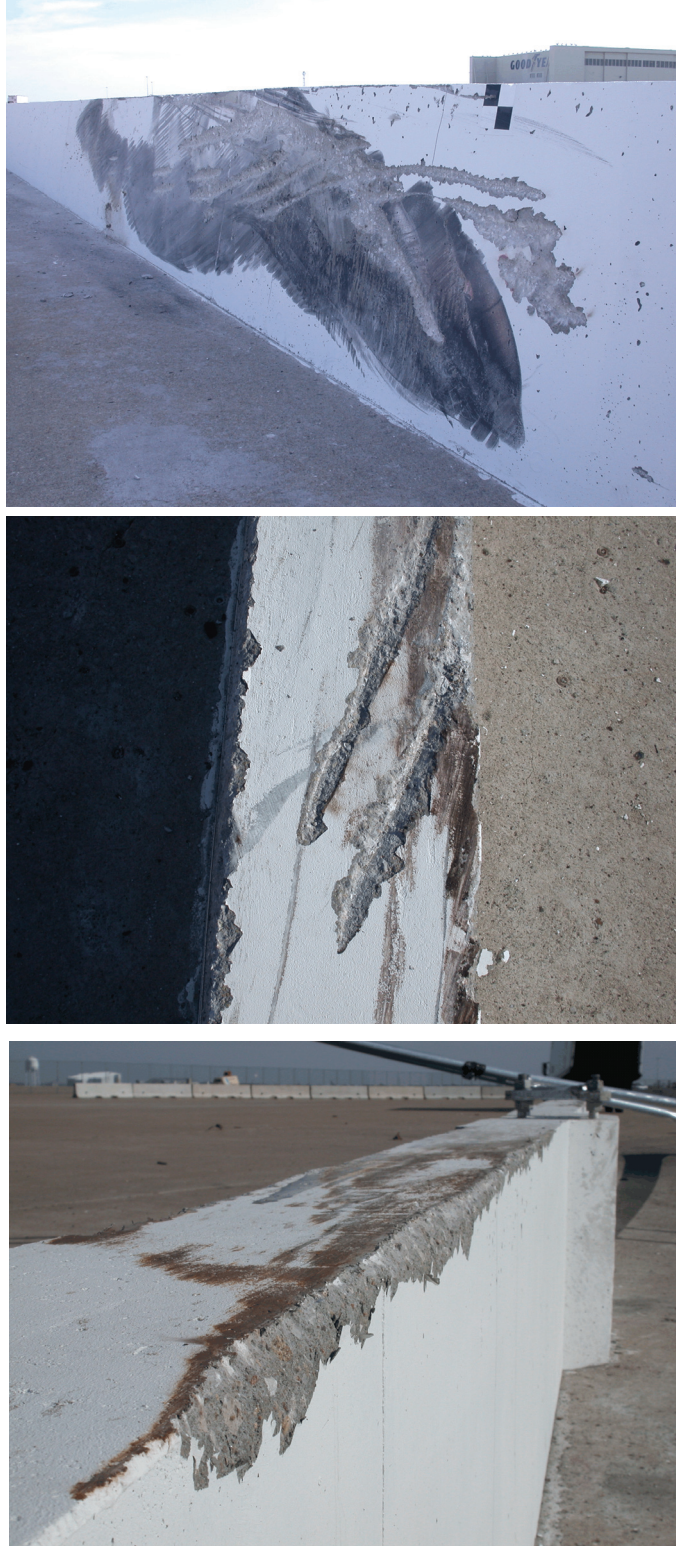
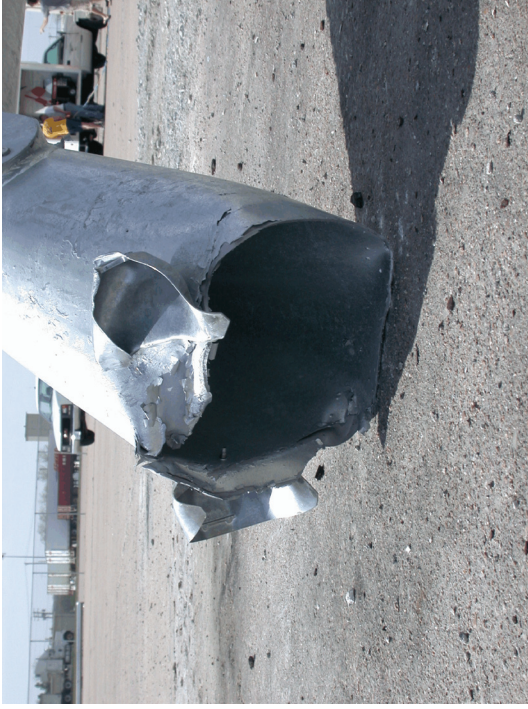
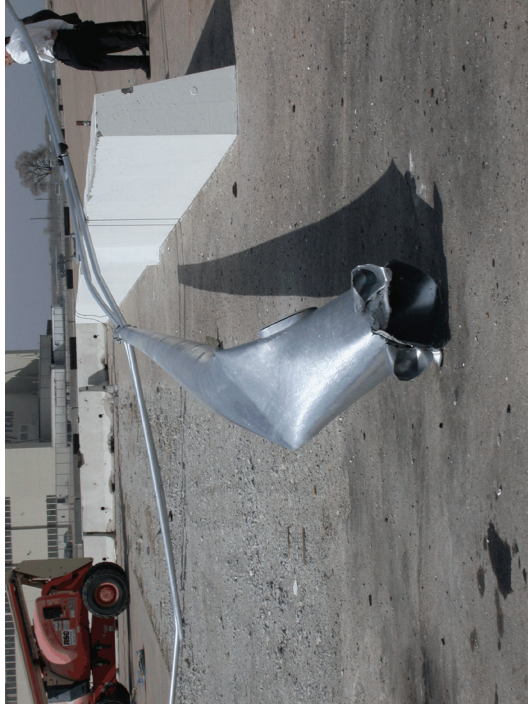
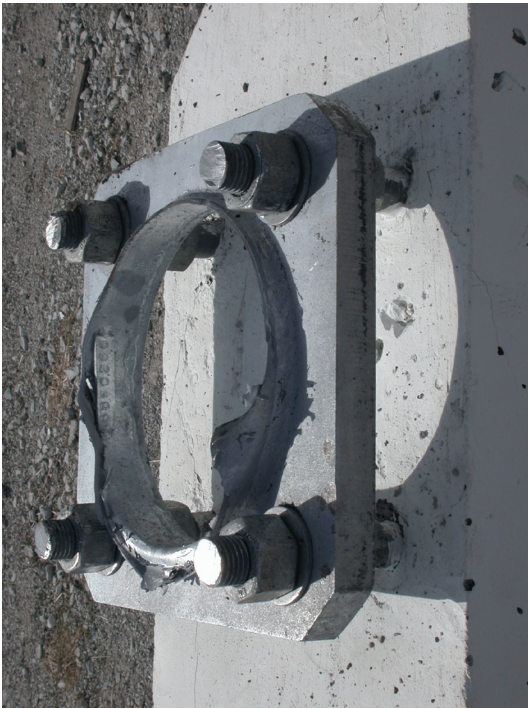
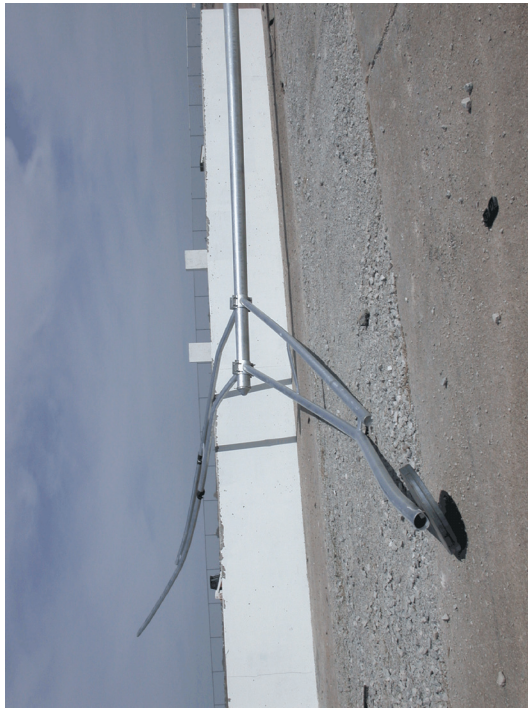
Figure 35. System Damage, Test No. ZOI-1

Damage to the barrier and pole was moderate, as shown in Figures 35 through 37. Barrier damage consisted of gouge marks and tire marks. The length of vehicle contact along the concrete barrier system was approximately 26.26 m (86 ft - 2 in.), which spanned from 17.12 m (56 ft - 2 in.) upstream of the centerline of the pole through the downstream end of the system.

A 25-mm (1-in.) deep wheel gouge began 17.12 m (56 ft - 2 in.) upstream of the centerline of the pole at a height of 256 mm (14 in.) to 559 mm (22 in.) from the ground and continued for a length of 4.88 m (16 ft). A 5.16-m (16-ft 11-in.) long tire mark began 76 mm (3 in.) downstream from the beginning of the first gouge. Tire marks and minor gouges were found on the top and back edges and front face from the barrier upstream of the centerline of the pole. Tire marks and gouges also began 305 mm (12 in.) downstream of the centerline of the pole and continued through the end of the barrier. Hairline cracks and surface chipping was found on the top of the barrier and extended diagonally from three of the bolts.

The pole fractured above the weld line on the impact-side face. Contact marks were found on the upstream edge of the pole plate and on one of the bolts and nuts. The pole buckled 610 mm (2 ft) above the ripped pole surface. The arms of the pole were bent due to contact with the ground and the barrier. One set of the ballest plates disengaged from the pole. After disengaging from the barrier and landing on the ground, the top of the pole was located 3.51 m (11 ft - 6 in.) downstream from its original position and 1.02 m (3 ft - 4 in.) behind the barrier and the bottom of the pole was located

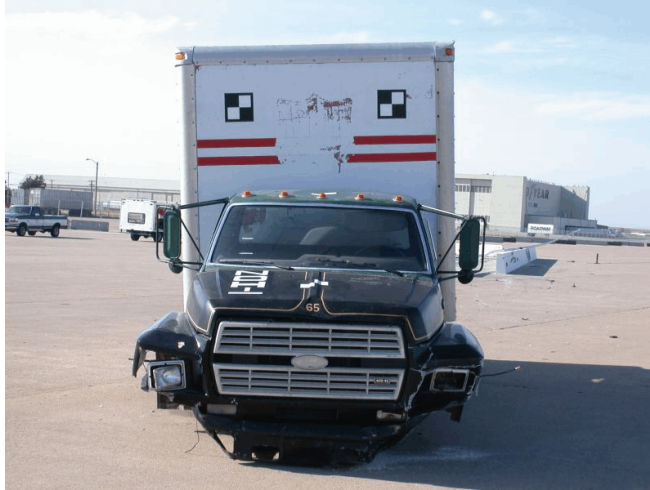
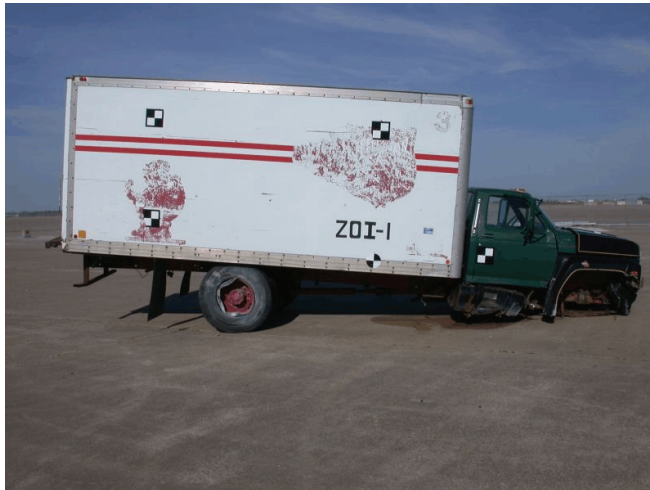
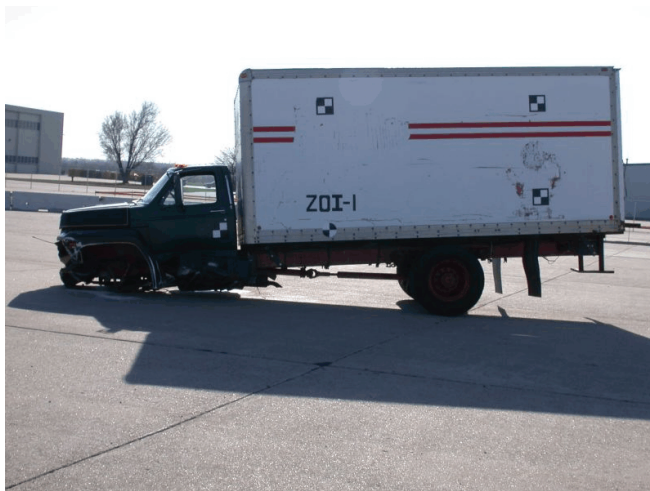
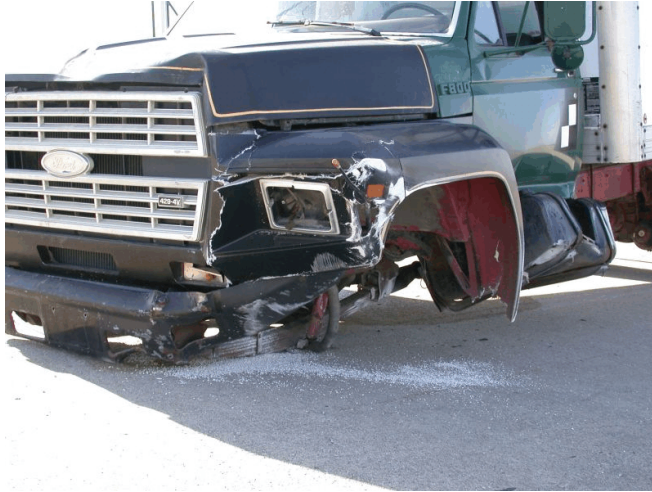
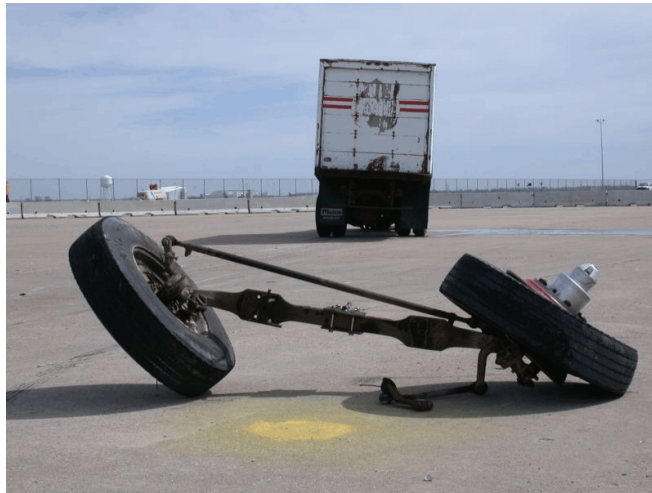
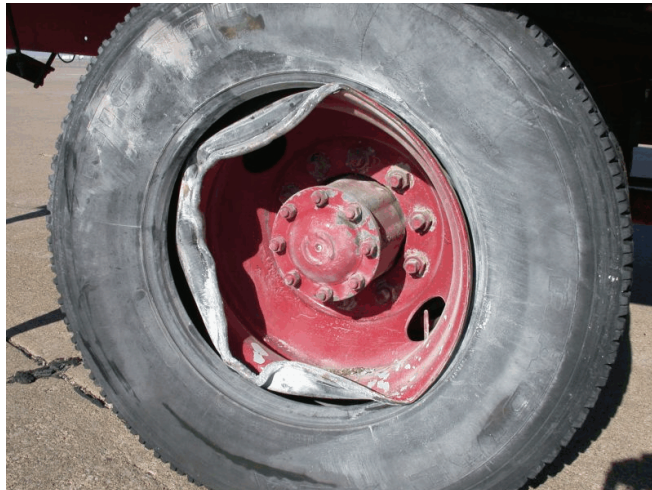
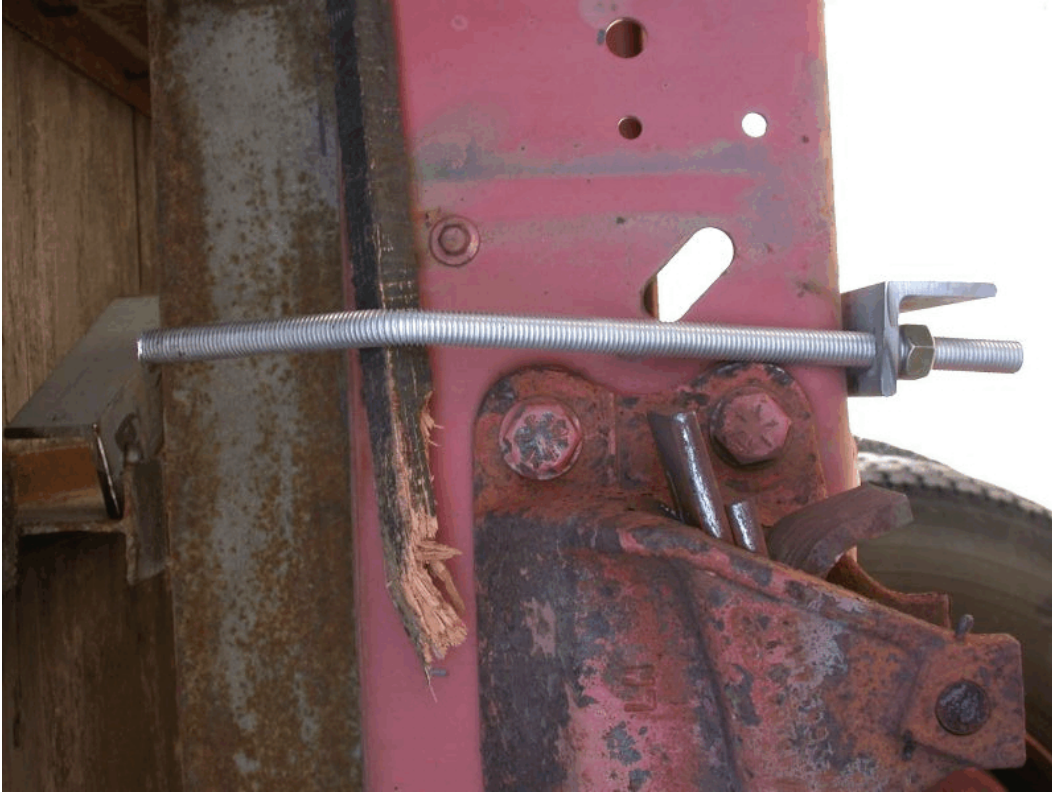
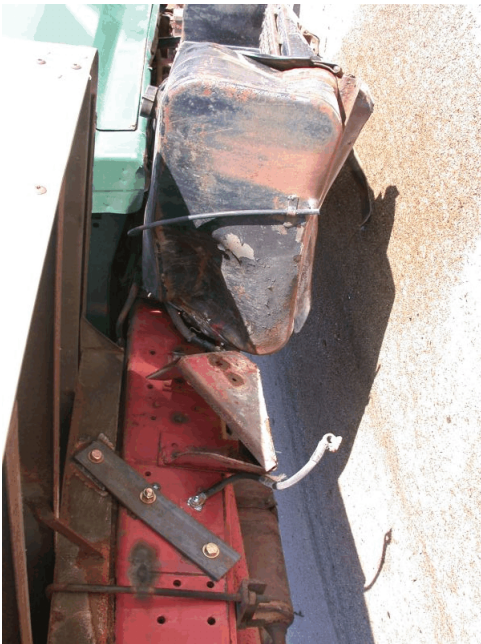
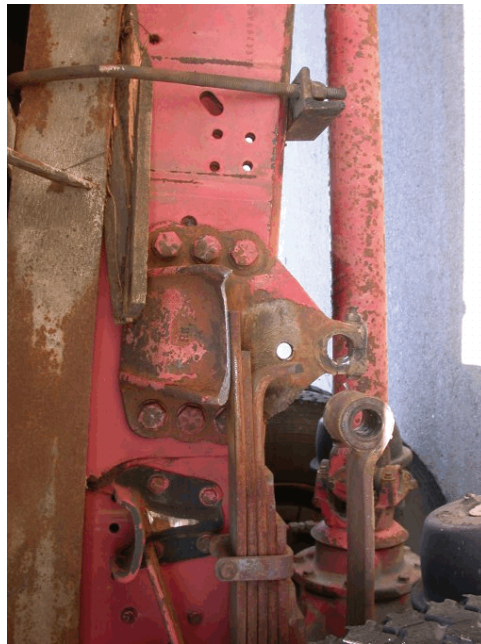
Figure 38. Vehicle Damage, Test No. ZOI-1

Exterior vehicle damage was moderate, as shown in Figures 38 through 40. Occupant compartment deformations did not occur. Damage was concentrated on the front and right sides of the vehicle. The outer rim of the right-rear was severely bent, and the tire deflated. The front face of the right-side fuel tank was deformed and dented. The left-side fuel tank was bent upward and lodged into the bottom of the door causing the door to not open. The front bumper bent backward around the frame support on both sides. Minimal separation was found between the fender, the hood, and the right-side door. The right-front shear plate on both sides was bent. All three U-bolts in front of both the right and left leaf spring attachments were bent, but remained attached. The right leaf spring attachment fractured. The additional U-bolt behind the leaf spring attachment on both sides fractured. The front axle disengaged. All four U-bolts for the front axle fractured. All window glass, the rear, and the box remained undamaged.

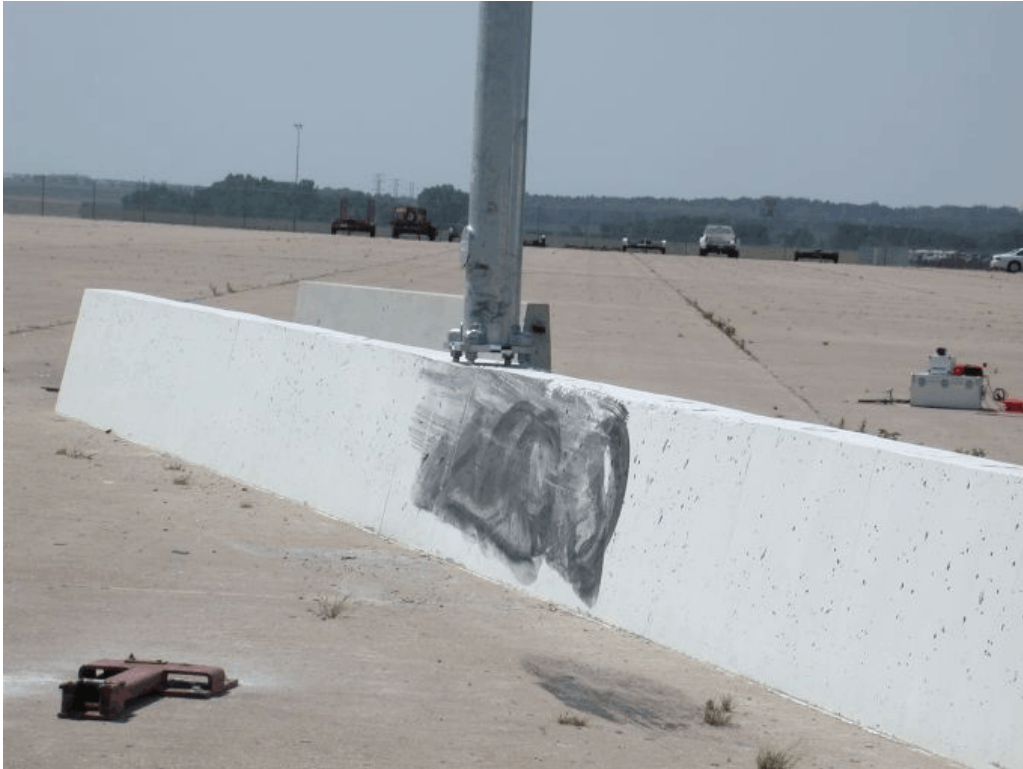
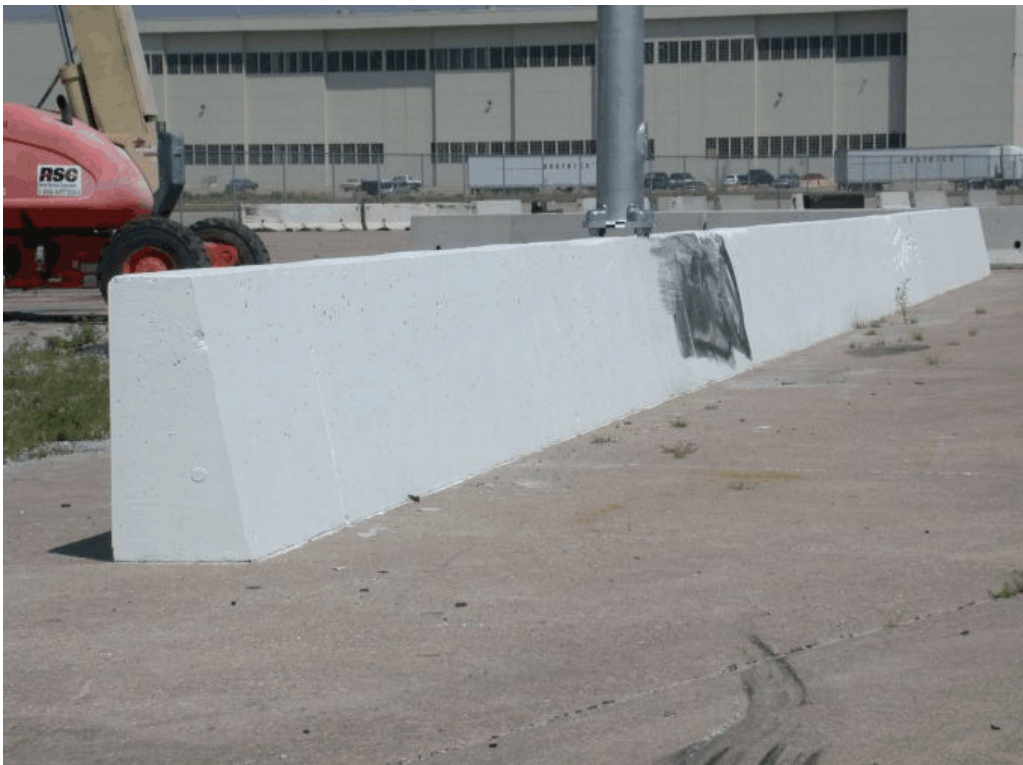
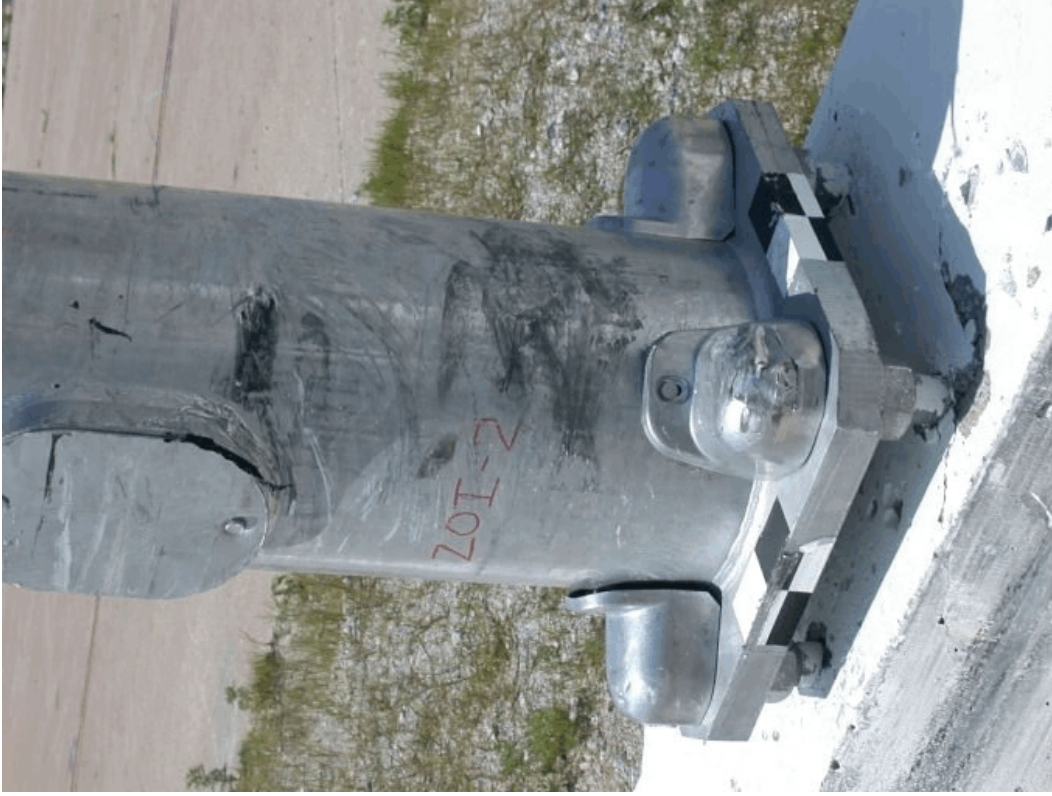
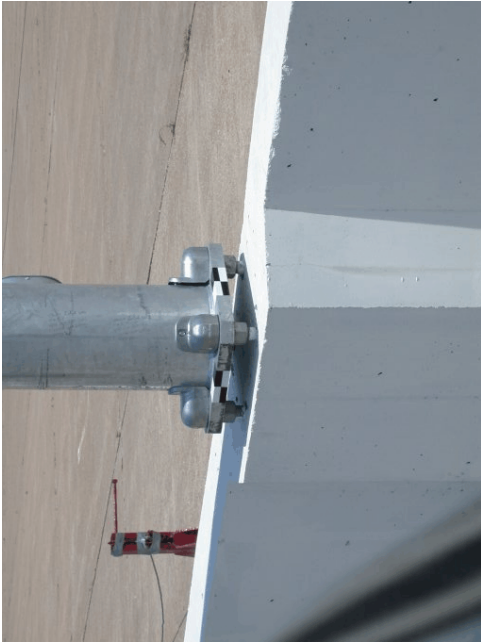
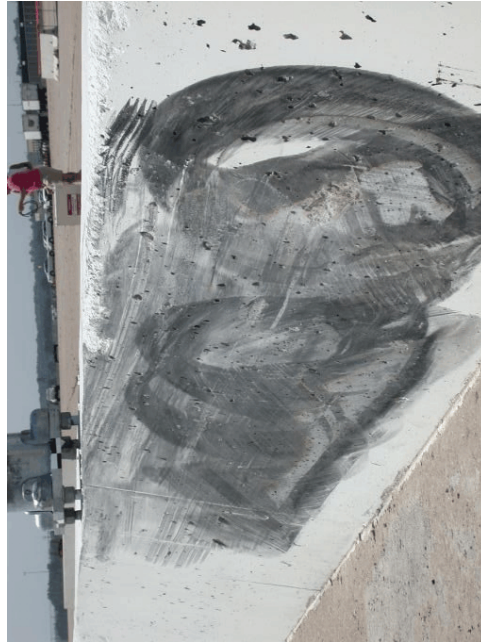
Figure 50. System Damage, Test No. ZOI-2

Damage to the barrier and pole was minimal, as shown in Figures 50 through 51. Barrier damage consisted of gouge marks and tire marks. The length of vehicle contact along the concrete barrier system was approximately 3.33 m (10 ft - 11 in.), which spanned from 2.90 m (114 in.) upstream from the centerline of the pole through 432 mm (17 in.) downstream from the centerline of the pole.

Tire marks on the front face of the barrier began 2.90 m (114 in.) upstream from the centerline of the luminaire pole and continue to 432 mm (17 in.) downstream from the centerline of the pole. Minor concrete gouges occurred at the front edge of the concrete barrier's top face throughout the tire mark region. Major gouges were found on the front-top edge of the barrier between 1,346 mm (53 in.) and 1,600 mm (63 in.) upstream from the centerline of the luminaire pole. A 254-mm (10-in.) long by 76-mm (3-in.) wide wheel gouge began 2,362 mm (93 in.) upstream from the centerline pole and 381 mm (15 in.) above the ground on the front face of the concrete barrier. Another 919-mm (7.5-in.) long by 32-mm (1.25-in.) wide wheel gouge on the front

face of the wall began 1,842 mm (72.5 in.) upstream from the centerline of the pole and 476 mm (18.75 in.) up above the ground. Another major gouge on the front face of the concrete barrier was located 2,654 mm (104.5 in.) upstream from the centerline of the pole and 330 mm (13 in.) up above the ground. Another 114-mm (4.5-in.) long by 121-mm (4.75-in.) wide gouge surrounded the bolt on the upstream-front corner of the pole. Another major gouge occurred on the downstream edge of the bolt on the upstream-back corner of the pole. Paint scratches were found at 2,769 mm (109 in.) upstream from the centerline of the pole and 178 mm (7 in.) above the ground through 622 mm (24.5 in.) above the ground. Another major region of paint scratches occurred from 584 mm (23 in.) through 1,905 mm (75 in.) upstream of the centerline of the pole and was 152 mm (6 in.) to 254 mm (10 in.) above the ground. The luminaire pole connection bolts were slightly bent.

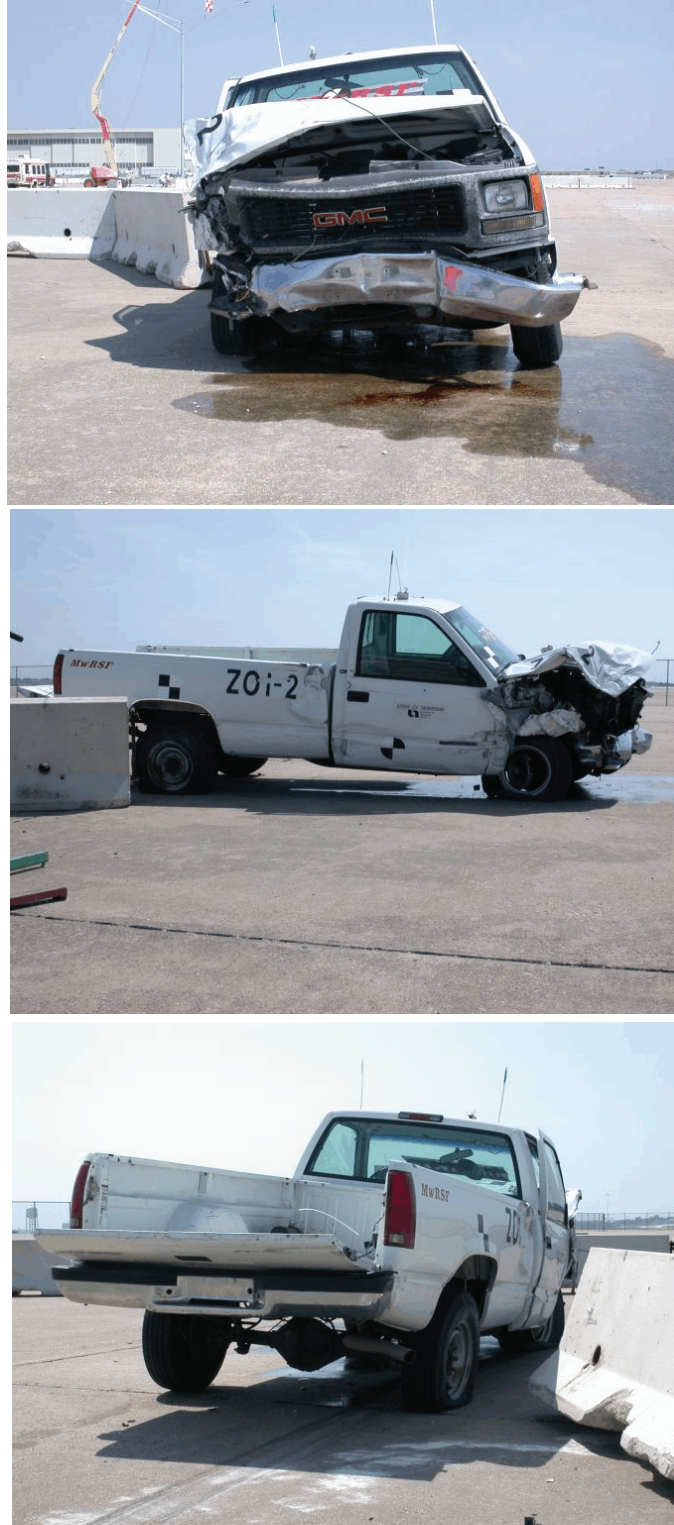
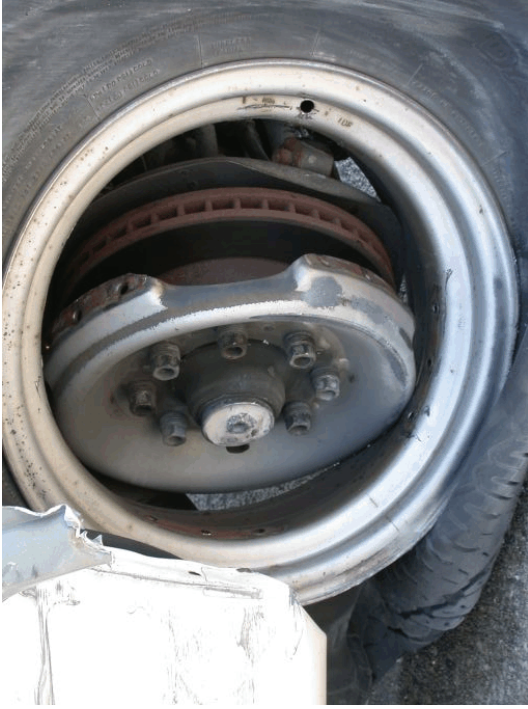
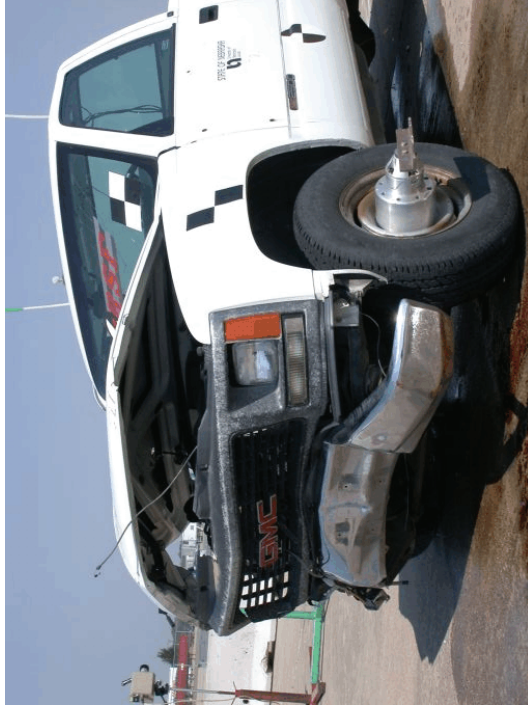
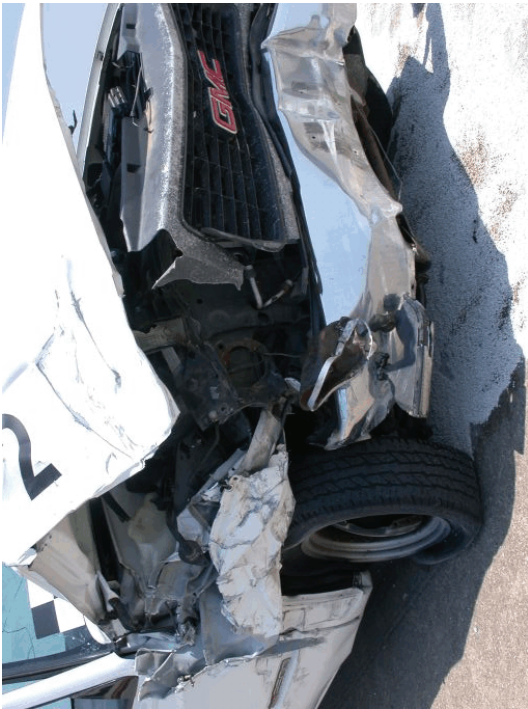
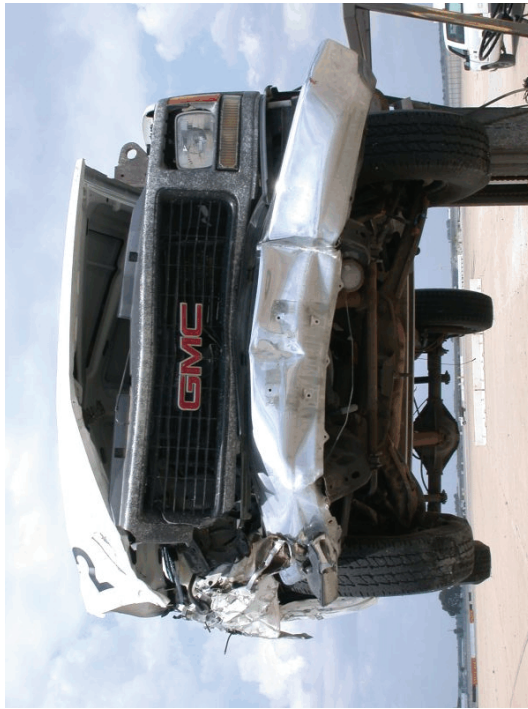
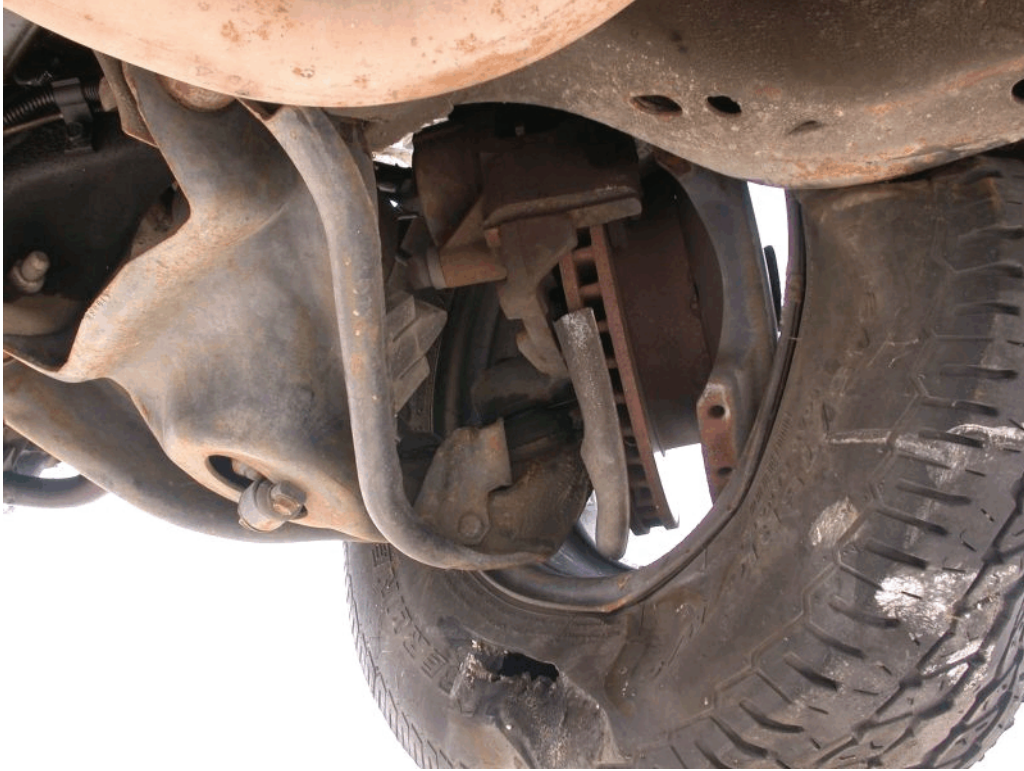
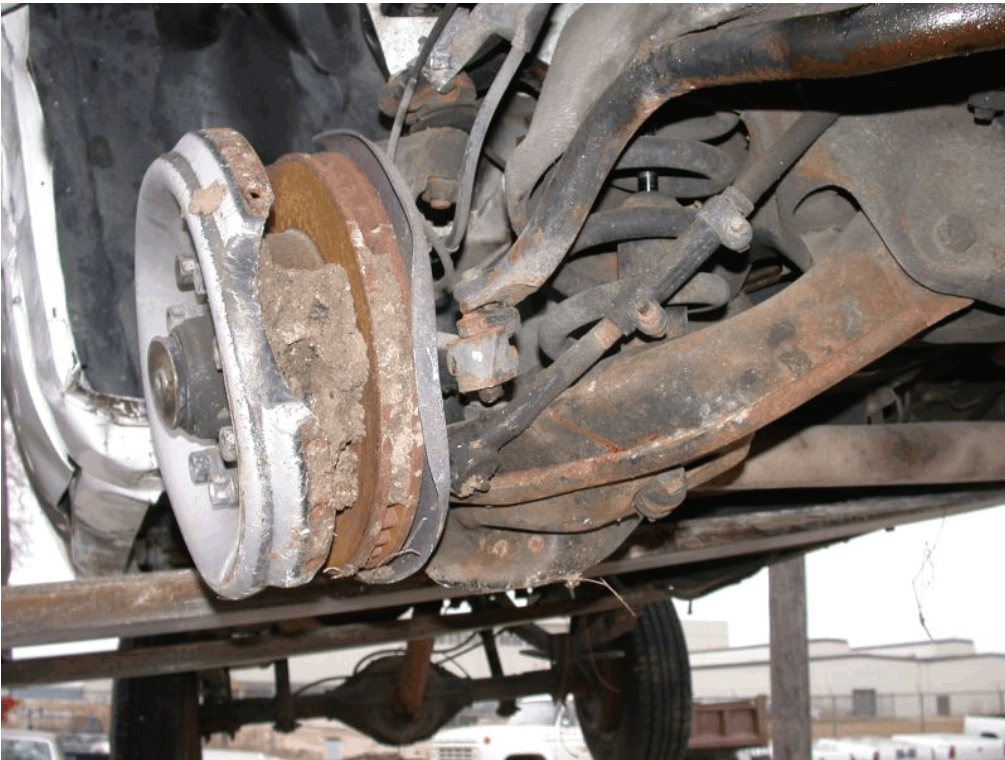
Figure 52. Vehicle Damage, Test No. ZOI-2

Exterior vehicle damage was moderate, as shown in Figures 52 through 54. Occupant compartment deformations to the right-side floorboard were judged insufficient to cause serious injury to the vehicle occupants, as shown in Figure 55. Maximum longitudinal deflections of 60 mm (2.375 in.) were located near the right-front corner of the right-side floorboard. Maximum lateral deflections of 70 mm (2.75 in.) were located near the right-front corner of the right-side floorboard. Maximum vertical deflections of 98 mm (3.875 in.) were located near the right center of the right-side floorboard. Complete occupant compartment deformations and their corresponding locations are provided in Appendix F.

Damage was concentrated on the front and right sides of the vehicle. The right-front quarter-panel, wheel well, and hood were deformed and dented. The bumper and bumper connections were deformed and damaged. The front bumper encountered two major buckle points. The hood buckled.

The right-front top corner of the box was dented. Light scrapes and deformations were found along the entire right side. One heavy contact mark was found on the right side near the rear of the truck. The top of the right-side door was ajar with a 127 mm (5 in.) gap. The drive shaft disengaged between the rear end and the middle joint. The lower right-side A-frame was deformed upward. The right-side frame horn encountered heavy contact marks and was crushed inward. The right-front wheel fractured but remained attached to the truck. The lower-right side of the windshield shattered. The right-side window glass was fractured and removed. The left side, rear end, and all other window glass remained undamaged.

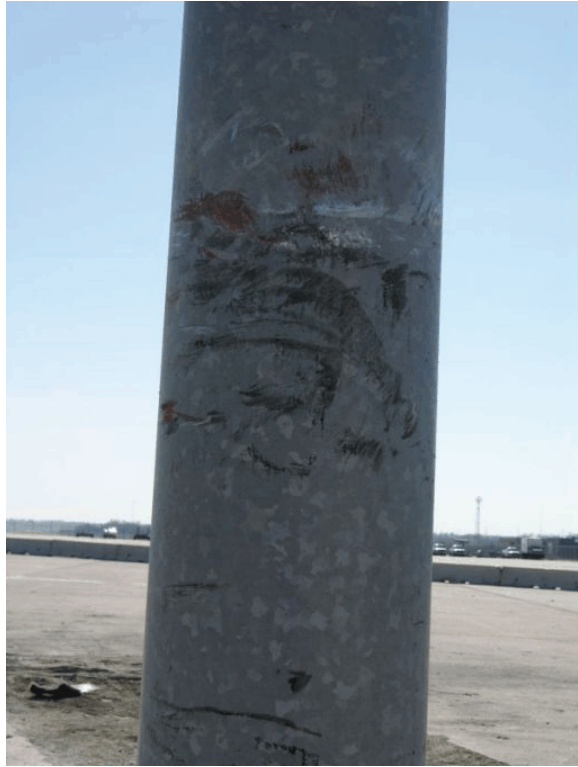
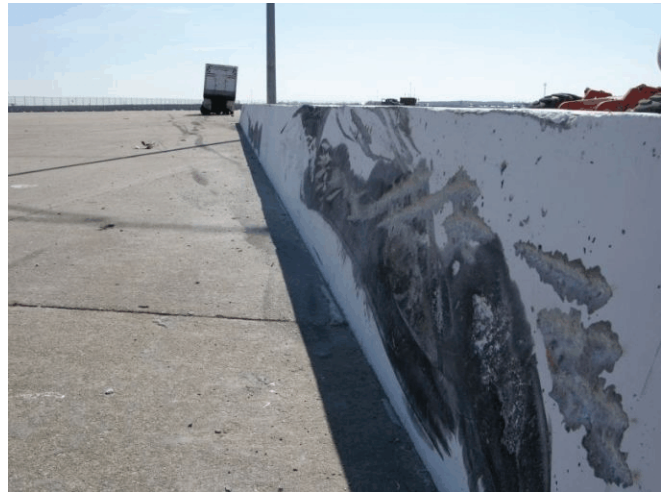
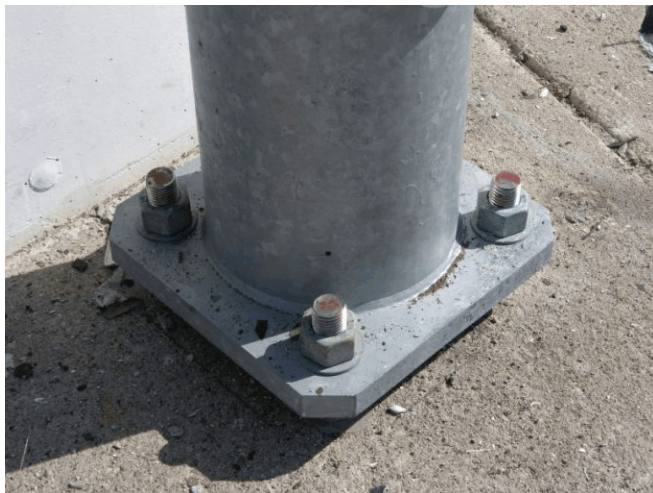
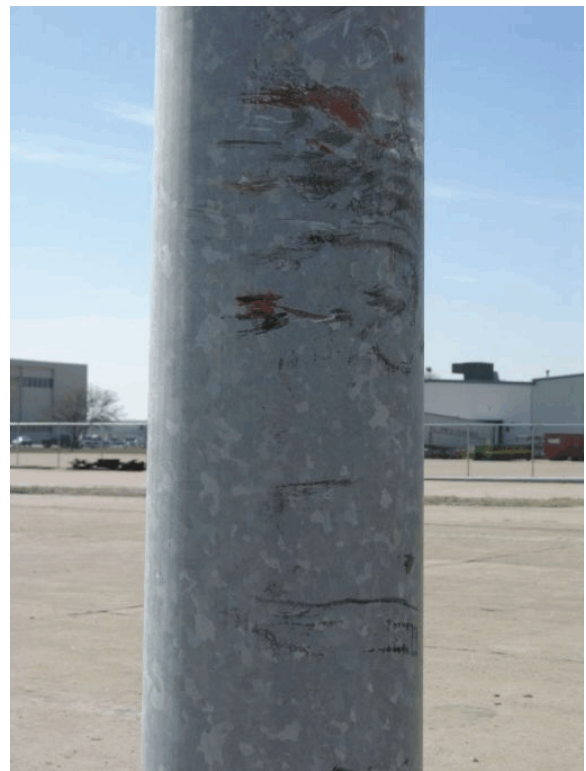
Figure 72. System Damage, Test No. ZOI-3

Damage to the barrier was moderate, as shown in Figure 72. Barrier damage consisted of gouge and tire marks. The length of vehicle contact along the concrete barrier system was approximately 28.78 m (94 ft - 5 in.), which spanned from 16.43 m (53 ft - 11 in.) upstream of the centerline of the pole through the downstream end of the system.

Major concrete gouging was found on the front face of the concrete barrier. One large area of gouging began 83 mm (3.25 in.) above the ground and 16.90 m (55 ft - 5.5 in.) upstream from the centerline of the pole and encompassed the majority of the front face through 11.26 m (36 ft - 11.5 in.) upstream from the centerline of the pole. Another large area of gouging with an average width of 381 mm (15 in.), spanned from 7.77 m (25 ft - 6 in.) upstream from the centerline of the pole and

The pole encountered minor scuff and scrape marks on the upstream face. The pole remained attached to the concrete. No deformations or damage occurred to the attachment mechanism, as shown in Figure 72.

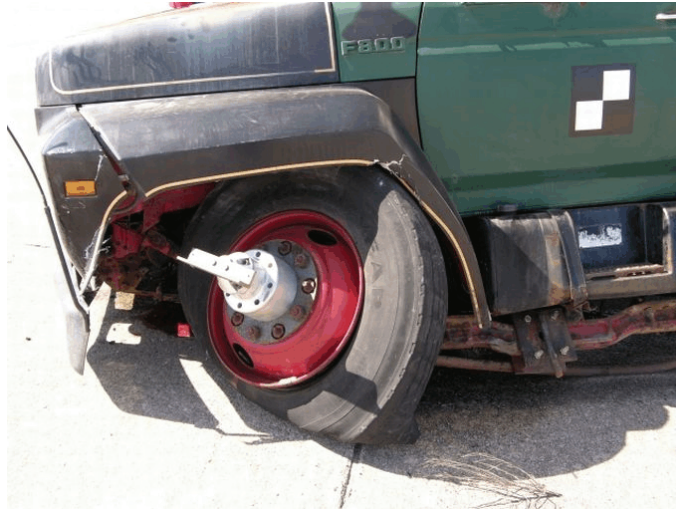
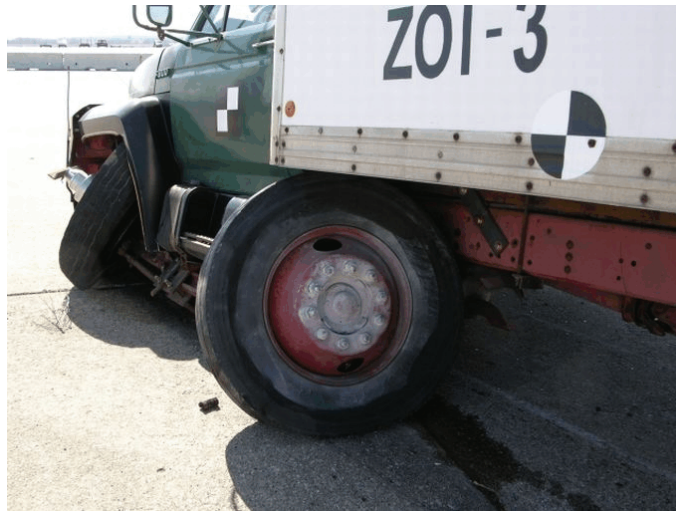
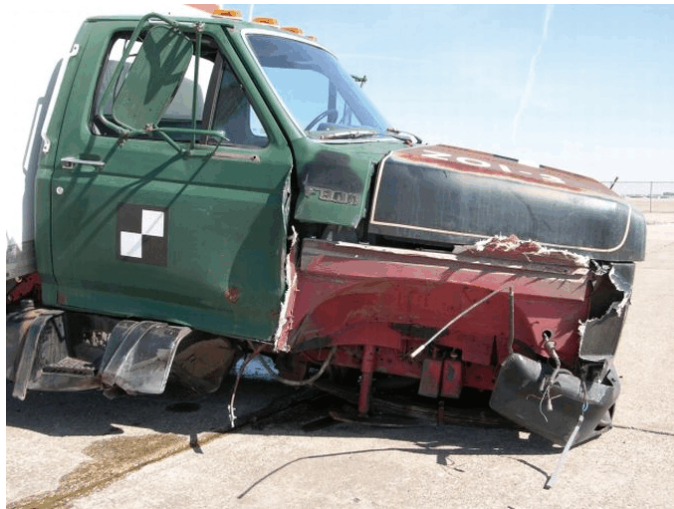
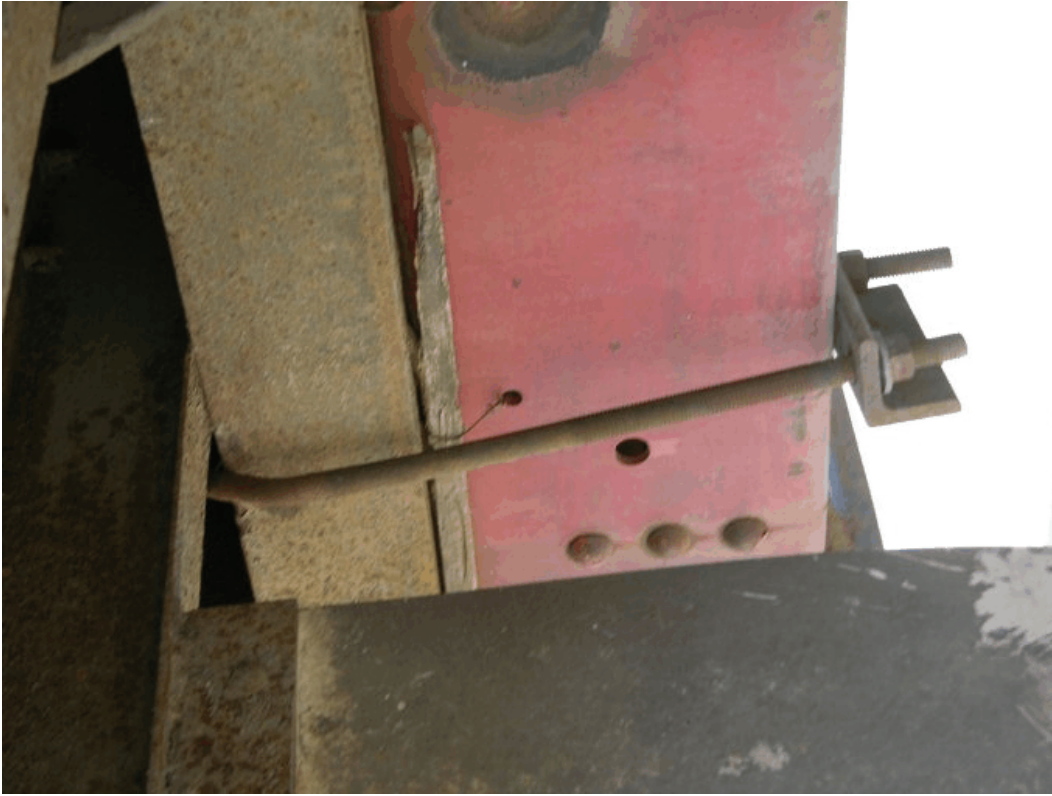
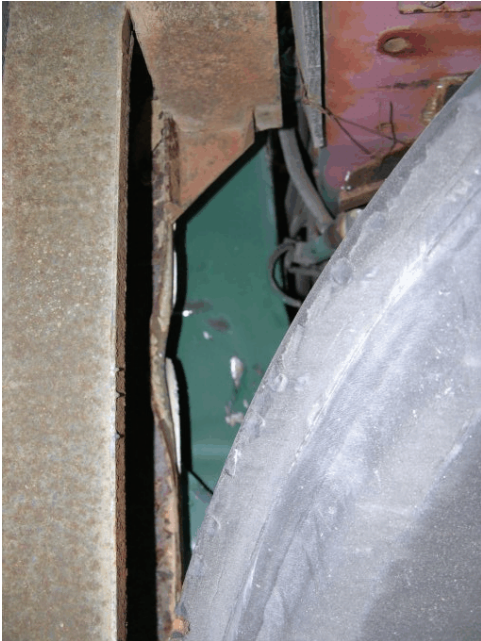
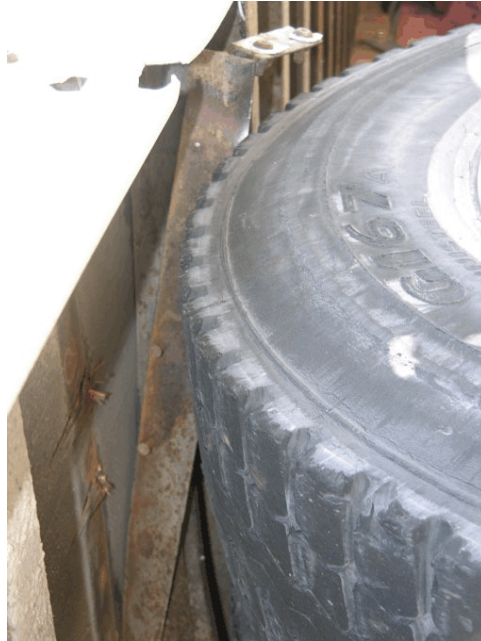
Figure 73. Vehicle Damage, Test No. ZOI-3

Exterior vehicle damage was moderate, as shown in Figures 73 through 75. Occupant compartment deformations did not occur. Complete occupant compartment deformations and their corresponding locations are provided in Appendix I.

Damage was concentrated on the right-front corner of the vehicle. The right side of the front bumper deformed inward. The plastic headlight housing fractured on both the left and right sides. The left-side fender was bent and deformed inward. The metal straps for the left-side and right-side fuel tanks fractured. The right-side fuel tank was dented. The box frame on the right side was severely bent above the tire. The wood supports fractured, and the box shifted. The U-bolts deformed. The right-side trim was deformed. The right-side mirror was severely damaged. The right-side suspension springs broke. The right-front fender disengaged. The front axle detached and was

rotated 90 degrees. The left-front tire bead broke, and the tire was deflated. The right-front wheel hub encountered scrapes and dents. The right-front tire was deflated. The right-rear steel rim was damaged, and the outside tire was deflated. The right-side door window shattered. The left side, rear, and all other window glass remained undamaged.
