BARRIERS IN CONSTRUCTION ZONES

VOLUME 4

Report No.
FHWA/RD-86/095

1. Report No. FHWA/RD-86/095		2. Government Accession No.		3. Recipient's Catalog No.	
4. Title and Subtitle BARRIERS IN CONSTRUCTION ZONES - THE RESPONSE OF ATYPICAL VEHICLES DURING COLLISIONS WITH CONCRETE MEDIAN BARRIERS VOLUME 4				5. Report Date April 1985

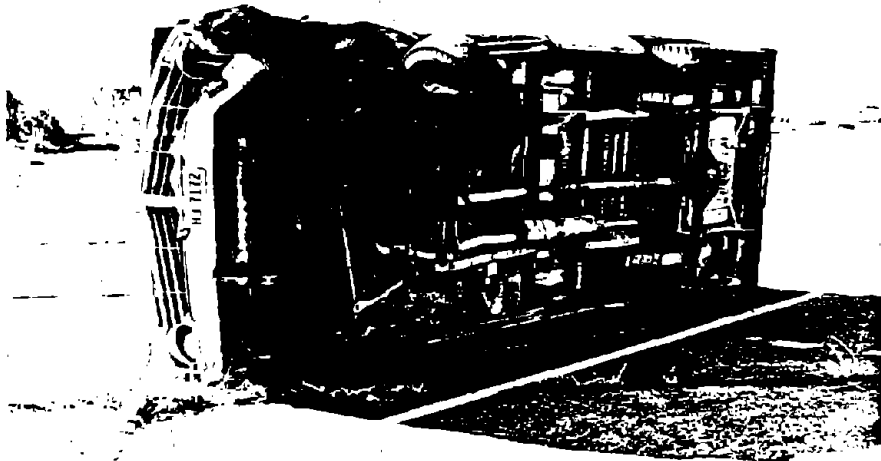
Figure 59. Vehicle after test 3825-15.
(Showing damage to undercarriage)

As shown in figure 59, the vehicle sustained damage to the undercarriage. The left I-beam (axle) was bent back, the left strut attachment bracket was sheared from the frame and both mainframe rails were bent. The left front tire was deflated and the rim bent (shown in figure 60).

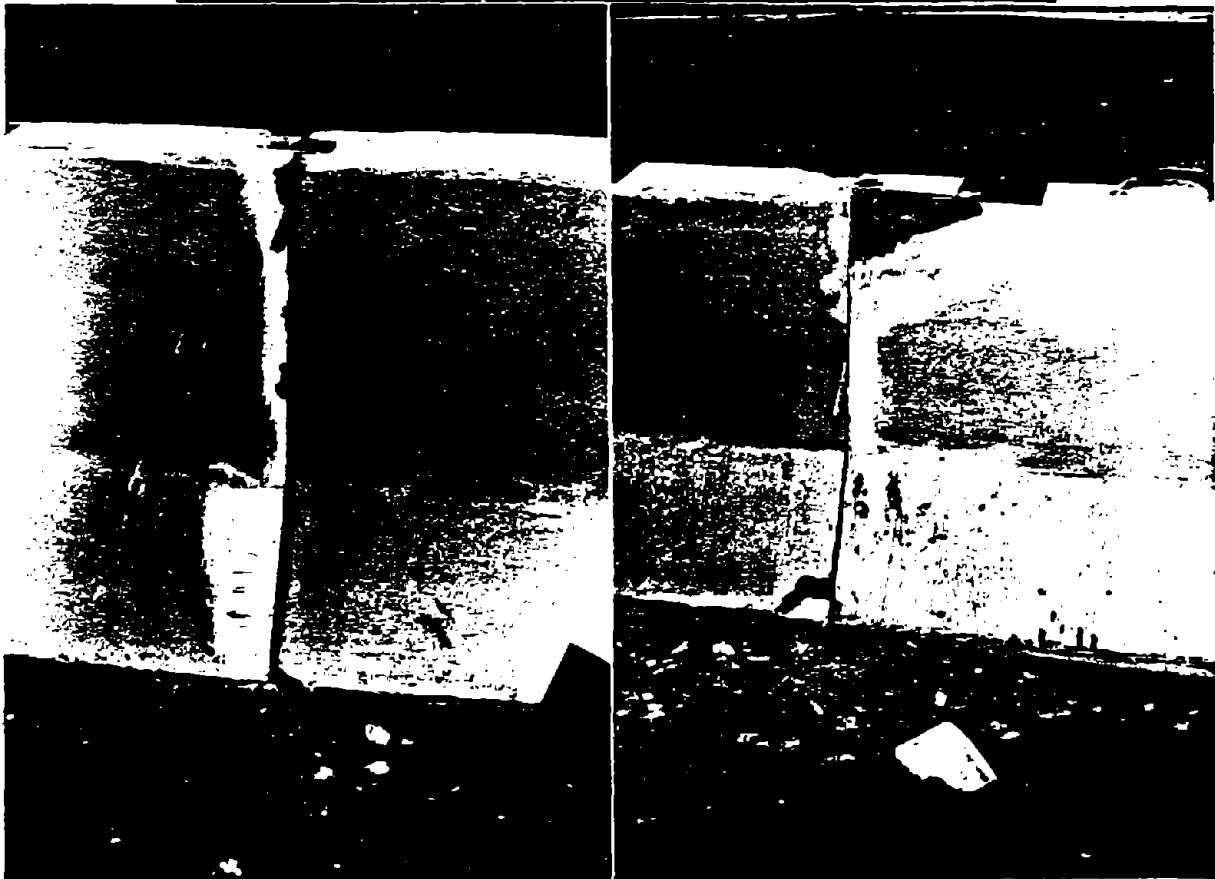
Figure 69. Barrier after test 3825-16.

The barrier received damage to segment 4 as shown in figure 69. Joints 3-4 and 4-5 were chipped and broken. The top of the barrier moved 0.14 ft (0.04 m) during the test and retained a permanent set of 0.03 ft (0.01 m).

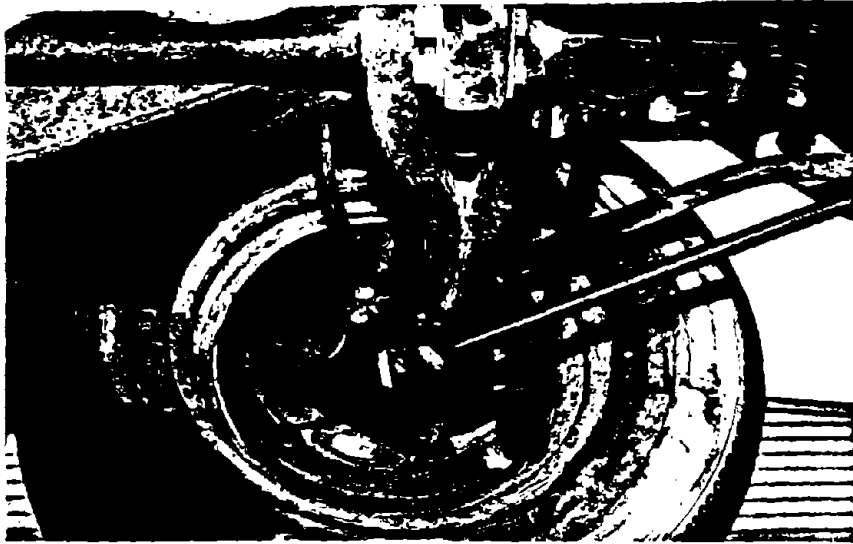
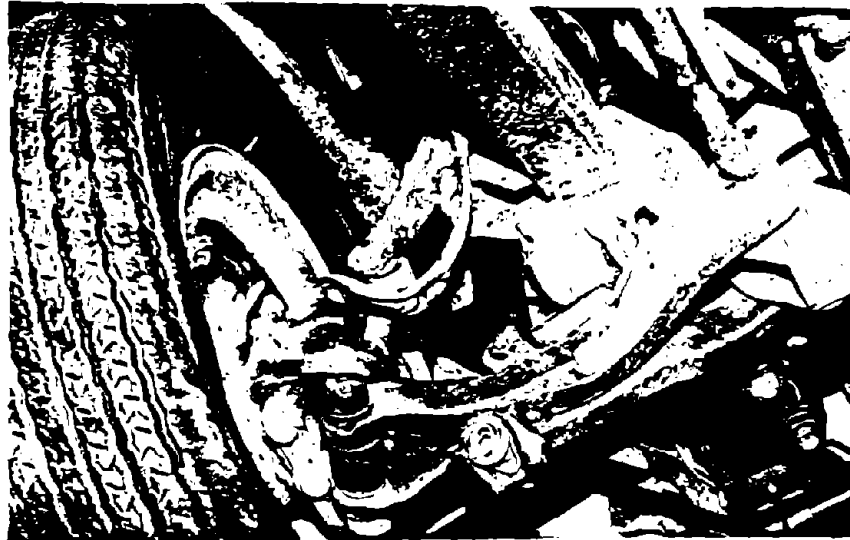
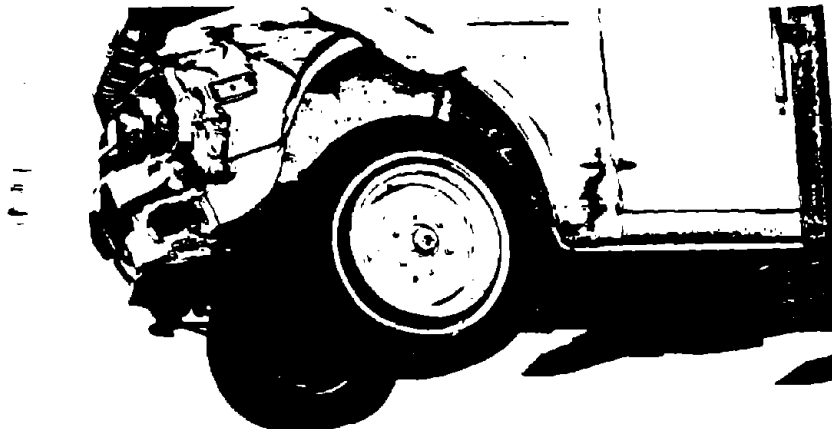
Figure 105. Damage to 1974 Datsun pickup suspension in test 3825-12.

There was significant damage to the suspension of the vehicle on this test, as documented in figure 105. The left front lower control arm was bent rearward approximately 3 in (8 cm) at its attachment to the spindle. The tie strut bracket on the lower control arm was severely deformed and partially separated from the arm. Both of these failures appear to be from the longitudinal loading from impact. There was a small amount of deformation to the left front wheel rim, however the tire was cut and punctured. This damage was probably not severe enough to prevent a driver from regaining control after redirection.

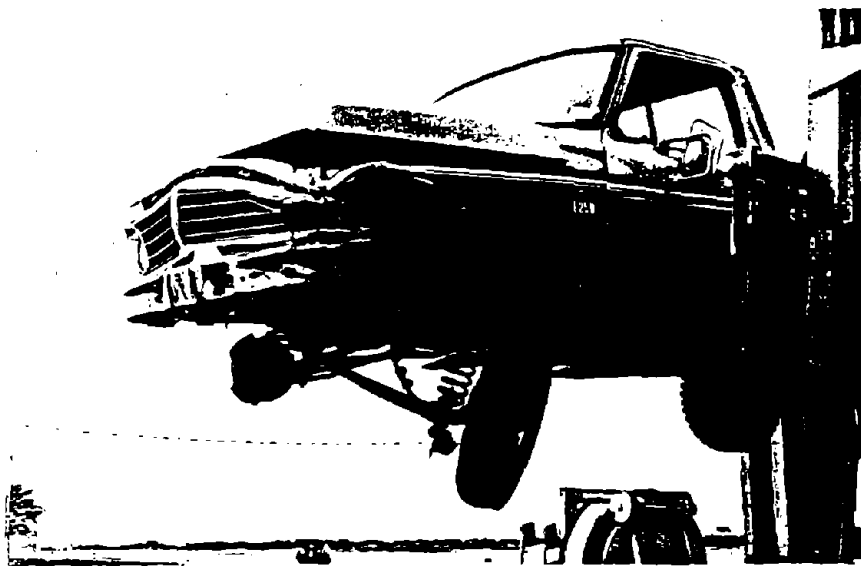
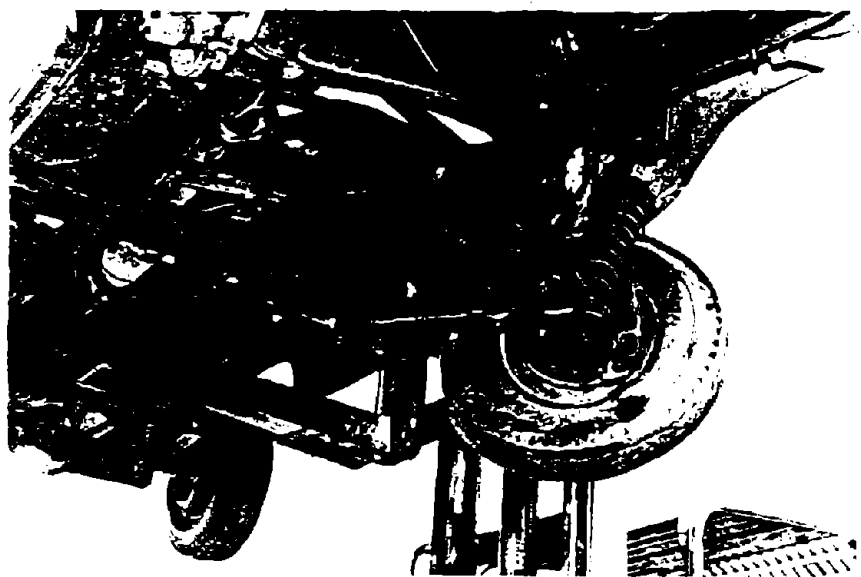
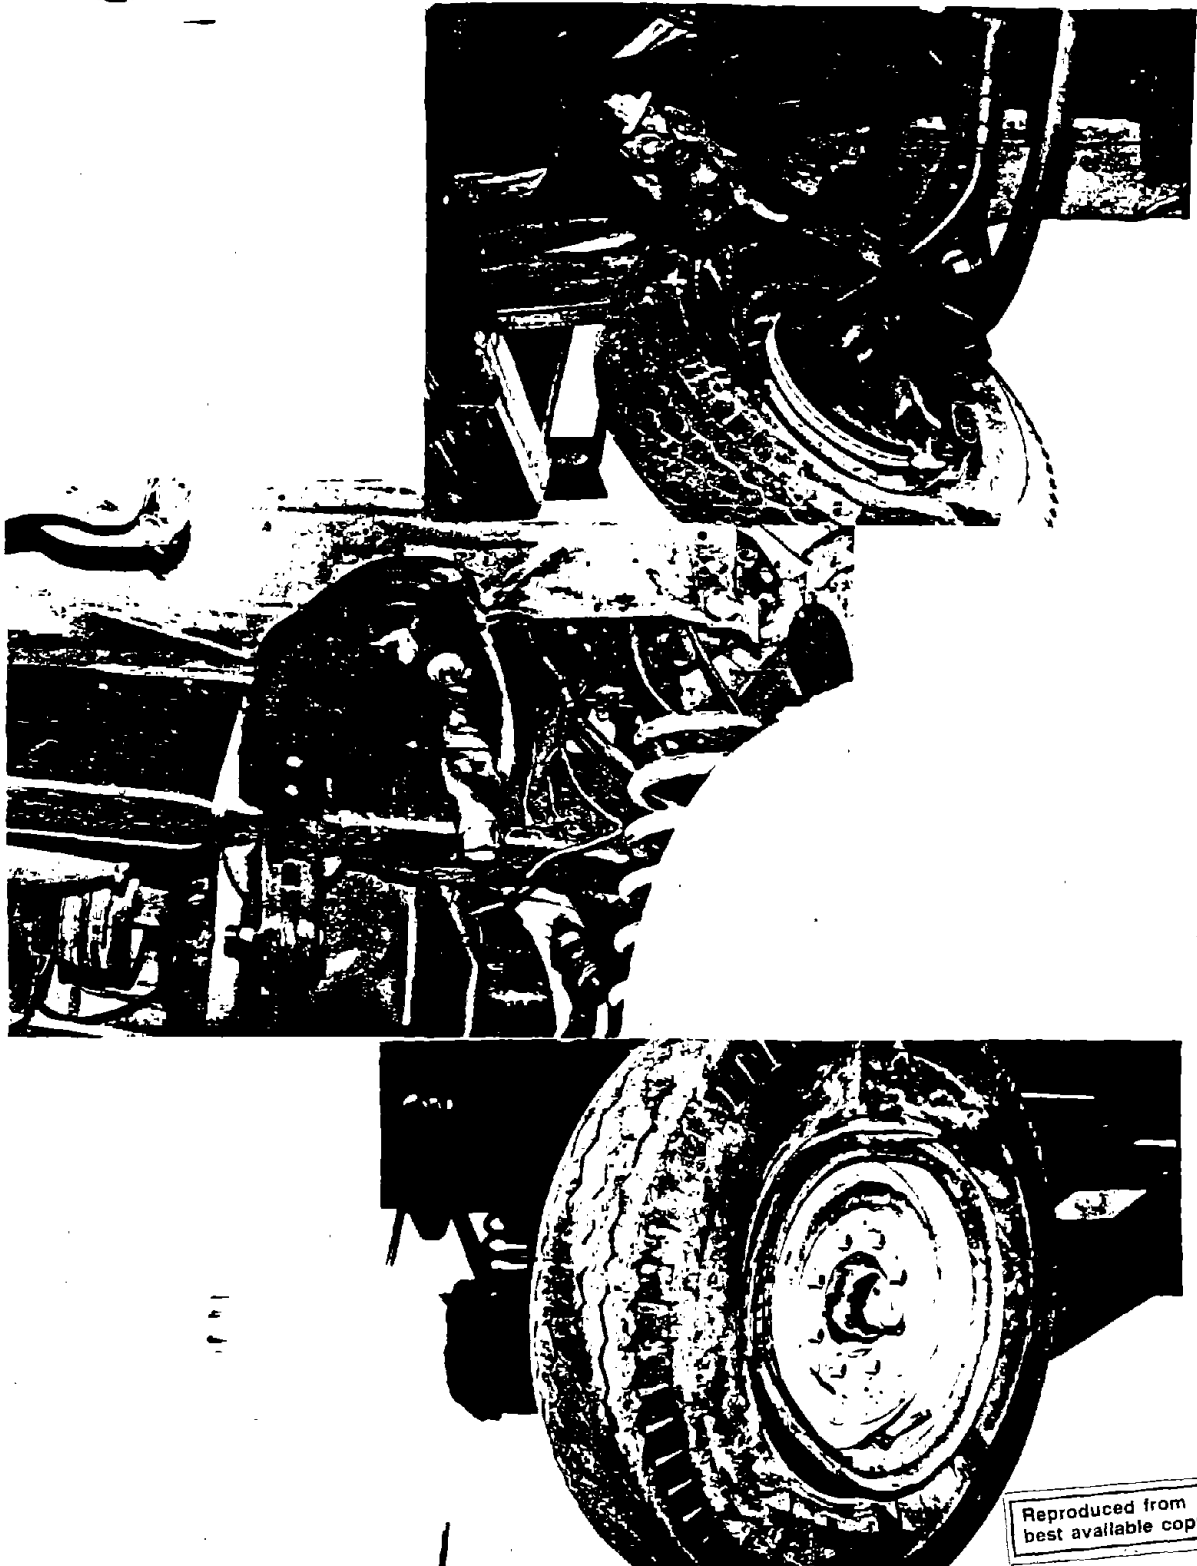
Figure 107. Damage to 1974 Ford F250 pickup suspension in test 3825-15.

1974 Ford F250 Pickup 60 mph 22-degree angle
There was major damage to the suspension of the vehicle on this test, documented in figure 107. The left front suspension was detached from the frame at all points except the inboard I-beam pickup point. The left I-beam suffered deformation similar to that in Test 3825-14, except to a greater degree. The left control arm suffered some compression deformation before its rear attachment bracket bolts (2) failed in shear. This permitted the shock to pull free and the spring to be pulled away from the top perch. The left front wheel rim and split ring was severely damaged, allowing an air out. The vehicle rolled after loss of contact with the barrier. The suspension damage was severe enough that a driver would not have been able to control the vehicle and prevent the roll from occurring.

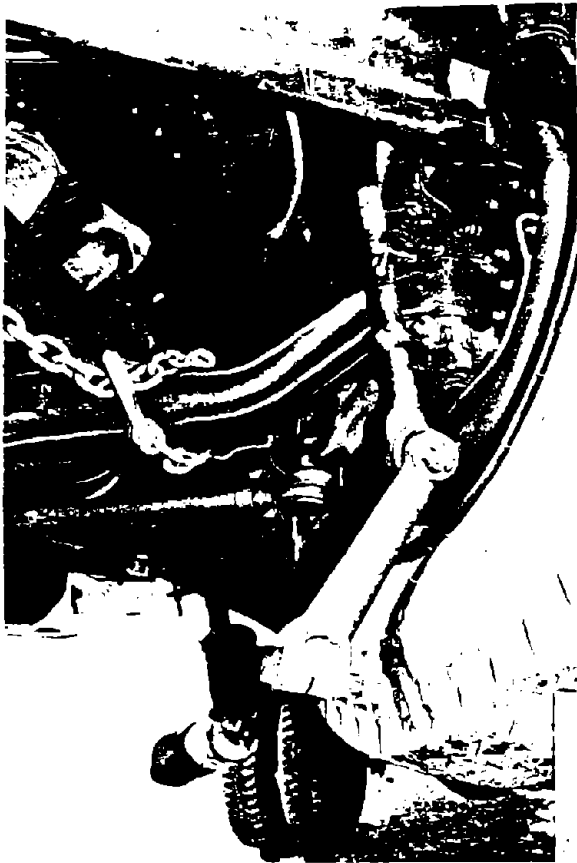
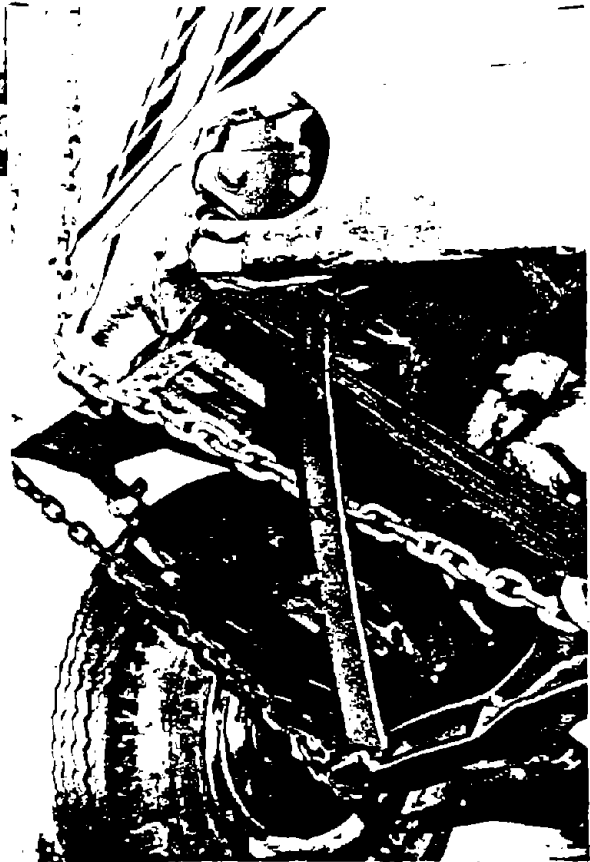
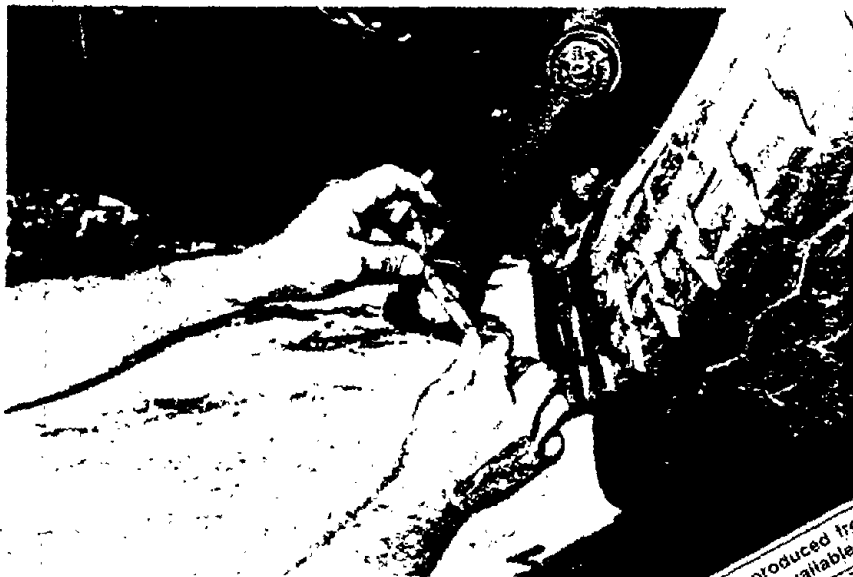
Figure 109. Damage to 1979 Ford LN 700 straight truck suspension in test 3825-17.

There was major damage to the suspension of the vehicle in this test, as documented in figure 109. The left front leaf spring failed about 18 in (46 cm) behind the front mount. The upper leaf fractured allowing the front of the spring to become unattached to the frame. The inside element of the rear spring attachment bracket was broken. This indicates the spring was not pulled out, but forced sideways through the bracket. The rear end of the spring then pierced the transmission case. On the right front, one of the U-bolts securing the spring to the drop axle failed. The shackle that held the spring pack together failed, allowing the leafs to separate horizontally. The left side frame rail was warped and twisted. All the motor and transmission mounts were broken, permitting the engine to set on the frame cross-member. The steering arm (1-3/8 in (3.5 cm) diameter) was sheared off where the pitman arm connects. The left front wheel was not structurally damaged, and the tire held air. The suspension damage was severe enough that a driver would not have been able to control the vehicle after redirection.

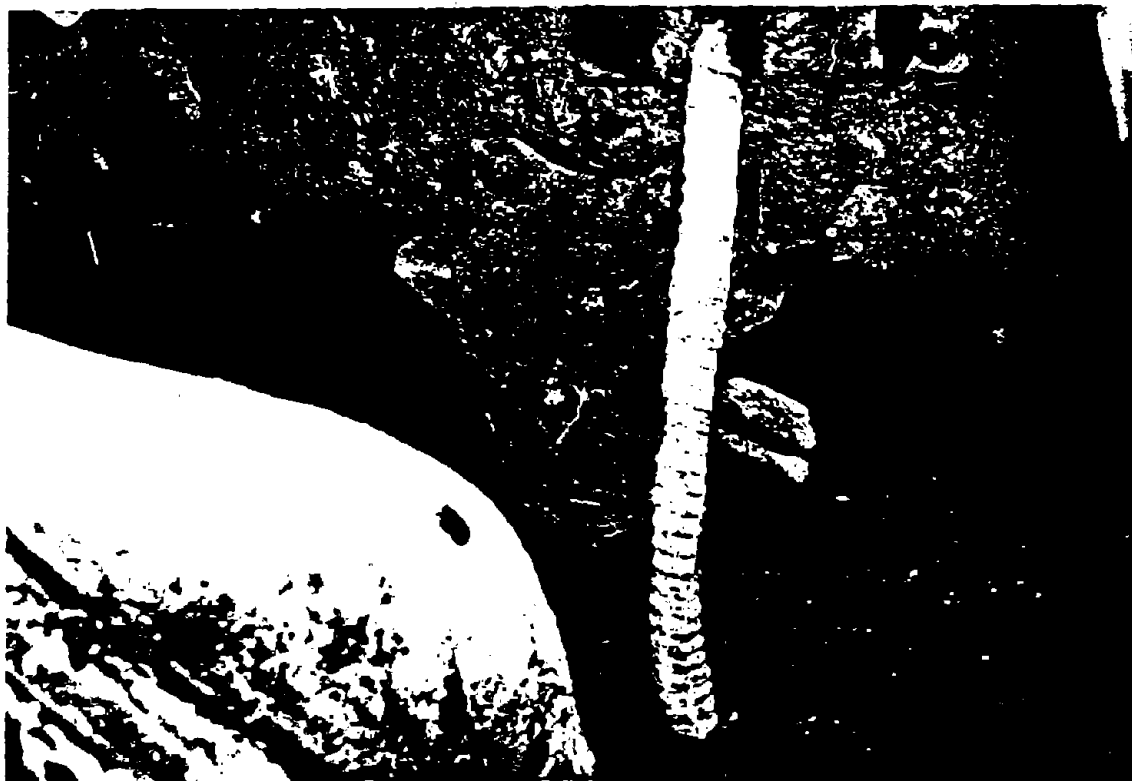
Comparison of these three cases indicate 1 and 3 are quite similar but both of these have a major difference from 2. In Case 2, a critical spring section (Section B) is placed in compression while in Cases 1 and 3 the critical section (Section A) is placed in tension. Considering the relatively small cross section, there is no doubt the compression situation is the most critical. A local buckling situation will be produced if the rearward force F_x' becomes large enough. This type of

failure is illustrated by figure 118. Another disadvantage of Case 2 is that Case 2—(slider forward) is the only one which can produce disengagement of the spring from the forward support if the spring bends in compression due to the force, F_x' (figure 117). It may be equally important to consider what happens if the bolts holding a pin bracket to the frame are sheared. Such an occurrence is shown in figure 119. In this case, if the pin bracket is forward, some support of the spring and axle is still available from the rear slider or shackle (See figure 120). This may be enough to hold the axle under the vehicle following a collision. In contrast, if the pin bracket is to the rear its failure allows the spring to move rearward and disengage from the front axle. Neglecting support from steering linkage, the axle is then completely unsupported on one side. This can lead to a progressive failure of supports on the other end of the axle and complete loss of the steering axle. This situation may make a roll more likely.

Figure 118. Break in spring adjacent to rear pin.
(Slider forward, pin to rear)

During the course of this contract examples of this slider forward condition were sought for straight trucks. None were found. The only examples of this found to date have been in pre-1970 school buses. The writers feel strongly that this suspension configuration should be discouraged.

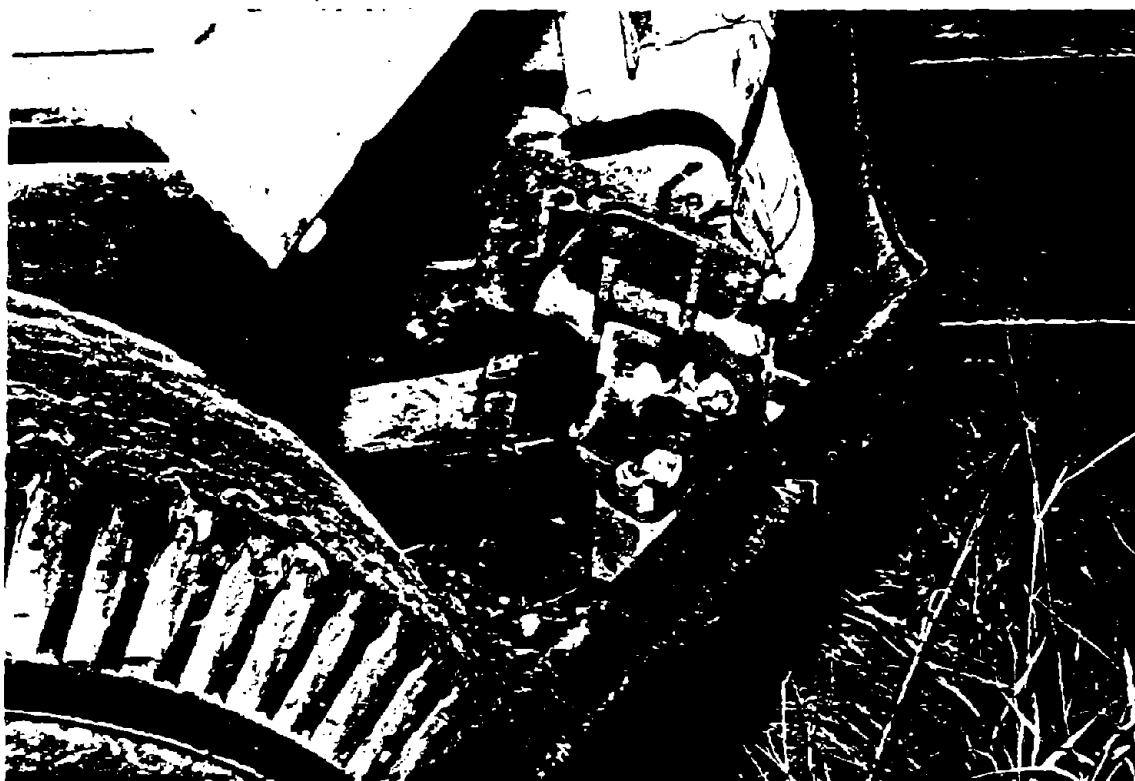
Figure 119. Pin bracket with frame bolts sheared.
