# **DOWNSTREAM ANCHORING REQUIREMENTS FOR THE MIDWEST GUARDRAIL SYSTEM**

## **WISCONSIN DEPARTMENT OF TRANSPORTATION**

MwRSF Research Report No. TRP-03-279-13

October 28, 2013

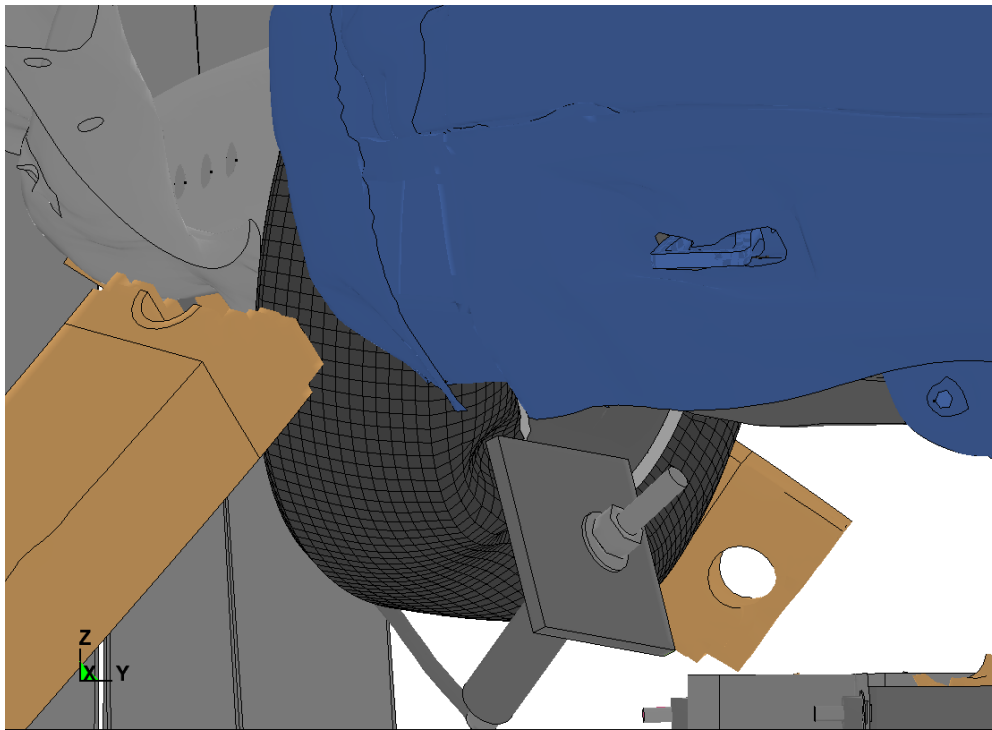
It should be noted that for an initial impact at the second post from the downstream end, the bearing plate disengaged away from the fractured BCT end post and engaged the vehicle's tire, as shown in Figure 94. Although this interference between the front tire and the bearing plate did not result in any vehicle instability in the simulation, there is still a potential that the vehicle could snag and become unstable if the edge of the bearing plate cuts through the tire.

Figure 94. Tire-Bearing Plate Contact for Impact at 2<sup>nd</sup> Post from Downstream End - 2270P

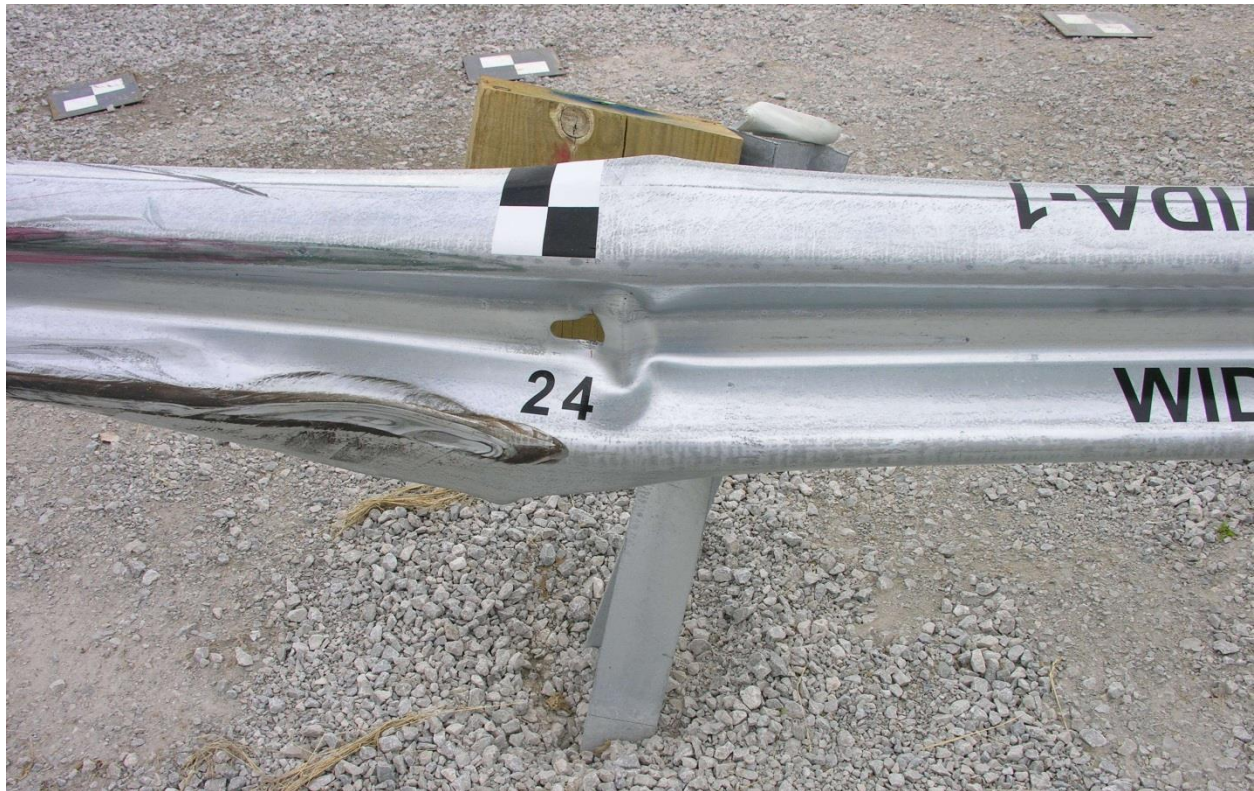
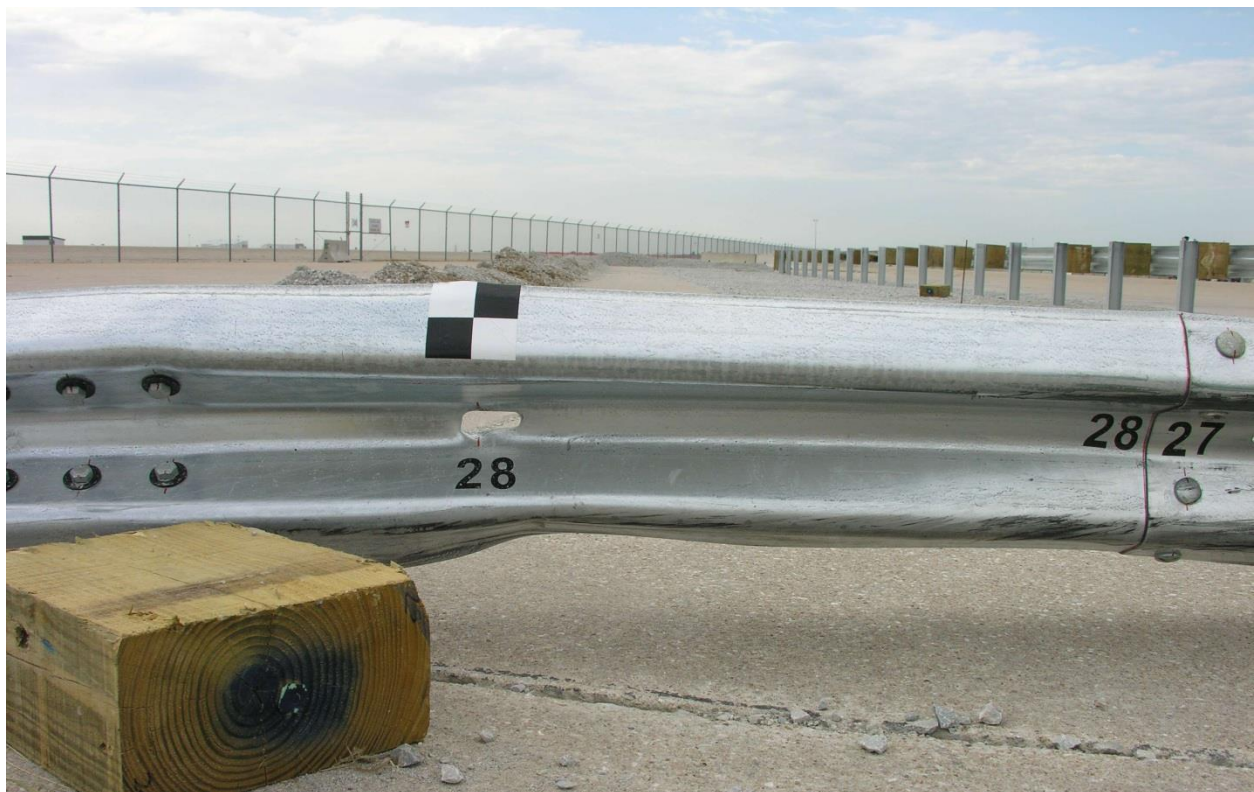
Figure 137. Rail Slot Tearing at Post Nos. 24 and 28, Test No. WIDA-1

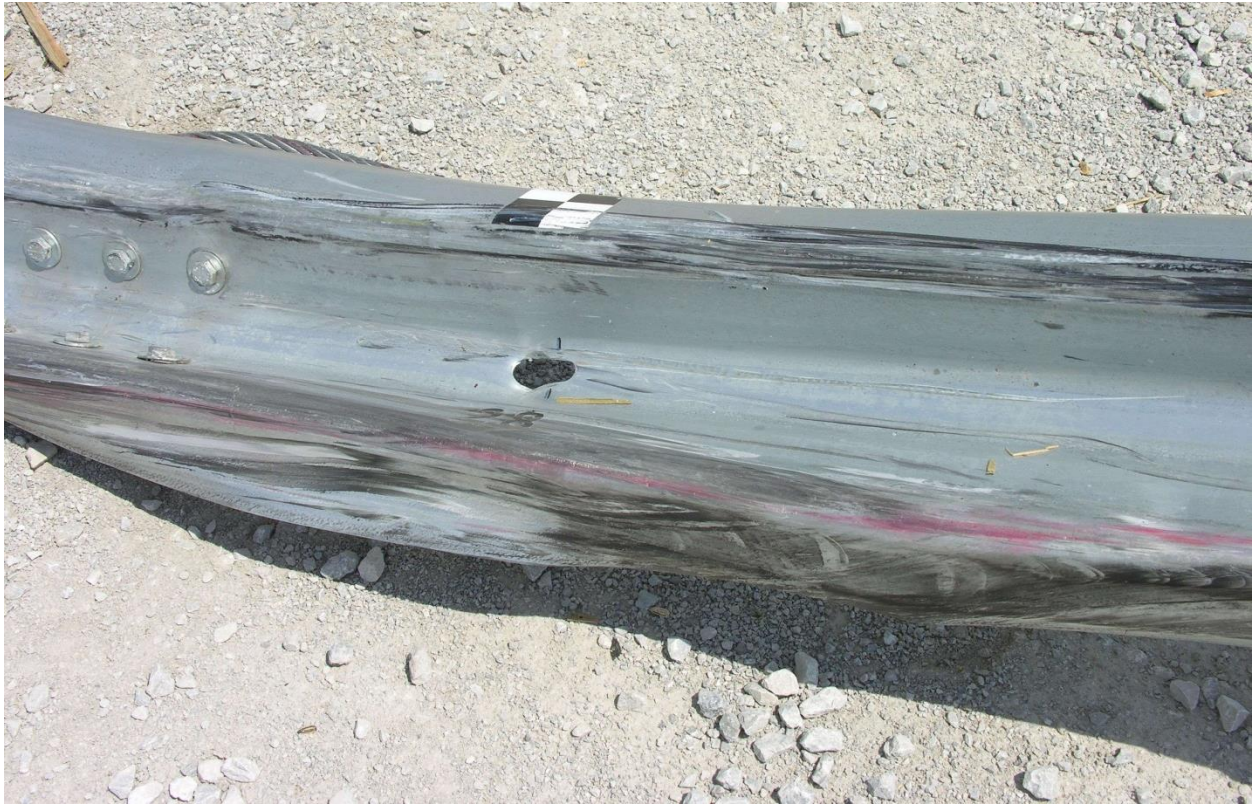
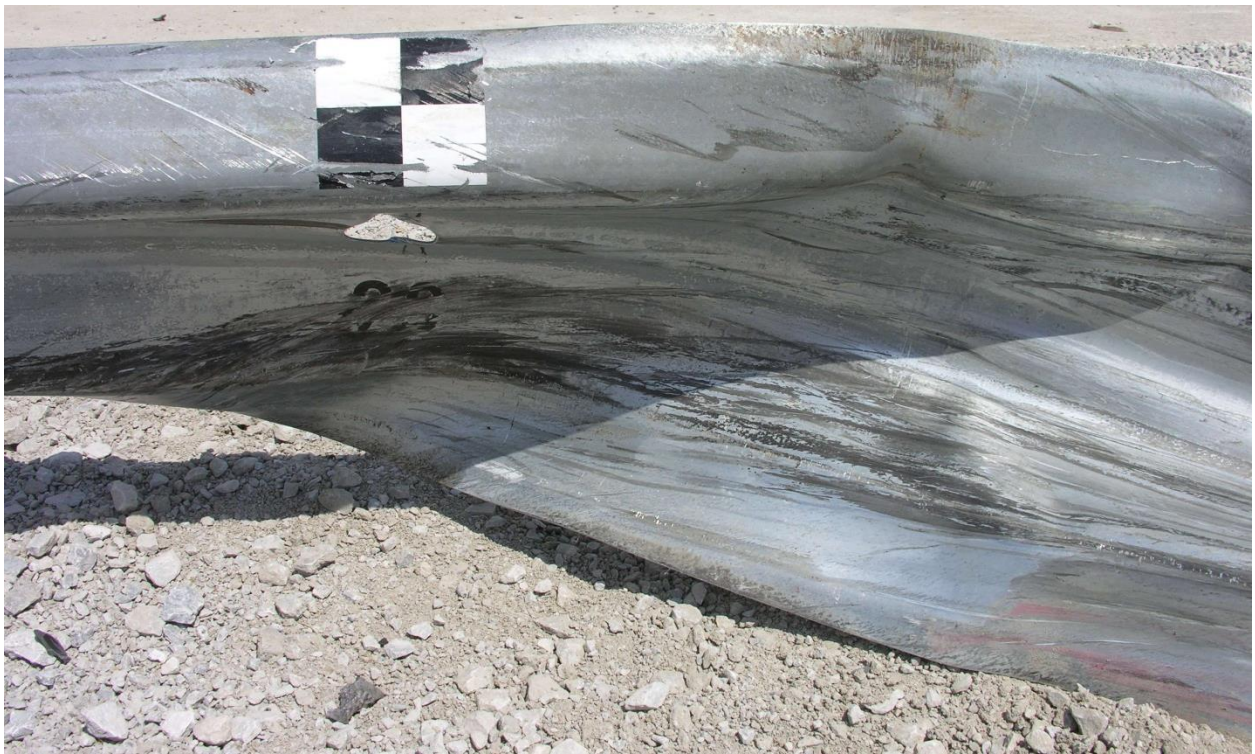
Figure 153. Rail Slot Tearing at Post Nos. 27 and 29, Test No. WIDA-2

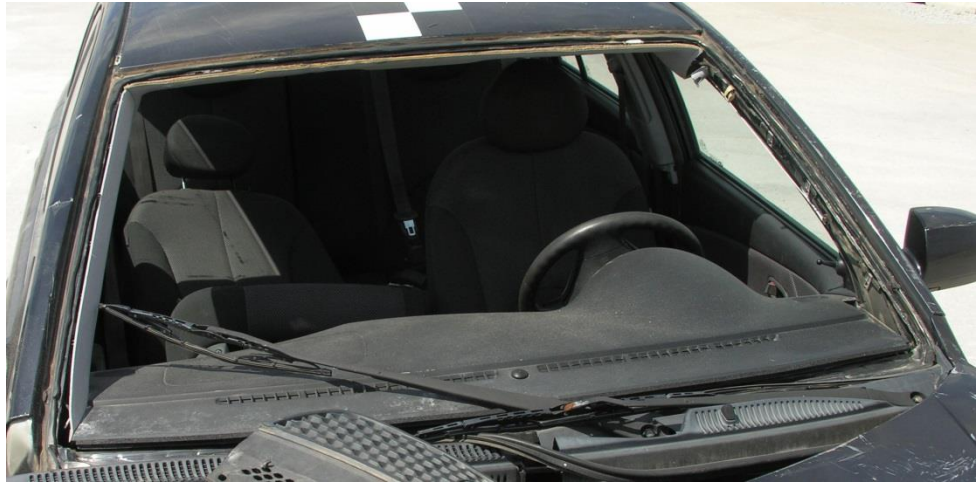
Figure 160. Vehicle Damage - Windshield, Test No. WIDA-2

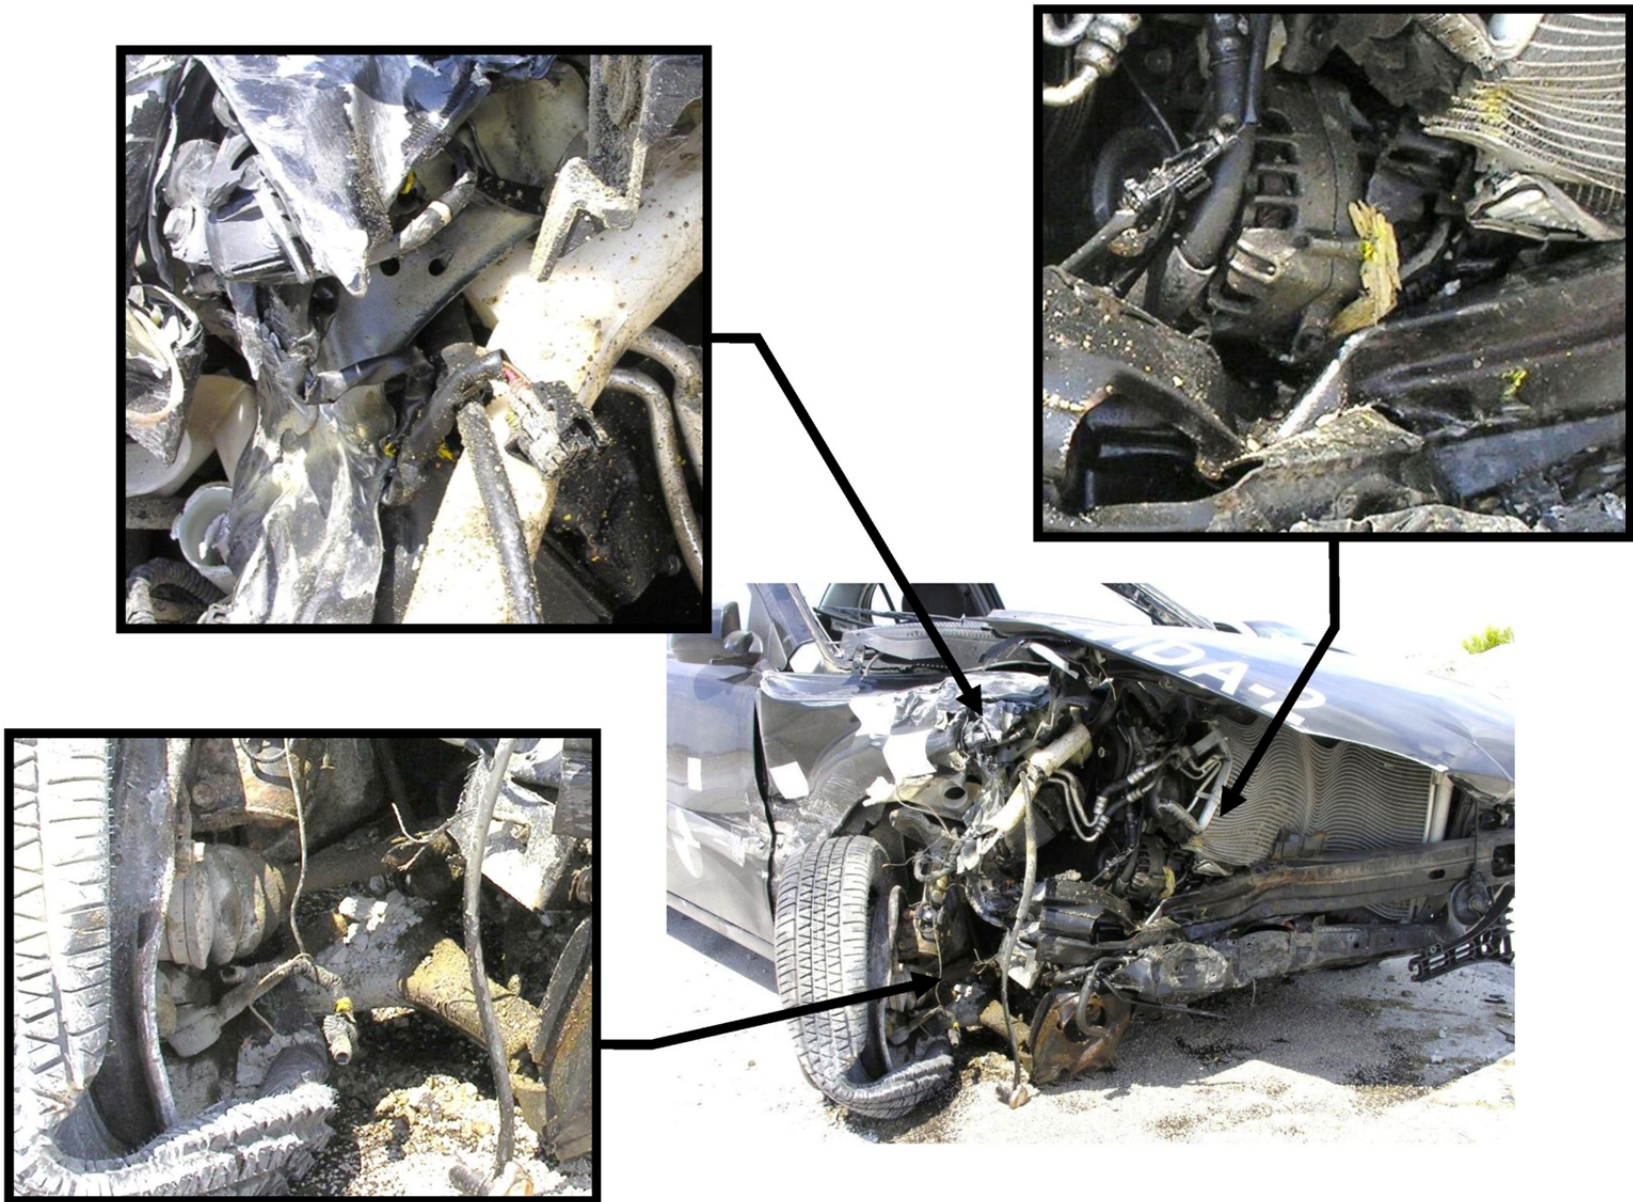
Figure 162. Traces of Bearing Plate Motion Path along Vehicle's Front End, Test No. WIDA-2
