**Evaluation of Corrosion  
Resistant Steel Reinforcing in  
the Deck Slab of a Three-span  
Prestressed Concrete Girder  
Bridge**

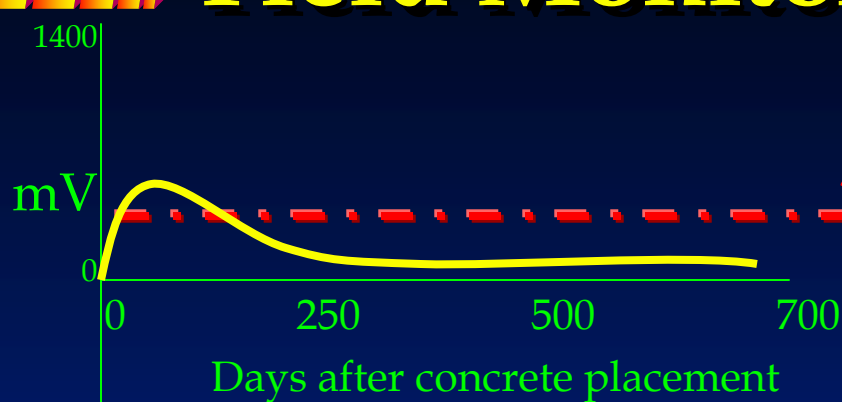
MMFX bridge

- In general, Readings on MMAX bridge lower than Epoxy bridge
- No significant active corrosion
  - Electric Current reading close to zero
- On-going investigation
  - More Data to be collected
