*Midwest States' Regional Pooled Fund Research Program  
Fiscal Year 2001-2002 (Year 12)  
Research Project Number SPR-3 (017)  
NDOR Sponsoring Agency Code RFPF-02-02*

## **Phase III Development of a Short-Radius Guardrail for Intersecting Roadways**

MwRSF Research Report No. TRP-03-183-07

December 6, 2007

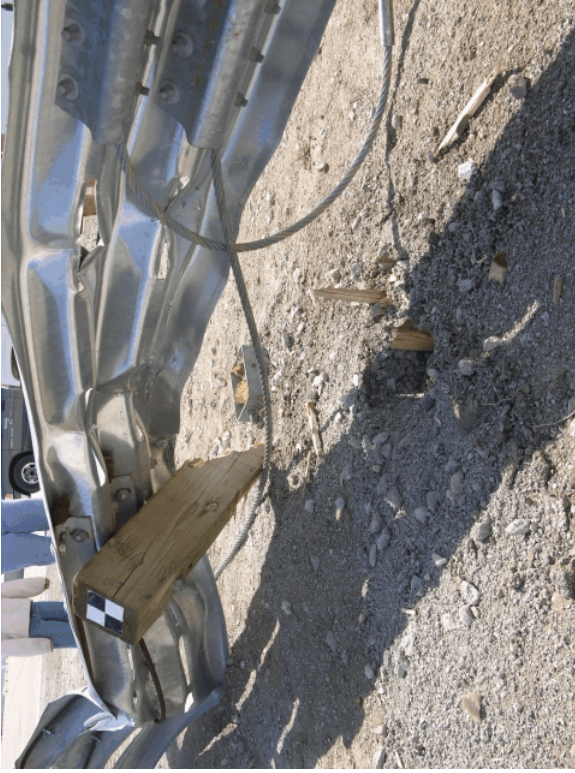
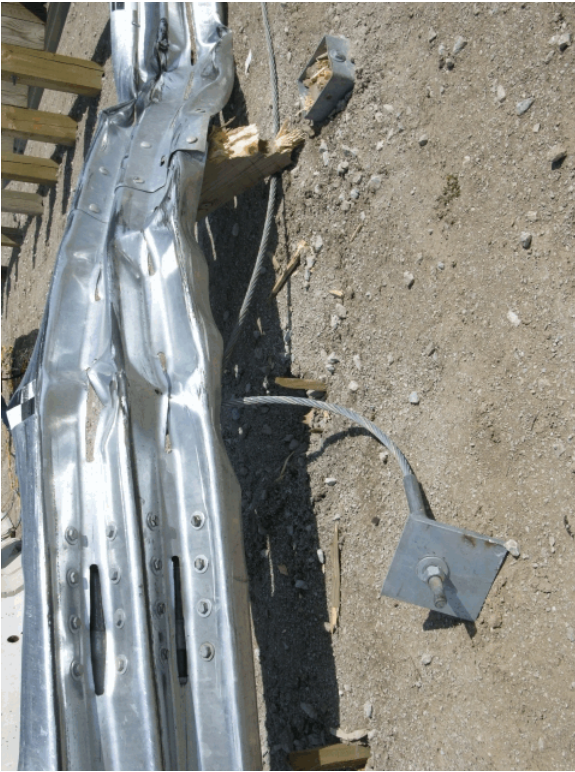
Figure 52. System Damage, Test SR-5

Contact marks were found on all three corrugations between the impact location on the rail and post no. 7P. The rail was flattened and deformed between the center of the nose section and post

no. 2P. Rail flattening also was found between post nos. 3P and 5P. Rail bending was observed along curved nose section. Additional rail bending was found at post nos. 3P, 4P, and 6P through 8P. The post bolts released from the rail at post nos. 2P through 4P. Significant post bolt rail deformation was found at post no. 6P. The rail slots between post nos. 3P and 4P were folded and closed by rail flattening and deformation. The rail was deformed backwards and the bottom corrugation deformed upward between post nos. 3P and 7P.

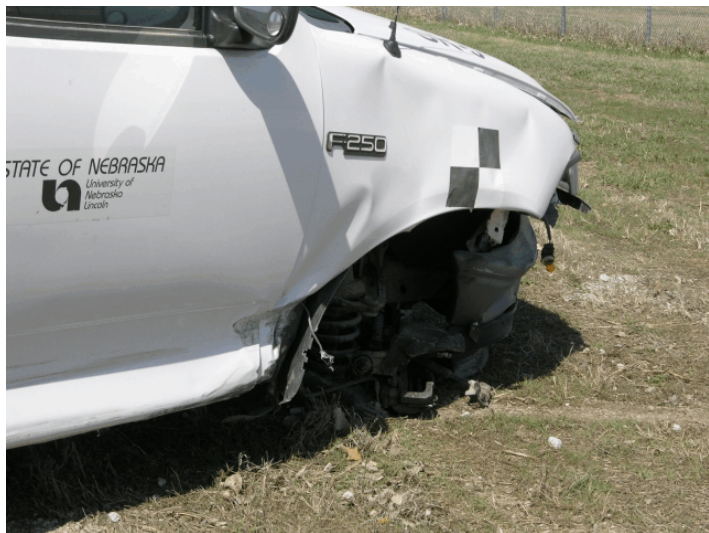
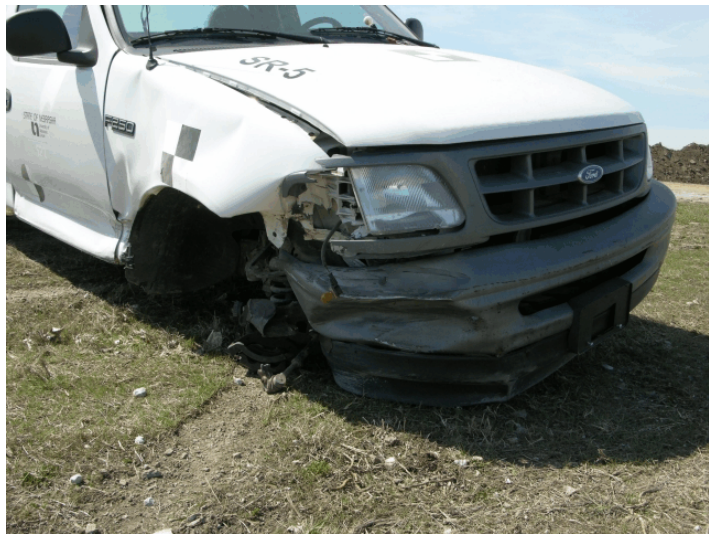
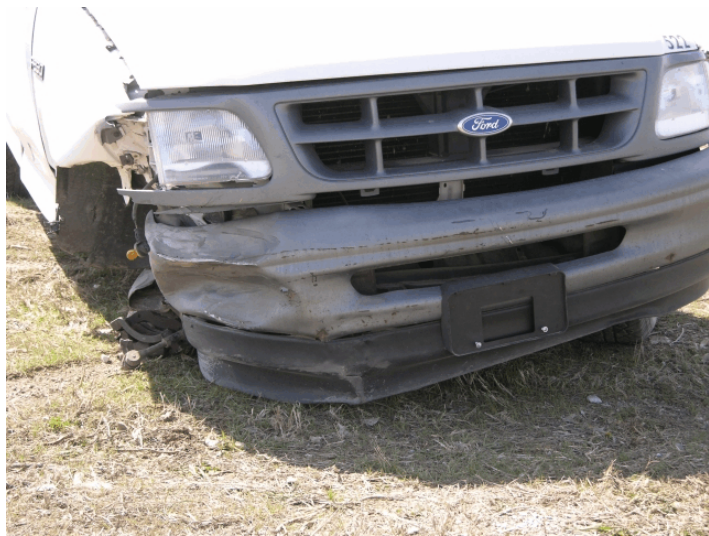
Figure 63. Vehicle Damage, Test SR-5

Exterior vehicle damage was minimal, as shown in Figures 62 through 64. Occupant compartment deformations to the right side and center of the floorboard were judged insufficient to cause serious injury to the vehicle occupants. Maximum longitudinal deflections of 13 mm (0.5 in.) were located near the left side of the right-side floorboard. Maximum lateral deflections of 25 mm (1 in.) were located near the right-front corner of the right-side floor pan. Maximum vertical deflections of 38 mm (1.5 in.) were located near the center of the right-side floorboard. Complete occupant compartment deformations and the corresponding locations are provided in Appendix C.

The right-front bumper corner was deformed inward and encountered significant dents and scratches. The right side of the grill was also deformed inward and fractured around the headlight.

The right-front turn signal cover was fractured and disengaged from the vehicle. The right-front quarter panel was crushed inward and wheel well was severely deformed. The entire right side of the vehicle sustained dents and scratches. The top of the right-side door was jarred open and it could not be opened nor closed. The right-front upper and lower ball joints fractured. The right-side steering arm fractured at the spindle. The right-side lower A-frame control arm was bent. The right-front wheel was separated from the vehicle and encountered significant scratches, dents, deformations, and gouges on both the inside and outside of the rim. The right-rear tire also encountered minor abrasions, but the rim remained undamaged. The spare tire under the vehicle was scratched and torn. The exhaust was fractured, and the gas tank was dented. The left side and rear of the vehicle, the hood, and all window glass remained undamaged.

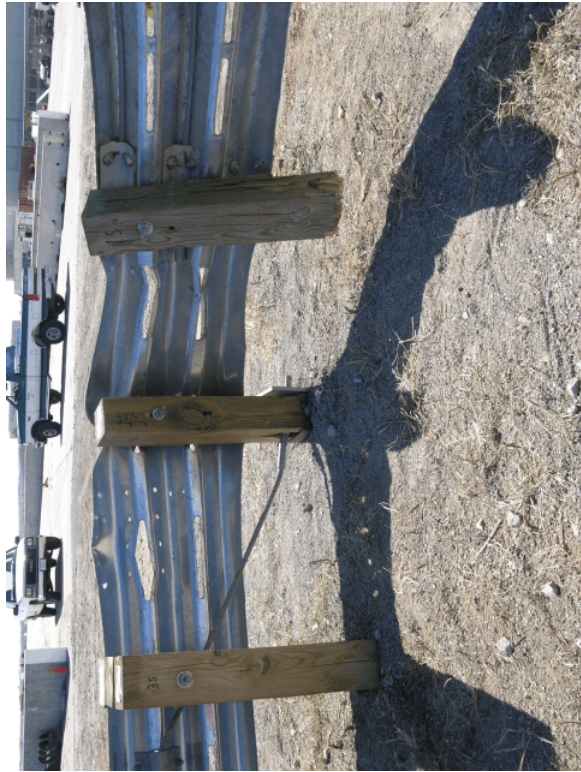
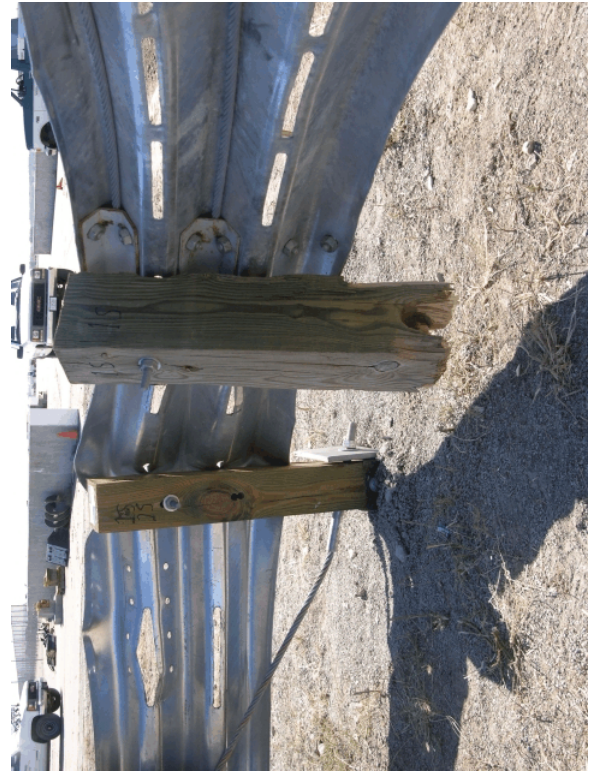
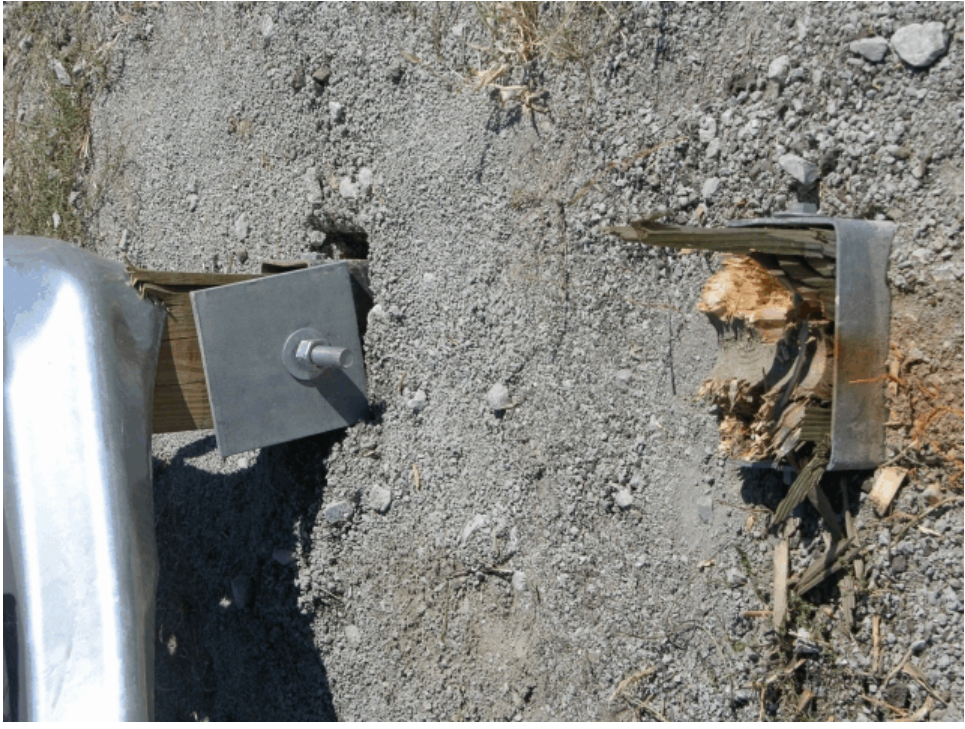
Figure 90. Post Nos. 1S Through 3S Damage, Test SR-6

Damage to the cable anchorage systems was minimal, as shown in Figure 90. The cable bracket at post no. 1P was bent and released the cable. The cable end plates at post nos. 1S and 2S remained attached to the posts. Both nose cables were stretched and the primary side ends disengaged from the rail.
