Phase IV Development of a Short-Radius Guardrail for Intersecting Roadways

MwRSF Research Report No. TRP-03-199-08

February 29, 2008

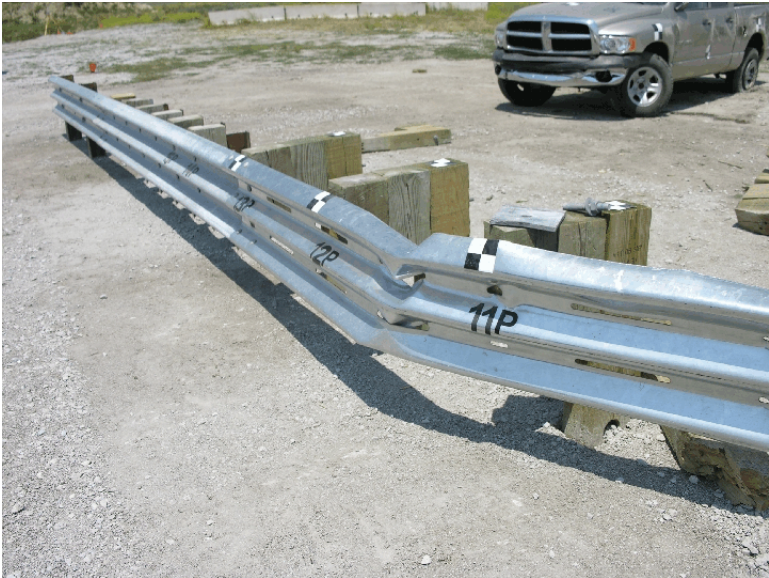
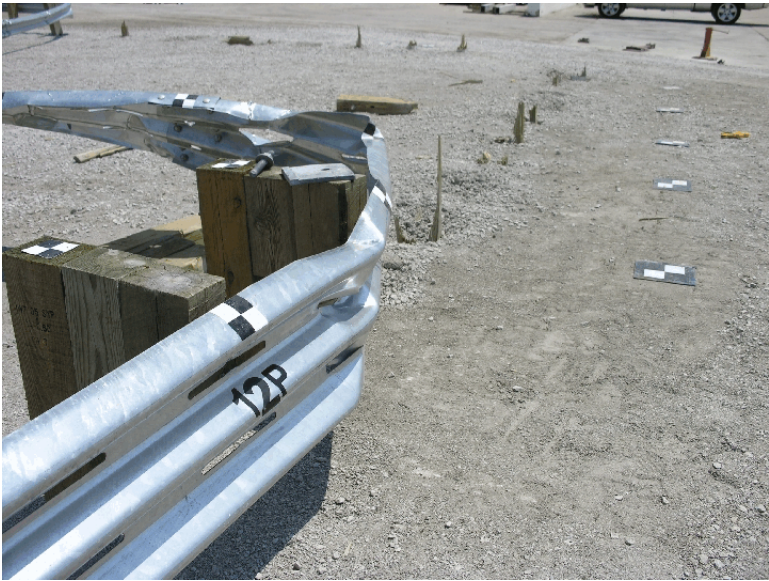
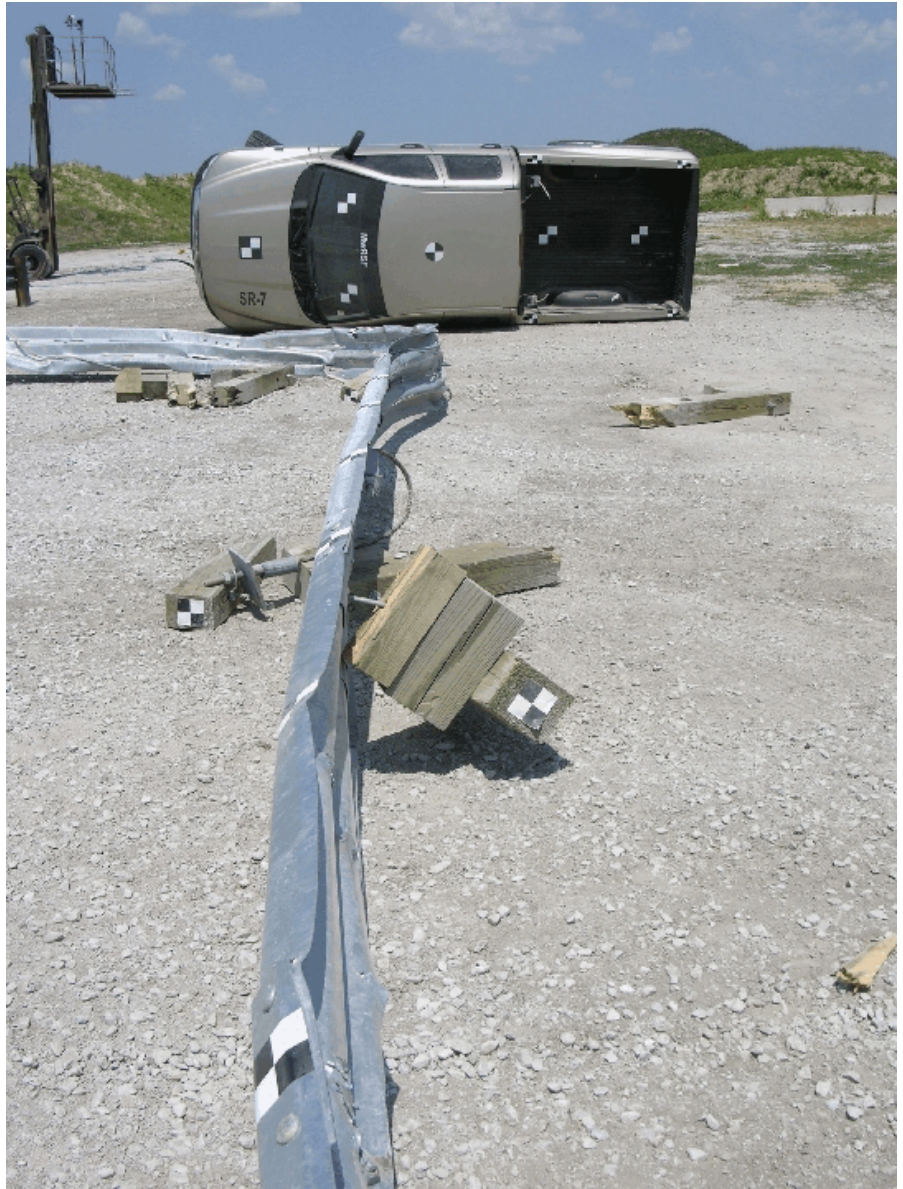
Figure 43. System Damage, Test SR-7

Barrier damage was extensive, as shown in Figures 43 through 58. Damage consisted mostly of fractured posts, fractured blockouts, damaged cable anchor hardware, and flattened and deformed guardrail.

Post nos. 1P, 1S and 2S fractured at the foundation tubes. The foundation tube at post no. 2S was dented and bent along the bolt centerline. Post nos. 2P through 10P fractured and disengaged from the rest of the system. Post no. 11P rotated backwards in the soil and cracked at the groundline. Post nos. 12P and 13P rotated backwards in the soil. Post nos. 1S and 2S fractured in the foundation tubes and were disengaged from the rest of the system. Post nos. 3S through 8S fractured at ground level and disengaged from the rest of the system. Post no. 9S rotated backwards in the soil and cracked through the transverse CRT hole, but remained in the ground.

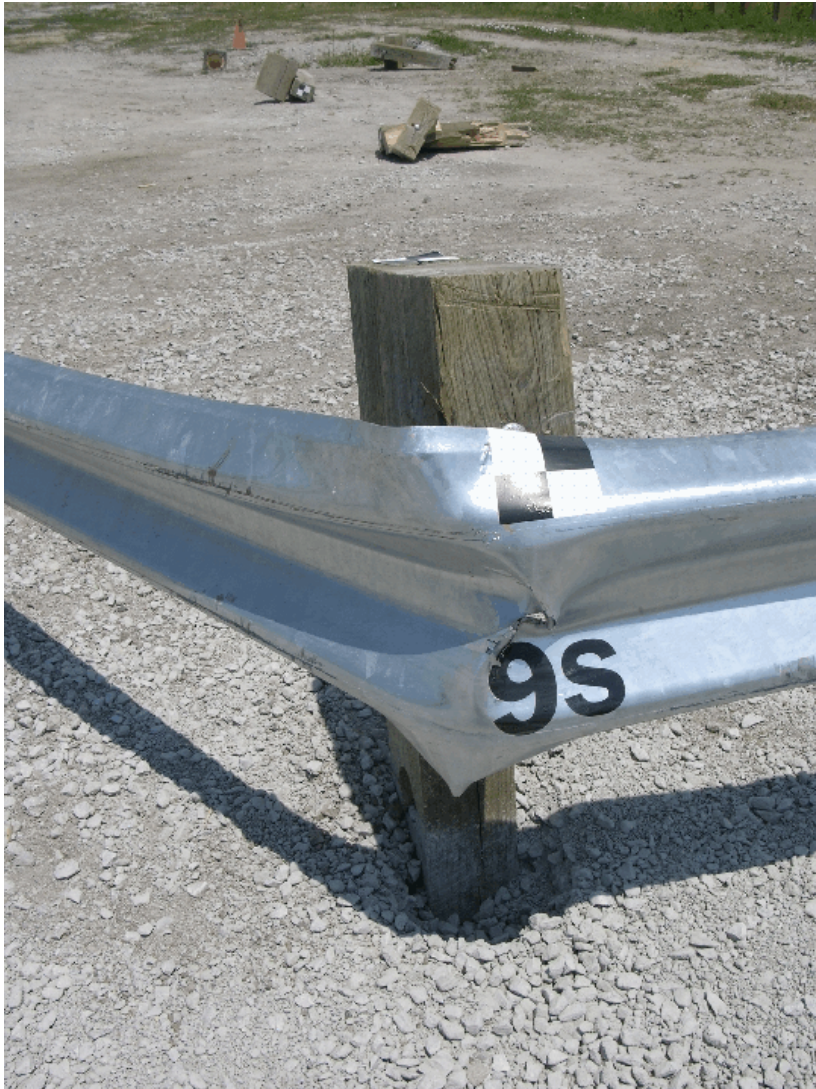
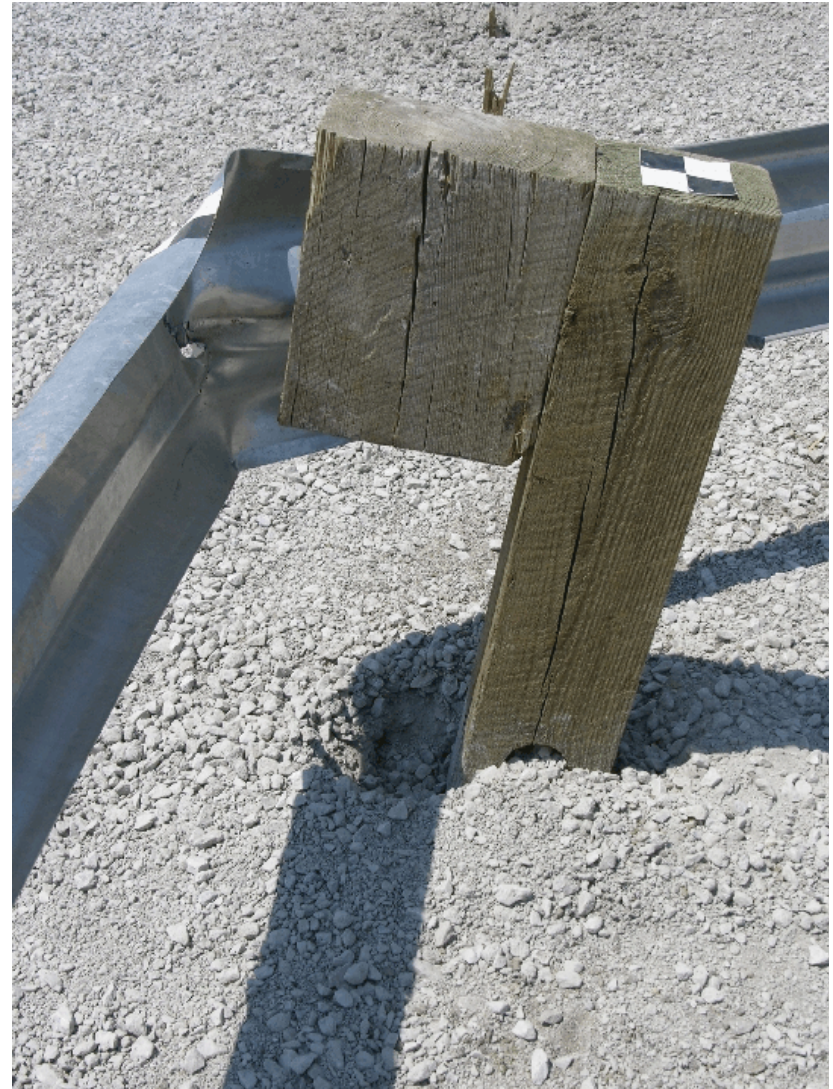
Figure 50. Post No. 9S Damage, Test SR-7

The blockouts at post nos. 2P through 10P deformed and were damaged around the bolt holes. The blockout at post no. 11P twisted on the bolt and the front face was deformed. The blockout at post no. 9S was compressed on the traffic-side face and the upstream top edge of the traffic face was chipped.

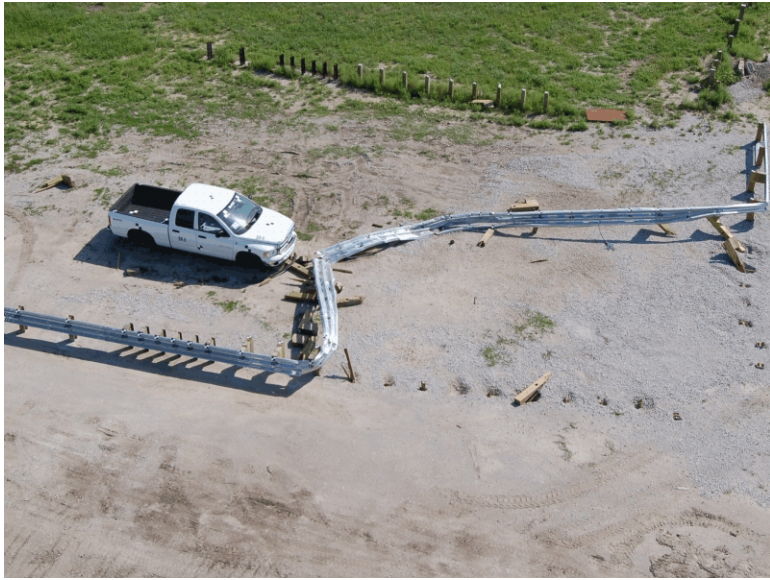
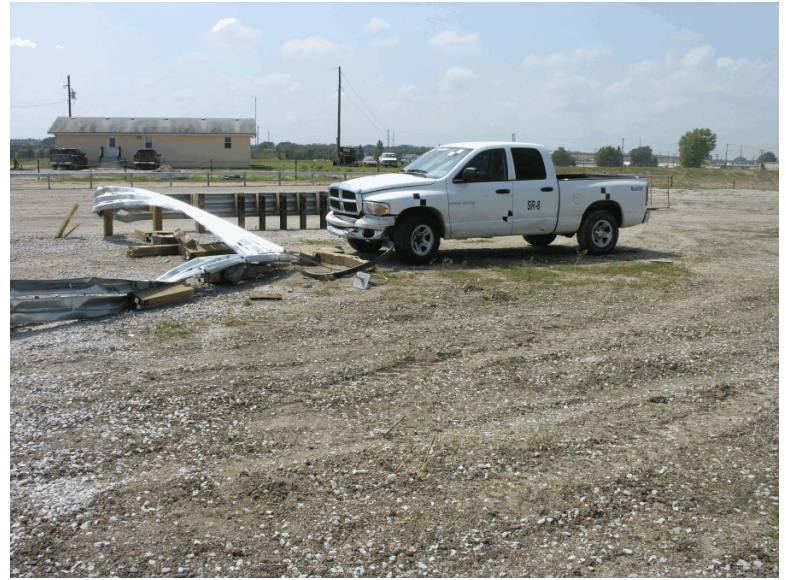
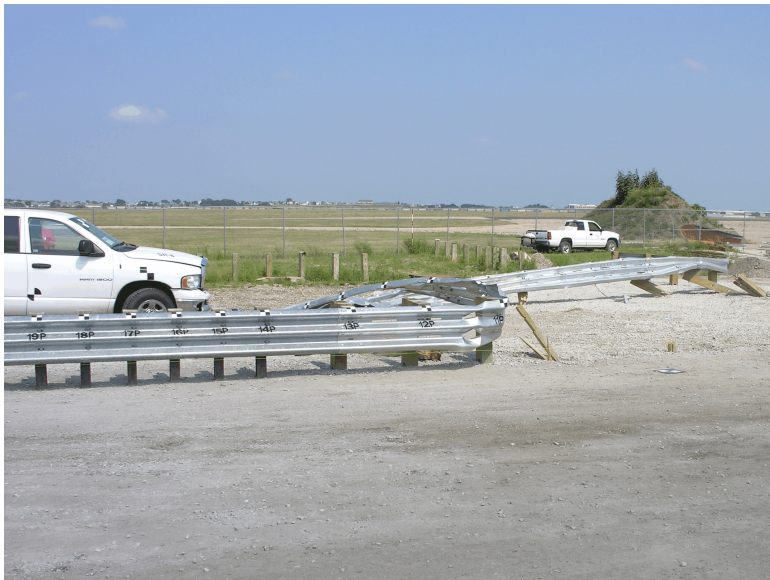
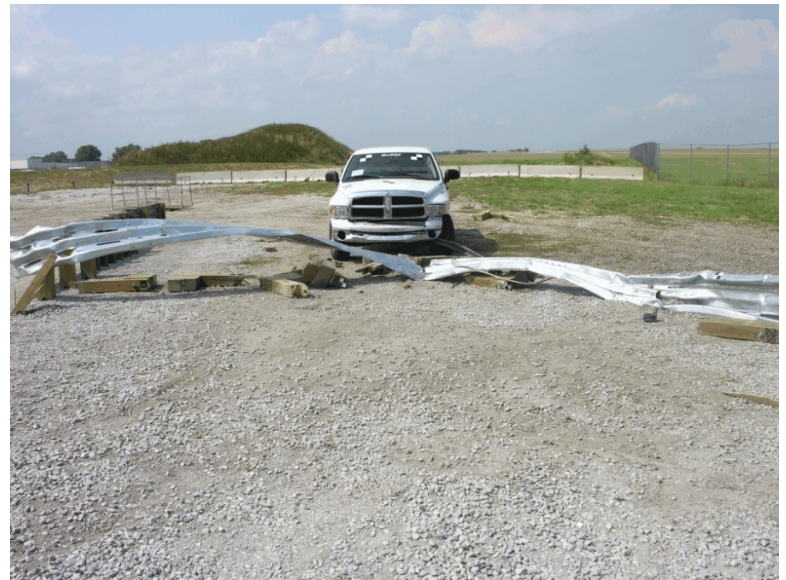
Figure 85. System Damage, Test SR-8

Barrier damage was extensive, as shown in Figures 85 through 93. Damage consisted mostly of flattened, deformed and torn guardrail, fractured posts, blockouts, and bolts, and deformed cable anchor hardware. System damage occurred between post nos. 8S and post no. 11P. The maximum permanent set of the guardrail was 6,518 mm (21 ft - 4.5 in.) from the primary side and 8,448 mm (27 ft - 9 in.) from the secondary side, measured to the center of the nose.

Contact marks were found on the nose section and on the primary side between post nos. 1P and 13P. Buckling was also found in the rail between post nos. 1S and 8S. Three of the bottom corrugation slot tabs were torn in the nose section. A 152-mm (6-in.) long tear occurred 330 mm (13 in.) downstream of impact on the primary side, and another small tear occurred 1,168 mm (46 in.) downstream of impact on the primary side. A 457-mm (18-in.) long tear occurred at the splice at post no. 5 and extended from the top of the thrie beam to the slot in the lower valley. A small tear occurred in the nose section, downstream of post no. 1. A 152-mm (6 in.) tear was also located between post nos. 1S and 2S. The rail slots at post nos. 2P and 4P opened up, and the post bolt washers pulled through. The lower nose cable was detached from the guardrail.

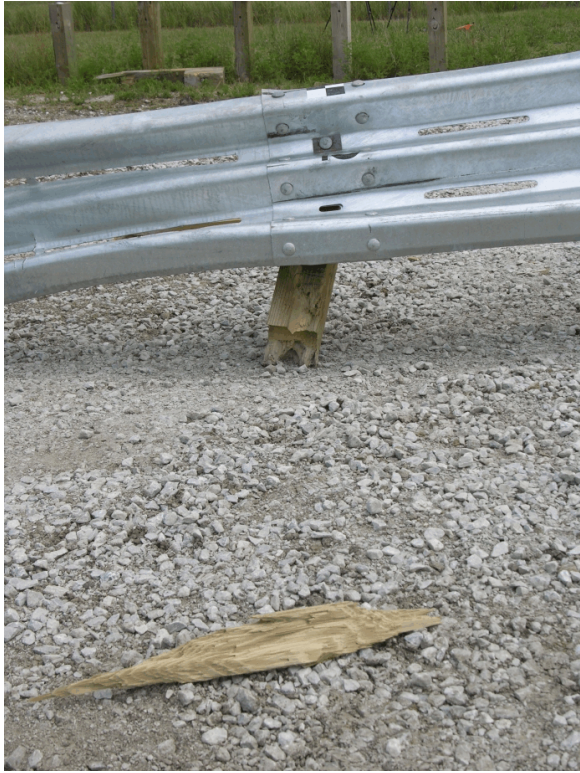
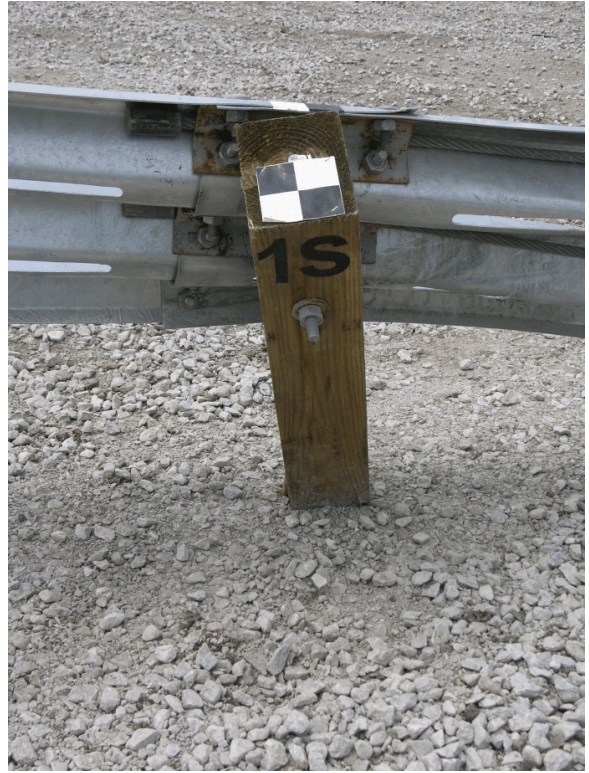
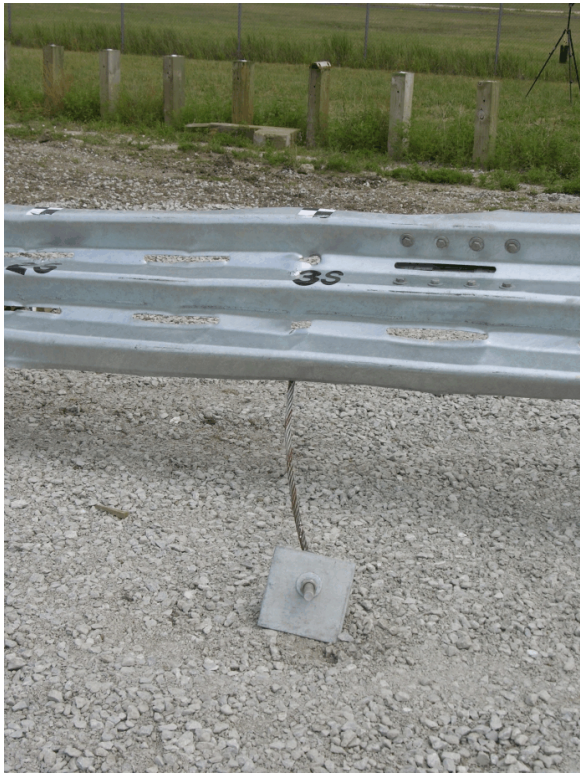
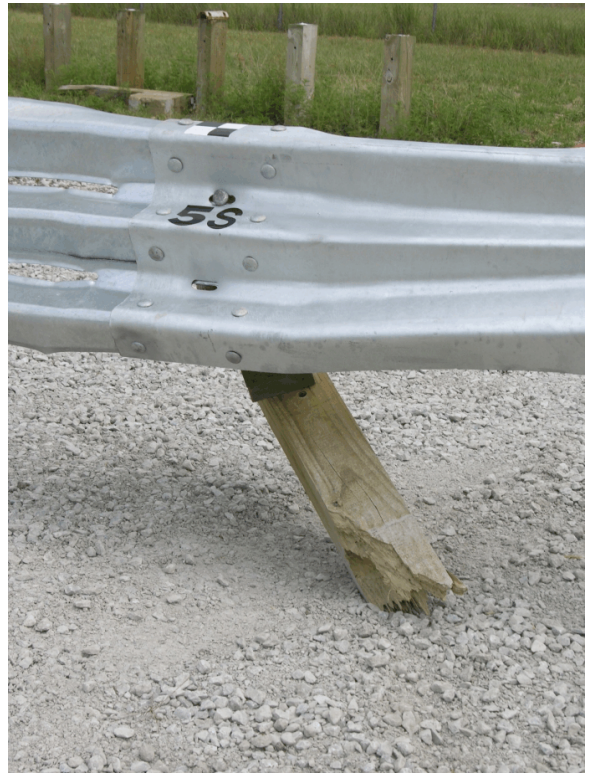
Figure 89. Post Nos. 1S through 5S Damage, Test SR-8

Post nos. 1S and 2S fractured at the foundation tubes. Post nos. 3S through 5S fractured in

the soil. Post nos. 2S through 4S also disengaged from the rest of the system. Post no. 6S split vertically. Post no. 7S was removed from the ground without damaged and remained attached to the system. Post no. 8S rotated backward in the soil. Post nos. 9S and 10S rotated downstream in the soil.

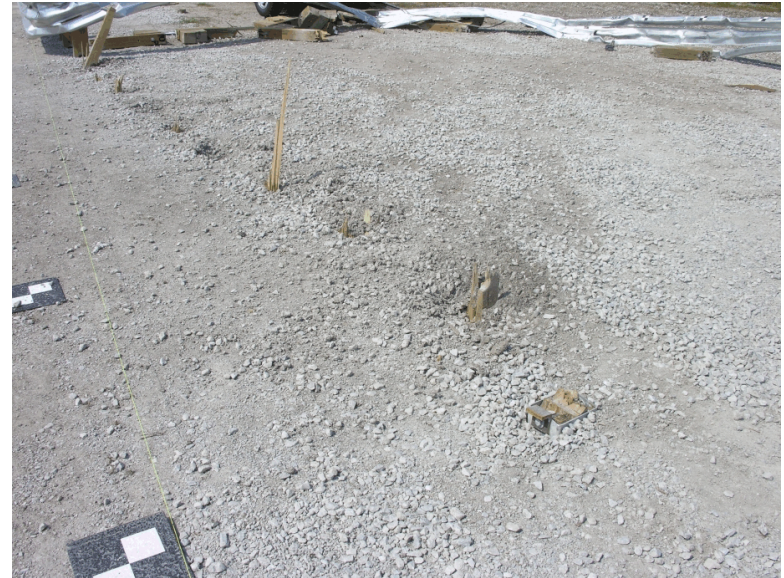
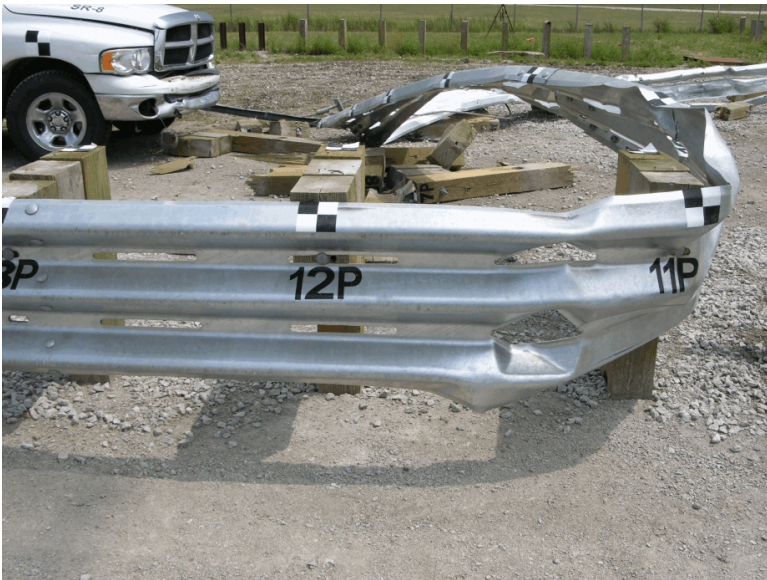
Figure 91. Post Nos. 1P through 12P Damage, Test SR-8

Post nos. 1P through 9P fractured at the ground line. Post nos. 2P through 9 disengaged from the rest of the system. Post no. 10P split vertically through the transverse CRT hole to the top of the post. Post no. 11P rotated backward in the soil. Post no. 12P disengaged from the guardrail but was not damaged.

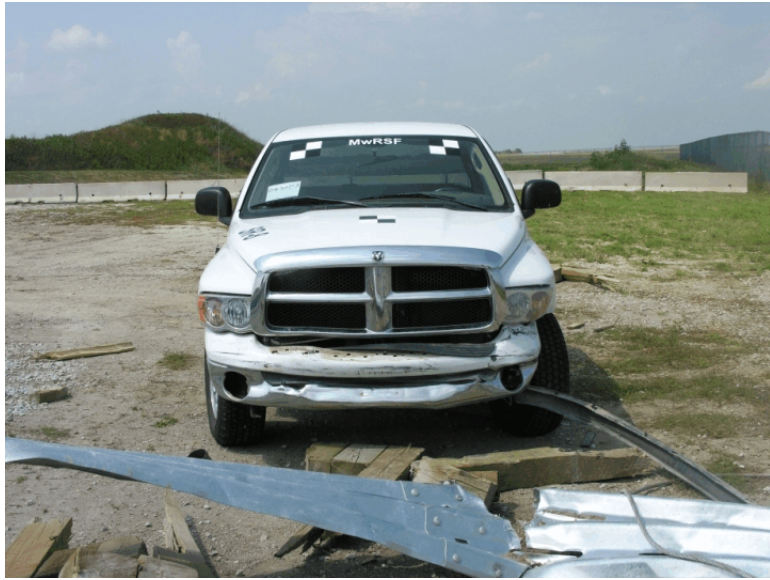
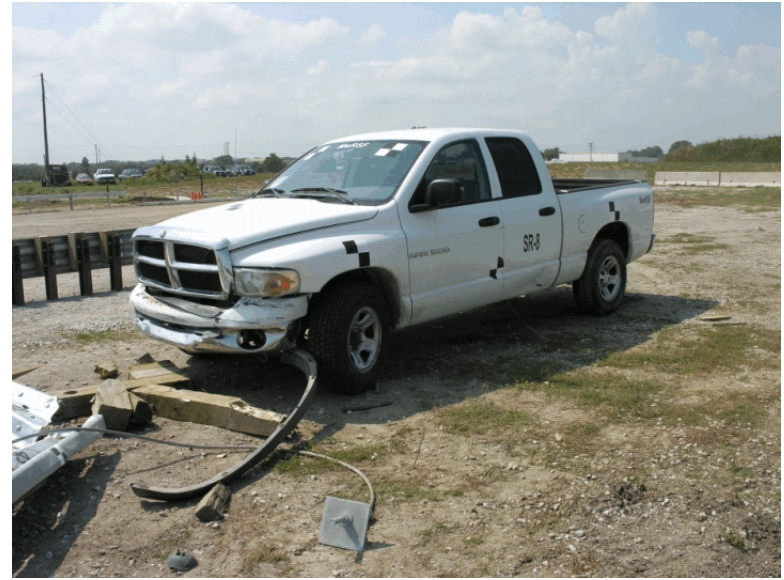
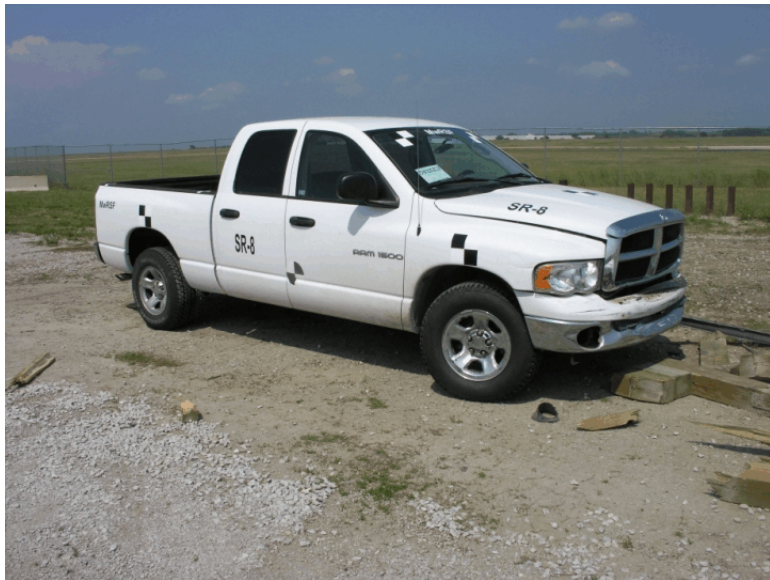
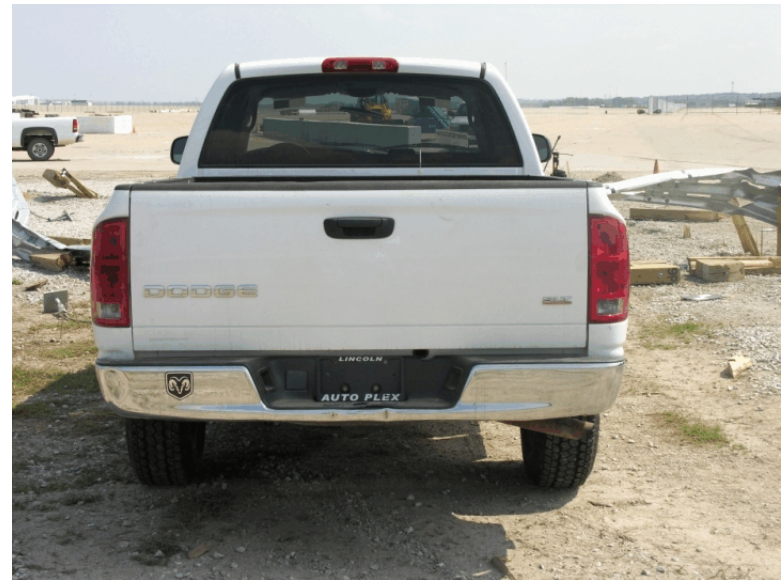
Figure 94. Vehicle Damage, Test SR-8

Exterior vehicle damage was minimal, as shown in Figures 94 through 96. Occupant compartment deformations to the right side and front of the floorboard were deemed insufficient to cause injury to the vehicle occupants. Maximum longitudinal displacements of 6 mm (0.25 in.) occurred throughout the right side of the floorboard. Maximum lateral displacements of 19 mm (0.75 in.) occurred at the left-front corner of the right-side floorboard. Maximum vertical displacements of 6 mm (0.25 in.) were located throughout the right-side floorpan. Complete occupant compartment deformations and the corresponding locations are provided in Appendix G.

Damage was concentrated on the front of the vehicle. The left-front bumper corner of the bumper was shifted and deformed into the frame and encountered tearing. The grill was crushed and deformed into the engine compartment, and the bumper bowed outward in the center. The vehicle's hood deformed upward approximately 25 mm (1 in.) above the grill. Both right-front and left-front foglights were broken. Contact marks, scrapes, scratches, and kinks occurred throughout the length of the bumper. A 102-mm (4 in.) tear occurred at the bottom of the left-front door. Dents were found
