THE APPLICABILITY OF INFRARED THERMOGRAPHY IN
THE DETECTION OF DELAMINATION IN BRIDGE DECKS

Virginia Highway and Transportation Research Council
(A Cooperative Organization Sponsored Jointly by the Virginia
Department of Highways & Transportation and
the University of Virginia)

VHTRC 78-R27

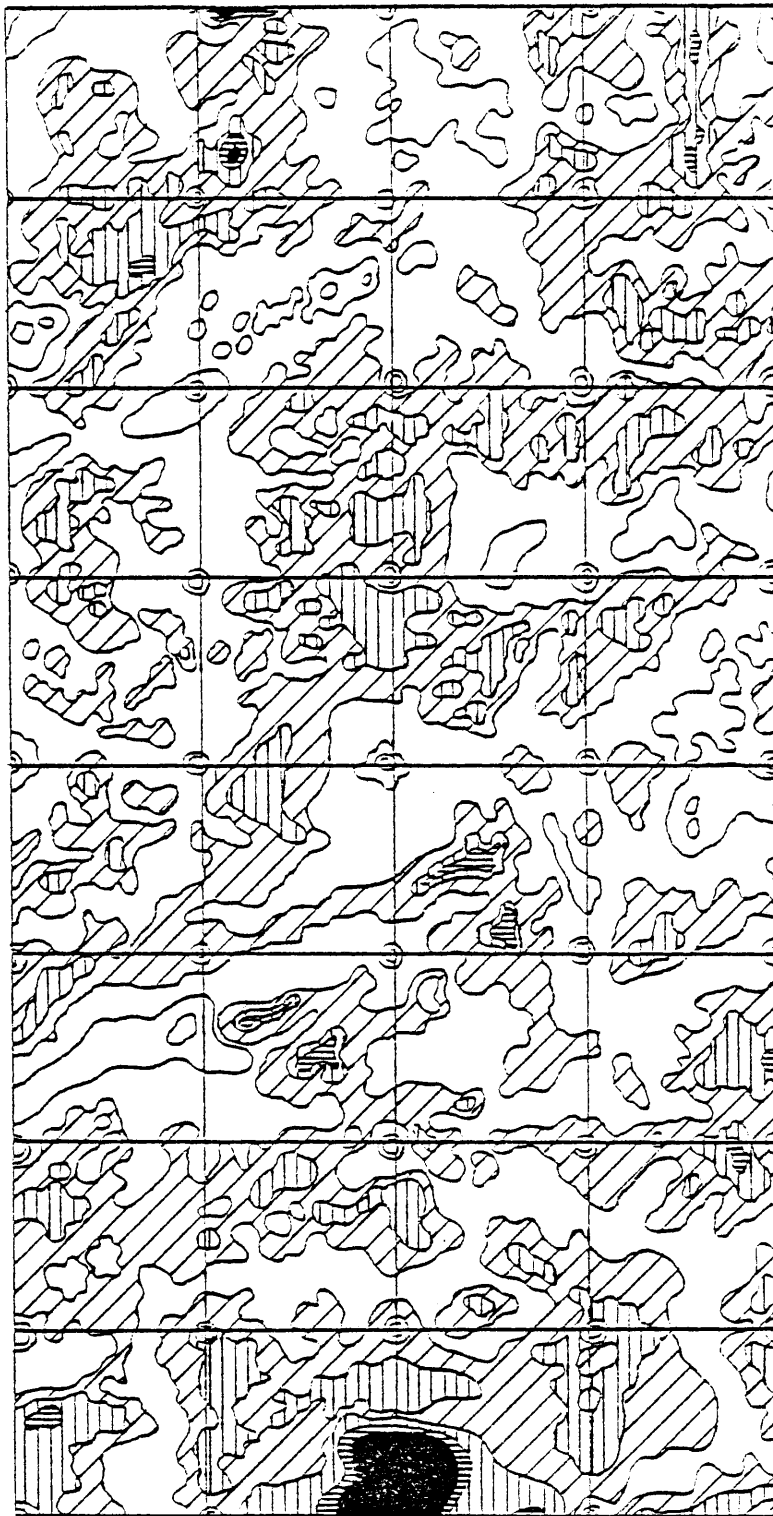
Figure 10. Typical thermogram.

One of the typical thermograms taken in the above described manner is shown in Figure 10. This mosaic thermogram covering a 180 cm x 360 cm (6 ft. x 12 ft.) deck area was made from individual thermograms of 45 cm (1.5 ft.) squares. In terms of pattern, the thermograms are exact duplications of the original photographs of color thermograms. However, because of the high expense of color reproductions, the warmer colors of white, yellow, orange, and red, in order of decreasing temperature, are replaced with shades of correspondingly decreasing intensity, while the relatively cooler colors are left unshaded because of their relative inconsequentiality.

Figure 10 shows that there were few delaminations in the medium stages; namely, the narrow band of intense shade around a spalled area that has been patched with asphaltic concrete (dark area), which overlaps squares 2-8 and 3-8, and the similarly shaded spots in squares 2-6 and 3-5. (The bands of relatively medium to incipient delamination around the patched area indicate that repairing a spalled area by patching probably does slightly more than improve the rideability of the surface.) In addition, the thermogram shows semi-regular patterns, the lightly shaded areas that run approximately 50° with respect to the X-axis of the thermogram. Since this angle is similar to the skew angle of the reinforcing steel and to the direction the two medium delaminations in squares 2-6 and 3-5 run with respect to each other, these lightly shaded areas are most likely incipient delaminations occurring around some of the reinforcing steel. Support for this conclusion is presented in a latter section.

In order to preclude misinterpretations, infrared thermography must be supplemented with visual examinations. This necessity is evident in the following examples: the dark spots in square 2-1 were spots of asphalt on the deck surface, and the narrow, vertical band of mediumly shaded spots in square 4-1 were tire marks left by a vehicle braking to an emergency stop. The spots of asphalt and the tire marks appeared warmer than the concrete because they have a relatively higher infrared emissivity. Incidentally, the irregular circles at the corners of each square in the thermogram are spray-paint markers, which apparently make the spots cooler than the rest of the concrete.

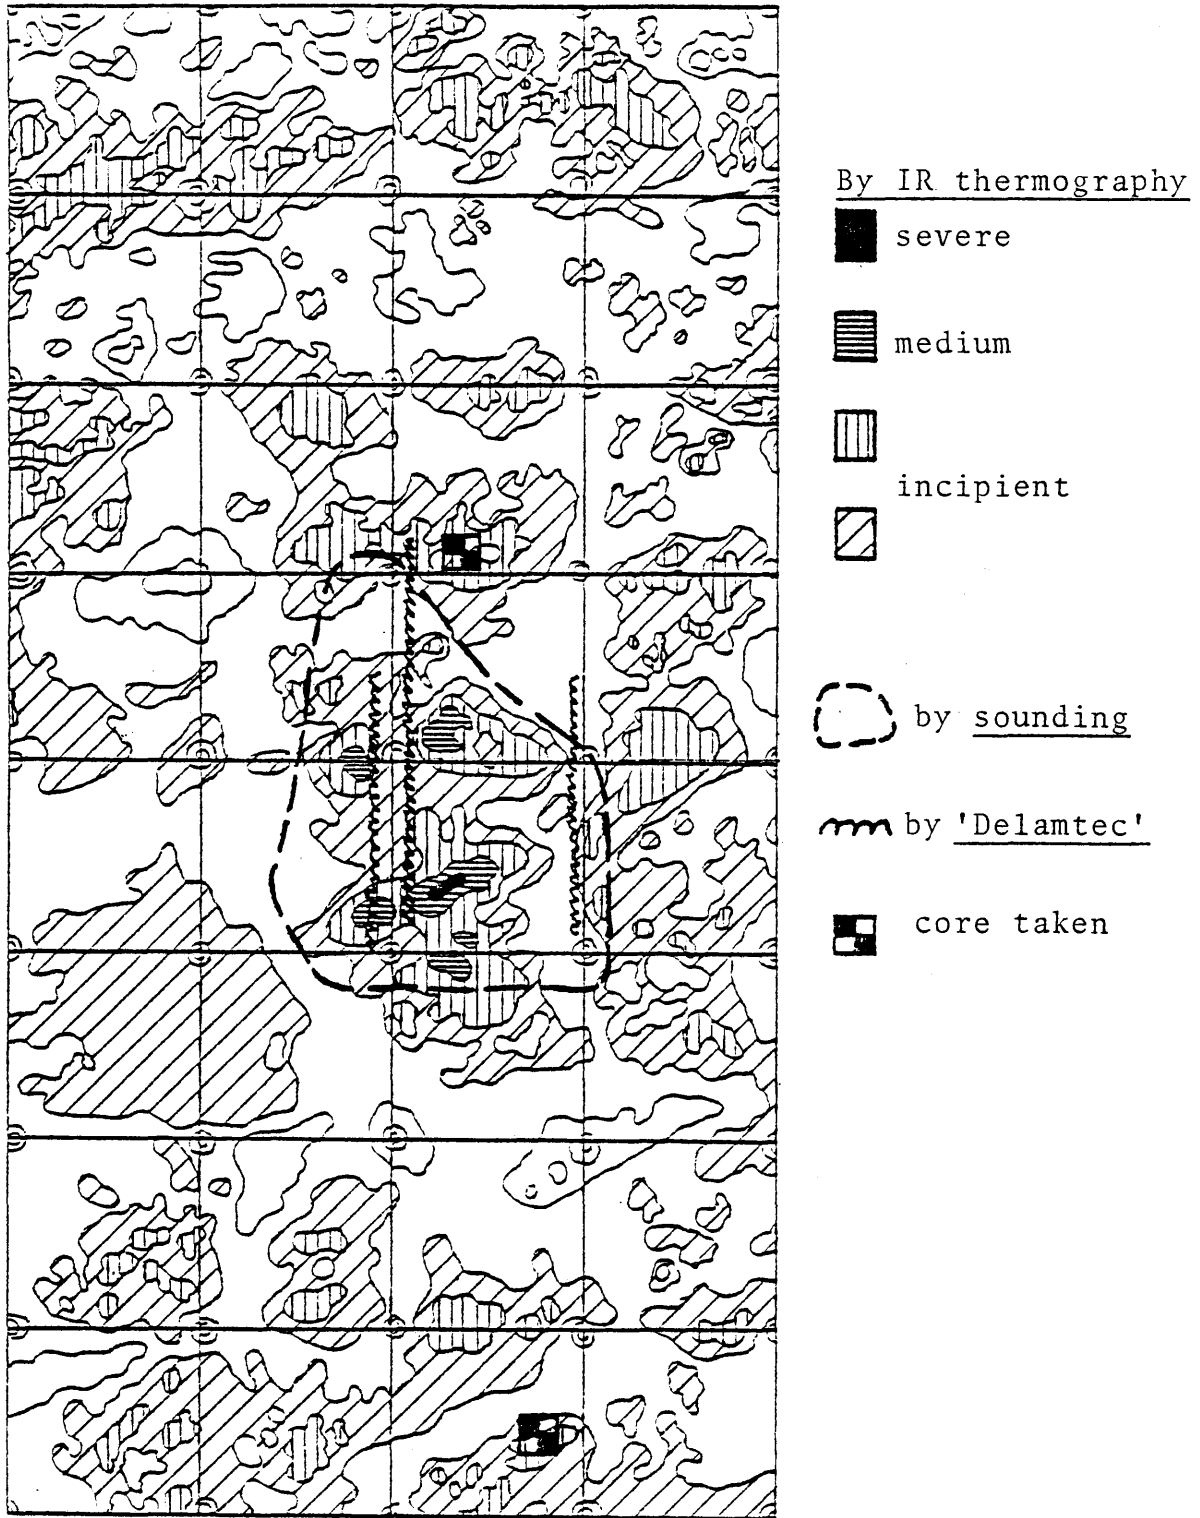
Figure 11. Delamination in test area 4 located by different techniques.

As mentioned earlier, the test areas were also evaluated with the conventional methods of sounding and with the delamination detector for comparison with infrared thermography. Figures 11-17 show the delamination located by the different techniques in some test areas.

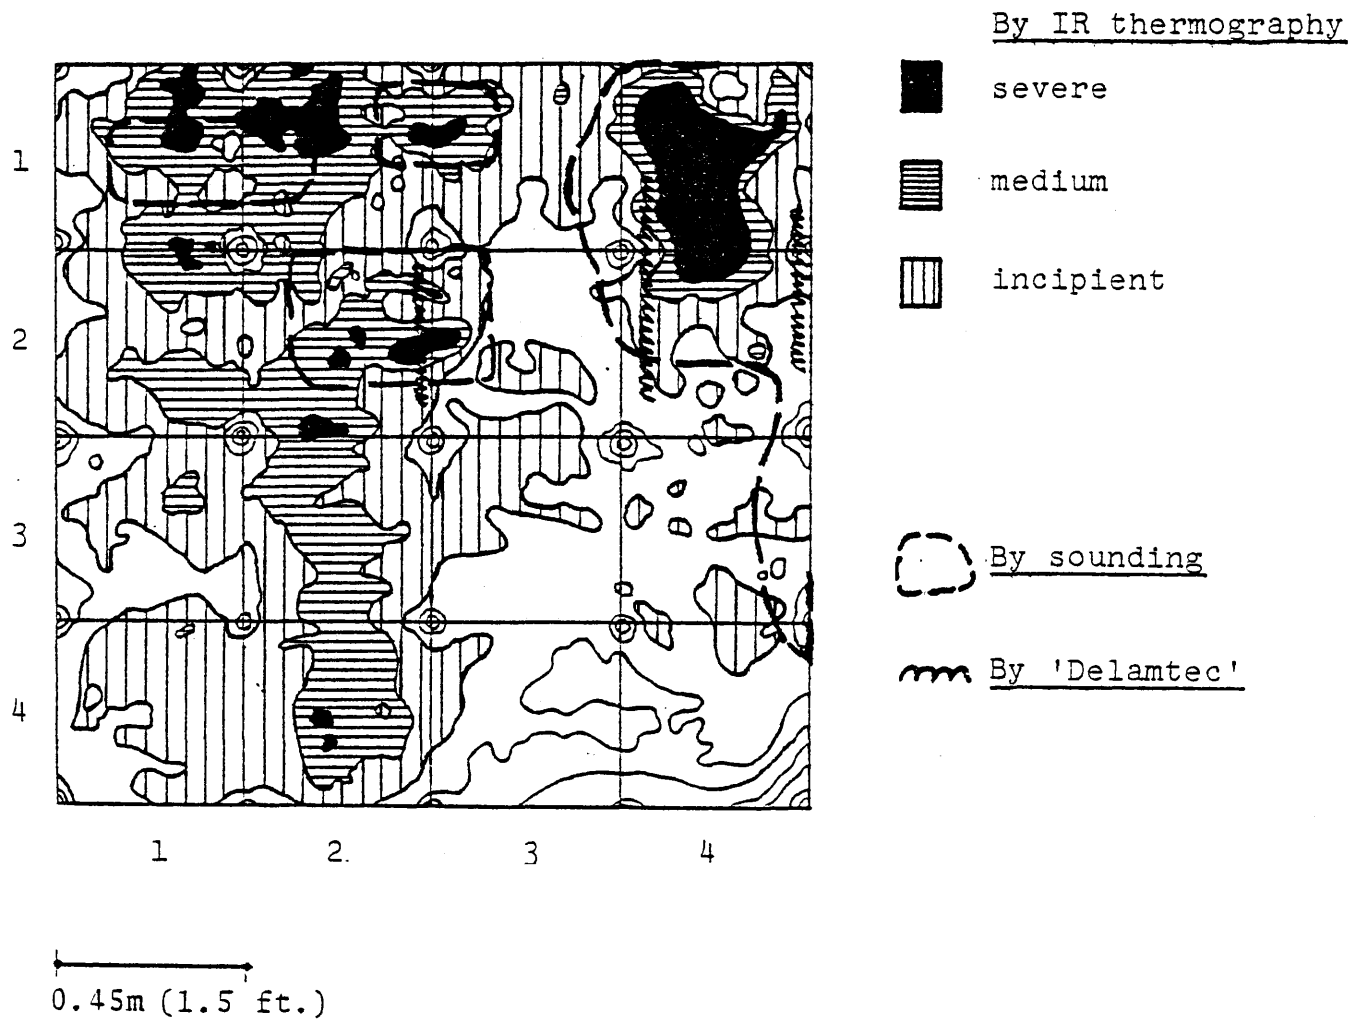
Figure 17. Delamination in test area 7 located by different techniques.

A similar problem occurs with sounding, as shown in Figure 17, where severe delaminations that extended across the top of squares 1-1 and 2-1 were dislocated by sounding. In addition, the medium delamination extending from square 2-2 down to square 2-4 was not located by either sounding or the delamination detector.

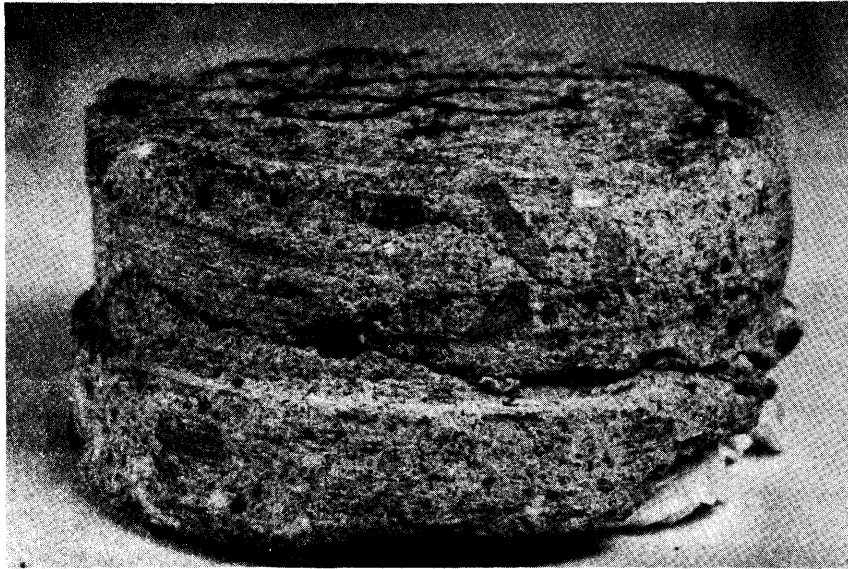
Figure 18. Side view of a core from a severely delaminated spot in square 2-7 of Figure 14.

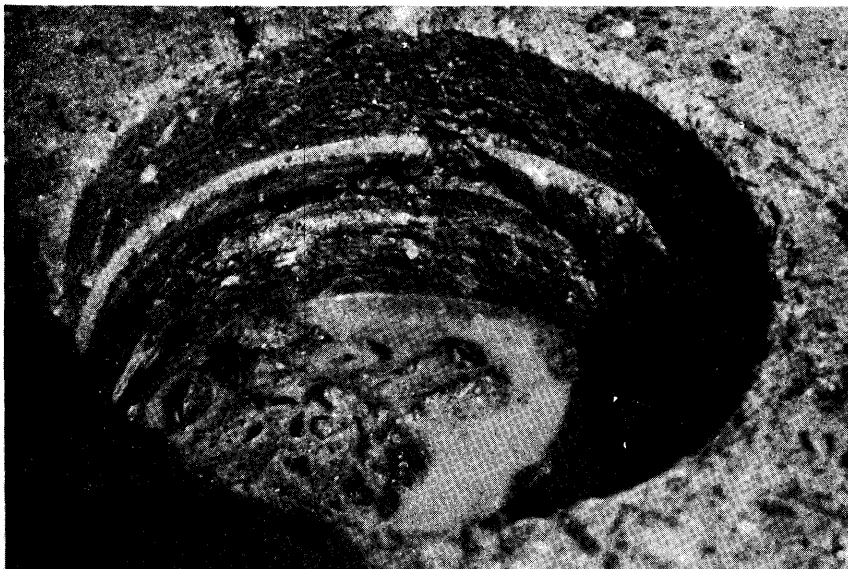
Figure 19. Cross section view of the delaminated spot showing extremely wide separation of concrete layers.

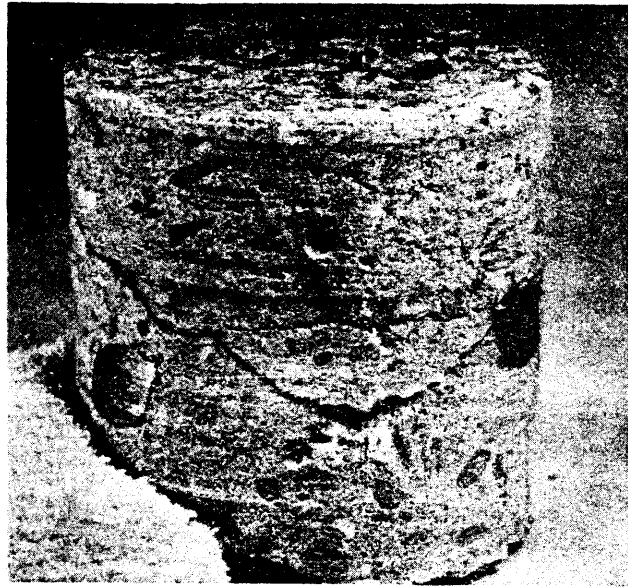
Figure 20. Core taken from a mediumly delaminated spot in square 2-6 of Figure 12. shows no corrosion at one end of the steel

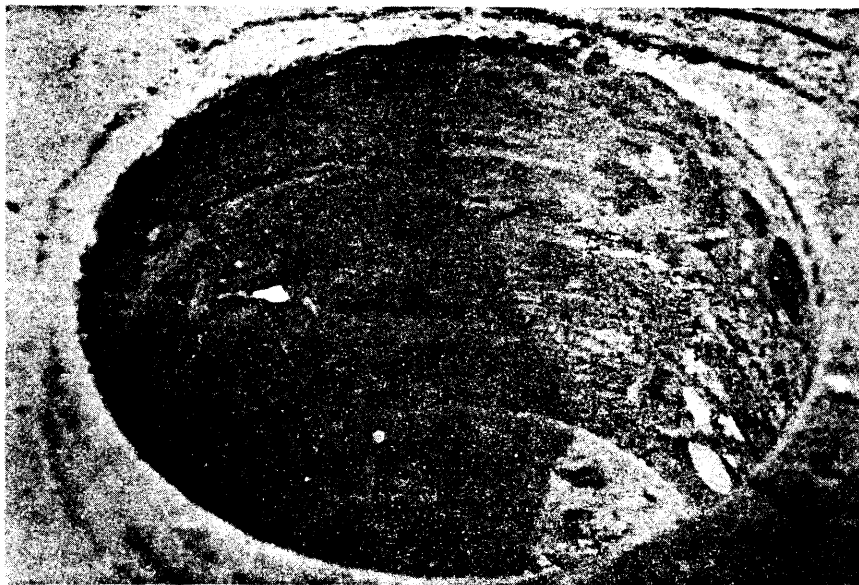
Figure 21. A cross-section view of the delaminated spot. Notice that the separation between concrete layers is narrower than that shown in Figure 19.

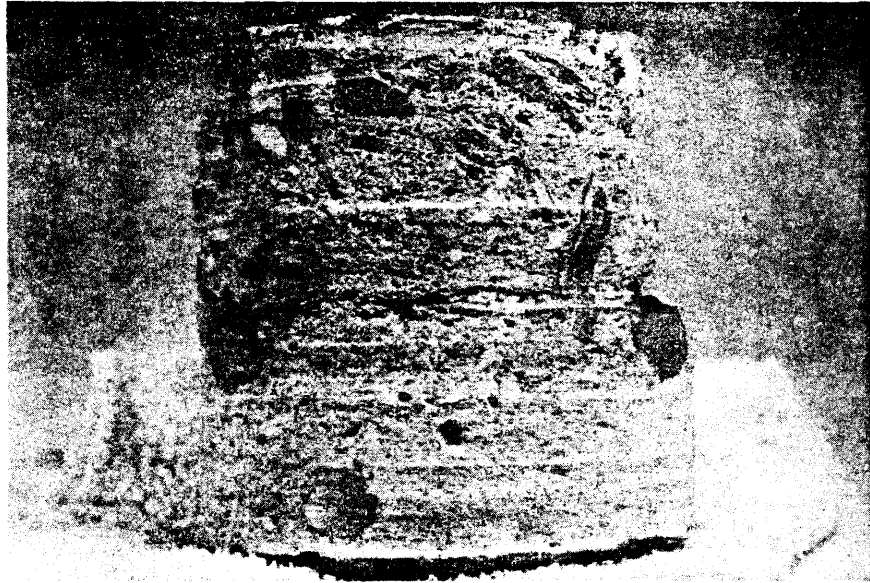
A core taken from an incipiently delaminated spot in square 3-8 of Figure 11 is shown in Figure 22. Notice that the delamination was in its early stage and that the crack had not yet completely extended across the core to separate the concrete into at least two layers, as was the case for the cores from severe and medium delaminations (Figures 18 and 20). A core taken from square 3-3 showed a similar type of delamination. Cores from other incipiently delaminated spots in other test areas have provided similar confirmation of the ability of thermography to detect such spots.

Figure 22. Core from incipiently delaminated spot in square of Figure 11 showing crack extending almost around its circumference.

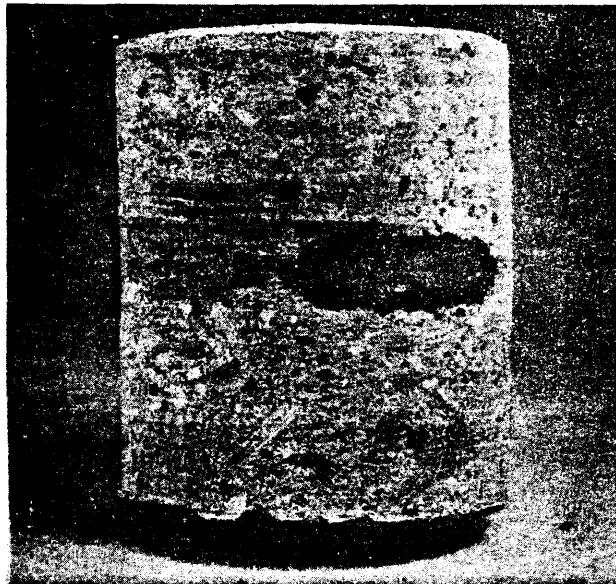
A core taken from square 2-4 of Figure 16, which provides perhaps the best illustration of the very beginning of delamination, is shown in Figure 23. The figure shows that the reinforcing steel had corroded and that a crack had started to propagate from the left end of the steel. An examination of the hole (Figure 24) left on the deck showed that slightly better than tiny cracks had actually started from both ends of the corroded steel.

Figure 23. Core taken from square 2-4 of Figure 16 illustrating the very beginning of a delamination. Tiny crack started to propagate from the left end of the rusted steel.

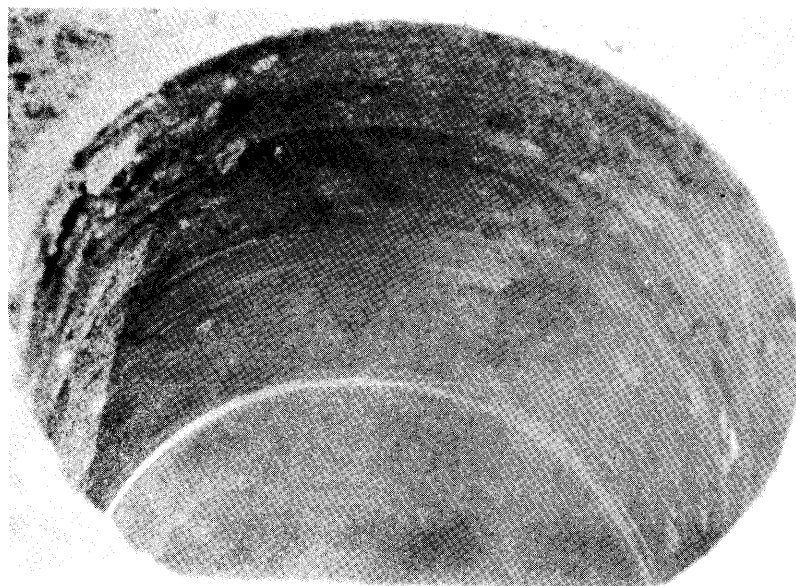
Figure 24. Cross section view of the spot showing tiny cracks originating from the rusted steel.

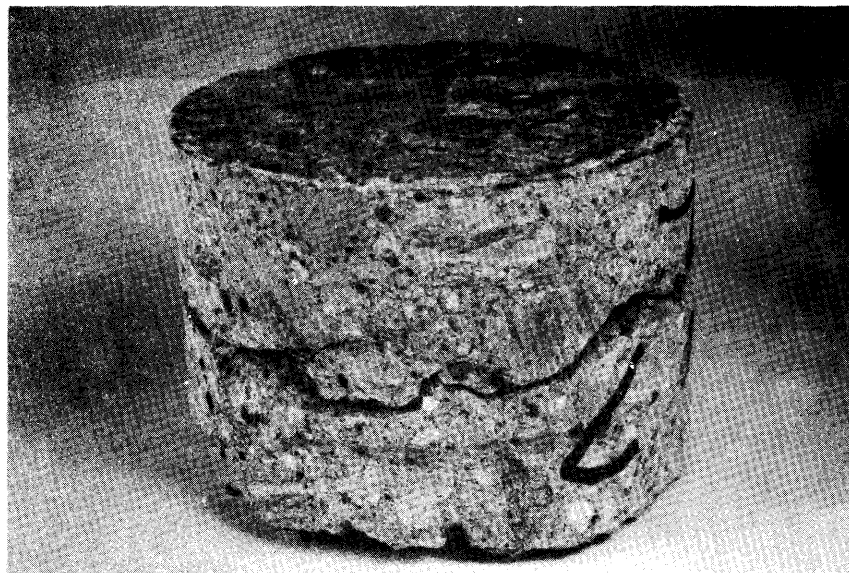
Figure 25. A core from a delaminated spot in square 2-7 in Figure 13.

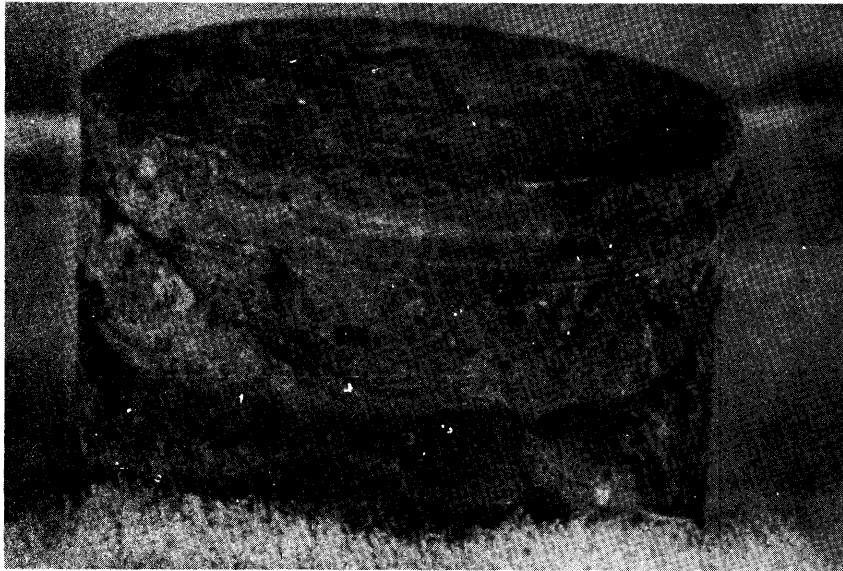
Figure 26. A core from a delaminated spot in square 3-8 in Figure 13.

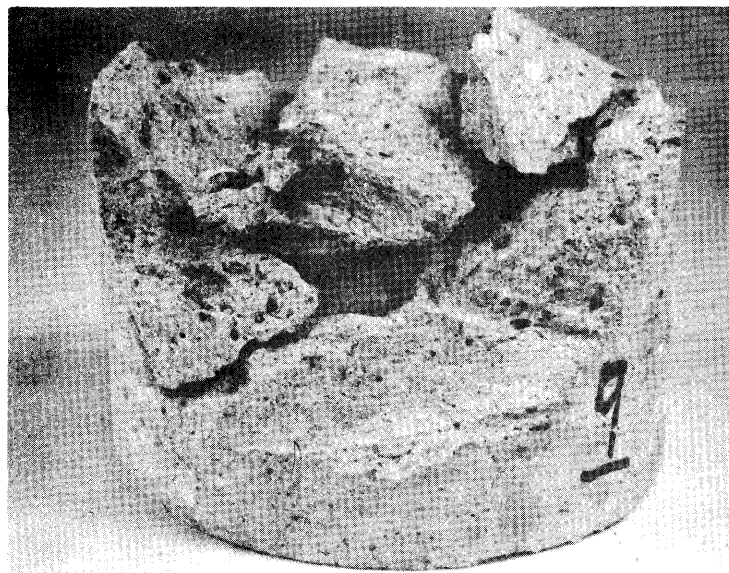
Figure 27. A core from a delaminated spot in square 1-3 in Figure 15.
