Premature Failure of Concrete Patching: Reasons and Resolutions

Final Report VTRC 19-R14

**PREMATURE FAILURE OF CONCRETE PATCHING:
REASONS AND RESOLUTIONS**

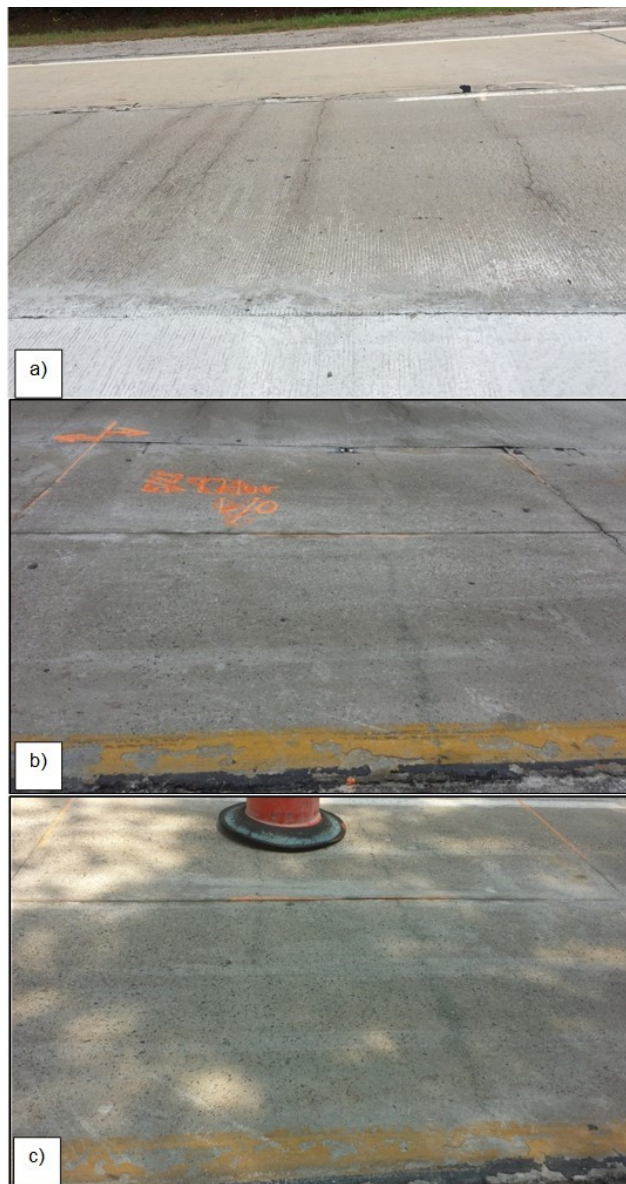
Site visits did not identify this as a cause. Typically, concrete was being replaced that one could argue could be left in place, as shown in Figure 3. The 40-year-old pavement (Figure 3b and 3c) to be removed has fewer and tighter cracks than a recent patch (Figure 3a).

Figure 3. Forty-Year-Old I-85 Pavement That Appears to Be in Good Condition: a) patch a few years old; b) section marked for removal; c) section marked for removal

- *One of the most significant causes of premature failures of patches was the use of high early strength concrete mixtures with high cement contents (as high as 800 lb) that cause excessive shrinkage cracking, as shown in Figures 3a and 10.* The narrow concrete sections between the transverse cracks soon crack in the longitudinal direction, providing weakened concrete sections that are prone to breaking into smaller sections, punchouts, and eventually spalls, typically in 1 to 5 years.

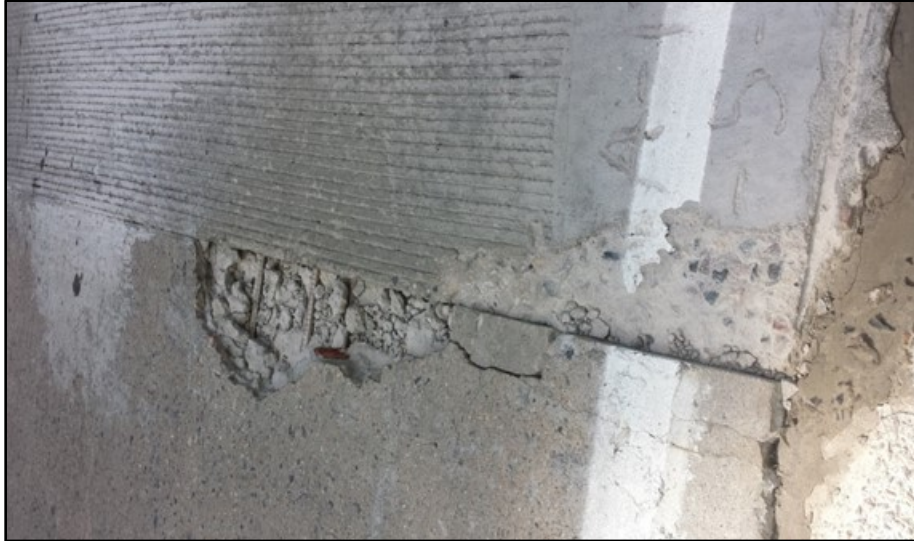
Figure 5. New Patch (*right*) Next to 40-Year-Old Pavement (*left*) on I-85. Pavement deterioration next to the patch suggests damage from concrete removal.

- improper consolidation of concrete at the joint because of congestion of reinforcement because of splicing
- damage because of concrete removal during the installation of the new patch
- base erosion near the joint (as shown in Figure 5)
- poor quality concrete (high cement content) and excessive cracks in old patches.

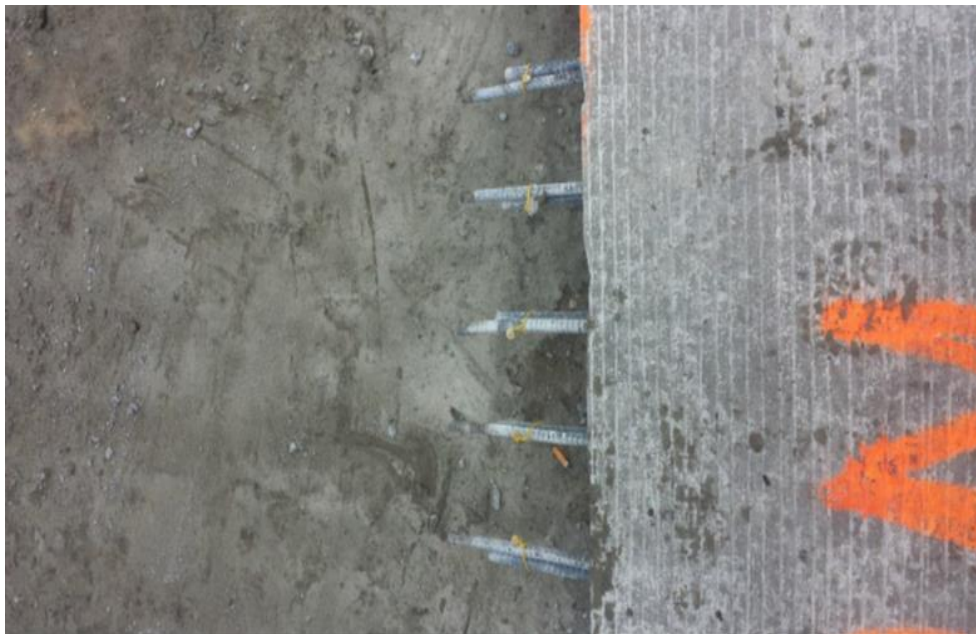
After the reinforcement is cut and the concrete is removed, the new reinforcement in the patch is lapped 18 in with reinforcement in the pavement and a tie wire is commonly used to connect the reinforcement. Figure 6 shows the tie wires that were used to connect the reinforcement in the failed patch that was removed. During field visits, the improper splicing of the reinforcement was not evident. It is important to note that when an 18-in lap is used, the continuity of the bar mostly relies on the development length rather than on a mechanical connection between the bars through tying.

Figure 6. Single Tie Wire for Connecting Reinforcement on I-85. The 5-year-old patch that has been removed (*left*) is being replaced.

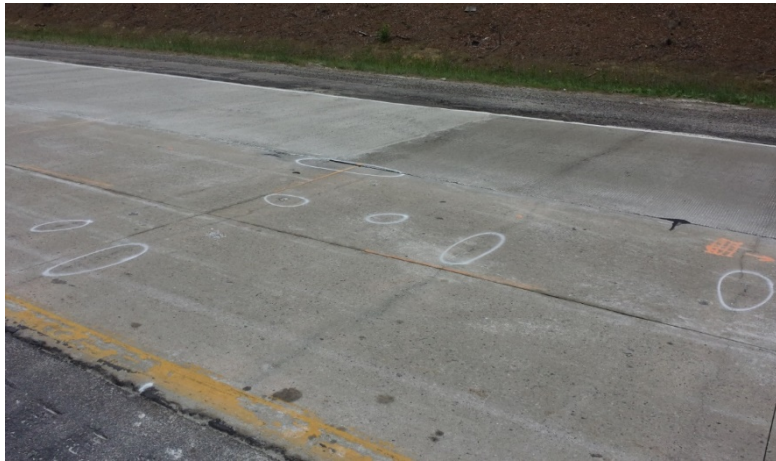
Figure 11 shows a section of I-85 marked for Type IV patching. The white circles indicate spalls along cracks that were used to justify patching the area. The pavement was in good condition. Placing an overlay would preserve the good condition. Type IV patching with high early strength concrete with many cracks, as shown in Figure 10, would not last as long as the pavement shown in Figure 11, which has fewer cracks. Unless there is a local unique problem with the concrete in the area when the pavement needs to be patched, the pavement should be overlaid to provide a long life.

Figure 11. Section of I-85 Marked for Type IV Patching. White circles indicate spalls along cracks that justify patching the area.

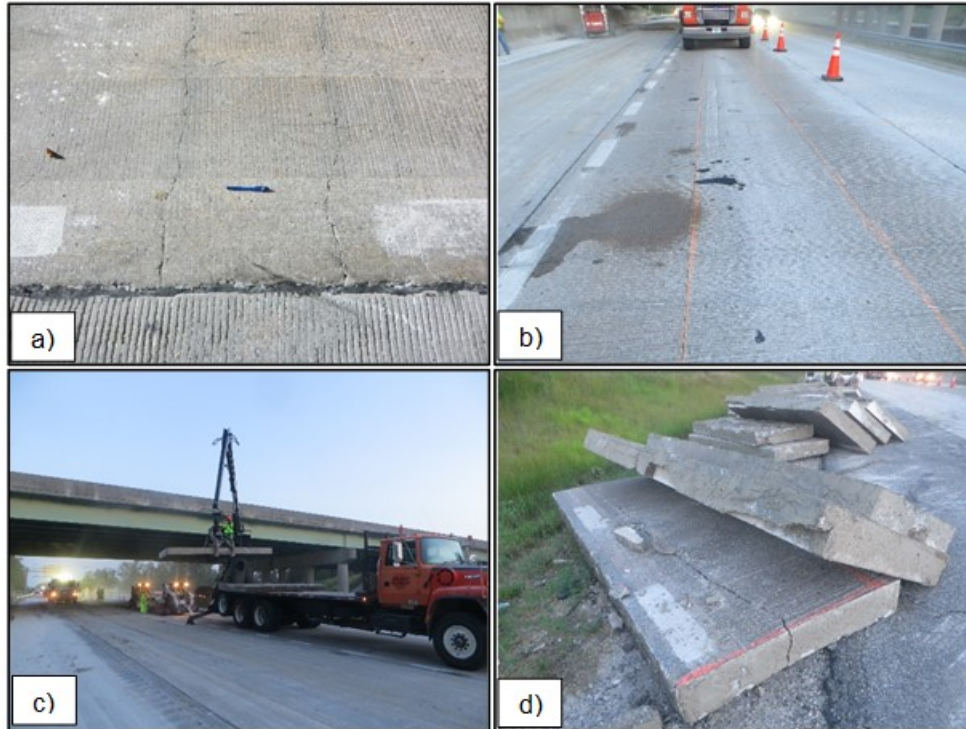
CRCP patching was performed on SR 288. Selection of the areas to be patched was based on visual observation. Conditions that influenced the decision to patch included existing temporary patches, spalls, and cracks, especially where the transverse and longitudinal cracks intersected, as shown in Figure 12a and 12b. Removal of old concrete to prepare for patching is shown in Figure 12c.

Figure 12. Patching on SR 288: a) area to be patched with closely spaced cracks; b) area selected for patching; c) old concrete slabs being removed; d) removed concrete slabs

The depth of the removed slabs was mostly 8 in, with some locations as deep as 9 in, as shown in Figure 12d; patches were cast to match the depth of the removed slabs. The observations were mainly focused on the strength development of patching mixtures with time as they are opened to traffic.

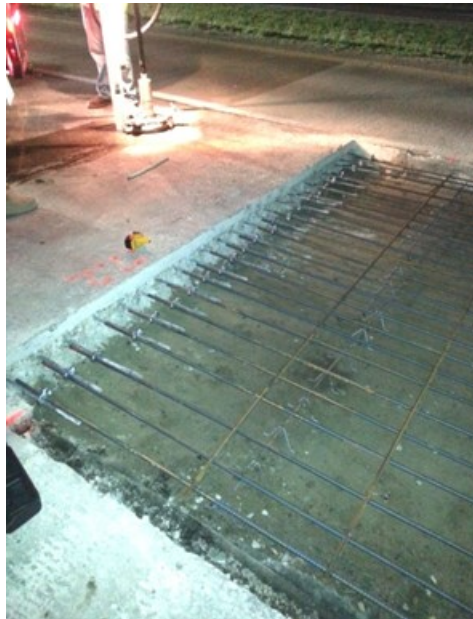
In the existing pavement, the reinforcement was placed through tubes that did not keep the steel at the desired depth in all cases. When the existing reinforcement was closer to the concrete surface, it was vulnerable to corrosion. In the patch area, continuous chairs were used to keep the reinforcement at the desired depth, as shown in Figure 24. Obviously, at the joints, the new reinforcement was at the same elevation as the existing reinforcement.

Figure 24. Additional Supports Keeping Steel at Constant Depth on SR 288
