Field Analysis of Wood Guardrail Post Decay

WA-RD 890.1

December 2018

WSDOT Research Report

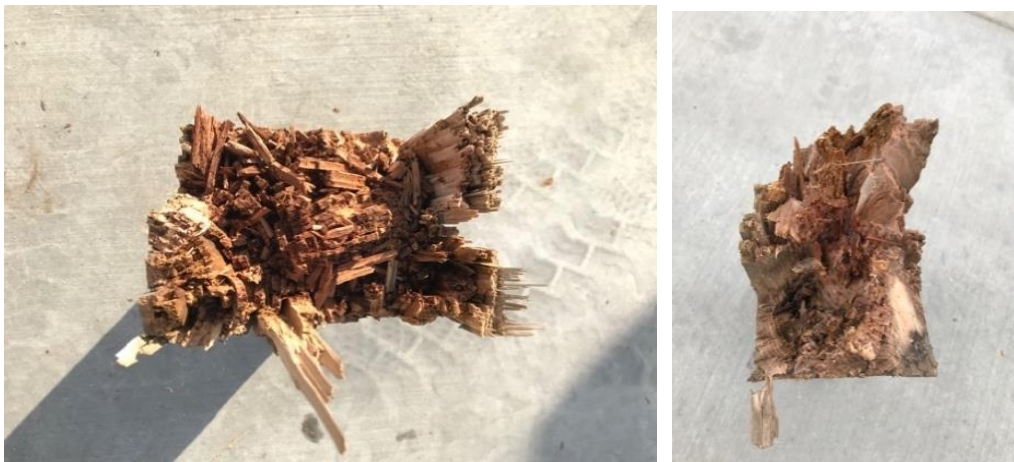
Figure 16. Photographs of broken posts from testing.

Figure 16 shows photographs of two fractured posts (Post 282 and Post 83) and their respective fracture energy, calculated using the difference in kinetic energy method. The interior of Post 282 was very soft and the wood crumbled with little effort, though the outside shell was relatively sound. Post 282 had a brash type of failure where the pendulum was able to break off the post with relative ease. Post 83 had no noticeable

internal decay and the wood fibers can be seen to have participated more in the shearing failure of the post.

(a) Post 282 ($FE_k = 1.06$ k-ft)

(b) Post 83 ($FE_k = 2.84$ k-ft)
