ASSESSMENT OF THE 40" WIDE PAVING SKID BOX FOR PREVENTATIVE MAINTENANCE

Ian Anderson, Research Engineer
Vermont Agency of Transportation
Research Section

December 2018

Final Report 2018-06

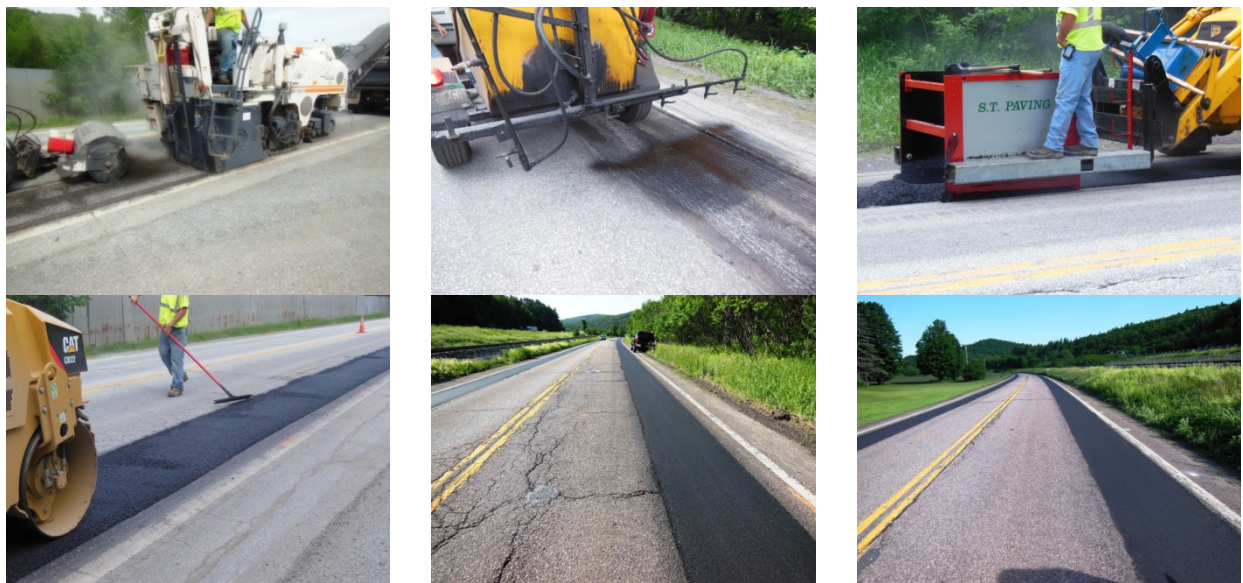
Figure 1: Construction

The pavement used in this study was Type IV 50 Blow Marshall Bituminous Concrete Pavement. The binder used was PG 52-34. Construction can be seen in Figure 1. The pavement was applied through a five-step process. The first; cold planning at variable depths at a width of 40”, second; sweeping before the application of the emulsion tack coat. The third step; applying the emulsion tack coat, which was a rapid setting (RS-1(h)). The fourth step; paving at variable depths using the 40” skid box. Lastly, the pavement was then rolled for compaction.

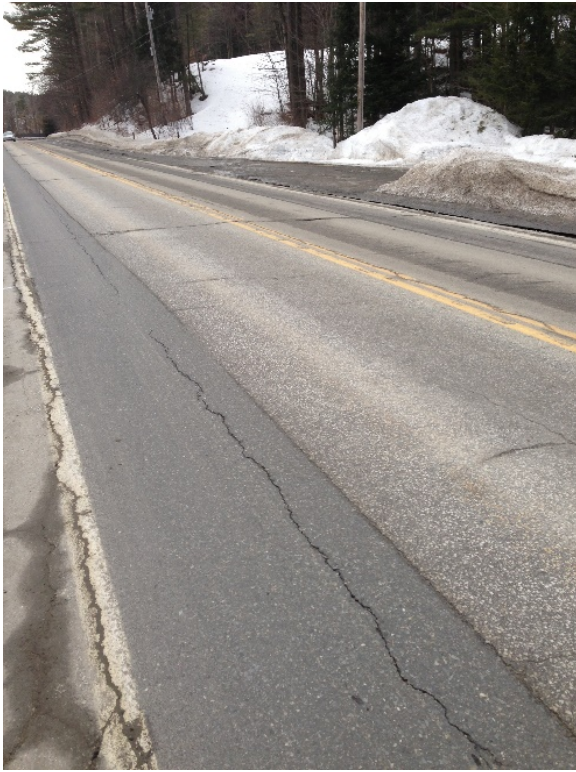
Test Site 1

The site was visited in March 2013 and July 2013 to evaluate the repair and measure rutting in each test site. Photographs and general observations were made at each visit. Figure 2 shows each test site during the April 2014 visit. Because the only sections milled and paved were around the right wheel paths for both lanes the only way to measure the effectiveness of the 40" pave box is by comparing the milled sections pre and post construction. Figure 3 shows the rutting values for the for the eastbound right wheel path over the test period. Of note, the high value on 5/21/12 shows the depth of milling, prior to repaving. As the data suggest, the repaved section is performing well and maintained rutting values less than the preconstruction over the test period. The westbound lane also has similar results for overall rutting, as shown in figure 4, with the milled depth being registered on 5/21/12. Paving for both directions was completed on 6/1/2012. The cracking summary for the two surveys is shown below in Figure 5, with 2012 representing preconstruction and 2013 showing results of one year of use. The percent reductions of all cracks are shown in Table 4. Test site 2 showed an increase in fatigue cracking post construction, likely related to the westbound lane fill being underflush with adjacent pavement and the eastbound lane fill being overflush with adjacent pavement.
