ASSESSMENT OF SUPER-SLAB, A PRECAST CONCRETE BRIDGE APPROACH SLAB

Ian Anderson, Research Engineer
Vermont Agency of Transportation
Research Section

December 2018

Final Report 2018-07

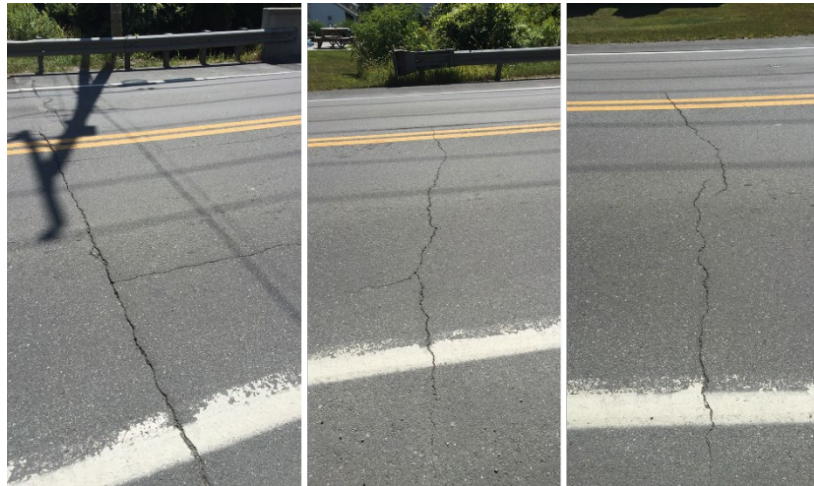
A site visit to Bridge 8 and 9 in Chester, August 30 of 2017, was conducted to close the project. Observations and photos on the performance and appearance of the Super-Slab System after installation were collected. Figure 4 shows the bridge joints of Bridge 8. Figures 5 and 6 shows cracking in the Bridge 8 approach slabs. The eastern approach of Bridge 8 showed a transverse crack approximately 19ft from the east end bridge joint, a second transverse crack approximately 39ft from the east end bridge joint, and a third transverse crack approximately 59ft from the east end bridge joint (figure 5). Two longitudinal wheelpath cracks (one for each wheelpath) were observed emanating from the 1st transverse crack on the westbound lane (figure 5). A longitudinal crack was also noted emanating from the first transverse crack on the left wheelpath within the eastbound lane. No wheelpath cracking was noted on the eastbound lane near the second and third transverse cracks, but a small 2-foot wheelpath crack was found on the westbound side near the third transverse crack.

Figure 5: Cracking at eastern approach of Bridge 8

The performance of the Super-Slab System is supported by the visual inspection and photographic evidence gathered during the recent site visits. This study has surpassed its initial (no less than 3 years) study duration detailed in the approved FHWA Work Plan. The field visit documentation shows longitudinal and transverse overlay cracking on the approaches of both Bridge 8 and 9 on VT 103 in the town of Chester. It is difficult to determine from just the visual inspections if the observed approach cracking was only and directly caused by the Super-Slab System, but the location of the transverse cracks at approximately 20ft intervals (slabs were 20ft in length) suggests that they are most likely reflective or thermal cracks caused by the movement of the Super-Slab beneath the surface overlay.

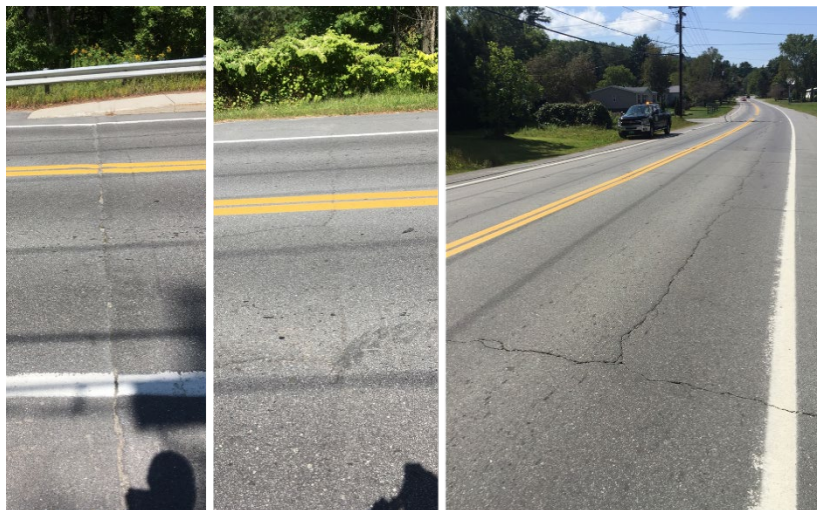
The western end approach to Bridge 8 showed a transverse crack approximately 20ft from the west end bridge joint, a second transverse crack (Eastbound side) and third transverse crack (Westbound side) both approximately 55-feet from the west end bridge joint (figure 6). On the eastbound side a 20-foot longitudinal crack between the wheelpaths was noted connecting the west bridge joint with the first transverse crack along with small wheelpath cracking (figure 6). Two wheelpath cracks that extended 8ft on the eastbound side (one on each wheelpath) near the second transverse crack were also observed and can slightly be seen in the middle photo (figure 6). An extensive wheelpath crack was also noted on the westbound lane near the second transverse crack (figure 6).

Figure 6: Cracking at western approach of Bridge 8

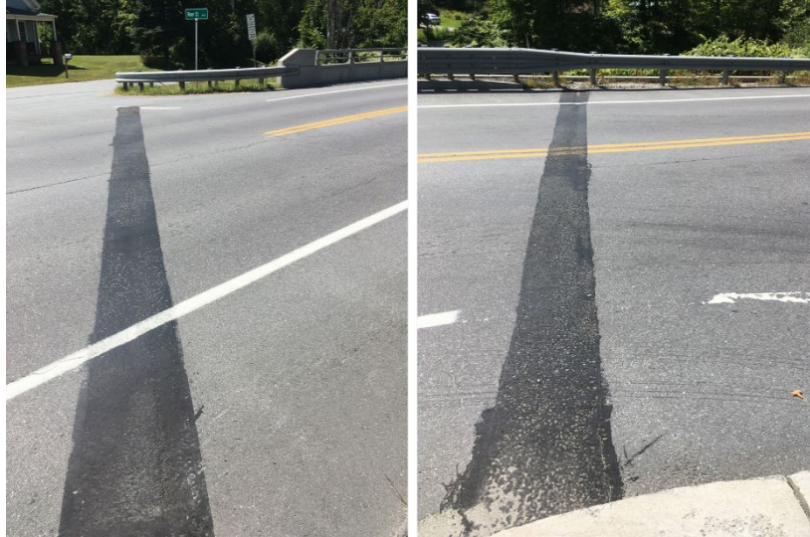
Figure 7: Joints at Bridge 9, appearing to be in good condition

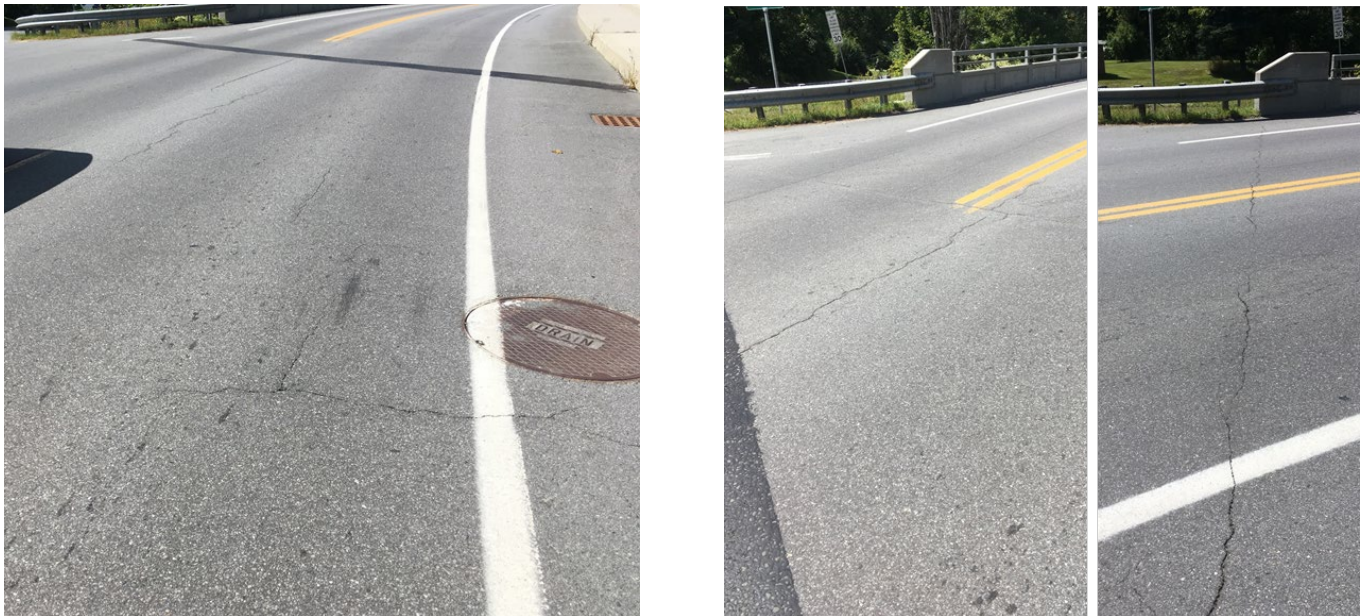
Bridge 9 bridge joints can be seen in Figure 7, and the cracking can be seen in Figures 8 and 9. The eastern approach of Bridge 9 shows both longitudinal and transverse cracking (figure 8) within the westbound wheelpath. There is a 26-foot centerline longitudinal crack emanating from the east end bridge joint, and a transverse crack across the width of the bridge approximately 19 feet west of the east end bridge joint (figure 8). A few wheelpath cracks were also observed on the westbound lane. Two of them were four to five feet in length and one was 18 feet in length. A 14-foot eastbound wheelpath crack emanating from the east end bridge joint was also noted. No other cracking was observed or noted on the bridge deck.

Figure 8: Cracking at eastern approach of Bridge 9

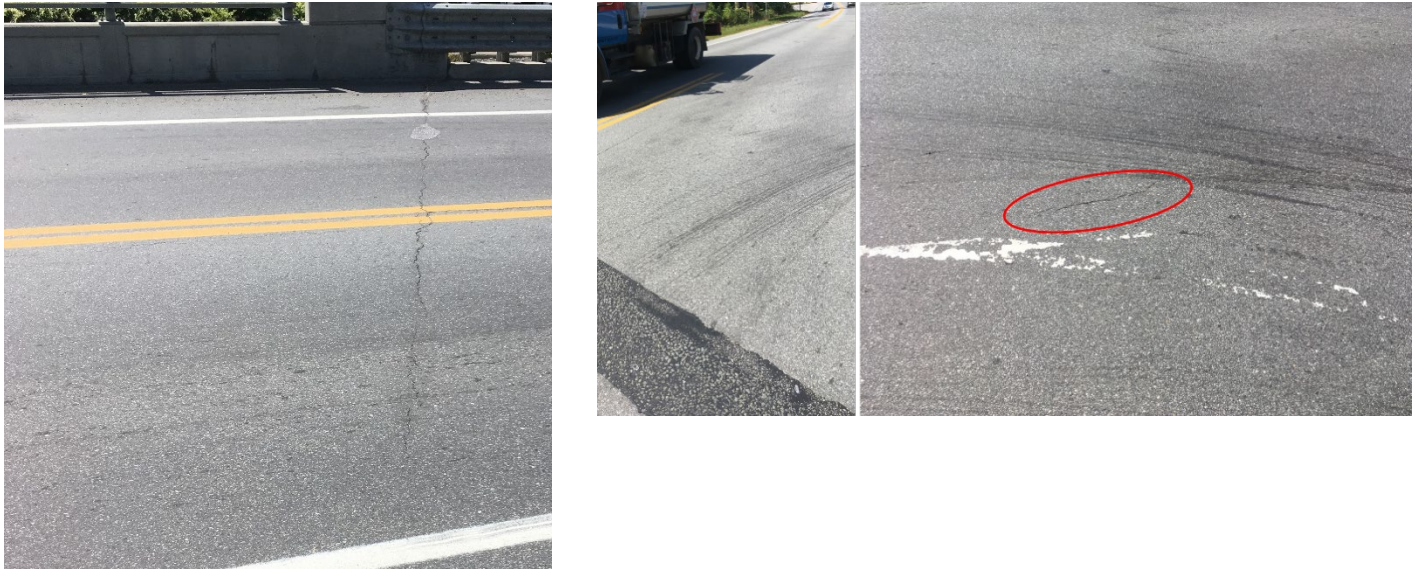
Transverse cracking across the width of Bridge 9 western approach was seen 18 feet east of the west end bridge joint. Wheelpath cracking, approximately 18 to 24 feet in length was observed extending from the western bridge joint on the westbound lane (figure 9). Smaller right wheelpath cracking was also noted on the westbound lane turning onto Pleasant Street (figure 9). No wheelpath cracks were found on the eastbound lane.

Figure 9: Cracking at the western approach of Bridge 9
