# ASSESSMENT OF POLY-CARB FLEXOGRID BRIDGE DECK OVERLAY SYSTEM

Ian Anderson, Research Engineer  
Vermont Agency of Transportation  
Research Section

Experimental Feature  
Reporting on Work Plan 2012-R-02

Final Report 2019-09

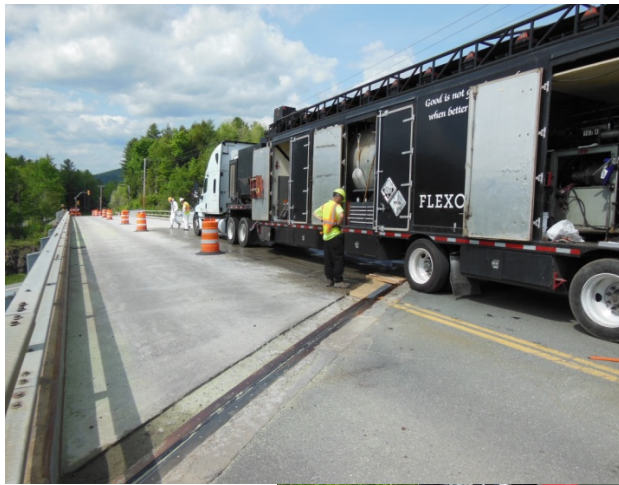
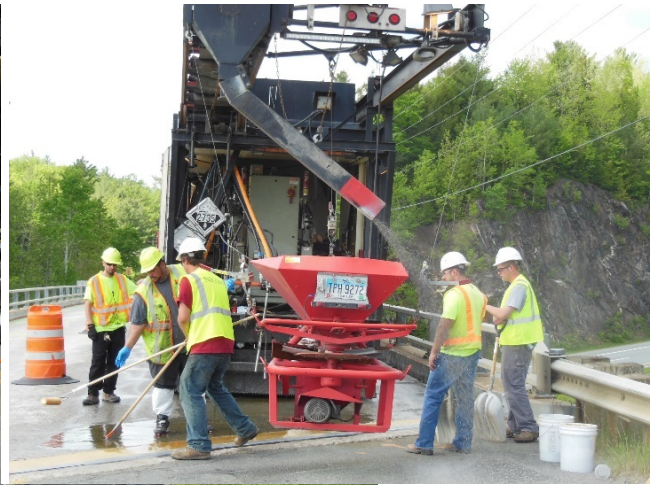
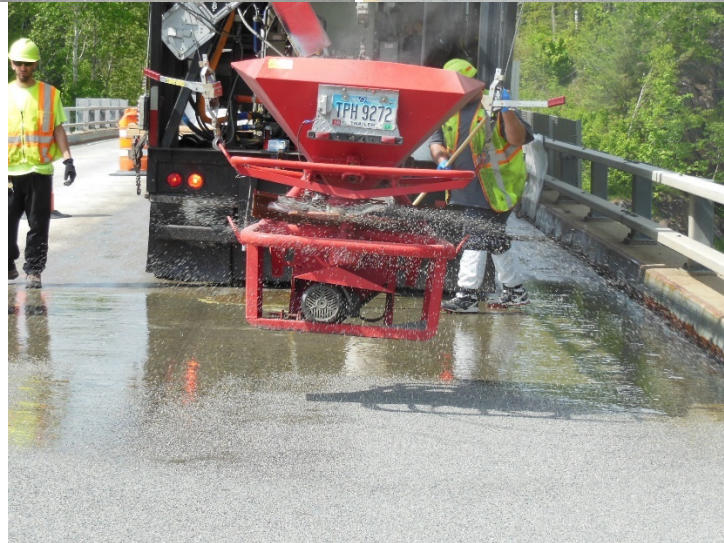
Figure 3: Flexogrid being Applied to the Deck

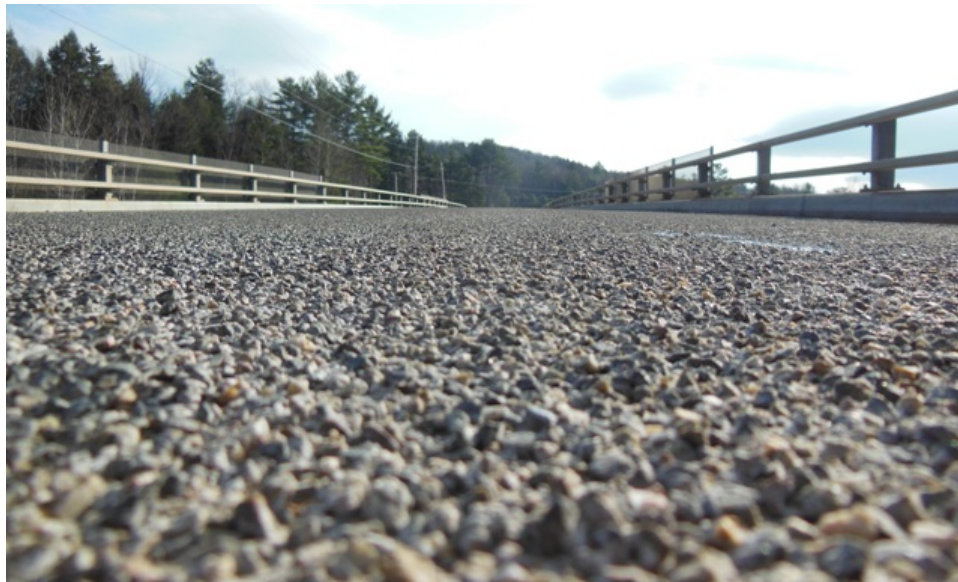
To apply Flexogrid, the hybridized copolymer must be mixed on site for three to four minutes. Once mixed, it is squeegeed onto the surface until it covers 35 square feet per gallon. After the Flexogrid is applied, aggregate is broadcasted onto the surface at a rate of 15 pounds per square yard. After the aggregate has been applied and has been given time to set, any excess aggregate is removed. Next, a second coat of Flexogrid is applied at a rate of 15-20 square feet per gallon and an aggregate distribution rate of 15 pounds per square yard. A close up of the material, showing its coarse texture can be seen in Figure 4.

Figure 4: Surface texture of the Flexogrid

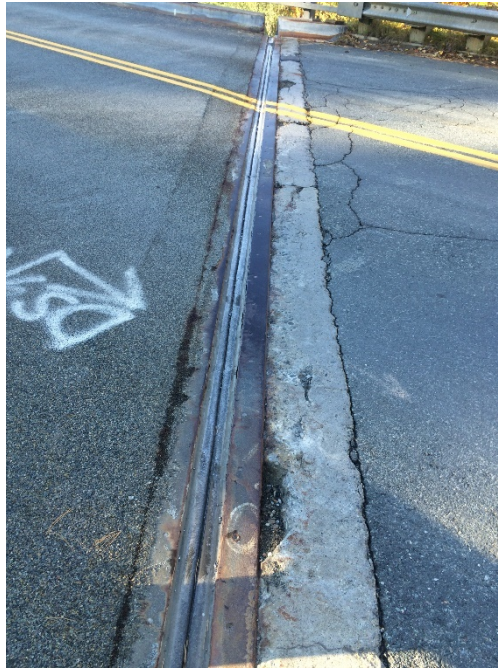
During the third site visit on October 15<sup>th</sup> 2015, no new surface deterioration was noticed on the bridge deck surface. The only evidence of damage was some evidence of cracking around the bridge joints which can be seen in Figure 5. While the source of this cracking is unknown, it is believed to be caused by damage to the concrete bridge joint underneath the Flexogrid system.

Figure 5: Cracking around bridge joints

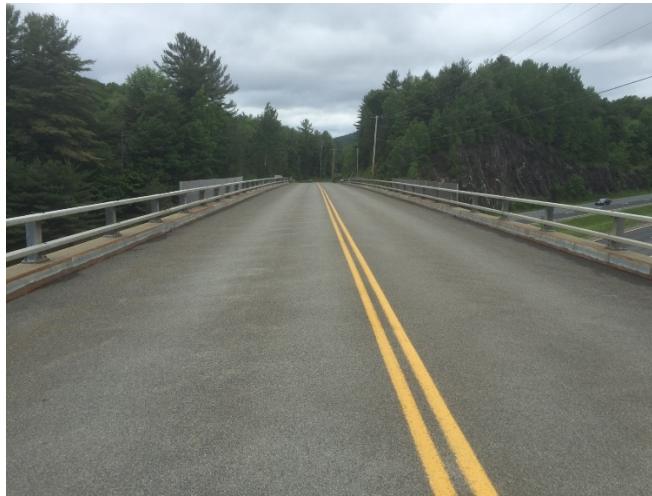
The fourth site visit on June 9<sup>th</sup>, 2016, showed very similar levels of wear to the first site visit a year earlier. The Flexogrid membrane had maintained good condition and showed no new signs of wear. The cracking around the bridge joint had increased slightly since the prior visit. Figure 6 shows the level of wear on the full bridge deck.

Figure 6: Overall view of Bridge 8 looking northbound

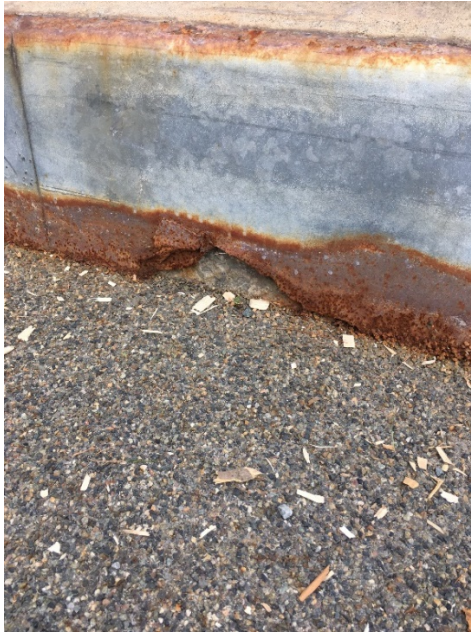
Site visit five was conducted on August 23<sup>rd</sup>, 2017. During this site visit, slight wear to the wheel paths had begun to appear. Along with this wear, small amounts of loose aggregate from the Flexogrid system surface were found around both the wheel paths and the bridge curb. Given that the Flexogrid system was installed in 2013, the surface is showing excellent resiliency to wear for being in its fourth year of use and had undergone five winter maintenance seasons. Other signs of wear can be seen in the slight rusting of the metal curb protector and the pavement cracking in the north and south approaches to the bridge. This wear can be seen in Figures 7 and 8. The deterioration of the metal curb protector is most likely attributed to the run off from agents used during the 5 seasons of winter maintenance. The north and south-bound approaches to the bridge experienced significant transverse and longitudinal cracking and some alligator cracking. The underside of the bridge along with the bridge abutments were in excellent condition. This is helped by the installation of an extended gutter which has carried the runoff from winter maintenance deicers away from the bridge.

Figure 7: Loose aggregate from Flexogrid surface and rusting of metal curb protector

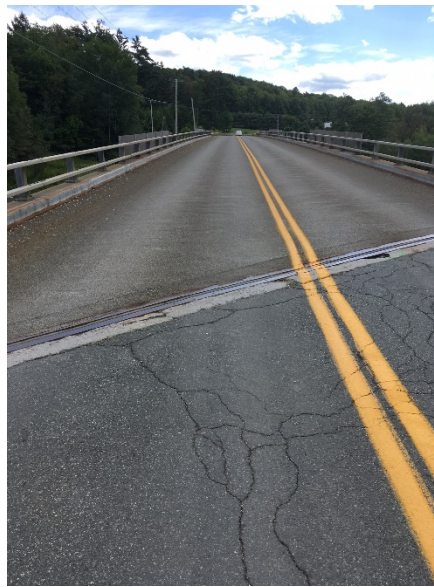
Figure 8: Cracking of southbound approach to bridge 8
