ALASKA DEPARTMENT OF TRANSPORTATION

The Effects of a Winter Ice Jam Event On Bioengineered Bank Stabilization Along The Kenai River

Prepared by: Kenneth F. Karle, P.E.
Hydraulic Mapping and Modeling

Date
October 2007

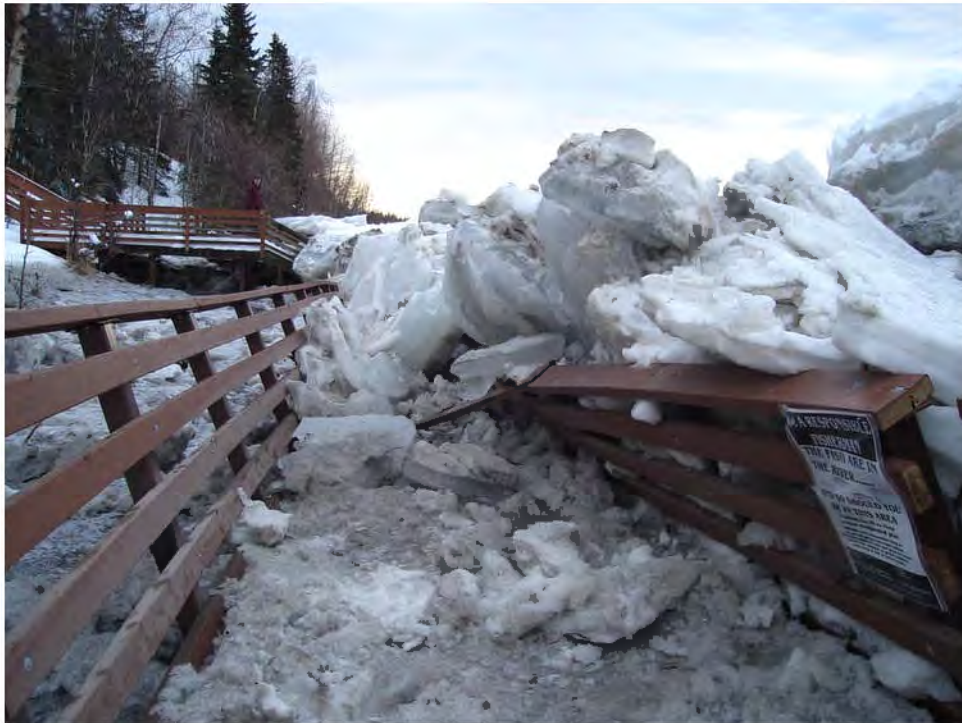
Figure 1. Elevated walk at Soldotna Park damaged by ice jam event, January 2007. ADOT&PF photo.

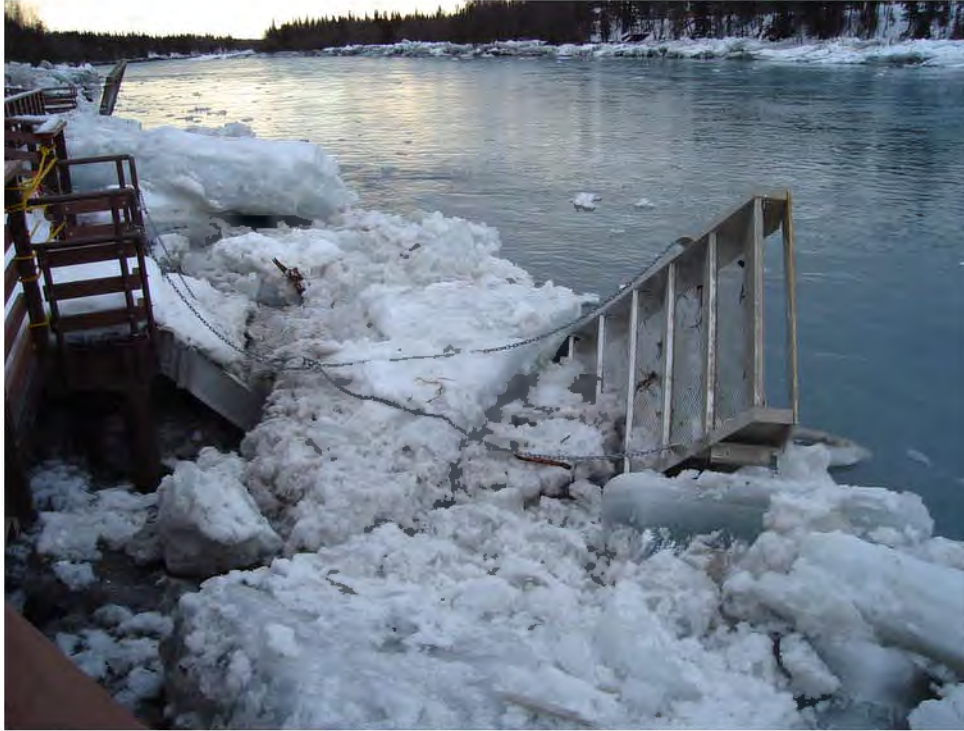
As the ice jams moved downriver, they damaged or destroyed a large number of manmade structures, including staircases, handrails, fish-cleaning tables, docks, fishing platforms, and other items (Peninsula Clarion, 2007). Many of these structures were either crushed by the ice as it pushed onto the banks, or were ripped from their pilings and taken downriver in the ice floe movement. Many of the staircases that provide access to the river were bent downstream or torn off completely by ice jam forces. See Figure 4.

Figure 4. Damaged folding aluminum staircase at Soldotna Park. ADOT&PF photo.

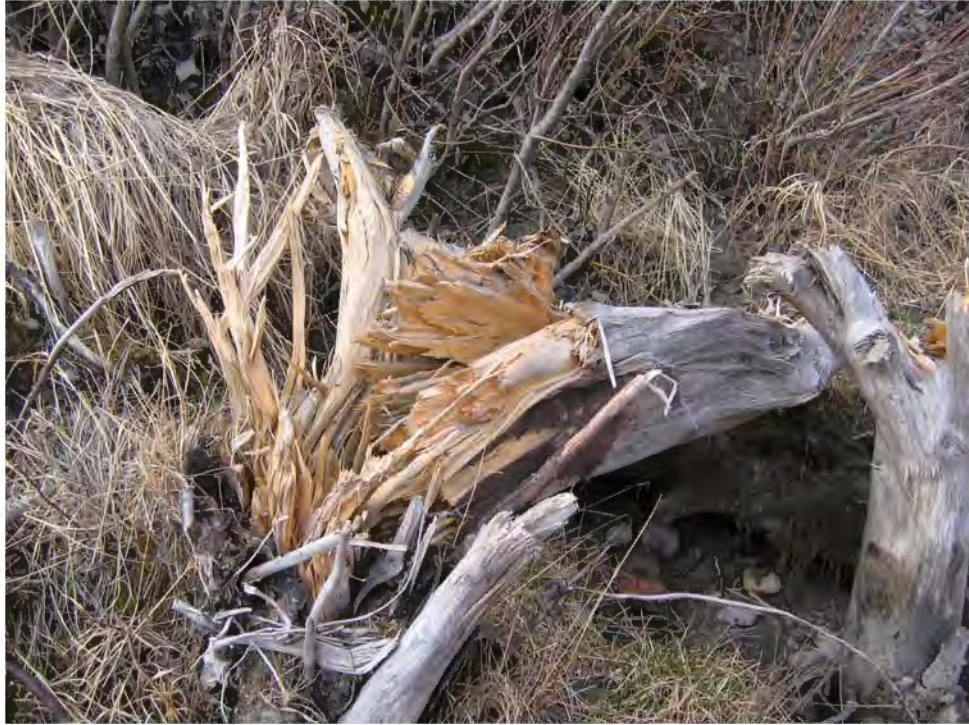
At Centennial Park, many of the root wads suffered damage to the roots or tines forming the wad (Figure 5). Root stems up to 8 inches in diameter were snapped off by ice floes, generally in a downstream direction. Generally, the longer stems were damaged, though some stems down to 1 foot in length were also broken. A substantial number of stems were broken from numerous root wads.

Figure 5. Root wad with damaged root tines at Centennial Park.

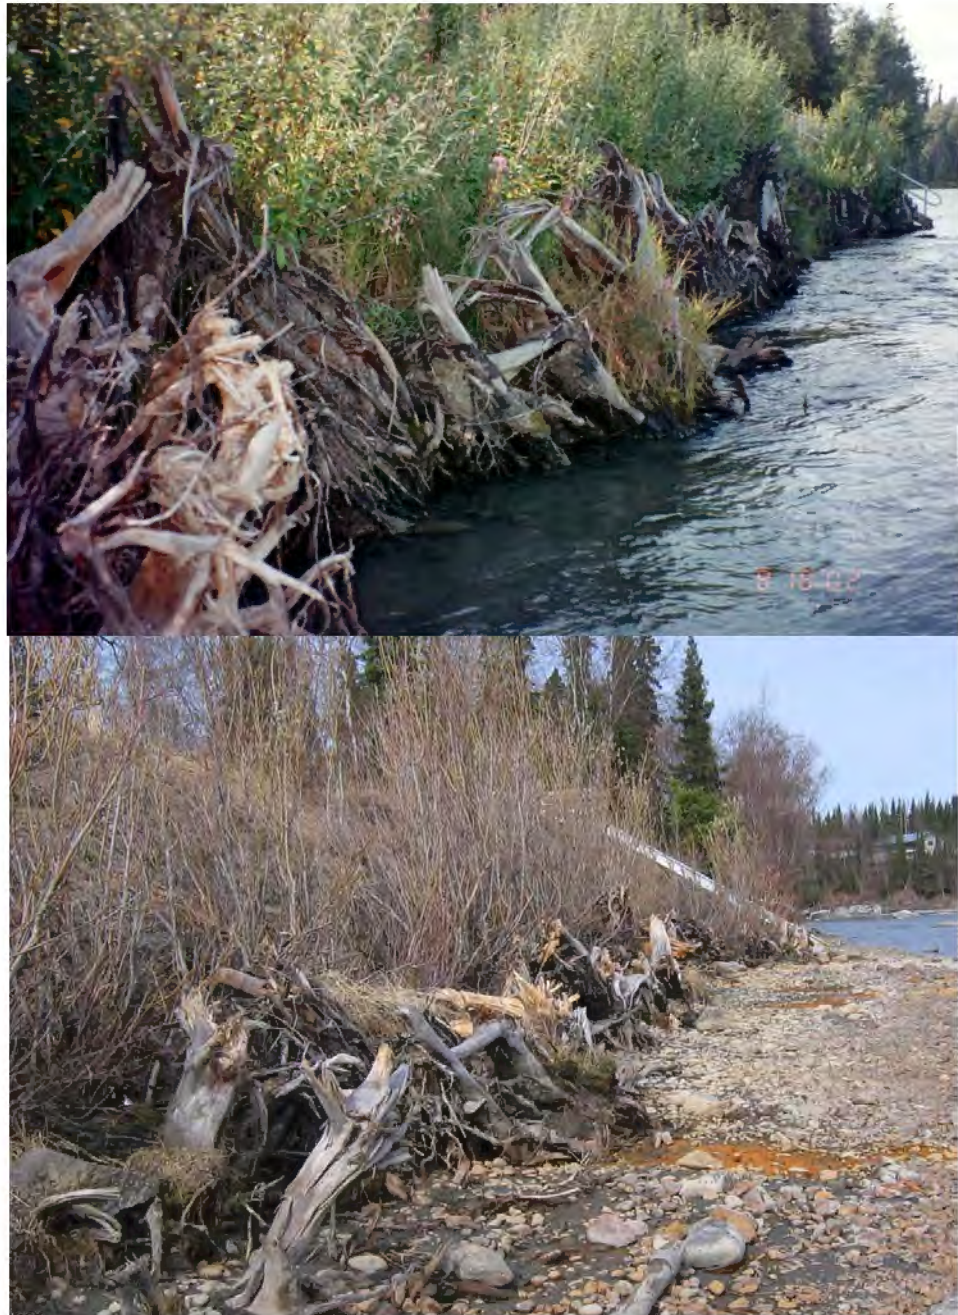
With one exception, the boles appeared to be undamaged in any way. At Centennial Park, one root wad bole had been pulled away from the bank approximately 1 foot. In many root wad installations, header and/or footer logs are used to secure and anchor the individual boles. However, such logs were not used in this section of the Centennial Park project.

In Figure 6, a photographic comparison of several individual root wads at the Centennial Park site shows their condition before the ice jam event (July 2002) and after (May 2007).

Figure 6. Root wads at Centennial Park. Top photo taken July 2002, bottom photo taken May 2007.

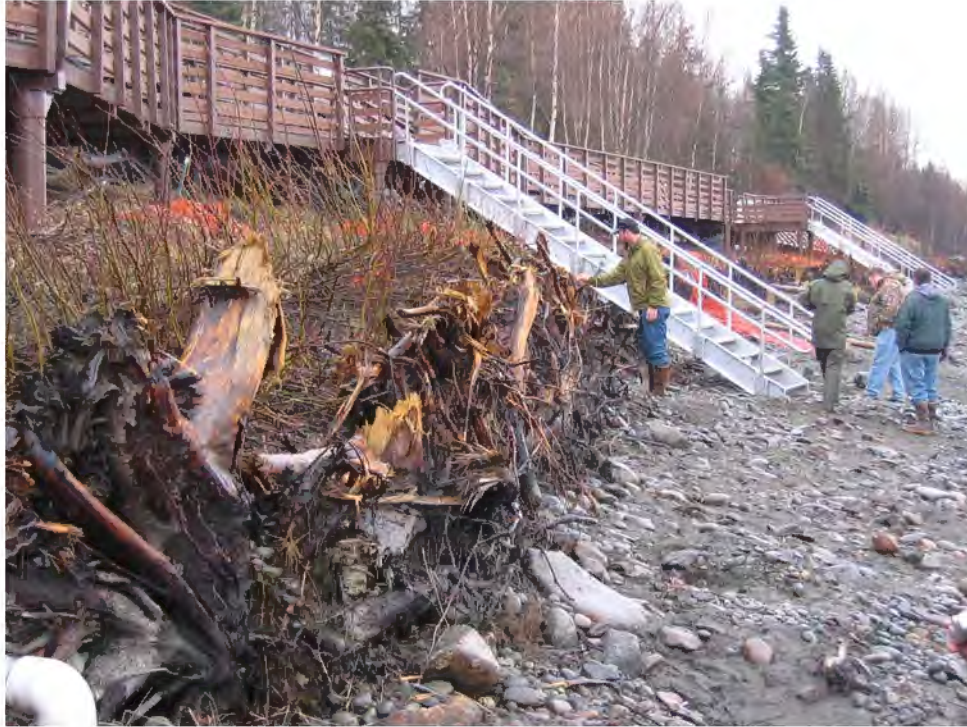
Root wads at Soldotna Park were installed in the spring of 2006. These root wads also showed signs of damage, though not as severe as the Centennial Park site. Again, root wads suffered damage to the roots or tines forming the wad, and the boles appeared to be undamaged. Header logs were used at this site. See Figure 7.

Figure 7. Root wads with broken root stems at Soldotna Park.

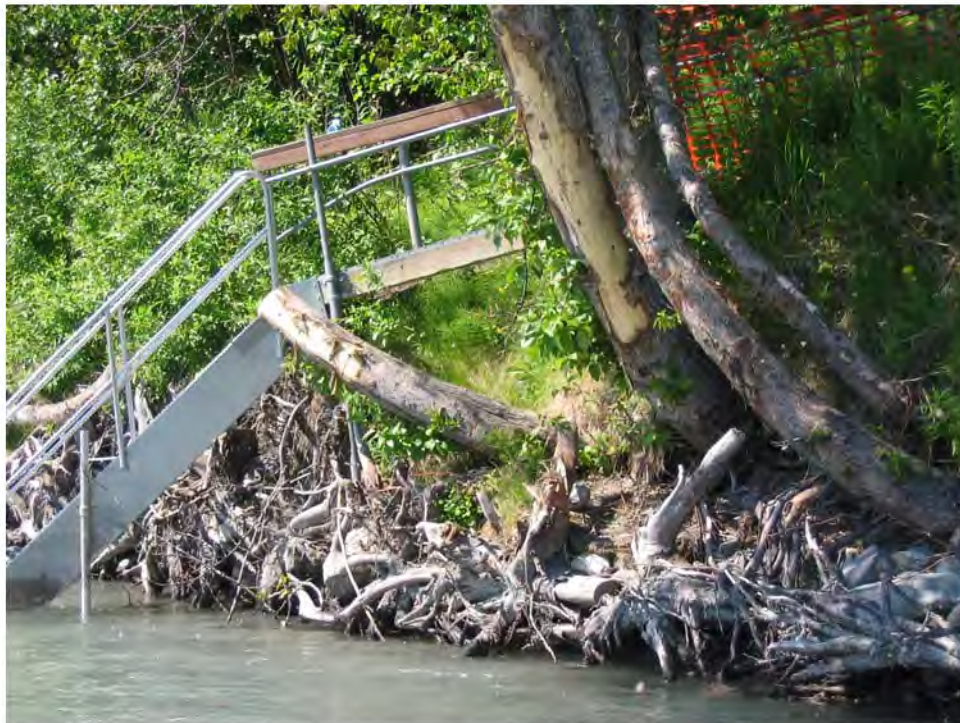
four years old. Though some root tines were broken, most of the installation appeared to be in excellent condition. A tree on the bank above the root wads shows the effects of bark being stripped off the trunk by the ice floes. See Figure 8.

Figure 8. Root wad installation at Soldotna B&B Lodge.

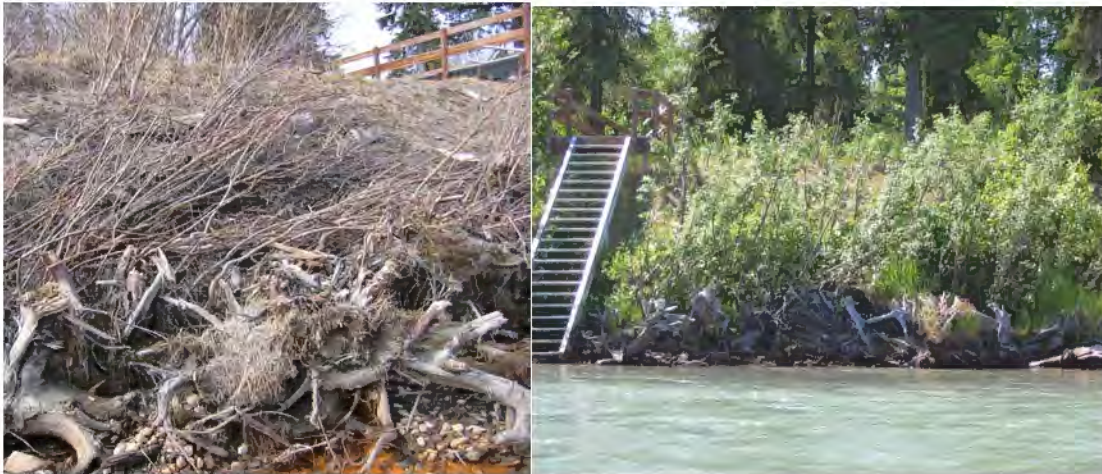
At the Centennial Park root wad installations, the upper bank above the root wads appeared to be well-protected by the willow trees growing there. The willows, planted as part of the brush-layering structure built on top of the root wads, are up to 1.5" diameter breast height (dbh), and up to 12 feet in height. During the May 2007 field visit, many of the willow trees were severely bent over in a downriver direction. This appeared to be the result of the ice-jam event; ice floes either knocked the willows over as they moved downstream, or flattened them as the water levels receded and the floes were left on the bank. During the late June visit, the vast majority of the willows appeared to be healthy. Stalks had straightened out, and were in the process of leafing out. See Figure 9.

Figure 9. Upper bank brushlayering at Centennial Park. Left photo taken May 2007, right photo taken June 2007.

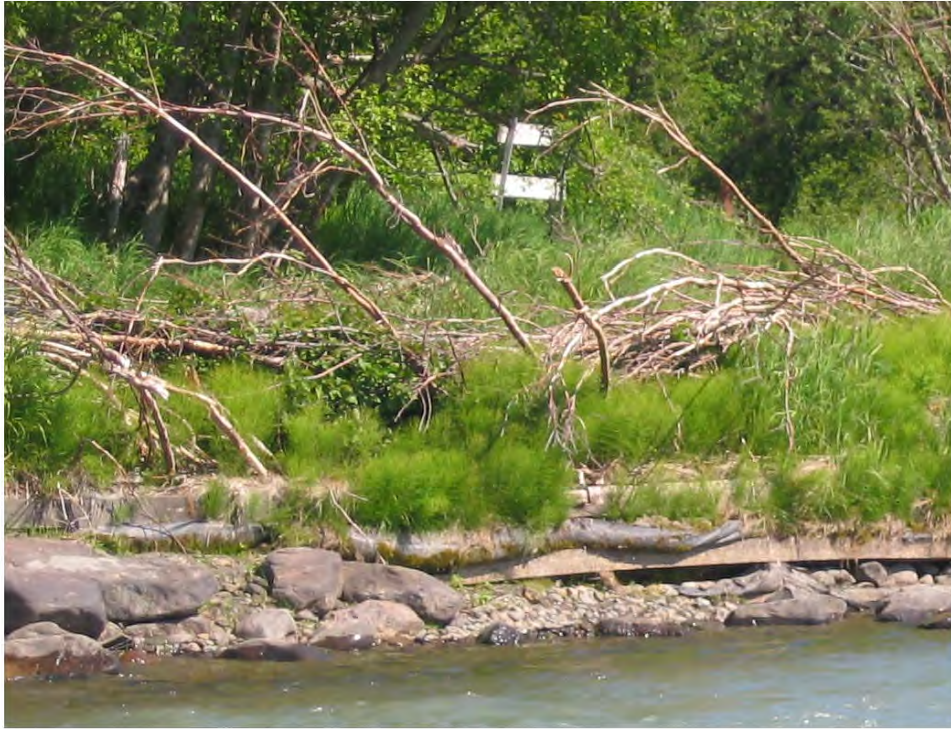
The upstream section of the Soldotna Park installation was constructed in 1997, using cribwalls to protect the toe of the bank. On this bank, the trees are mature, 15 to 20 feet in height, and a 2 to 3 inch dbh. Following the ice jam, many of these trees were flattened in a downstream direction, and had much of their bark scraped off by ice floes. In June 2007, they were in poor condition, still flattened, and were not leafing. See Figure 10.

Figure 10. Bark stripped from trees at the Soldotna Park cribwall site.

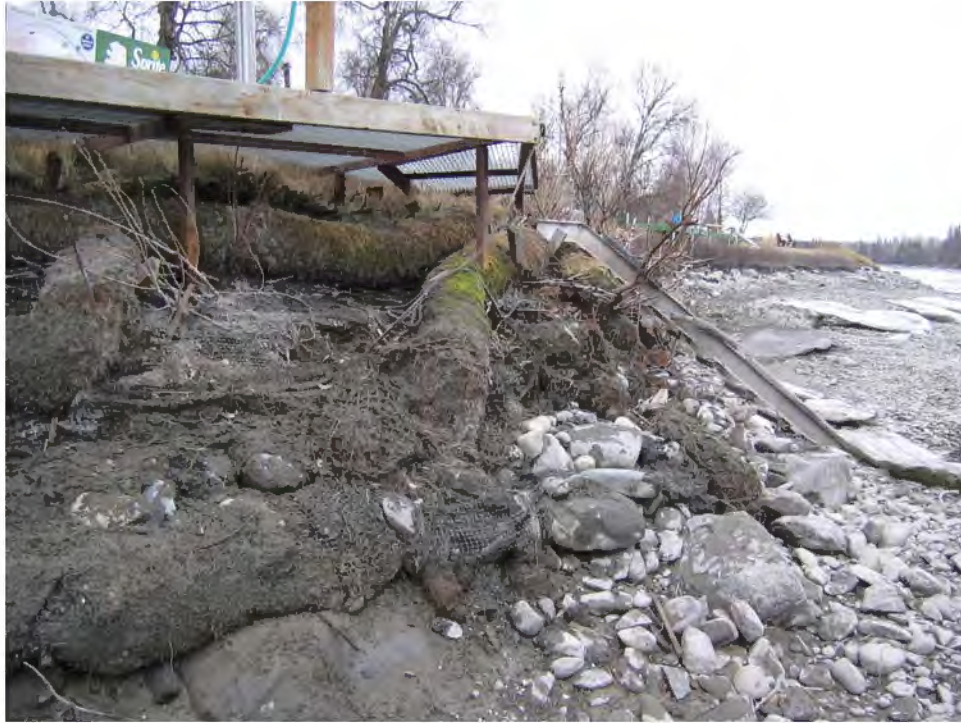
Several smaller bioengineered installations were inspected during the 2007 field visits. A small coir log/brush layer installation is located on the bank adjacent to a commercial guiding operation, at approximately Mile 16 on the Kenai River. This structure is approximately 10 years old. Some damage to the coir logs was noted. Coir logs were displaced and pulled out away from the bank. The culprit for the damage was likely ice floes moving downstream. The installation is still functional; however, it is scheduled for replacement soon using more current techniques. The original near-vertical installation may have contributed to the damage that occurred, and such an installation is now generally discouraged. See Figure 11.

Figure 11. Ice damage to coir log installation.

In the 2003 report, field evidence at one site indicated some damage to coir fabric used in fabric-encapsulated soil lifts from ice floes moving downstream. Though we found no examples of such damage for this project, the potential for such damage on streams that experience ice floes and ice jams should be of concern to project planners. The installation of root wads in front of such fabric-encapsulated soil lifts could be one potential solution for providing protection against annual ice floes.

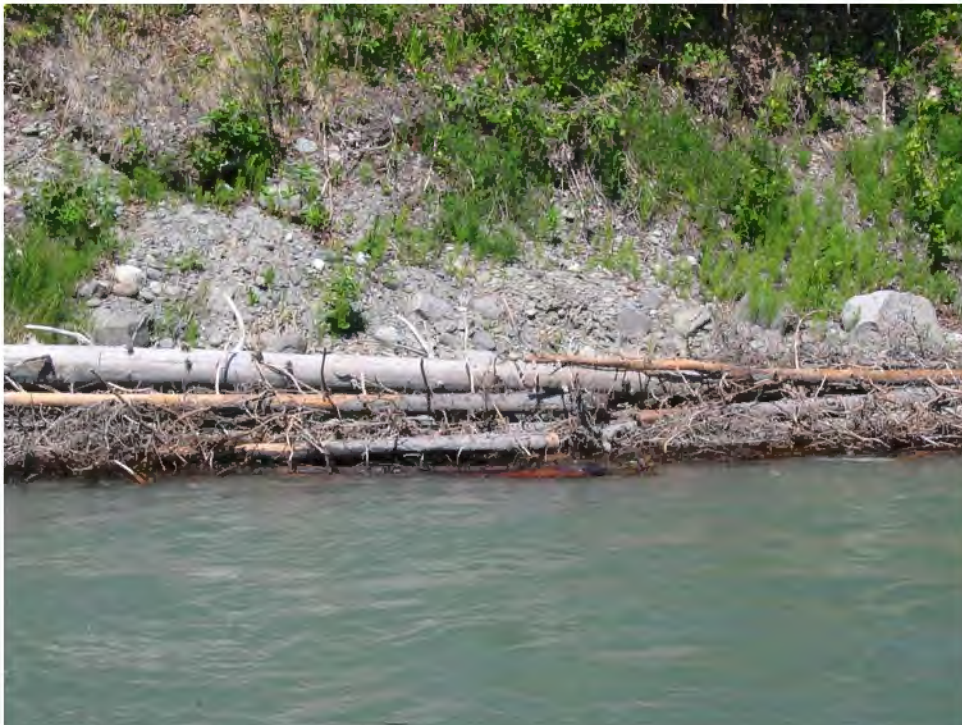
The Soldotna Lodge root wad installation described earlier also includes a spruce tree revetment section, located downstream from the root wad section. The spruce trees cabled to the bank appeared to be in excellent condition, and were not damaged by the ice jam event. See Figure 12.

Figure 12. Spruce tree revetment at Soldotna B&B Lodge.

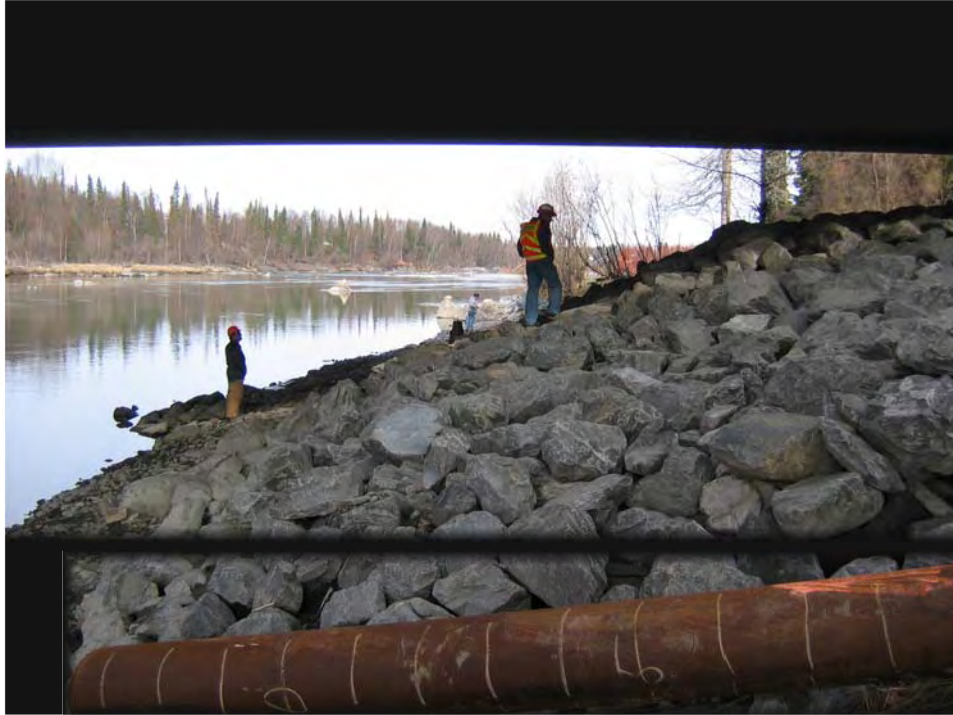
Though pre-flood photographs were not available, the post-flood inspection showed the riprap installation to be in excellent condition. There was no indication that any of the rock was displaced by either the water or the ice floe movement. See Figure 13.

Figure 13. Riprap beneath the new Sterling Highway Bridge.

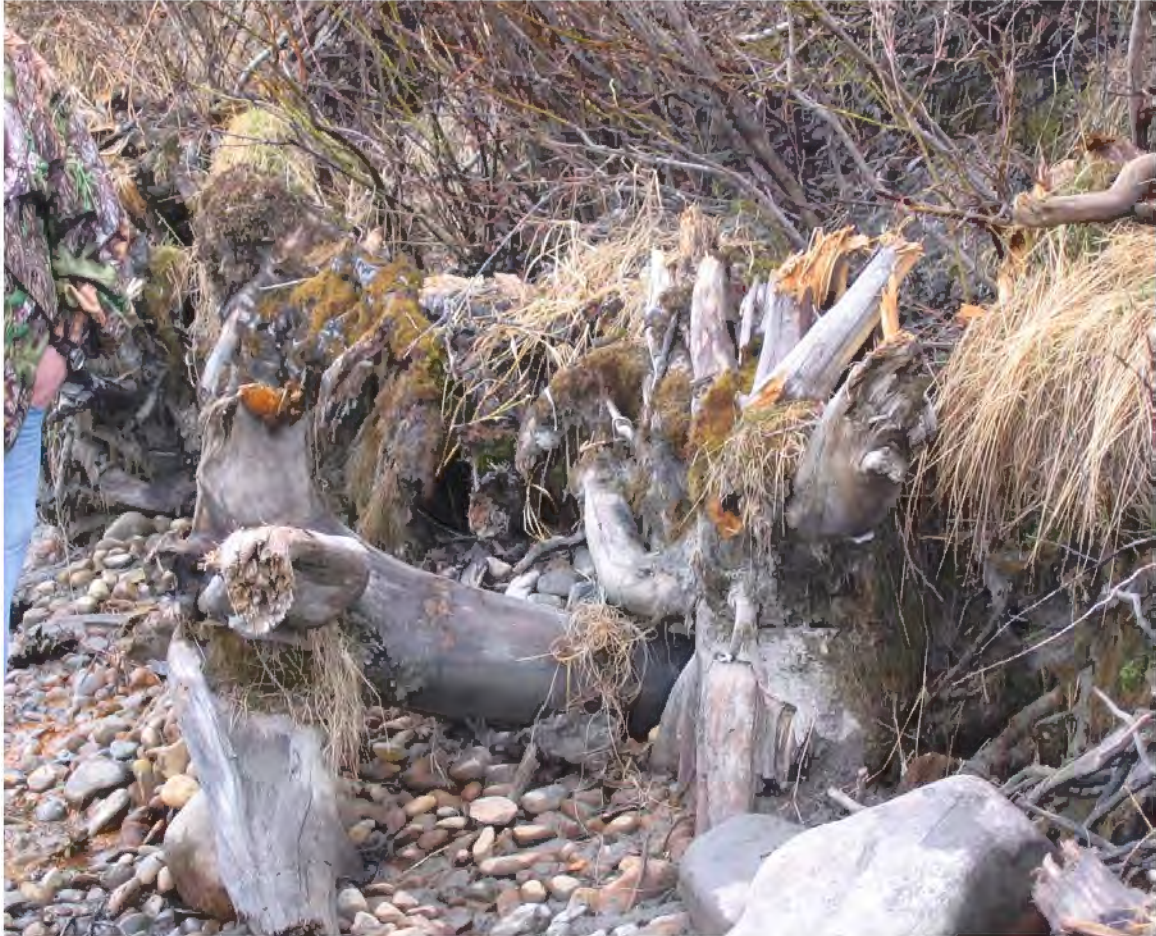
A-Centennial Park. The Centennial Park site was constructed in 1997, and is approximately 500 feet in length. An addition was added in 2002. The project was constructed using root wads, coir logs, brush layering, live siltation, and live willow staking. Design documents show the root wad trunks to be 8 feet long, 12 inches in diameter, and a root fan diameter of 5 to 12 feet. Root wads were spaced every 5 feet, and the wad centers were to be installed at an elevation of ordinary high water. Header or footer logs were not noted on the design drawings or during project inspections.

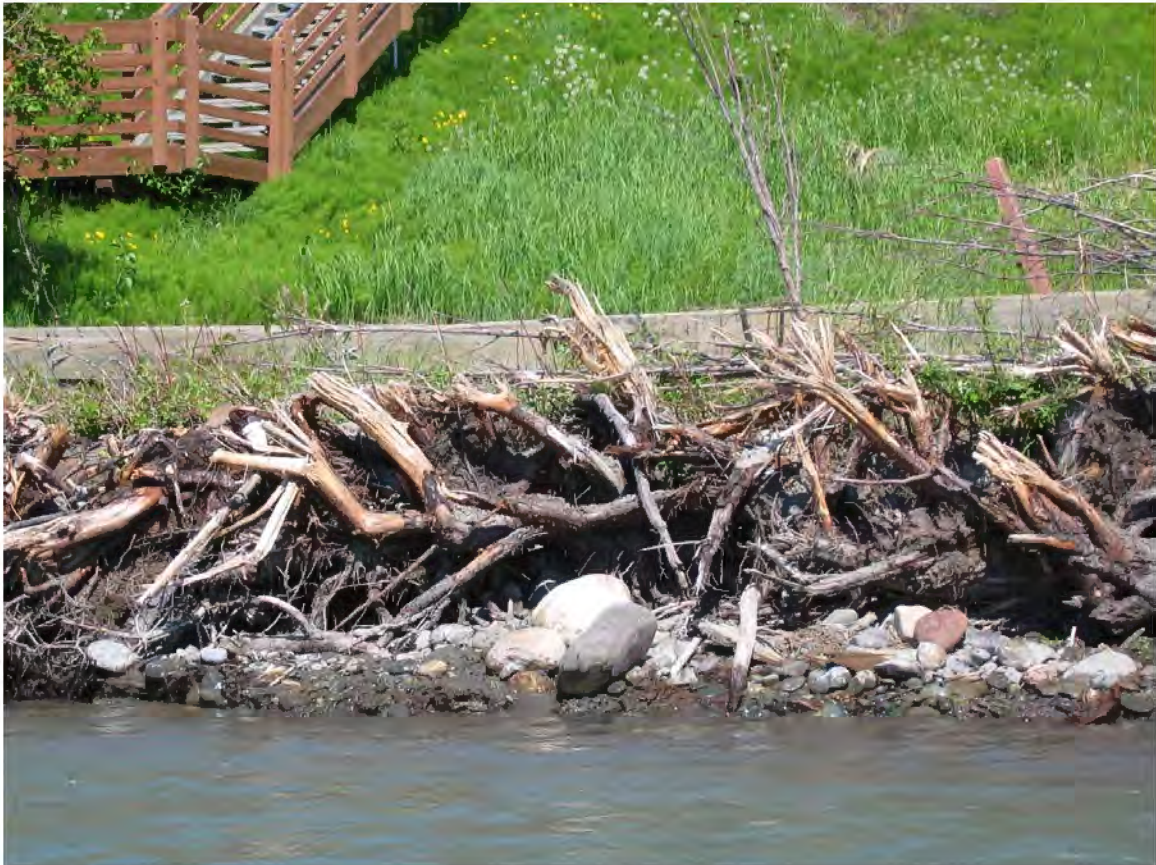
B-Soldotna Park. A 650 foot section of streambank at Soldotna Creek Park was stabilized in 1994 using several bioengineering methods. A live cribwall was constructed up to 3 feet in height, and live siltation techniques were used to provide over-hanging cover. In wet areas, native sod rolls and live fascines were used to stabilize the bank line and reestablish vegetation. Large rocks, placed randomly in the shallow water in front of the live cribwalls, and small rootwads, anchored further out, were used to create additional fish cover. In the spring of 2006, a long section of root wads was installed downstream of the cribwall section. Fabric encapsulated soil lifts with willow brushlayering were used to protect the upper bank.

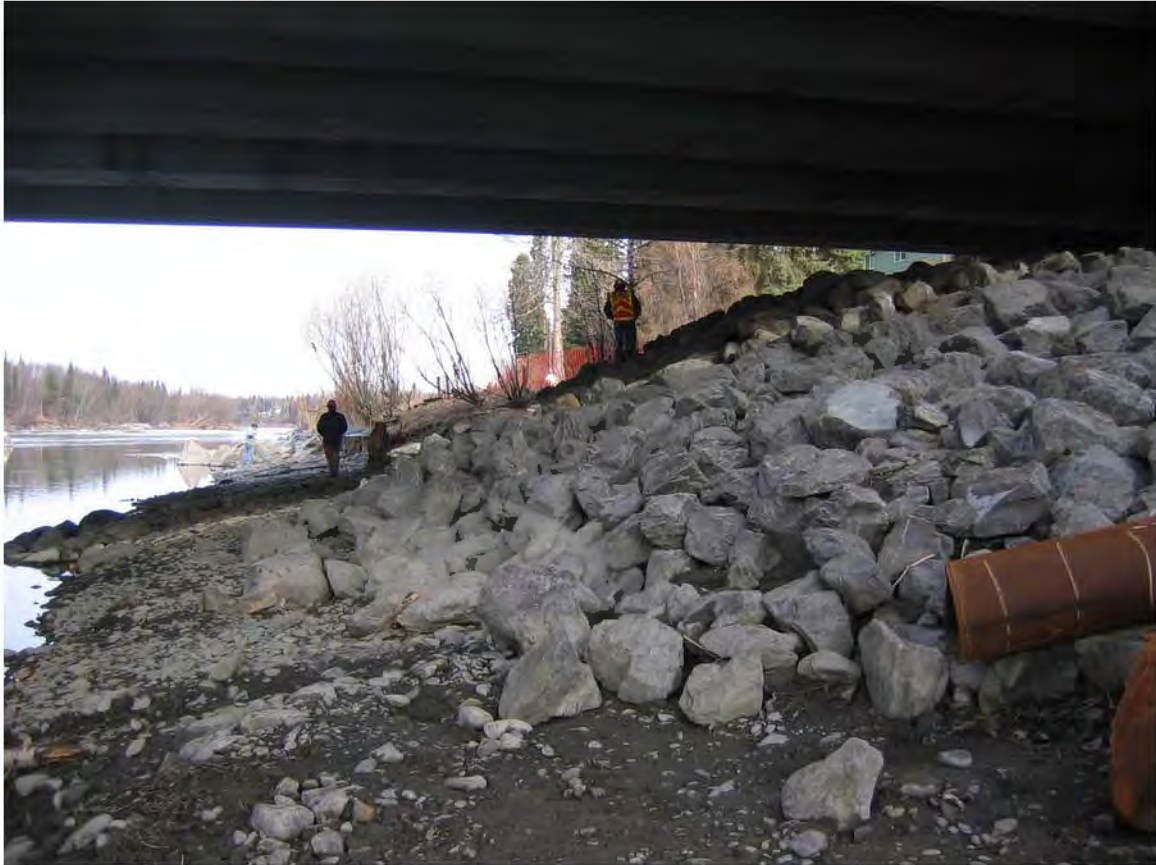
C-Sterling Highway Bridge #0671. A new 5-lane bridge was constructed at this site and finished during the summer of 2007. Abutments were protected with a riprap blanket, consisting mostly of Class II and some Class III rock.

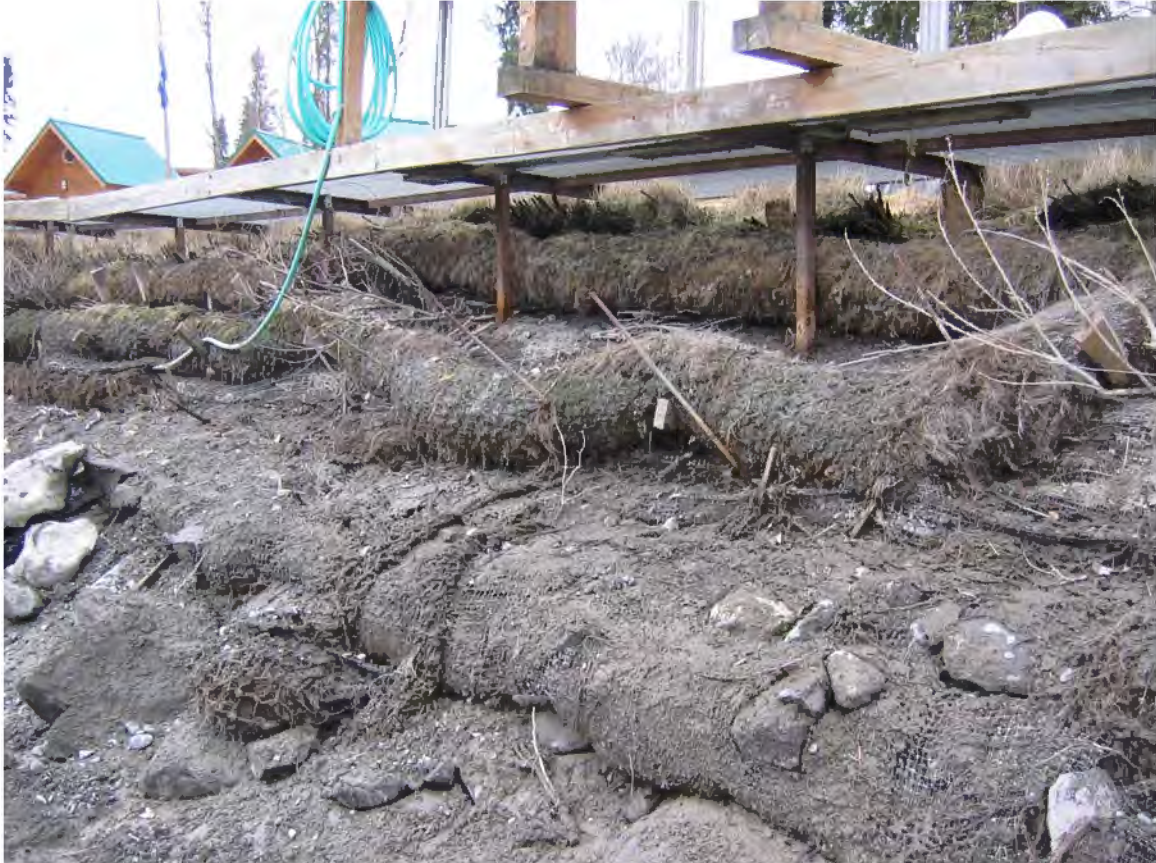
D-Private Coir Log Installation. This private business/residence is approximately 10 years old, and consists of coir logs and fabric encapsulated soil lifts with an upper willow brushlayer treatment. An elevated light-penetrating walkway protects the structure from foot traffic.

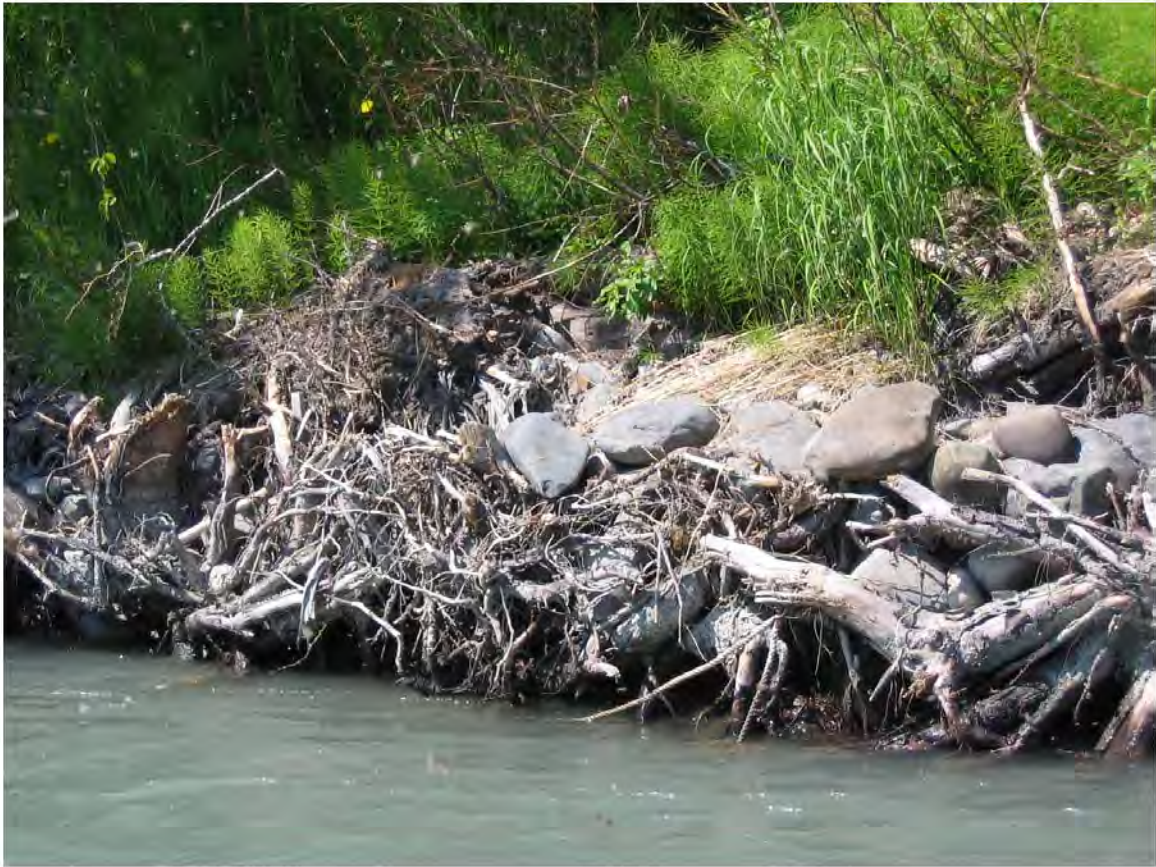
E-Soldotna B&B Lodge. A small root wad revetment is located at the Soldotna B&B Lodge bank upstream of the Sterling Highway Bridge, and is approximately three to four years old. This project also includes a spruce tree revetment section, located downstream from the root wad section. A row of spruce trees is cabled to the bank. The root wads were installed approximately 3 to 4 years ago, and the spruce tree revetment was added in the spring of 2006.
