GEORGIA DOT RESEARCH PROJECT 16-26

FINAL REPORT

**CRASH TESTS ON GUARDRAIL SYSTEMS
EMBEDDED IN ASPHALT VEGETATION
BARRIERS IN ACCORDANCE WITH GDOT
DESIGN SPECIFICATIONS**

GDOT Research Project No. 16-26

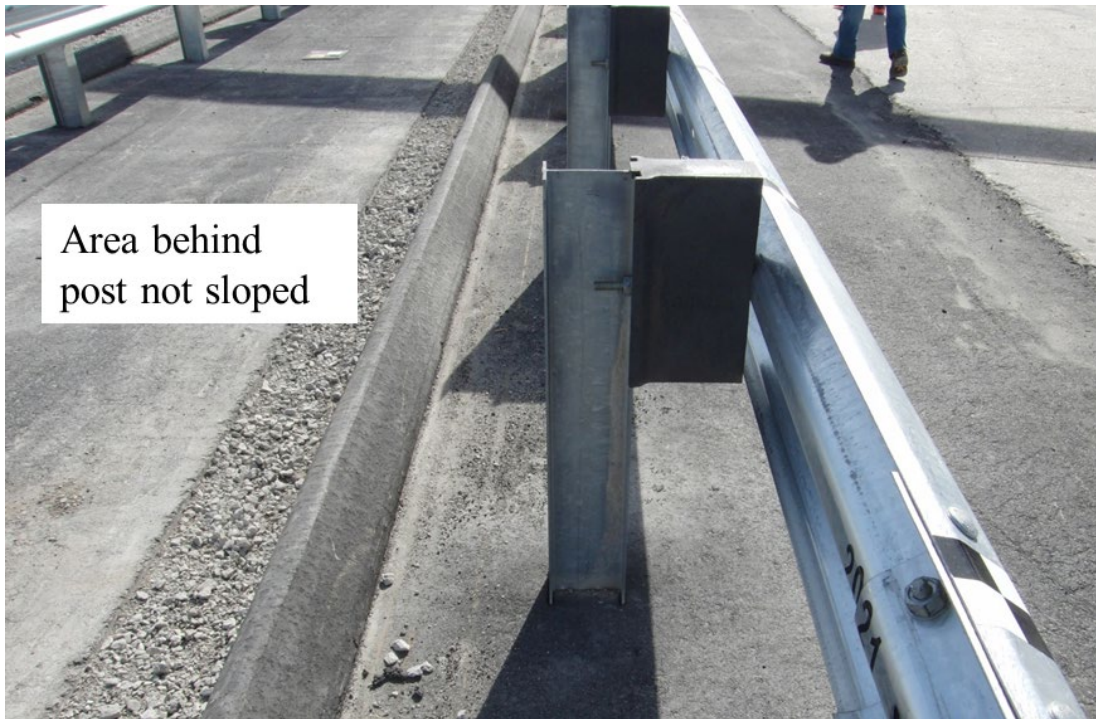
A detailed description of the test bed construction is given in Chapter 3 of the MwRSF report found in the Appendix. In general, the installation of the test site appeared to adhere to the material specifications and dimensions found in GDOT S-4-2002. One variation was noted in that the GDOT detail indicates a graded slope located approximately 42 in. behind the face of the guardrail, as shown in Figure 3. As can be seen in Figure 4, the area behind the post in the test installation was graded horizontal, with an additional pad/test bed located behind the test bed.

FIGURE 4 Test Bed Site – View Showing Area Directly Behind the Post

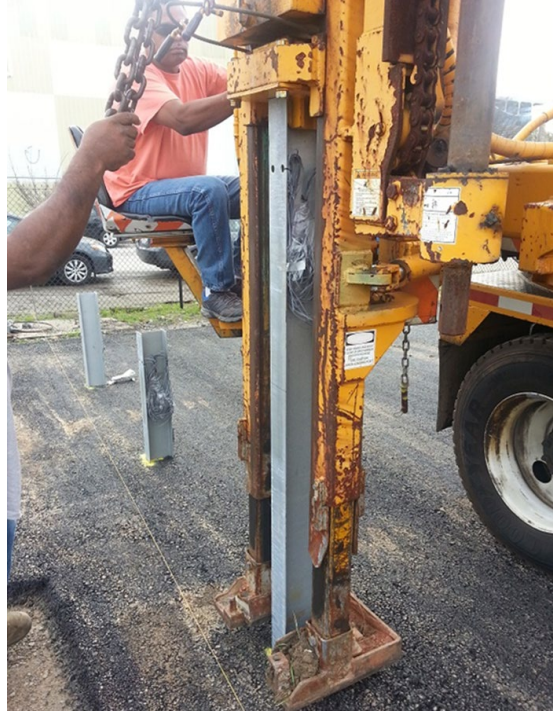
One other variation was noted in the test bed compared to a standard installation on Georgia roadways. As shown in Figure 5, in Georgia, posts are installed by driving them through the asphalt using a hydraulic post driver. However, for the test bed installation at the MwRSF proving grounds, the ends of each post were first heated using a torch to a high temperature. The heated posts were then driven through the asphalt layer, effectively melting the asphalt around the installation location. As such, there was no fracturing in the asphalt layer around the post, as is commonly seen in installations in Georgia. A typical installed post on the test bed site is shown in Figure 6.

FIGURE 5 Typical Post Installation Procedure in Georgia

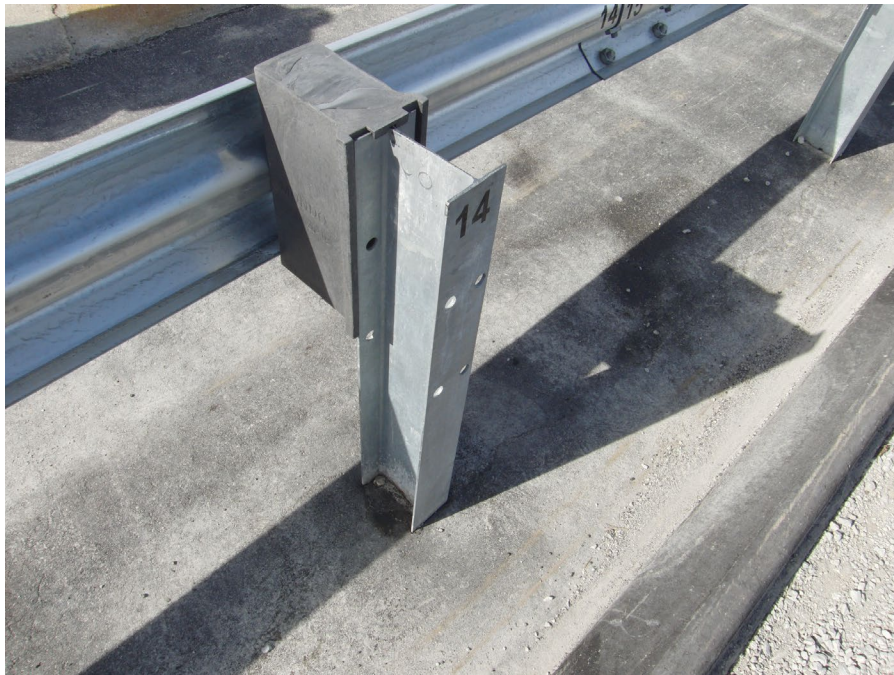
FIGURE 6 Typical Post Installation at MwRSF Test Site

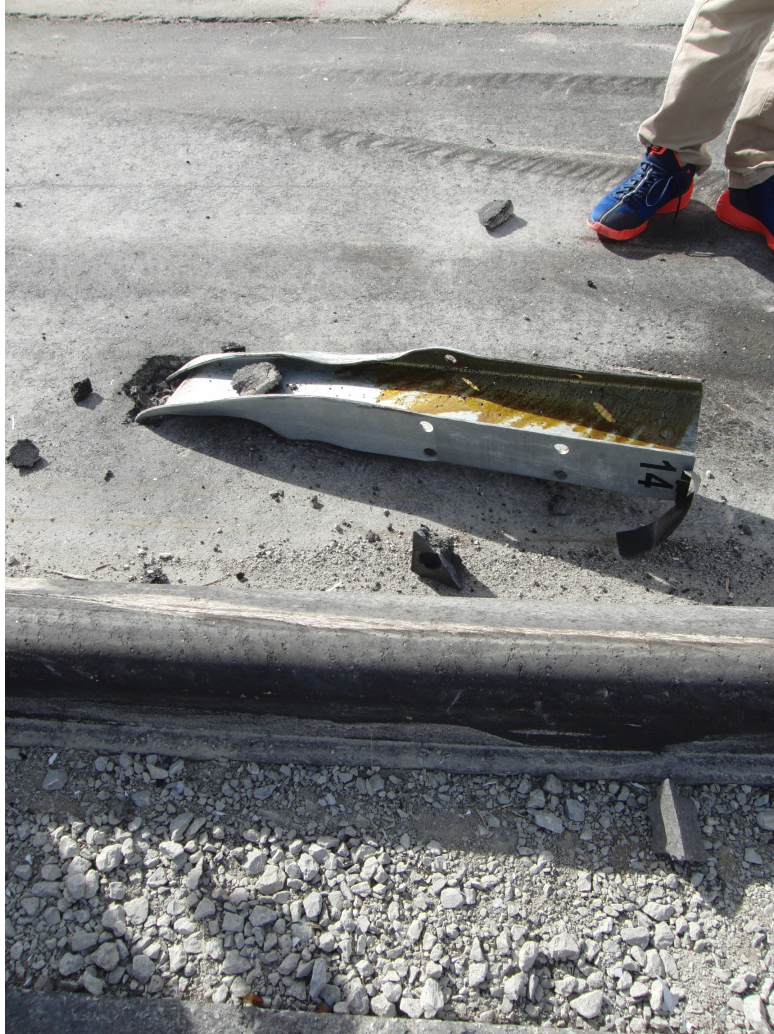
It was noted that many of the posts impacted during test GAA-1 did not translate at all in the asphalt layer, with a hinge forming right at the groundline and the post buckling

as shown in Figure 10. This behavior differed significantly compared to static and dynamic subcomponent testing done at Georgia Tech during Phases 1 and 2 of this research program, where significant post translation at the groundline was typically observed.

FIGURE 10 Buckled Post from Test GAA-1

At the request of the Georgia Tech research team, a number of these posts were excavated and the resulting holes examined. Rough estimates using hand rulers indicated that the asphalt layer may have been slightly thicker than the 3.5 inches specified in GDOT S-4-2002. As such, three cores were recovered from the test site asphalt layer for

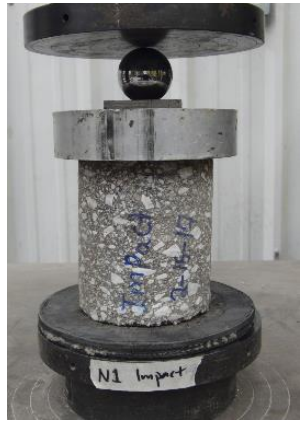
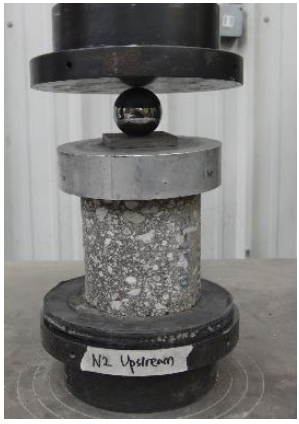
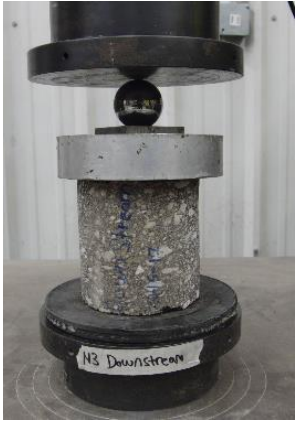
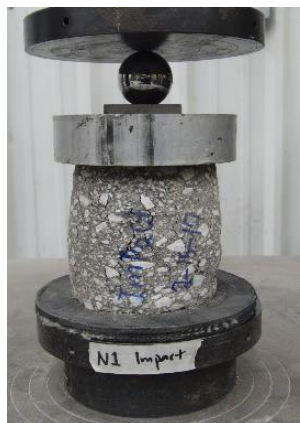
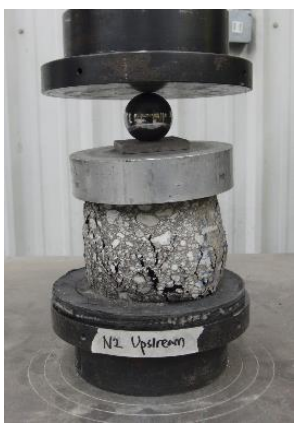
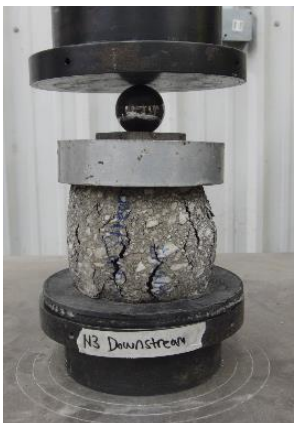
FIGURE 11 Test Results from Asphalt Cores Taken from MwRSF Site After Test GAA-1

analysis and testing. To determine a representative strength, each specimen was taken from a different location: (1) near the impact point of the crash vehicle, (2) the upstream section, and (3) the downstream section. Based on the heights of the cores taken from the test site, the asphalt strip at the site ranged from 3.75 to at least 4.25 inches in thickness. Though this was higher than the value specified in the GDOT detail, asphalt mow strips of this thickness and more are routinely encountered in Georgia. Compression tests on the cores were performed at the Structural Engineering Mechanics and Materials (SEMM) Laboratory on the Georgia Tech campus. All test protocols were based on ASTM D1074-09: “Standard Test Method for Compressive Strength of Bituminous Mixtures” [32]. Figure 11 includes compression test results and other test information including specimen dimension, test condition, and photographs taken during the test. All specimens showed a similar failure mode represented by lateral expansion and vertical cracks. The average compressive strength from the 3 cores was approximately 400 psi. This value was higher than the average value of approximately 250 psi found for the asphalt used in the laboratory testing, but asphalt strengths in Georgia could reasonably be expected to approach this value in cold weather months. In addition, the cylinders from the MwRSF test site did fail in a manner similar to that seen in cores from asphalt used in Phases 1 and 2 of the research program. As such, the asphalt layer was not considered to be significantly unrepresentative of mow strips found on Georgia roadways.

Actual diameter	3.70 in.	3.70 in.	3.70 in.
Thickness (height)	4.25 in.	3.75 in.	3.80 in.
Test temperature	70°F	71°F	67°F
Age of specimen	76 days (curing time from asphalt placement)		
Compressive strength	371.0 psi	396.5 psi	430.6 psi
	Average compressive strength = 399.4 psi

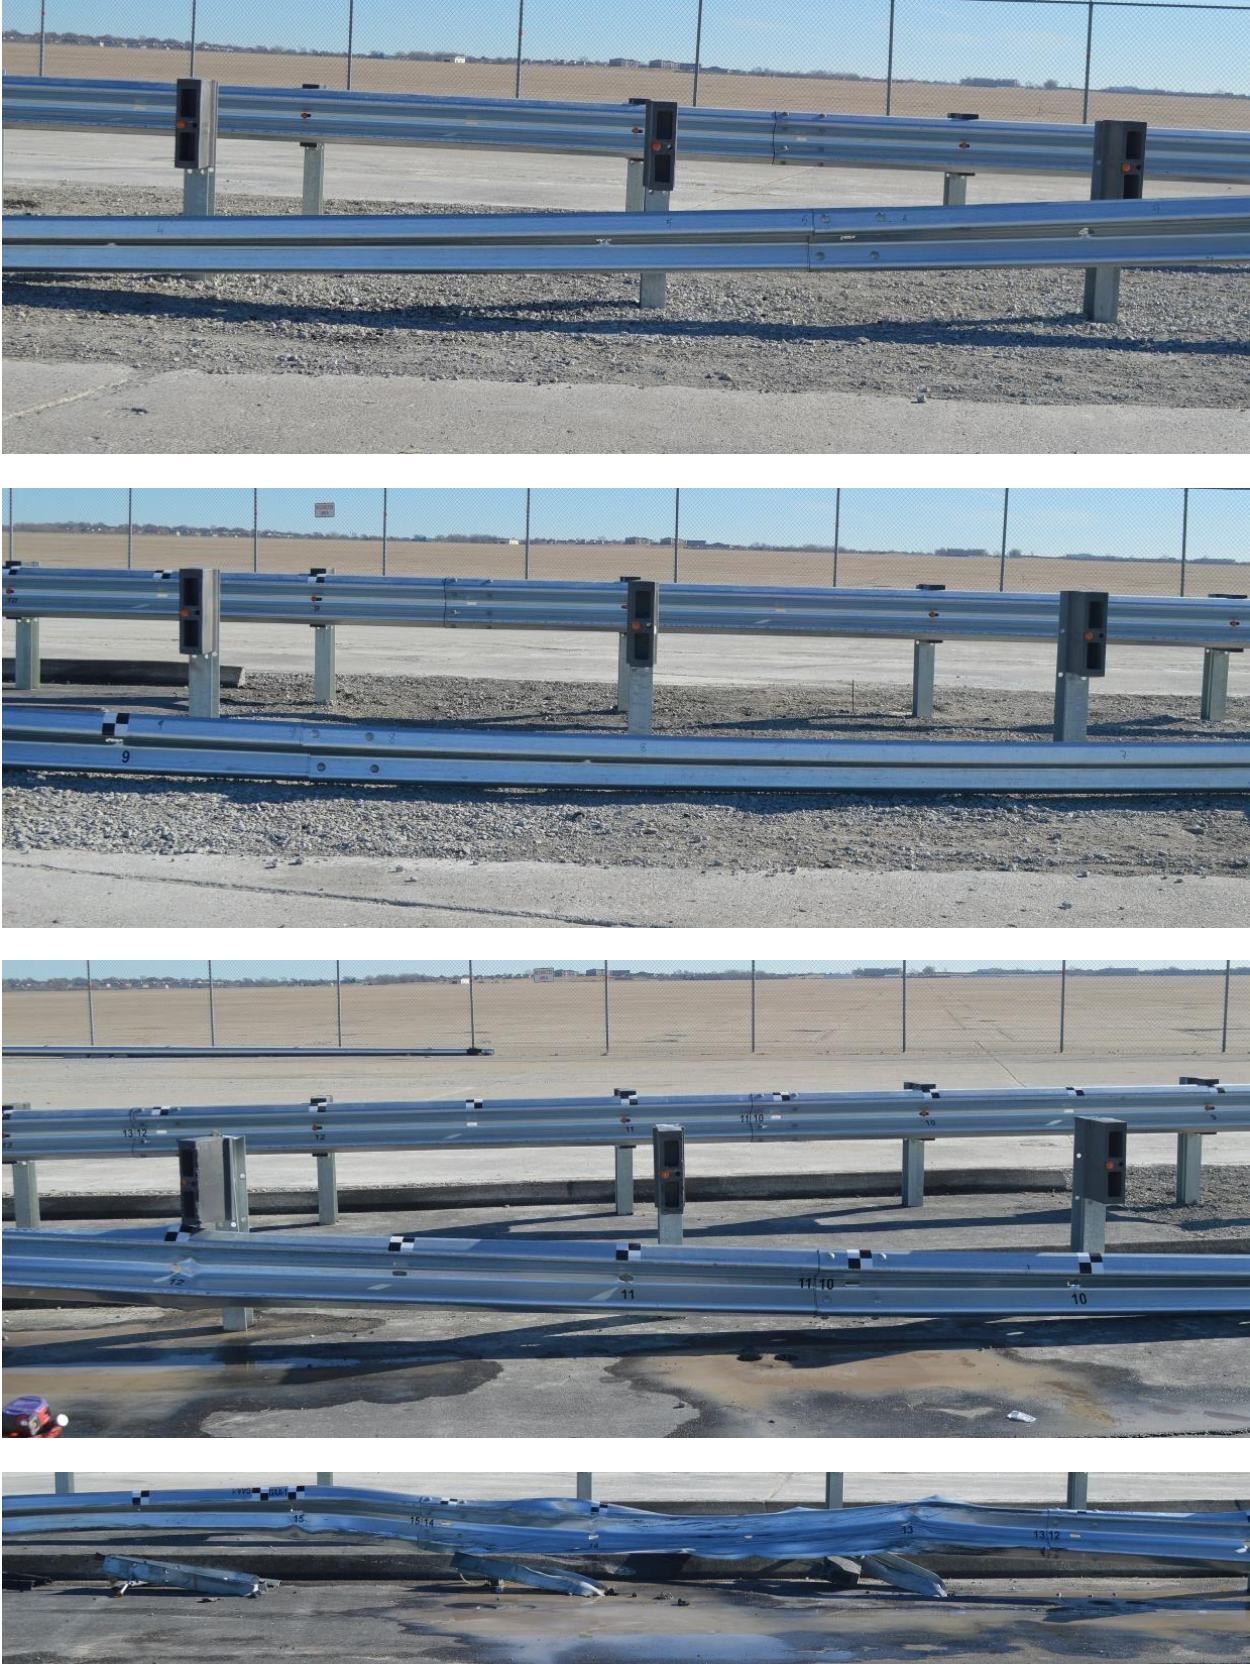
Figure 38. System Damage – Post Nos. 4 through 15, Test No. GAA-1

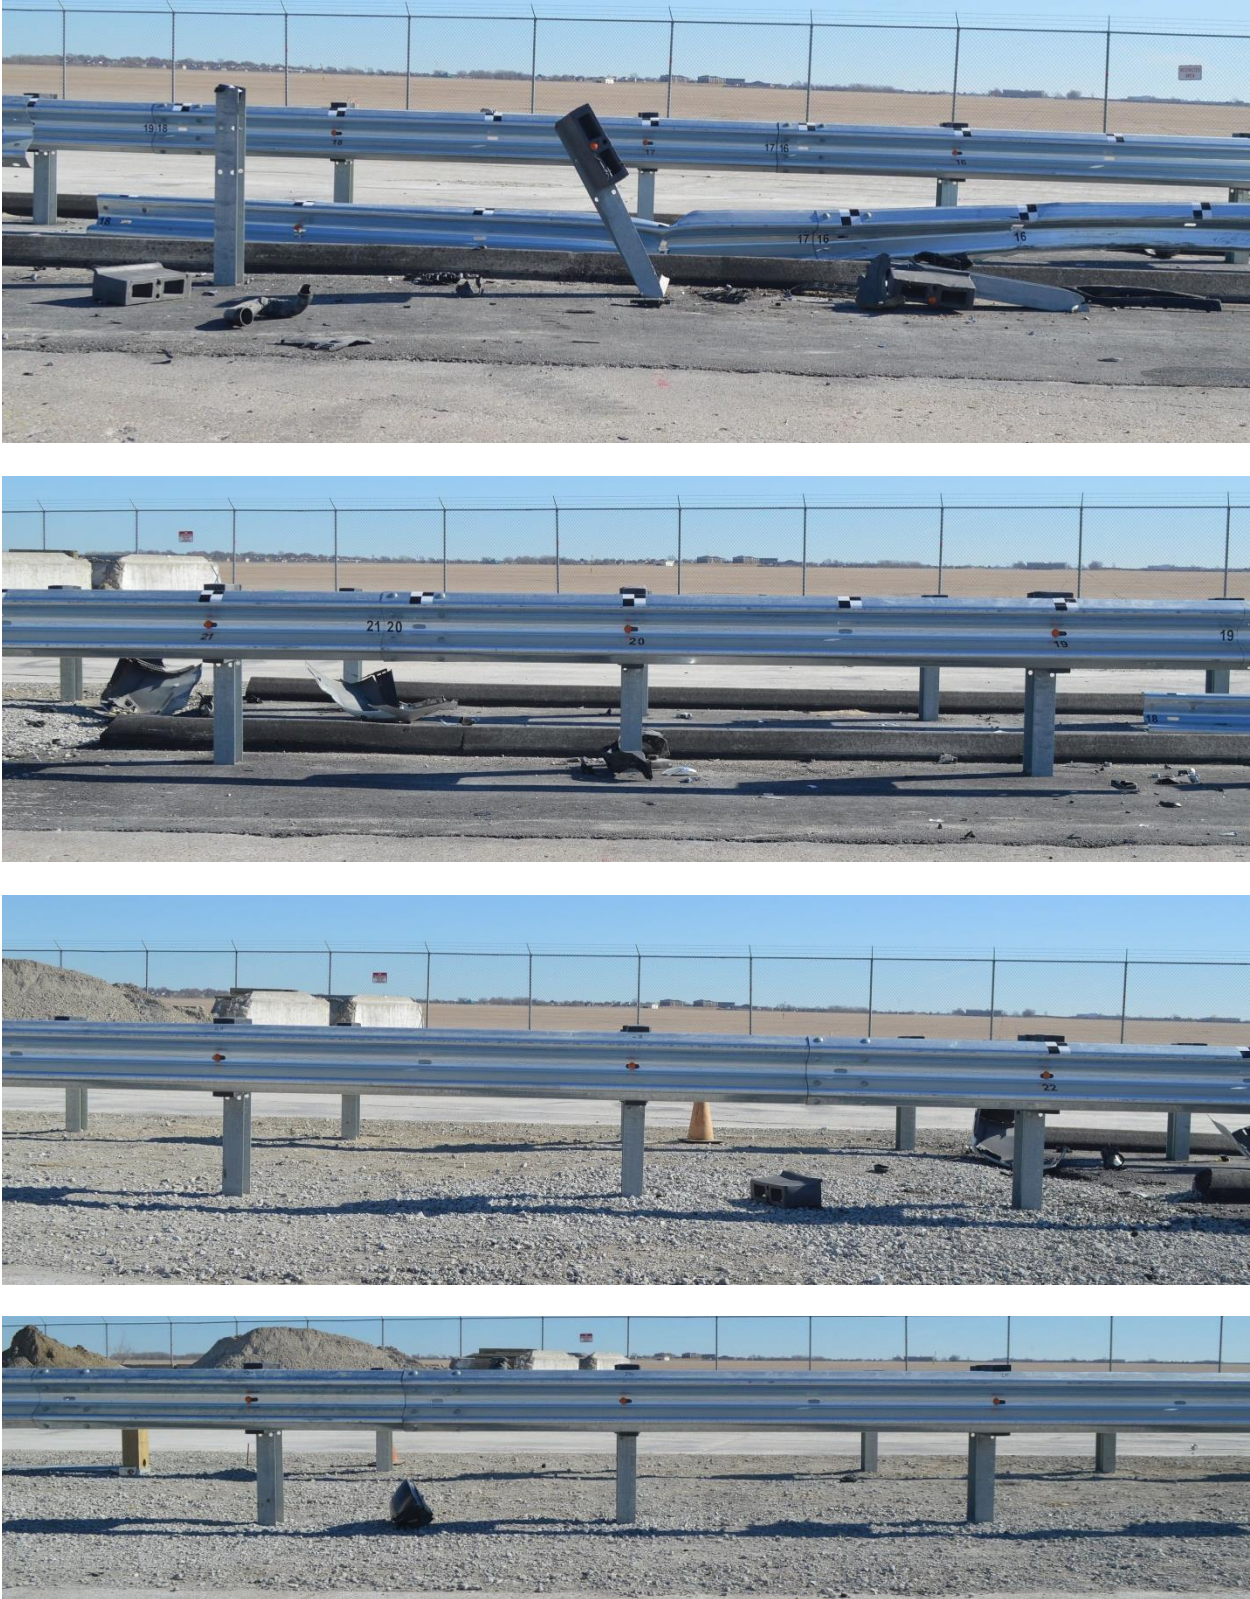
Figure 39. System Damage – Post Nos. 16 through 27, Test No. GAA-1

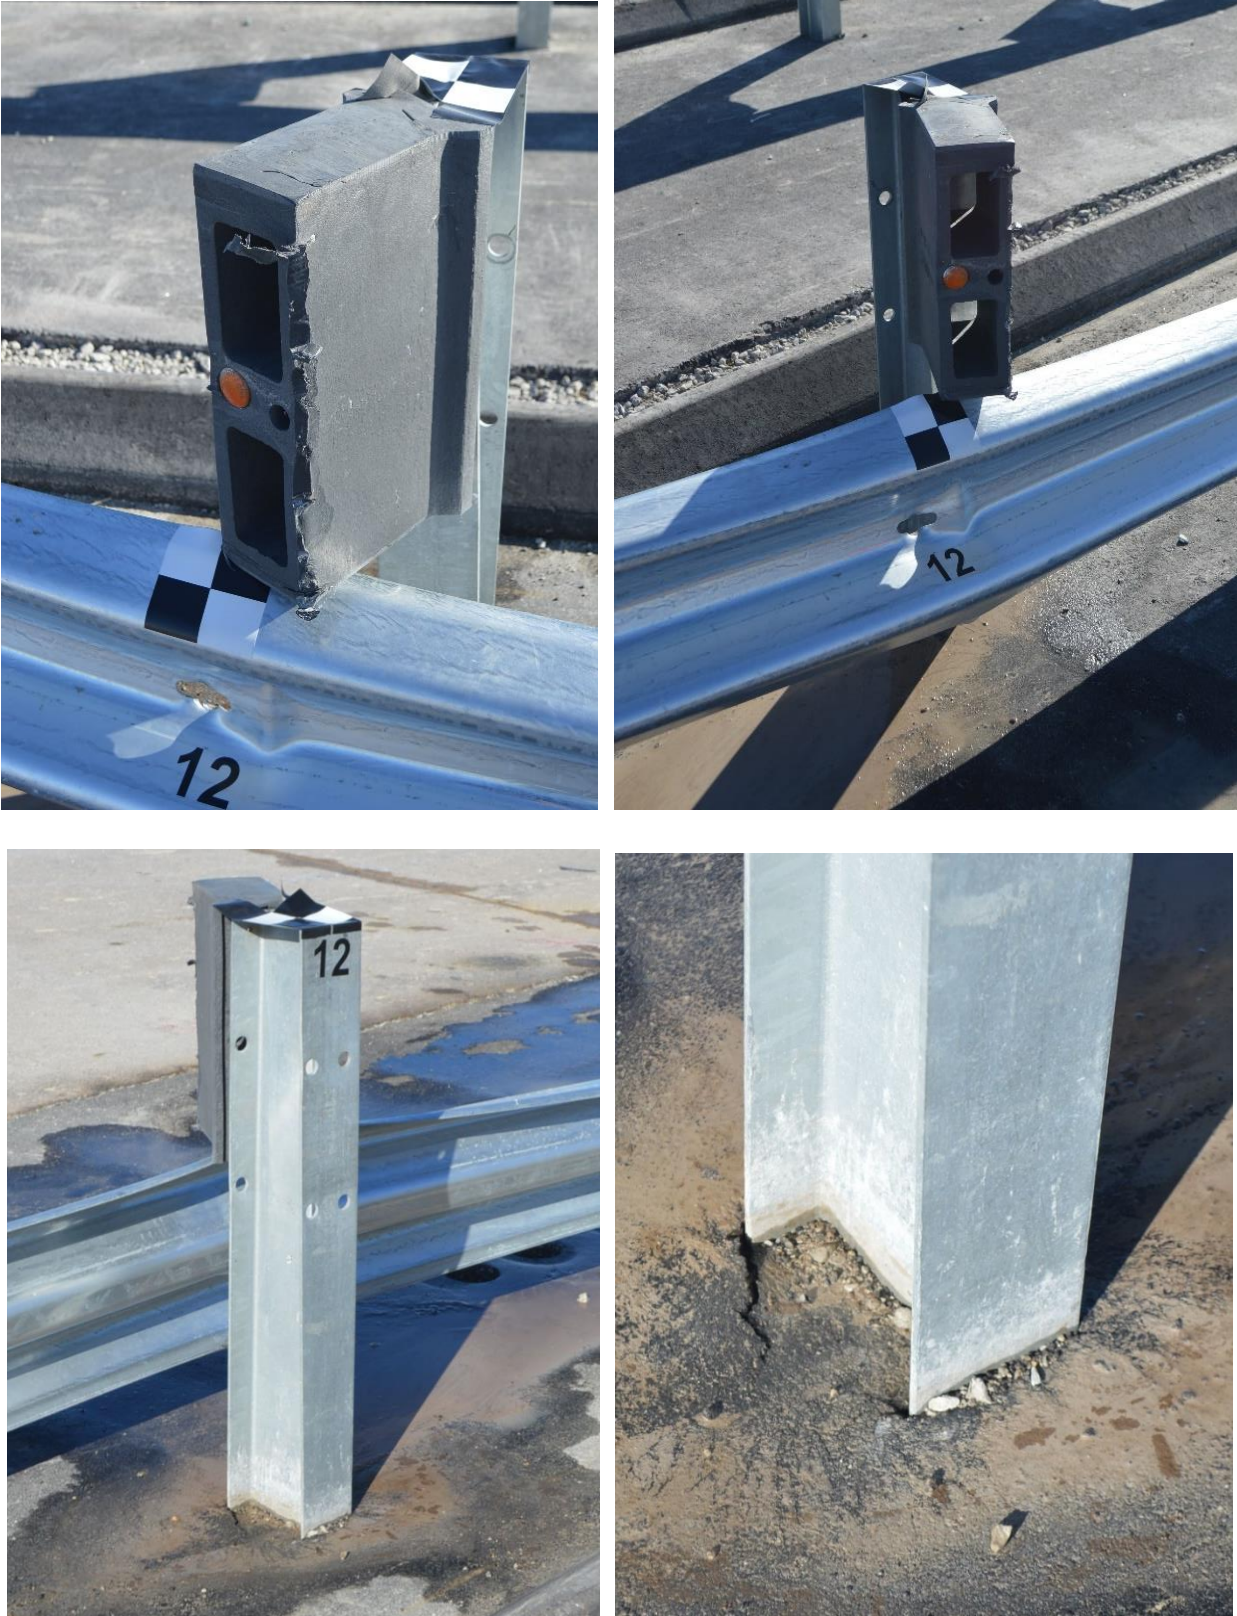
Figure 40. Post No. 12 Damage, Test No. GAA-1

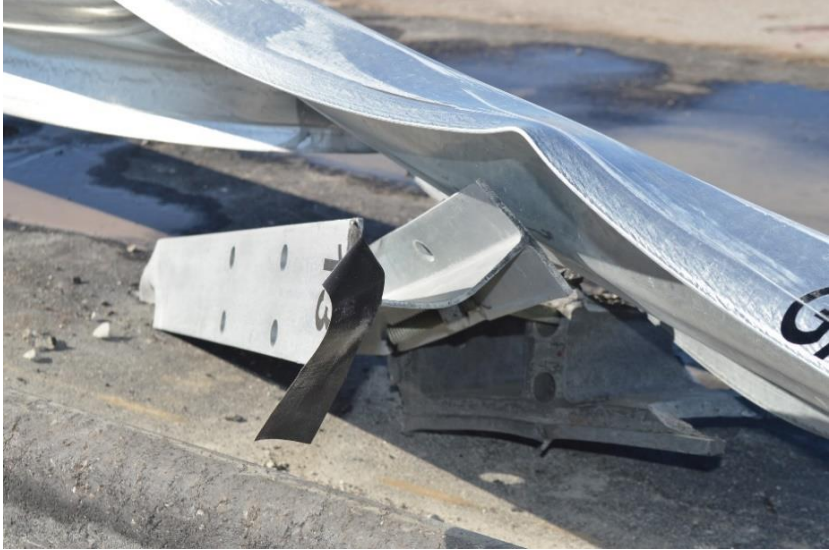
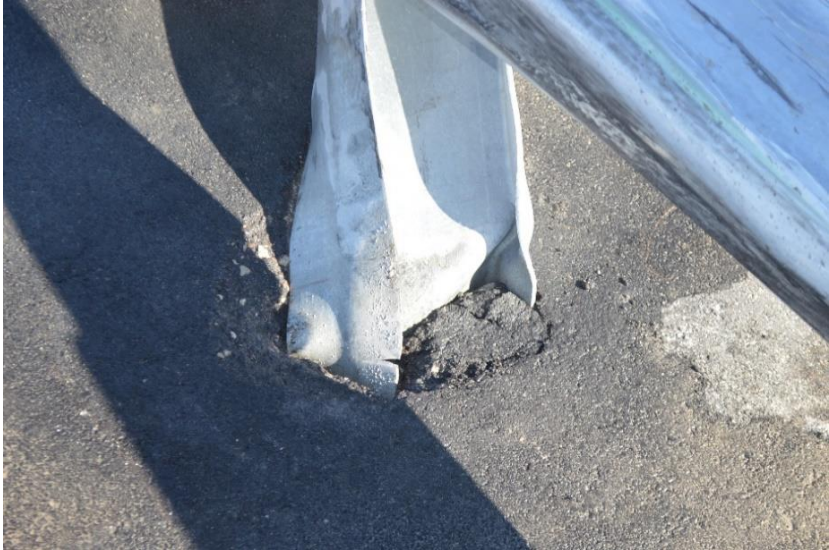
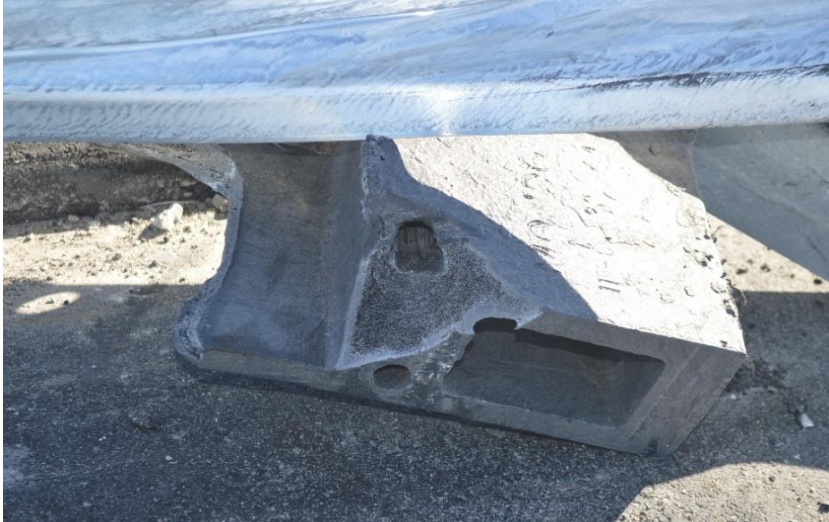
Figure 41. Post No. 13 Damage, Test No. GAA-1

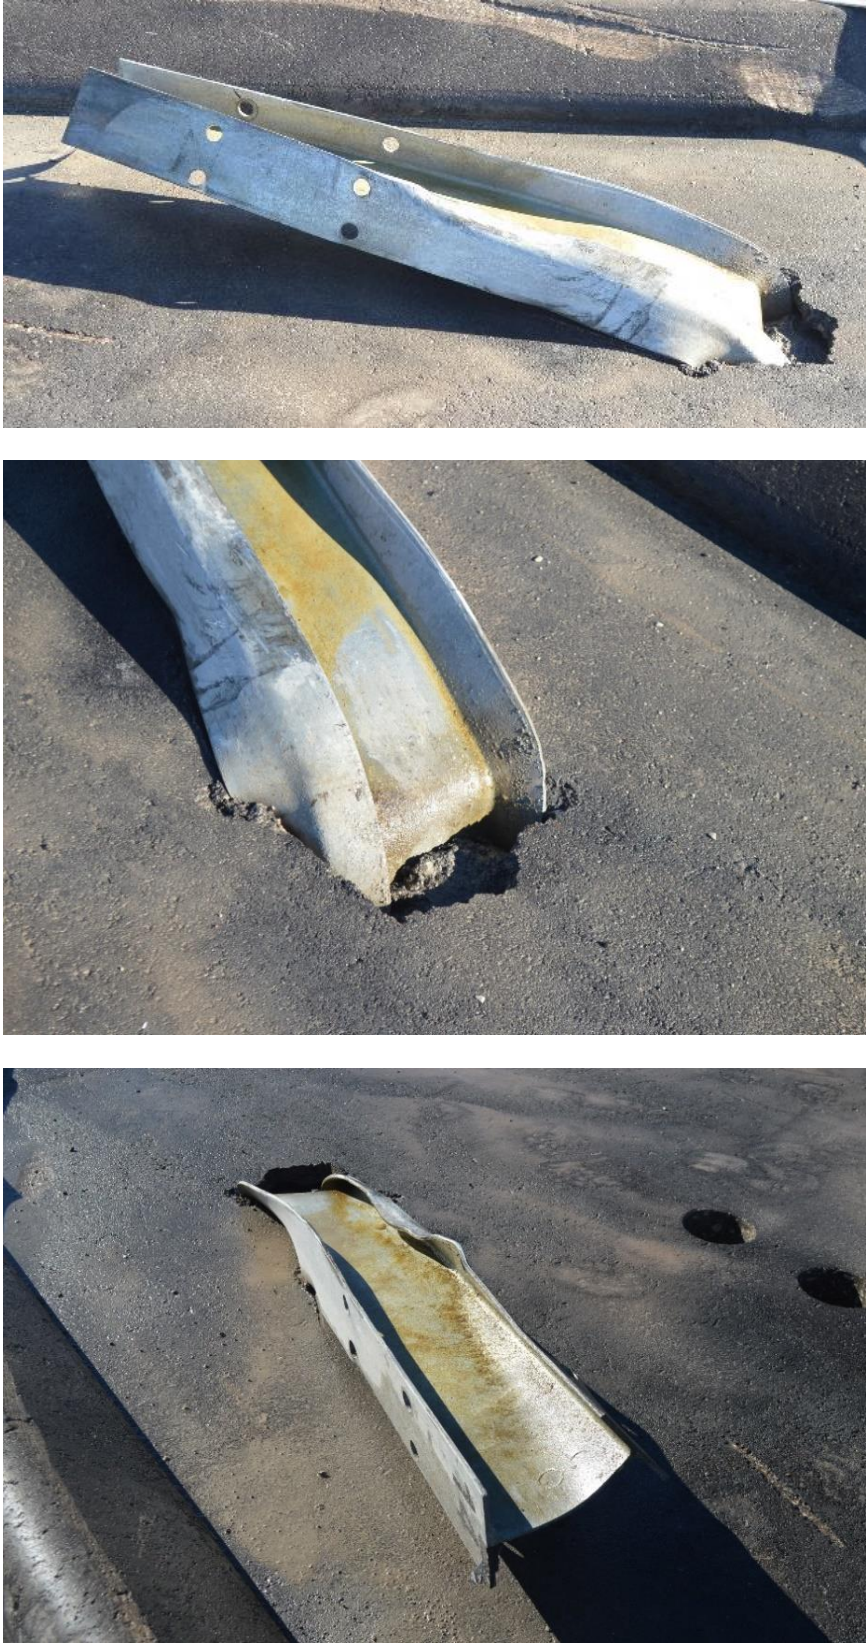
Figure 42. Post No. 14 Damage, Test No. GAA-1

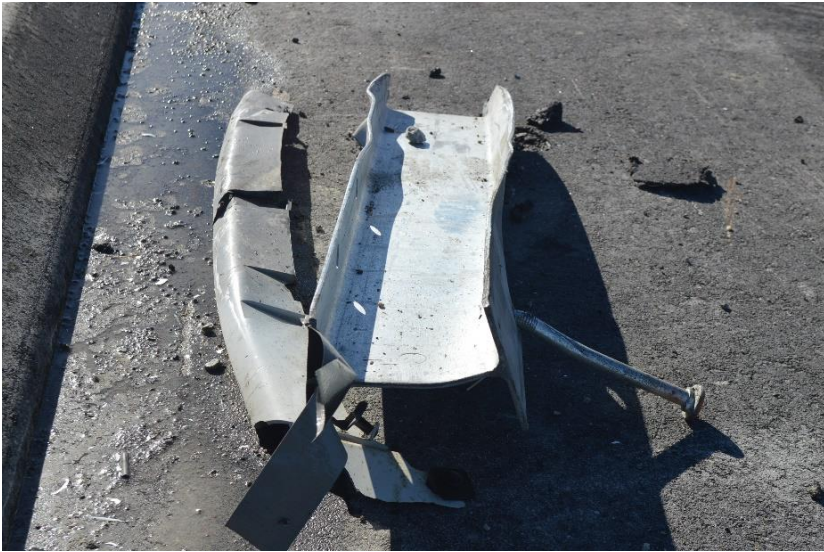
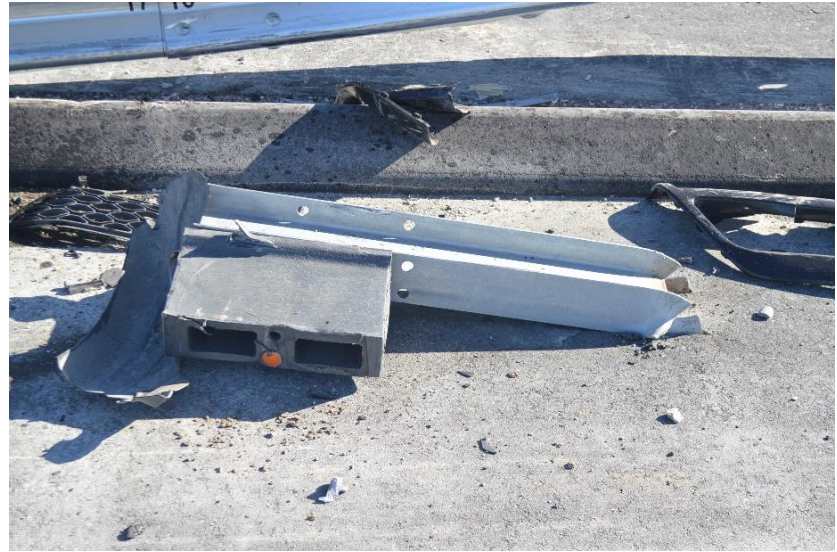
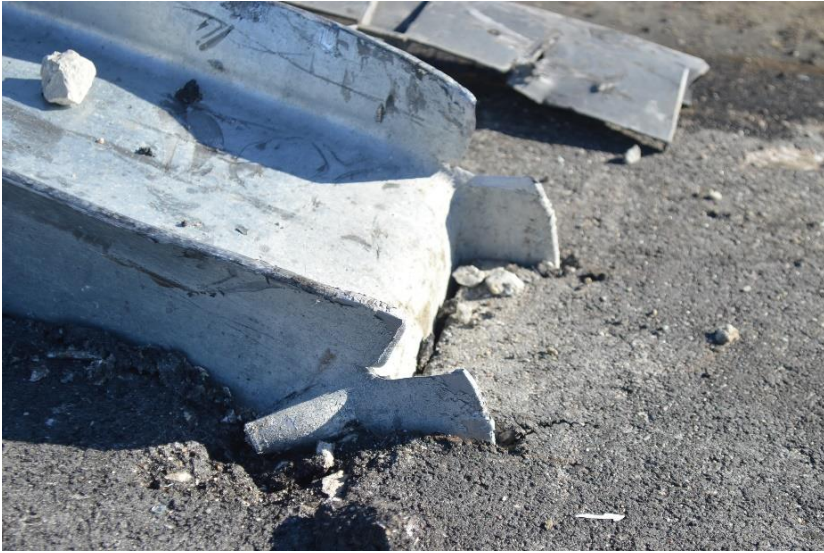
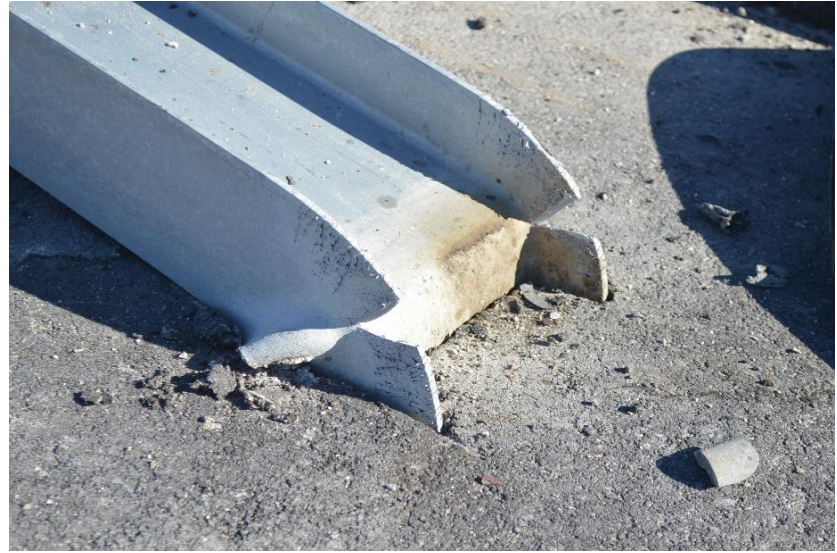
Figure 43. Damage to Post Nos. (a) 15 and (b) 16, Test No. GAA-1

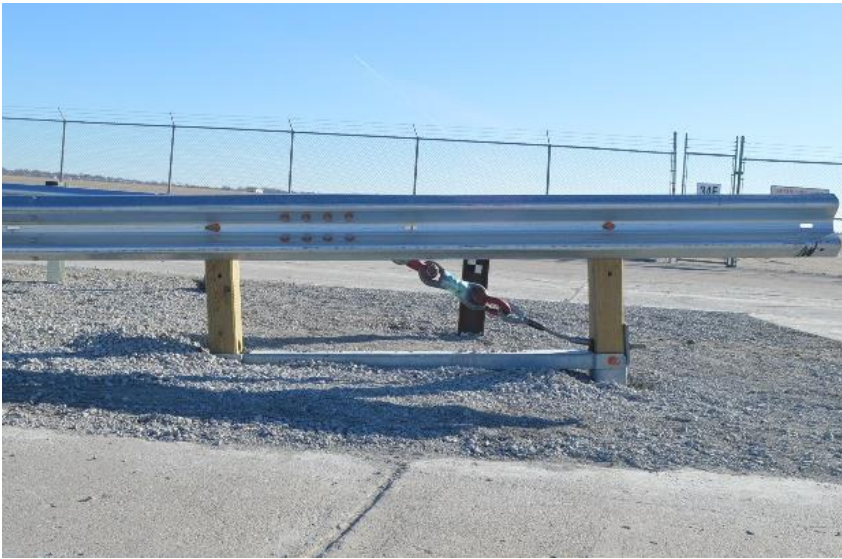
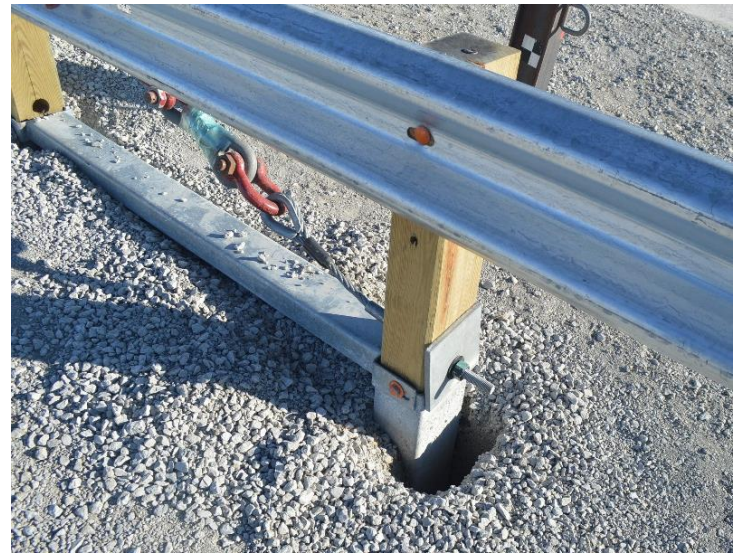
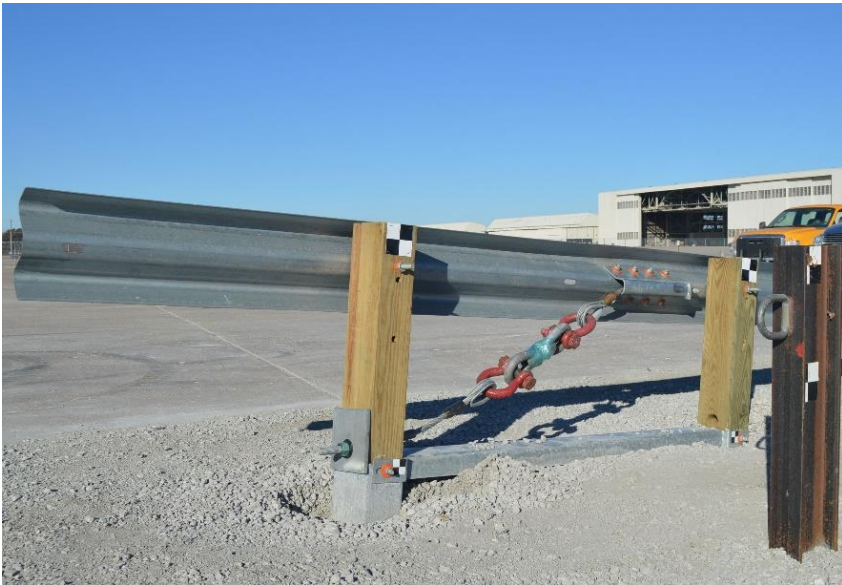
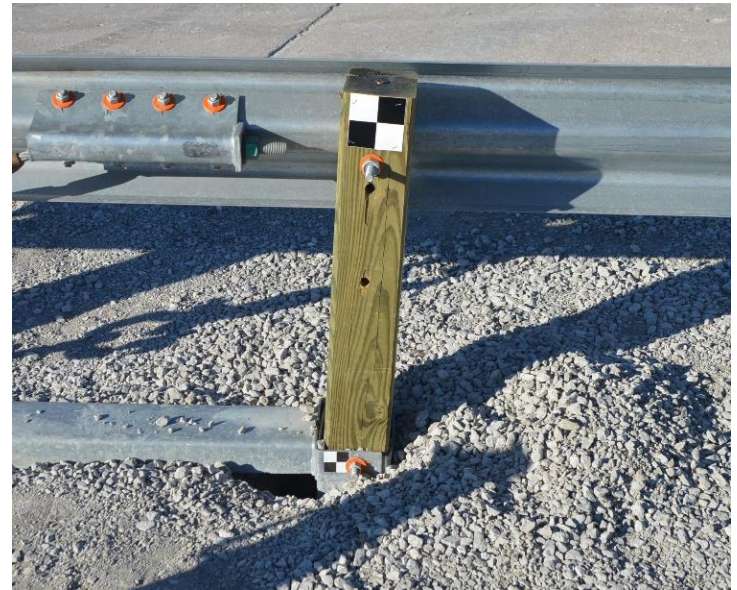
Figure 44. Upstream End Anchor Movement, Test No. GAA-1

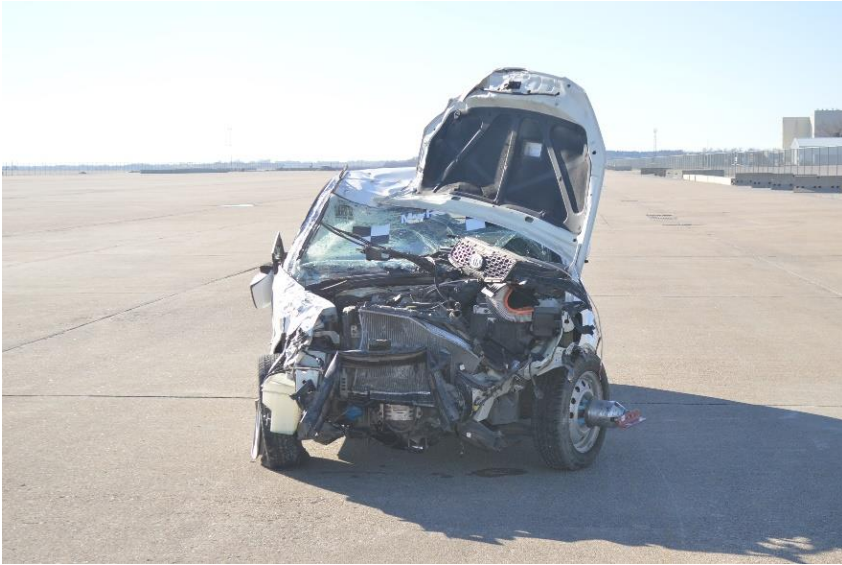
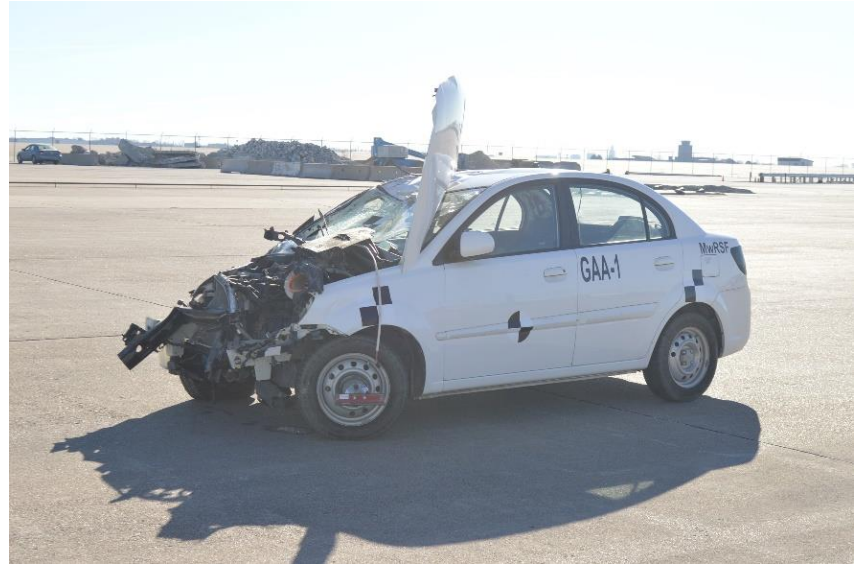
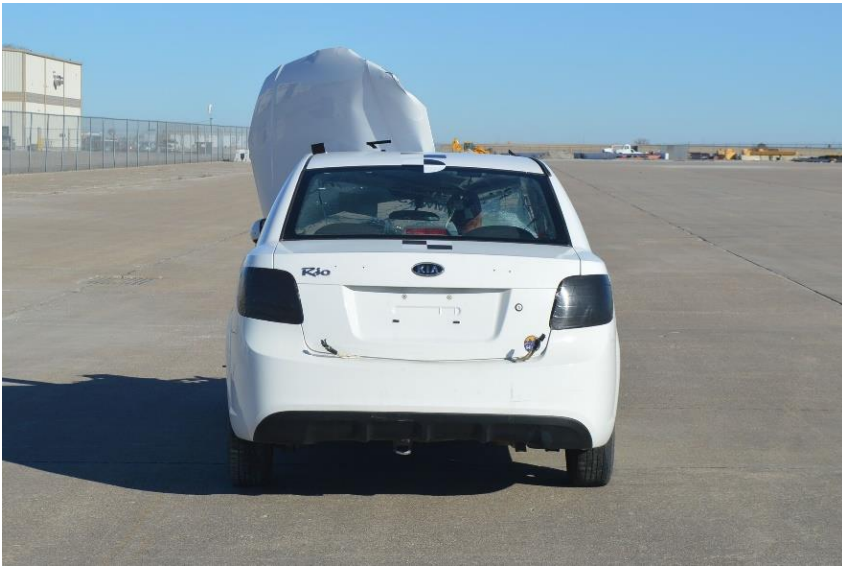
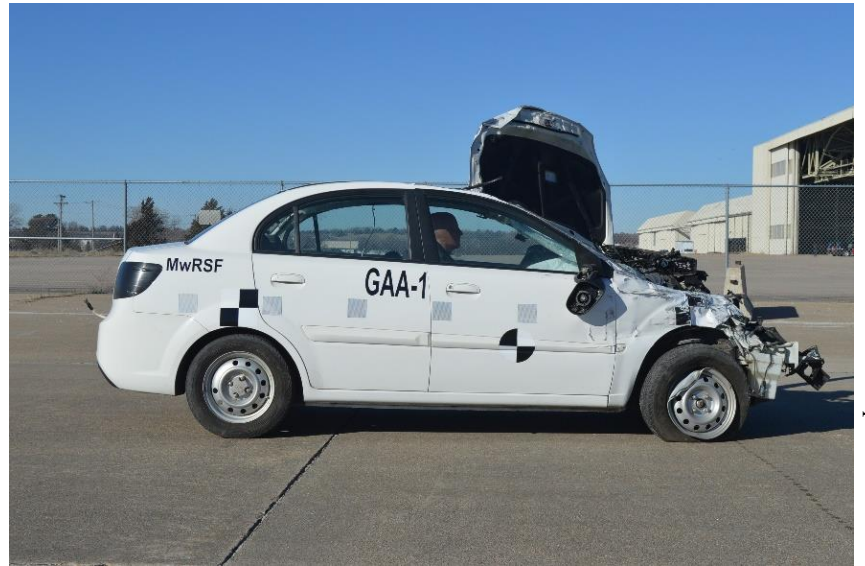
Figure 47. Vehicle Damage, Test No. GAA-1

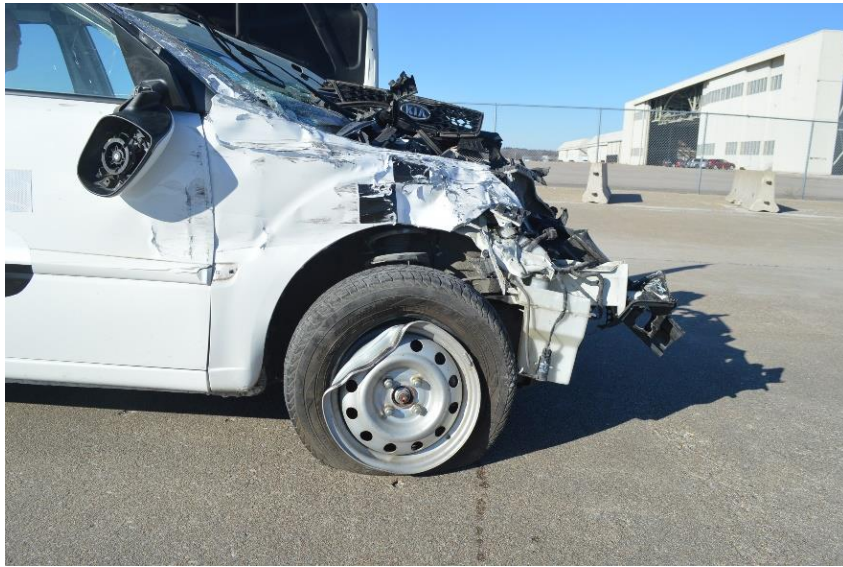
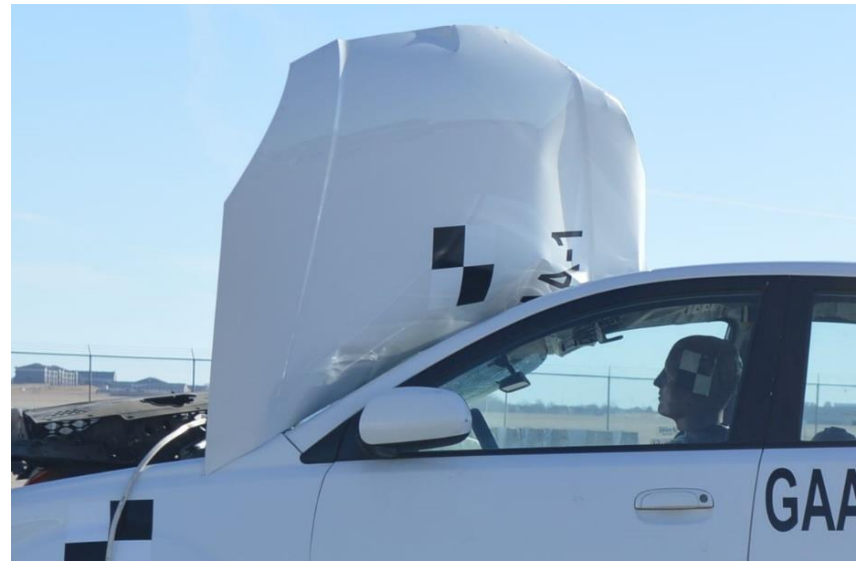
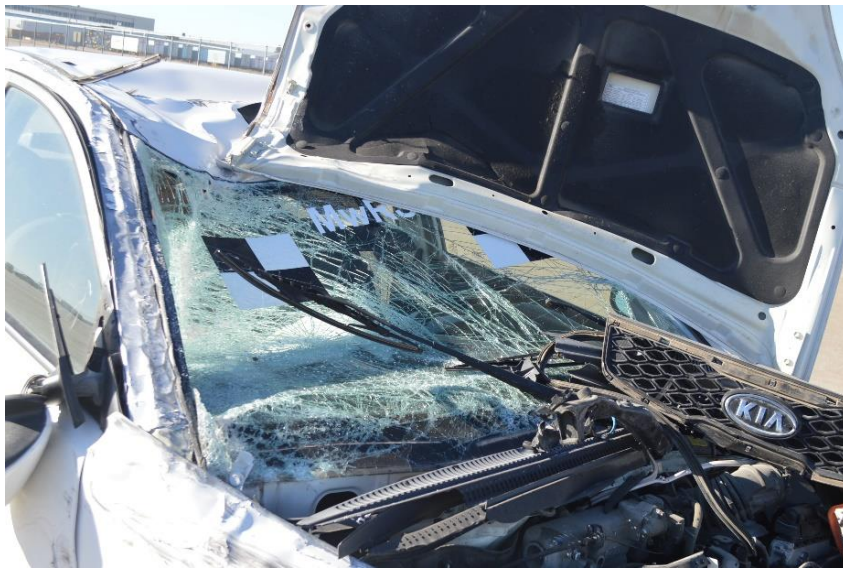
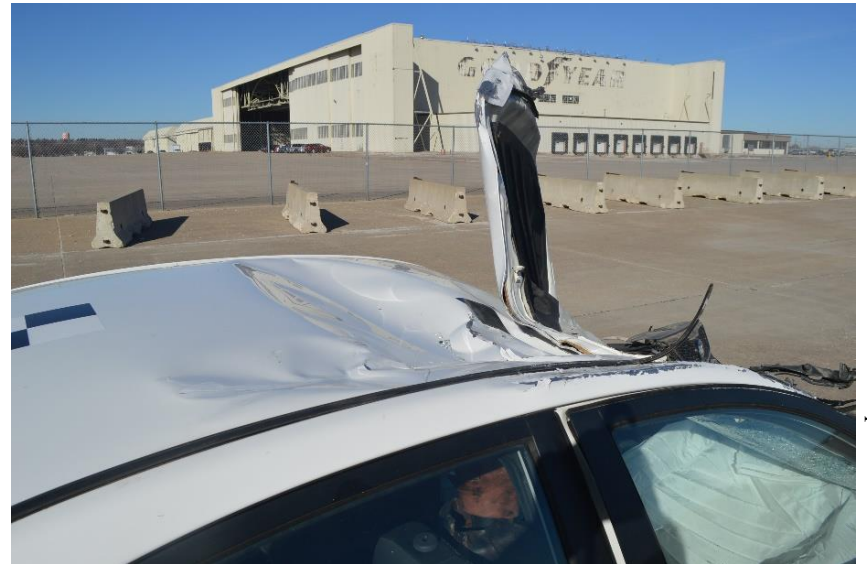
Figure 48. Vehicle Damage, Test No. GAA-1

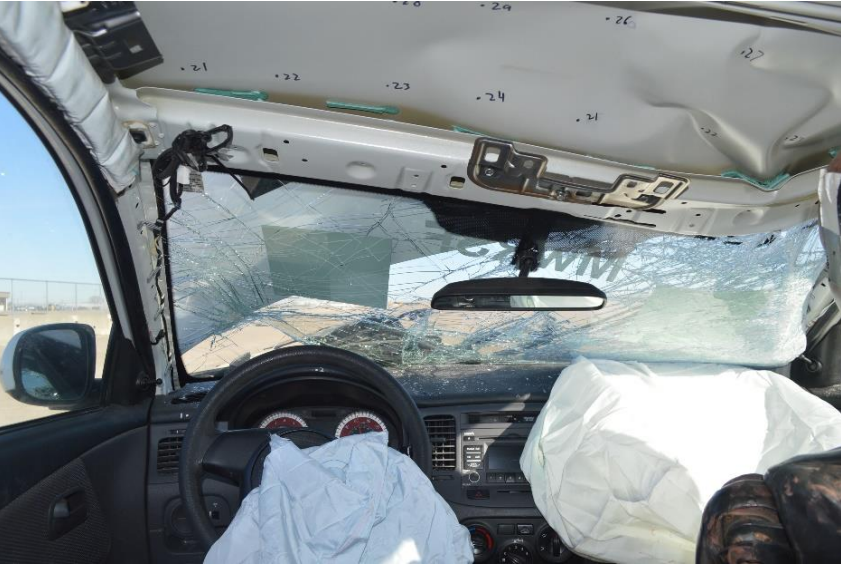
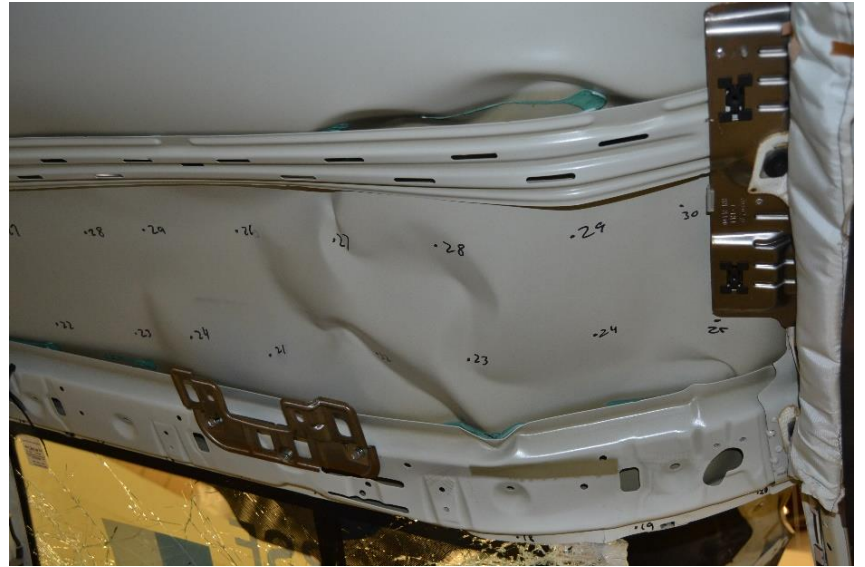
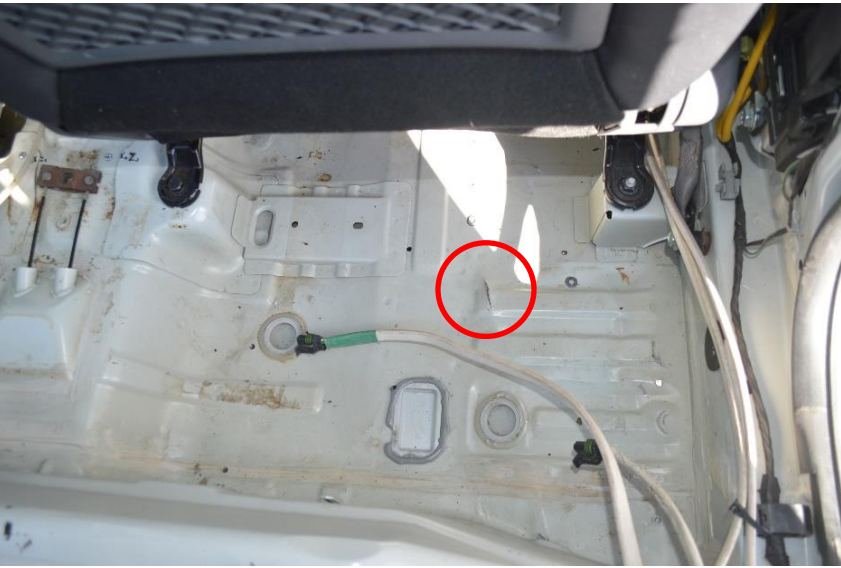
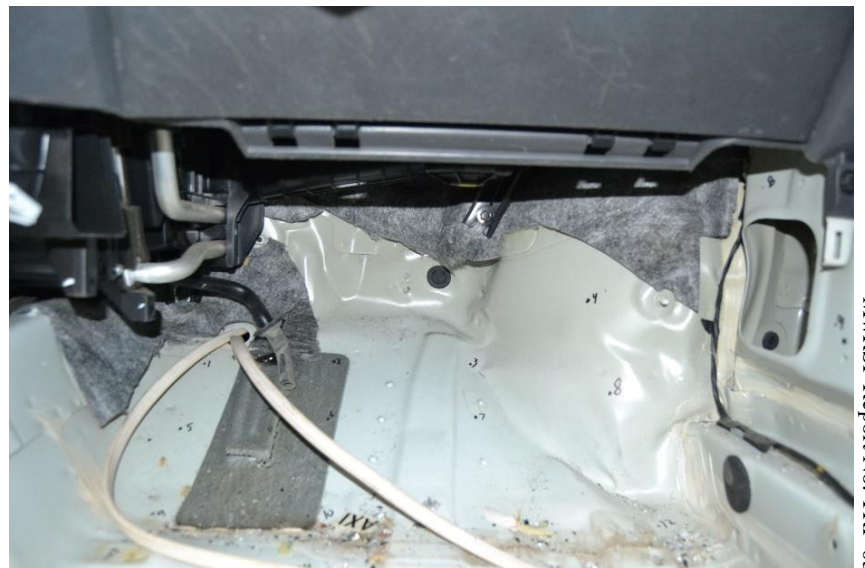
Figure 49. Occupant Compartment Deformation, Test No. GAA-1
