GEORGIA DOT RESEARCH PROJECT 16-26

FINAL REPORT

**CRASH TESTS ON GUARDRAIL SYSTEMS
EMBEDDED IN ASPHALT VEGETATION
BARRIERS IN ACCORDANCE WITH GDOT
DESIGN SPECIFICATIONS**

GDOT Research Project No. 16-26

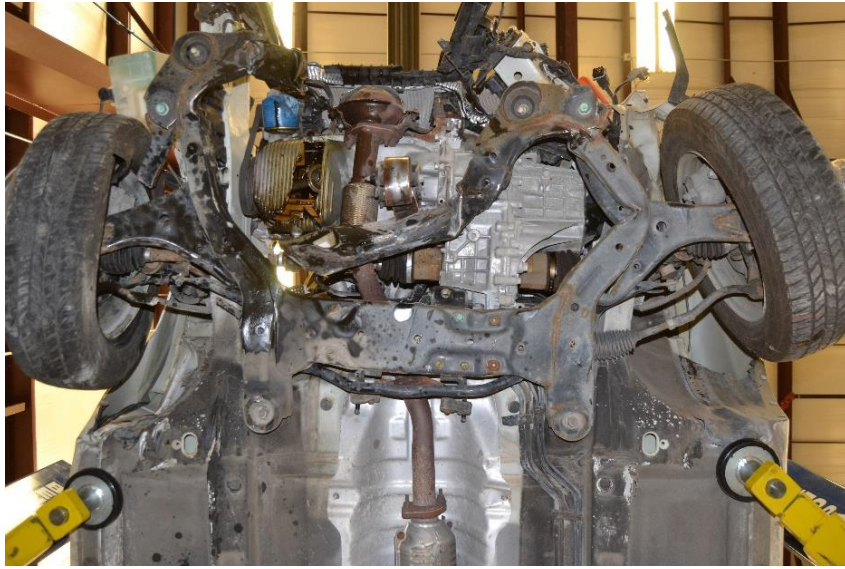
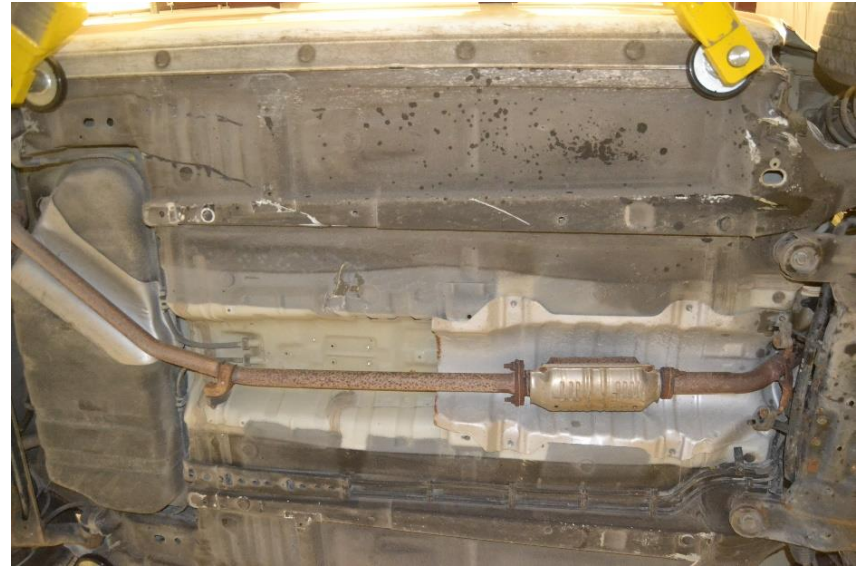
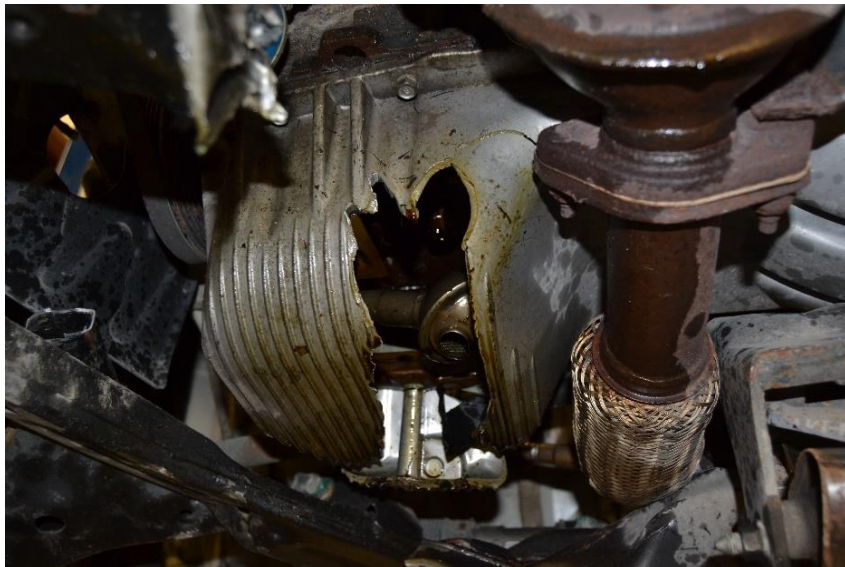
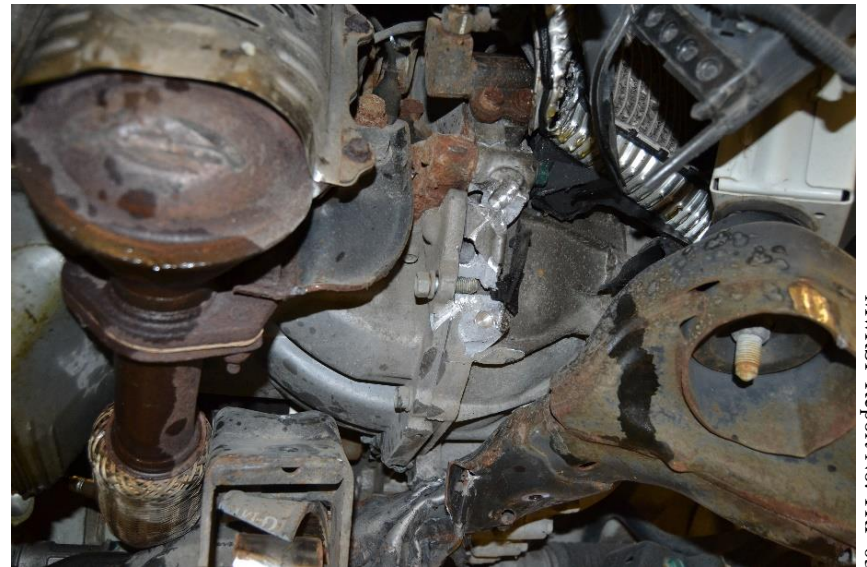
Figure 50. Vehicle Undercarriage Damage, Test No. GAA-1
