RESEARCH REPORT 1857-1

BRIDGES WITH PREMATURE CONCRETE
DETERIORATION: FIELD OBSERVATIONS
AND LARGE-SCALE TESTING

A. Boenig, L. Fúnez, R. E. Klingner, and T. J. Fowler

*STRUCTURAL ASSESSMENT OF IN-SERVICE BRIDGES
WITH PREMATURE CONCRETE DETERIORATION*

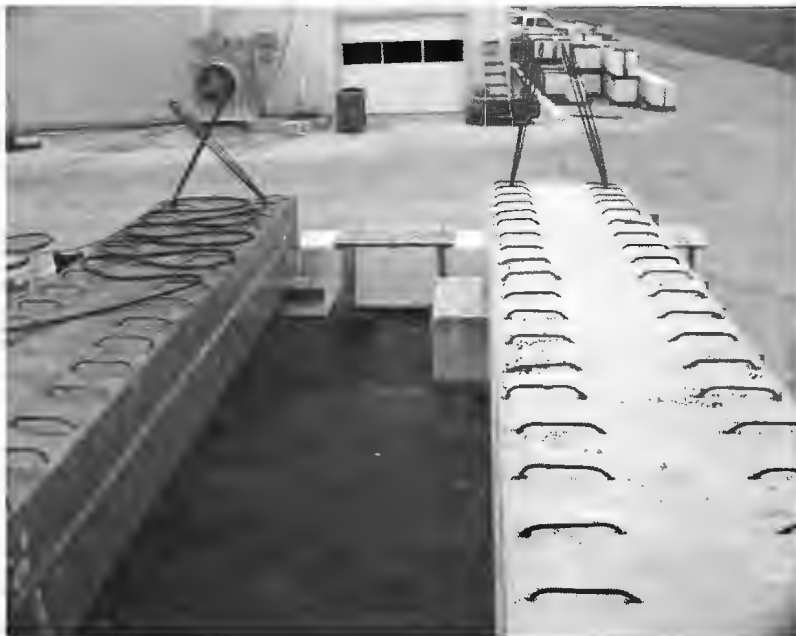
Figure 3.3 BG3 and BG4 (wetted) outside of FSEL

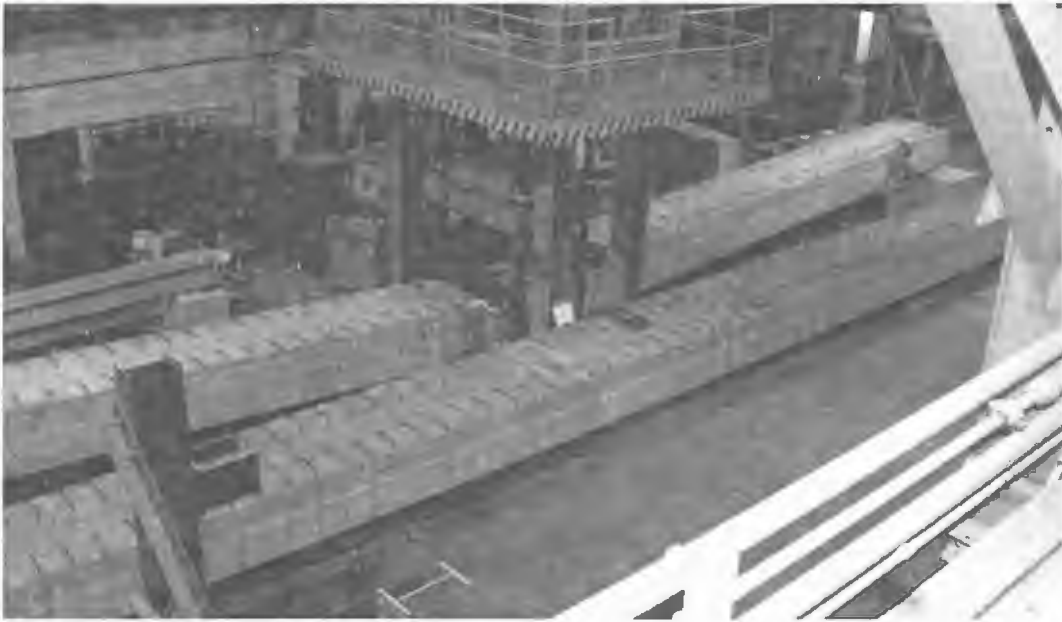
Figure 4.1 Failure of BG1F at 118.6 kips (527 kN)

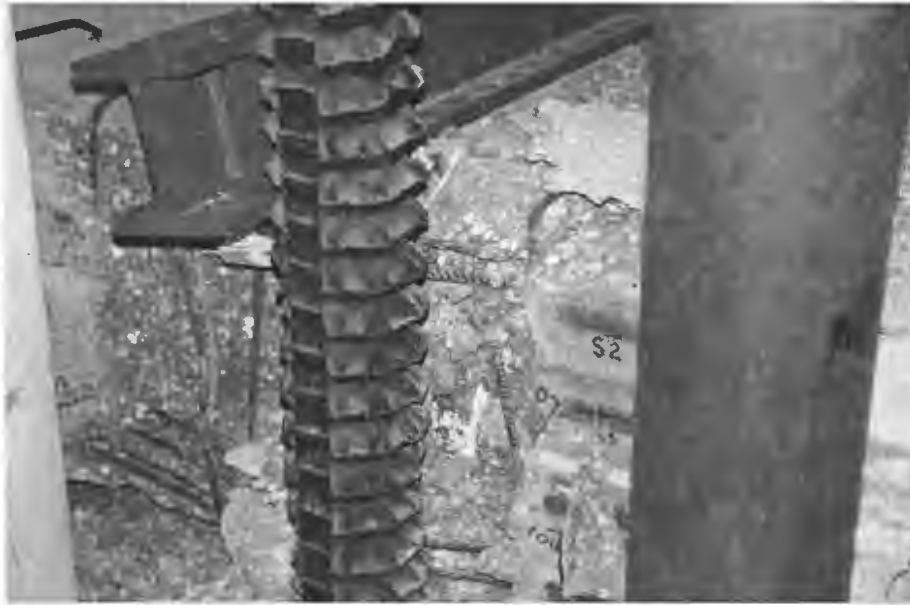
In Figure 4.4 are presented the strain gradients at a section of BG1F 1 ft (0.30 m) north of midspan, at increasing levels of applied load. The maximum compressive strain measured was $2582 \mu\epsilon$. A flexural crack propagated directly through Gages S3, S4, S5, S6, and S7 as seen in Figure 4.5.

Figure 4.5 Flexural crack through Gages S3 and S4

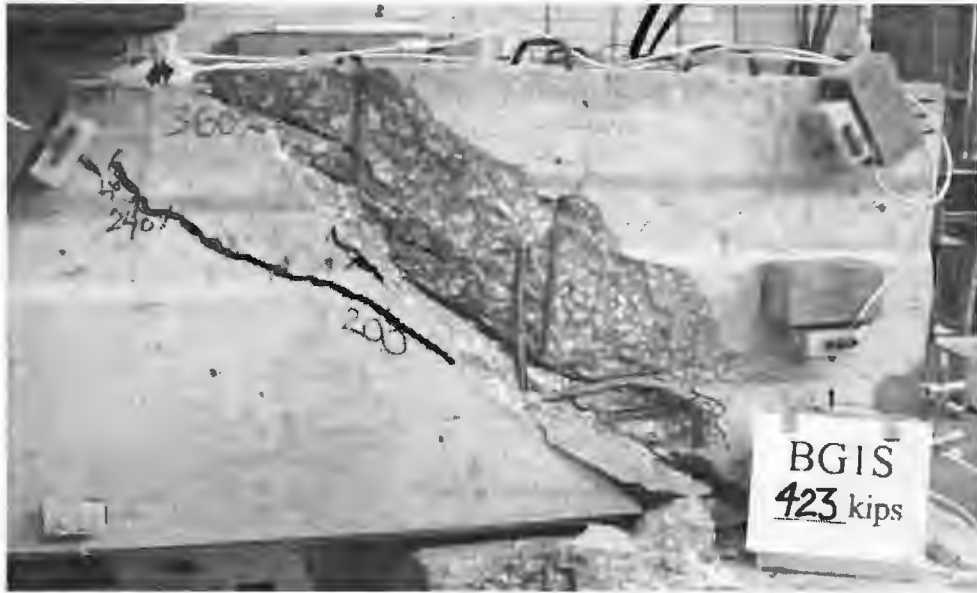
Figure 4.22 Failure of the east face of BG1S at 423 kips (1880 kN)

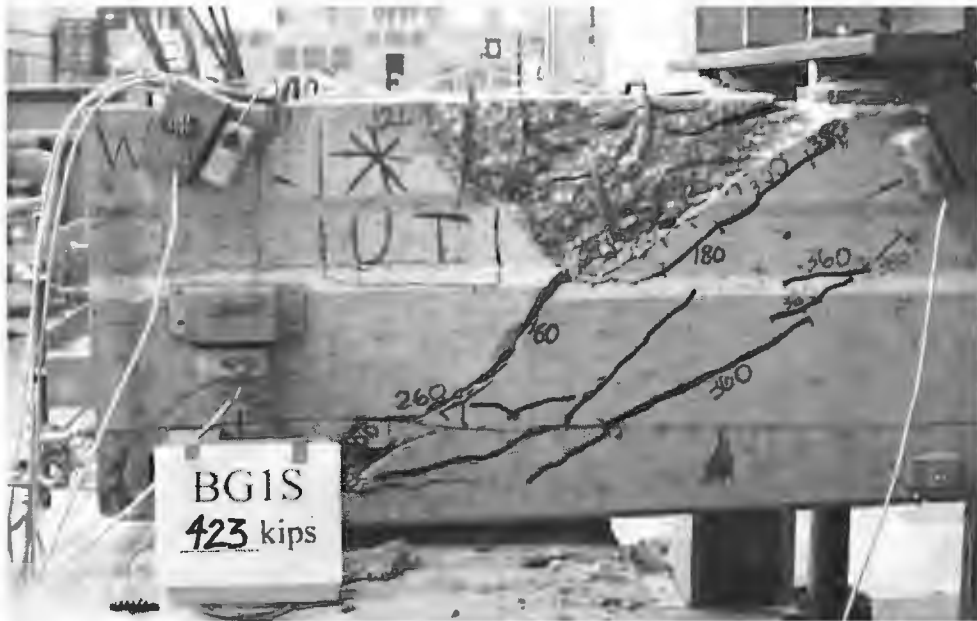
Figure 4.23 Failure of the west face of BG1S at 423 kips (1880 kN)

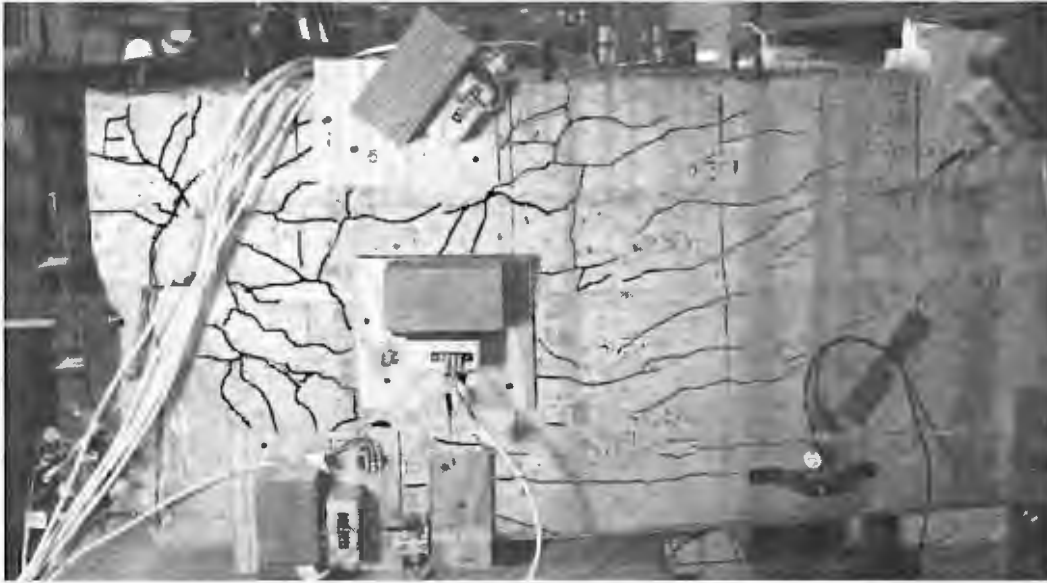
Figure 4.28 Pre-existing cracks on the east face of BG2S

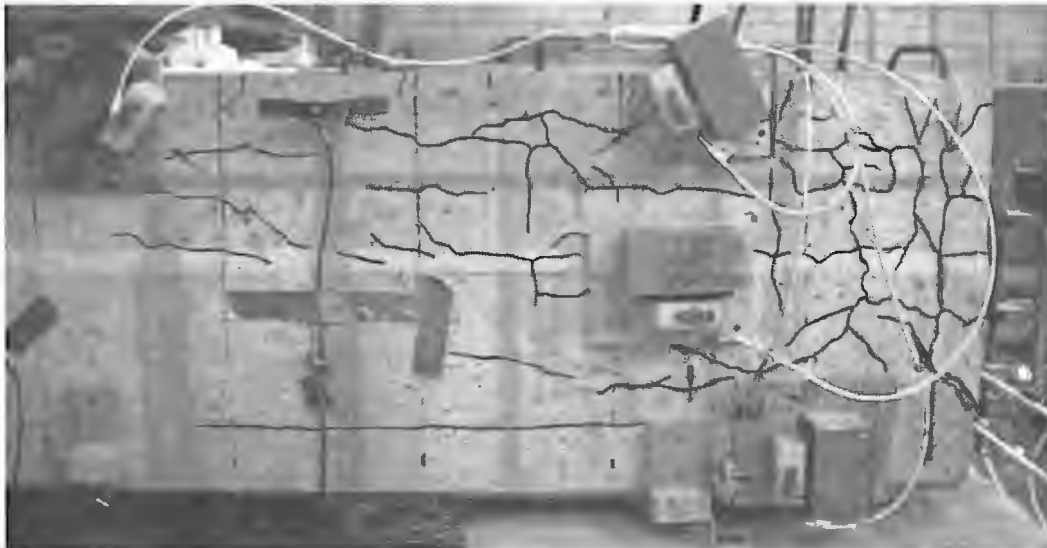
Figure 4.29 Pre-existing cracks on west face of BG2S

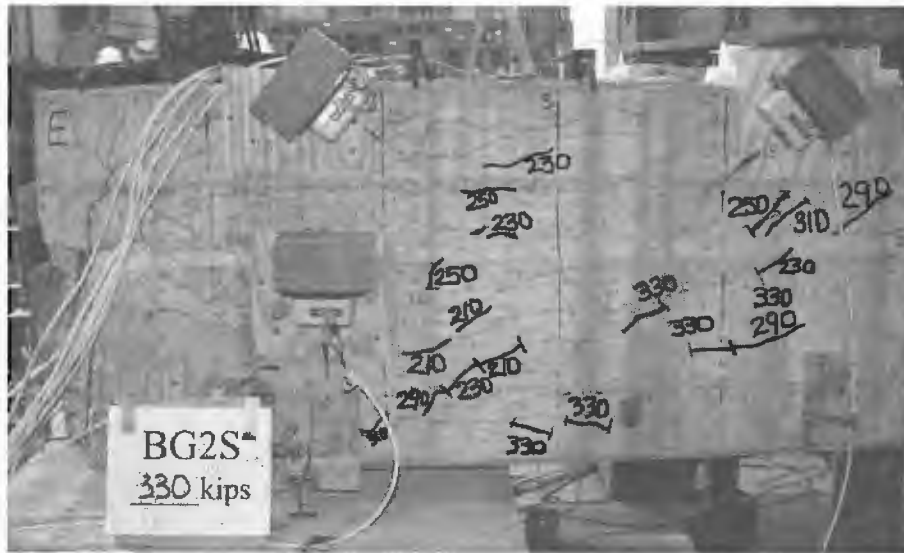
BG2S was tested on November 30, 1999. Shear cracks first appeared at 170 kips (756 kN) on the west side, and at 210 kips (934 kN) on the east side. Figures 4.30 and 4.31 show the development of cracks at 330 kips (1470 kN) on the east and west sides.

Figure 4.30 Shear-induced cracks on the east face of BG2S under a load of 330 kips (1470 kN)

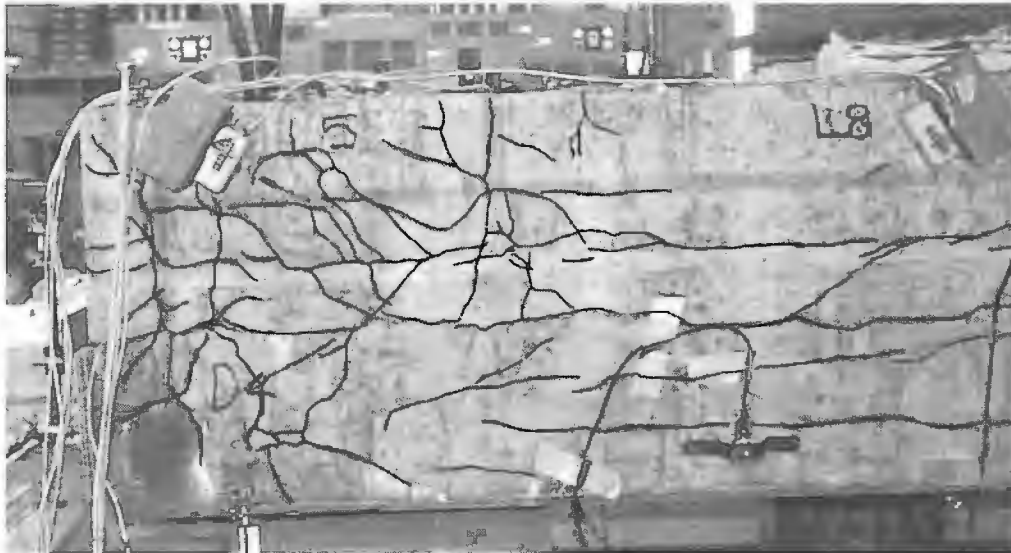
Figure 4.39 Pre-existing cracks on the east face of BG4S

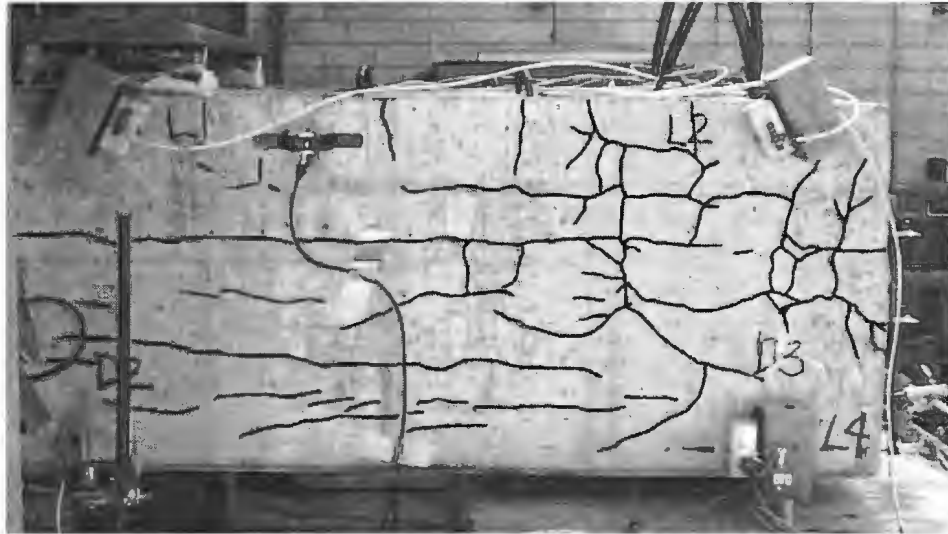
Figure 4.40 Pre-existing cracks on the west face of BG4S

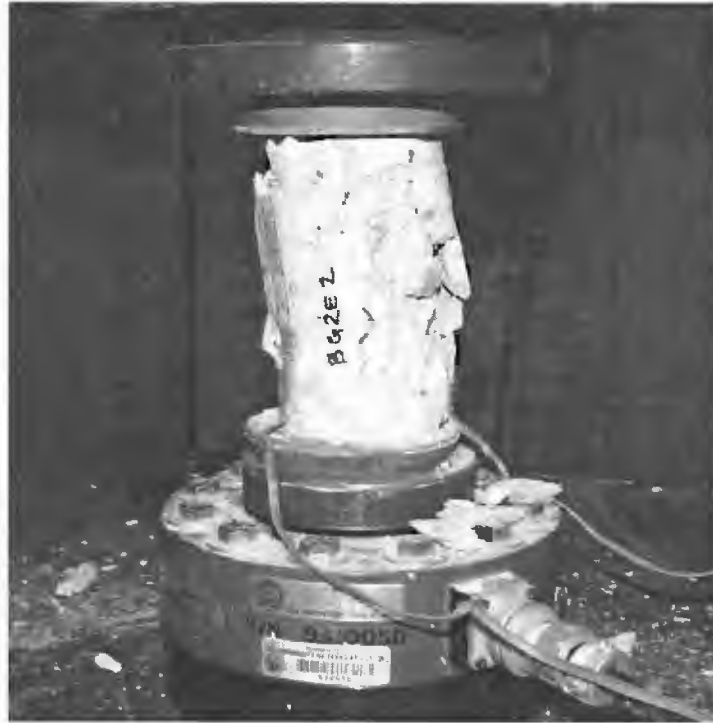
Figure 4.51 Failure of BG2E-2, typical of more-damaged cores

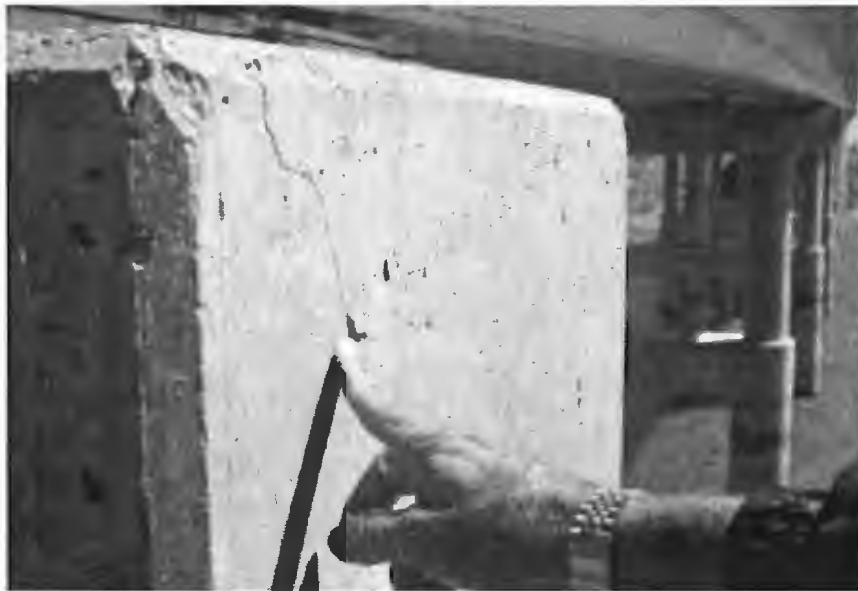
Figure 7.28 Map cracking at ends of bent cap (Bent 5)
